OXFORD STATION (REWLEY ABBEY)

Archaeological Field Evaluation

March - April 1994

OXFORD ARCHAEOLOGICAL UNIT

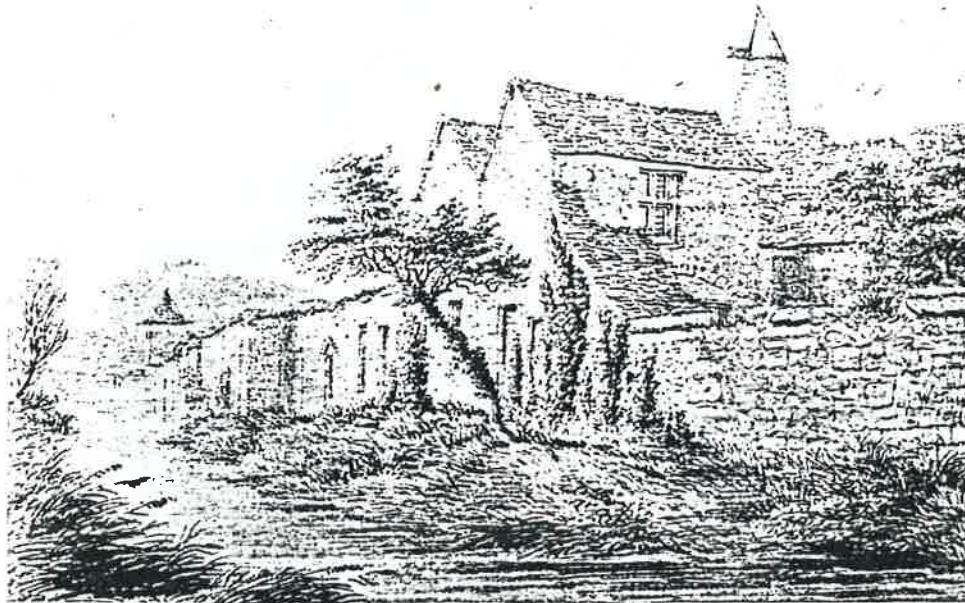
Figure 18B: North range and north-west corner, seen from beyond the moat. Drawing by W. Turner, 1851

The approximate position of an assumed reredorter extending over the north moat from the north precinct wall was known from both historic maps (Figs 13, 14) and views of the Abbey. Some of the views (e.g. Figs 18B, 19B, and particularly 20) show that the position of the springers for the reredorter's supporting arch were situated just east of a kink in the north precinct wall, and a doorway through the same wall. The trench for this area, Trench 16, was accordingly shaped like a crucifix (Fig.4), being designed to pick up the kink in the north wall, and then extend northwards across the moat to investigate the reredorter itself. As Figure 4 shows, this strategy was entirely successful.

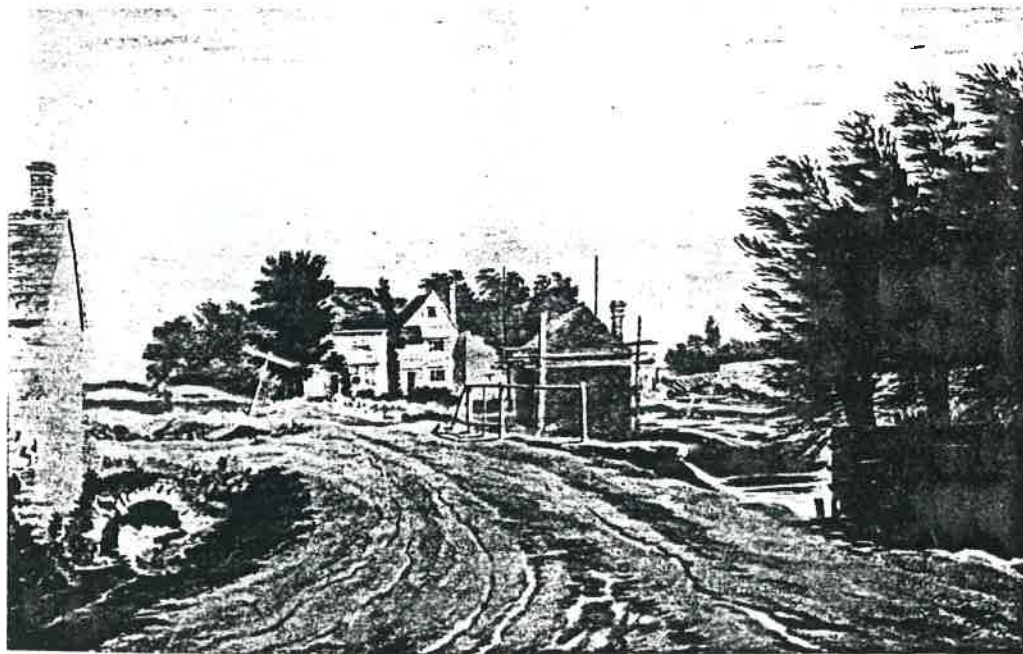
Figure 19B: View north along Rewley Road in 1851, painted by W. Turner
