# St Bartholomew's Church Lower Basildon Berkshire

## Archaeological Watching Brief Report

**Oxford Archaeology**

**Document Type:** Watching Brief

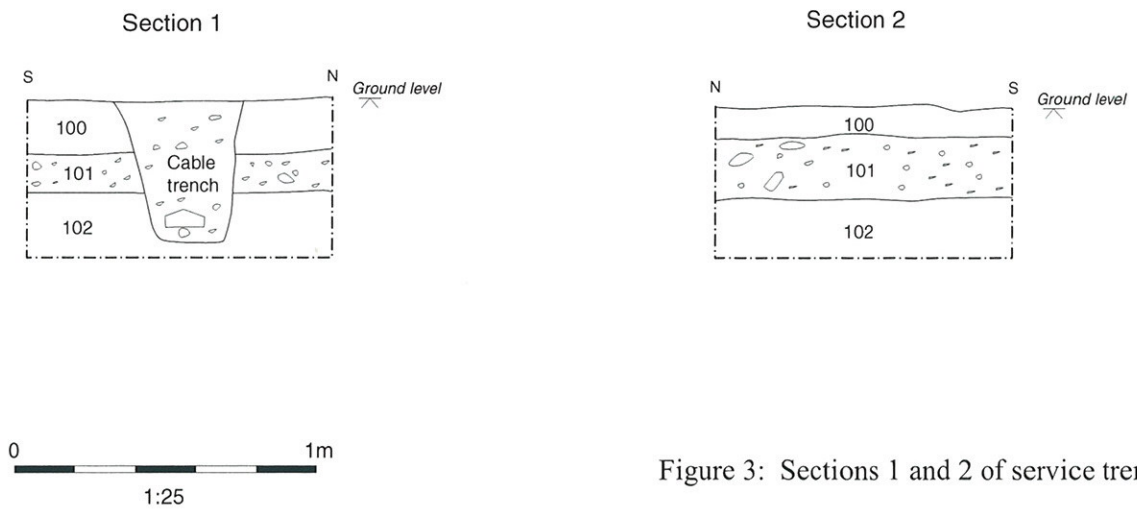
Figure 3: Sections 1 and 2 of service trench

- 3.1.1 A total of four deposits were exposed during the excavation of the trench. The present day topsoil and turf was a friable greyish brown loamy silt (100), which was between 0.1 m to 0.2 m in depth. This sealed a very compacted layer of clay silt (101) mixed with fragments of CBM, mortar and flint gravels, gradually increasing in depth from 0.1 m to 0.2 m as it neared the tower. The underlying deposit (101) was a friable yellowish brown clay silt (102), representing alluvium from the nearby River Thames. At the base of the west tower a compacted mortar spread (103) was observed under layer (101), identified as the construction debris from the construction of the tower.

4.1.2 The ground level to the west and south of the tower show evidence of having been raised and landscaped using redeposited topsoil, which would also have sealed the construction debris associated with the building of the west tower. The fact that this construction layer lies directly on top of undisturbed alluvium could suggest that the ground was stripped prior to construction. This action would have removed any surviving archaeological remains above the alluvium, before being re-instated after construction of the west tower (in 1734). However the apparent lack of any residual remains of human bones within this area may equally suggest that no burials, whether sanctified or not, were placed in this area of the churchyard.
