A34/M4 Junction 13
Improvement Scheme
Chieveley
West Berkshire
Trial Pitting Survey, Phase 1

Archaeological Evaluation

**M4 Junction 13
Chieveley
West Berkshire
Trial Pitting Survey
Phase 1**

ARCHAEOLOGICAL EVALUATION

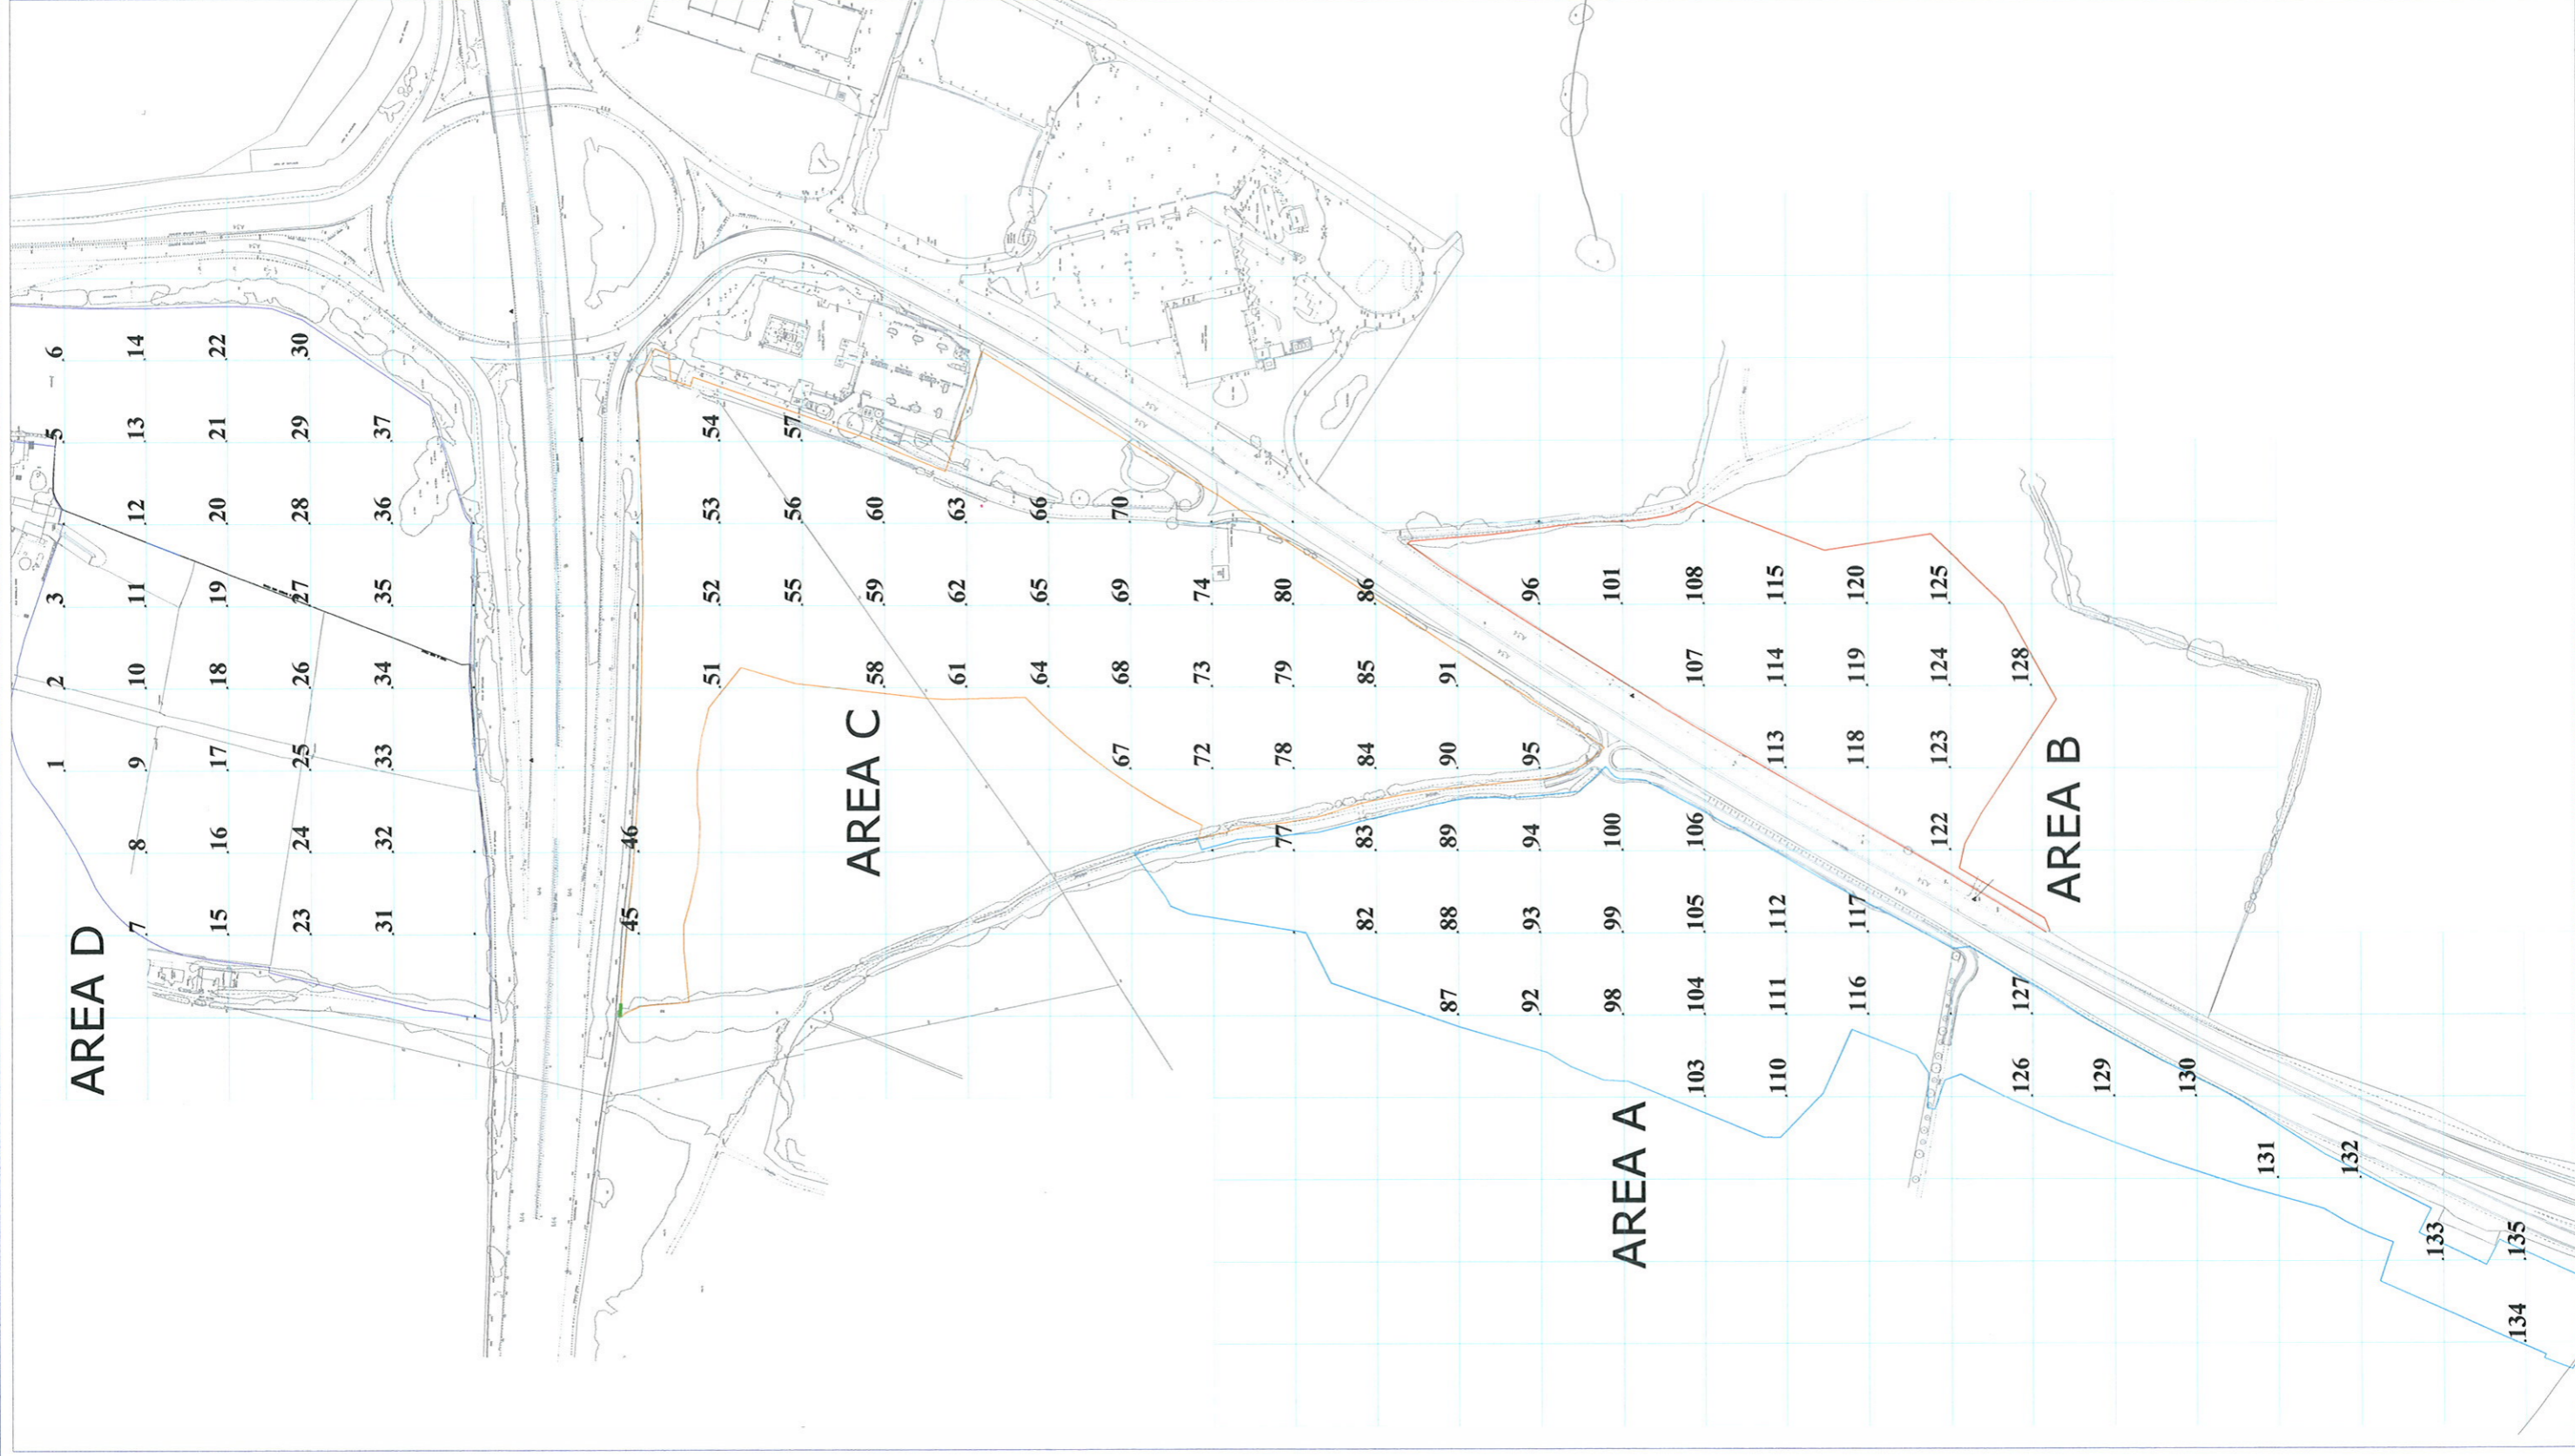
Figure 2

Site Grid with Excavated Test Pits

- 1.1.1 In June 2002 OA carried out a field evaluation on land adjoining the M4 Junction 13 on behalf of the Highways Agency in advance of a Road Improvement Scheme at Junction 13 (Fig. 1). The works were carried out in respect to a strategy document issued by Gifford and Partners outlining the methodology of the evaluation 'A34/M4 Junction 13 Improvement Scheme: Strategy Document For Archaeological Investigation' (Gifford Report B4303A.R03B). The development site is situated at c. 113 m OD and comprises a strip of land 400 m wide and 800 m long south of the M4 and a strip of land the same size to the north of the M4 both areas lie on the west side of the A34. A smaller strip of land measuring 200 m wide and 300 m long was also investigated on the east side of the A34 (Fig. 2).

- 3.1.1 The evaluation comprised the excavation of 114 1 m x 1 m test pits. To ensure that the area was evenly evaluated the test pits were distributed on a 50 m site grid and located with an electronic Total Station. The grid used was the same as that utilised by Stratascan for the magnetometer survey (Fig. 2).

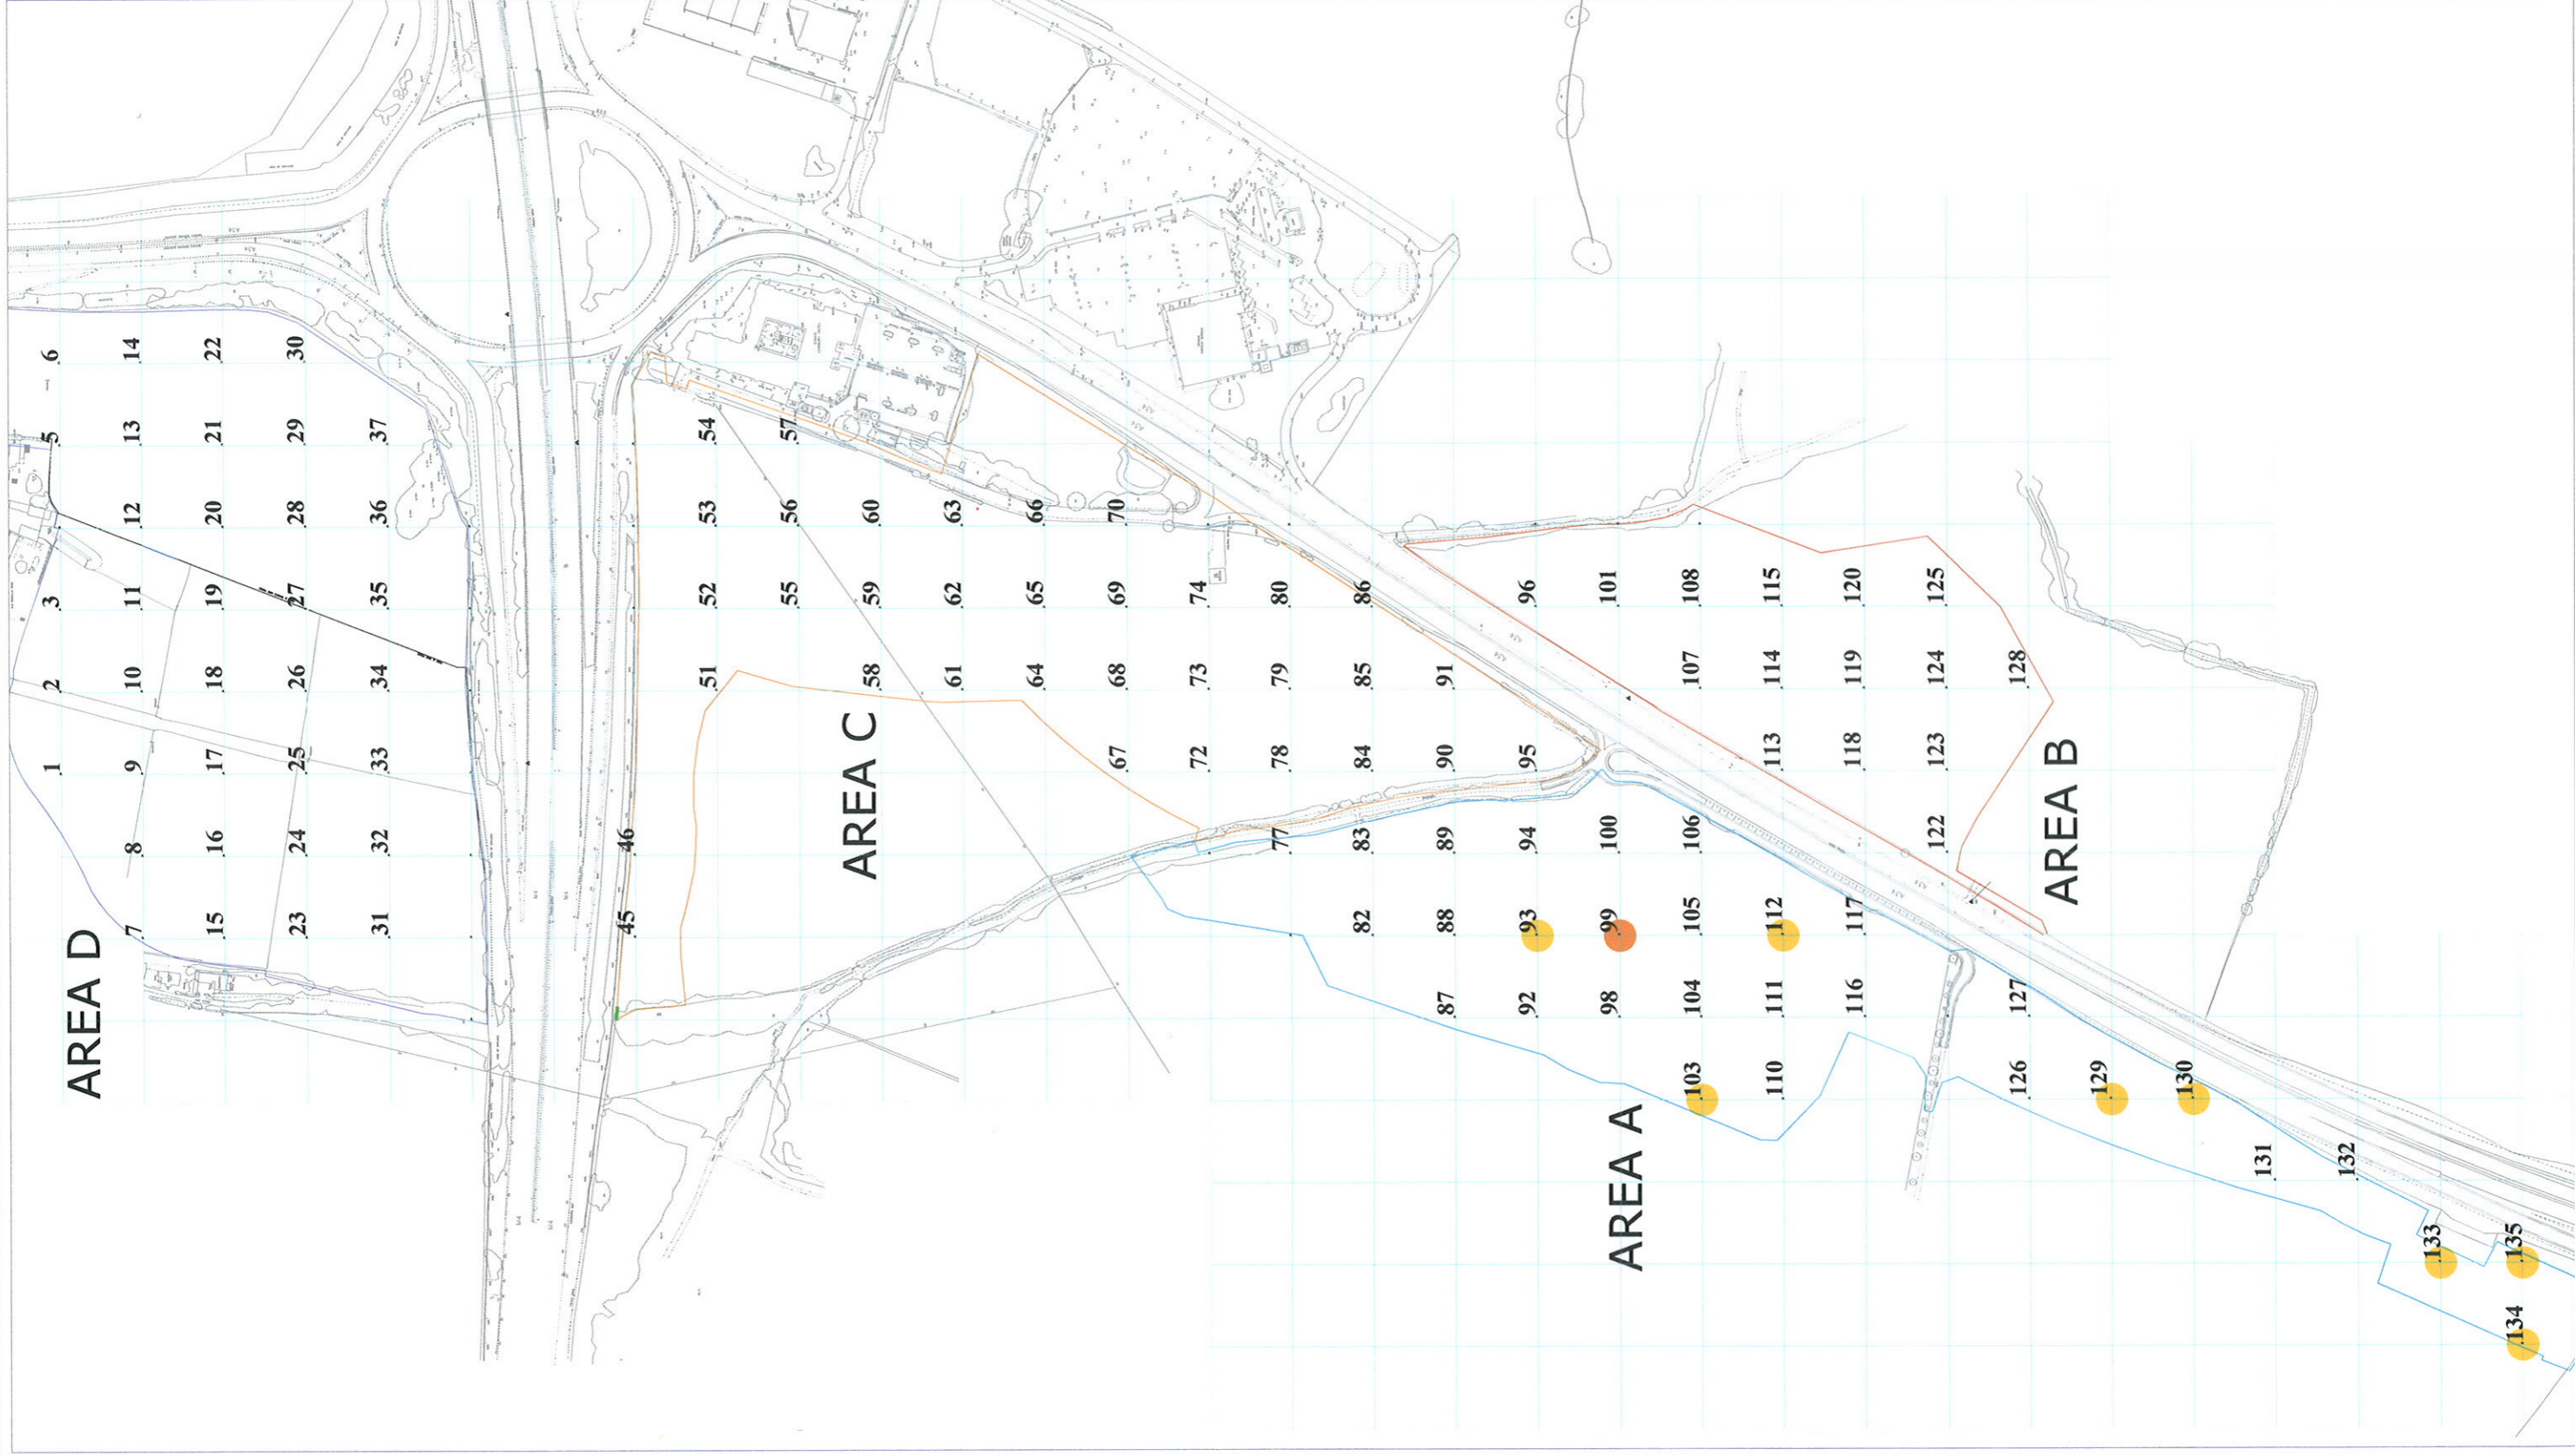
Figure 4

Site Grid with Excavated Test Pits and Plotted Distribution of Pottery

- 1-5 sherds per m³
- 6-10 sherds per m³
- 11-15 sherds per m³

distribution of the recovered flint and pottery assemblages from Areas A,B,C and D are shown in Figures 3 and 4. Little regarding interpretation of their distribution can be inferred given the general poor quality and mixed nature of the material recovered, the contexts it was recovered from and the general bias in sampling strategy for Area A.

Pottery by Paul Blinkhorn (Fig. 4)
