# St John the Baptist Church Burford Oxfordshire

## Archaeological Watching Brief Report

**Client Name: Burford Parochial  
Church Council**

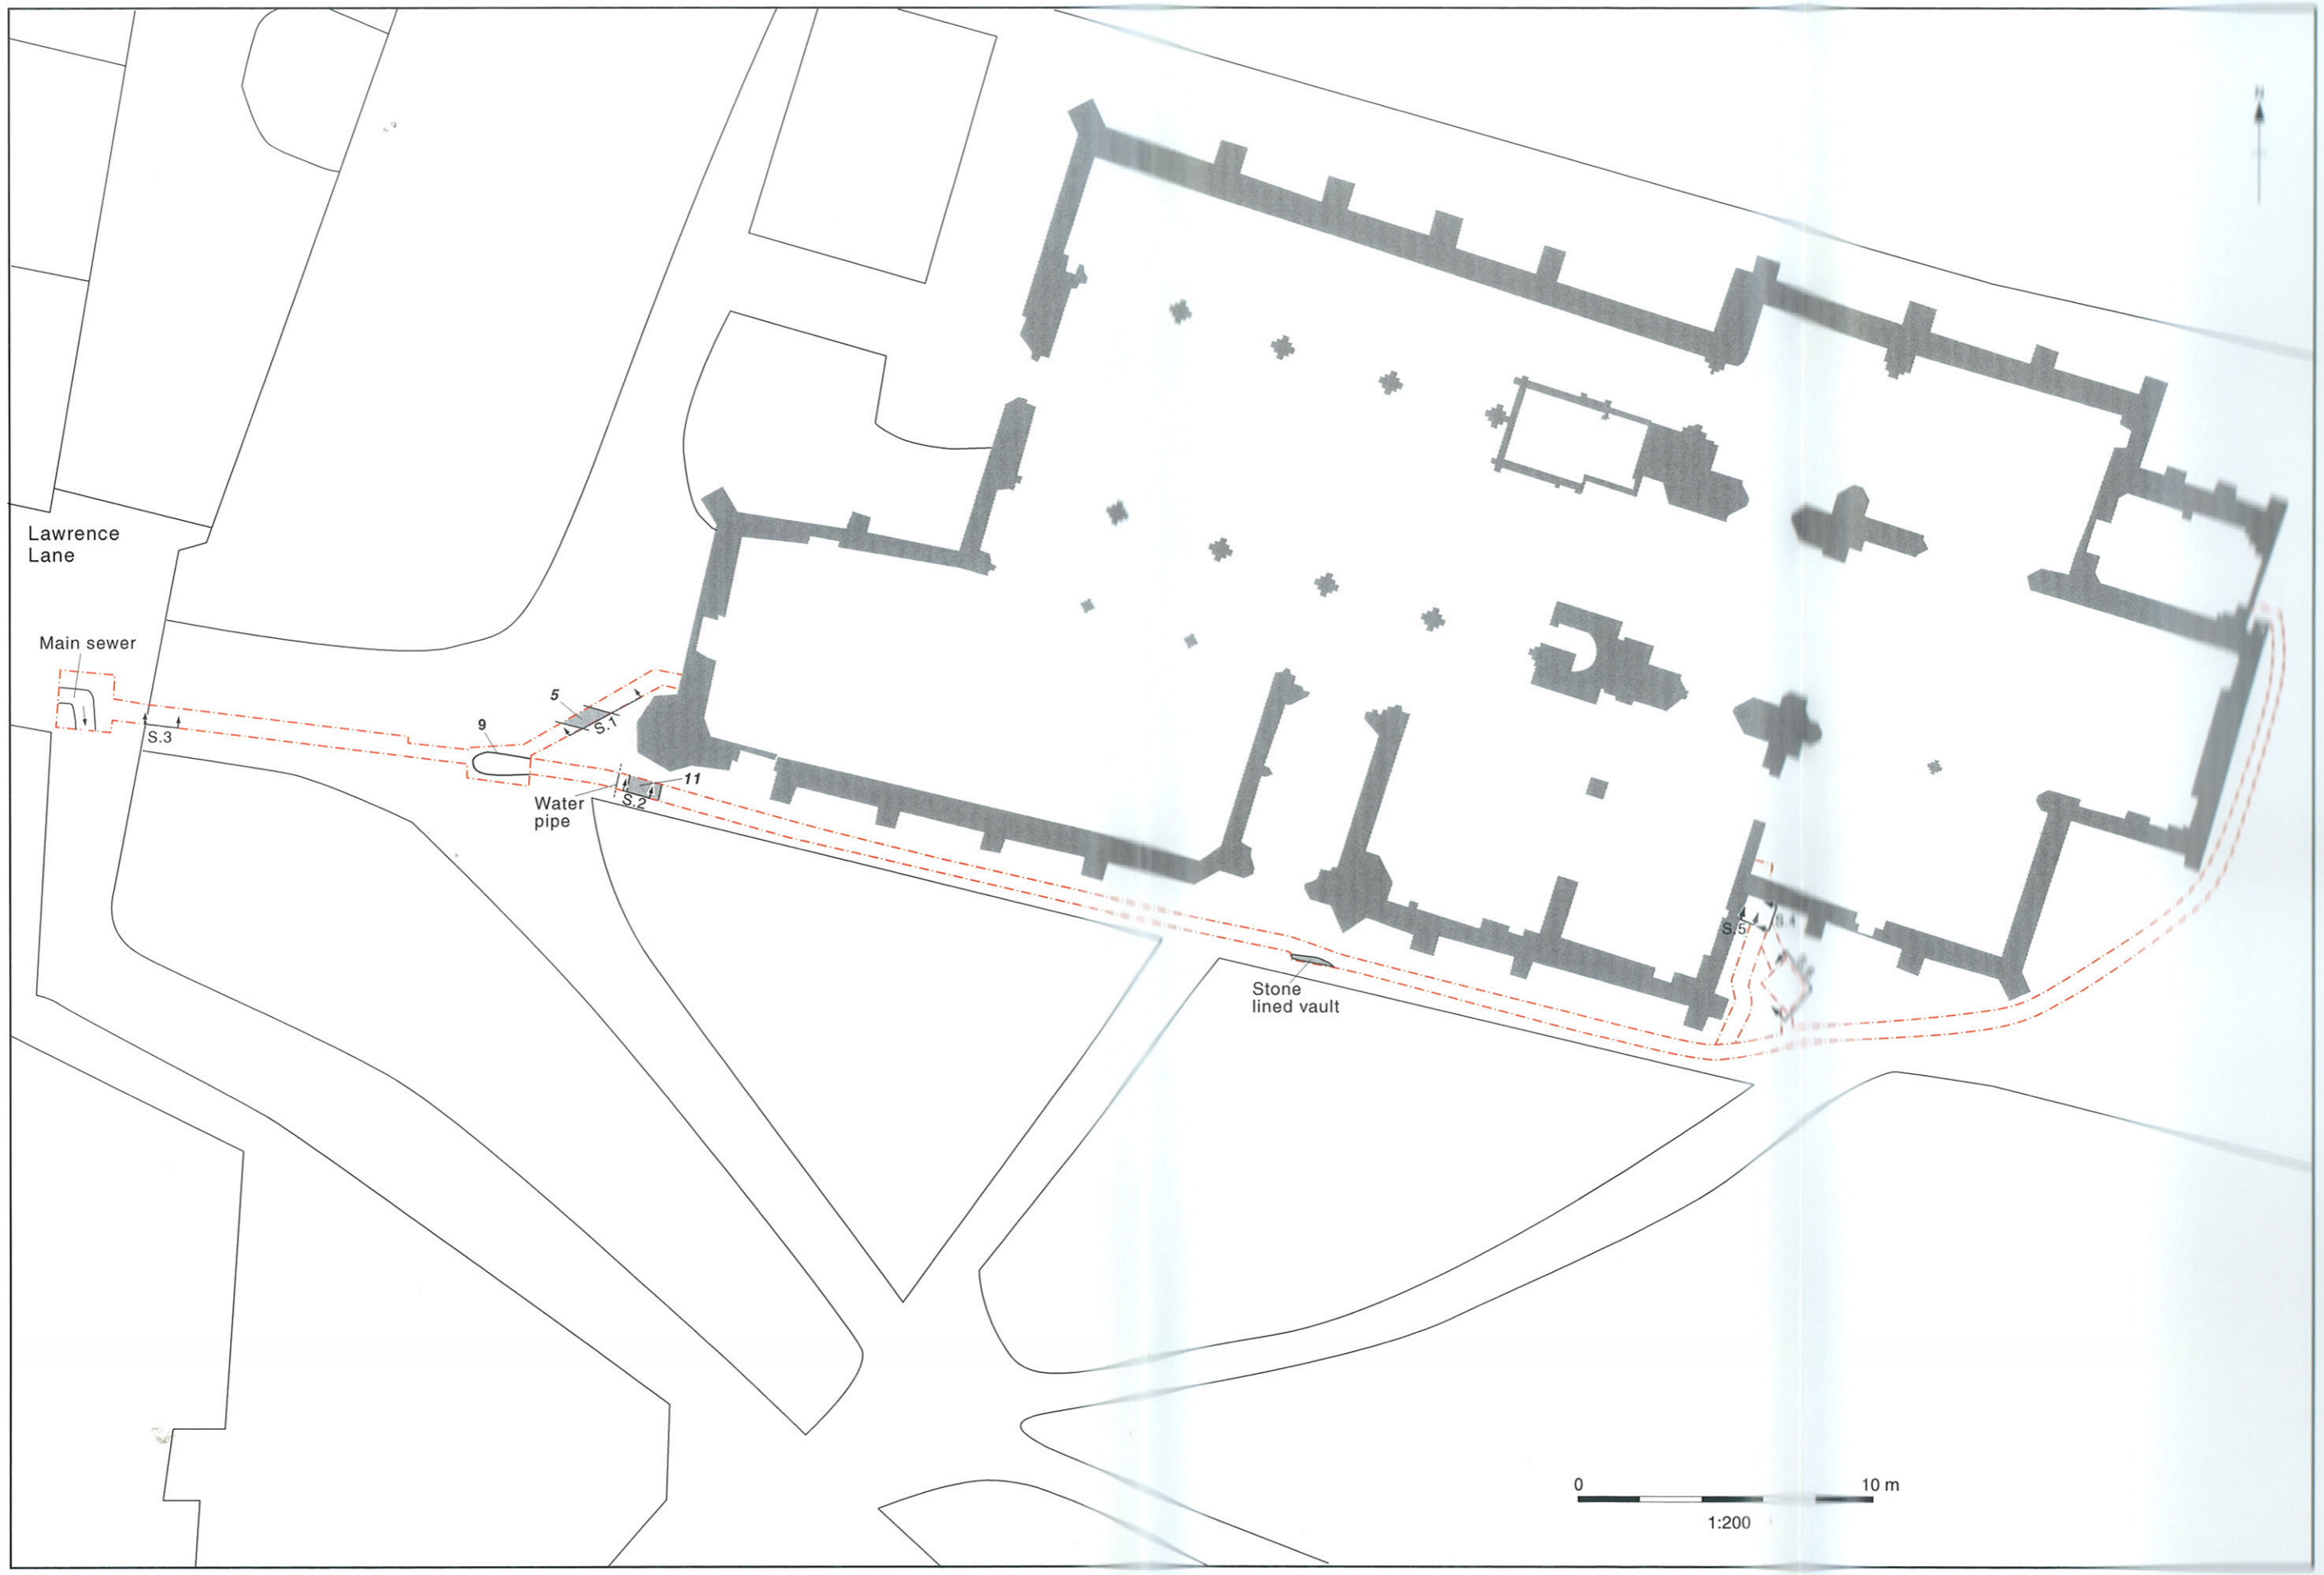
Figure 2: Site plan of trench and section locations

- 3.1.1 A service trench was excavated from the west end of the church and along its south side to the east end. The natural subsoil was yellowish brown gravel. This was overlain by a thick layer of light reddish brown silty sand loam (3), the cultivate graveyard soil. This had been cut by a number of features. The foundation for the south wall of the Guild Chapel prior to it being shortened in 1475 was exposed (Guide to Burford Church). It was constructed in a trench (4) with vertical sides and a base below impact level that was not exposed. It contained the base of the wall (5) constructed of rough limestone blocks laid in six courses and bonded with a yellowish brown silty clay and measured 0.8 m x 1 m x 0.65 m. There was a fill of material of dark brown silty sand (6) between the wall and the trench (Figs 2 and 4, Section 1).

- 3.1.3 Just to the east of the south door the top of a limestone-built vault was uncovered, but was not disturbed as the trench was moved to the north to avoid it. It was sealed by 0.30 m of graveyard topsoil (35) (Fig. 2).

- 3.1.5 This work was located in the south-east corner of the church where the south chancel chapel meets the east wall of the south aisle of the church. The work consisted of the excavation of a small hole in the inside of the church. This measured 0.4 m x 0.5 m x 0.46 m and cut through a 0.05 m thick stone floor slab into a 0.16 m thick layer of sand and hardcore floor make up. Sealed below this was disturbed dark brown silty sand similar to context 3. A hole was then knocked through the south wall of the Chancel Chapel (Fig. 2).
