The Former Site of the Nuffield Press Hollow Way, Cowley, Oxfordshire

December 2005

The Former site of the Nuffield Press, Hollow Way, Cowley

Historic Building Recording and Investigation

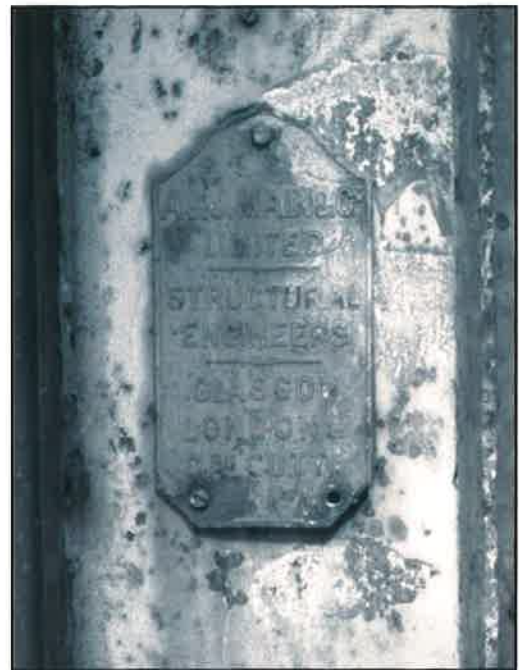
Plate 54: Maker's plate on a steel girder, inscription reads "A & J MAIN & Co LIMITED, STRUCTURAL ENGINEERS, GLASGOW LONDON CALCUTTA"

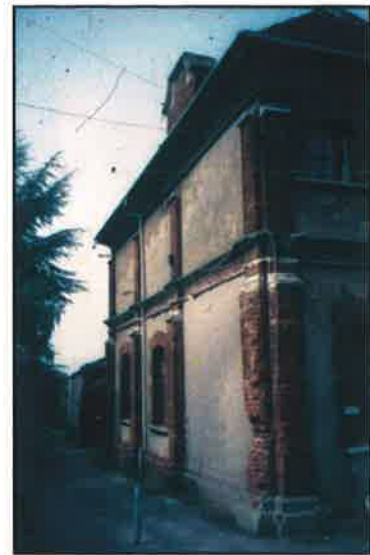
Plate 4: South Elevation showing the damage to brick work and the south chimney (from the south-east)

- 3.1.3 The cornice had weathered quite badly in exposed areas but was well preserved under the later extension (plate 3 b&w 4/26a). Likewise, plate 4 shows damage to the brickwork, which appears to have been most extensive on the south-east corner of the
