Unit Superheaters Engineering Swansea

Archaeological Evaluation and Watching Brief Report

February 2009

**Client: Waterman
on behalf of DFWJ Ltd
and Unit Holdings Ltd**

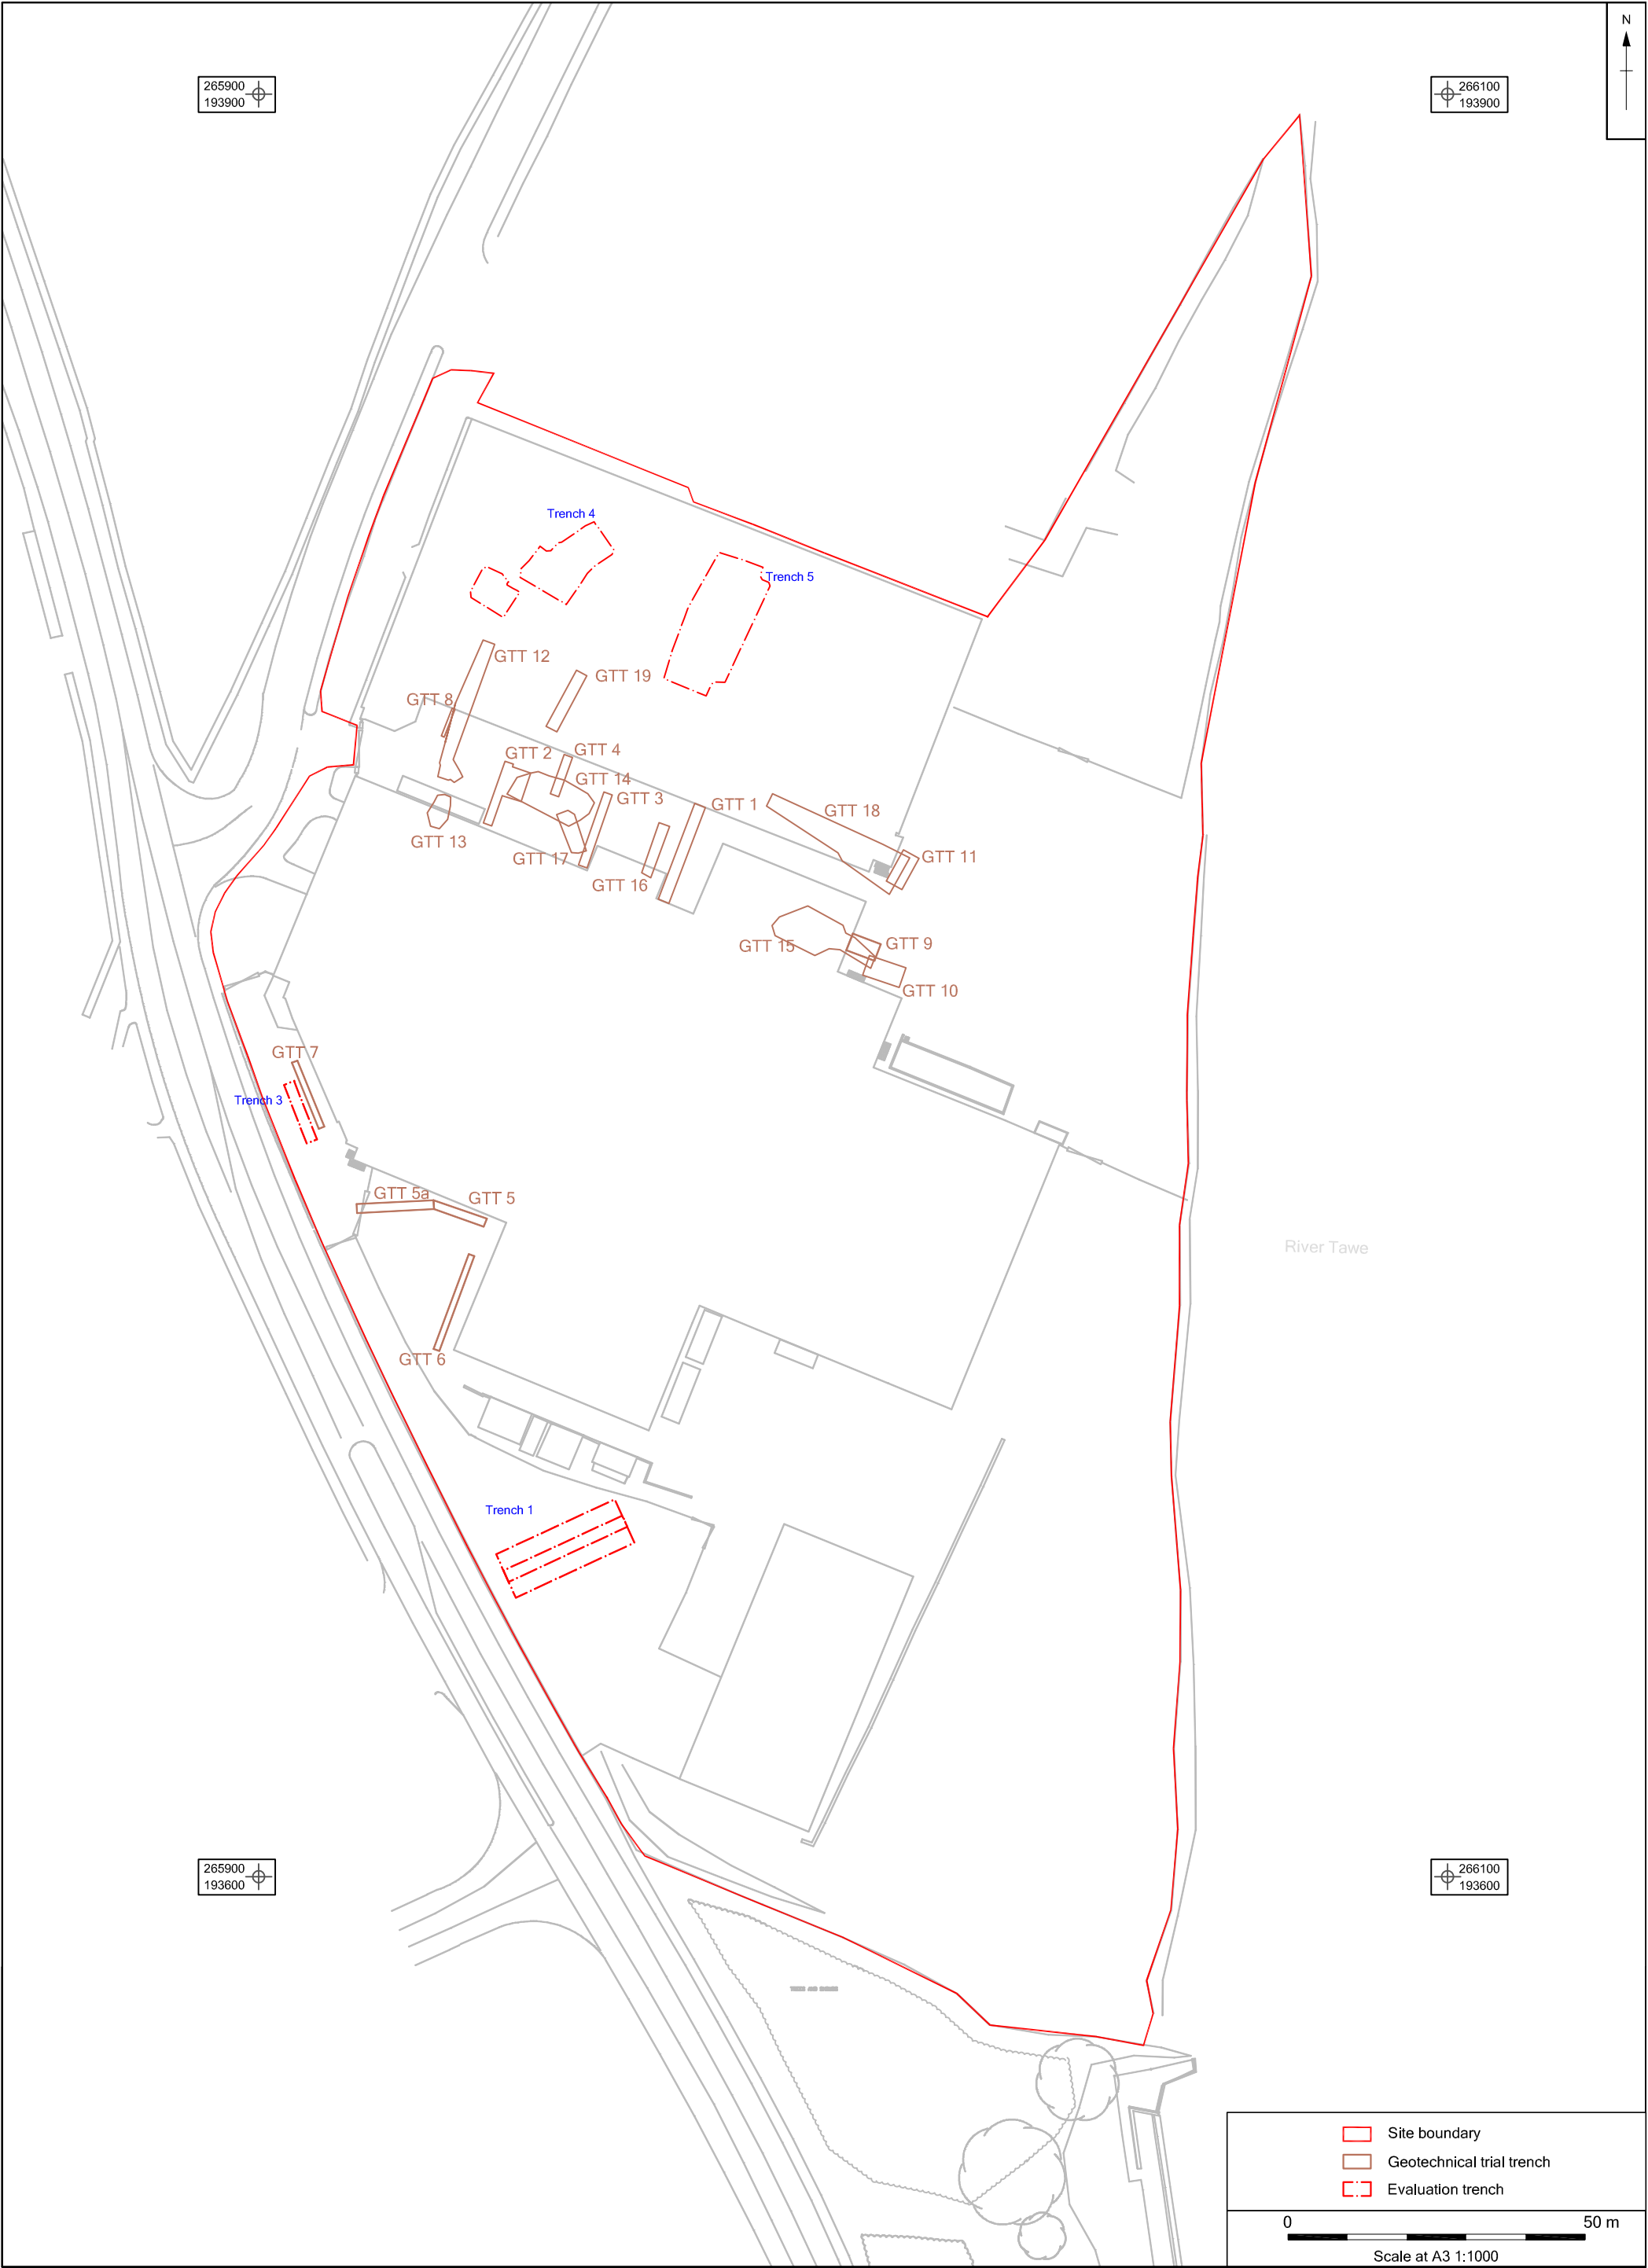
Figure 2: Evaluation and geotechnical trial trench location

- 3.1.1 The evaluation comprised two trenches, 4 and 5 (Fig. 2). These were positioned within the footprint of the northern building of the former works. At the time of the evaluation the above ground remains of this building had been demolished and the ground slab had been removed leaving open ground. A small area of below ground obstructions had also been removed to the east of Trench 5 prior to the archaeological attendance as part of the demolition although this ceased immediately once the contractor had been informed that these required observation and recording. Trench 4 was excavated in two sections to avoid a monitored borehole. It was aligned north-east south-west. The north-east section measured 13.3 m by 9.4 m. The south-west section measured 6.7 m by 7.1 m. Trench 5 was aligned NNE to SSW and measured 23.6 m by 10.9 m.

- 3.1.3 Following demolition a watching brief was also undertaken on an additional eight geotechnical trenches (GTT 12 to GTT 19) that were positioned to further investigate the location of Villiers' Dry Dock (Fig. 2).

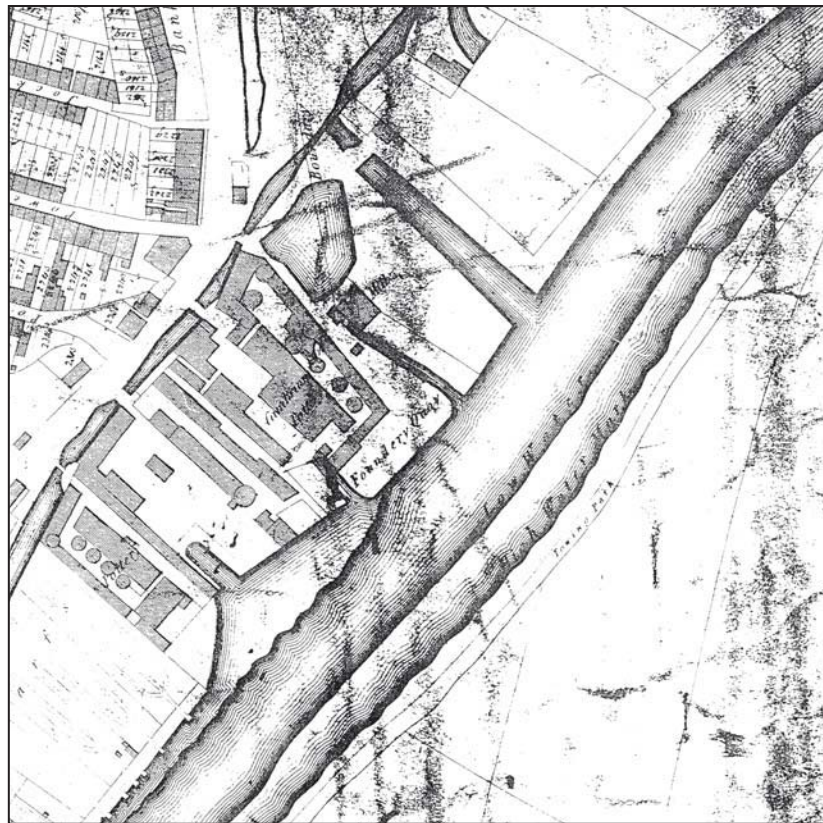
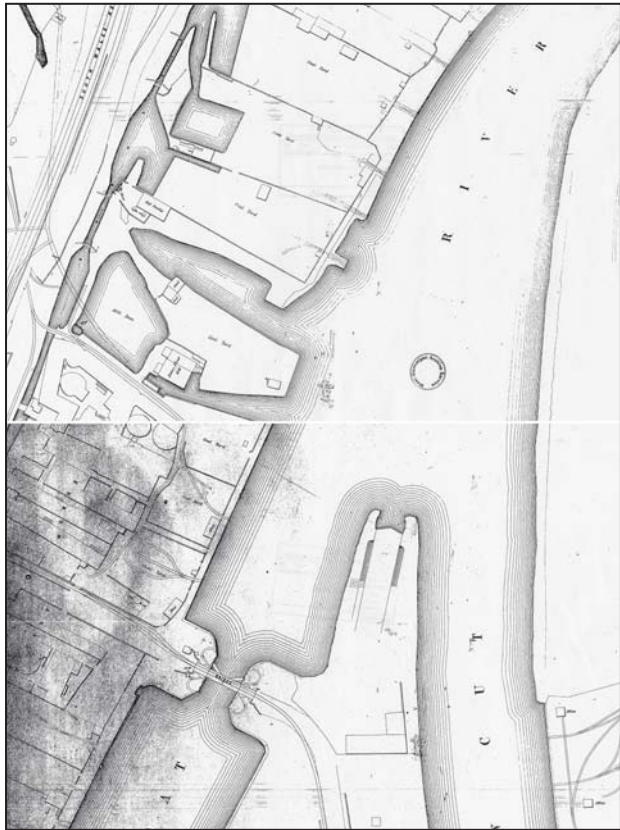
Figure 3: Historic maps (courtesy of Waterman)

a. Plan of the Town of Swansea, Glamorganshire 1843

b. Swansea Local Board of Health, Survey of the Borough of Swansea, 1852

c. First Edition Ordnance Survey Map, 1879

d. Third Edition Ordnance Survey Map of 1919

e. New Series Ordnance Survey Map of 1949/1950

- 1.3.4 The Pottery Mill is also shown within the site on the 1852 plan of Swansea Harbour, towards the centre of the development area (Fig. 3b). The Cambrian Pottery works were located to the immediate south of the mill and produced high quality earthenware and porcelain between 1764 and 1868 (*Ibid.*).

- 1.3.6 The historical map sequence (Fig. 3 a-e) also shows the numerous developments of the canal and dock system that developed alongside the River Tawe and, in the case of the North Dock Basin, directly from the river. Photographs from 1965 supplied by the former Unit Superheaters works show the final stage in the history of water management here with the infilling of the North Dock Basin and reclamation of a large swathe of the former river frontage (OA 2008b plates 5-8).

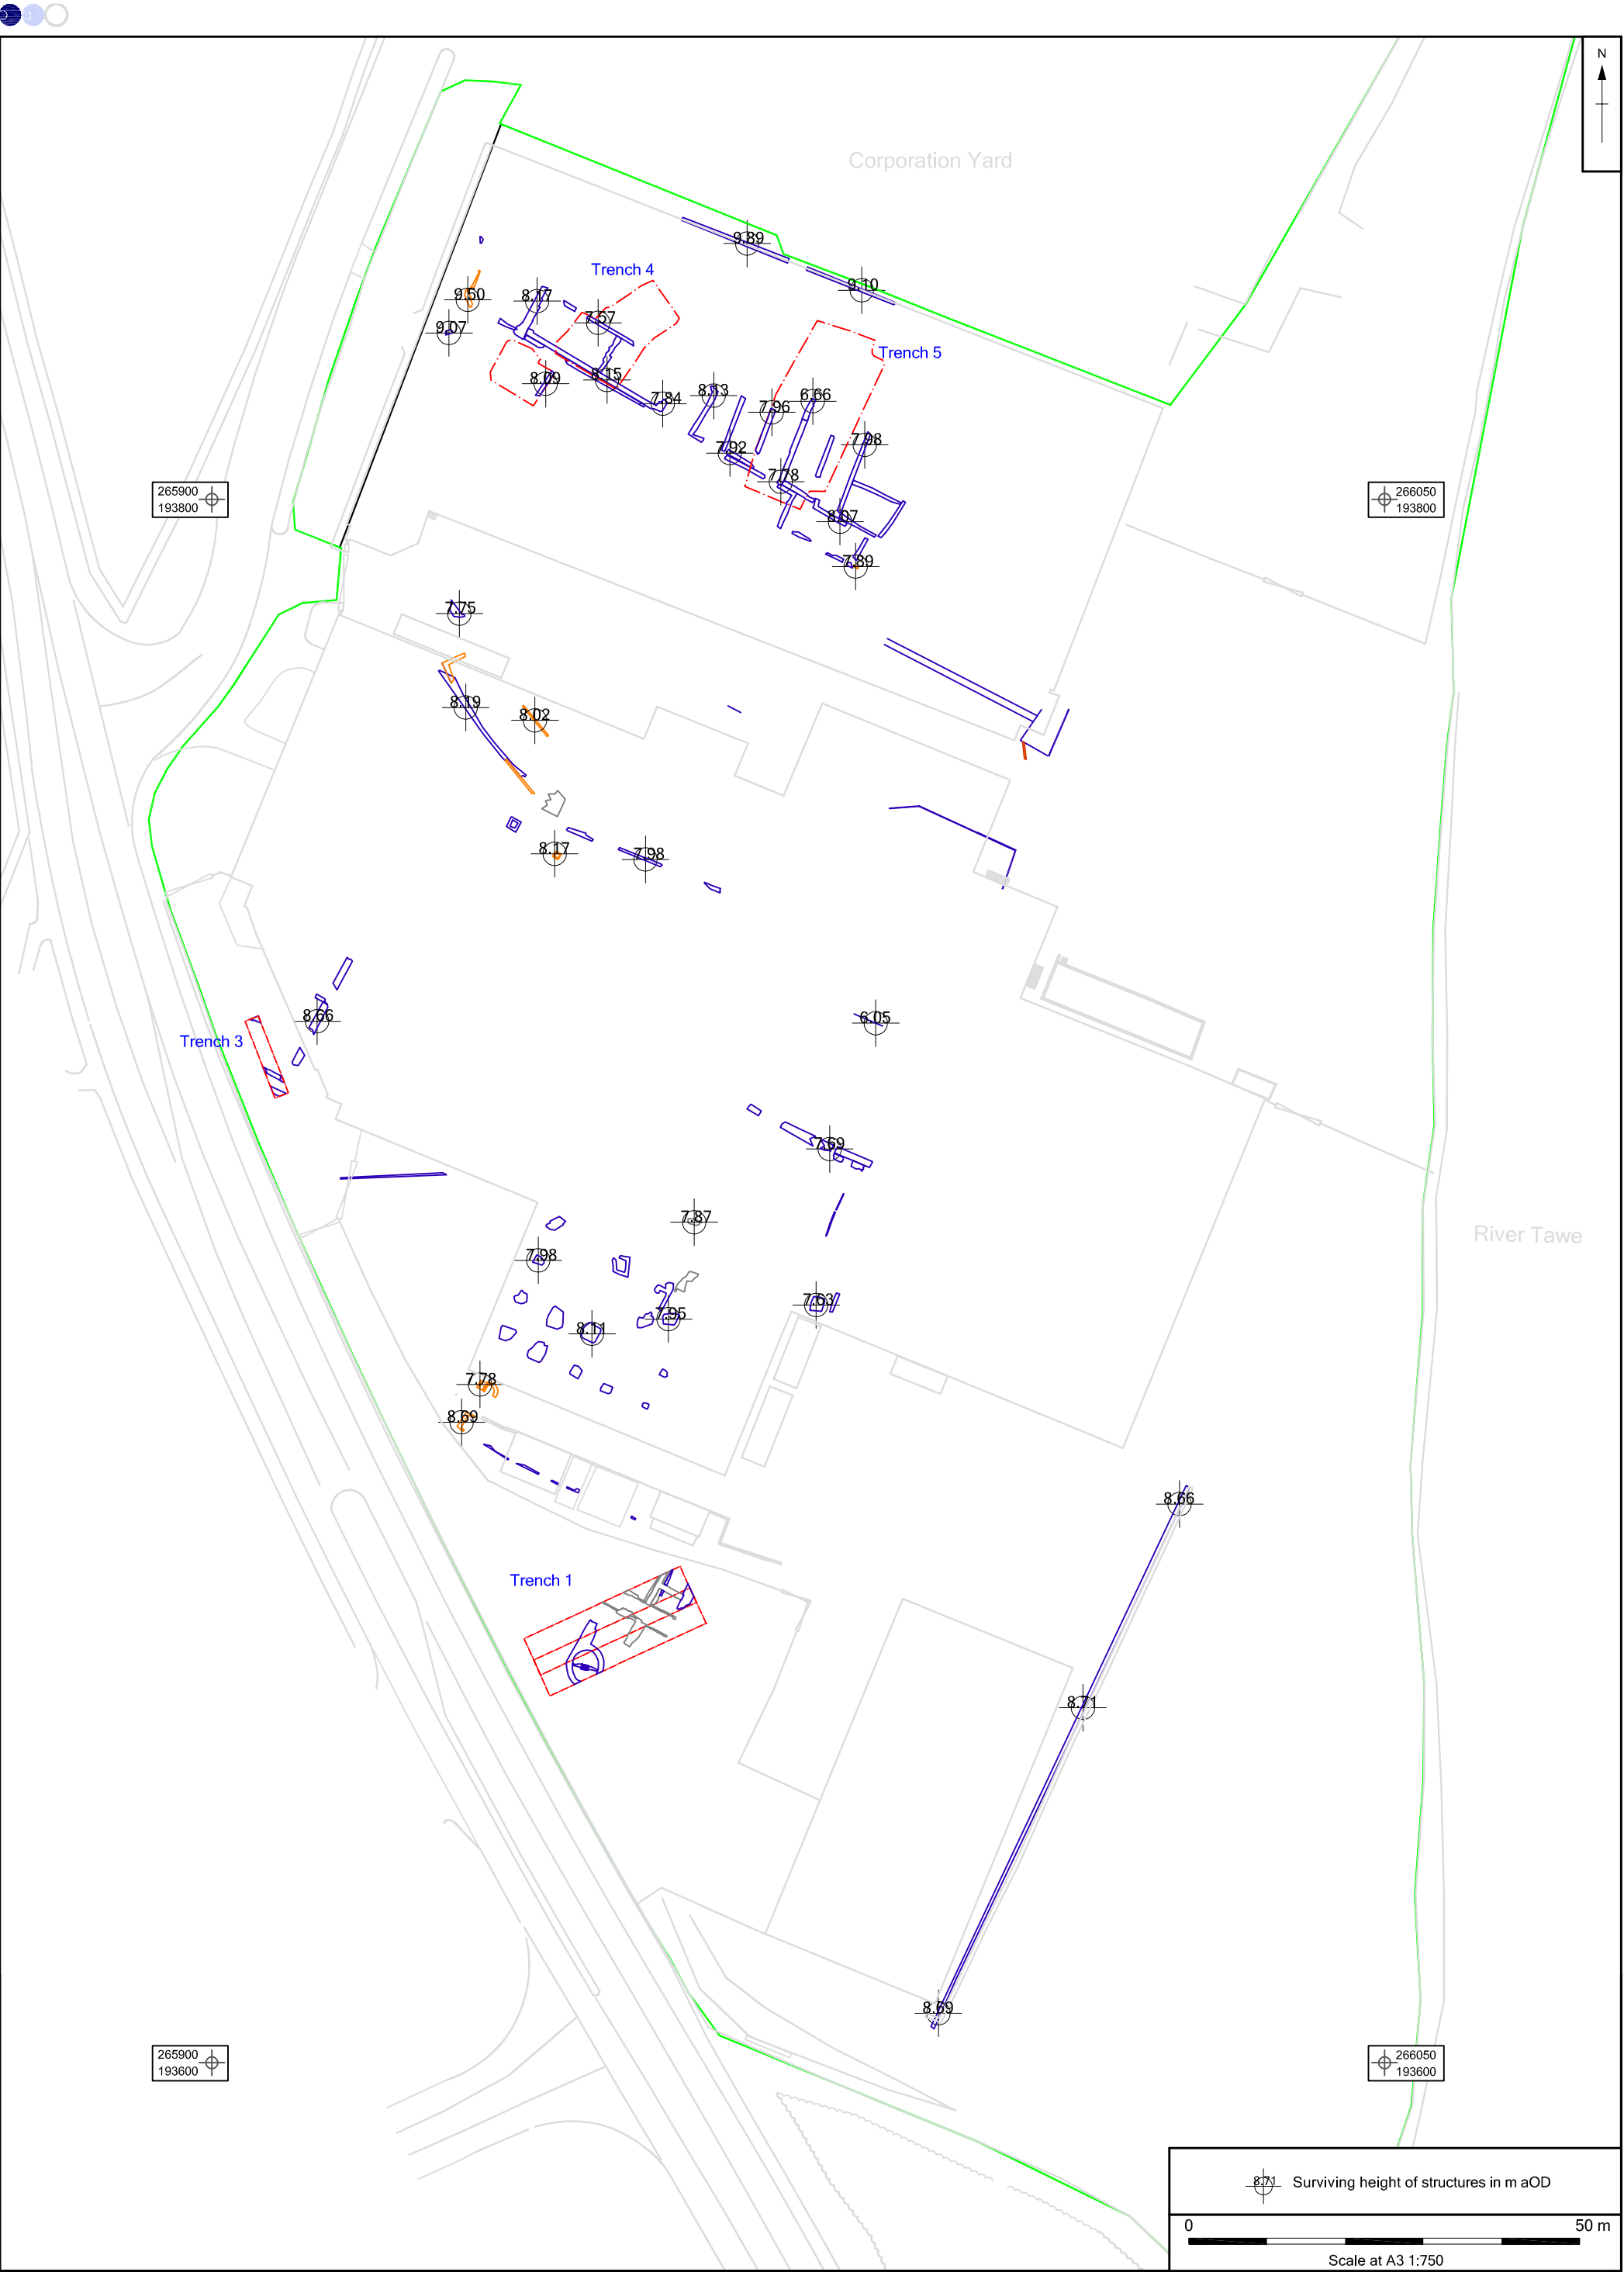
Figure 8: Upper levels of structural preservation in m aOD

- 5.1.2 The guidance of the demolition crew by the attending archaeologist proved to be very successful and large modern foundations were able to be removed with very little or no impact upon earlier remains. In the few cases where the existing foundations proved to be too difficult to remove, these were noted and remained *in situ*. The upper level of preservation of all structures was recorded in relation to Ordnance Datum (Fig. 8). These values provide a means of assessing future impact levels.

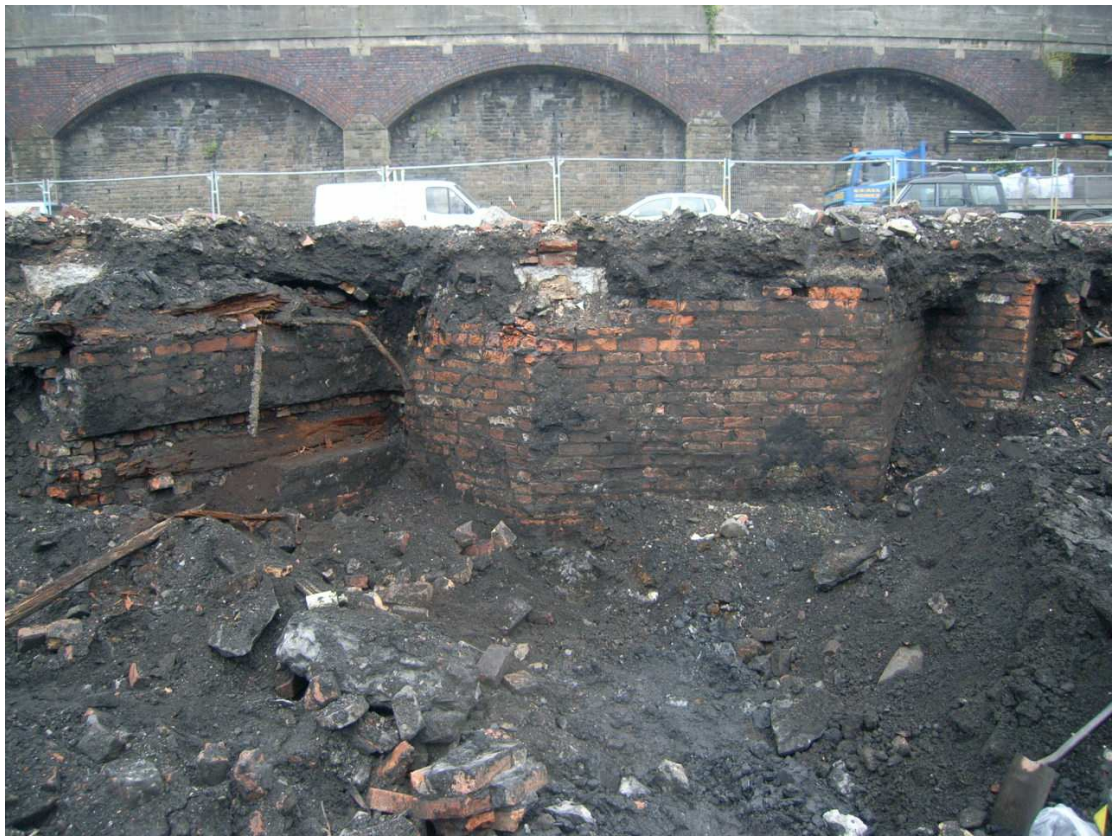
Plate 1: Walls 520 and 521

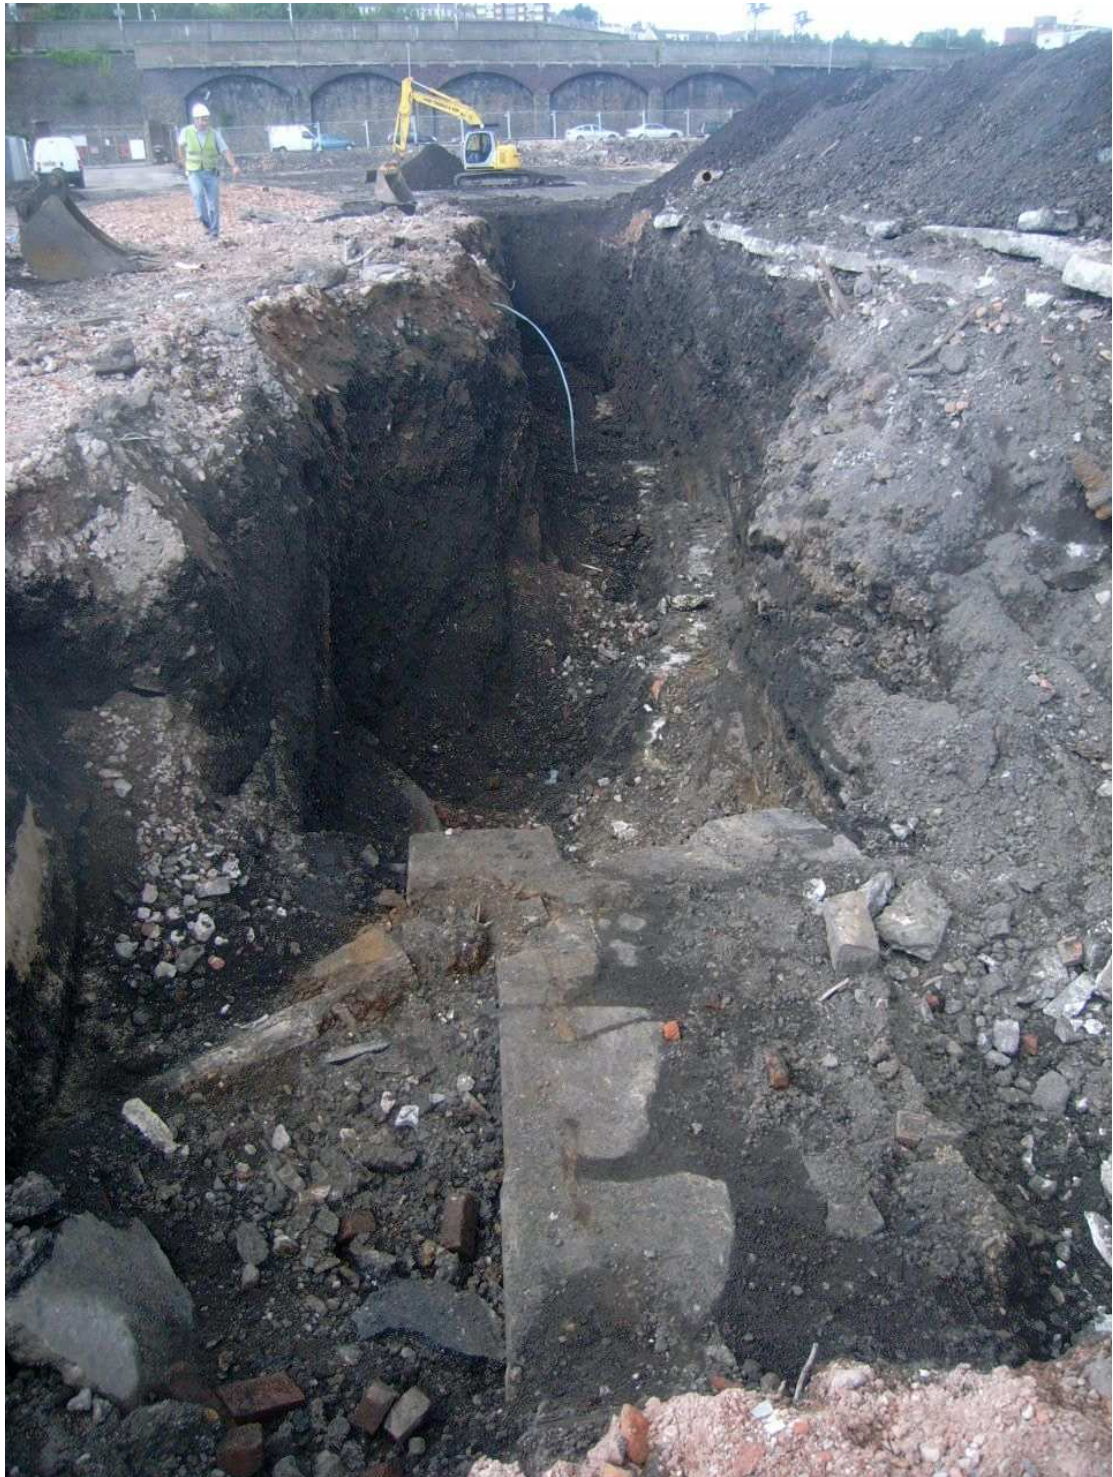
Plate 2: Villier's Dry Dock entrance

- 4.3.9 The south side of the dock entrance was further investigated in GTT 15 and was encountered 2 m below ground level consistent with the evidence from GTTs 9 and 10. This was constructed in Pennant sandstone blocks with pecked faces that were well preserved with the top course displaying a curved edge indicating that the original height of the dock and river walls survives at this point. A modern brick and concrete wall aligned north-south was built across the dock wall. This wall and the stanchion foundations had caused some truncation to the dock wall with the height of this sharply dropping to 3.5m below ground level where the faced sandstone blocks had been removed. The core of the wall comprised rough sandstone blocks bonded with a pale yellowish grey mortar. The line of this wall was followed to the northwest before it fell below the water table at 4 m below ground level. The machine bucket was used to follow the line of the wall below the water level where it was found to turn to the west. The extent of this part of the wall was not established. Due to the depths that the wall was encountered and the narrow trench that was dug to investigate it, this was only recorded as an alignment from the surface and it was not possible to record exact levels to the top of the remains.

- 5.1.8 The entrance and northern side of this structure were conclusively identified during the watching brief phase of work. However, this has suffered varying degrees of truncation/preservation. Surprisingly, the entrance to the dock was immaculately preserved with the wooden gate surviving and parts of the iron mechanism. However, the interior had been substantially damaged and/or removed and much of the southern side along its western end could not be identified despite the excavation of several deep trial pits designed to locate it.

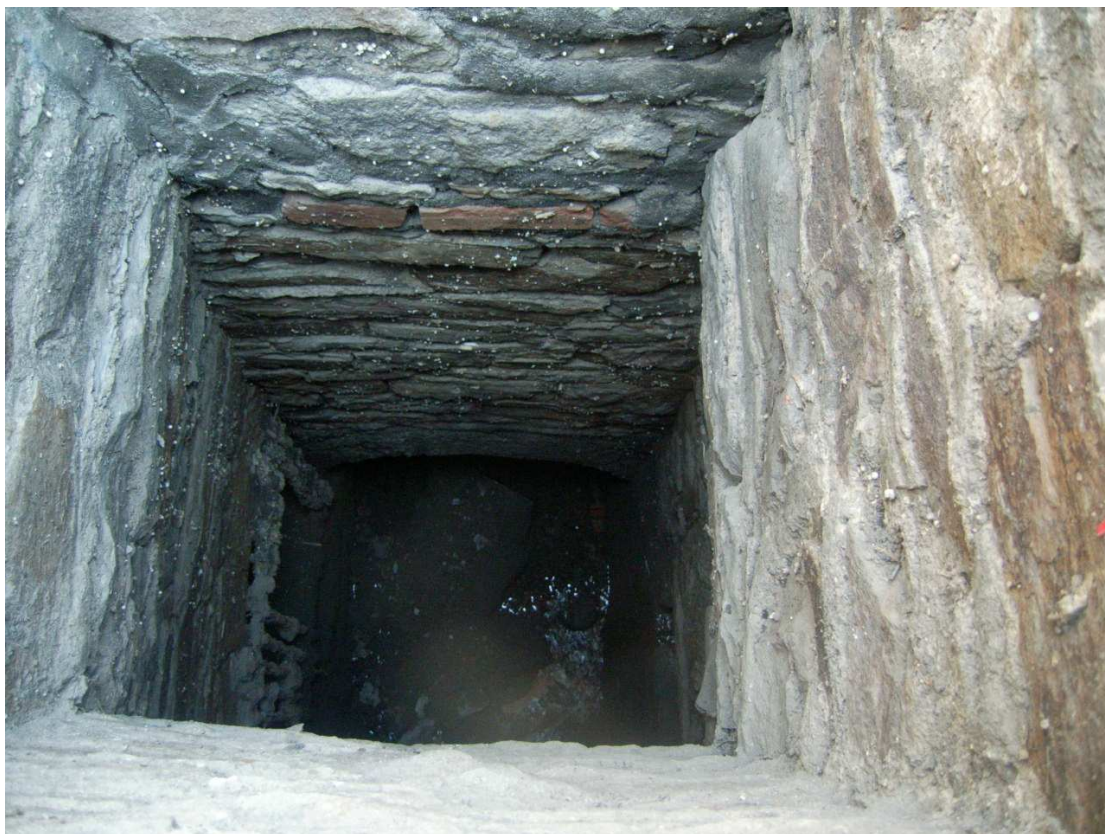
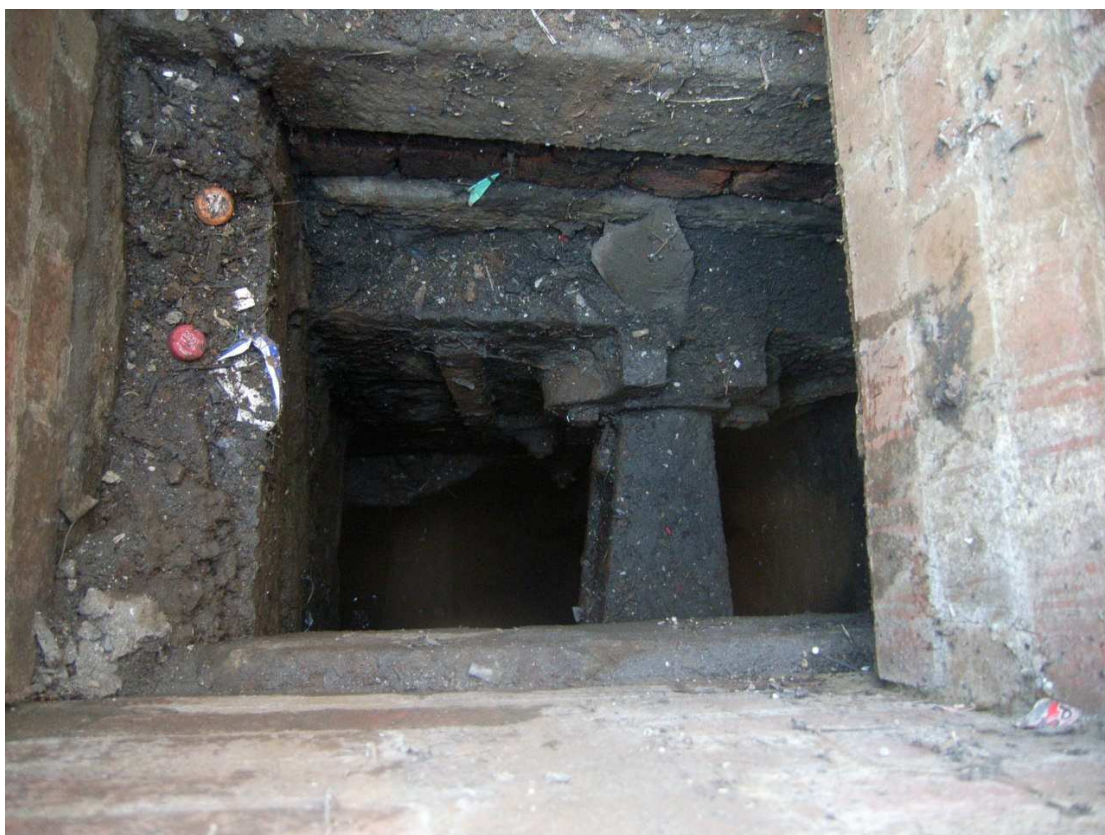
Plate 3: Stone culvert structures 518 and 519

- 5.1.7 Across the central, and eastern part of the site significant remains of the dock walls, canal basin, north dock basin (528 and 529) and associated structures (514-519) were seen during the removal of stanchions and in the geotechnical trenches. These remains were very well preserved with the upper courses of stone remaining *in situ* and the walls undamaged by the later foundations. It is quite clear from the image mentioned above that this is the result of methodical infilling during the 2nd quarter of the 20th century immediately preceding the expansion of the Unit Superheaters works over this area (Plate 8).

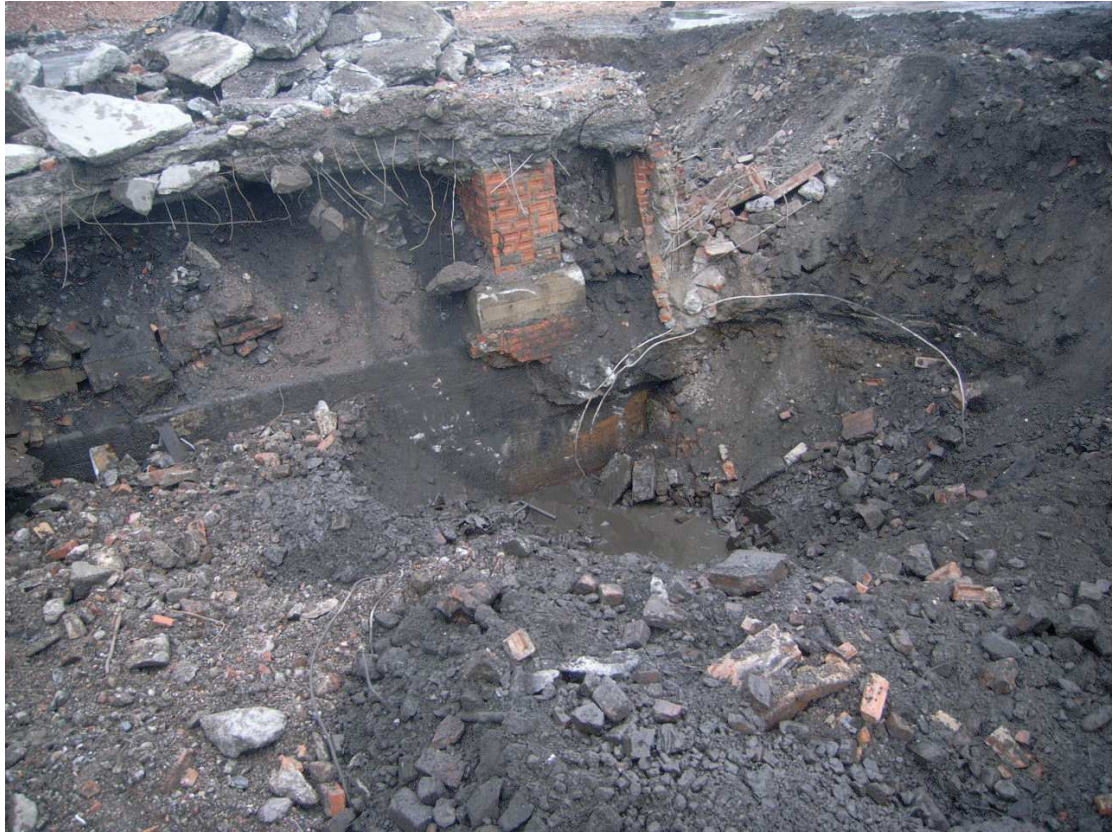
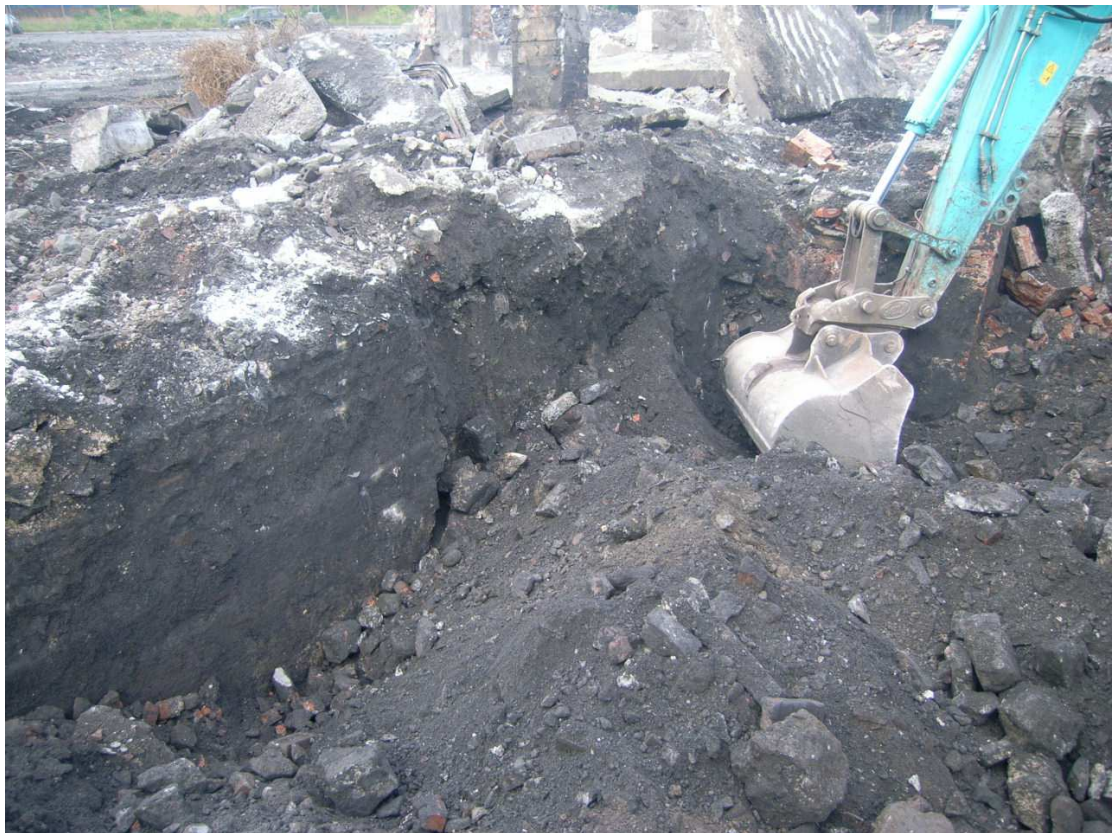
Plate 4: North Dock Basin walls 529 and 528

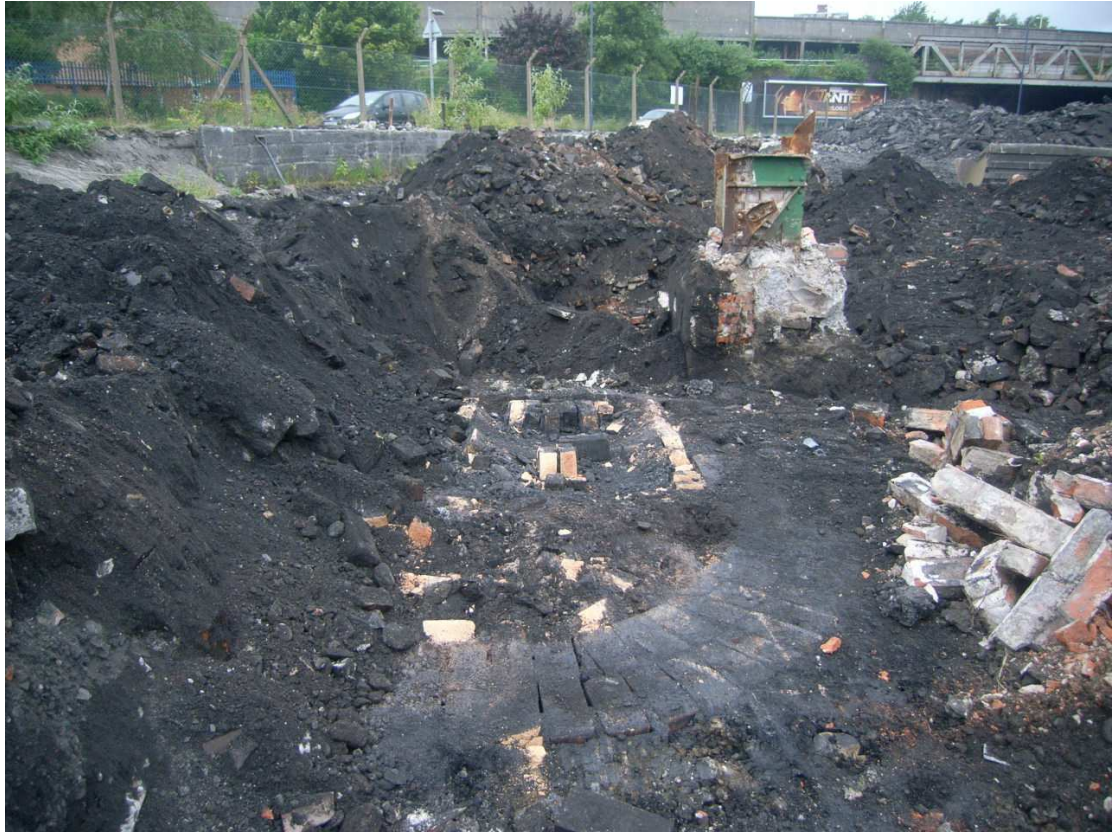
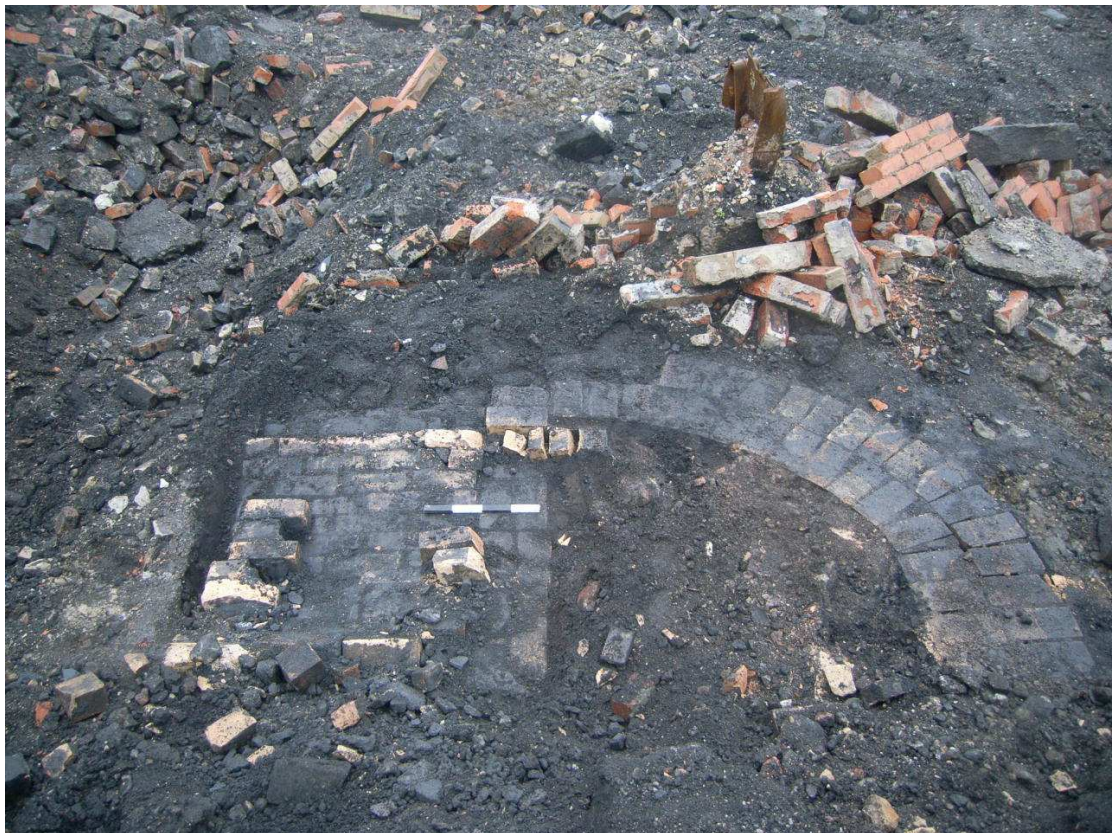
Plate 5: Firebrick structure 525

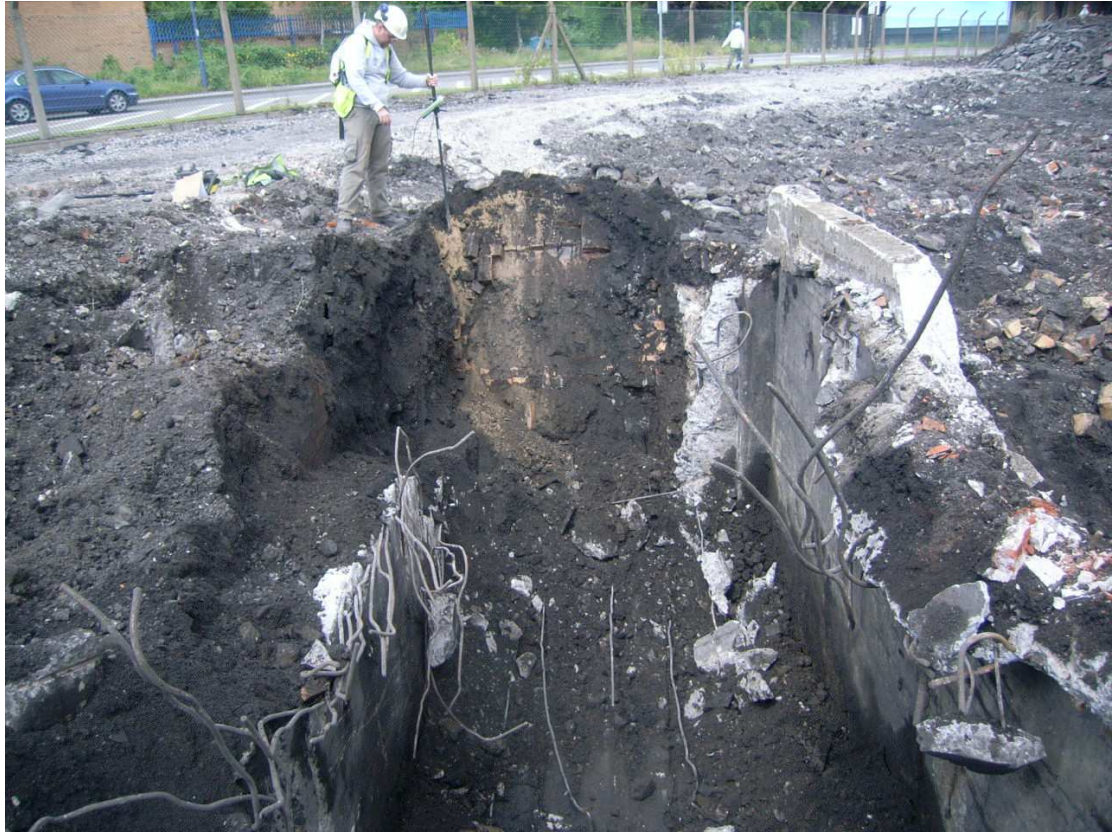
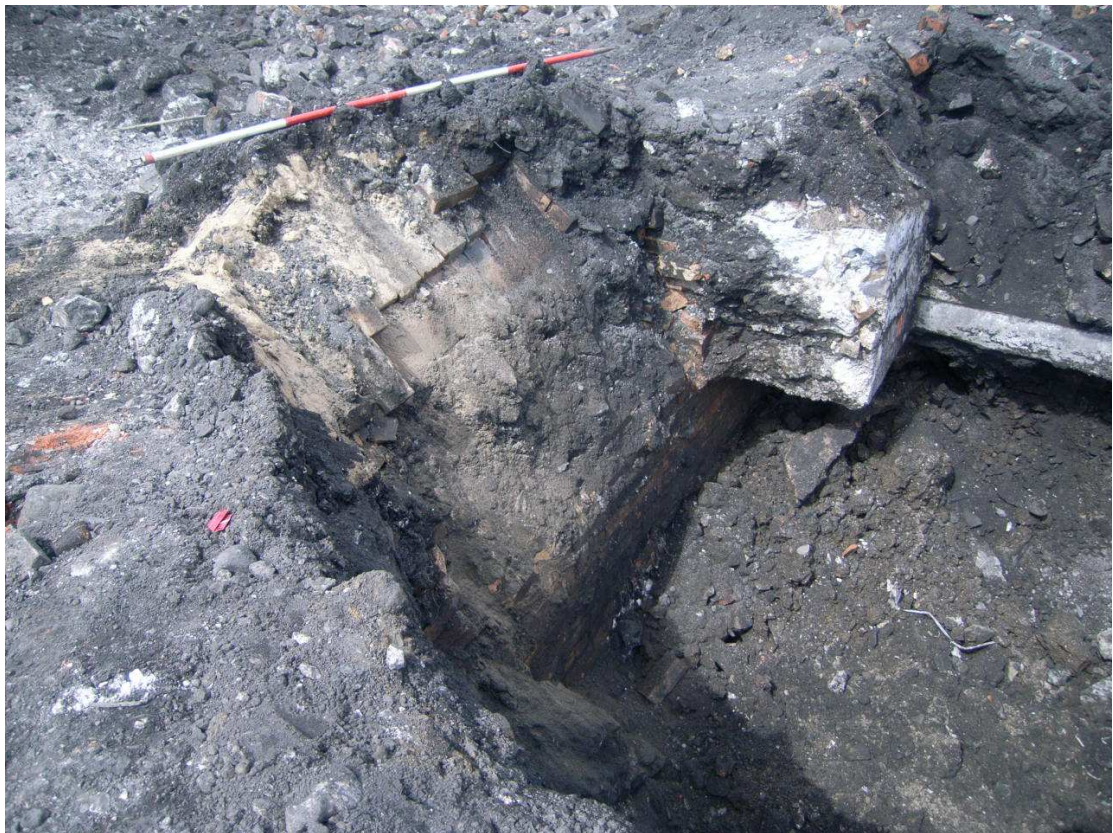
Plate 6: Firebrick structure 526 and reinforced concrete structure

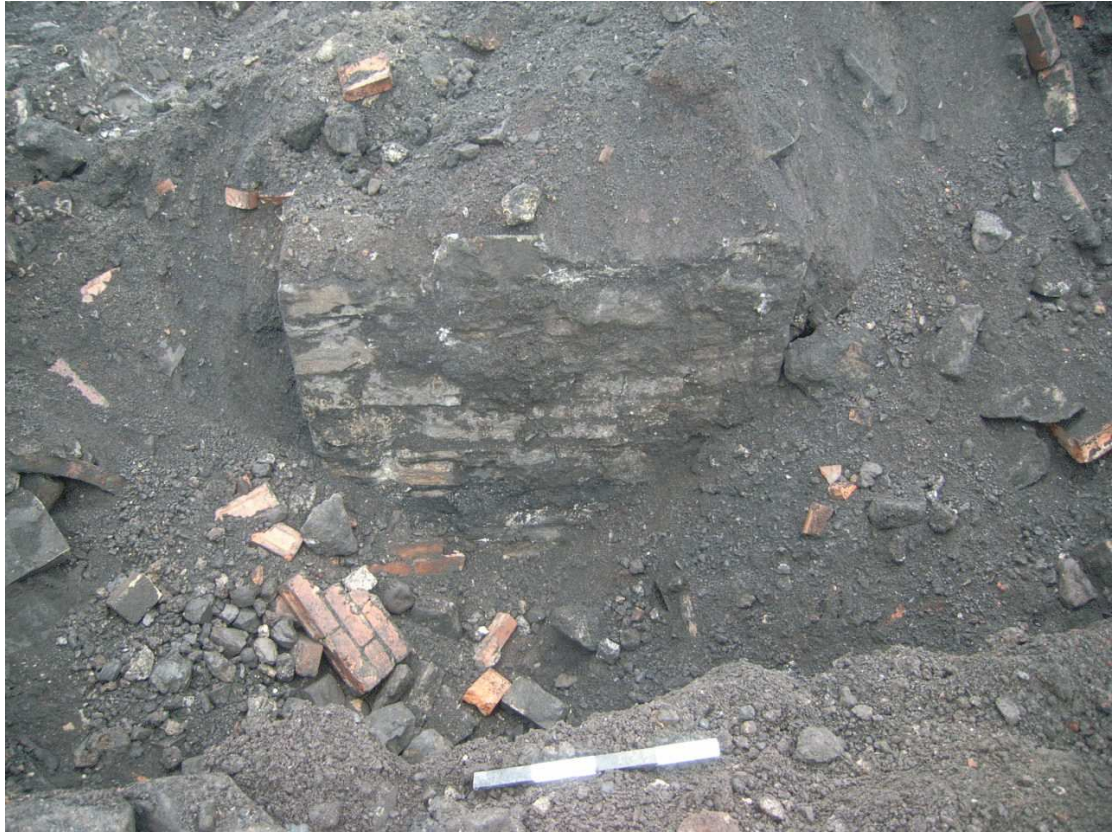
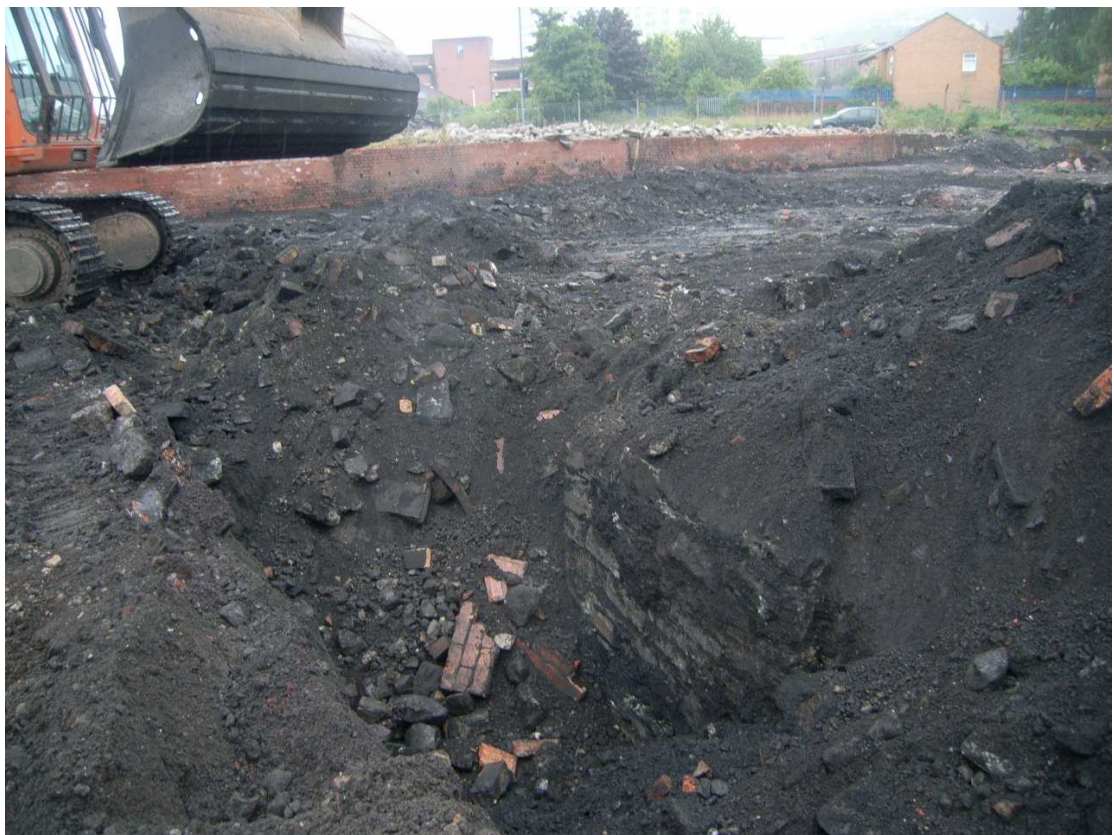
Plate 7: Stone pillar from structure group 531

A series of well preserved stone pillars arranged in a grid pattern also encountered across the southern part of the site relate to the Graigola Merthyr Patent Fuel works and can be seen on a contemporary watercolour view of Swansea from 1881. Alongside the Patent Fuel works significant contemporary remains were recorded of the North Dock Basin, canal basin and wharf. These were only exposed at intervals although, combined with a 1940s view photo of workmen infilling these, it is clear that they are likely to survive in very good condition. Likewise, the photo shows that the Patent Fuel Works was levelled and has probably acted as an effective protective covering to any earlier deposits and structures buried at depth.
