Unit Superheaters Engineering Swansea

Archaeological Evaluation and Watching Brief Report

February 2009

**Client: Waterman
on behalf of DFWJ Ltd
and Unit Holdings Ltd**

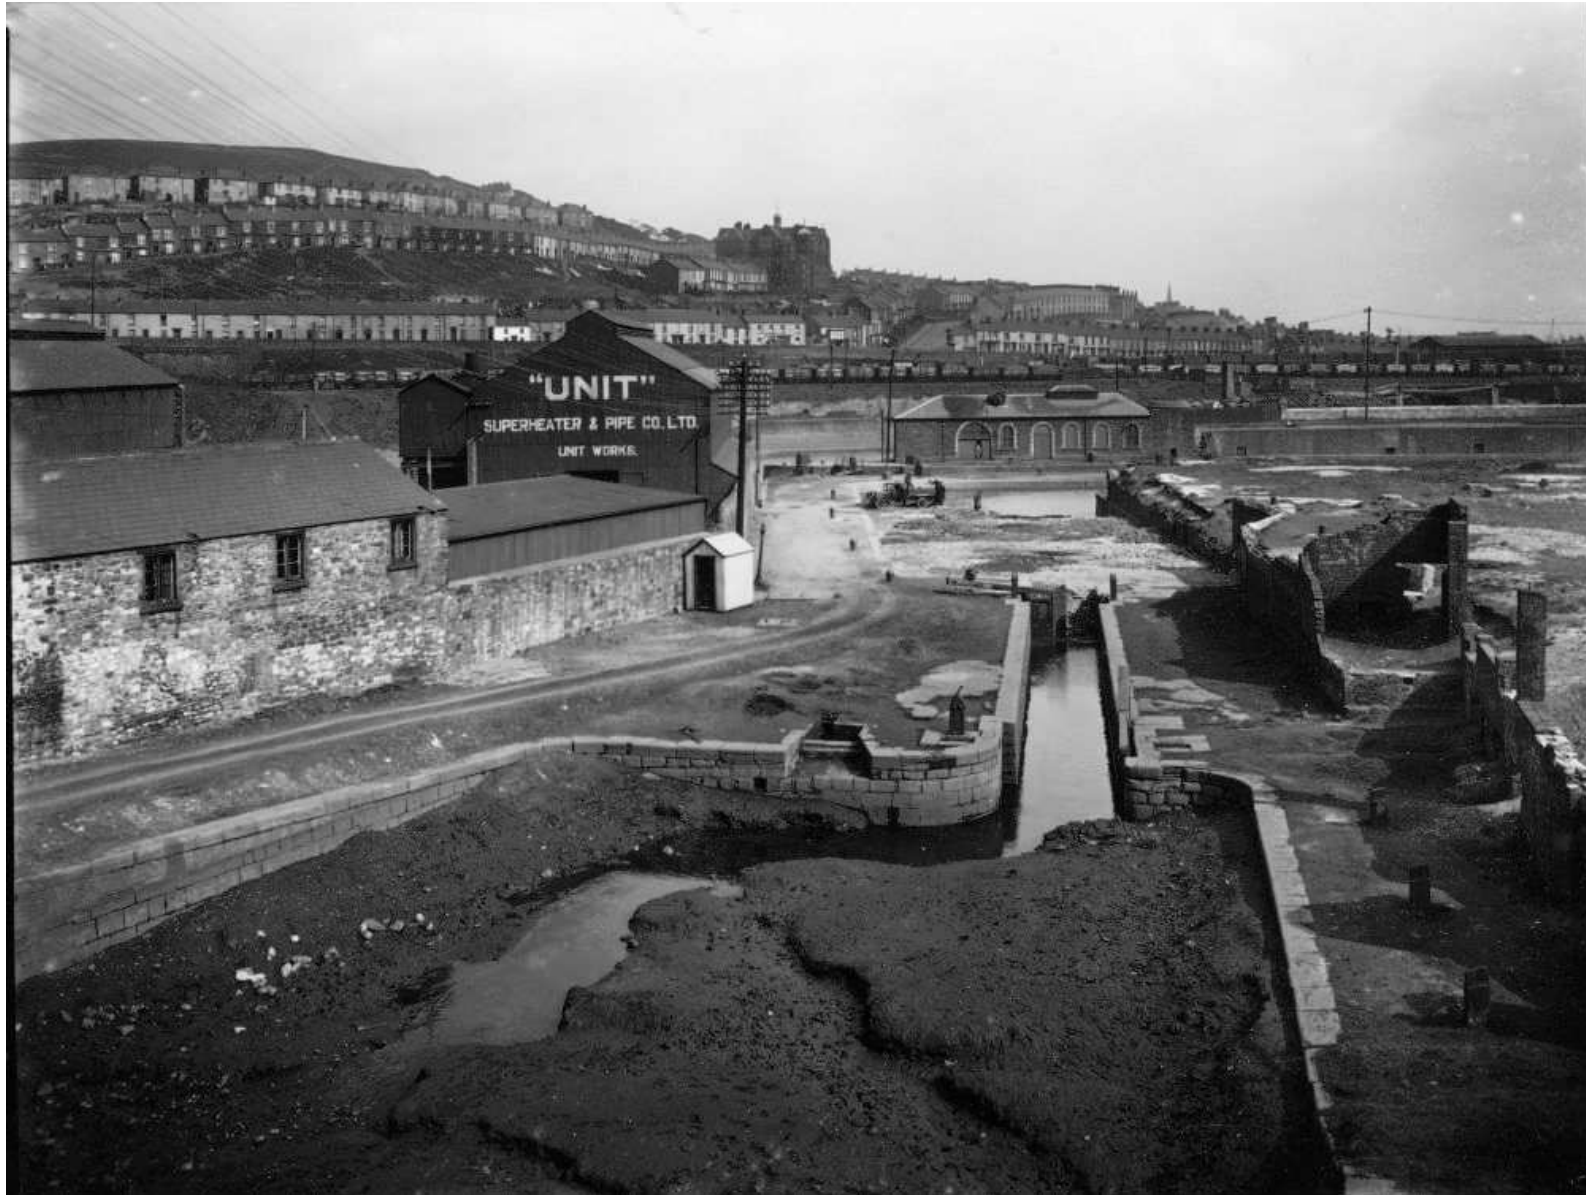
Plate 8: The Lock Basin, Lock and North Dock Basin being infilled (?1940s)

- 5.1.7 Across the central, and eastern part of the site significant remains of the dock walls, canal basin, north dock basin (528 and 529) and associated structures (514-519) were seen during the removal of stanchions and in the geotechnical trenches. These remains were very well preserved with the upper courses of stone remaining *in situ* and the walls undamaged by the later foundations. It is quite clear from the image mentioned above that this is the result of methodical infilling during the 2nd quarter of the 20th century immediately preceding the expansion of the Unit Superheaters works over this area (Plate 8).
