Unit Superheaters Engineering Swansea

Archaeological Watching Brief Report

oxfordarchaeology
April 2008

Summary results of an Archaeological Watching Brief

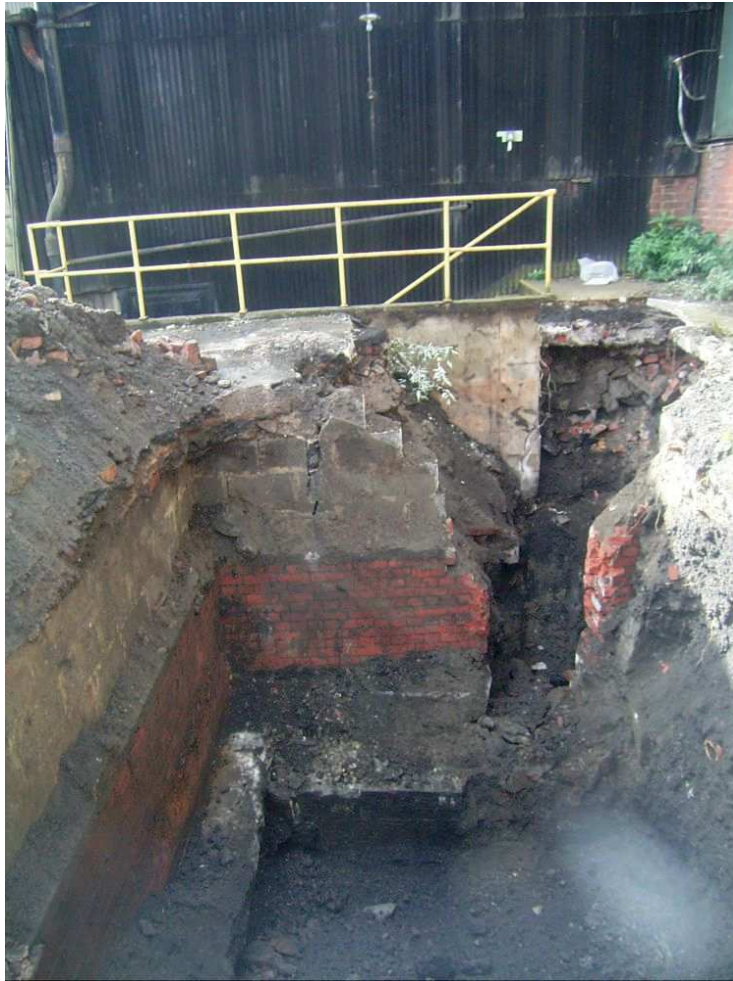
- 6.1.5 The entrance to the dry dock and the river walls were conclusively identified close to their projected locations. Trial Trenches 9 and 10 revealed the southern side of the entrance 2.3 m BGL (Plates 1 and 2). This had been truncated by a modern brick possible cellar that had utilised the wall as a foundation. However, the degree of this truncation was not entirely evident within the trench although the few courses revealed of the Pennant Sandstone dock structure were well preserved. Trial Trench 11 revealed the same construction of the river frontage wall 2.0 m BGL.

Plate 1. Trial Trench 9/10 showing the dry dock wall beneath a modern brick and block wall.
View SSW

7.1.2 Trial Trenches 9, 10 and 11 did provide conclusive remains that precisely locate the river wall and dry dock entrance. These were encountered at 2.3 m BGL and constructed with pecked-faced Pennant Sandstone blocks.

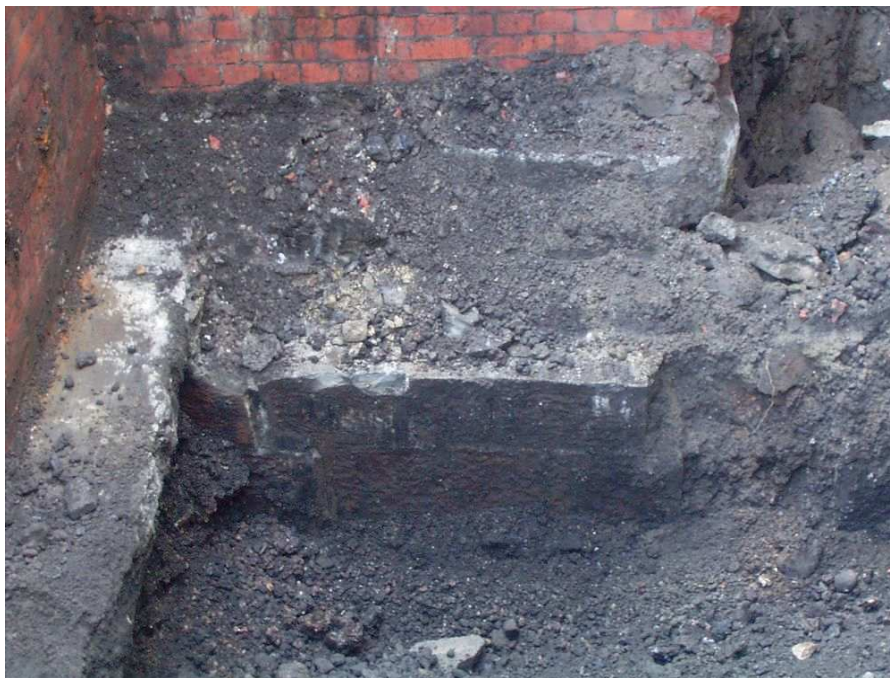
Plate 2. Trial Trench 9/10 showing detail of the dry dock wall beneath a modern brick wall

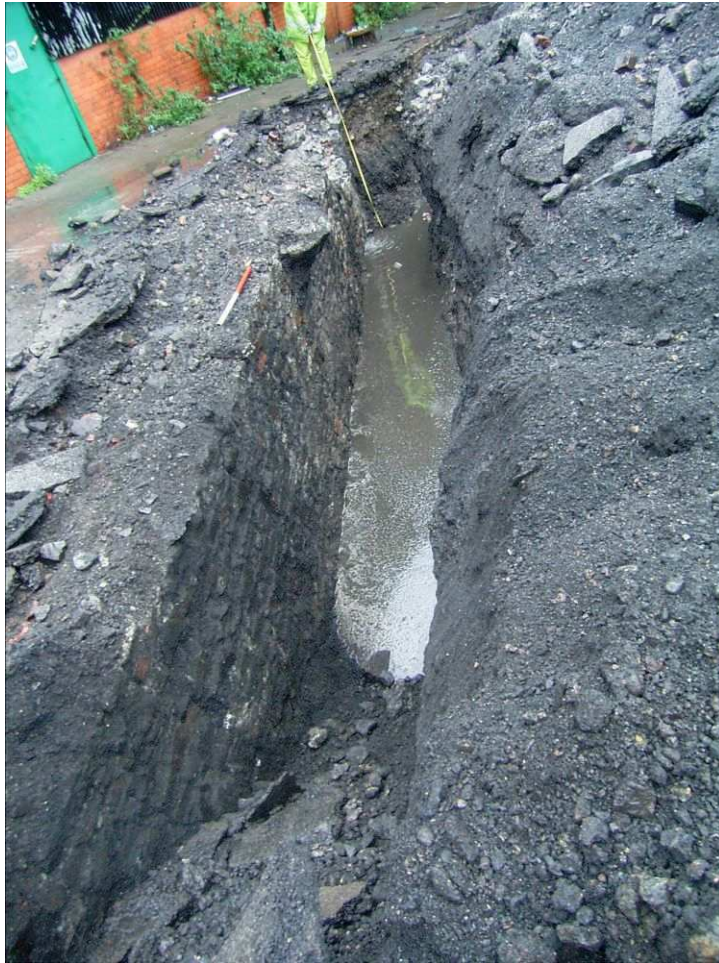
- 6.2.1 Geotechnical Trial Trenches 5, 6 and 7 were located between the previous evaluation Trenches 1 and 3 (Fig. 2). These revealed a high concentration of structures encountered at shallow depths. Within Trial Trench 5/5a a substantial wall constructed of sandstone blocks with occasional reddish orange bricks was followed for 13 m along its east to west alignment (Plate 3). Only its south face was exposed to a depth of 1.7 m BGL with its upper courses encountered 0.3 m BGL. At the SE end of the trench two other walls appear to have formed a right angle. One was of a similar construction to that described above with the other built entirely of brick. This could suggest a difference in either the date of construction or function/use. Where possible each of these walls was preserved *in situ* although the brick structure did suffer some damage during excavation.

Plate 3. Trial Trench 5/5a wall. View east

7.2.1 This title is not intended to mislead and should only be used to refer to the area where potential remains of the pottery works were previously recorded within the evaluation (OA 2008a). Trial Trenches 5, 6 and 7 each produced positive results with well preserved walls constructed of brick and sandstone present. Trenches 5 and 6 were excavated in the area not previously available to evaluation which lies c. 1 m below the surrounding level of Evaluation Trenches 1 and 3. Significant structures were encountered here immediately below the existing surface and associated with a small assemblage of 19th century pottery production waste. This is consistent with the evidence from the evaluation and clearly points to the high potential for significant well preserved remains across this area.

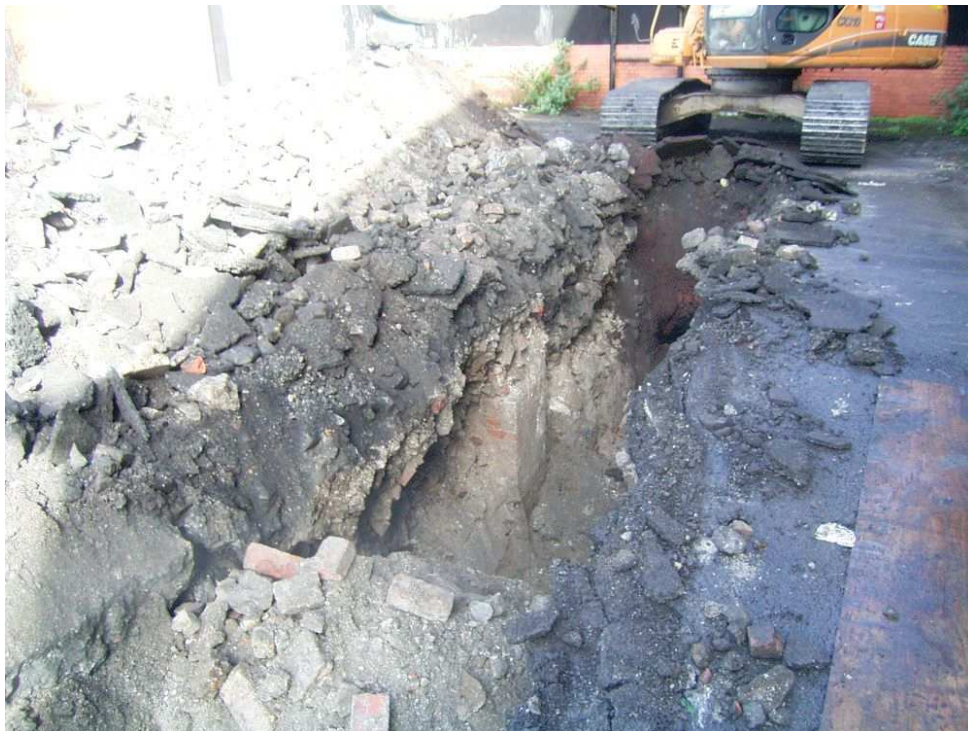
- 6.2.3 Trial Trench 6 partially exposed two substantial brick structures 0.3m BGL (Plate 4). These appear to be free standing within the trench with faces to three sides with the structures extending to the WNW. A wall constructed of sandstone with faces to either side was also located at the northeastern end of the trench. This was partly disturbed by the excavation of the trench although it was roughly aligned NW-SE and was similarly encountered 0.3 m BGL. Rubble deposits surrounded these structures.

Plate 4. Trial Trench 6 brick structure in the centre of the trench. View north
