Cuddesdon House Cuddesdon Near Oxford Oxfordshire

Archaeological Watching Brief

4th October 2002

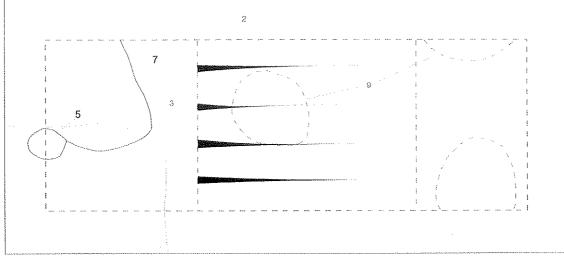
Figure 3: Site plan showing features

- 3.1.2 The soakaway cut a large sub circular feature (7) with steep sloping sides, whose base lay below impact level and measured 2.8 x 2.9 x 1 m. It was filled by a dark reddish brown silty sand (8) and appeared to be an old quarry pit or garden feature which had silted up. These features cut through a 0.3 m thick dark reddish brown silty sand (2) subsoil overlying a natural (3) of yellowish brown sand with patches of limestone. Also cutting these two layers were a number of large tree holes (9) filled with a dark yellowish brown patchy sand (Fig. 3).

Extent of 4

- 3.1.1 The excavation for the swimming pool cut through a 0.28 m thick layer of dark greyish brown silty sand loam garden topsoil (1). This was sealing a 0.6 m thick layer of demolition rubble (4) spread out from the old bishop's house after it was destroyed by fire in the 1960's. Sealed below this layer was a small circular cut (5) (measuring 0.9 x 1 x 1.1 m) with a steep sided concave profile which appeared to be a small soakaway. It was filled with reddish brown silty sand (6) with limestone fragments (80%) and tile (1%).
