St Leonards Church Grendon Underwood Buckinghamshire

Archaeological Evaluation Report

Oxford Archaeology

January 2004

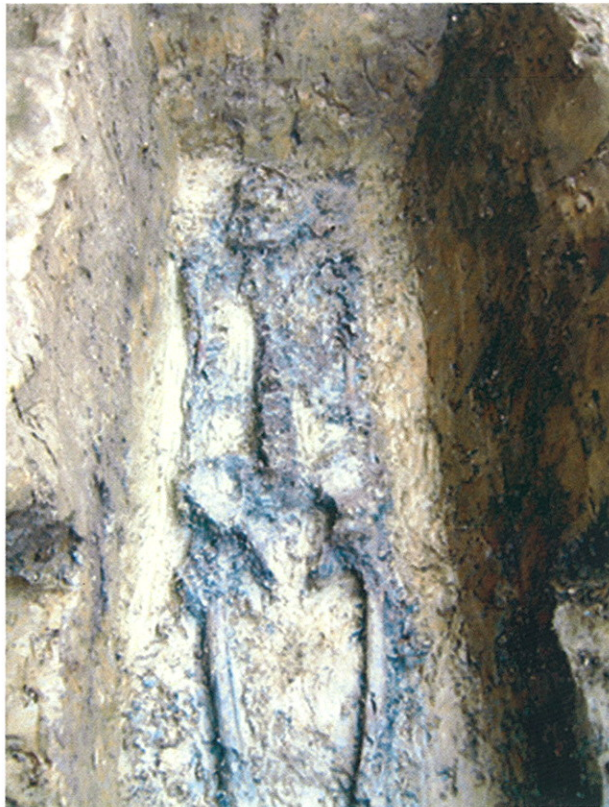
Plate 1: Skeleton 109

- 5.1.14 Grave (108) was 1.6 m in length on a west to east axis, 0.7 m wide and 0.6 m deep cut from the top of buried soil (102). The upper part of the grave had been truncated at its eastern end by the foundation cut (105) for buttress (401), (Fig. 4, Plate 1).

- 5.1.16 The inhumation (109) within grave (108) was in an extended supine position orientated west to east. There was no indication of the presence of coffin nails or staining attributable to the presence of a coffin. There was a degree of staining immediately adjacent to the bones which could represent soft tissue or the presence of a winding sheet/shroud. The skeleton's feet had been truncated by the foundation cut (105) for buttress (401) (Plate 1).

- 5.2.3 A single burial (109) was investigated in Trench 1. The burial was positioned between buttresses (400 and 401). The burial comprised a single extended supine skeleton orientated west to east in a traditional Christian manner. The legs were fairly close together and the arms bilaterally to the sides, so close that the forearm bones lay under the pelvis. The hands rested alongside the femoral shafts. The feet and distal tibia and fibuli were truncated by the placement of buttress (401) and its associated foundation cut.

- 5.2.4 It was impossible to be specific about the age of the skeleton due to the poor preservation of the bones. The long bones appeared to be fused, this and the length of the skeleton indicate that the skeleton was an adult.

- 5.2.5 The skeleton exhibited a rounded mandibular angle, shallow anterior symphysis, gracile post-cranial skeleton and a flared pelvis, all indicative of the skeleton being that of a female. The rest of the sexable features were not observable or had been destroyed.

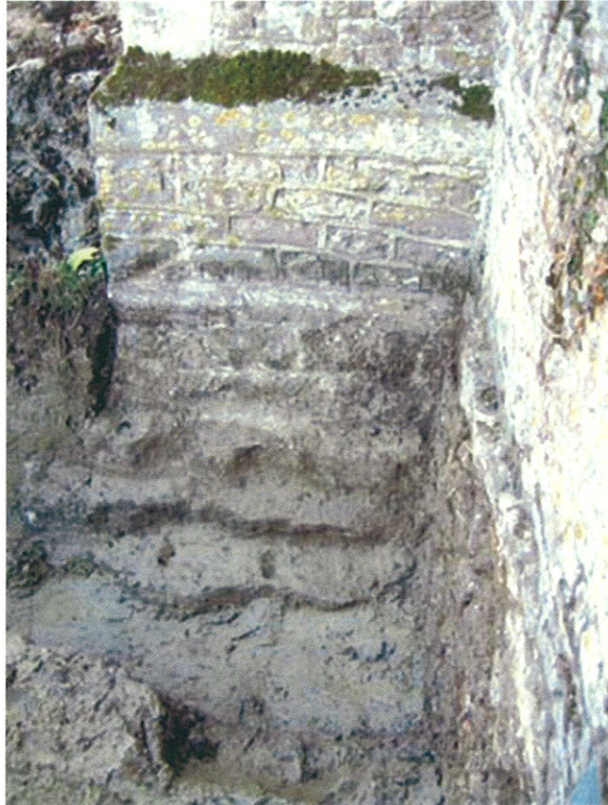
Plate 3: Buttress foundation 402

- 5.1.24 Buttress (402) differed from the others being constructed wholly from very large limestone ashlar blocks with a pronounced splay occupying the entire width its foundation trench (207). This footing was uncovered to a depth of 0.9 m below the present without revealing its lowest course. The lowest course visible included a massive block of limestone ashlar that had clearly been worked with two shallow rectangular indents visible in its ventral surface, (Fig.6, Plate 3).

- 6.2.5 The different construction technique used in the footing for buttress (402) compared to (400, 401 and 403) suggest that this buttress was not constructed at the same time as the others. The use of very large ashlar for this buttress, one stone of which had clearly been worked, could indicate that it was constructed when such pieces were available on the site. It seems likely that this could only have been during the construction of the west tower in the 15th century.
