Towles Mill Sluice Oxford

Archaeological Desk-based Assessment

**Towles Mill Sluice,
Oxford**

**ARCHAEOLOGICAL DESK-BASED ASSESSMENT
INCLUDING TEST-PIT AND GEO-ARCHAEOLOGY REPORTS**

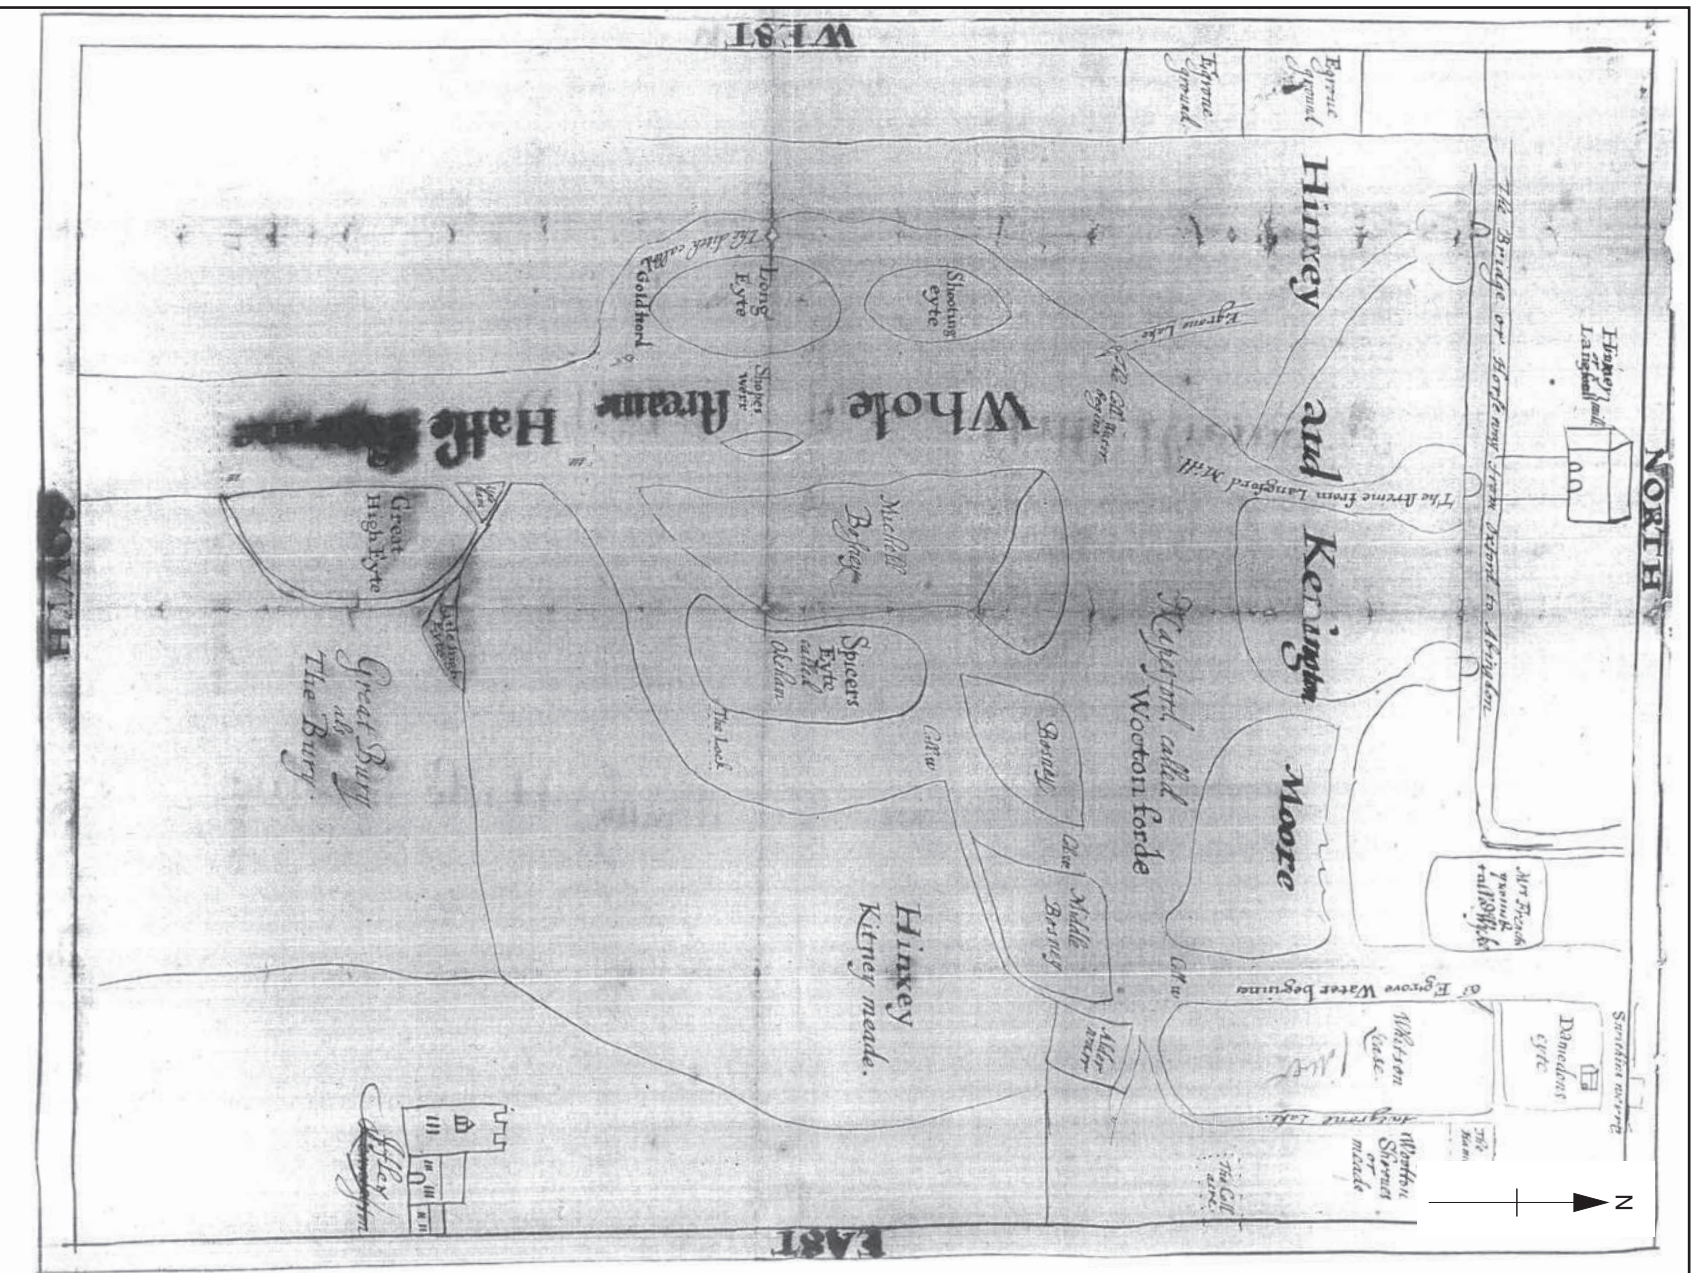
Figure 3: 16th - 17th century map, New College

- 4.3.1 The earliest map located of the Study Area is an undated map of the 16th - 17th century commissioned by New College. The map is most concerned with the numerous watercourses to the south of the bridge, a number of which are labeled 'Coll. Water' and 'Coll. W' and are presumably the reason for the map. The mill is depicted to the north of the bridge with a gabled roof and two archways presumably

over the watercourse which is shown flowing from the mill and labelled 'The Streme from Langford Mill'. The mill is labeled 'Hinxe or Langford mill'. No further detail is given to the north of the bridge. Three watercourses are shown exiting to the south of the bridge that join with another water course to the east labeled 'Egrove Water beginnes'. The area to the south of the bridge is shown as a mass of water courses and islands of land with 'Hinxe and Kenington Moore' and 'Hinxe Kitney Meade' interspersed between.

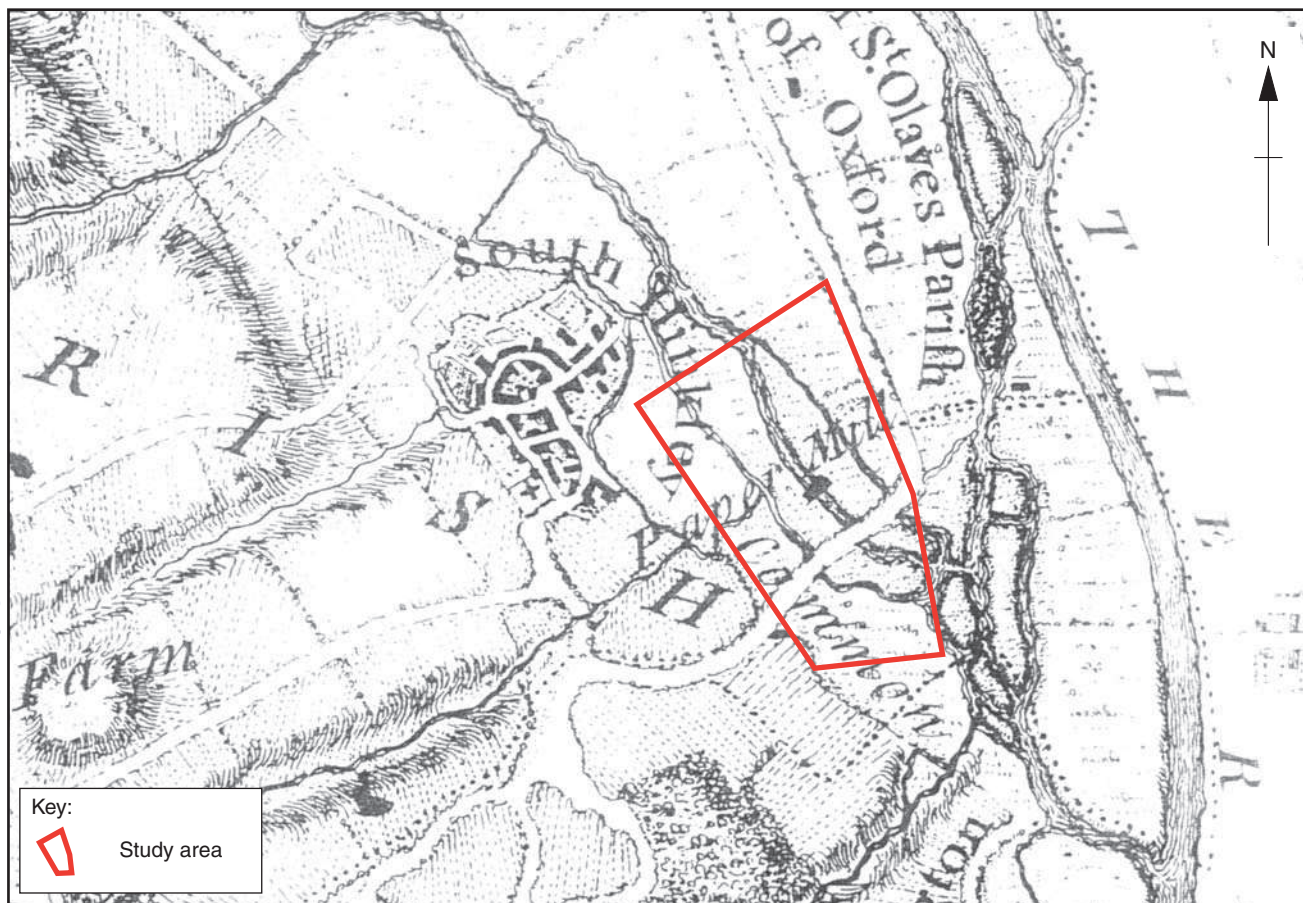
Figure 4: Rocque's map of Berkshire 1761

- 4.5.1 Rocque's map of Berkshire of 1761 forms the next map in the sequence. Within the Study Area Hinksey Stream is depicted, split into the three courses suggested by the earlier New College map (OA 6). A further leat is shown skirting the eastern edge of the settlement of South Hinksey and defining the boundary to the east of the mill between the wet meadow land and the arable fields. The distinctive right-angled course of Abingdon Road crosses the streams. To the south of the bridge the mass of watercourses and islands are shown with land marked 'Common' along the west side. Further meadows are shown to the north of the Study Area. The mill (OA 1) is depicted to the north of the bridge flanked by two islands of land defined by the three streams. The mill is shown as a rectangular structure straddling the main, central watercourse and is labeled 'Paper Mill'. Therefore by 1761 the mill had ceased to be a corn mill and had converted to a paper mill.

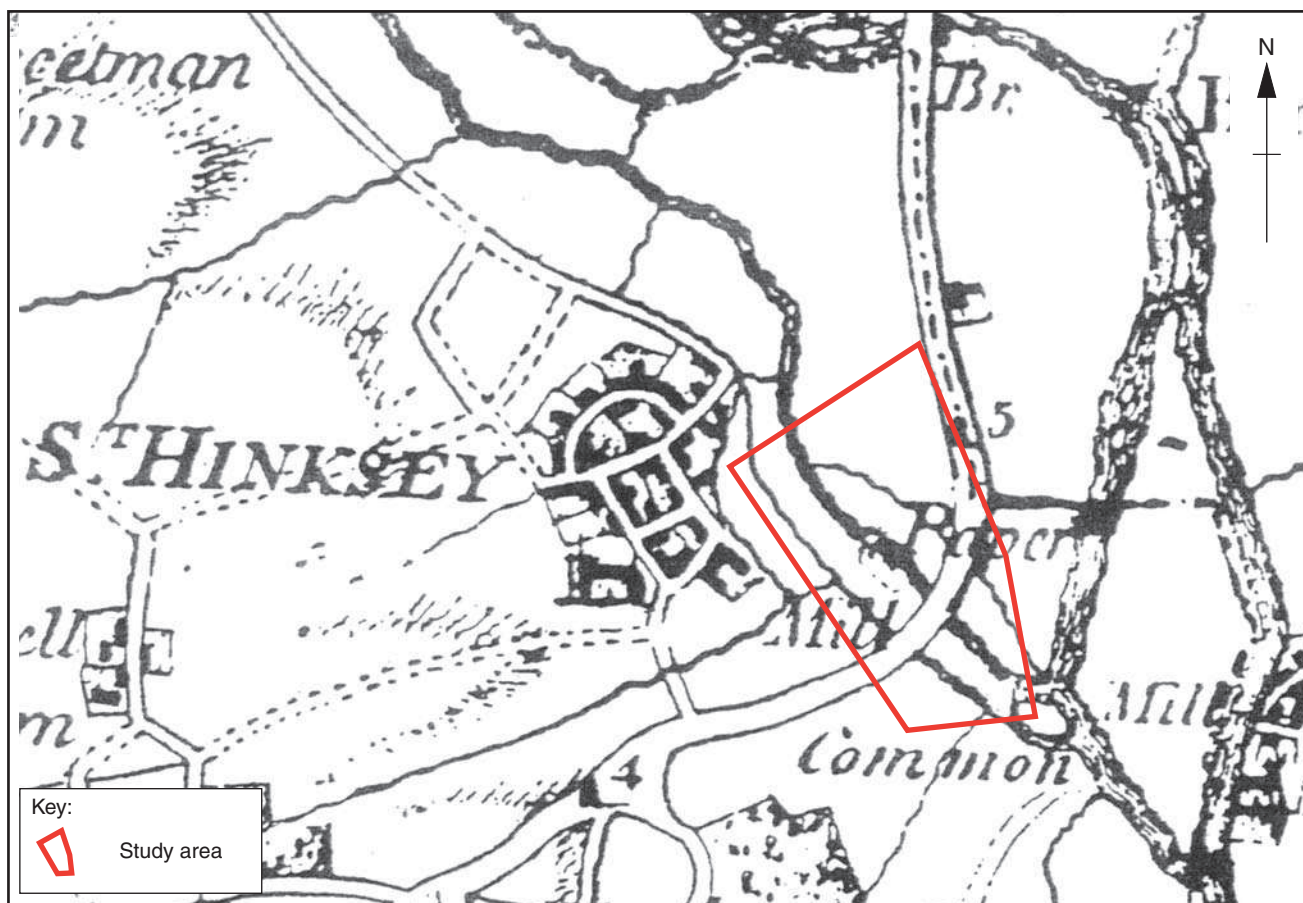
Figure 5: Andrew's and Drury's map of the country around London 1777

- 4.6.1 Andrew's and Dury's map of 1777 is at 1 inch to the mile scale and therefore provides less detail than Rocque's view. The mill, however, is depicted and labeled as 'Paper Mill'. The numerous watercourses to the south of the bridge are shown as three courses rather than the more complicated arrangement shown in Rocque. This

may be a simplification due to scale, or it may suggest that some degree of engineering or water management had been carried out between the surveys.

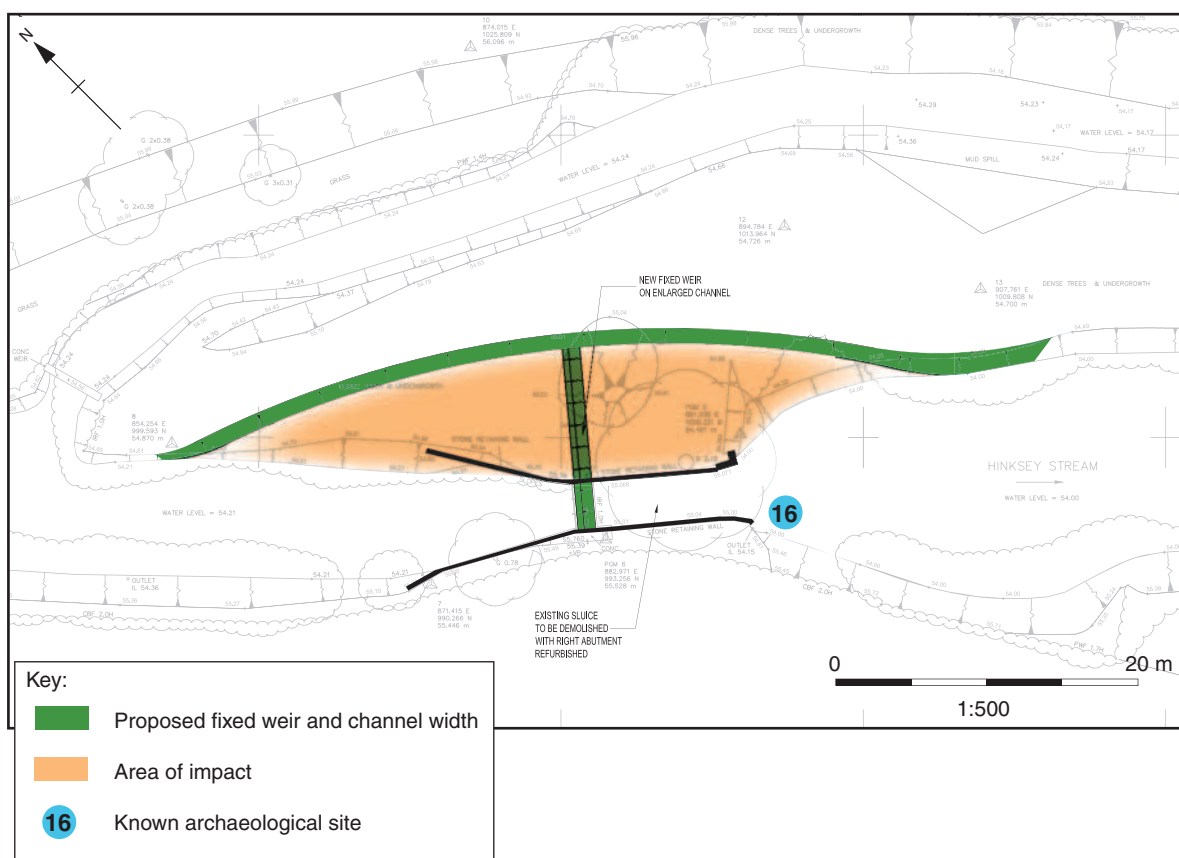
Figure 13: Atkins Oxford Feasibility Study, Towles Mill Sluice Improvements, Option 3

- 7.1.4 Option 3 is to replace the sluice entirely with a concrete Crump Weir (Figure 13). This involves the construction of a new weir on an enlarged channel involving the removal of part of the right bank. The archaeological implications of this option are significant with the total loss of the historic ashlar retaining wall on the east side of the main channel. The area of the island to be removed to form the new enlarged channel includes the mound (OA 17) identified during the walkover survey and is likely to contain below-ground remains from the sequence of mill buildings on the site. Further assessment is recommended to provide information on survival and significance of any archaeological remains, and to inform detailed design. If significant remains were identified and preservation *in situ* could not be guaranteed then mitigation, which is likely to involve recording of the ashlar retaining walls, and excavation and/or watching brief on remains possibly surviving behind these walls would be expected.

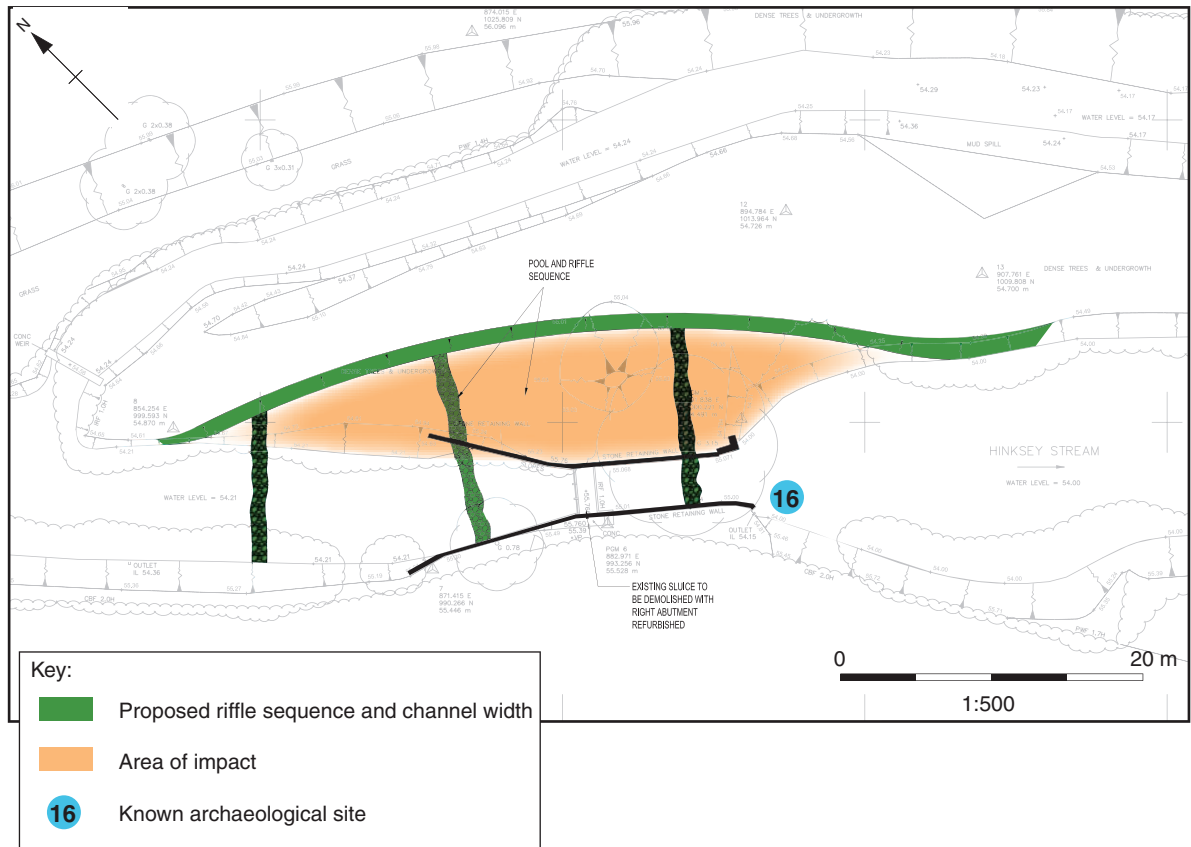
Figure 14: Atkins Oxford Feasibility Study, Towles Mill Sluice Improvements, Option 4

- 7.1.5 Option 4 is to replace the sluice entirely with a riffle (Figure 14). This involves the construction of three linear constructions across an enlarged channel. This has largely the same archaeological implications as Option 3 with the same area of the right bank being lost to create the enlarged channel. Three times as much impact is likely on the left bank, including on the historic ashlar retaining wall, due to the three constructions rather than the single weir construction of Option 3. These impacts are, however, not likely to be extensive. If this Option were chosen it is likely that archaeological mitigation would be required as outlined for Option 3.

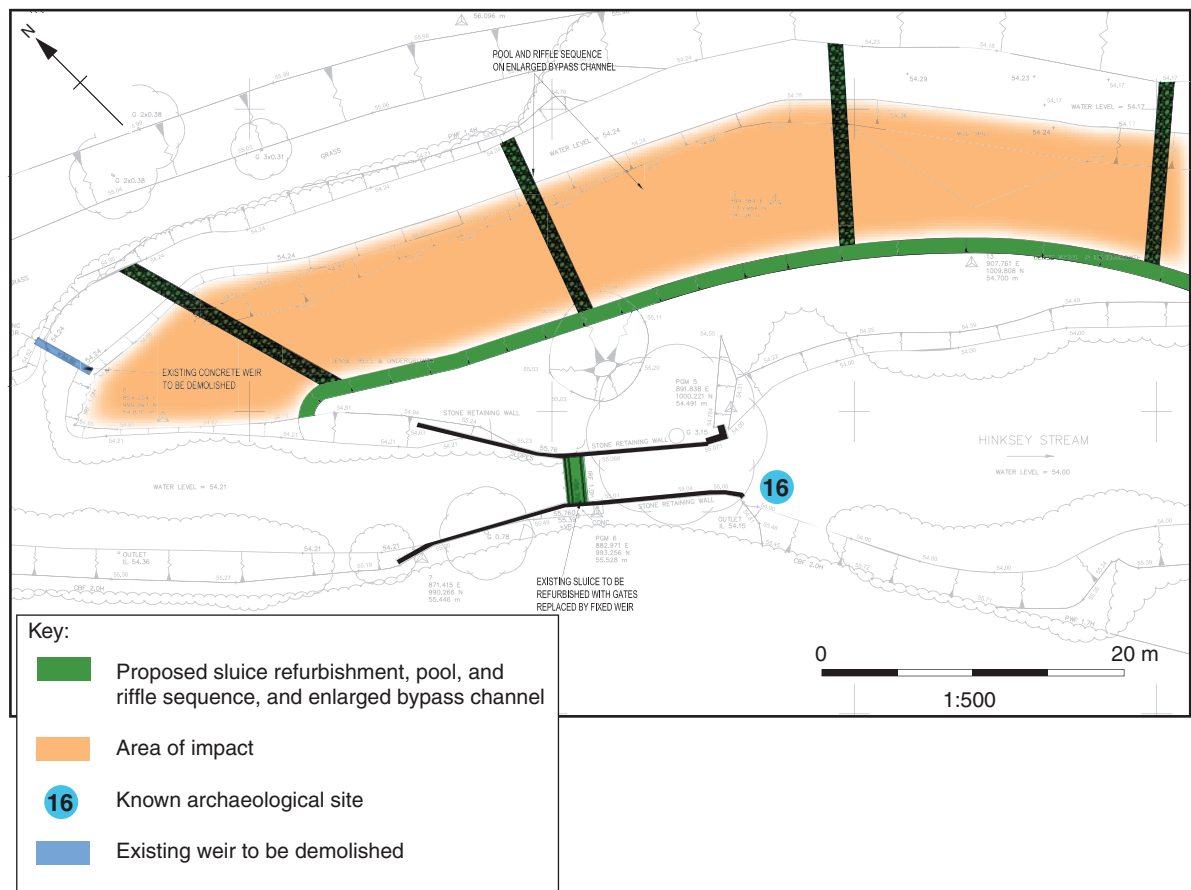
Figure 15: Atkins Oxford Feasibility Study, Towles Mill Sluice Improvements, Option 5

- 7.1.6 Option 5 suggests a larger scale of works with the replacement of the existing sluice with a fixed overfall weir and the enlargement of the side channel to the east of the main Hinksey Stream (Figure 15). The archaeological benefits of this option is that the historic ashlar retaining walls are retained as are the historic mill remains that may survive immediately behind. However, the enlargement of the side channel has greater impact on the site of the mill buildings known on the island from the historic map sequence. If this Option were chosen further assessment would be recommended to define the specific limits of any mill structure or archaeological deposit, as outlined for Options 3 and 4.

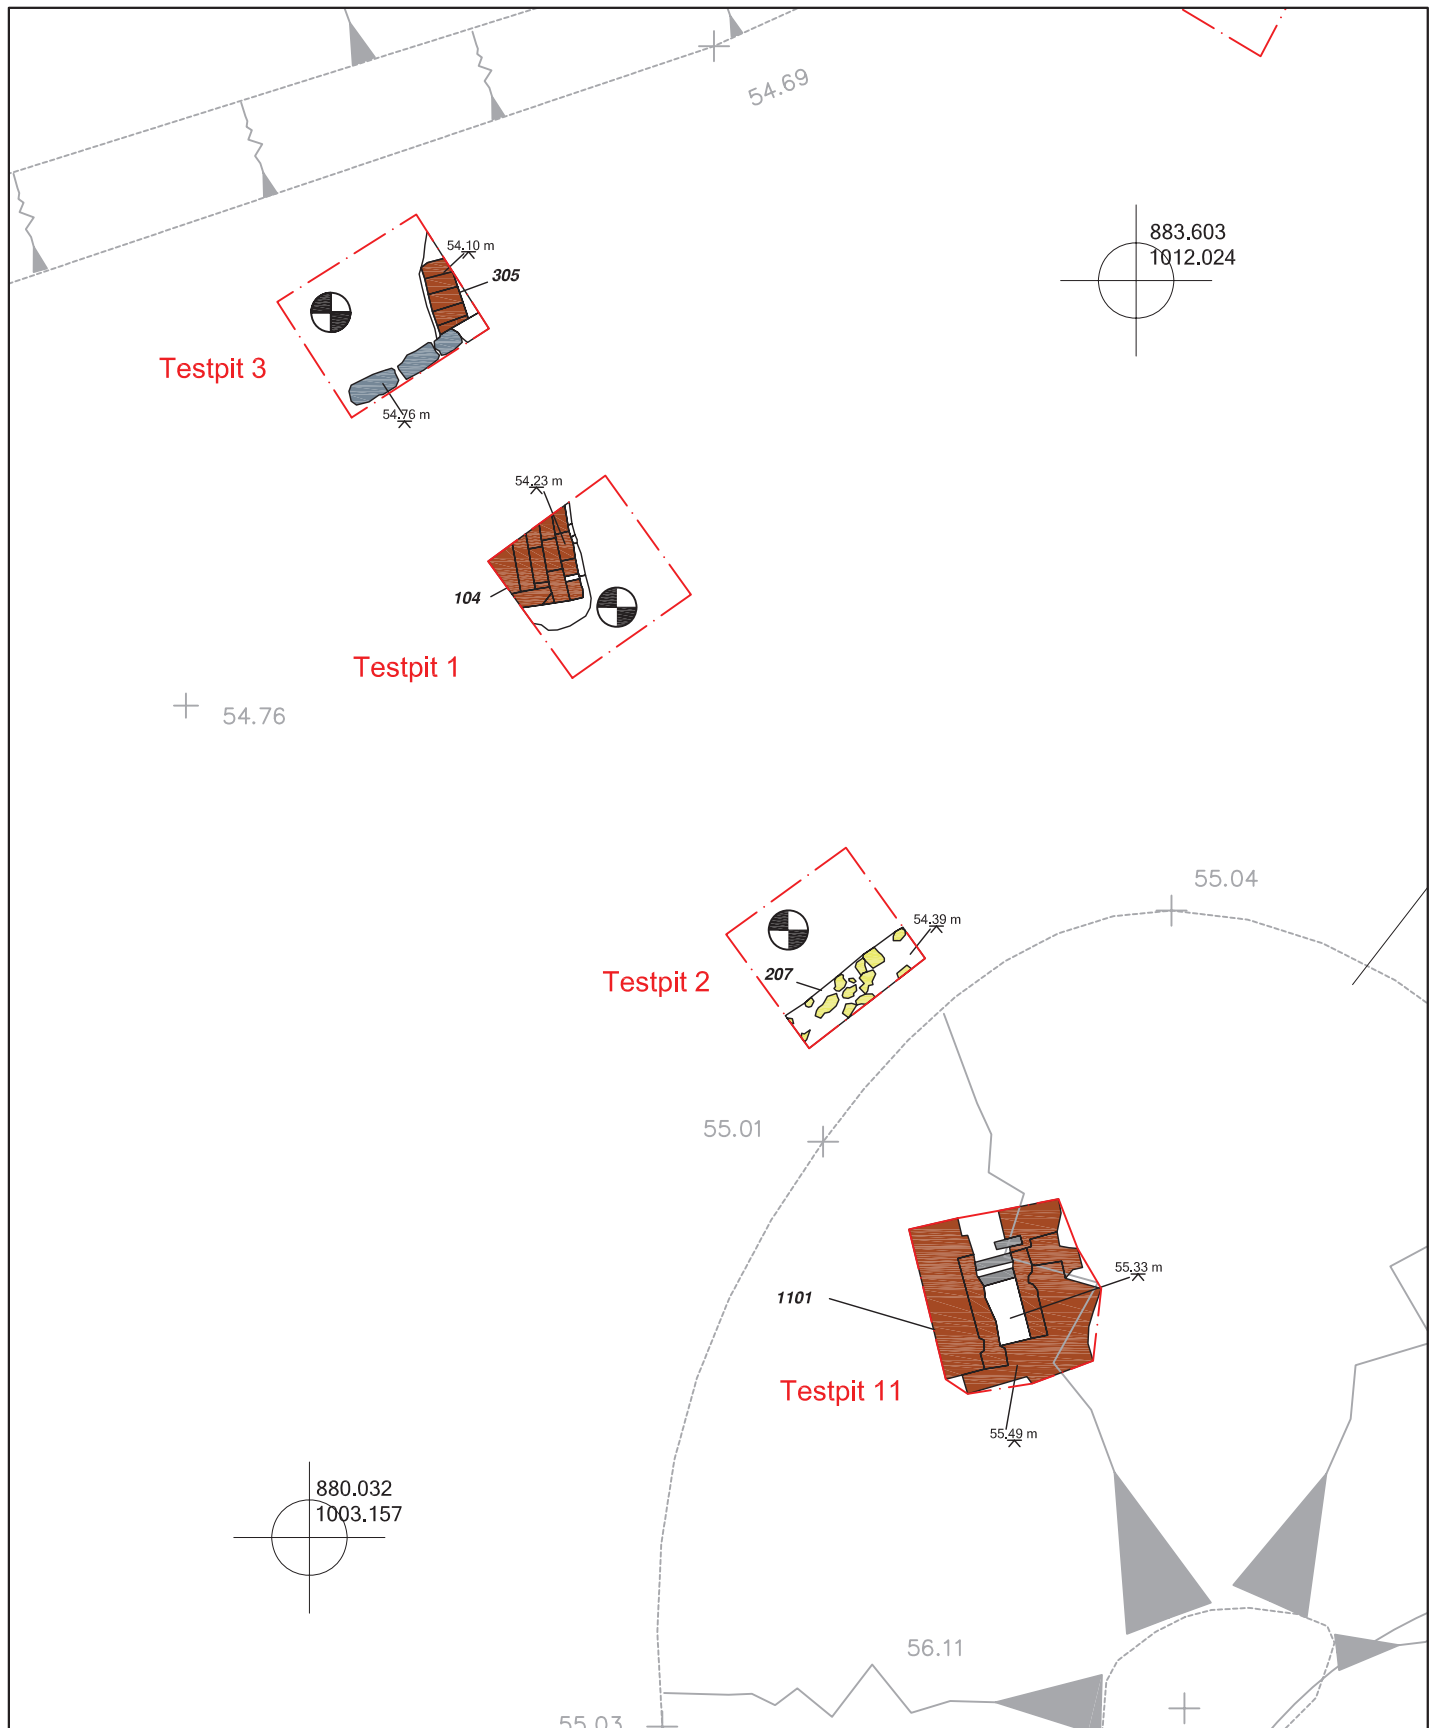
Figure 17: Detail Plan of Test-pits on the historic footprint of the mill building

Trench 11 was located within the ivy-covered mound and revealed extant mill structure 1101. This brick structure formed a U shaped housing around some rusted iron fittings mortared into the brick for strength. The bricks were 7 - 8 cm thick indicating an 18/19th century date. Immediately to the north Test pit 2 revealed a truncated linear foundation

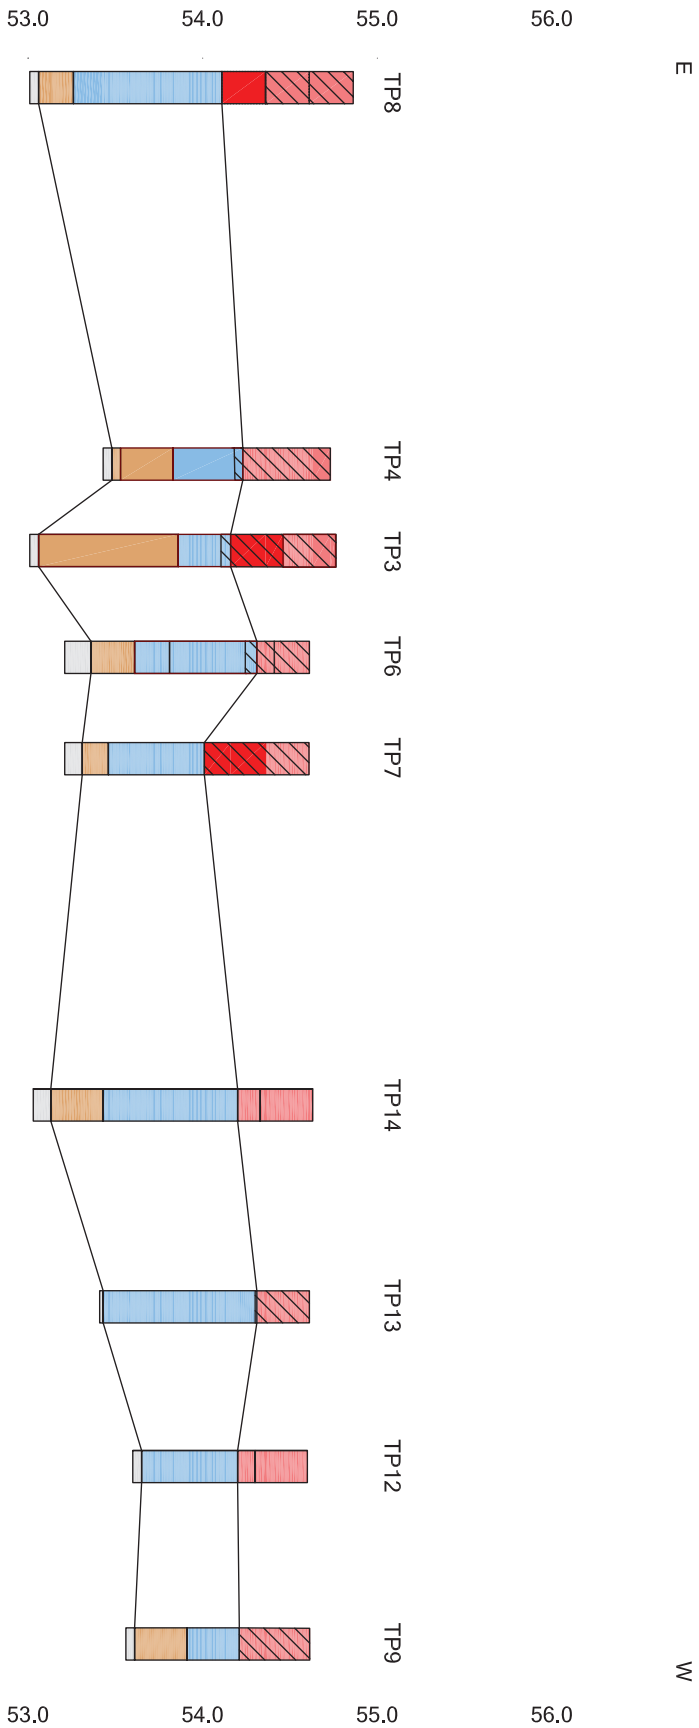
Figure 18 Stratigraphy and correlation of boreholes at Towles Mill

Boring was not possible below the sands and gravels at the base of the boreholes. This coarse sedimentary unit was encountered at *c* 53.06m in BHs 3, 8 and 14, appearing to rise slightly between these points. The apparently raised basal unit in BH4 (*c* 53.43m OD) may have been caused by an obstruction to the auger rather than true variation in the height of the gravels.

In general, a slight rise in the height of the gravel is observed to the south of the site to *c* 53.60m OD.

Variations in sediment thickness and consistency are largely attributed to local topography. For example, thicker organic alluvial clays noted in BH3 from *c* 53.86m to 53.06 m OD (Log 3) may have accumulated in a local depression. Alternatively, increased erosion prior to overbank deposition in the surrounds may have resulted in observed deposit thickness. The lack of organic alluvial clay sediments in BHs 12 and 13 and the height of the gravels suggests that this area was subject to increased erosion until surrounding flood deposits were able to build up, or remained dry until alluvial flood deposits encroached.

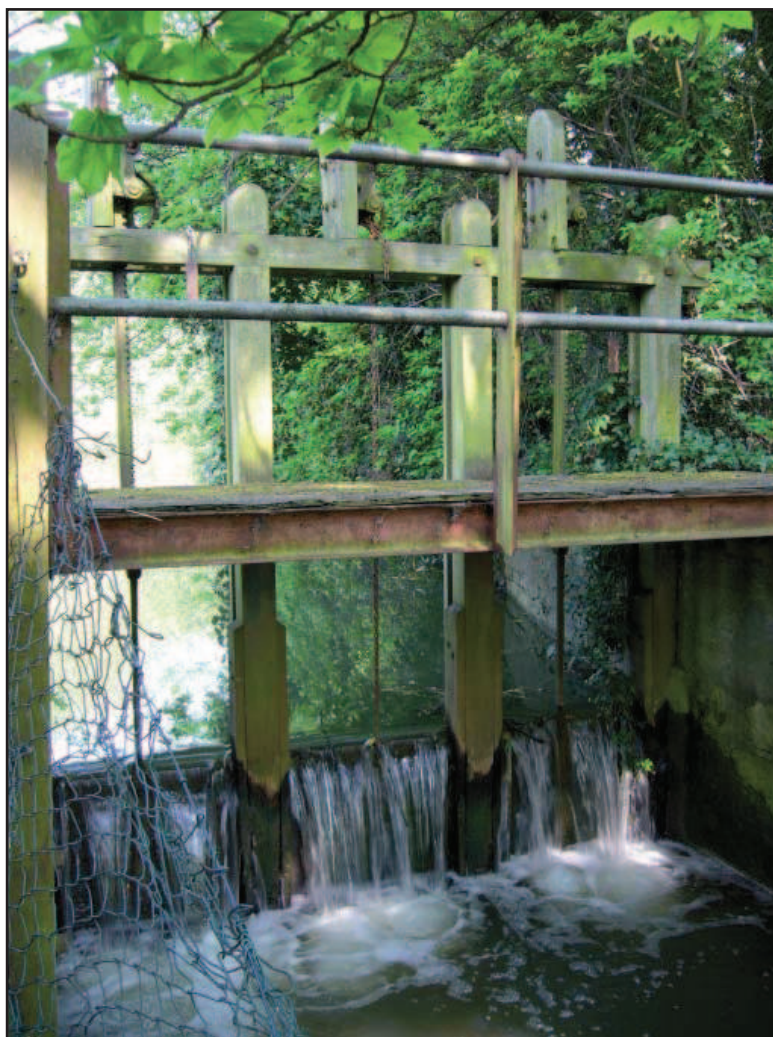
Plate 2: Towles Mill sluice (OA15)

- 5.1.3 The construction of the sluice itself was investigated (OA 15, Plate 2). The relatively crisp condition of the timber of the structure and the metal work of the ratchet system did not suggest a great age for this feature and it was seen to be associated with concrete repairs to the side of the channel. It is likely to be the sluice first shown on the 1971 OS 25" map which was surveyed in 1960 (Fig 12). Dairy Crest may hold records relating to its construction or upkeep that may more securely date this feature.

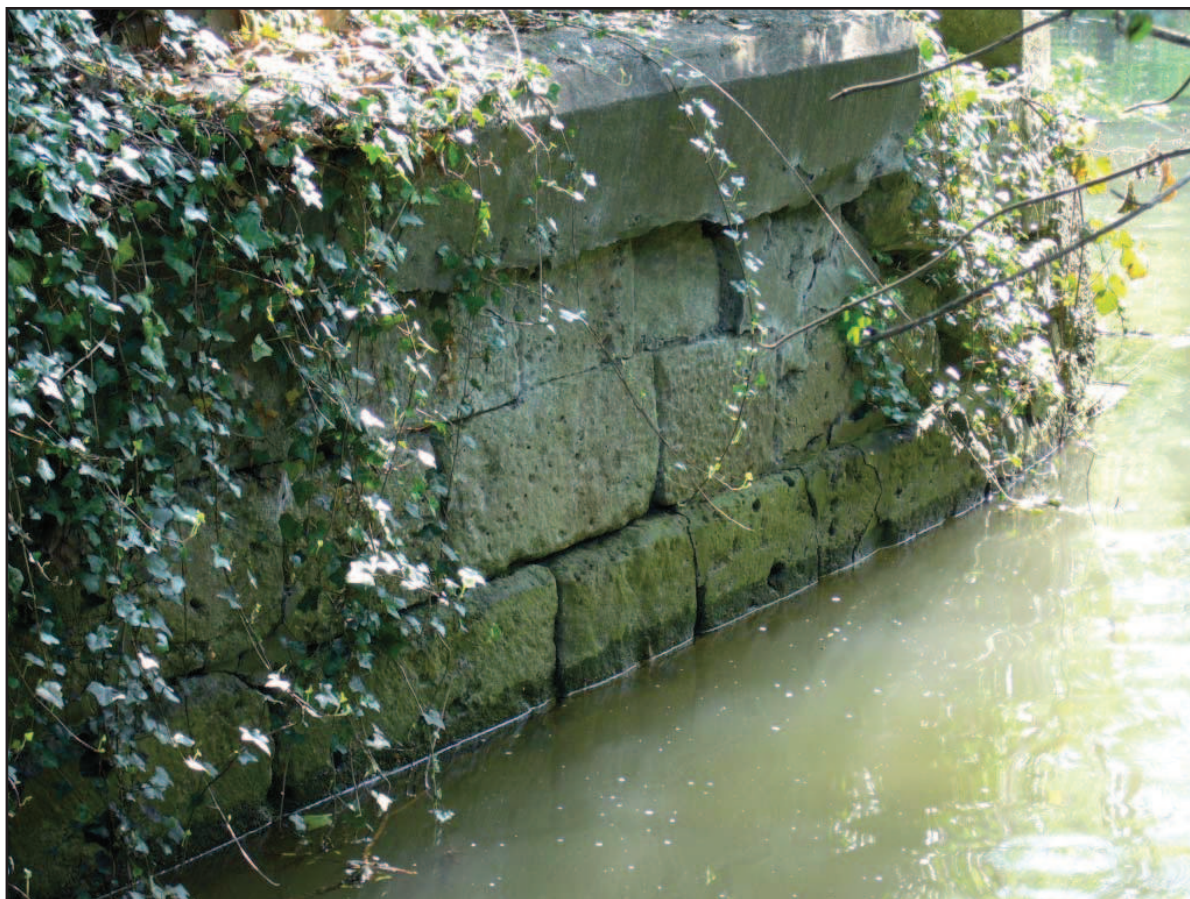
Plate 3: High quality historic ashlar watercourse retaining walls (OA16)

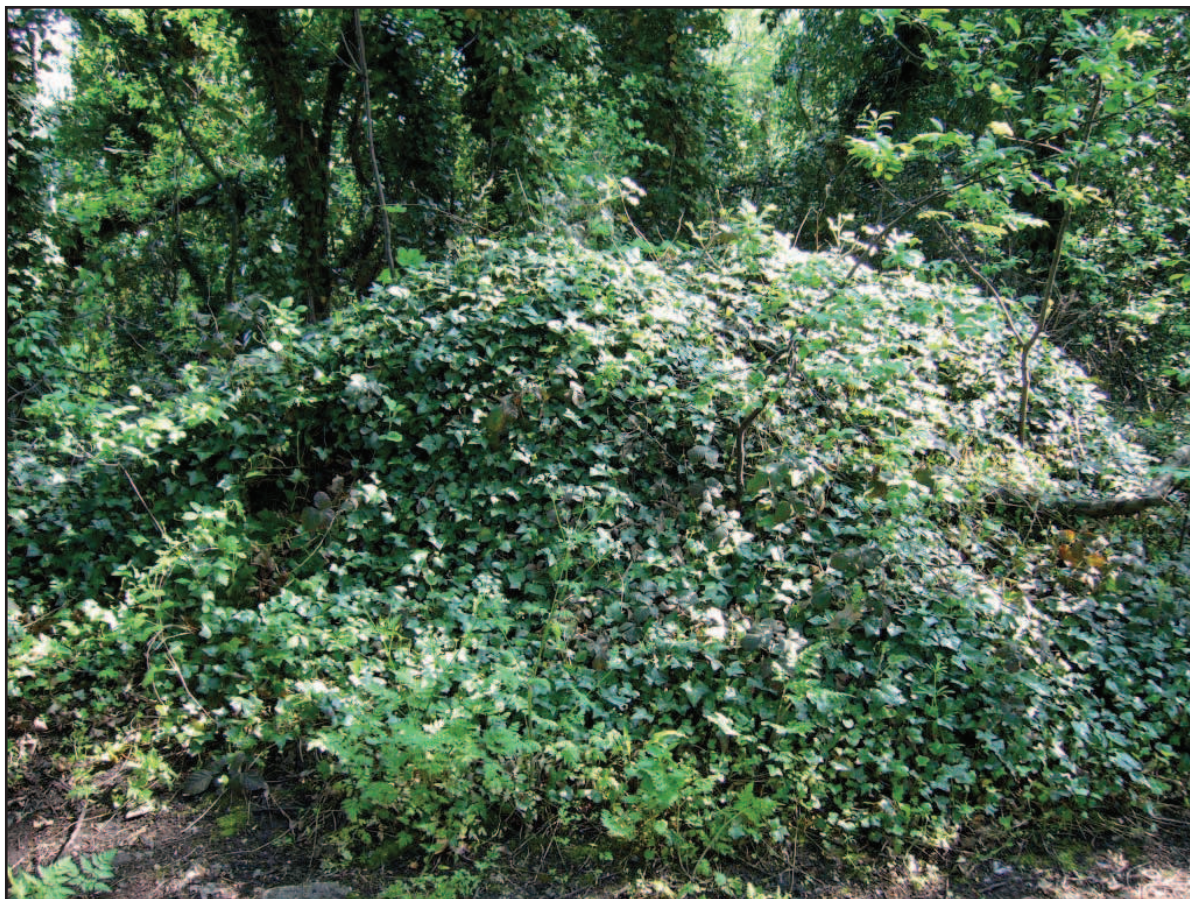
Plate 4: Mound indicating possible building remains (OA17)

- 5.1.5 Immediately opposite the sluice, on the island in between the channels, a large ivy-covered mound was observed (**OA 17**, Plate 4). Rapid investigation suggests that this represents the remains of a structure (possibly that shown in this location on the 1971 OS map (Fig 12)). The mound may represent a pile of demolition material from this structure but has the potential to disguise something beneath, possibly extant mill structure. Building materials including asbestos sheet roofing, a large metal bolt and a fragment of thick glass milk bottle marked 'County' were observed during this rapid investigation (and replaced).

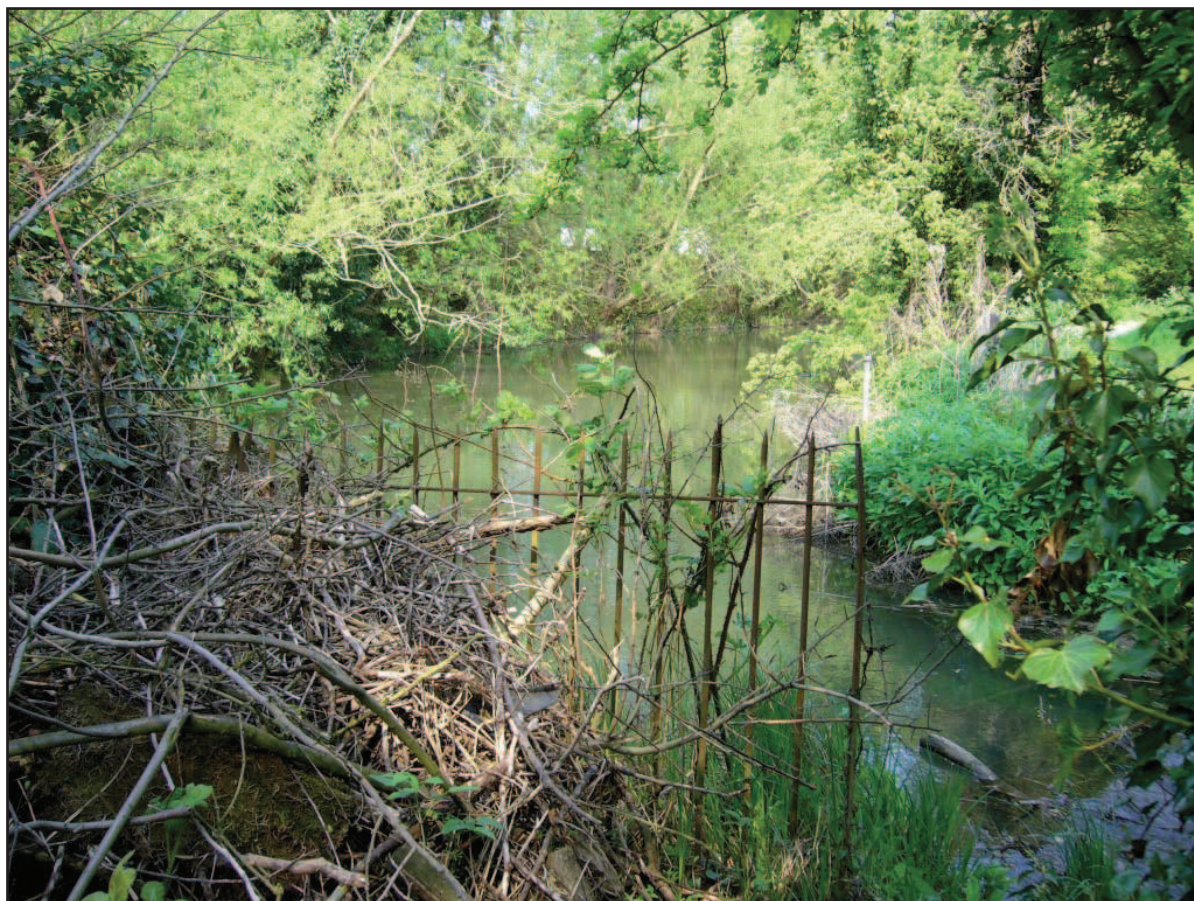
Plate 5: Length of historic railing at north end of island (OA18)

- 5.1.6 A length of historic iron railing (**OA 18**, Plate 5) was observed at the northern end of the island close to the weir crossing the eastern mill leat (**OA 7**, Plate 6). No built element was observed at the point where the leat rejoins the main channel at the southern end of the island.

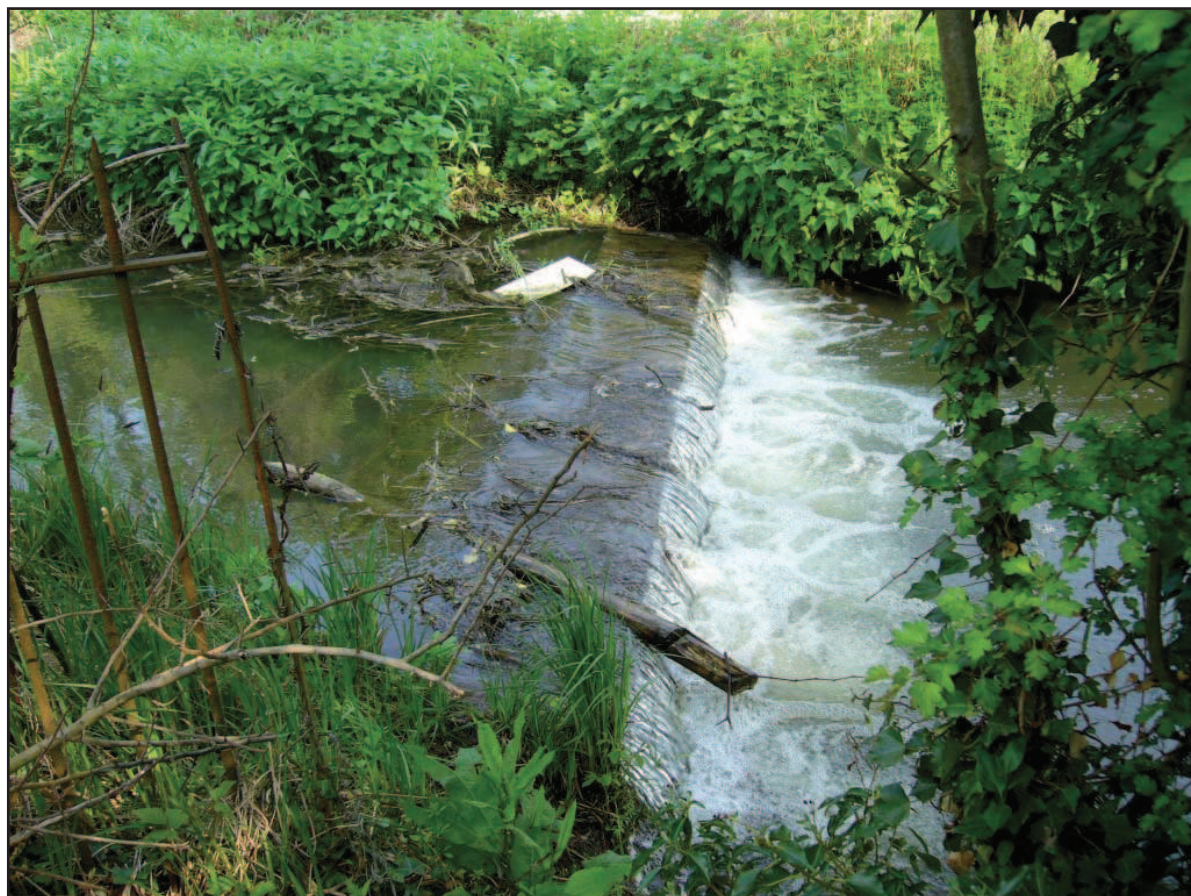
Plate 6: Weir crossing eastern mill leat at north end of island (OA7)
