St Peter's Church Stoke Lyne Oxfordshire

Archaeological Watching Brief Report

October 2007

Client: Parochial Church Council

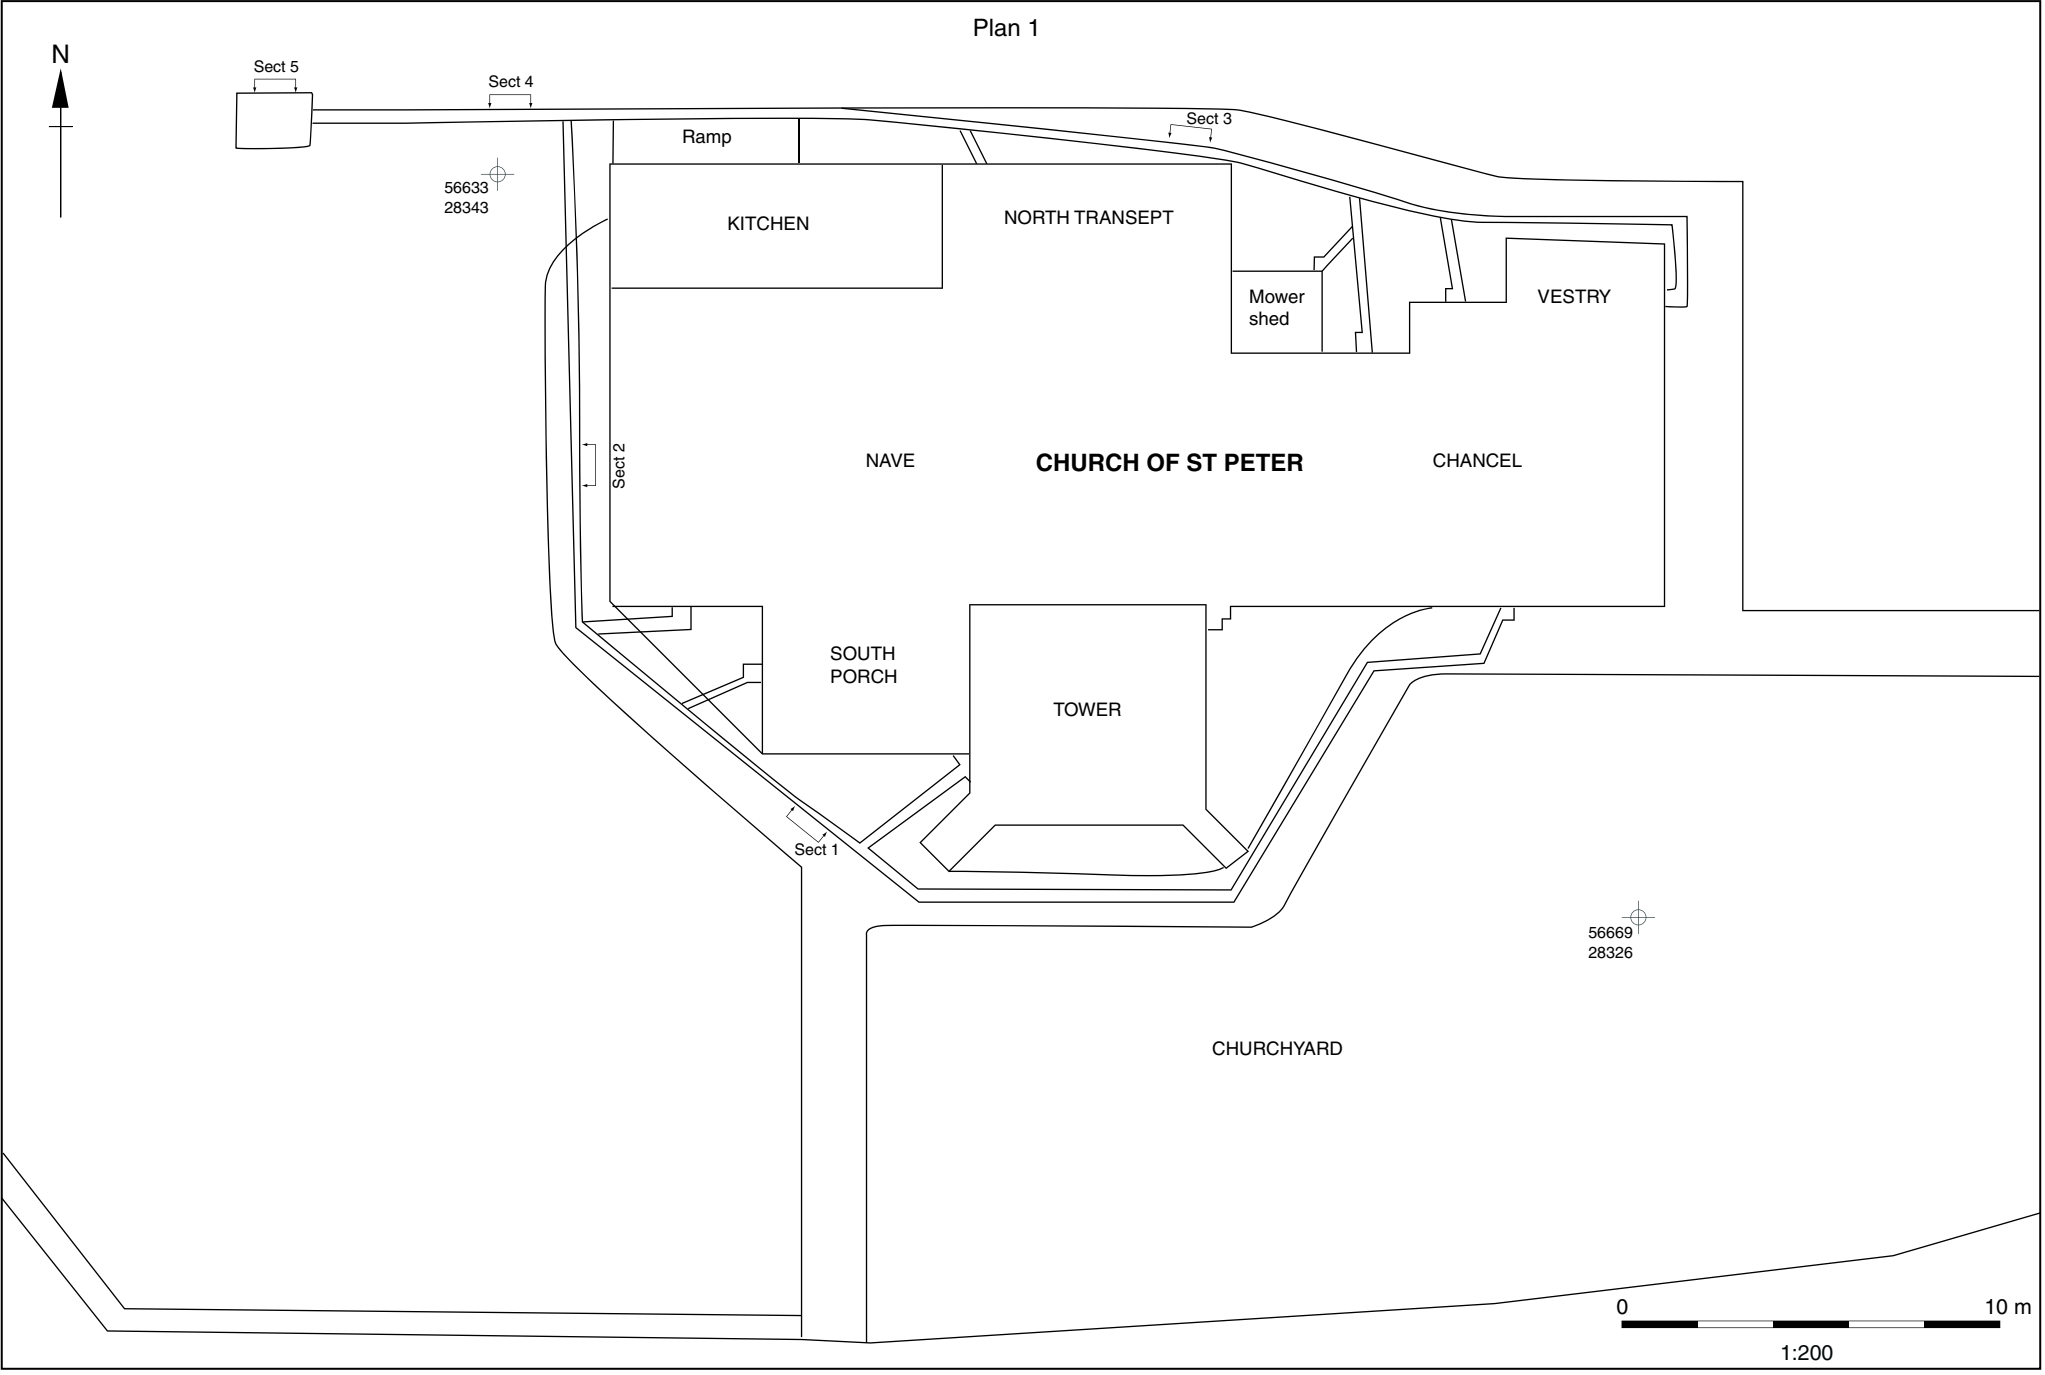
Figure 2 : Site plan showing extent of works

- 2.2.1 The majority of the trenching was excavated using a mechanical excavator fitted with a 0.5 m wide toothless bucket, with hand digging used to supplement this adjacent to the church walls. The watching brief was conducted as a series of site visits during the period of ground works.

- 2.2.2 A plan showing the extent and location of any excavations was maintained at a scale of 1:100 and where recorded any sections were drawn at a scale of 1:20. All excavations and recorded sections were photographed using colour slide and black and white print film. A general photographic record of the work was also made. Recording followed procedures detailed in the *OA Field Manual* (ed. D Wilkinson, 1992).

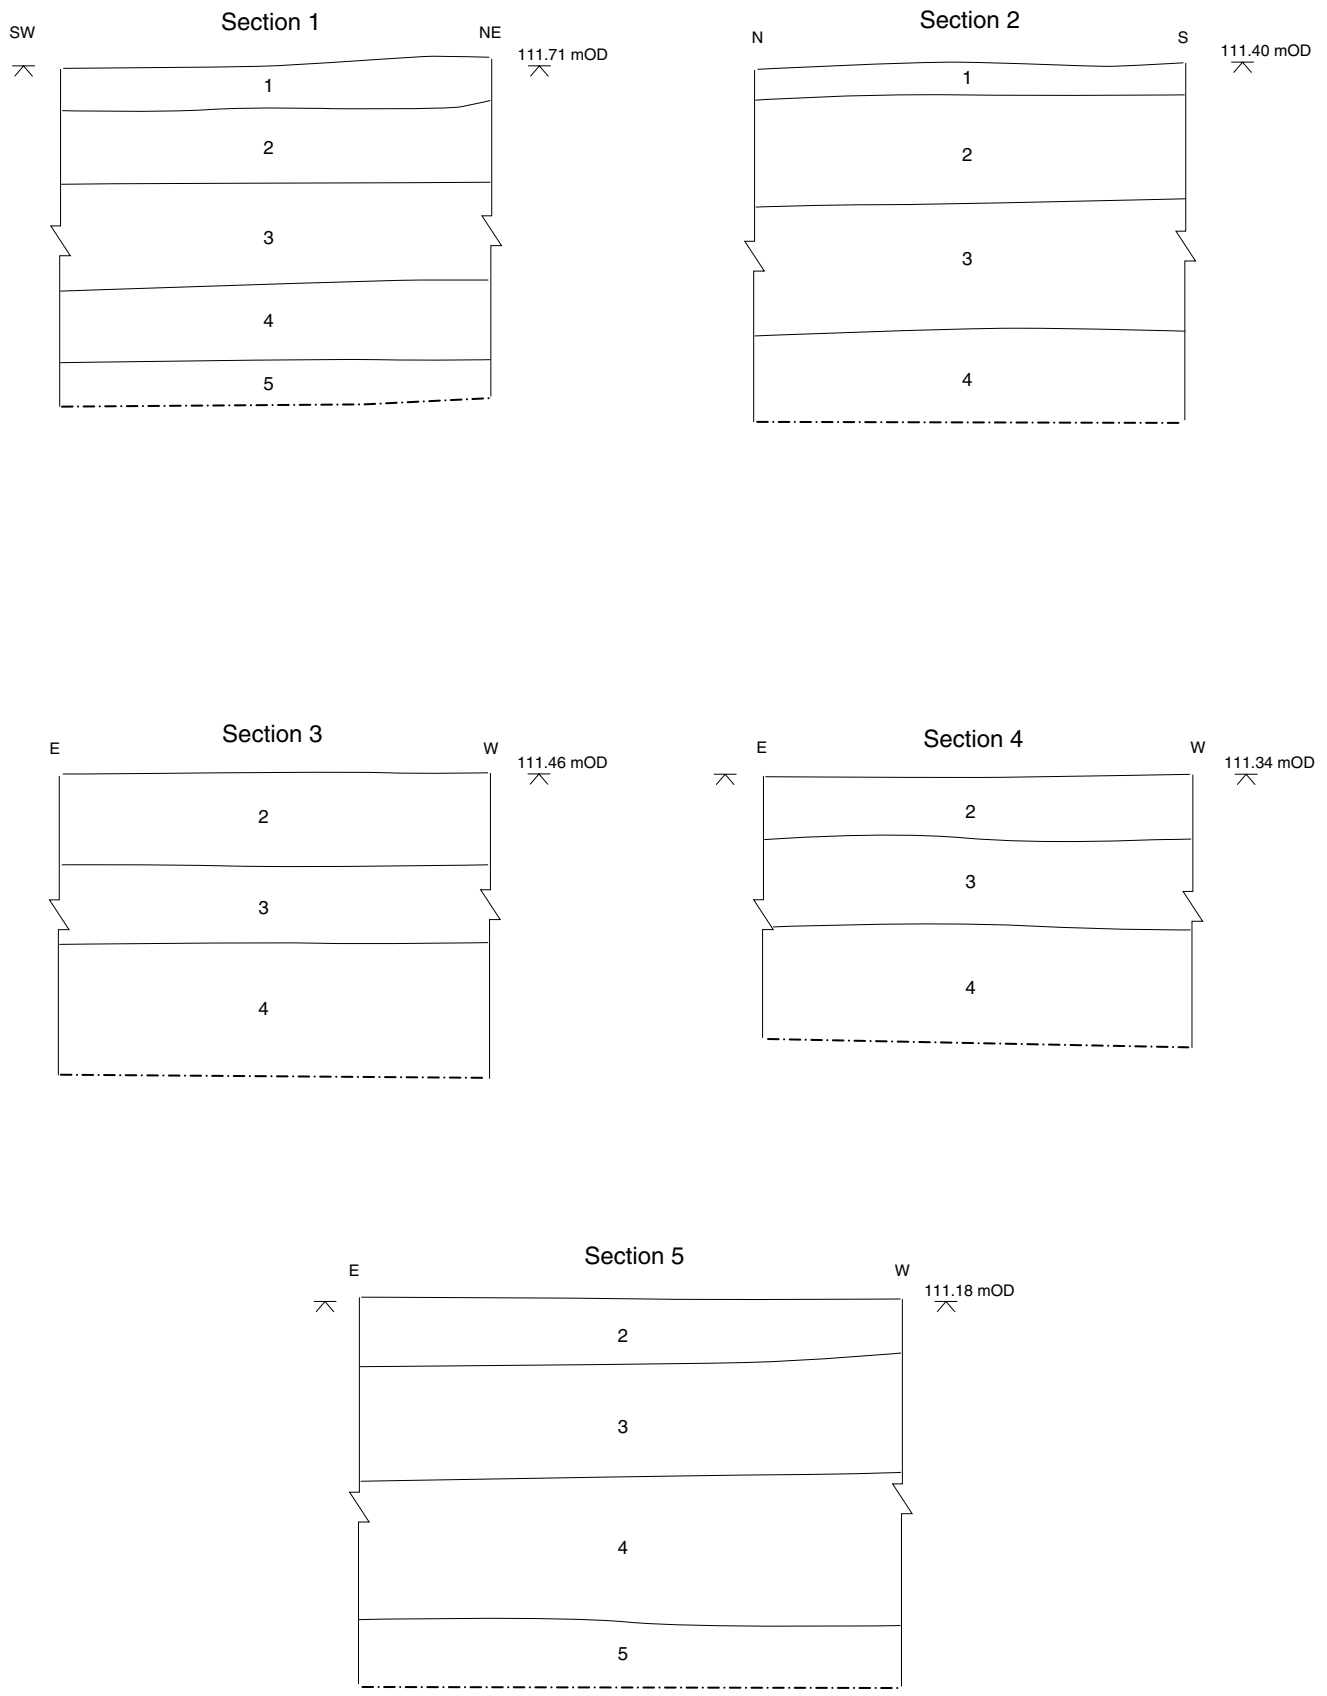
Figure 3 : Sections 1-5

- 3.1.1 At the base of the deepest excavation (for the soakaway pit) the underlying natural, a tabular limestone in a yellow-brown clay matrix (5), was encountered at a depth of 1.2 m below ground level (Fig. 3, section 5). This was overlaid by a layer of dark orange-brown silt clay (4) which measured up to 0.6 m in depth (Fig. 3, sections 1 to 5). This deposit contained numerous angular fragments of limestone and represents a layer of weathered natural. This layer was encountered throughout the length of the excavation.

- 3.1.2 Overlying this was a layer of orange-brown clay silt (3), measuring between 0.3 m and 0.4 m in depth. This layer contained small sub-angular fragments of limestone and represents a subsoil, probably an earlier churchyard soil. Two fragments of charnel (unarticulated bone) were recovered from this context and were reburied *in-situ*. Sealing this deposit was a layer of grey-brown silt loam (2), measuring between 0.3 m and 0.4 m in depth. This deposit also contained small sub-angular fragments of

limestone and represents the present day churchyard soil and turf. Several abraded fragments of charnel (unarticulated bone) were recovered from this deposit and were reburied *in-situ*.

- 3.1.3 On the south, east and west sides of the church layer 2 was overlaid by a 0.1 m deep layer of compacted pea gravel (1) (Fig. 3, sections 1 and 2), which formed a pathway encircling the church.

- 4.1.1 The watching brief showed evidence of two phases of activity within the churchyard as evidenced by the two layers of churchyard soil, 2 and 3. No evidence was encountered for any of the earlier phases of church construction and no articulated inhumations were encountered.
