County Square
Land off Elwick Road
Ashford
Kent

Archaeological Evaluation Report

Document Title: County Square, Land off Elwick Road, Ashford, Kent

Document Type: Evaluation

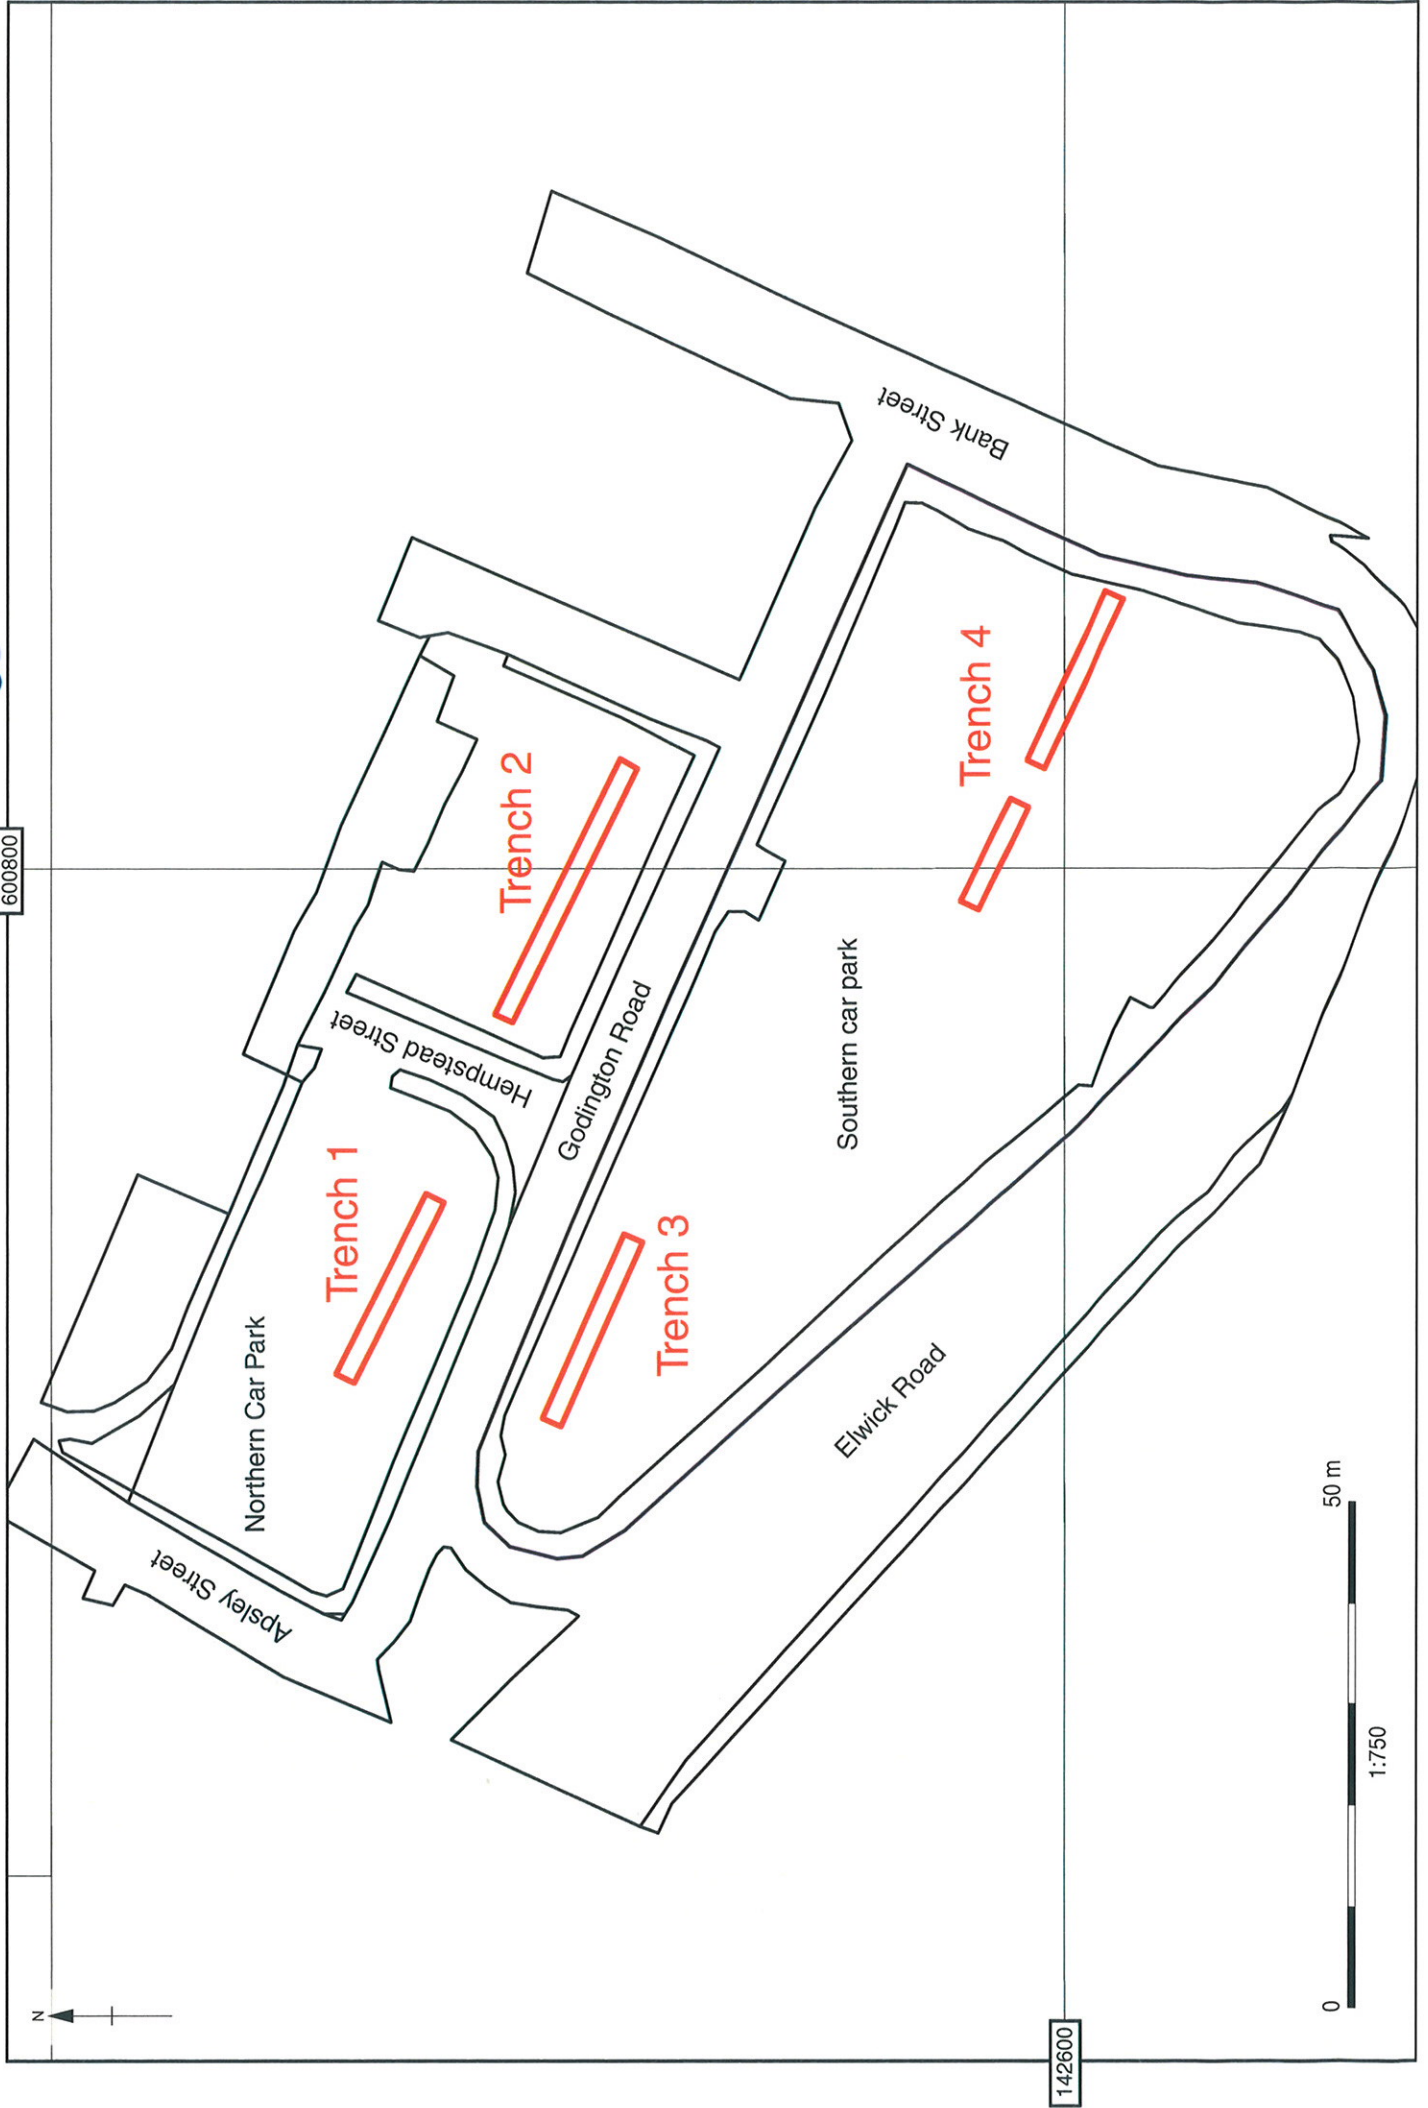
Figure 2: Trench location plan

- 3.1.1 The investigation consisted of four evaluation trenches; the location of each was agreed with the County Archaeologist prior to the start of the evaluation. Trenches 1 and 2 were located in the northern car park and Trenches 3 and 4 were located in the southern car park (Fig. 2).

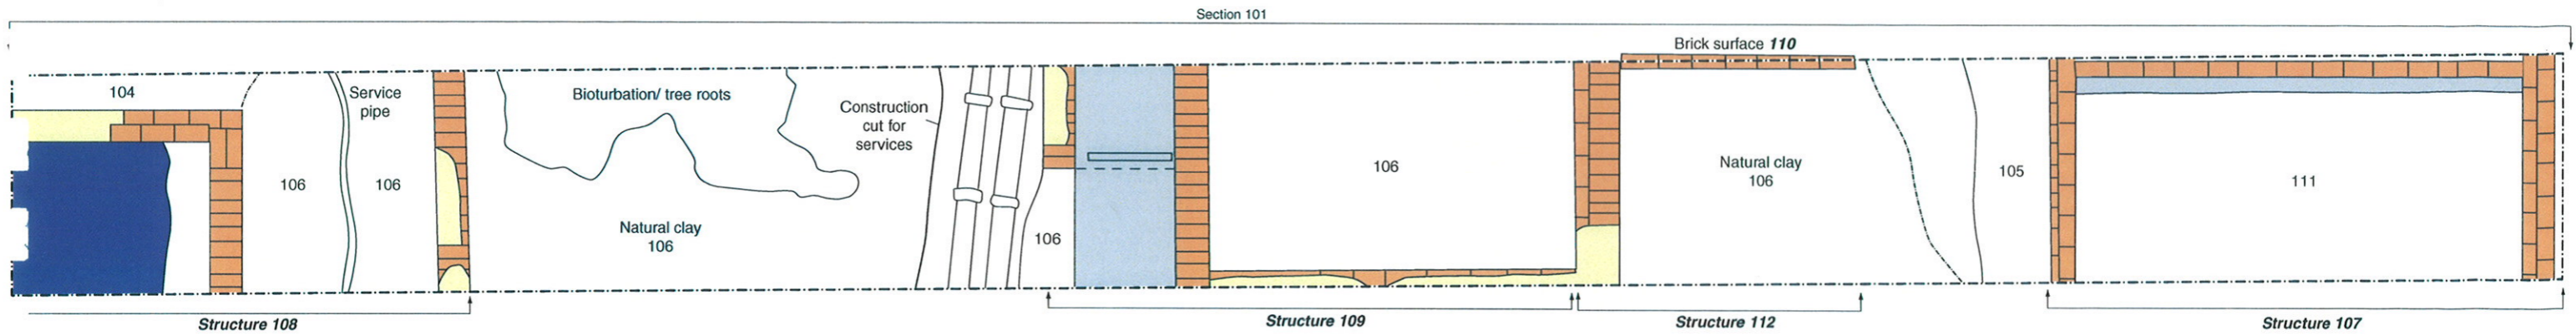
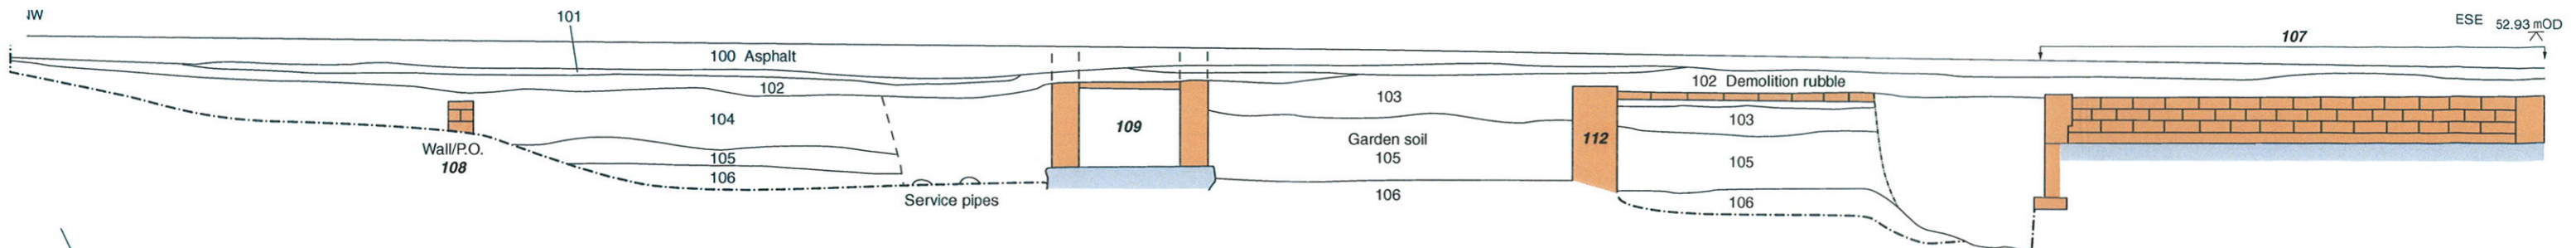
Trench 1 Plan

- 4.2.1 Trench 1 was oriented WNW-ESE and was located on the western corner of Hempsted Street and Godington Road. The trench was excavated to an average depth of 1.2 m throughout (see Plate 3).

- 4.2.2 Natural clay (106) was encountered at the bottom of the trench. It was disturbed slightly by bioturbation at the western end of the trench, but was otherwise fairly clean throughout. The natural was directly overlain by a layer of mid brown clay loam (105) with an average depth of 0.5 m. This layer was mixed throughout and represents an accumulated garden soil or former plough soil.

- 4.2.3 Deposit 105 was overlain by layers 103 and 104 which were friable, mottled light and mid brown clay loams and are probably the same re-deposited and mixed garden soil which had subsequently been disturbed and cut by the construction of brick structures 107, 108, 109 and 112.

- 4.2.4 Structure 108 probably was the earliest of the structures encountered and was constructed of red bricks (measuring 235 mm x 110 mm x 70 mm) laid in an English bonding pattern and bonded with a mid brown lime mortar. The structure probably represented the easternmost of a row of Victorian terrace houses which were located on the northern side of Godington Road (see Plate 5).

- 4.2.5 Structure 109, wall 112 and brick surface 110 represented elements of the same building. Structure 109 and wall 112 were constructed of red bricks (measuring 225 mm x 110 mm x 70 mm) laid in alternate layers of headers and stretchers with a mid brown sandy cement mortar. The bricks survive to a depth of up to 10 courses and have been laid on a concrete foundation. Brick surface 110 was constructed of red brick (measuring 220 mm x 105 mm x 65 mm) and abutted the eastern face of wall 112. The surface had been laid on a layer of yellow sand bedding and represented a former internal surface. The structures described above were the remains of the former Invicta Public House, which was built in the latter part of the 19th century (see Plate 4).

- 4.2.6 Brick surface 110 was truncated on the eastern extent by a modern 20th century structure (107). The structure was constructed of red brick (measuring 225 mm x 110 mm x 70 mm) surviving to a height of eight courses, and was constructed on a concrete foundation.

- 4.2.7 Structures 107, 108, 109 and 112 were demolished and overlain by brick rubble throughout. The rubble layer 102 was subsequently overlain by limestone aggregate and two phases of asphalt surfaces laid out as part of the car parks in the 1960s and 1980s associated with the County Square shopping precinct (formally the Tufton centre).

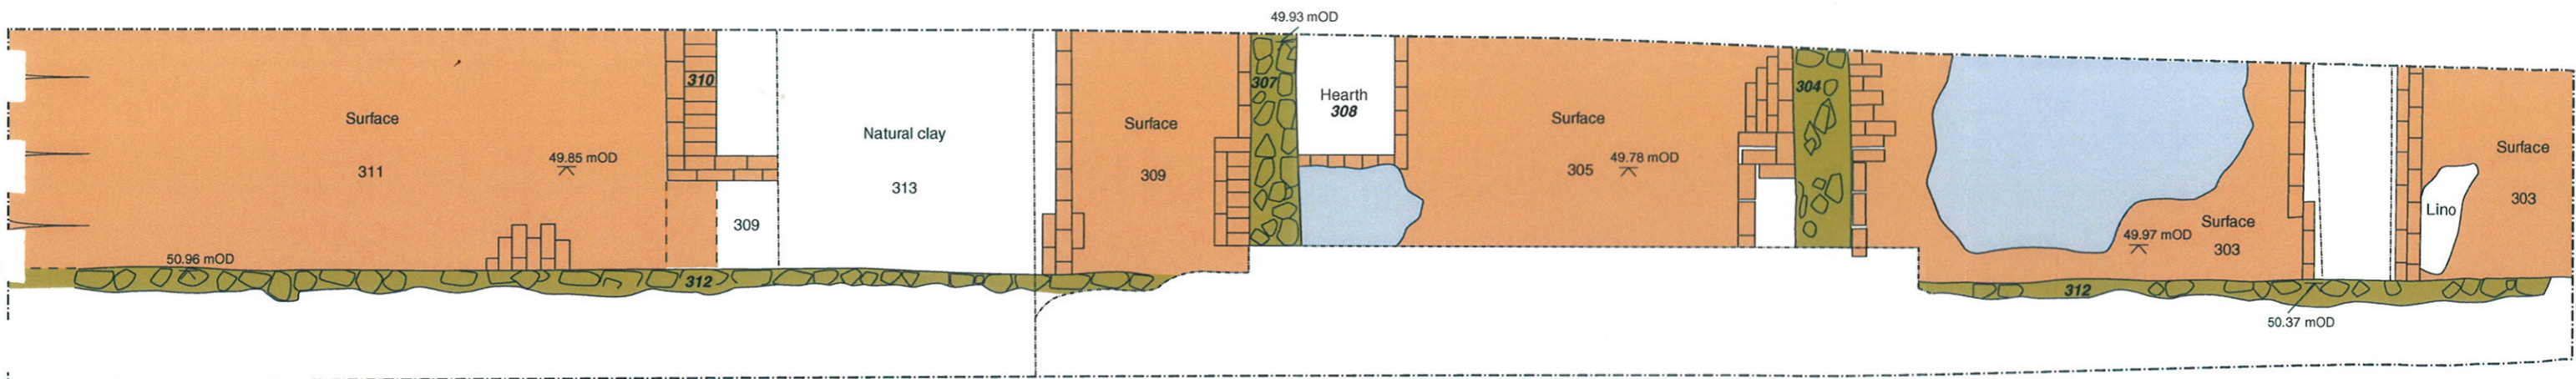
Trench 3 Plan

- 4.2.17 Trench 3 was oriented WNW-ESE and was located on the southern side of Godington Road. The trench was excavated to an average depth of 1.7 m throughout. The northern side of the trench was stepped to reduce the height of the overburden (Plate 7).

- 4.2.18 Natural clay (313) was encountered at the bottom of the trench in a single machine excavated sondage. Its upper limits were disturbed and stained. It was truncated by the construction cuts for walls 304, 307, 310, 312 which were the remains of a Victorian terrace housing that formally occupied the site and was called Hempsted Terrace (Plates 2 and 8).

- 4.2.19 The walls had the same construction technique and the same materials were used throughout. The internal walls 304 and 307 were constructed of roughly hewn Kentish Ragstone laid in fairly level courses, bonded with a soft light brown lime mortar. The walls were reduced to their foundation levels and only survived to a depth of two courses. They had an average width of 0.45 m and have each been

abutted on their western and eastern faces by internal red brick surfaces. Several courses of the external northern wall of the terrace houses survived at the eastern end of the trench, to approximately 1.10 m above the brick surfaces. The base of the wall within the machine excavated sondage had shallow foundations and was only cut into the natural clay 313 by 0.20 m below brick surface 311, at 49.0 m OD.

- 4.2.20 The terrace houses were constructed on ground that was sloping down to the south. Consequently the elevation at the front of the terrace were two floors high, while the rear of the terrace had an extra floor level and was three stories in height.

- 4.2.21 The red bricks (measuring 225 mm x 105 mm x 65 mm) from which the internal floor surfaces were constructed had the same dimensions throughout the trench. They had been laid on a shallow layer of yellow bedding sand directly above the natural clay. The internal surfaces were covered in places with a thin concrete screed and in the westernmost structure with linoleum. The surfaces increased in height slightly from west to east reflecting the original contours of the rise on which the terrace housing was built.

- 4.2.22 The terrace houses were demolished in the 1960s in advance of the construction of the Tufton centre and the truncation was extensive. The majority of the walls only remain in plan, having been demolished to the same height as the internal floor level.

- 4.2.23 The internal floor surfaces were overlain by a demolition rubble layer (302) which consisted of dark brown clay loam garden soil and mixed rubble throughout. The average depth of the deposit was 0.7 m throughout. Layer 302 was subsequently overlain by a 0.7 m thick layer of limestone aggregate (301), which formed the make-up for the 1960s asphalt car park surface.

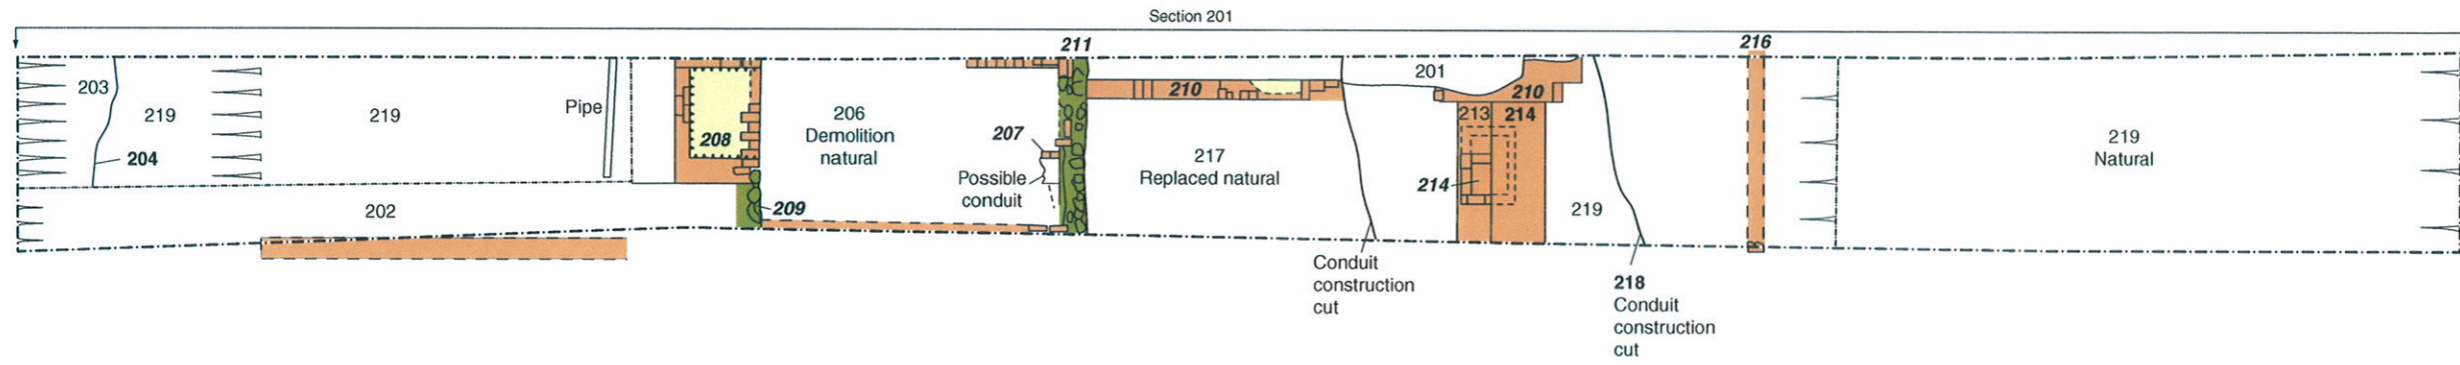
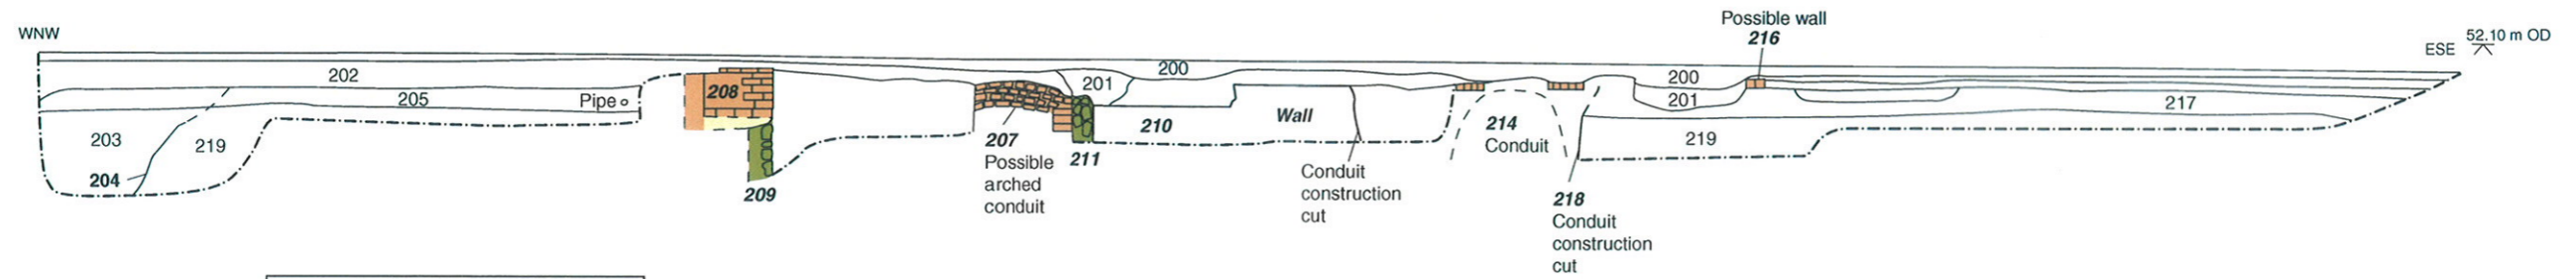
Trench 2 Plan

- 4.2.8 Trench 2 was oriented WNW-ESE and was located on the eastern corner of Hempsted Street and Godington Road. The trench was excavated to an average depth of 1.2 m throughout.

- 4.2.9 Natural clay (219) was encountered at the bottom of the trench. It was disturbed throughout the length of the trench. The natural was directly overlain by a layer of mid brown clay loam, with an average depth of 0.35 m, and represented by contexts 205, 211 and 217. The layer was mixed throughout and represented an accumulated garden soil or former plough soil.

- 4.2.10 This deposit was overlain by layer 202, which was a friable, mid brown clay loam and was likely to have been the same re-deposited and mixed garden soil. Deposit 202 was subsequently truncated by the construction of brick structure 208, the construction trench for brick conduit 214 and tree root disturbance 204 at the western end of the trench.

- 4.2.11 Structure 208 was constructed of red brick (measuring 230 mm x 110 mm x 70 mm) laid in an English Bond pattern and bonded with a sandy yellow brown lime mortar. The structure represented an L-shaped building, which was the former number 16 Godington Road, built after 1871 and which occupied the corner of Hempsted Street and Godington Road.

- 4.2.12 Structure 208 re-used an earlier wall (211) for its foundation. This earlier wall was constructed in fairly even courses of roughly hewn Kentish Ragstone, bonded with a soft light brown lime mortar and survived to a minimum height of 0.75 m. The wall represented the western wall of the former terrace house at number 14 Godington Road. The eastern wall of the house was represented by wall 211 and followed the same construction technique as 209.

- 4.2.13 Wall 211 was abutted by brick conduit 207 on the western face and brick wall 210 on the eastern face. Structure 207 was constructed of red brick (measuring 230 mm x 110 mm x 65 mm) laid in random courses and were bonded with a soft brown lime mortar. The bricks were constructed in a barrel vault form and probably represented a brick conduit. The structure was contemporary with structure 208.

- 4.2.14 Wall 210 was constructed of red brick (measuring 230 mm x 110 mm x 65 mm) laid in level courses in a random brick bonding pattern and were bonded with a soft brown lime mortar. The wall was probably contemporary with structure 208 and part of the house at number 12 Godington Road. The eastern extent was truncated by the construction cut for brick conduit 214.

- 4.2.15 The brick conduit was constructed of red brick (measuring 235 mm x 110 mm x 65 mm) laid in stretcher courses and were bonded with a soft light brown sandy lime mortar. The structure is believed to be late 19th or early 20th century in date.

- 4.2.16 All the structures within the trench had been demolished in the 1960's and were overlain and abutted by brick rubble throughout. The rubble layer 206 and 215 were subsequently overlain by limestone aggregate and two phases of asphalt surfaces laid out as part of the car parks in the 1960's and 1980's associated with the County Square shopping precinct (formally the Tufton centre).

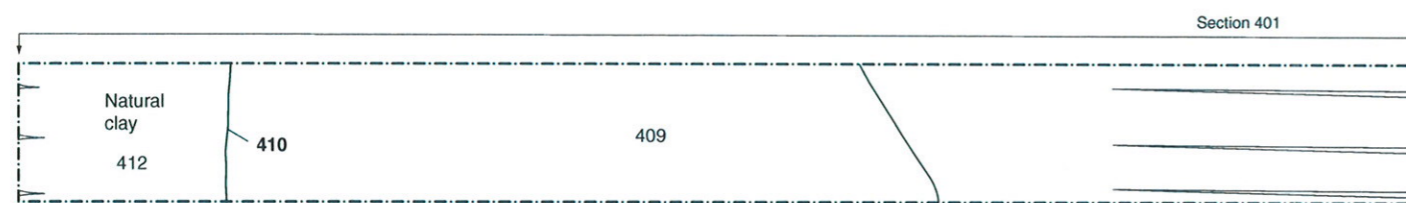
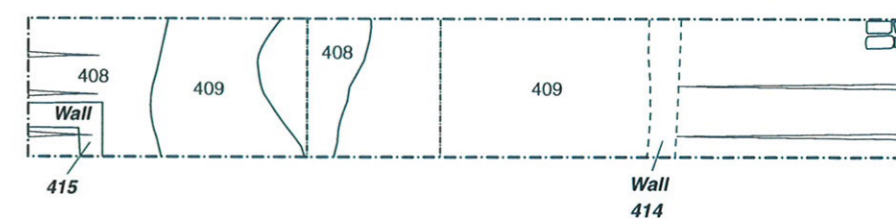
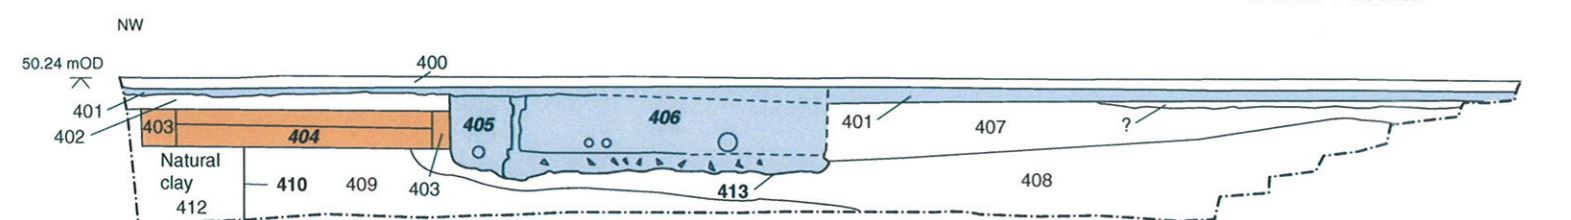
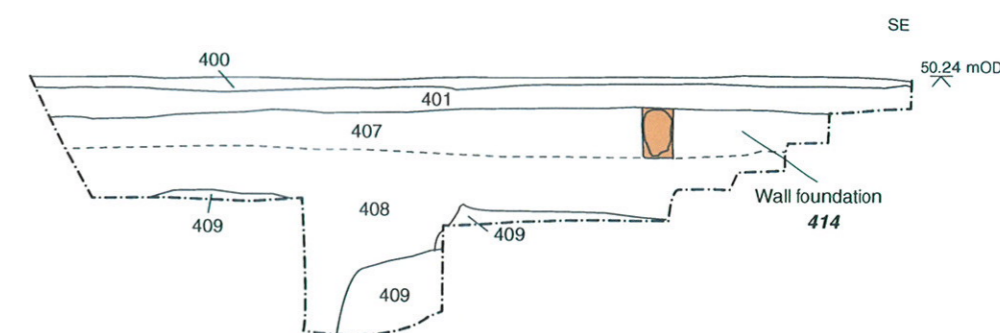
Figure 5 : Trench 4 plan and section

- 4.2.24 Trench 4 was oriented WNW-ESE and was located on the western side of the southern end of Bank Street on the former spur of Elwick Road. The trench was excavated to an average depth of 1.7 m throughout the trench. A machine excavated sondage at the western end was excavated to a depth of 3.4 m (46.84 m OD) (Plate 9).

- 4.2.25 Natural clay (412) was only visible at the eastern end of the trench where it was cut by feature 410, a large pit or truncation area.
- 4.2.26 Feature 410 had near vertical sides and was visible throughout the length of the trench. At the western end of the trench the truncation continued to a depth of 3.40 m below the existing ground level, and the base of the feature was not reached. The function of the pit is unknown and the date of excavation remains uncertain. The pit could reflect truncation in the 20th century or possibly a bomb crater from the Second World War. The pit was backfilled with two fills (409, 408). Deposit 409 was loose, light brown clayey silt with no visible inclusions and a minimum depth of 0.90 m. It was overlain by fill 408 which consisted of friable, mottled light and dark

brown clay and silt clay with an average depth of 0.8 m. This deposit was mixed throughout and could represent re-deposited garden soil and natural Weald Clay. Both deposits were contemporary and were rapidly deposited to backfill pit 410. Fill 408 was overlain by layer 407 and was also truncated by the construction cut for walls 403 and 404 at the eastern end of the trench.

- 4.2.27 Layer 407 was friable mid-dark brown clay loam and grey clay. The deposit probably represented accumulated garden soil which formed or was re-deposited after the backfill of pit/truncation 410.

- 4.2.28 Walls 403 and 404 were part of the same structure and were constructed of red brick (measuring 225 mm x 110 mm x 75 mm) laid in level courses in an English Bond and was bonded with a soft brown sandy lime mortar. The walls were probably constructed in the 20th century and were part of the Stanhay Works that produced agricultural machinery from the 19th century (Plates 10 and 11).

- 4.2.29 Red brick wall 414 at the western end of the trench had the same construction techniques as those seen in 403 and 404 and was also part of the Stanhay Works.

- 4.2.30 Structure 406 and 413 were similarly associated with the Stanhay Works and represented 20th century service pipe conduits. The conduits were overlain by a concrete floor layer 401 which was subsequently overlain by the asphalt car park surface.

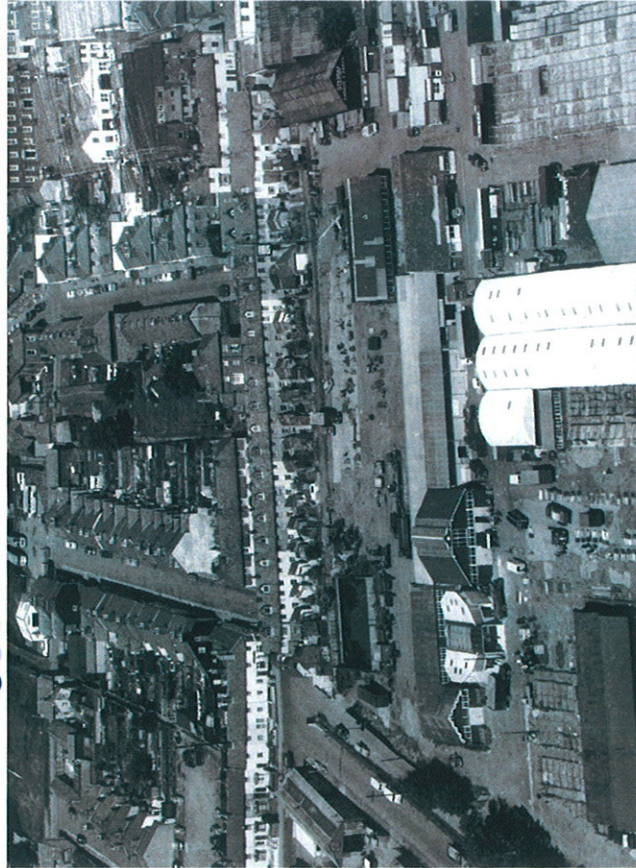
Plate 2: Aerial photograph of Godington Road and Hampstead Street (1963)

- 1.3.4 The construction of terraced houses with associated roads and services in the 1860s and their subsequent demolition in the 1970s for the construction of Elwick Road and its adjacent areas of car parking, is likely to have destroyed any remaining archaeological potential (see Plates 1 and 2, aerial photographs).
