Hill Farm Little Wittenham Oxfordshire

Archaeological Investigation Report

April 2004

Hill Farm, Little Wittenham, Oxfordshire
ARCHAEOLOGICAL CHARACTERISATION TEST PIT REPORT

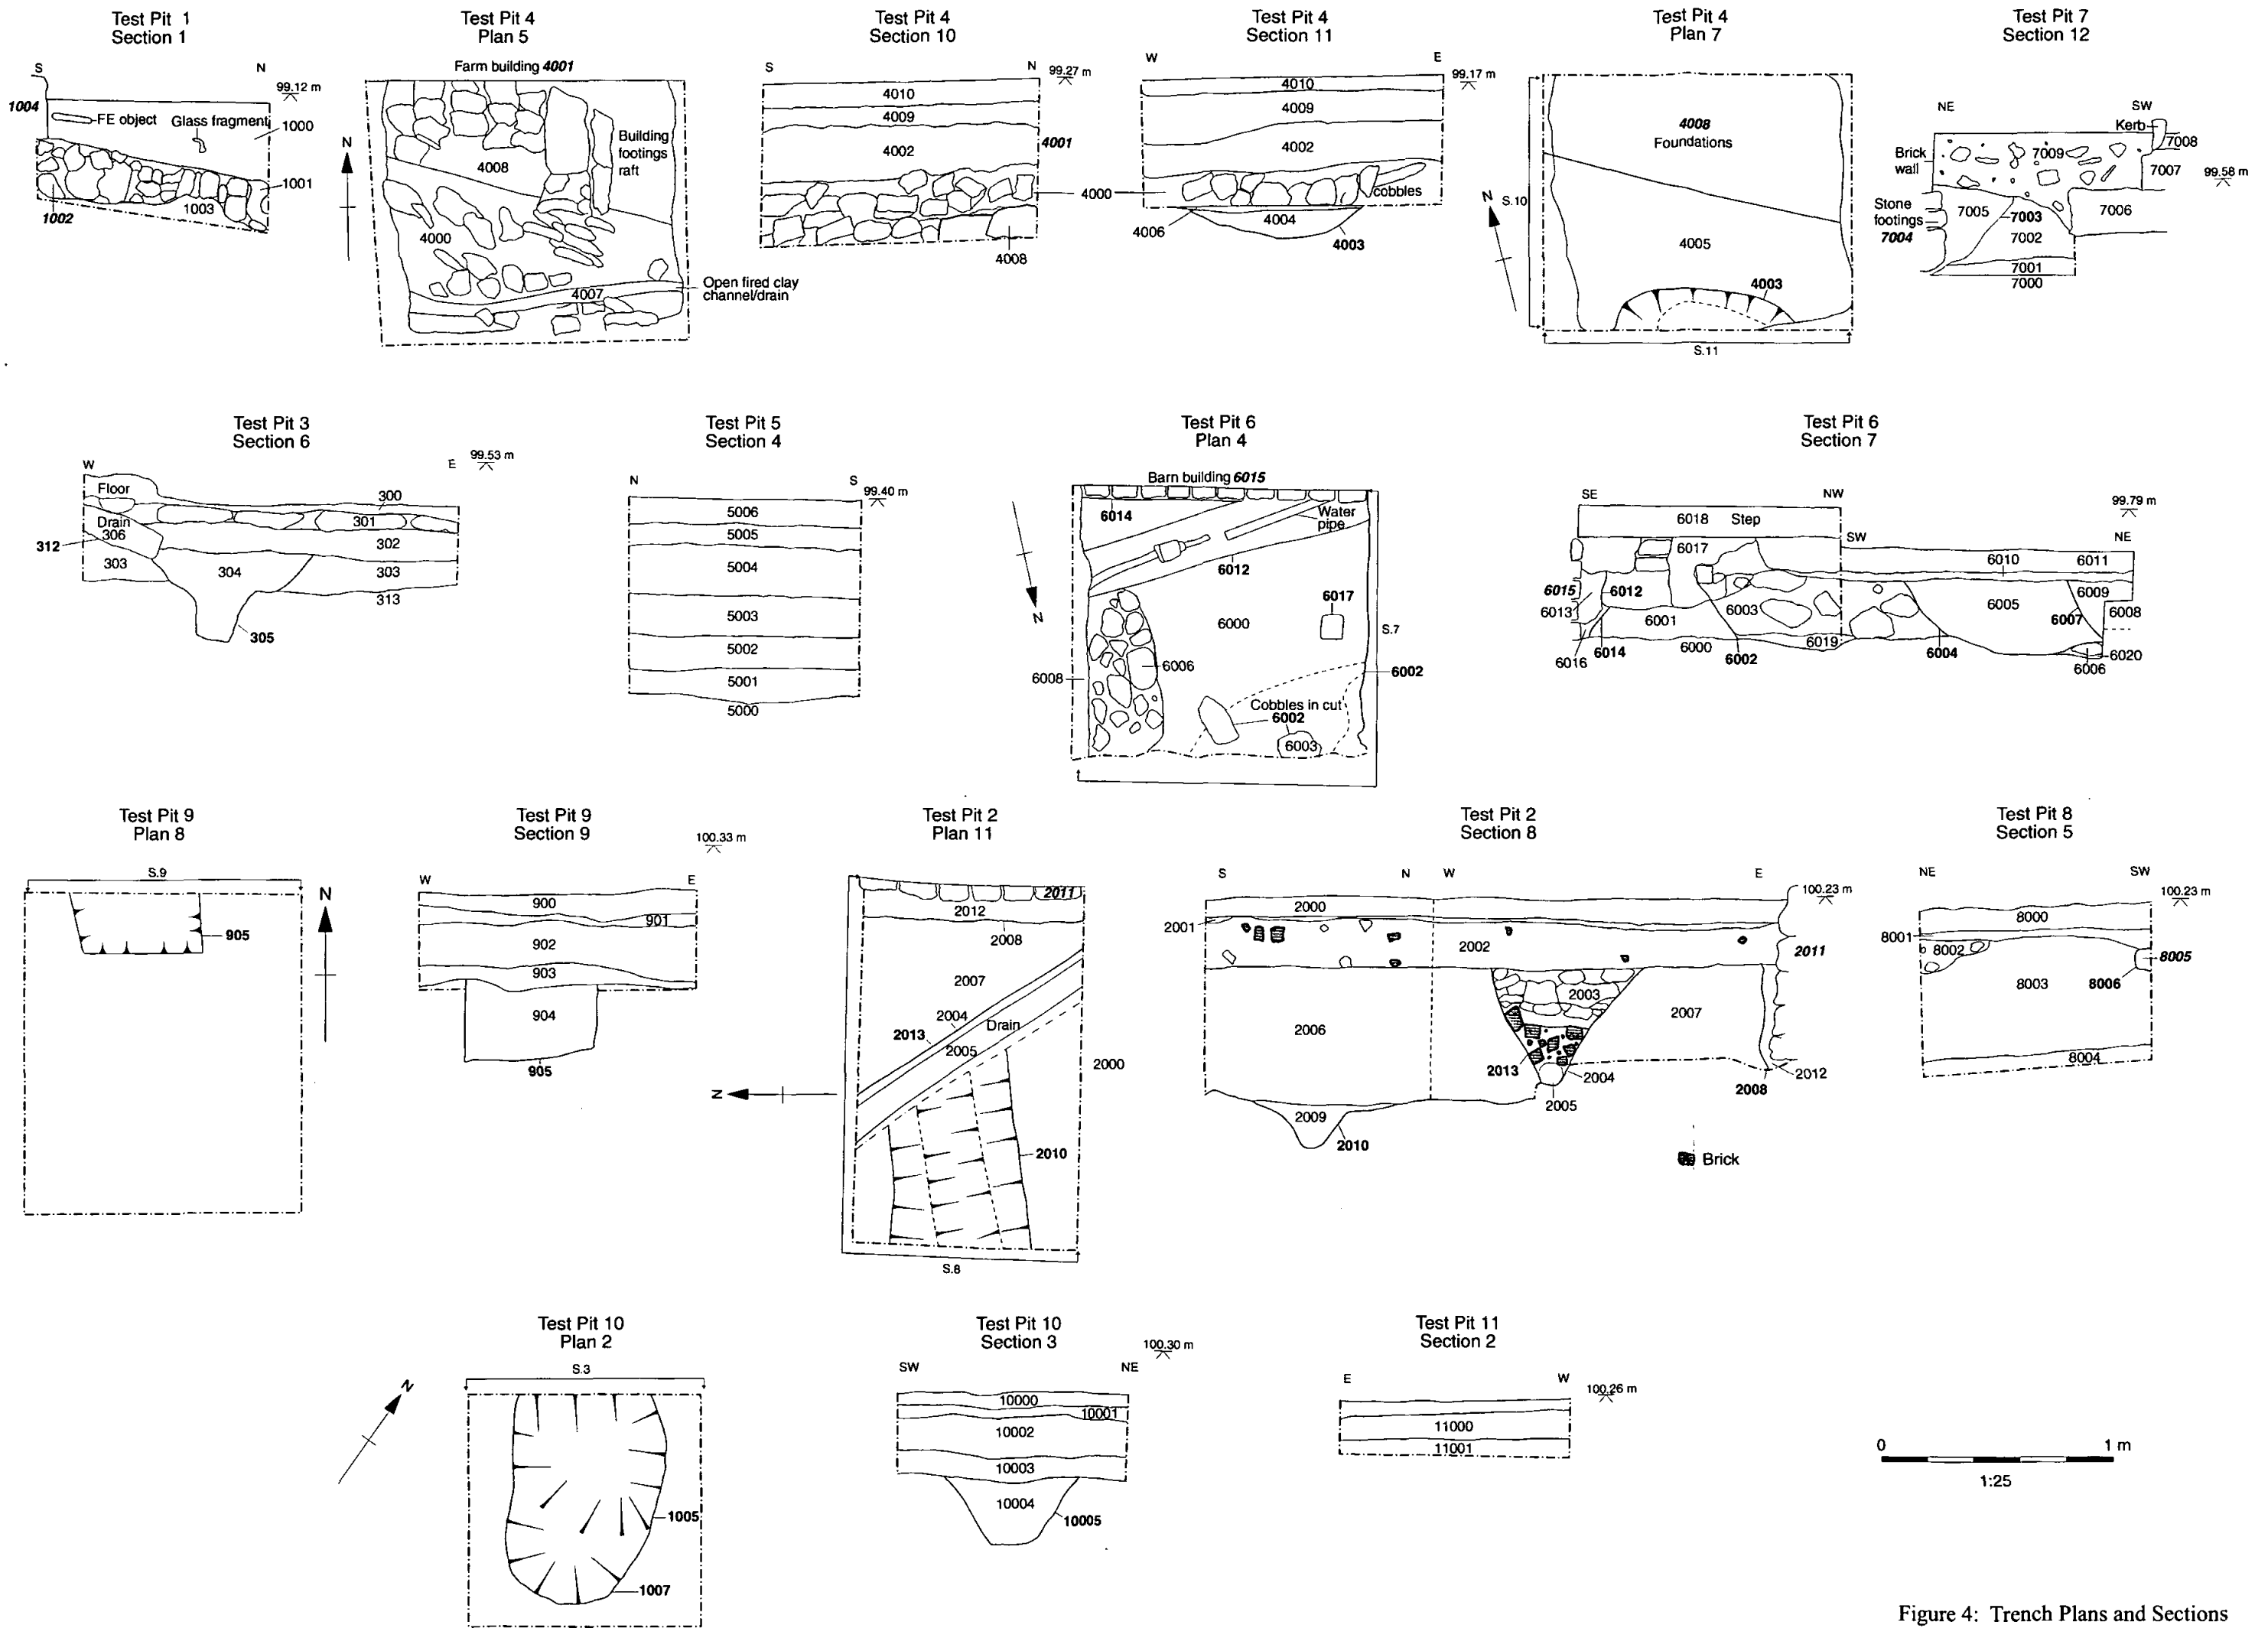
Figure 4: Trench Plans and Sections

5.1 Description of deposits (see Figure 4 for plans and sections of the test pits)

greensand (Fig. 4). The wall was abutted by the make-up deposits for concrete surface 8000.
