Archaeological Investigations at Well Hall Pleasance Eltham Greenwich London

Archaeological Watching Brief Report

**Archaeological Investigations
at
Well Hall Pleasaunce, Eltham,
Greenwich, London, SE9**

A Watching Brief Report

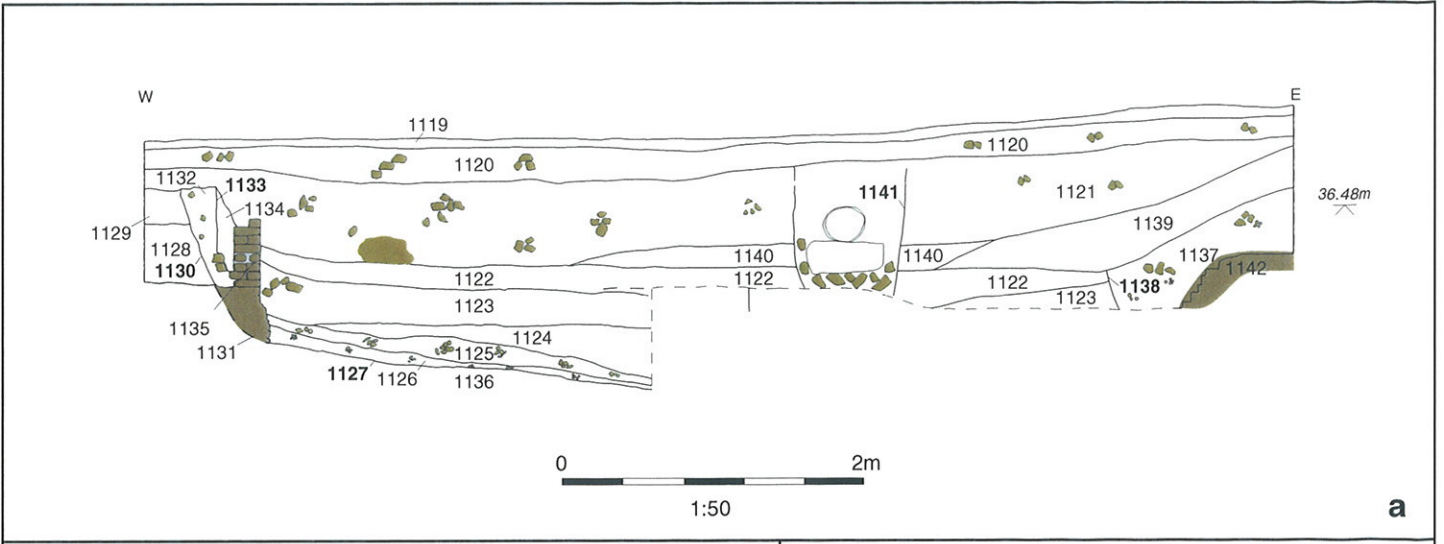
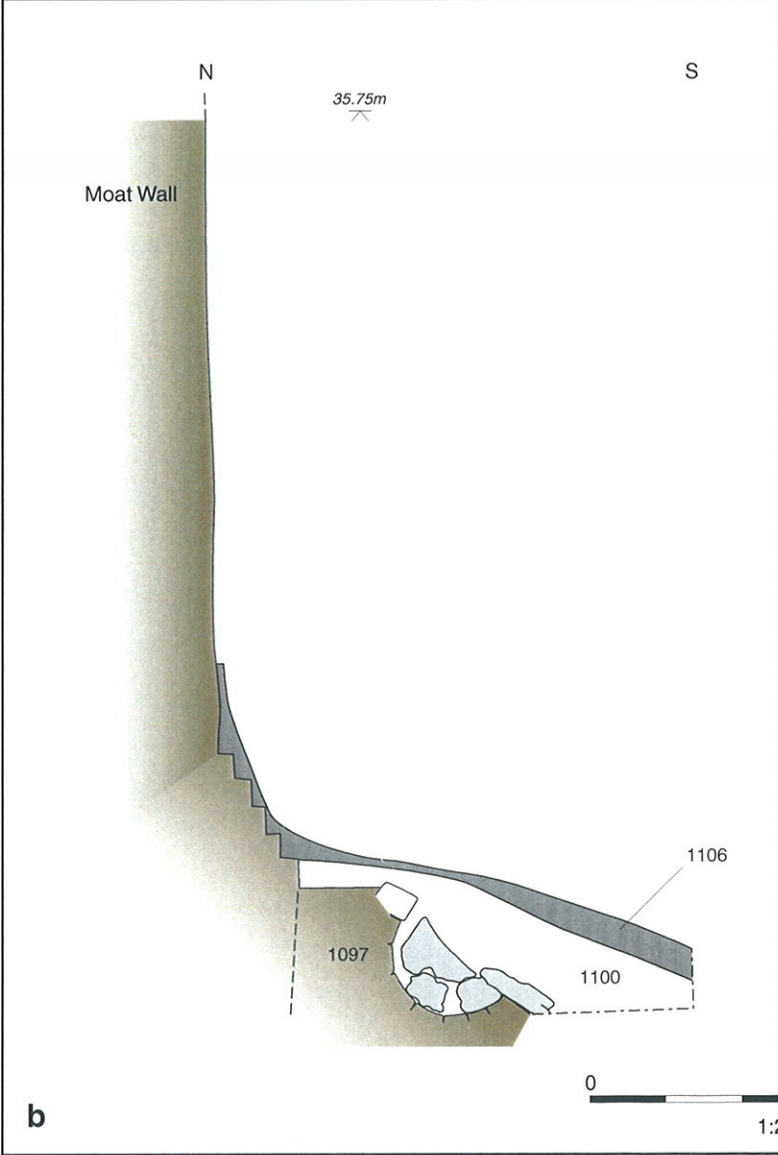
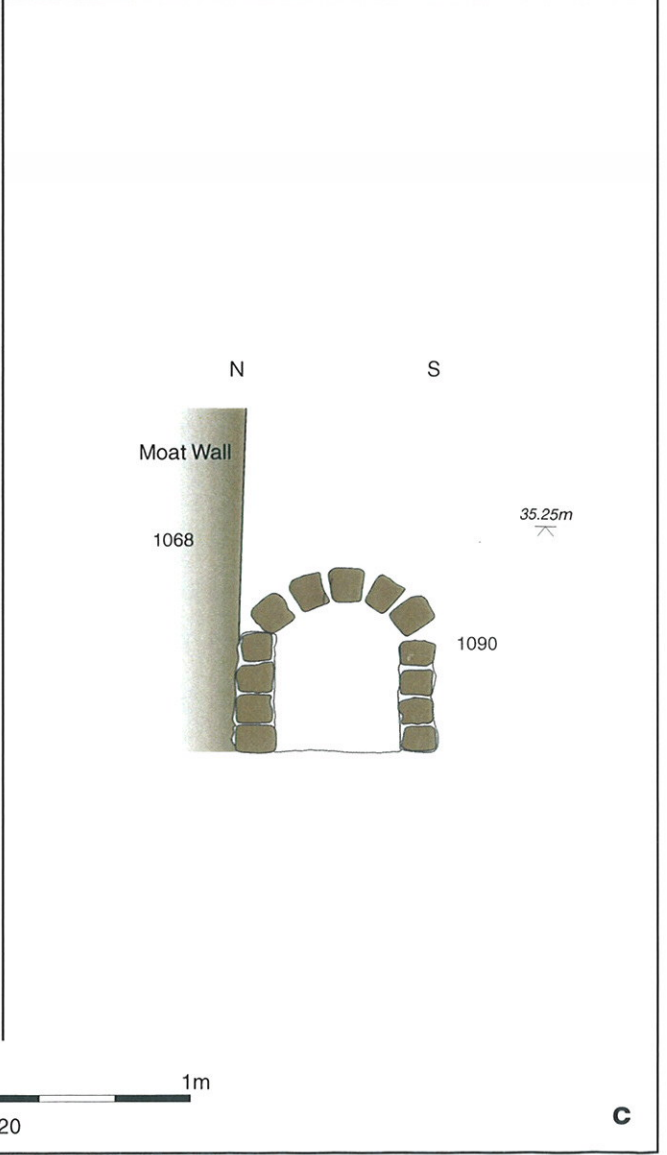
Figure 7: Various sections showing the moat construction with associated fills and structures

a: South facing section through infilled moat at the moat head in AA 11
b: East facing section showing moat wall/circular culvert and 20th century lining in AA 7
c: North facing section showing moat wall and culvert 1090 in AA 4

- 4.2.2 A full cross section across the breadth of the moat head, including its retaining walls and the fills between them, was recorded during AA 11 (Fig. 7a). Natural orange clay 1128 was encountered at c. 36.40m OD, and was overlain by subsoil 1129. Both had been truncated by a substantial cut 1130 which ran north-south. This cut formed the west side of the construction of the moat and no equivalent cut was seen on the east side. Running north to south along the foot of the cut was a red brick wall 1131. This wall survived to a truncated height of 0.58m. At its base it was over 0.4m wide, which was offset by 0.10m from two courses of narrower wall above. Deposit 1132, a rubble fill of 1130, is interpreted as the backfill which would have filled the gap between the construction cut and the retaining wall. This fill was level with the top of the cut, at 36.63m OD, indicating the minimum height of the wall 1131. Together these elements probably represent a footing and the truncated remains of the retaining wall of the west side of the moat. The structure continued both to the north and south beyond the excavated area. These remains had been truncated to a height of 35.80m OD by later construction activity, cut 1133. Within this cut, and mortared onto the retained upper surface of the remains of 1131, was red brick wall 1135. This rebuild was constructed in English Bond; it measured 0.25m wide and survived to a height of 0.56m (36.38m OD). It also extended south and north beyond the excavated area.

- 4.3.3 Archaeological Actions 6-9 were excavated adjacent to the north facing moat island wall which ran on an east-west alignment. In all the AAs the wall was considered to be part of one large structure 1096. However there were differences in the foundations, in AAs 6 and 7 the wall had an offset stepped brick foundation 1099, measuring at least 0.36m deep, whereas to the west in AAs 8 and 9 the wall had been underpinned at a later date using concrete foundations 1098. Through each intervention a circular brick culvert 1094 ran parallel to, and at the foot of, 1096. The culvert had an external diameter of 0.43m (Fig. 7b).

- 4.3.4 In AA 10 a further brick-built culvert 1090 was encountered. A brick barrel vault spanned two vertical brick walls, between which was a flat brick base, creating an internal space 0.33m wide and 0.40m tall. It ran east-west along the line of the retaining moat wall to which it abutted, for a distance of over 10.0m to the south and 1.0m to the north (Fig. 7c).
