Highfield Grove
Craigavon
Co. Armagh
Northern Ireland

Archaeological Investigation Report

Oxford Archaeology

1st November 2001

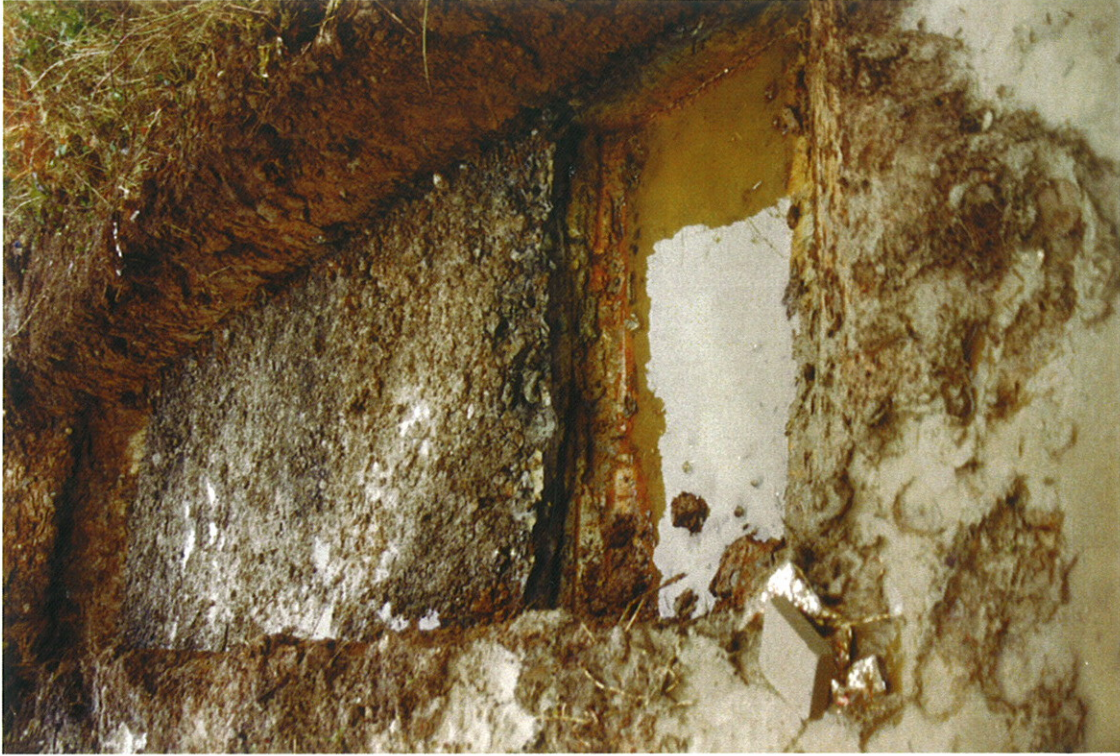
Plate 1: Evaluation trench 2, section of Coach Road

- 6.1.2 Trench 2 clearly revealed a portion of the coach road (OAU 25) which was situated as recorded by historical documentation. The level of preservation was excellent and the construction type appeared to be Macadam or a variation thereof. A small section of the kerbstones and bedding layer for the coach road were revealed during the strip and record which demonstrated that the build of the existing 1960s road had utilised the coach road as a foundation.

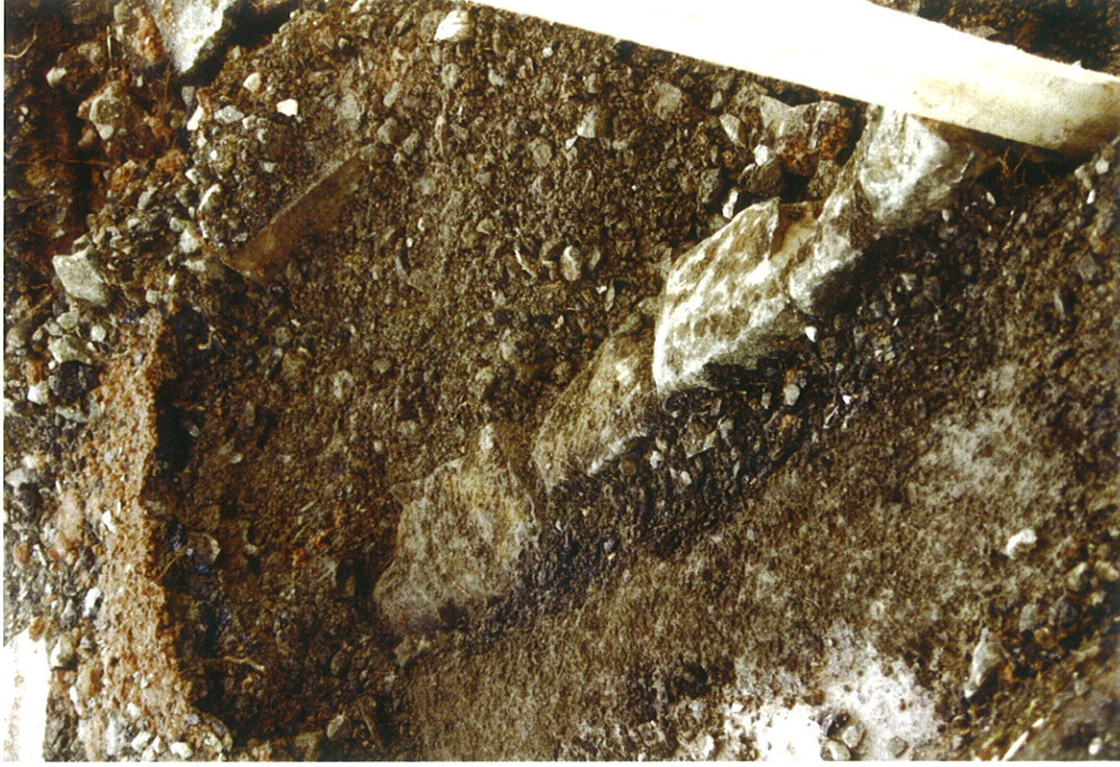
Plate 2: Strip and record, Kerb stone alignment

- 4.2.1 The evaluation revealed a significant section of the coach road (OAU 25) in Trench 2, a portion of tarmac track-way (OAU 17) in Trench 1 and during the watching brief a small section of the coach road and a segment of kerb-stone sets were identified
