67 Honey Lane and the
site of the former Thames
Water Pumping Station
Cholsey
Oxfordshire

Archaeological Evaluation Report

December 2006

ARCHAEOLOGICAL EVALUATION REPORT

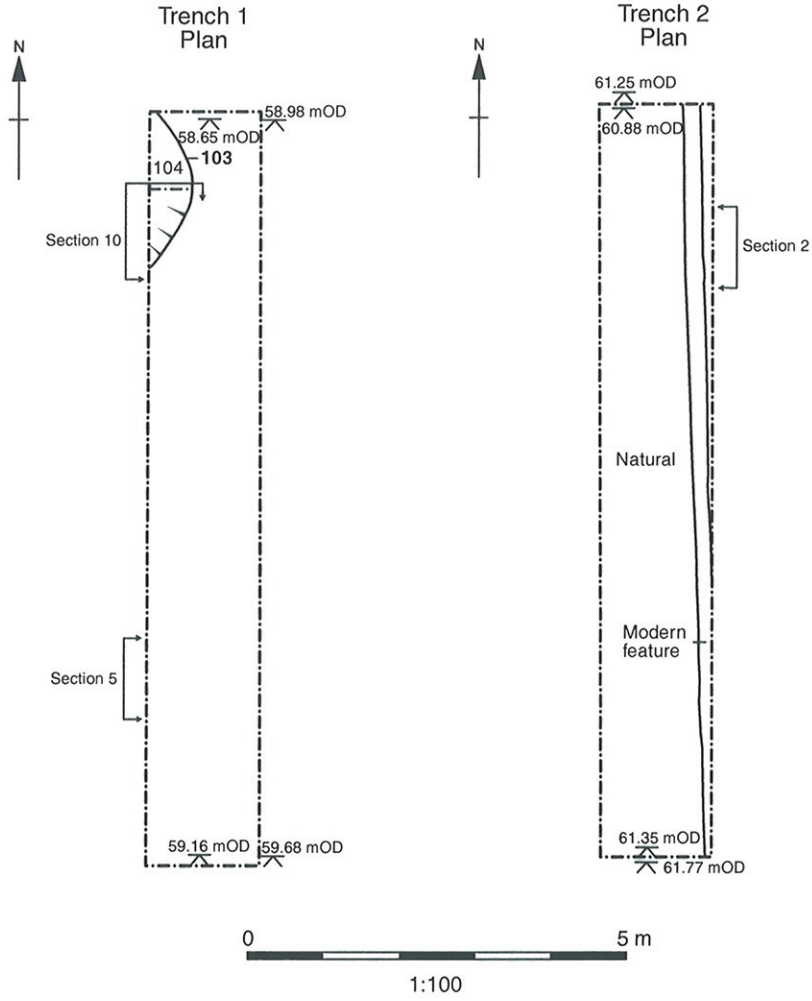
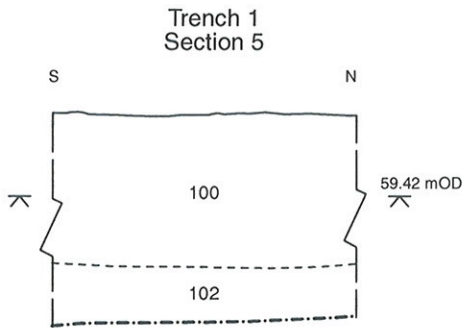
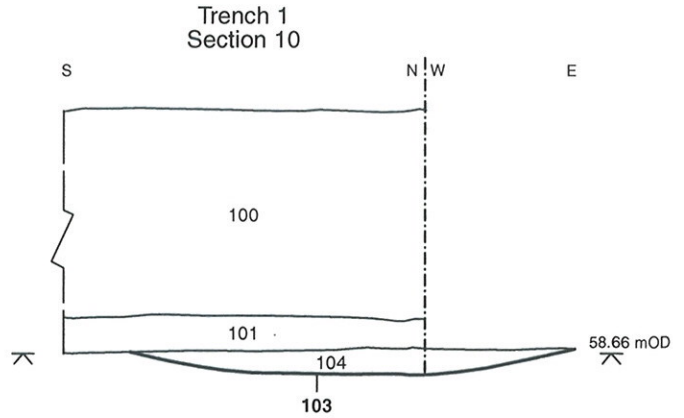
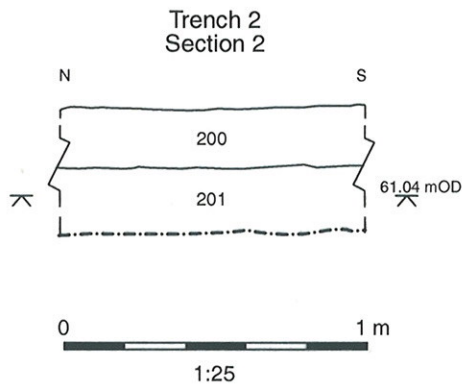
Figure 3: Trenches 1 and 2, plans and sections

- 4.3.1 Trench 1 (Fig. 3) was orientated north-south and located at the northern end of the site. It was excavated to a depth of between 0.9 m at the northern end and 0.7 m at the southern end. Natural chalk geology (101) was encountered at a height of 59.16 m OD at the southern end and sloped gently down to 58.65 m OD at the northern end. This was overlain by patchy remnants of clayey loam subsoil (101) up to 0.1 m thick.

-
- 4.3.2 The subsoil was only present in the north-west corner of the trench, where the chalk sloped gently down, presumably removed by landscaping elsewhere. One of these patches (103) was partially excavated and interpreted as tree root disturbance topsoil between 0.5 m - 0.7 thick contained modern debris (see Fig 3; Section 10). No finds were recovered.

- 4.3.3 In Trench 2 (Fig. 3) all soil deposits appeared to have been removed from this area of the site during the construction of the water pumping station. The trench was excavated to a maximum depth of 61.35 m OD at the south and 60.88 m OD at the north. A layer of crushed concrete and gravel hard standing (201) overlay natural chalk (200). No archaeology was present; modern pipe trenches cut into the chalk were visible.

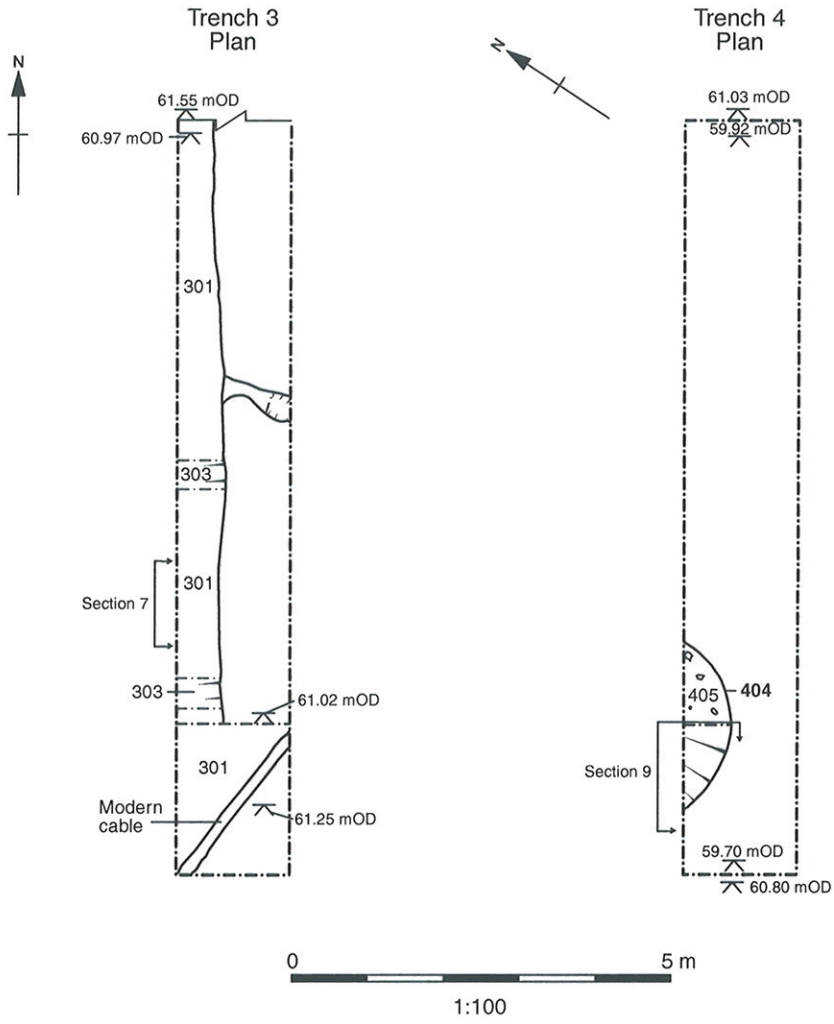
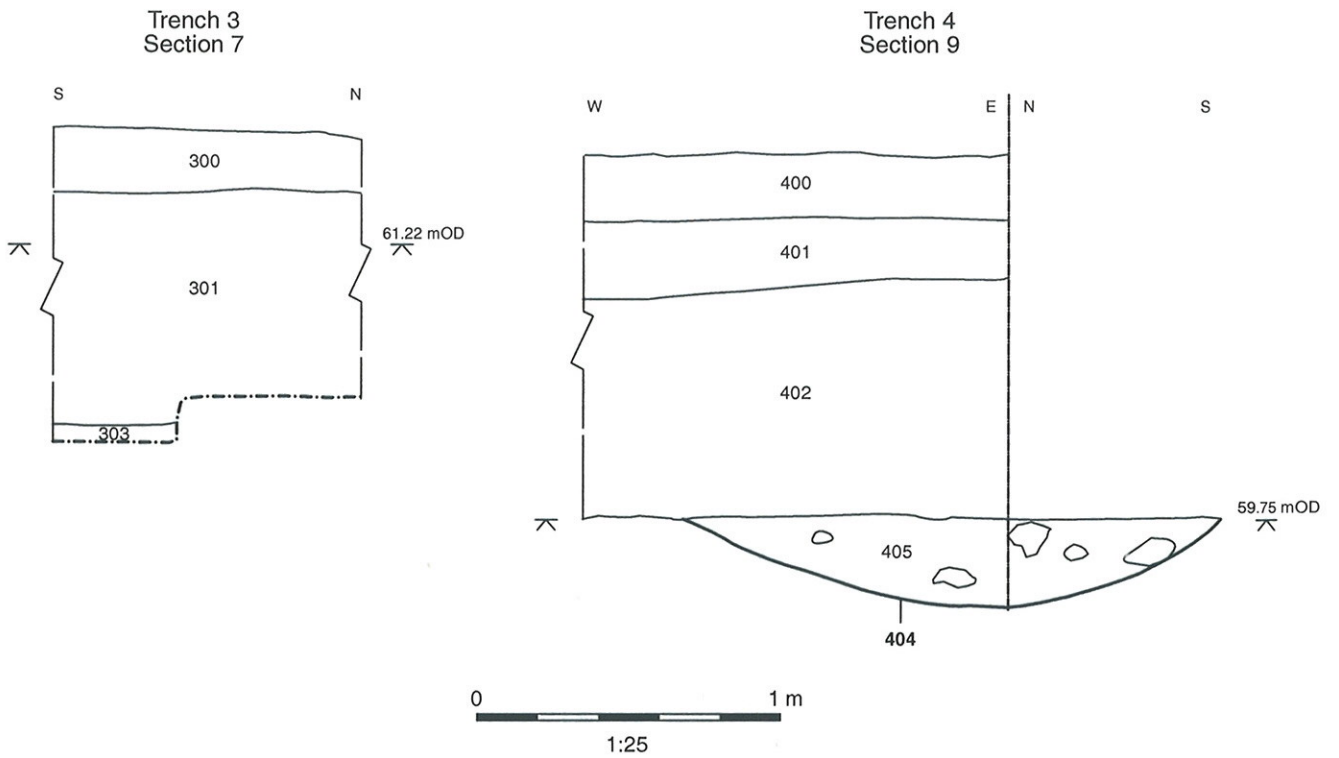
Figure 4: Trenches 3 and 4, plans and sections

- 4.3.4 Trench 3 (Fig. 4) was excavated to a depth of 61.25 m OD (where a modern cable was located), requiring a further step down to 61.02 m OD at the south end and 60.97 m at the north. The natural chalk (303) contained geological fissures running roughly east west filled with clay rich soil (304) derived from the original subsoil (302). Above 302 lay a 0.6-m thick clay soil layer containing modern CBM (301) that was more notable at the west edge of the trench where the shallow chalk ridge falls away. Layer 301 was sealed by the topsoil (300) that also contained modern CBM. No archaeology was present in the trench. The south end of this trench contained numerous service runs associated with water pumping station buildings within modern make-up layer 301.

- 4.3.5 In Trench 4 (Fig. 4) the natural chalk was located at 59.7 m OD at the southwest end of the trench and 59.92 m OD at the north-east end. At the base of the trench (404) cut natural (403), the base of a refuse pit containing a stony, chalky loam fills (see Fig. 4; Section 4). Voids in the fill (405) suggest that although predating the landscaping of the site, this feature was not very old. Animal bone and oyster shell was recovered from the fill. The fill of the feature and the natural were overlain by a clay soil layers (402 then 401) containing modern ceramic building materials. Topsoil (400) containing a single worked flint sealed the trench. Owing to its position at the base of a general incline to the east the modern topsoil and make-up clay layers formed a deeper sequence than elsewhere.
