**King's Mill Lane, Marston Road, Oxford
Centre for Islamic Studies**

Archaeological Field Evaluation Report

Planning Application No 99/812/NFZ

Oxford Archaeological Unit
October 2000

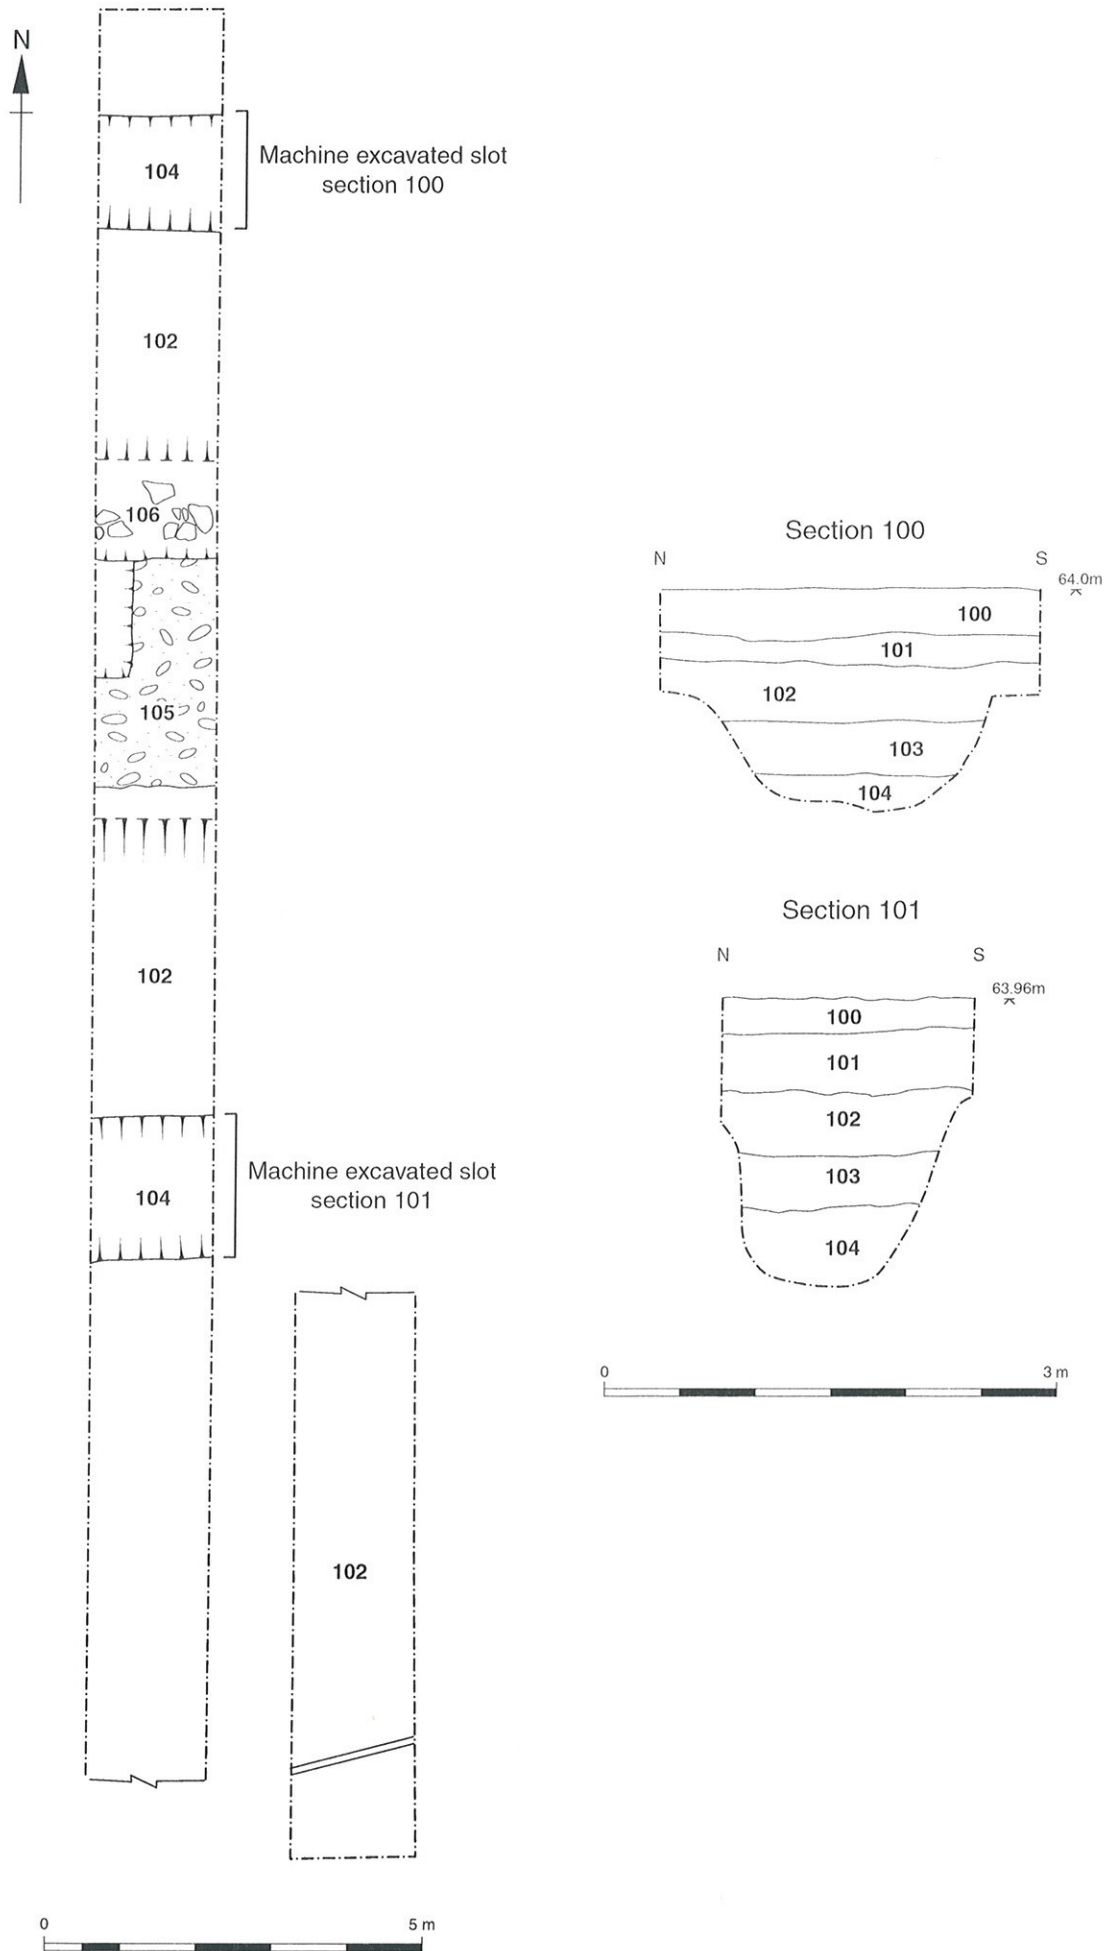
Figure 3: Trench 1, plan and section.

The earliest deposit within this was trench was a compact layer of dark blue-grey clay (104) that was at least 0.53 m thick. This layer was exposed in two machine-dug slots and is assumed to have been continuous along the length of the trench. Above lay a tenacious grey-brown clay layer with grits (103) that was 0.34 m deep. This layer was sealed by a tenacious light yellow-brown clay (102) containing chalky grit to a depth of 0.25 m. Layer 102 contained two sherds of post-medieval pottery, a sherd of building tile and one abraded sherd of flint tempered pottery. Three geological shells were also recovered from this deposit. This layer extended fully along the length of the trench. Overlying this was a further layer of yellow-brown silty clay (101) that contained some small stones. Set into this layer was spread of sandy limestone hardcore mixed with ash and cinders (105). The deposit was 3 m wide and a minimum of 0.2 m deep. A total of 35 sherds of a single flower pot were recovered from a slot excavated through the layer, that also contained pieces of sandstone. The pottery is probably 19th century in date and may have been incorporated in the make-up for the trackway. North of this spread of material was an east-west linear arrangement of sandstone blocks (106) loosely set. The stonework was 0.75 m wide and extended across the width of the trench. The stones appeared to have been set into deposit 105. The topsoil (100) covered the stones and the other layers in the trench.

The layer at the base of the trench was a natural clay, probably the Oxford Clay. Over this were three further clay layers, all probably naturally formed, though the upper clay layer (101) in the trench may have been affected by natural weathering or may have derived from hillwash or colluvial/ alluvial processes. The wide spread of hardcore and ash represents the remains of part of a trackway that once extended from Marston Road to King's Mill Farm - evidently the track was bounded on its north side by a retaining wall, the remains of which were partly uncovered; the track is shown on the 1913 O.S. map of the site (Fig. 8), though may it date to the previous century.

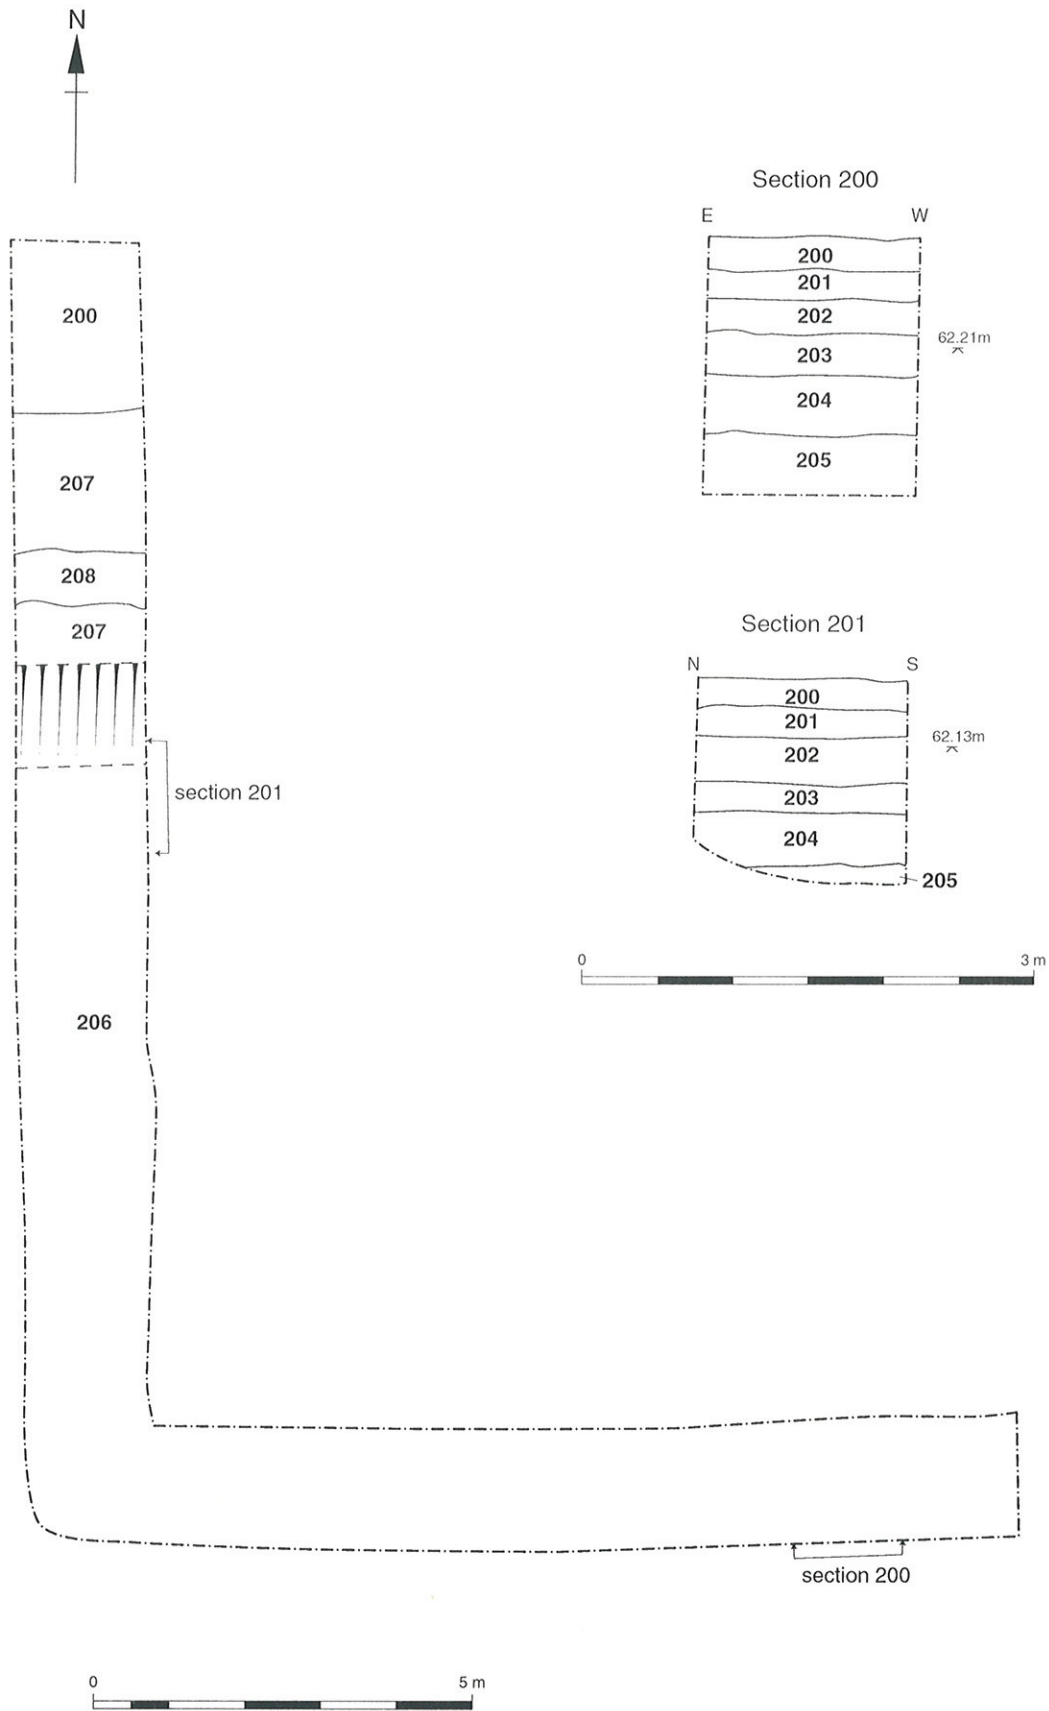
Figure 4: Trench 2, plan and section.

This was originally designed as a 30 m long east-west trench extending up to the east side of the farm compound. Local ground conditions were soft and caused problems for the JCB excavator. In order to maintain the investigation in this part of the site, part of the trench was re-aligned on a north-south axis. At the base of the trench was a layer of dark-blue-grey clay (205) at least 0.4 m thick, sealed beneath a 0.42 m thick layer of tenacious grey clay (204). This was overlain by a tenacious light yellow-grey clay layer (203) containing chalky grits. Above lay a further layer of light brown-yellow clay with

occasional flecks of charcoal (202) that was 0.3 m thick. Beneath the topsoil (200) lay a tenacious reddish-brown silty clay with charcoal flecks and some pieces of tile (201) to a depth of 0.22 m. Set into this layer at the north part of the trench was a spread of compact mortar and crushed stone (207) mixed with ash and cinders and some brick fragments. The spread was bounded to the south by the foundations of a dry sandstone wall (208) that was 0.7 m wide and at least two courses deep. The wall had been cut into spread 207 on its south side.

The lower clay layers are naturally formed and the earliest in the sequence was probably the Oxford Clay. The latest clay layer was similar to that observed in Trench 1 and may have derived from colluvial or alluvial processes. The spread of stones and ash was a continuation of the trackway remains seen in Trench 1 leading to the farm entrance, and here it appears to have been bounded by a wall on its south side. It seems probable that the trackway was originally flanked by walls on both sides, the remains of which have only partially survived *in situ*.

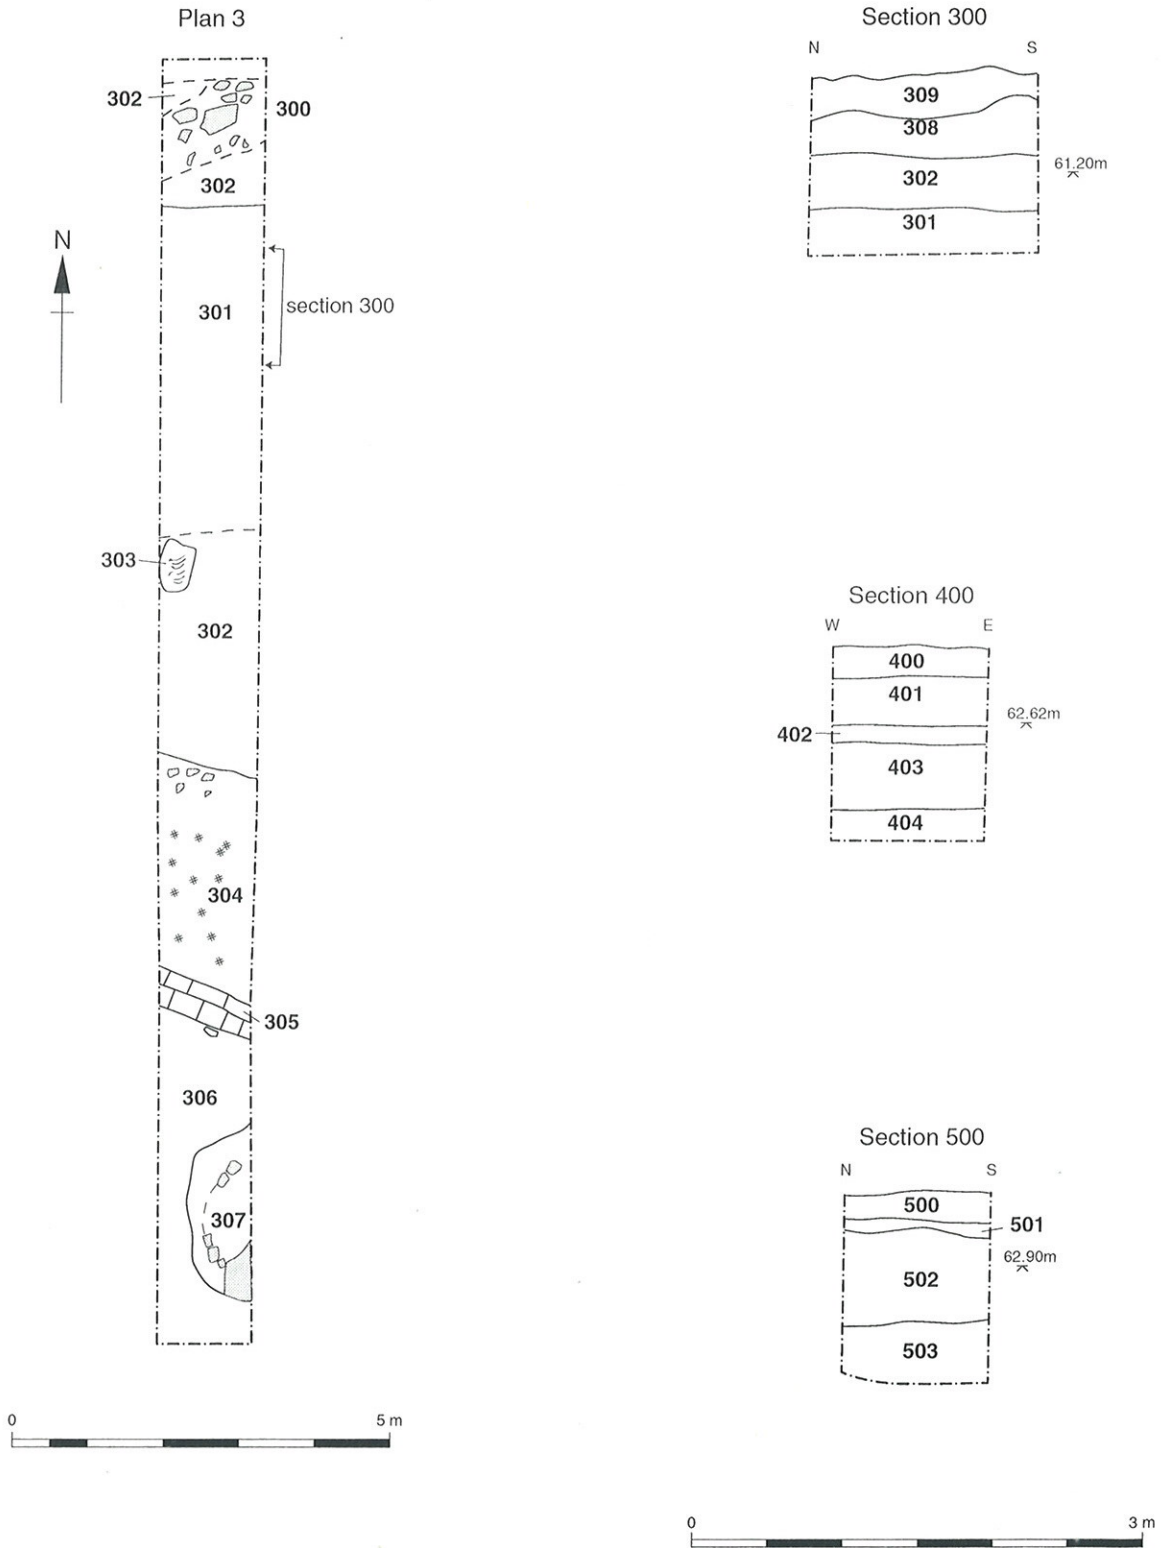
Figure 5: Trench 3, plan and section, and sections from trenches 4 and 5.

The earliest deposit within Trench 3 was a tenacious light-grey clay (301) with occasional limestone grits that was a minimum of 0.28 m thick. The layer was exposed in several parts of the trench. Above this lay a light brown silty clay (302) that was clean and probably naturally formed. To the centre of the trench and set within layer 302 were the remains of a small dog skeleton (303) set within a shallow cut feature. A total of 37 bones were recovered including rib bones.

At the south end of the trench was a mixed layer of mid-dark brown clay (306) with patches of brown loam, brick fragments and charcoal. This layer was overlain by a 2.9 m wide spread of clinker/cinder and limestone pieces (304) extending fully across the width of the trench. On the south side of this spread were the truncated remains of a two-course wide brick wall footing (305) that abutted or was set into layer 304.

At the south end of the trench was a broad semi-circular arrangement of bricks (307) with clay fill in the centre. This feature was not formally investigated though a void in the centre suggested that it might have been an infilled well. At the north end of the trench was a spread of limestone blocks (300) that may have derived from a demolished structure, sealed beneath the present topsoil (308) and garden refuse (309).

The basal clay layers in the trench were similar to those seen in the other trenches and were naturally formed. The spread of limestone and cinders represents the remains of a trackway that extended around the south side of the farm and is depicted on the 1913 O.S. map (Fig. 8). The adjacent wall appears to represent one of the footings of a greenhouse that is also detailed on the 1913 map, bordering the track on its south side. The possible well may have been an internal feature within this greenhouse. The animal burial was that of a small dog, perhaps a family pet. The rubble at the north end of the trench presumably derived from the demolition of the south range of farm structures in the last century.

At the base of the trench was a layer of dark-blue/grey clay (404) that was at least 0.2 m thick. This was sealed beneath a 0.44 m thick layer of mid-dark blue-grey clay (403) with flecks of chalk and small patches of sand. This lay below a reddish-brown clay silt (402) containing charcoal and sand that was 0.12 m thick, above which lay a yellow-brown clay layer (401) that was 0.32 m thick. A ceramic field drain (405) was set within this layer which was also overlain by a dark reddish-brown clay silt (406) containing charcoal and brick fragments. Above lay the present topsoil (400).

The lower clay layers were the same as exposed in the other trenches, the upper two clay layers are likely to have formed as a result of alluvial or colluvial processes. Layer 406 may represent a ploughsoil of recent date.

At the base of the trench was a layer of blue grey clay (504, not illustrated) that was at least 0.5 m thick. Above lay a layer of dark grey-brown clay (503) to a depth of 0.4 m, sealed beneath a layer of grey-brown clay (502) that was 0.5 m thick. Above lay a reddish-brown clayey sand (501) containing small pebbles beneath topsoil (500).

The lower clay layers were natural. The uppermost layer of clay (502) was suggestive of a colluvial deposit. No features or finds were recovered from this trench.

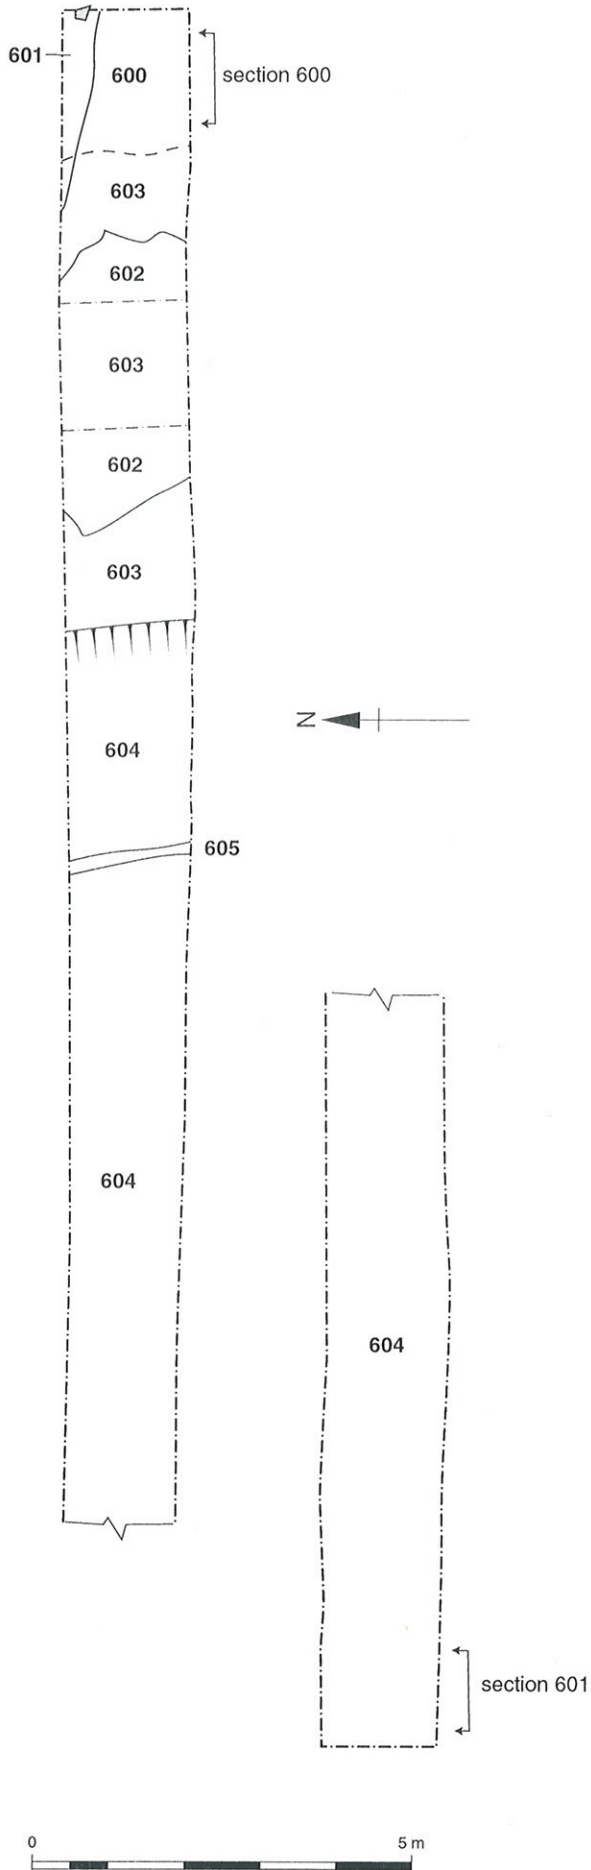
Figure 6: Trench 6, plan and section.

At the base of the trench was a 0.5 m+ thick layer of blue clay (604) sealed beneath a tenacious brown silty clay (608) that was 0.45 m thick. Above lay a layer of light brown sandy clay (603) that was 0.45 m in thickness. At the east

end of the trench at this level were two patches of dark grey brown loam (600, 602) that contained pottery and animal bone.

The pottery from both deposits included sherds of willow pattern china, white china and a post-medieval glazed vessel. All of this material need be no earlier than late 18th/19th century in date. Both deposits were less than 0.15 m thick and it was unclear whether they were within deliberately cut features or had formed in hollows within the natural clay. Both patches were sealed beneath a clay soil layer (607) that had a yellow hue, over which had formed the present topsoil (606). A field drain (601) was noted at the east end of the trench.

The lower layers were similar to the natural clays seen elsewhere. Localised activity of 18th/19th century date was noted at the east end of the trench, which was otherwise sterile.

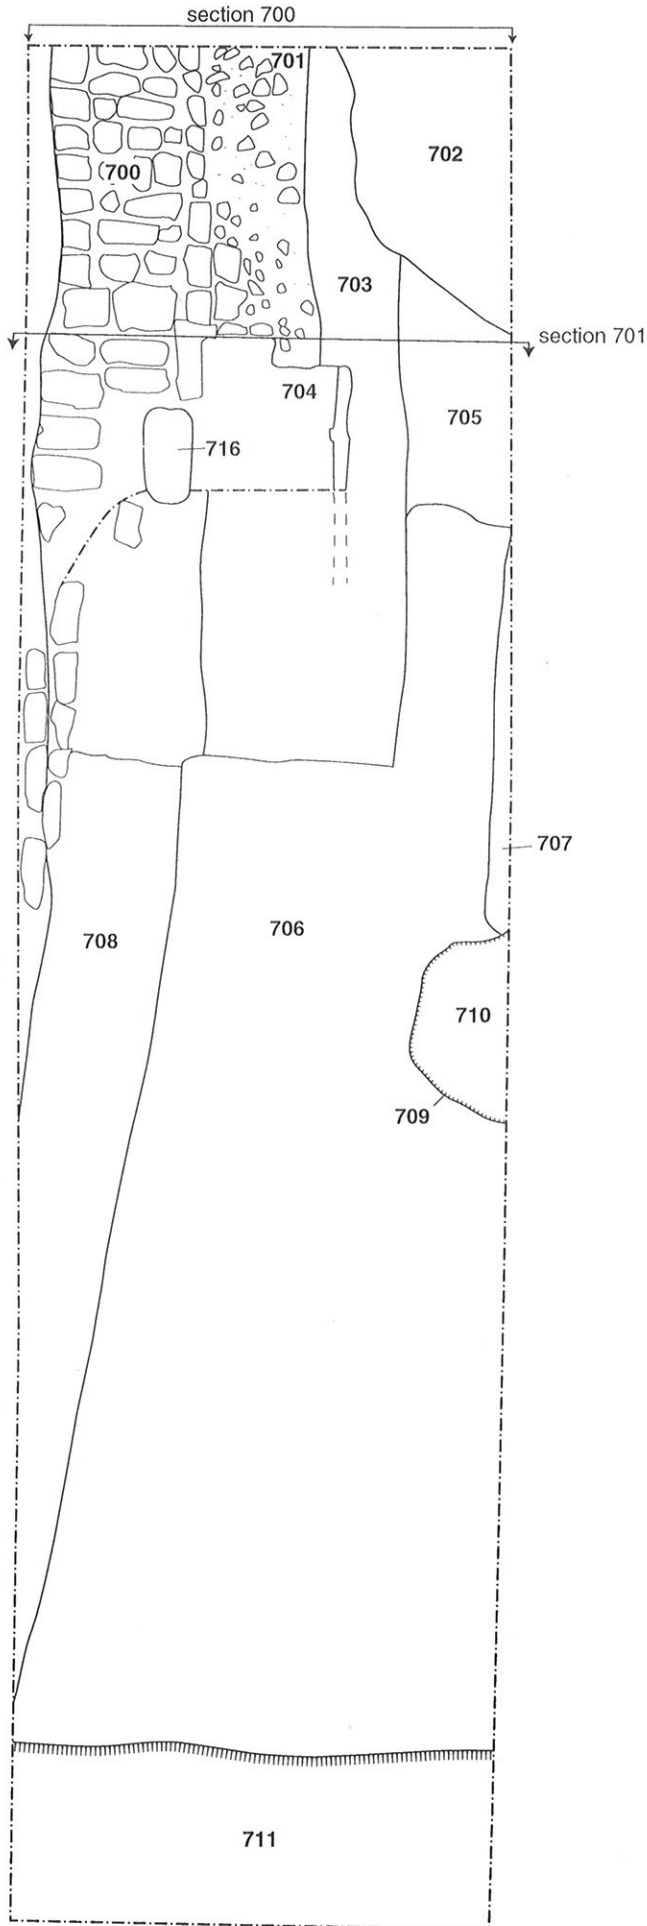
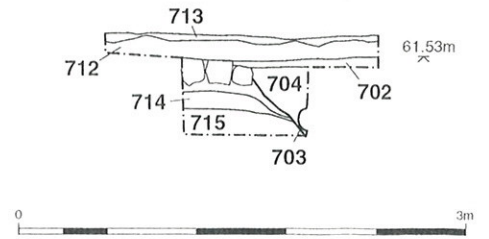
Figure 7: Trench 7, plan and section.

Trench 7 was excavated along the line of the former trackway within the limit of the present farm buildings. Building remains were encountered within 0.1 m of the surface of the present yard. Full excavation of these remains was not possible within the confines of the trench, so the interpretation is based on what was recovered in plan and from information provided by a single section excavated through a large square pit to the east end of the trench.

The earliest deposit within the trench was a tenacious yellow-brown clay layer (715) that was a minimum of 0.14 m in thickness. This was overlain by a 0.06 m thick deposit of grey-yellow mortar and crushed stone (714). A total of five sherds of willow pattern china pottery of 18th/19th century date were recovered from this layer. This layer appeared to act as the bedding material for a number of structural elements that occupied the whole of the area of the trench.

At the centre of the trench was a substantial stone slab (706) covered with yellow-grey mortar. This may have been a floor of a building. It was bounded by a linear arrangement of stone and bricks (708) on the north side, and overlain by a linear arrangement of limestone blocks (707) at the south side of the trench. At the west end of the trench a substantial stone structure (711) was partly machined but was not further investigated owing to the presence of foul water. A possible pit (709) was cut through the floor slab; the function of this feature was unclear but may have contained a post or stone structure since removed.

East of the floor slab at the north side of the trench was a layer of tightly packed stone cobble sets (700) bonded with a grey mortar. The cobbles abutted structures 706 and 708. Adjacent to the cobble sets was a stone surface of small limestone and sandstone pieces (701). The cobbles and the surface are illustrated as Plate 1 at the end of this report. Above the cobbles and the stone surface lay a 0.05 m thick layer of black ash and cinders (702) that contained a

piece of animal bone and two iron nails, in turn overlain by a loose black-brown layer of clay silt and gravel (712), possibly an occupation soil. This was overlain by a compact layer of sandy gravel and brick fragments (713), a further metalling of the surface here. The present farm surface of grass and general debris sealed this layer.

The structures and a layer of limestone rubble (705) had been cut through by a service trench (703) filled with a large ceramic pipe (704), which was joined to a large pit (716) of unknown purpose, but was located between the cobble sets/stone surface and slab 706.

The earliest layer observed in this limited investigation was a layer of colluvial clay similar to the material seen in the other trenches. At this level there appeared to have been a layer of make-up material (714) for the prior to the construction of the structural elements. The building(s) represented here were not clearly understood, though it would appear that the base of at least one structure was present in the trench. The stone surface at the east end of the trench appears to have been the original (but undated) trackway surface into the farm, whose yard was furnished with a substantial cobbled floor. These are likely to have been the primary surfaces associated with the late 18th/19th-century farm. The trackway was resurfaced twice on the evidence of this trench, such that the original track and yard completely disappeared. The later incarnation of the track represented by the ash and gravel layer (702) may be contemporary with the trackway surfaces found in Trenches 1 and 2.

The building appears to have had at least two walls associated though it is unclear if these were external or internal divisions. Likewise the function of the building is uncertain. A wider excavation area would be required to understand the layout of this part of the farm, and to gain more precise dating evidence from the deposits beneath the structures.

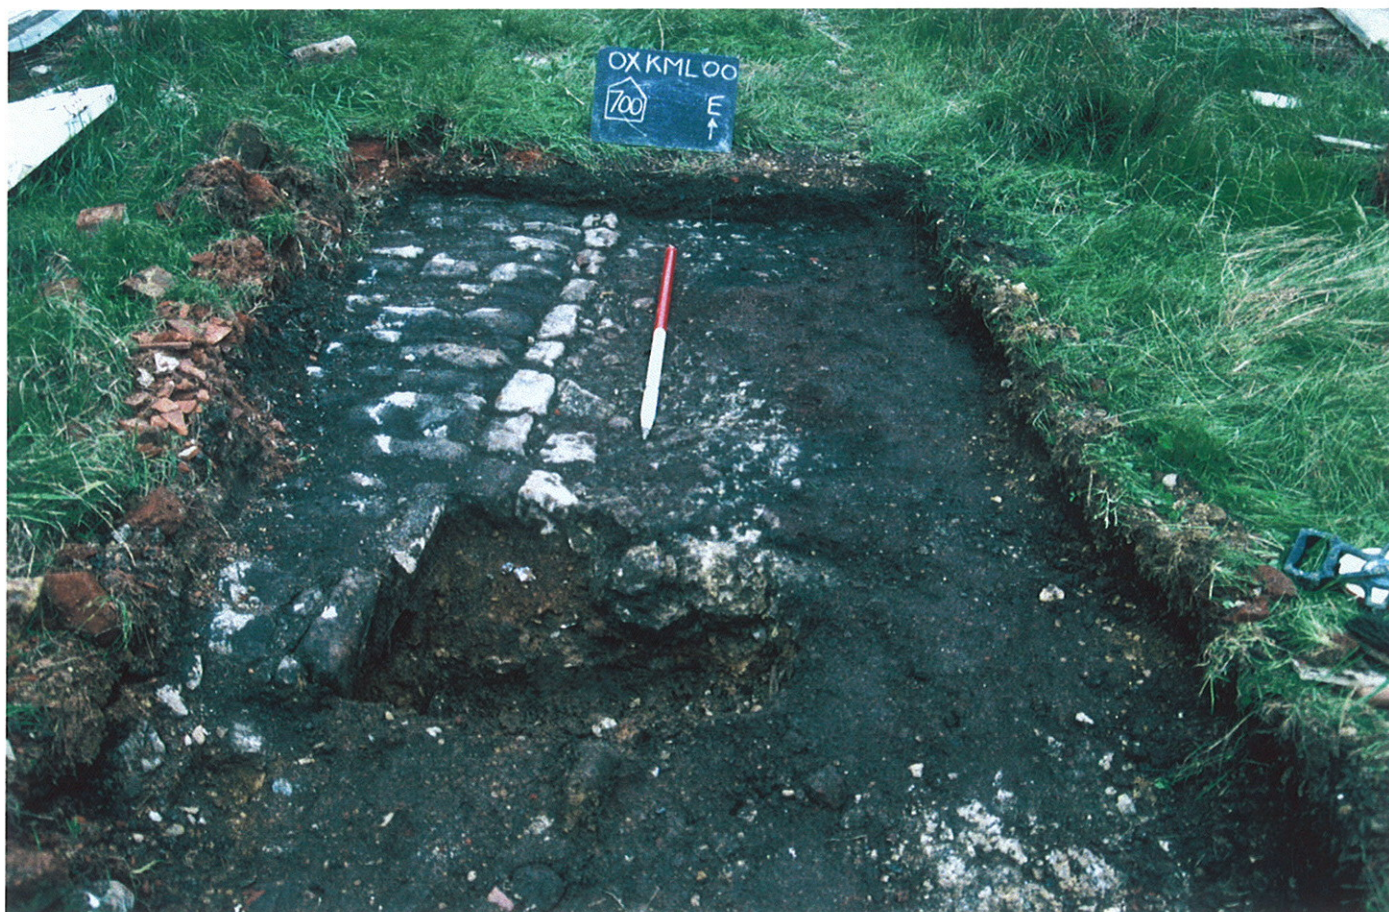
Plate 1: Cobble surface (700) and track surface (701) at the east end of trench 7

An absolute date for the structures in Trench 7 was not ascertained from the limited investigation, although the pottery from the layer below the cobbling contained sherds of late 18th/19th-century date, so these may date the cobbled surface.
