FORMER LMS STATION  
REWLEY ROAD, OXFORD

ARCHAEOLOGICAL INVESTIGATION

OXFORD ARCHAEOLOGICAL UNIT  
MARCH 1998

NMR DATA	
Site Name	Former LMS Station
Address	Rewley Road
Town	Oxford
NGR	SP 5062 0629
Listed Status	Grade II*
Visit/Survey Date	Sept 1997 - Jan 1998
OAU Site Code	OXLMSBS

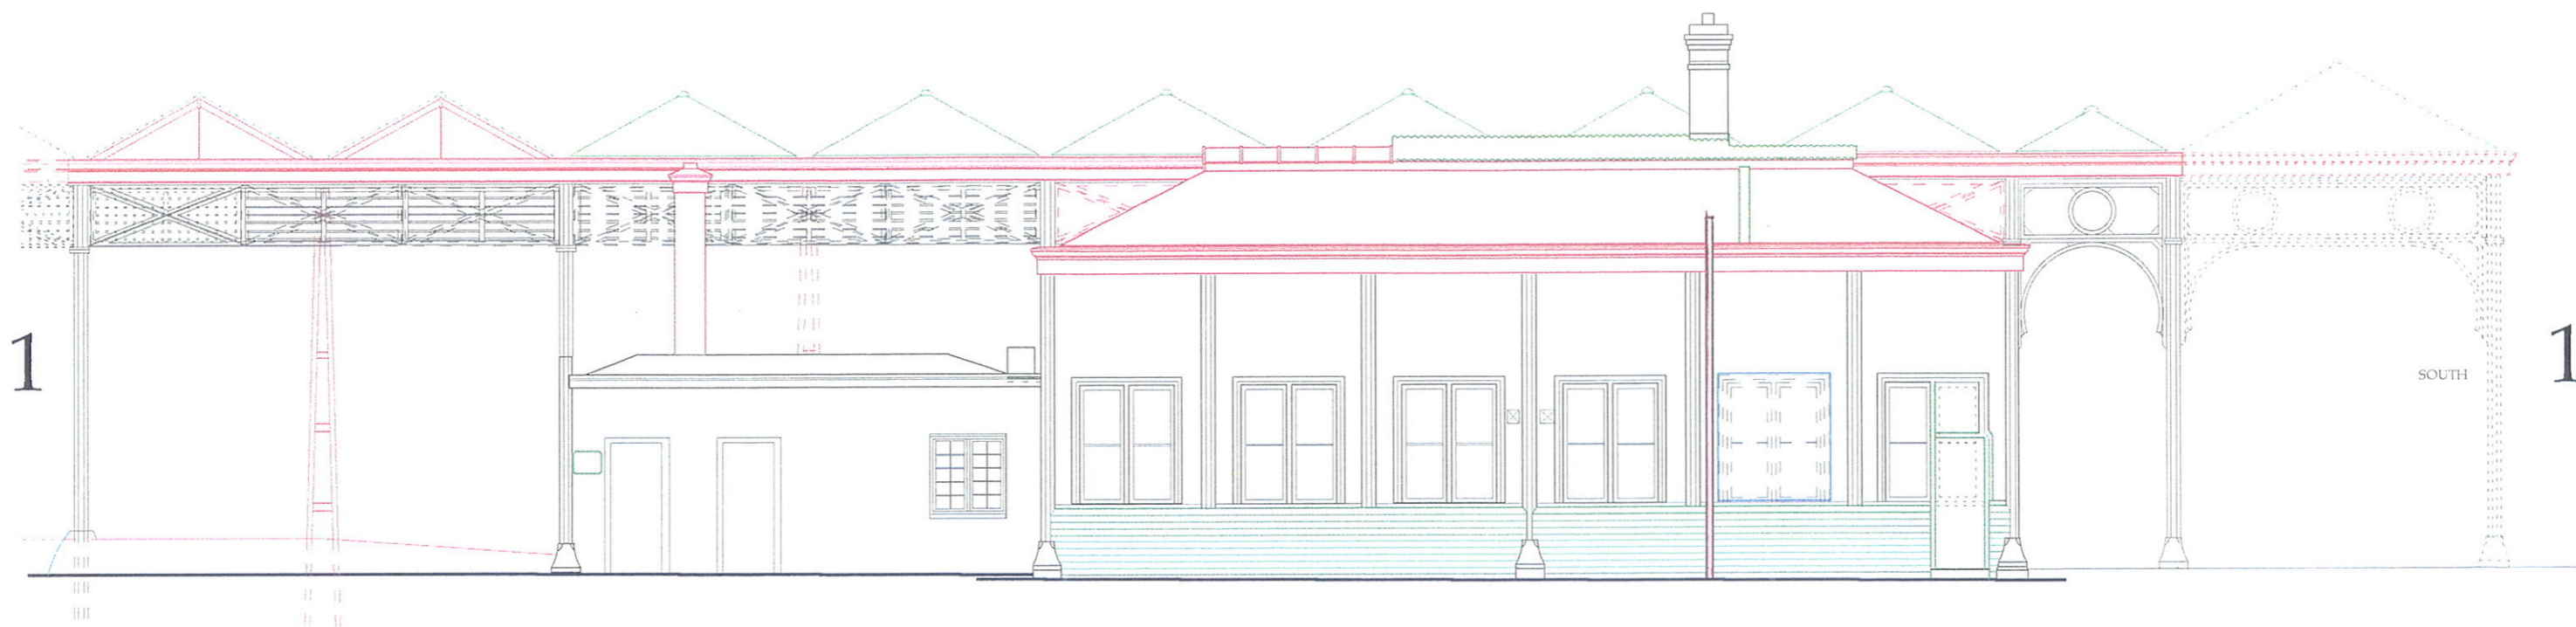
Former LMS Station Building  
 Rewley Road, Oxford.  
 West Elevation & 2-2  
 1:100 Record Drawings  
 Dwg No : 1597/14, March 1998  
 For Oxford Archaeological Unit

WEST ELEVATION

SECTION 2-2

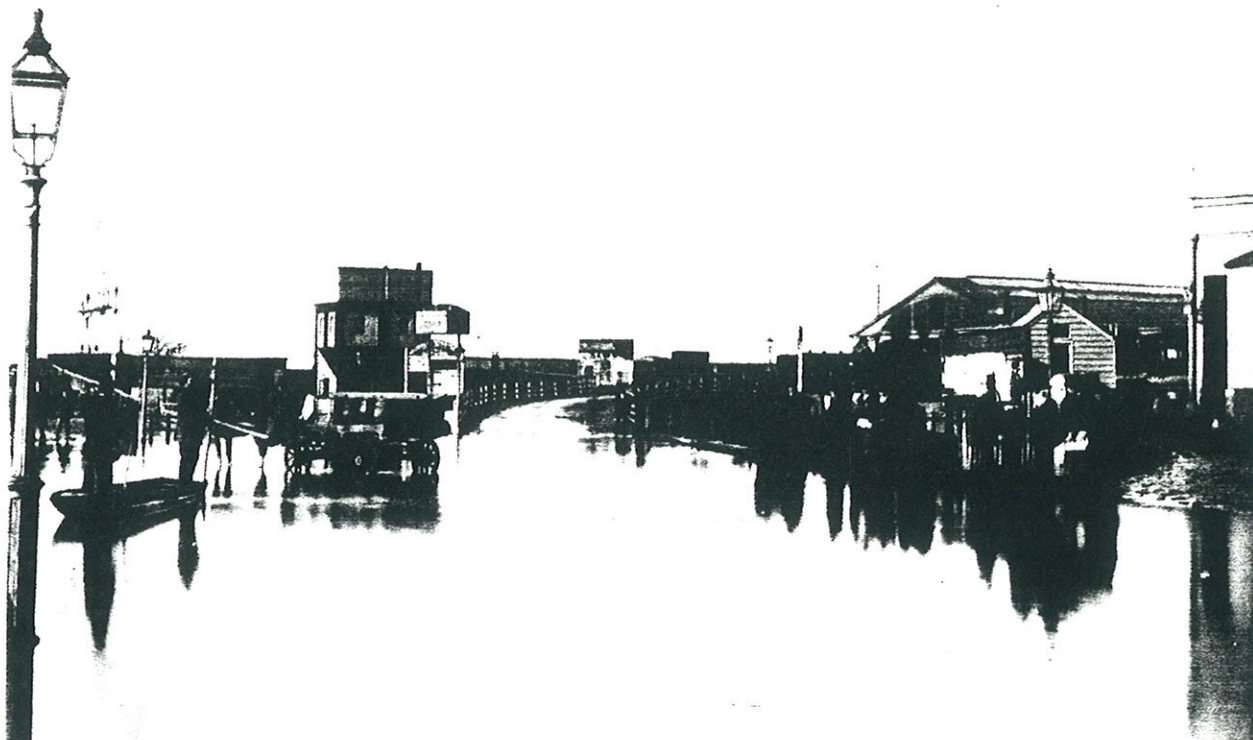
**Plate 1** The earliest known photograph of the LMS station, taken during the floods of 1875. whilst this view more clearly shows the original GWR station, the corner of the goods shed can just be glimpsed on the extreme right. The 'Crystal Palace' elements can be clearly seen including the decorative finials and crests. It is apparent that the roof is not that seen on later views. *(Minn collection, Bodleian Library)*

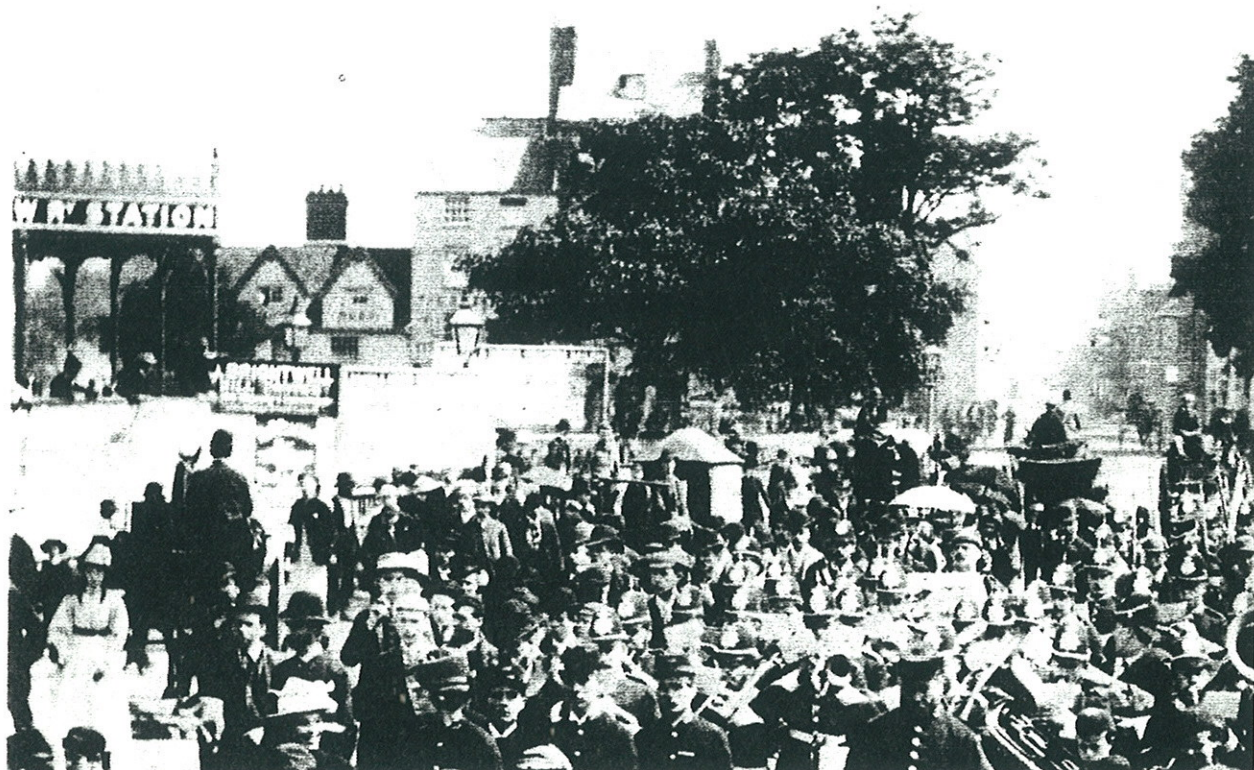
**Plate 2** Another early view is this one showing the Oxford Volunteers marching to the GWR station in 1883. The portecochère of the station itself can be glimpsed on the extreme left. The original roof, finials and crests are again apparent. *(Minn collection, Bodleian Library)*

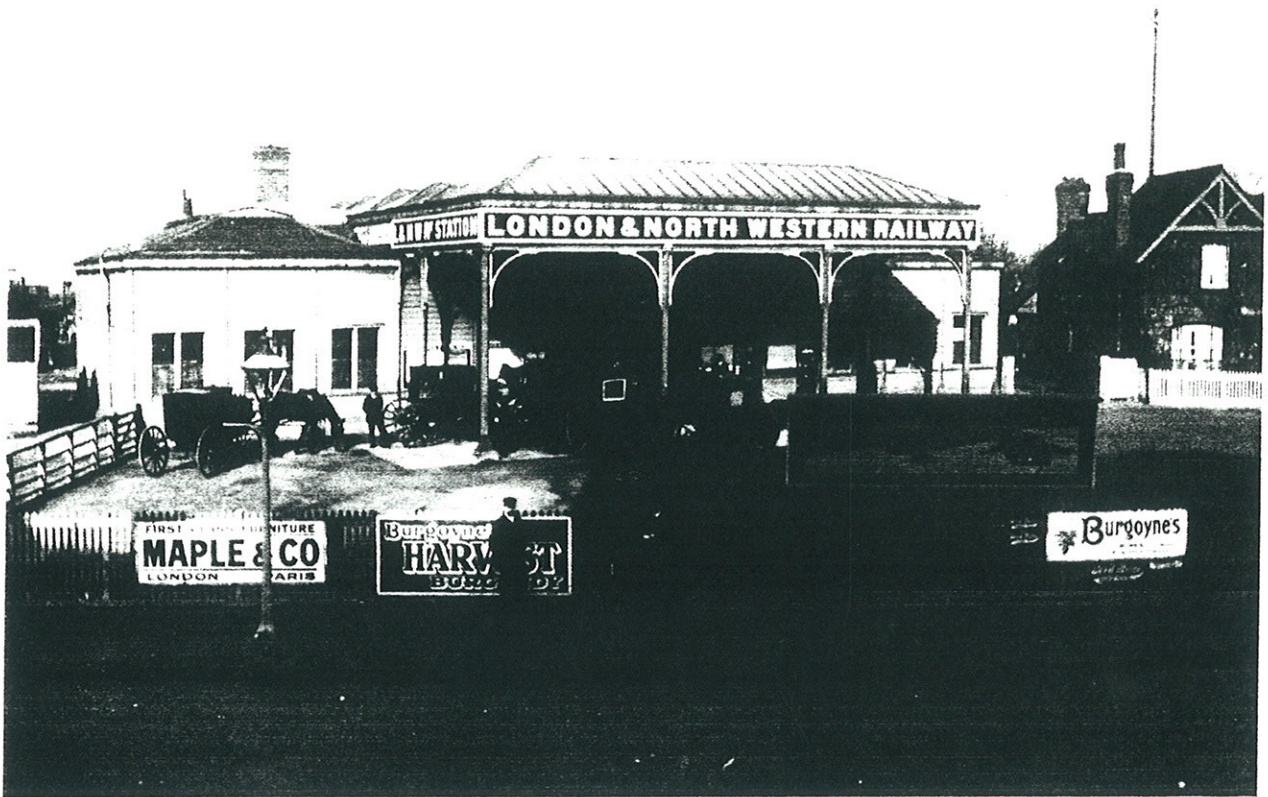
**Plate 4** The exterior of the LMS station in 1914 showing the porte-cochère. Note the later style of transverse ridge-and-furrow roof over the concourse/trainshed and the timber cladding of the side extending to ground level. (*Oxford County Libraries*)

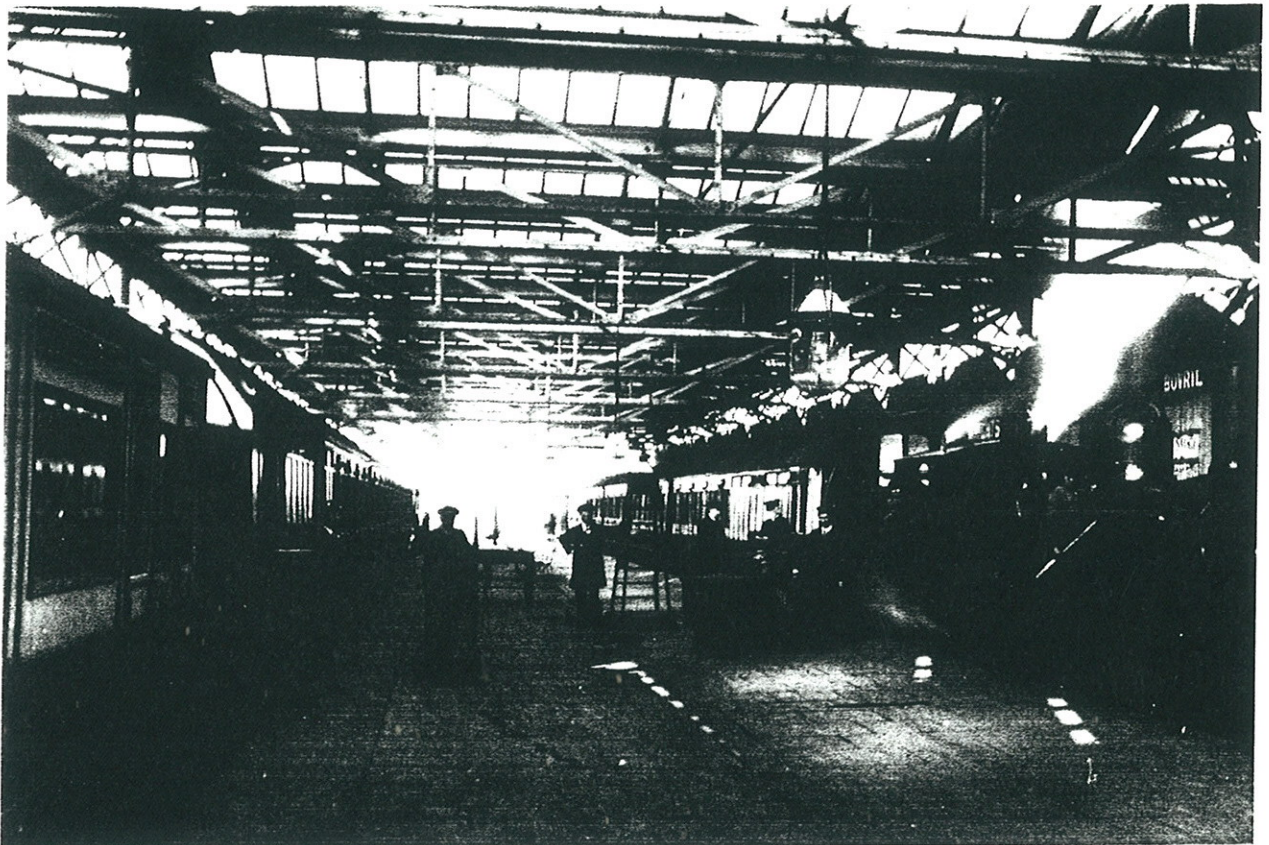
**Plate 5** The interior of the trainshed looking north, 1914. The transverse ridge-and-furrow roofing is clearly shown extending the full length of the trainshed. Note the raised platform level (*Oxford County Libraries*)

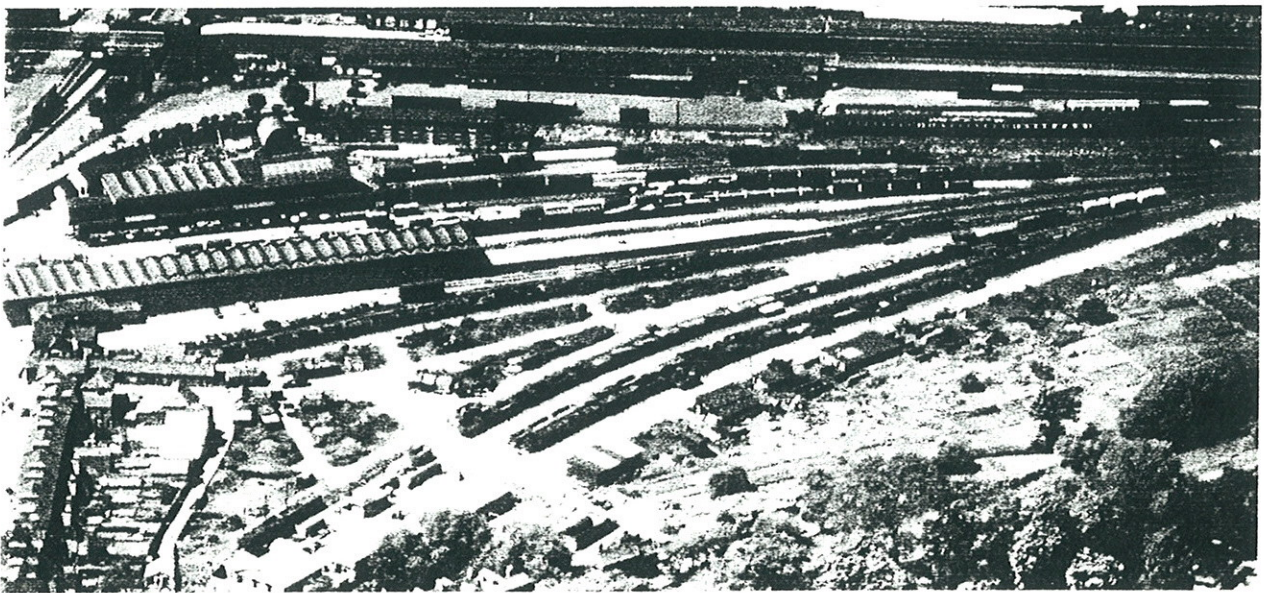
Plate 7 Aerial view of the GWR and LMS stations, 1934. The extreme similarity between the roofs of the station and the goods shed (above) will be noted. The pitched-roofed section of the goods shed is a later LNWR-built extension. (*Aerofilms*)

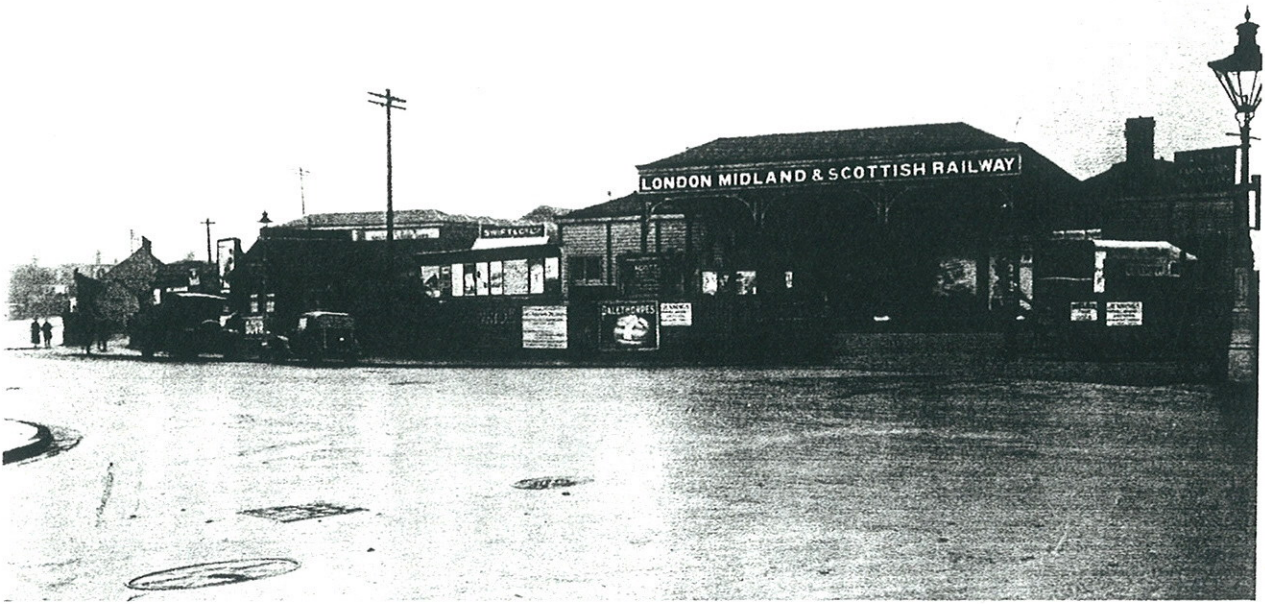
Plate 11 The goods shed from the south-east, 1936. The louvred wooden ventilation panels below the roof can be clearly seen (BR/OPC)

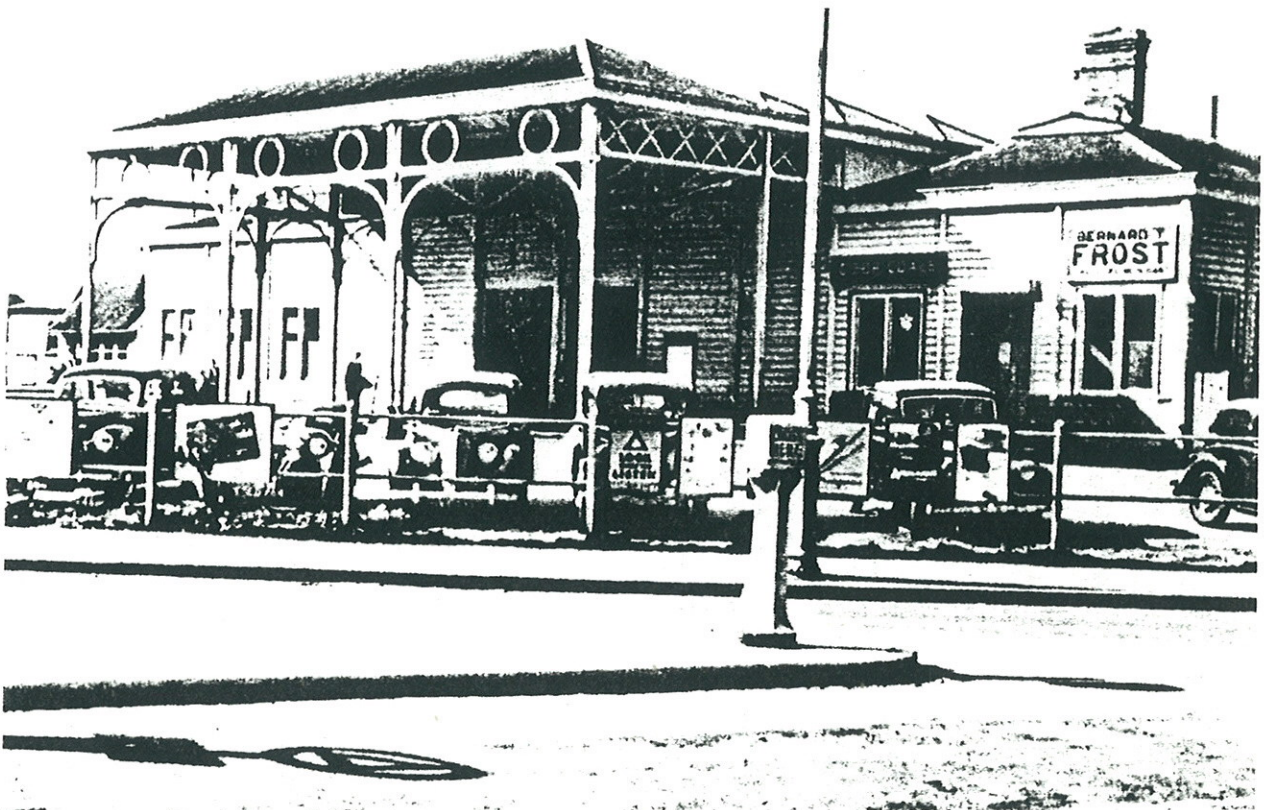
**Plate 19** A similar view, also taken in 1951, showing more clearly the replacement lattice girders and rolled steel column supporting them. (*Dr. R. Preston Hendry & R. Powell Hendry*)

- 5.4.9 Column C6 (BDP C5) supports the eastern corner of the truncated porte-cochère. It is a rolled steel universal column section and is clearly secondary, probably contemporary with the lattice beam B3 and B4 which it supports/supported. Photographic evidence shows that this column dates from sometime between 1940 and 1951 (Pl. 19). It replaces a cast iron column of type C2 and it is thought likely that this replacement is likely to have been the result of a lorry accident (see §5.3.3 and 5.3.4).

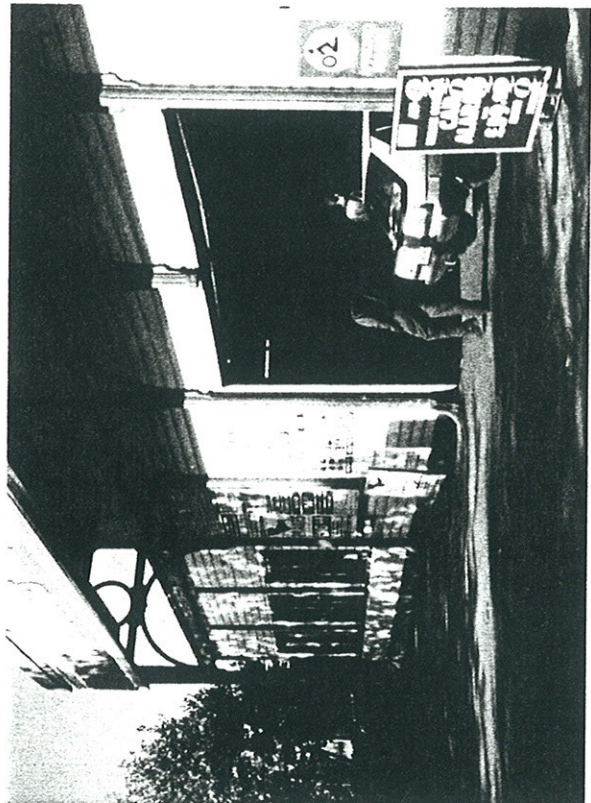
Plate 28 South elevation from the south-east showing truncated column in doorway and the remaining portion of the porte-cochère.

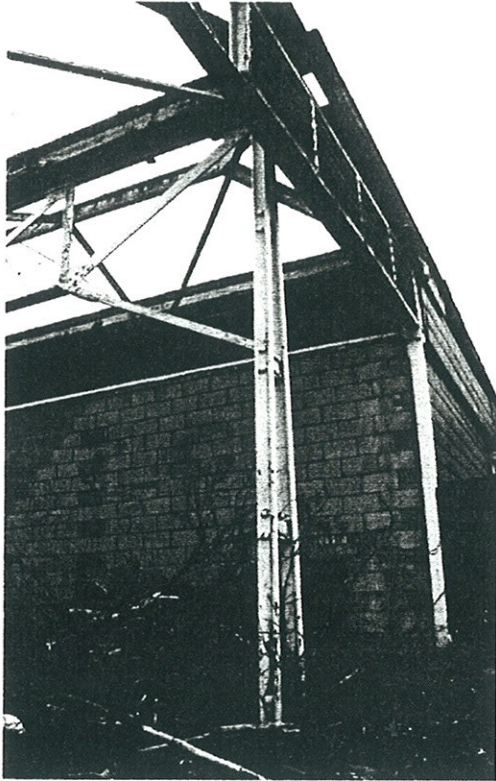
**Plate 38** Rail-built C5 type column supporting inserted T2 type truss.

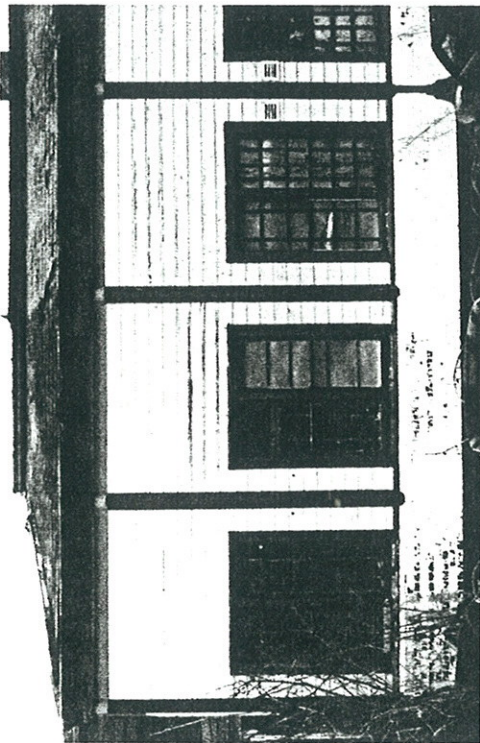
**Plate 44** Typical W1 type wall panel as used on the flanking wings. Both the panels and columns originally continued to just above ground level.

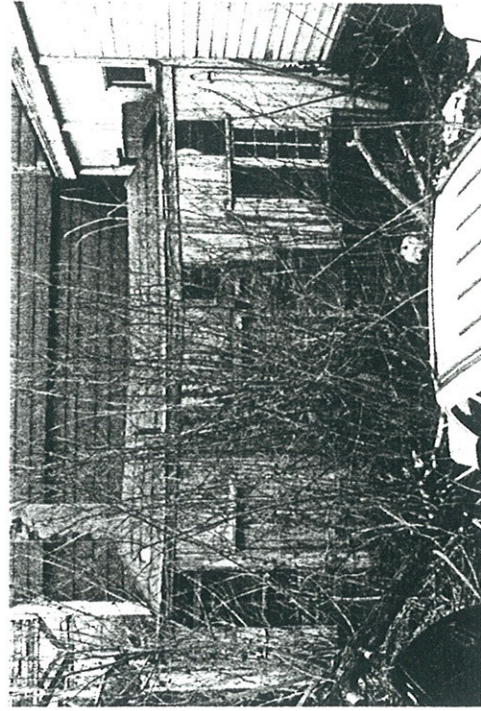
**Plate 52** The exterior of the western low side wing showing the vertical boarding used.

7.3.1 The roofs over the low side wings deserve little comment (Pls 51-2). They each have a pair of low hipped roofs arranged longitudinally (Fig. 6), appearing to mimic the original arrangement of the roof over the trainshed/concourse. The valley/spine between each pair of hipped roof is supported on a substantial joist, that in the eastern wing having stop-chamfers on its lower arrisses. The roofs are generally conventional, being constructed in situ from sawn softwood, lathed and slated. They are construed as being primary features of the low side wings, i.e. pre-1876 but not original. From the exterior, the roofs are partially hidden behind the external walls, mimicking the original appearance of the primary roofs over the trainshed/concourse and flanking wings.

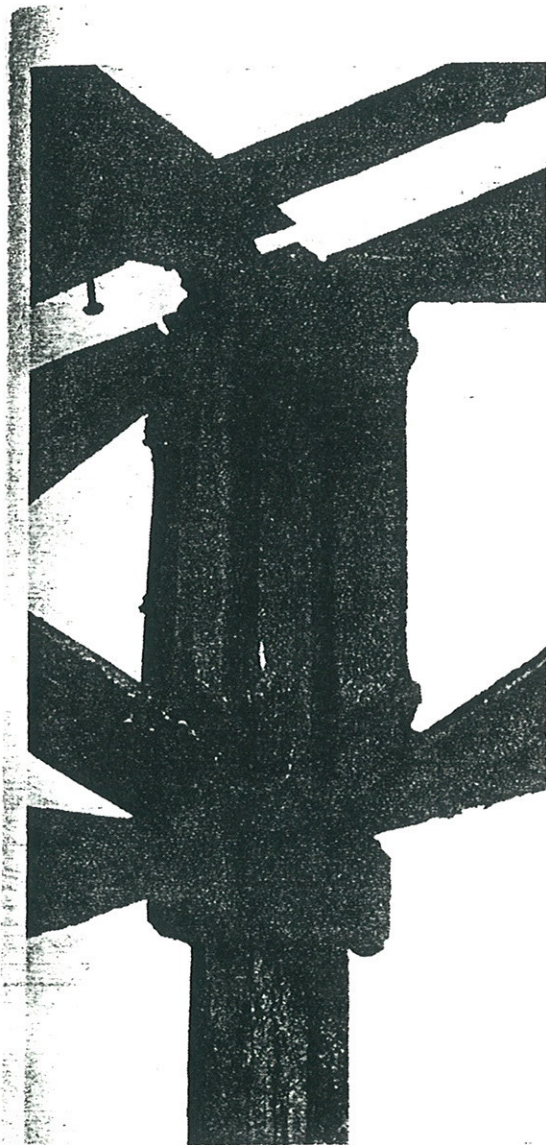
Fig 3. Beam to column fixing at Oxford Station

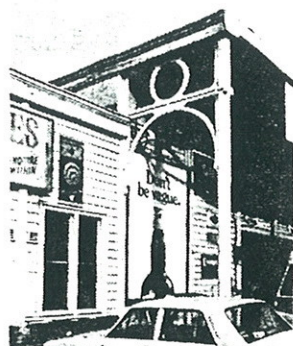
Fig 6. Comparison of decorative cast iron cladding sections  
Great Exhibition Building      Oxford Station

Almost more telling as a comparison than the structural components are the remains of the decorative iron cladding at Oxford which was clearly made from the same castings as in the Exhibition Building, (Fig 6).
