# Postmaster's Hall Yard Merton College Oxford

## Archaeological Watching brief

**Document Title:** Postmaster's Hall Yard, Merton College, Merton Street, Oxford

**Document Type:** Watching Brief

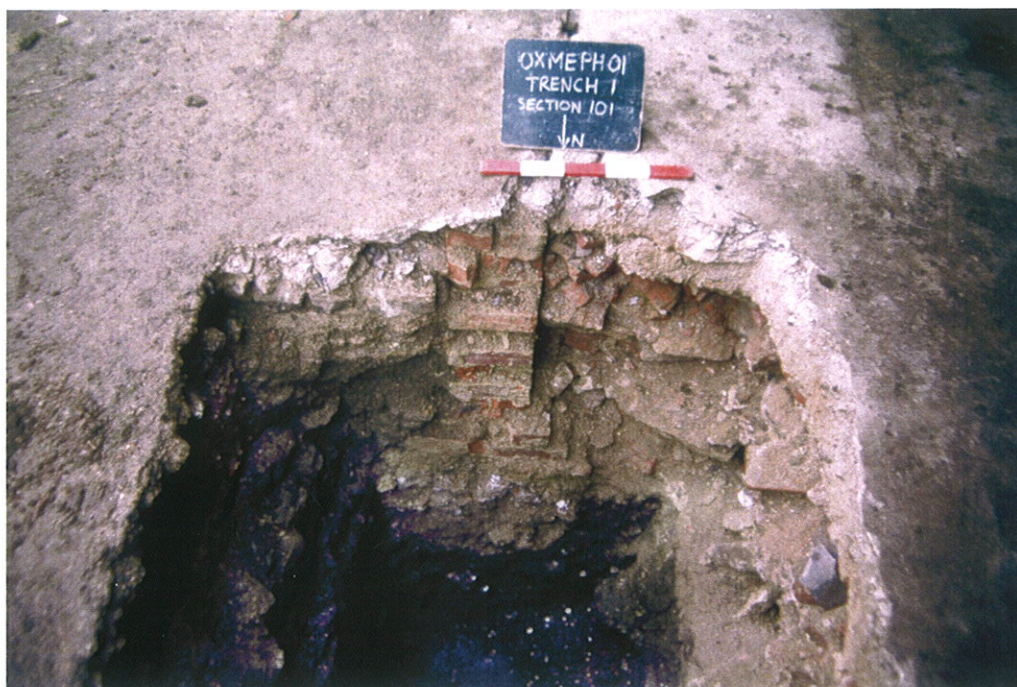
- 4.1.1 This test pit (Fig. 4, Fig. 8 plate 1) measured c 1.3 m x 1.1 m and was excavated to a maximum depth of 2 m below existing ground level (to 58.78 m OD). Natural gravel was not reached during excavation.

Plate 1: Trench 1a showing footing of garage cutting post-medieval and medieval soil layers, looking South

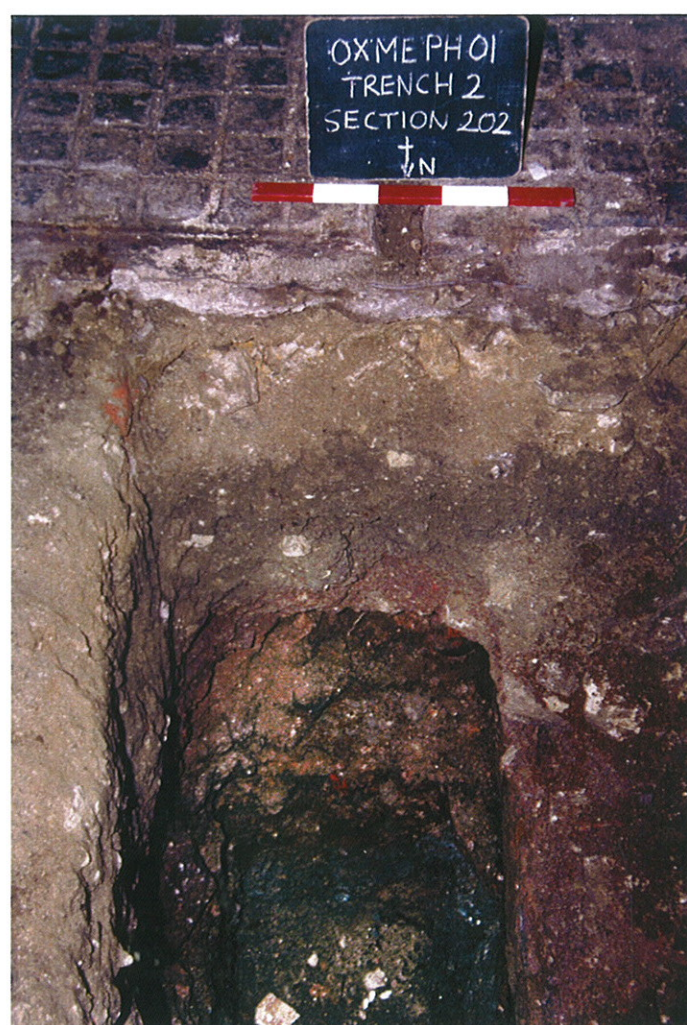
- 4.1.6 This test pit (Fig. 5, Fig. 8 plate 2) measured *c* 1.65 m x 2 m and was dug adjacent to the garage wall, which incorporates the current Merton College boundary wall. The pit was a maximum 2.1 m deep (to 58.70 m OD). Natural gravel was not reached during the excavation of this trench, which was stepped for safety reasons.

Plate 2: Trench 2a showing medieval soil layers at depth, looking South

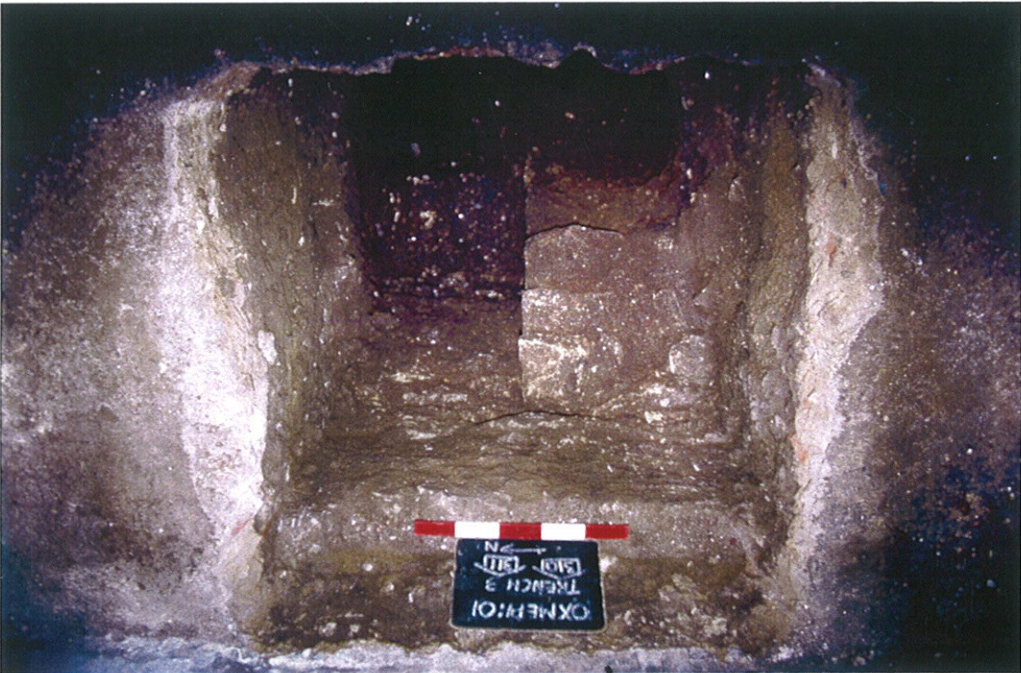
- 4.1.12 Wall 310a was abutted by two well constructed stone walls (311a) that formed a corner of a probable building, possibly a cellar or basement. The footings for the walls were cut down into the gravel to a depth of *c* 3.8 m below ground level, so it is likely that the full depth of wall 310a is comparable.

Plate 3: Trench 3a Walls 310 and 311
