## ST NICHOLAS CHURCH ABINGDON

ARCHAEOLOGICAL EVALUATION

ST NICHOLAS CHURCH, ABINGDON.

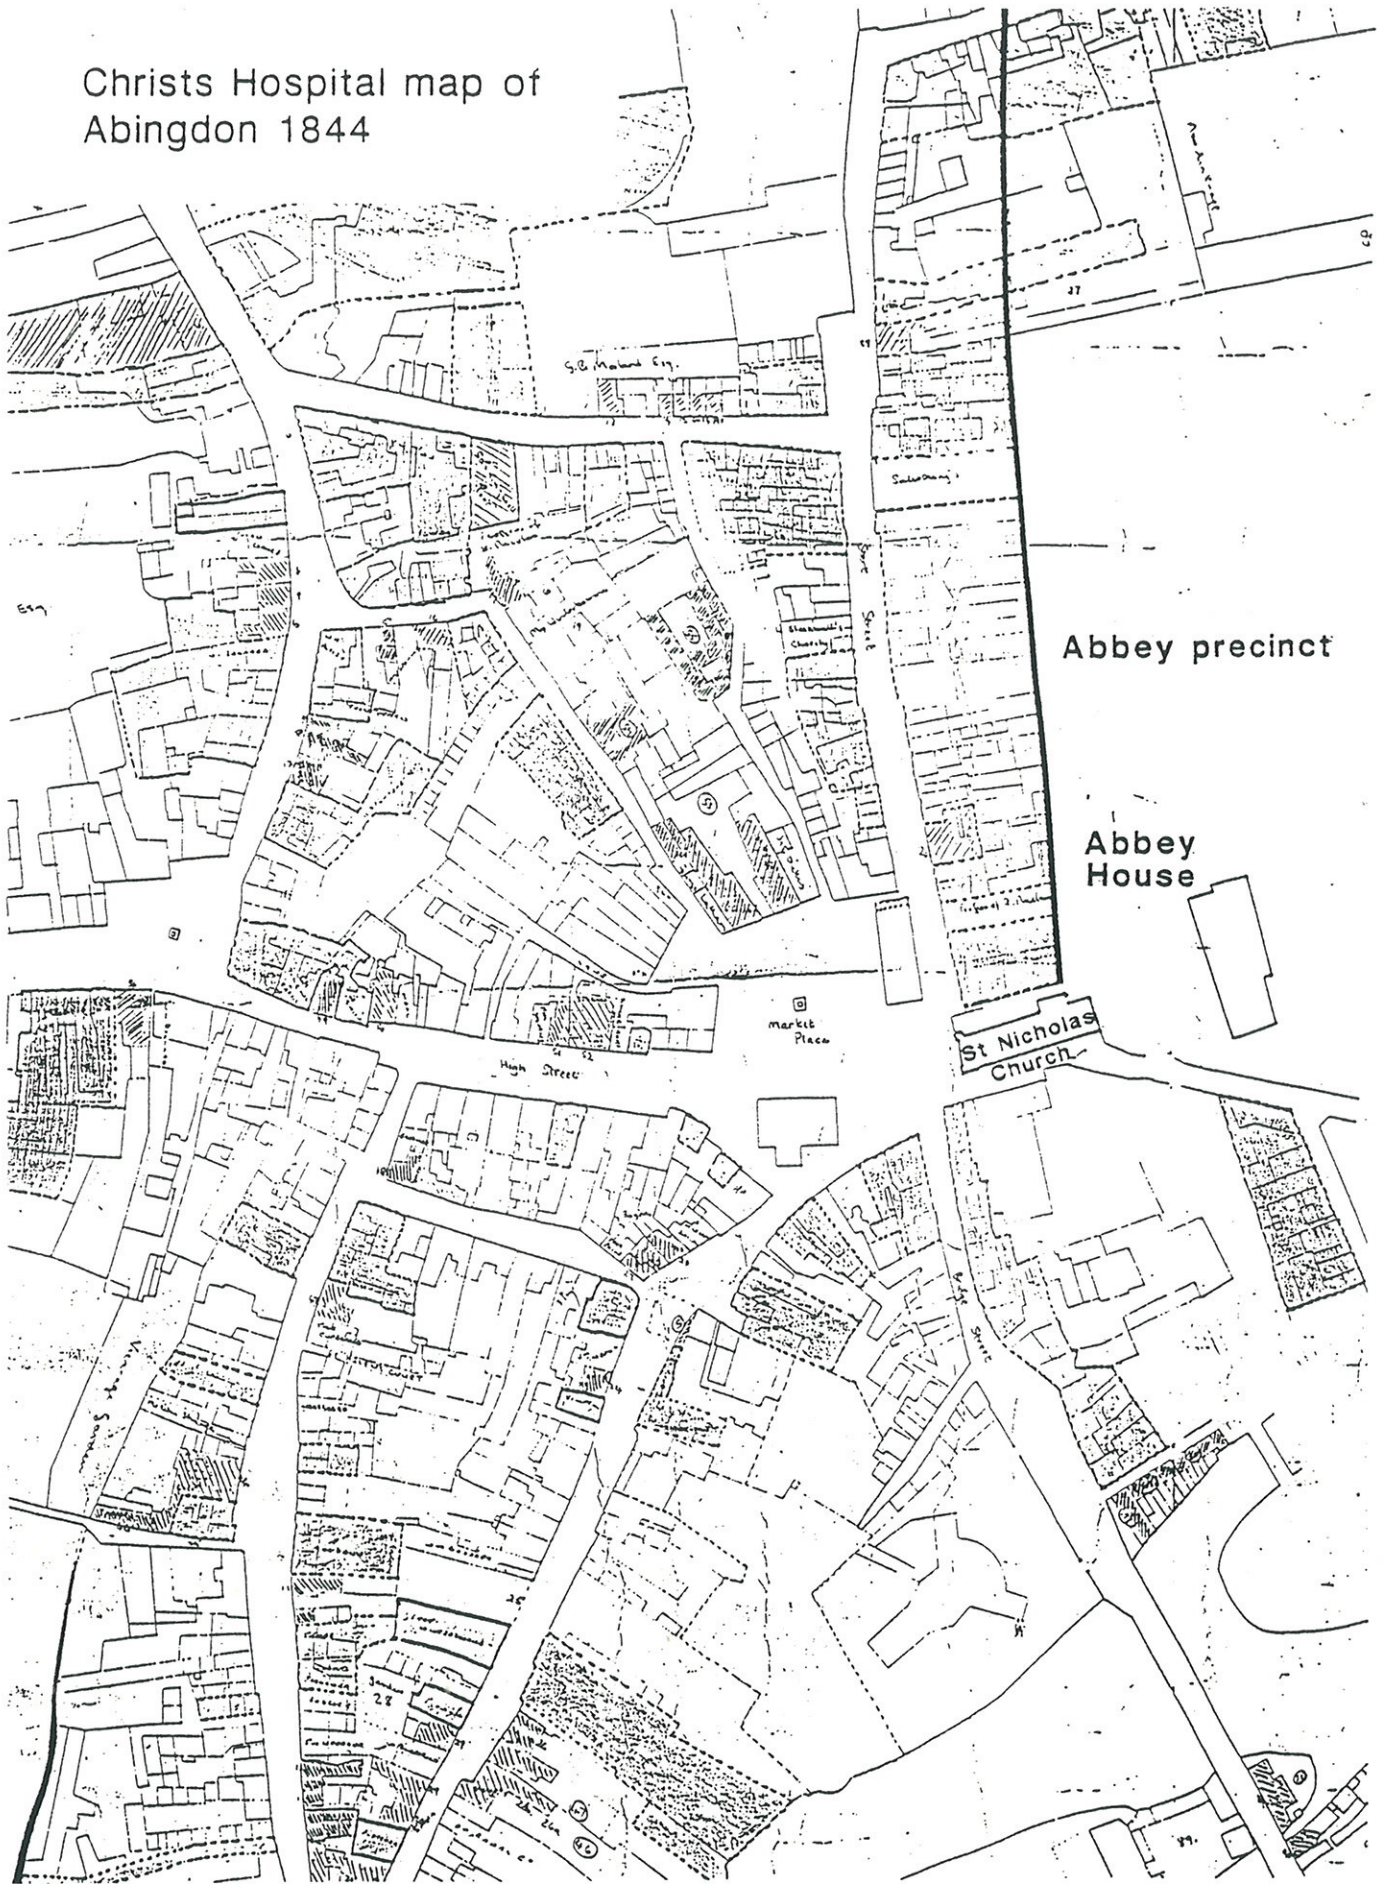
Figure 1

Trench location

The line of the existing wall runs straight northwards for c. 110 m, and forms the boundary between the properties along Stert street and the former cattle market. Before being used as a cattle market the land east of the wall was occupied by an orchard, and the boundary is shown along the same line on the first Ordnance survey of 1881 and on the Christ's Hospital Map of 1844 (Figure 1).
