White Hart Hotel
Chipping Norton
Oxfordshire

Archaeological Excavation Report

**White Hart Hotel,
Chipping Norton, Oxfordshire**

ARCHAEOLOGICAL EXCAVATION AND WATCHING BRIEF

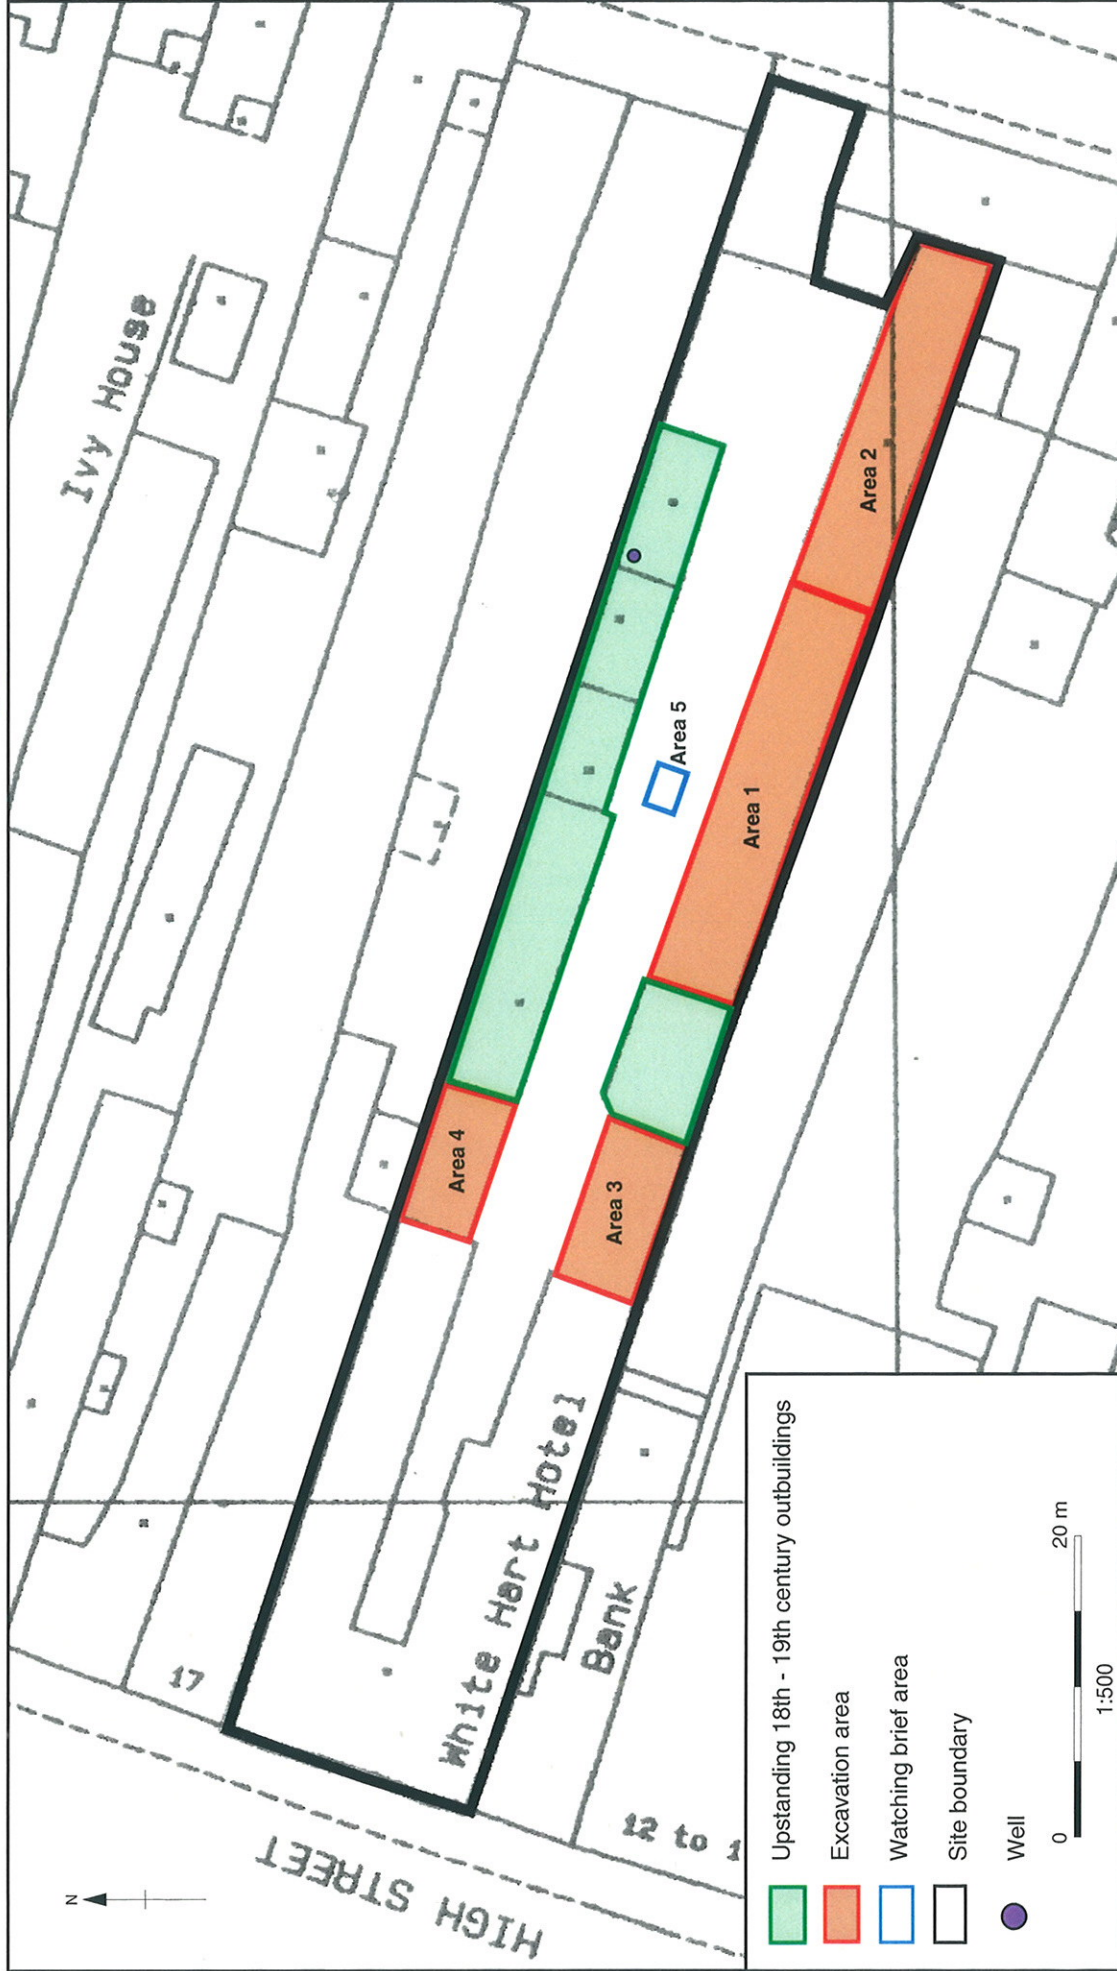
Figure 2: Site plan showing Excavation and Watching Brief Area

1.2.2 Prior to excavation, the site was occupied by outbuildings and a car park. Of the four discrete areas excavated, Area 1 lay within a recently demolished 18th-19th century building, Area 2 was the site of a recently demolished row of 1960s bungalows, and Areas 3 and 4 were under tarmac (see Fig. 2).

3.1.1 Four discrete areas were excavated (Areas 1-4), corresponding to the footprints of proposed buildings (Fig. 2). A total of four test pits (c 0.75 x 0.75 m) were initially dug in Areas 1 and 4, confirming the presence of archaeological deposits. Modern overburden was then stripped from each of the four areas under archaeological supervision, using a mechanical excavator with a toothless bucket. Stripping proceeded to the first archaeological horizon, with the exposed archaeological features then being excavated by hand.

3.2.1 Works that may have disturbed or destroyed below ground archaeological remains were undertaken under archaeological supervision. This included the excavation of an E-W aligned service trench through the centre of the site, the removal of floors from upstanding outbuildings, and the laying of foundations. Any archaeological features encountered were excavated and recorded as outlined in section 3.1 above. In the event, this was only necessary in a single location, referred to as Area 5 (Fig. 2).

4.2.6 The eastern edge of a further quarry pit (1120) was encountered in Area 5 (Fig. 2). The pit was 1.65 m deep with steep sides and a fairly flat base, and contained a back-fill deposit of silty clay. It was directly sealed by the 'made ground' for the modern tarmac yard surface. No datable finds were recovered, and the feature is only tentatively placed in the medieval period by analogy with the quarrying in Areas 3 and 4.

4.3.2 The present boundary wall running along the southern side of Area 1 was found to overlie an earlier limestone foundation (1010; Fig. 2). Keyed into this was the foundation to a demolished limestone wall running north-south along the eastern edge of the excavated area (1002). The full extent northwards of 1002 was unclear due to truncation by a modern pit. Butting up to wall foundations 1002 and 1010 in the eastern part of Area 1 was the remains of a limestone-cobbled floor surface (1004), directly overlying the natural. This stretched across the full width (5 m) of the excavated area north-south, and survived for 5 m westwards from wall 1002. It thus seems likely that, prior to the building of the boundary wall in its present form, wall foundations 1002 and 1010 formed the eastern and southern sides of a building with an internal cobbled floor.

- 4.5.1 Groundworks within one of the upstanding 18th-19th outbuildings along the northern side of the site revealed the presence of a well (Fig. 2). This was placed only 0.5 m from the rear (northern) wall of the building and was lined with dry-stone walling constructed from unfaced limestone blocks. The feature was rectangular in plan, measuring 1 x 1 m internally, and its depth was measured at 10.5 m to the surface of the water. It had been capped with large limestone blocks resting on inserted iron bars. Unfortunately, no artefacts were recovered in association with the well, and it showed no stratigraphic relationship to the original features of the outbuilding within which it was found. It seems intrinsically more likely that the well preceded the outbuilding rather than being constructed within it, not least due to its closeness to a structural wall. Nevertheless, on the available evidence the well must be categorised as undated.
