White Hart Hotel Chipping Norton Oxfordshire

Historic Building Recording and Analysis

Oxford Archaeology

July 2005

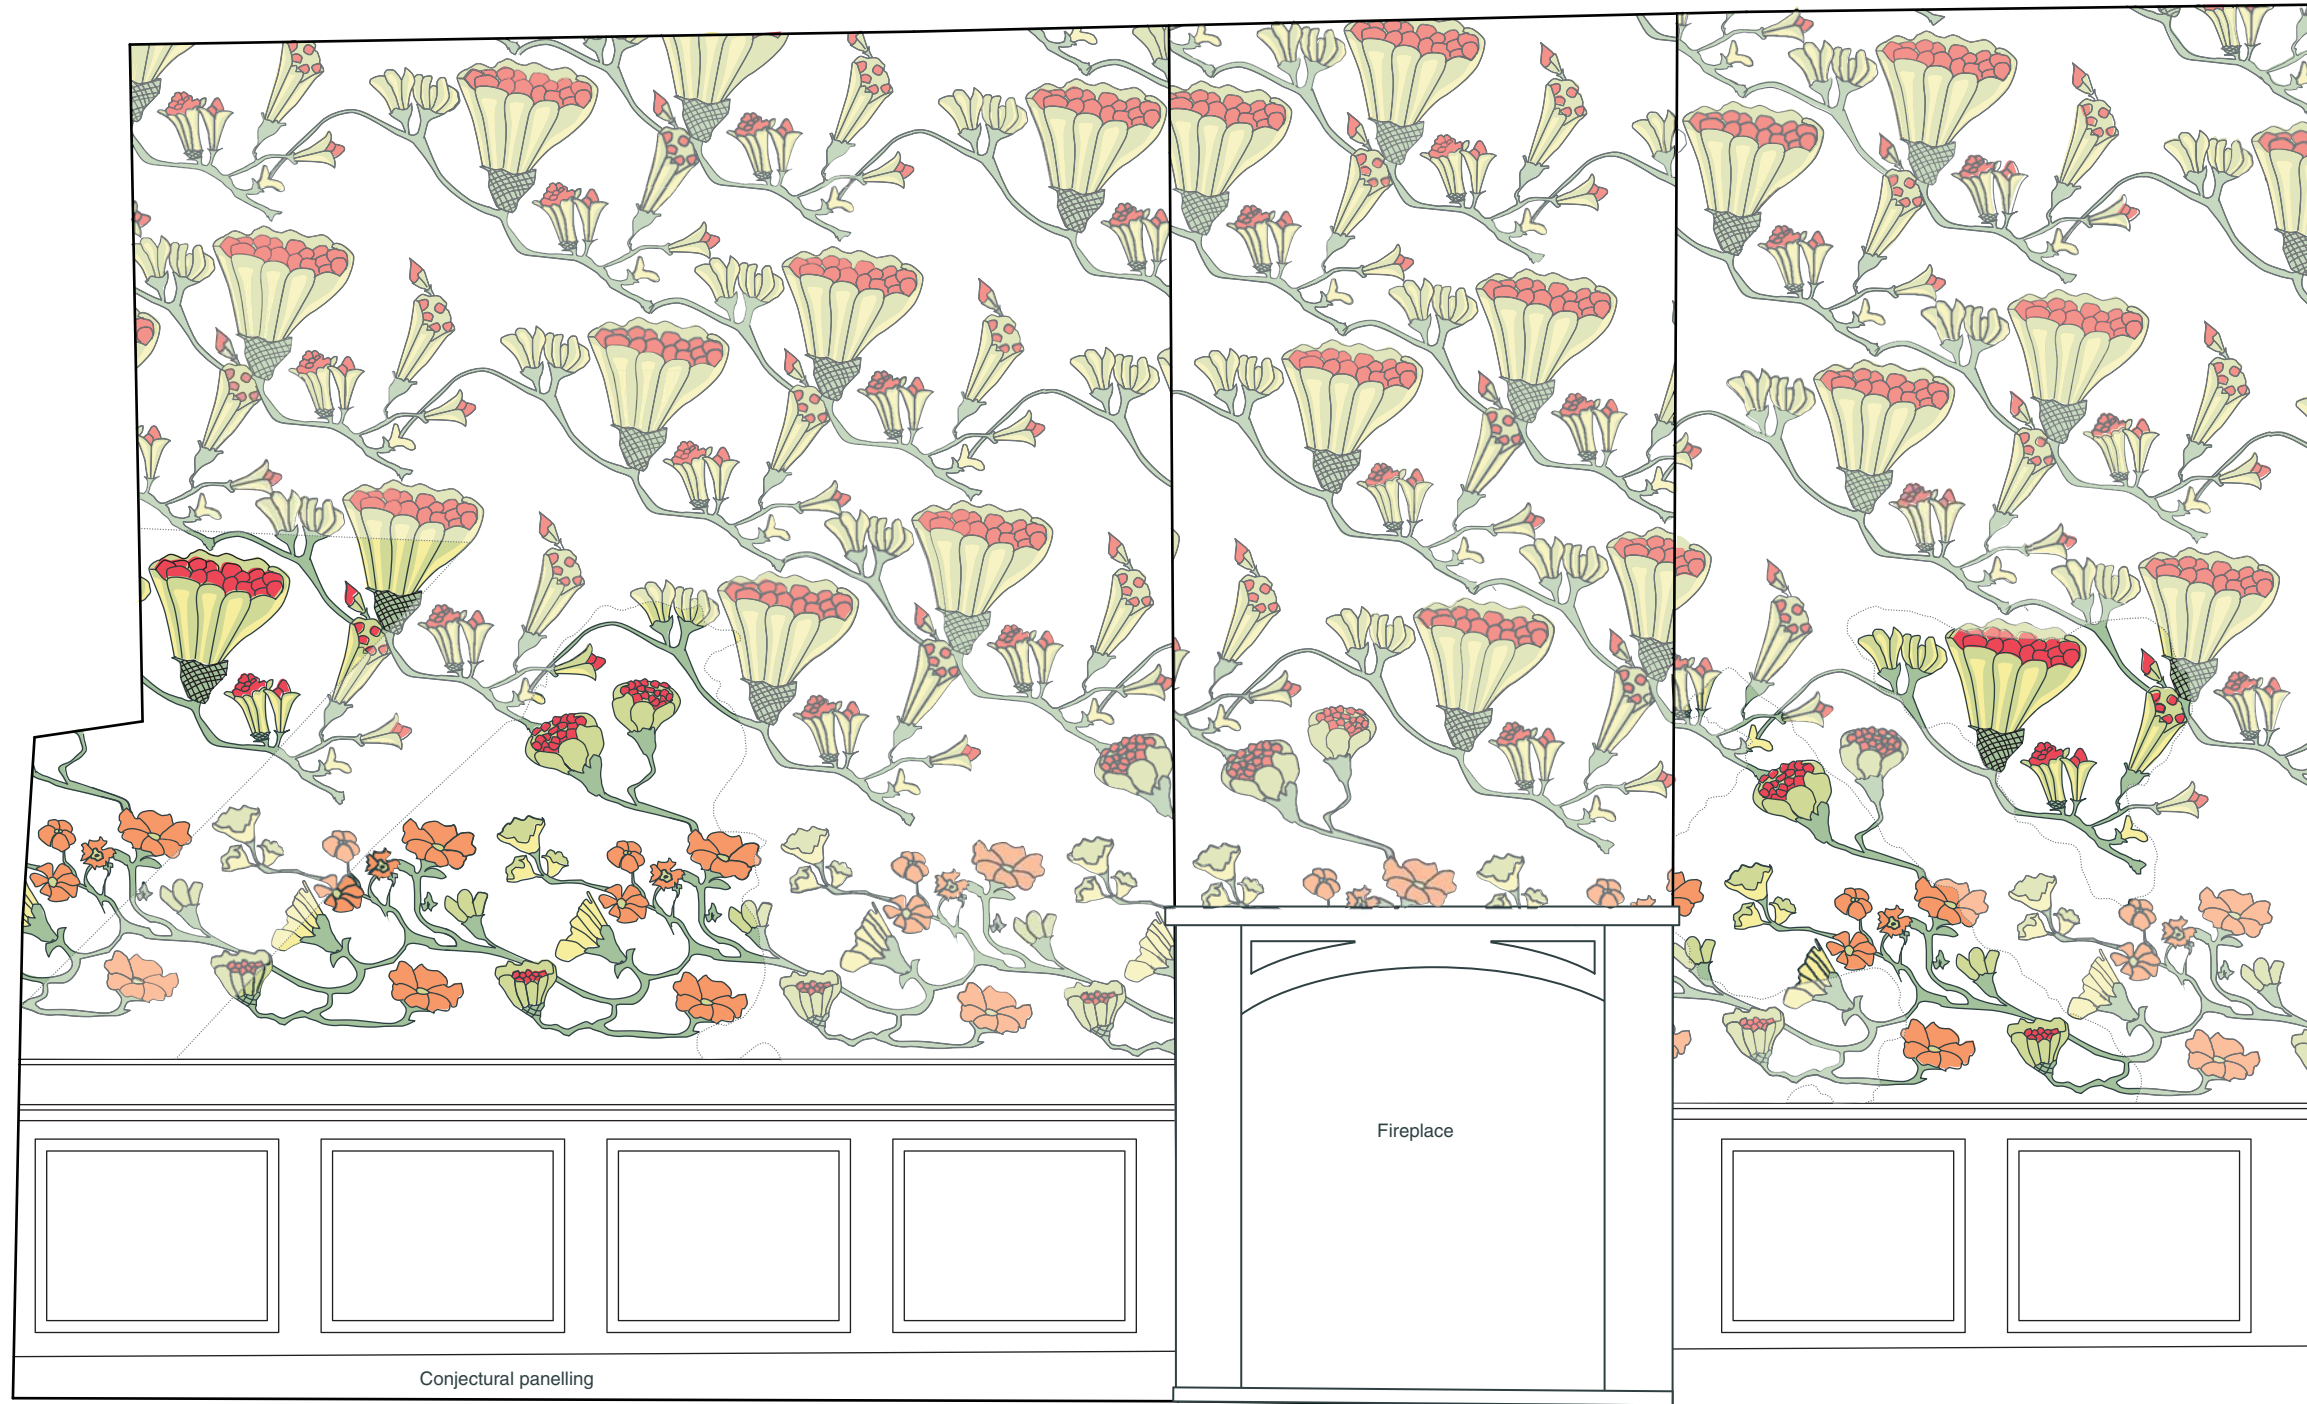
Figure 9 : Conjectural reconstruction of wall paintings in the first floor south chamber, brighter fragments survived to 2003 in part

- 3.2.22 Much of the south wall was still covered with a layer of plaster which had been hidden by the later panelling. On this plaster surface were the very fragmentary and faint remains of wall paintings (Plate 12). The paint only survived in isolated patches many of which were very small and all of which were faded. It was clearly possible to see however that the paintings that remained showed a pattern of large stylised flowers and tendril like branches (see Figure 9 for reconstruction).

- 3.2.23 In addition to photography OA recorded these fragmentary remains by taking a 1:1 tracing on acetate, which was then digitised. It was noted that the pattern was a repeat design on both sides of the chimney breast and that the surviving part of the pattern on the right could be used to reconstruct the more fragmentary pattern on the left. This pattern was made up of a band of small orange flowers and leaves at the base above the rose tendrils supporting large round flowers with upturned petals and red centres and groups of smaller long fluted tulip like flowers. It was noted that to the left (east) of the chimney breast the pattern began higher up the wall leaving a blank area (perhaps a low item of furniture sat here?).

- 3.2.24 A speculative and conjectural reconstruction based on the slight evidence which remains is presented as Figure 9. Although to modern eyes this pattern looks rather crude and odd and it does not relate to other known Oxfordshire wallpaintings, it does appear remarkably similar to the large embroidered hangings popular from the 16th to the early 18th centuries. The repeat pattern of very large stylised flowers in particular has much in common with designs found on local textiles.²

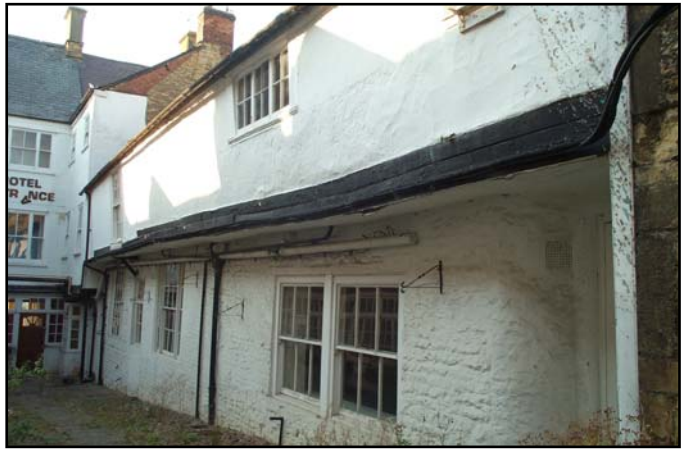
Plate 8: The North Range 2003

3.3.1 The north range is a long narrow building lying on the north side of the narrow yard (Plate 8). This two storey building has a projecting jettied first floor facing into the yard. The rear (north) wall is stone built and terraced partly into the hillside. During the latter life of the hotel the lower part of the range was taken up by a large function room and several smaller auxiliary rooms. These were divided from each other by late 20th century brick or concrete partition walls. On the floor above lay an east-west passage (partly projecting over the yard on the jetty) giving access to a number of rooms. This passage was at a slightly higher level than the Market Street range and was accessed by several steps. On the west end of the jettied range a small stone range housed a spiral stair which gave access to the passage from the yard.

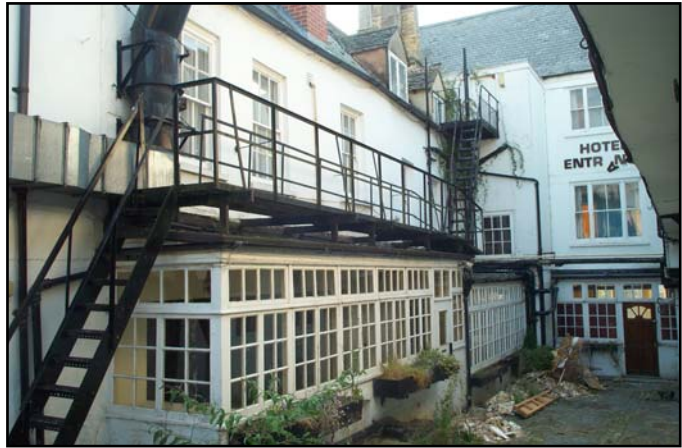
Plate 9: The South Range 2003

3.4.1 The south range mirrors the north across the yard but in construction and appearance it was quite different (Figure 2; Plate 9). As with the north range a smaller stone building was appended to the northern side. The main part of the building was of brick and whitewashed stone. On the ground floor was a large projecting glazed structure. This was probably associated with the re-arrangement of the 1920s. On the roof of this structure sat an iron fire-escape consisting of walkway and stairs, this led up to another set of escape stairs leading up to the second floor of the main (west) building.

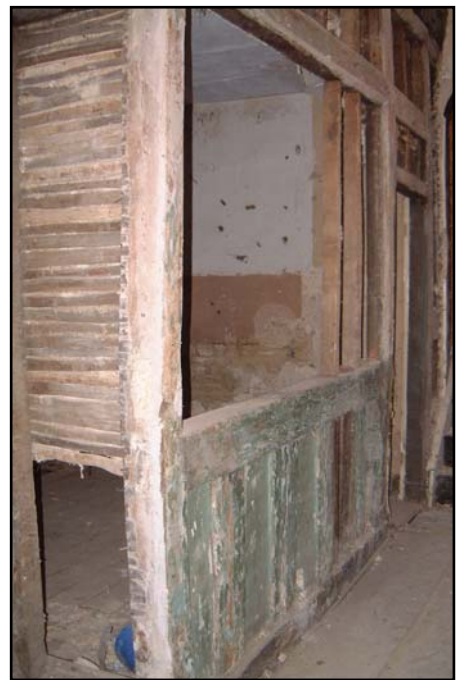
Plate 11: The North Range gallery (west end)

- 3.3.8 The main part of the gallery to survive was the east-west timber framed wall which made up the inner face of the gallery, this was complete with original doors, windows and substantial areas of fabric. The outer wall of the gallery was also well preserved and encased in the later jetty wall. A small north-south element of the framing survived and was situated at right angles to the west end of the gallery (within the west block; Plate 11). Although some early beams supported the gallery and survived in the function room beneath and some elements of the roof structure survived, these were only fragmentary and the gallery was by far the most important surviving early element.

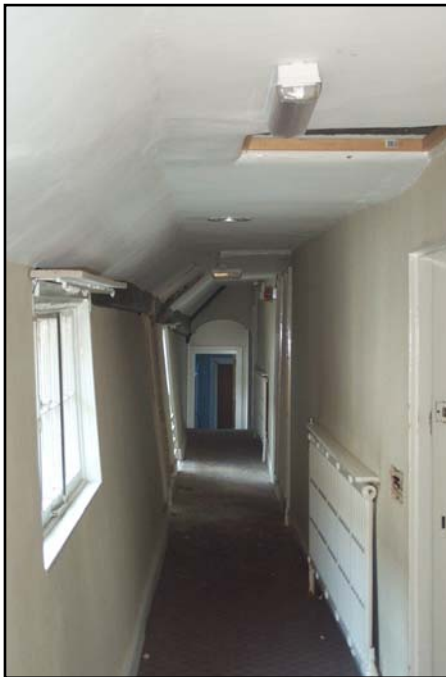
Plate 14: The North Range gallery
Prior to strip 2003

- 3.3.11 As the gallery was preserved beneath later accretions, elements survived of colour schemes which are so often obliterated in half-timbered buildings. Large areas of red and green paint were noted on all the early elements of the frame and areas of panelling were often covered with a thin light pink colour wash. These remains were fragmentary and undated but it is possible that some elements relate to an early colour scheme. Fragments of wallpaper were also found on the frame. This part consisted of an elaborate repeat arabesque pattern of interlinking green and red tendrils (Plate 13). Although the pattern is suggestive of an early 17th century date the pattern is of an unknown type and the paper lacks any stamp. Despite its seemingly Jacobean design it is possible that the paper is in fact 19th century in origin.
