# Greys Court Rotherfield Greys Henley-on-Thames Oxfordshire

## Archaeological Recording Action Report

2nd November 2001

**Document Type:** Archaeological Investigation Report

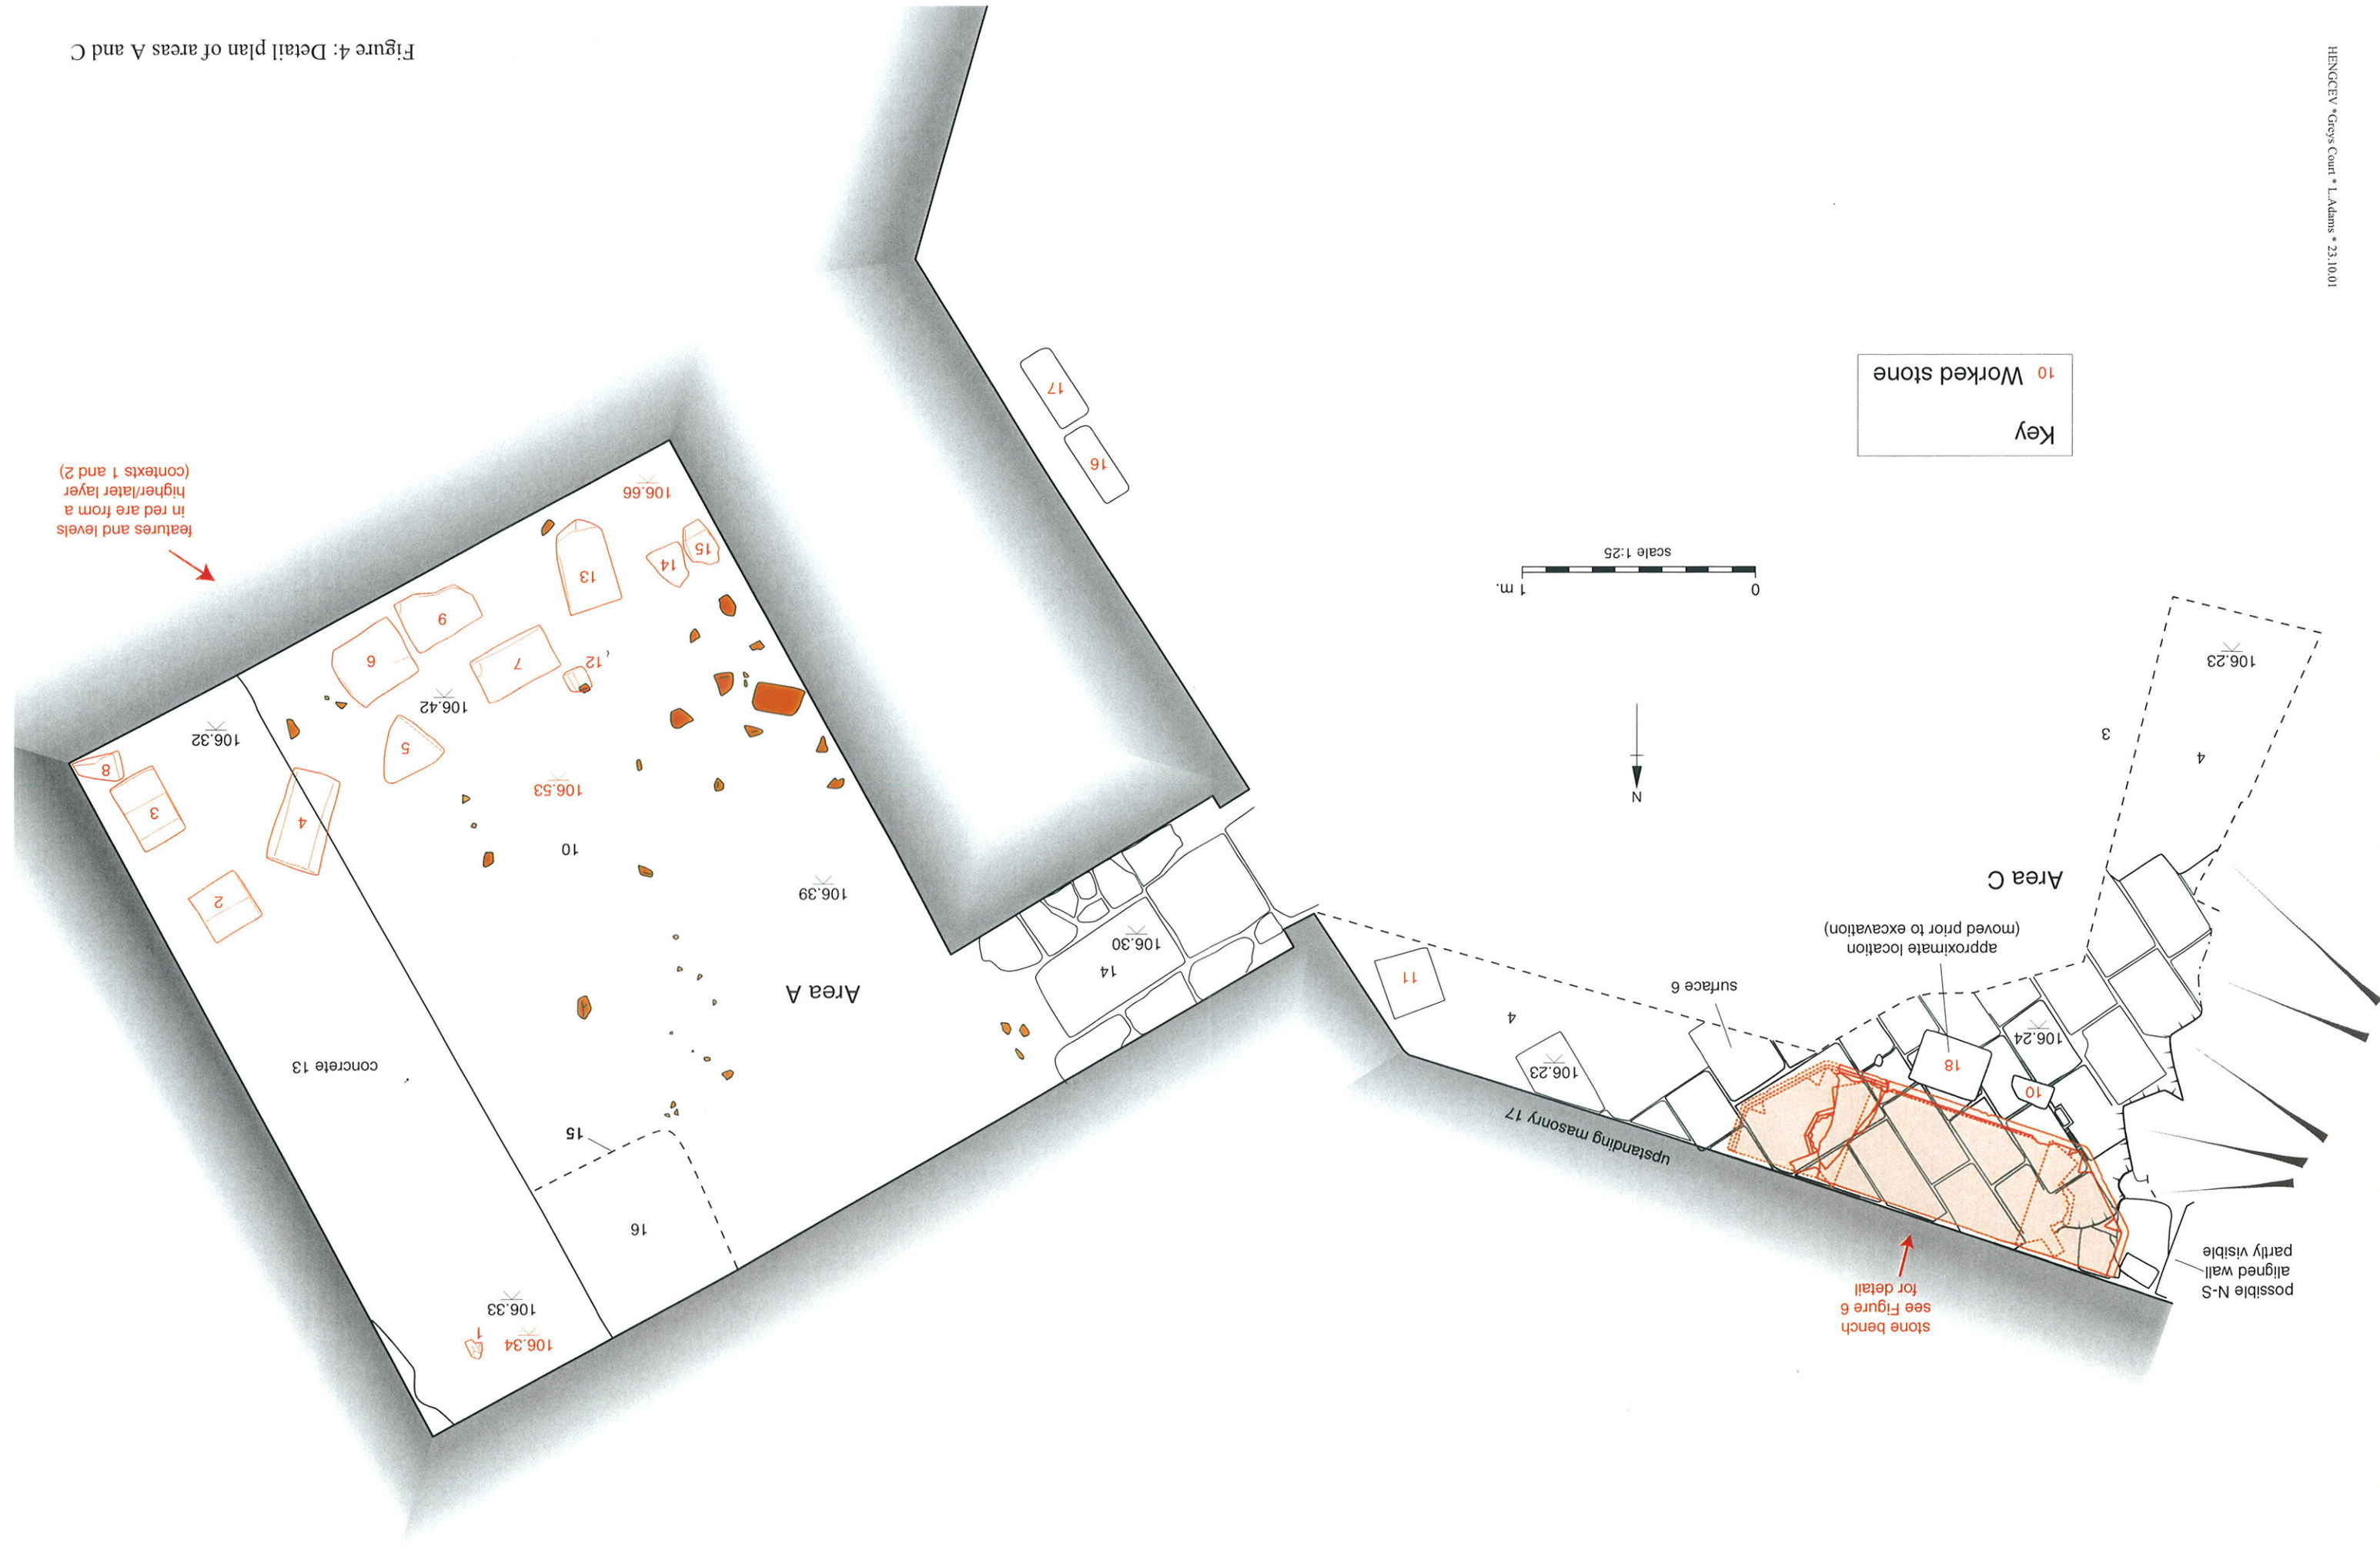
Figure 4: Detail plan of areas A and C

2.1.1 Area A measured approximately 3.4 m x 3.1 m, comprising the internal area of the North Tower (see Fig. 4). The deposits encountered consisted of a dense concentration of flint and brick rubble (Context 2) located in the southern corner of the tower and measuring approximately 2.20 m NW-SE by 1.20 m NE-SW and 0.20 m in thickness. Included within the building rubble were a number of architectural stonework fragments (building material nos. 13-15). This deposit was partly overlying a dark, humic soil (Context 1) which was spread throughout the remainder of the Tower, and had a maximum thickness of around 0.28 m. This contained occasional building debris plus a distinct concentration of architectural stonework

- 2.1.2 Subsequent removal of Deposit 1 revealed what appeared to be a crude surface (Context 10), comprising loosely compacted rubble within an organic matrix, measuring approximately 3.4 m (NW-SE) x 2.2 m (NE-SW). Some wood fragments were visible which seem to suggest that this was a fairly modern deposit. Directly to the north-east of this deposit and abutting three walls of the tower was a level surface of concrete (Context 13 - see Plate 4) which formed a 0.90 m wide strip aligned parallel to the north-east wall of the tower. Surface 13 had a raised 'lip' on its south-western edge, possibly formed during the process of pouring the concrete into a construction trench dug to form the structure. The function of this surface remains unclear, but must also be of fairly recent date. Surface 13 appeared to be abutted by Deposit 10, which may have formed as a layer of trample during the period of use of Surface 13. One small square pit (Context 15) was seen to cut Surface 10, and measured around 0.7 m x 0.7 m. This was not investigated further, but must also represent a recent intrusion.

2.1.6 Area C represents the area directly adjacent to the south facing elevation of the E-W aligned curtain wall and consisted of an L-shaped intervention running E-W from the entrance to the North Tower, parallel with the curtain wall for around 4.0m, then turning south and continuing for a further 3.0 m. The area contained a patchy organic soil (Context 3) similar to that encountered in Area B. This was seen to directly overlie a well constructed stone surface (Context 6 - see Plate 5). The surface was constructed of dressed blocks of what appeared to be a limestone, generally rectangular in shape (averaging 0.38 x 0.22 m), and laid in diagonal bands at approximately 45° to the line of the northern section of curtain wall (Context 17); that is, parallel to the internal wall of the North Tower. Several blocks showed evidence of additional working beyond the rectangular shape, with notches cut into upper arisses and corners, suggesting that they are not in their original context. The uneven edge of the surface at its south-eastern limit would suggest that it has been truncated, although it may be that this represents the true limit of the surface, which could have been laid as a limited area of hard-standing around the stone seat. Some stones clearly abutted the curtain wall, though the majority were noted to extend beneath the upstanding masonry, with one penetrating at least 0.08 m beyond the face of the wall. This would suggest that the surface either pre-dates the original wall, or that the internal elevation of the wall has been refaced, the latter being the most reasonable explanation.

2.1.7 The western limit of the surface was obscured by a large earth mound which contained numerous large stones. These generally showed no evidence of bonding, the exception being in the NW corner at the junction with wall 17. Here three articulated blocks did suggest the possibility of a further N-S aligned wall being buried beneath this earth mound. Three worked stones were recovered from this area (building material nos. 10, 11 and 18), all on or within the modern organic soil and therefore likely to have been recently deposited.

features and levels in red are from a higher/later layer (contexts 1 and 2)

stone bench see Figure 6 for detail

possible N-S aligned wall partly visible

3.1.2 The material excavated from within the tower probably represents the degree of deterioration of the walls of the tower over a relatively short period of time, as the underlying concrete and compacted soil surface appeared quite modern. The linear arrangement of some of the worked stones recovered, however, may suggest an episode of deliberate storage/dumping of material gathered from elsewhere on the site (see Fig. 4).

- 3.1.3 There is no obvious interpretation for the strip of concrete (Context 13). A small amount of hand excavation at its edge suggests that it lies on a silty clay deposit, and not an earlier surface as might have been expected.

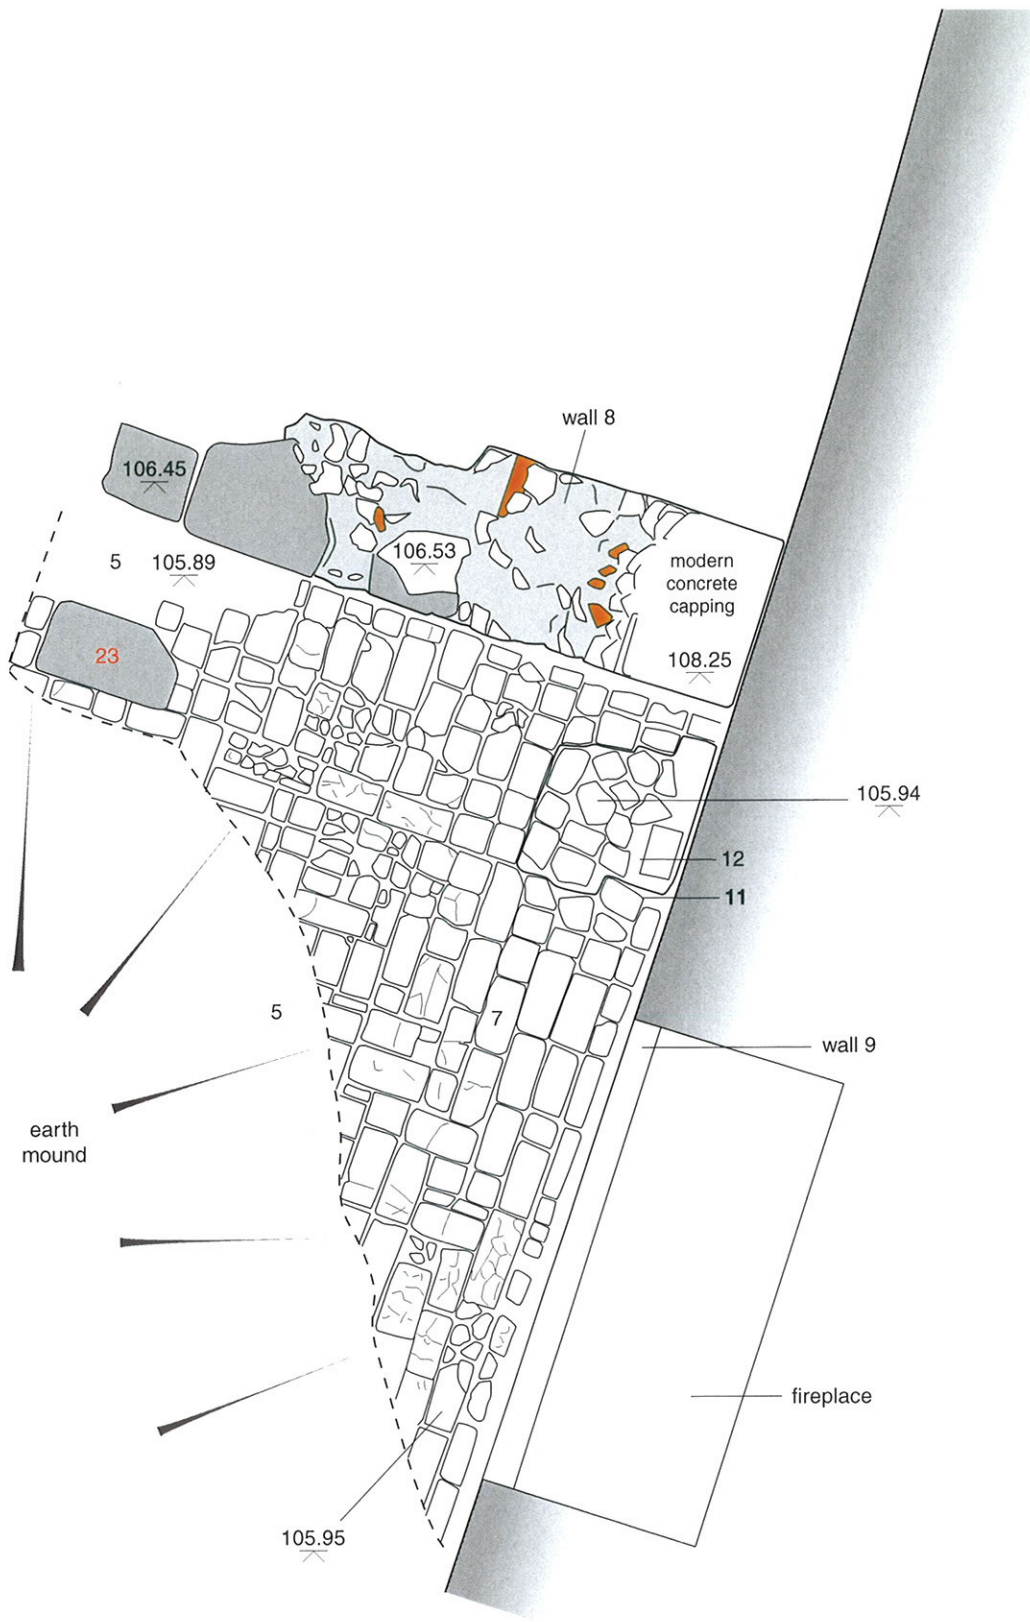
Figure 5: Detail plan of area B

- 2.1.3 Area B was located adjacent to the brick-lined fireplace within the west wall elevation and included a partly exposed surface (Context 7 - see Plate 1) and an upstanding section of E-W aligned wall (Context 8 - see Plate 2). The surface was overlain by a patchy deposit of humic soil (Context 5), which contained quantities of undecayed organic material obviously of very recent date. This deposit was removed to expose part of the underlying surface. The maximum area of Surface 7 exposed measured approximately 2.9 m (N-S) x 2.4 m (E-W). The surface was constructed of closely laid red bricks which, though laid in a rectilinear fashion, did not form a discernible bond. Where complete, the bricks measured 0.25 x 0.11 m (only length and width was visible). The condition of the surface was poor, with many bricks showing signs of fragmentation which is likely to be the result of both chemical and physical weathering. The north-east corner of the surface also appeared to have undergone some later alteration (Contexts 11 and 12), the later work clearly representing inferior workmanship.

- 2.1.4 Set within this brick surface, at the north-western limit of the exposed area, one fragment of worked stone was recorded (building material no. 23). The fine grained limestone/sandstone fragment was rectangular in shape with the exception of one chamfered corner. Its function remains unclear but could possibly represent the remnant of an internal feature. The eastern limit of the surface was noted to abut the western wall (Context 9) while the northern limit was clearly seen to abut the surviving length of E-W aligned wall (Context 8). The western and southern limits of the surface extend beneath a large earthen mound, probably the result of recent (19th- or 20th-century) landscaping.

2.1.5 At its northern limit, Area B was bounded by the E-W aligned wall fragment (Context 8). The exposed extent of the wall measured a maximum of 2.3 m (E-W) in length x 0.60 m wide (N-S) and stood to a maximum height of 1.95m at its eastern end where it is capped in concrete. The masonry of the wall appears to represent successive periods of rebuilding and alteration, with a wide range of building materials being used in its construction. These comprised flint nodules, brick and dressed stone, some of which were clearly re-used. The western end of the wall has clearly been truncated, with material having been removed from its northern face, and narrows to 0.30 metres in width. This western limit of the wall is marked by a dressed stone block which appears not to be bonded to the remaining wall, and could represent a recent addition. This abuts a second large dressed stone which measures approximately 0.5 x 0.4 m and is well bonded into the wall fabric. This may represent the remnant of either a opening through the original structure or a change in the wall alignment.

- Key for wall 8
- cbm
  - flint
  - mortar
  - worked stone

- 3.1.4 The stub wall (Context 8) and brick floor (Context 7) clearly suggest that there was once a building of some sort constructed up against the curtain wall, with a substantial fireplace. The construction of the fireplace, with its chimney apparently formed during the original building of the curtain wall, suggests that the building would have been contemporary with the original crenellation. The wear to the floor certainly suggests an early date for its construction.

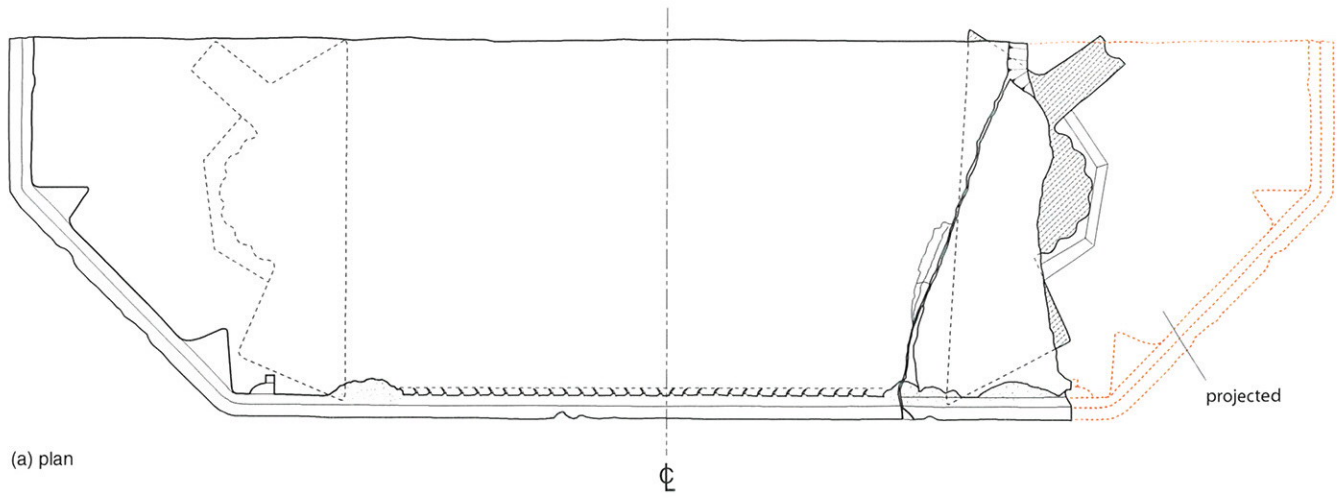
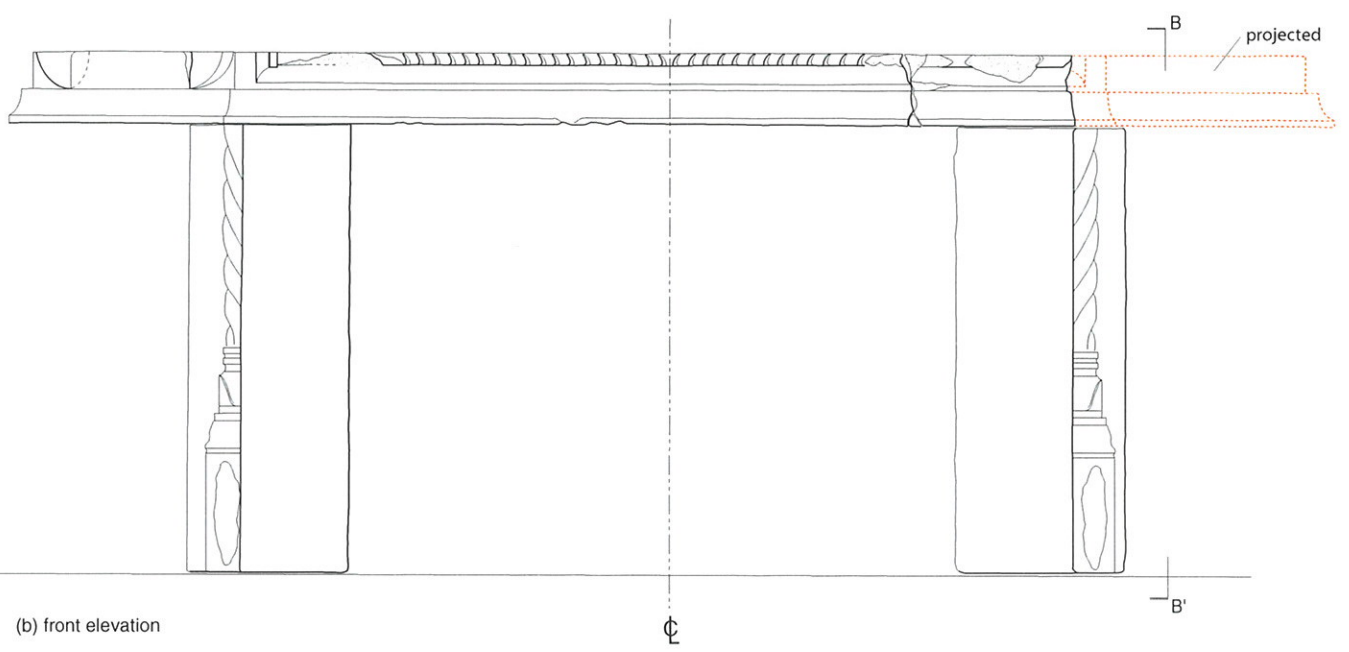
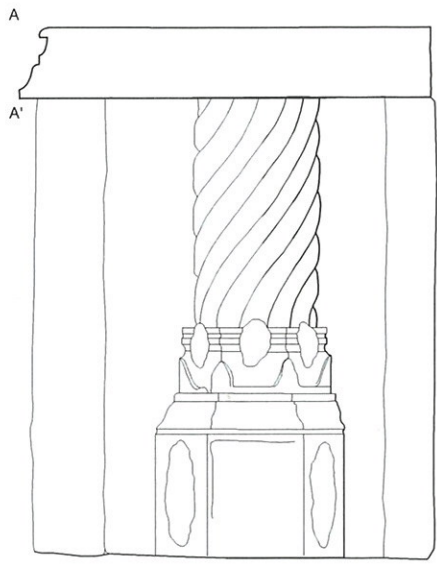
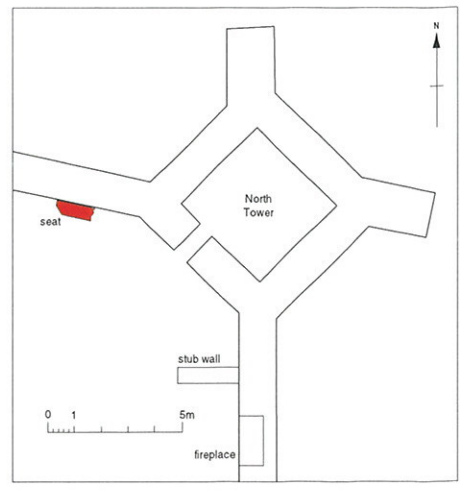
Figure 6: Garden seat

- 2.2.1 An ornamental garden seat, formed of three re-used architectural fragments, is located against the base of the south-west wall of the North Tower (Fig. 6). The opportunity was taken to make a drawn record of the seat prior to its dismantling and removal to a new location.

- 2.2.2 The seat of the bench is formed of an incomplete, inverted fireplace mantel. The mantel is rectangular with one surviving chamfered corner, 1.40 m long x 0.50 m wide x 0.09 m deep. Sufficient survives for the full original length of the mantel to be established as 1.80 m. A single fillet and ovolo moulding extend around the whole, the front section being further embellished with a cable moulding along the original bottom arris (ie. to the top in its present arrangement) enclosed within a further concave moulding. The mantel is truncated at its eastern end, and is badly cracked.

- 2.2.3 The mantel section is supported on a pair of matching applied columns with capitals in the Venetian Gothic style, standing to a maximum of 0.60m. The shafts of the column fragments are 0.17 m in diameter. The polygonal capitals stand 0.30 m tall and are decorated; the mouldings however, are unfortunately too weathered to attempt any meaningful reconstruction. Stylistically, the columns may represent early gothic (12th century) material, though they may equally be of later, 16th century origin.

- 2.2.4 The column sections are set within irregular angular blocks of masonry forming an obtuse angle. Their original function is unknown.

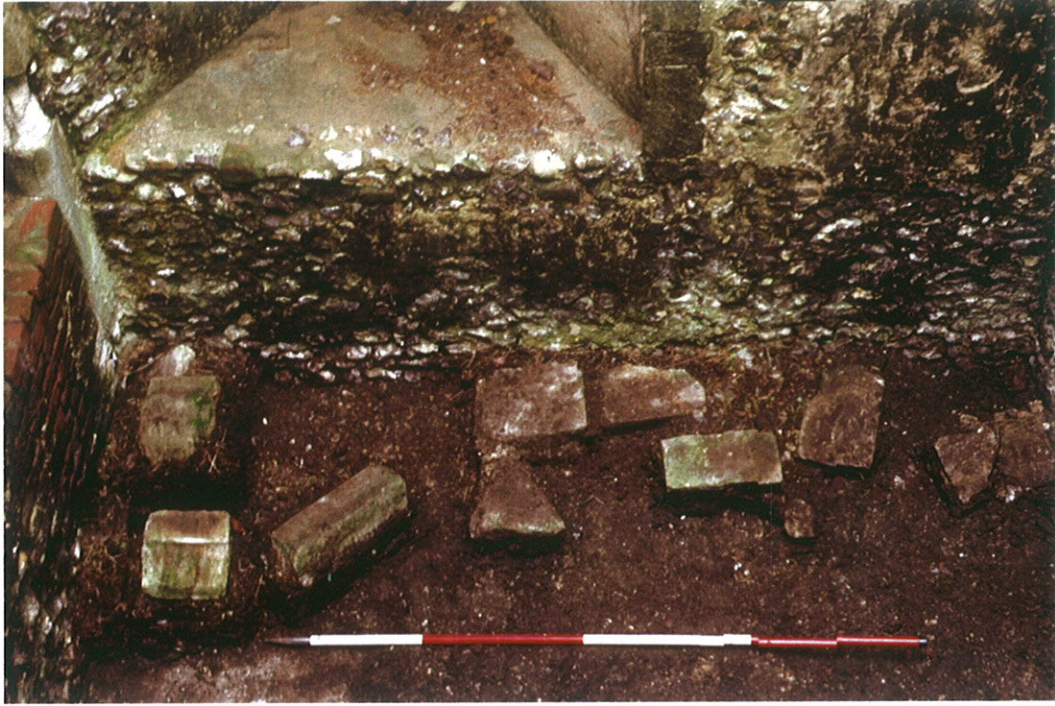
Plate 3: Fallen masonry

aligned parallel to the north-west facing elevation of the Tower (building material nos. 2-9 - see Plate 3). However this soil deposit also contained modern materials including plastics, suggesting a very recent deposition.

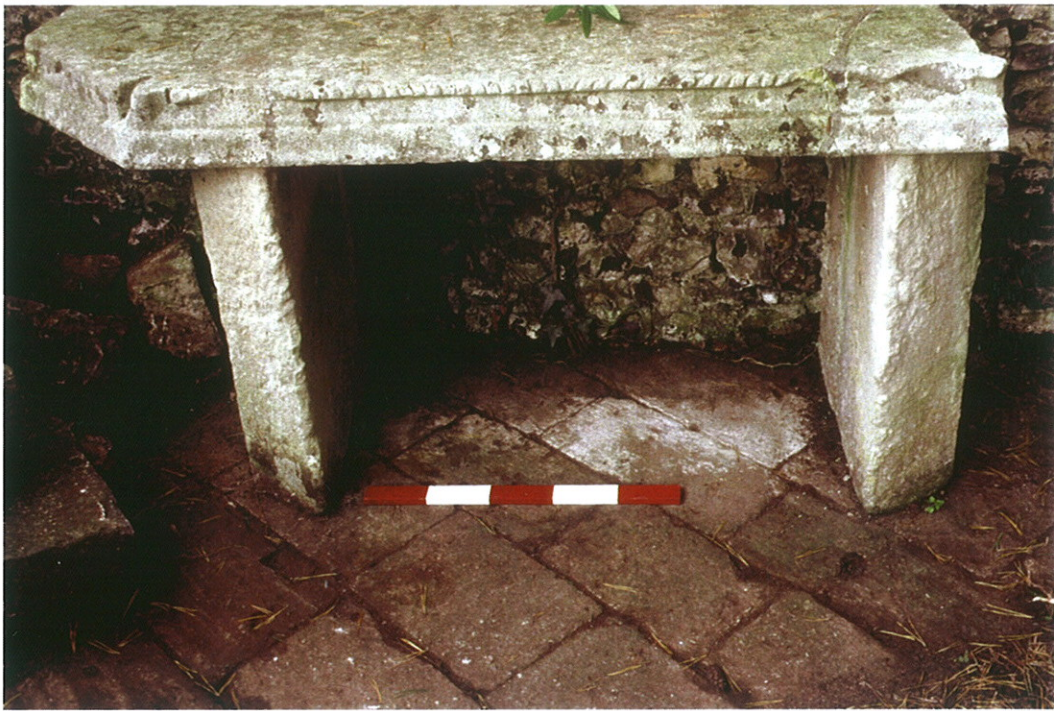
Plate 5: Seat and stone floor

- 3.1.5 The relationship of the stone surface (Context 6) to the curtain wall (Context) 17 implies that the wall may have been refaced, possibly during 19th or 20th century 'improvements' to the grounds of the Manor. The presence of the stone seat certainly suggests the use of this part of the gardens as an area to relax in. The alignment of the stones forming the surface with the walls of the tower is worth noting but again no obvious interpretation is forthcoming.
