Camoy's Court, Chislehampton

Investigation of Building

Camoy's Court, Chislehampton Investigation of Building

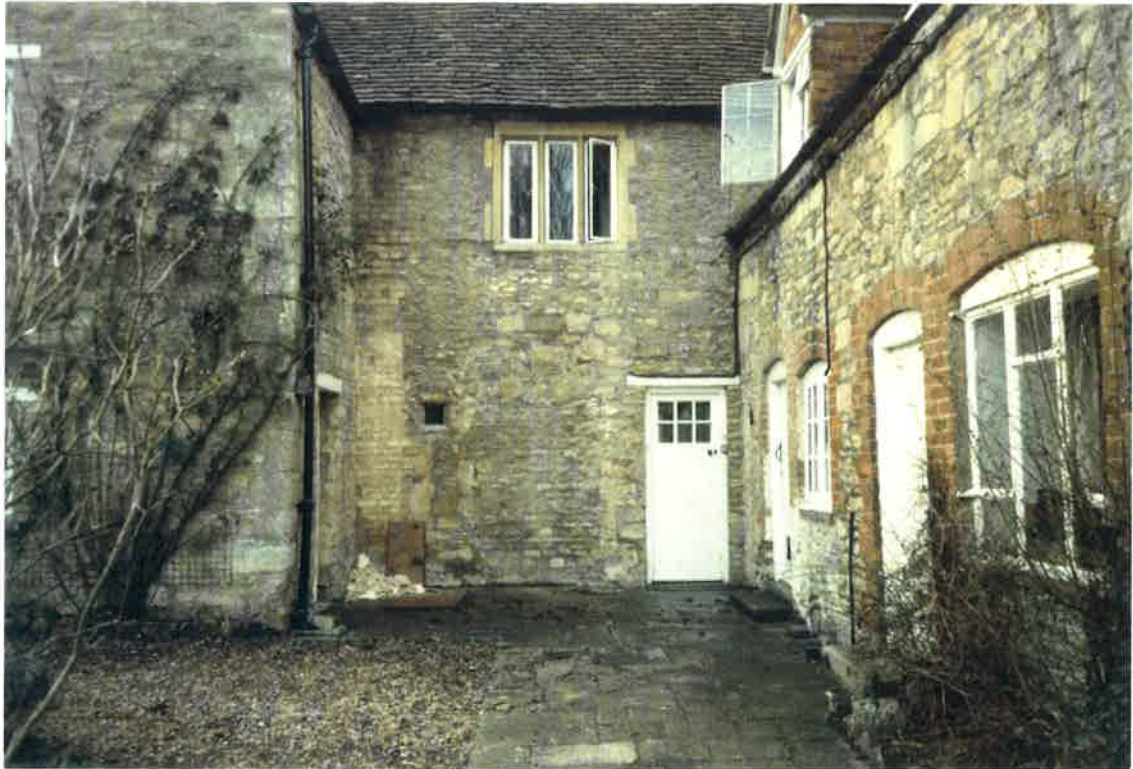
Fig. 2 Camoys Court: East side of kitchen

2.1.1 This is at present an alcove in the kitchen opposite a blocked opening on the outside. Internally, small areas of plaster were removed from the top and bottom of the right-hand (S) jamb of the alcove, immediately next to the kitchen fireplace. These were found to be of modern plaster over a mortar containing black grits, and seem to represent a blocking of a former opening. The support for the top of the alcove (at 1.77 m above the floor) was not seen, but it may be a timber or steel lintel, and was faced with brick and tile. The left-hand (N) jamb of the door is the N wall of the kitchen, and is covered with fitted cupboards, and so is inaccessible.

2.1.2 Externally, there is a rubble patch blocking a former entrance. The present door to the N has a S jamb cut through old stonework and a new N jamb of clean unpainted stone. The blocking of the former door is of rubble or ragstone with a modern pointing and no trace of any painted decoration. The right-hand (N) jamb exists for the full height of almost 2 m and has squared ashlar blocks with old paint surfaces that continue round the corner of the jamb (which is slightly rounded), clearly demonstrating that this was a door. The lintel can be traced less certainly, and it may be that a timber has been removed here, but several stones above the top of the opening have traces of paint on them. The left-hand (S) jamb is irregular, the stones with old paint adhering to them do not form a continuous edge, and some may have been reset. Beyond this to the S is a vertical brick band which is presumably the back of the chimney flue, and which is painted. The door into the medieval SE extension has

painted jambs similar to the blocked door already described, and a timber lintel.

2.1.3 The earlier painted surfaces have a sequence of a white/cream wash, red, and white/cream (several coats of each): these are found on all the old stonework described above. Later additions have only the white/cream wash: this is found on the brickwork and also on the NE wing which may be of 19th-century date. Yet later additions have no paint at all: the blocking of the door and the N jamb of the present door.

2.1.4 It is therefore likely that old door was blocked and the new door was made in the present century, but both these events had taken place by the time the house was surveyed for the *VCH* (published in 1962).

4.1 The opening of the door from the existing kitchen would be the re-opening of a door blocked in the present century.

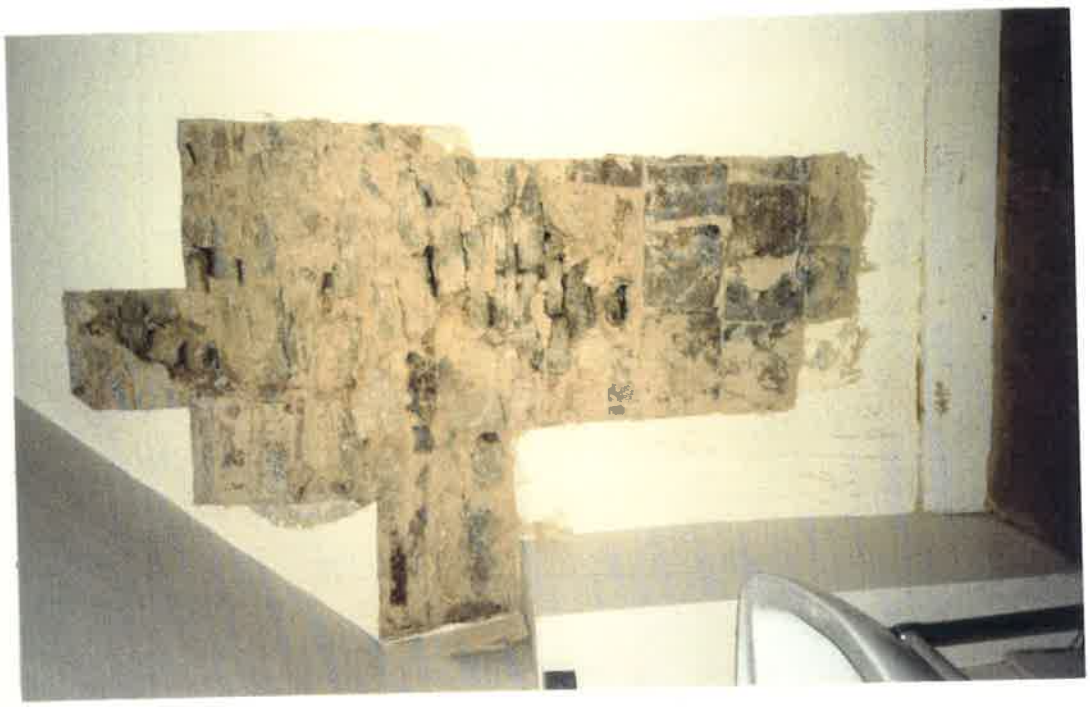
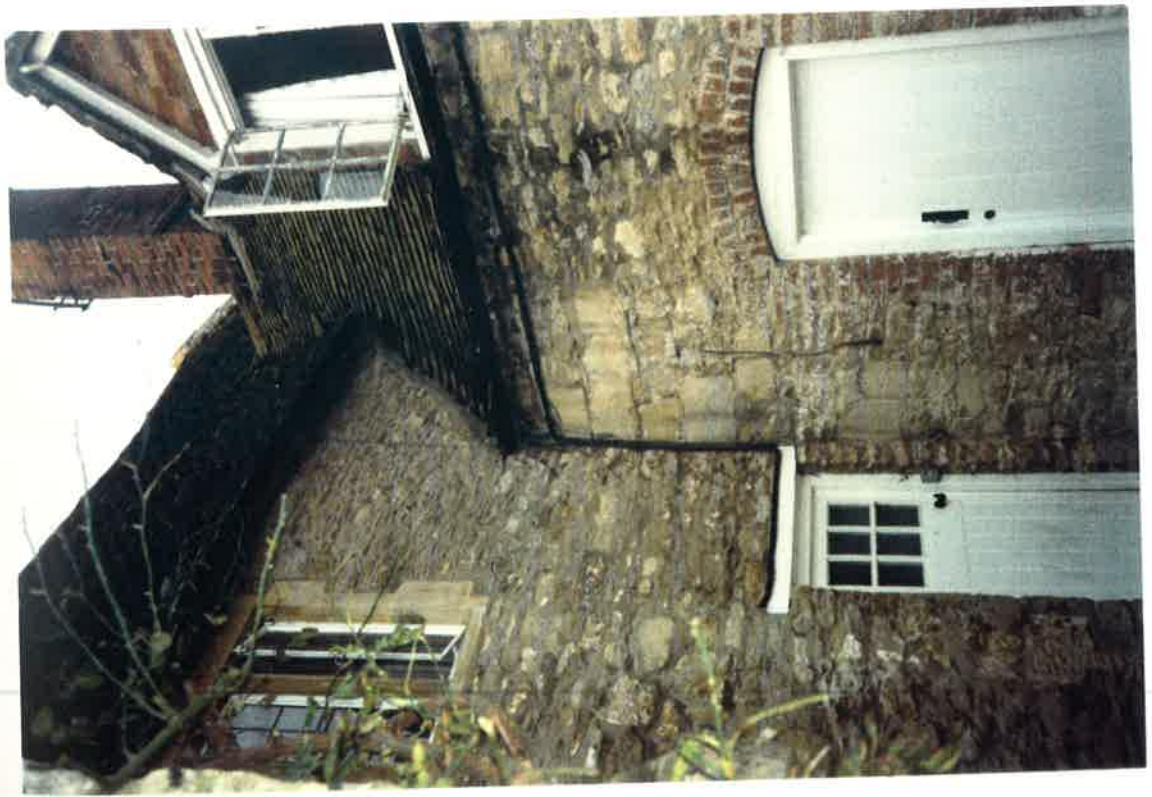
Fig. 5 Camoy's Court: First-floor opening in east wall

2.4.1 The east wall of the medieval half of the house is obscured by the 'garderobe tower' at the S end, and the 19th-century wing at the N end. The one open length of wall has a medieval window that was later blocked, perhaps similar to the fine decorated window existing in the S wall at first-floor level. The proposal to open a first-floor door through the east wall into the 19th-century wing necessitated an investigation of the wall at this point to determine whether another window might be present.

2.4.2 Plaster was stripped off E side of the wall, for an area slightly wider than the proposed door and to a height of about 1.9 m above the floor. The central part of the exposed area was of random rubble, presumably medieval, mortared with a dark loamy fill of a type often encountered in medieval walling (where proper mortar was only used superficially). This was covered with a thick off-white mortar, consistent across the entire area examined. In the upper left corner was a patch of brickwork, and in the lower part there was a facing of clay roof tiles set flat against the wall. The removal of one of these revealed rubble continuing behind it, and it appeared that the tiles had been placed to level off the wall surface, perhaps when the accommodation in this room had been upgraded. No trace of any window opening was found, nor were there any signs of an outer arch of rubble voussoirs (see exterior of original window in S wall) which would have been seen if there were a window in the lower right-hand side of the area examined.

2.4.3 A door in this position would be cut through plain rubble walling, presumably of medieval date, and seems unlikely to disturb any original openings in the wall. The existence of a window at this point is inherently unlikely, since it would come below one of the roof tie-beams, not that this would be impossible for the medieval builder.

4.4 The proposed door on the first floor would pass through medieval walling with no apparent original features.
