Ely North Range 1987

AFU REPORT - NO.5

ELY NORTH RANGE ARCHAEOLOGICAL EXCAVATIONS

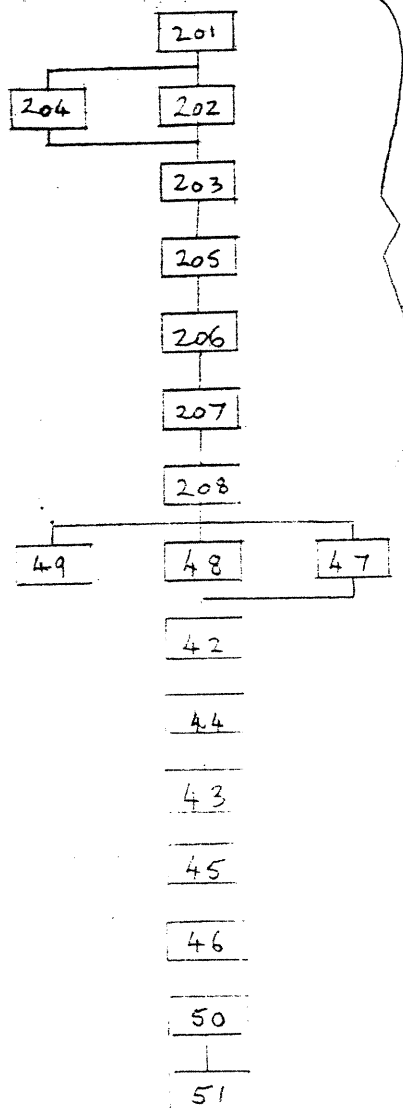
41

ENR 3
STRATIGRAPHIC MATRIX

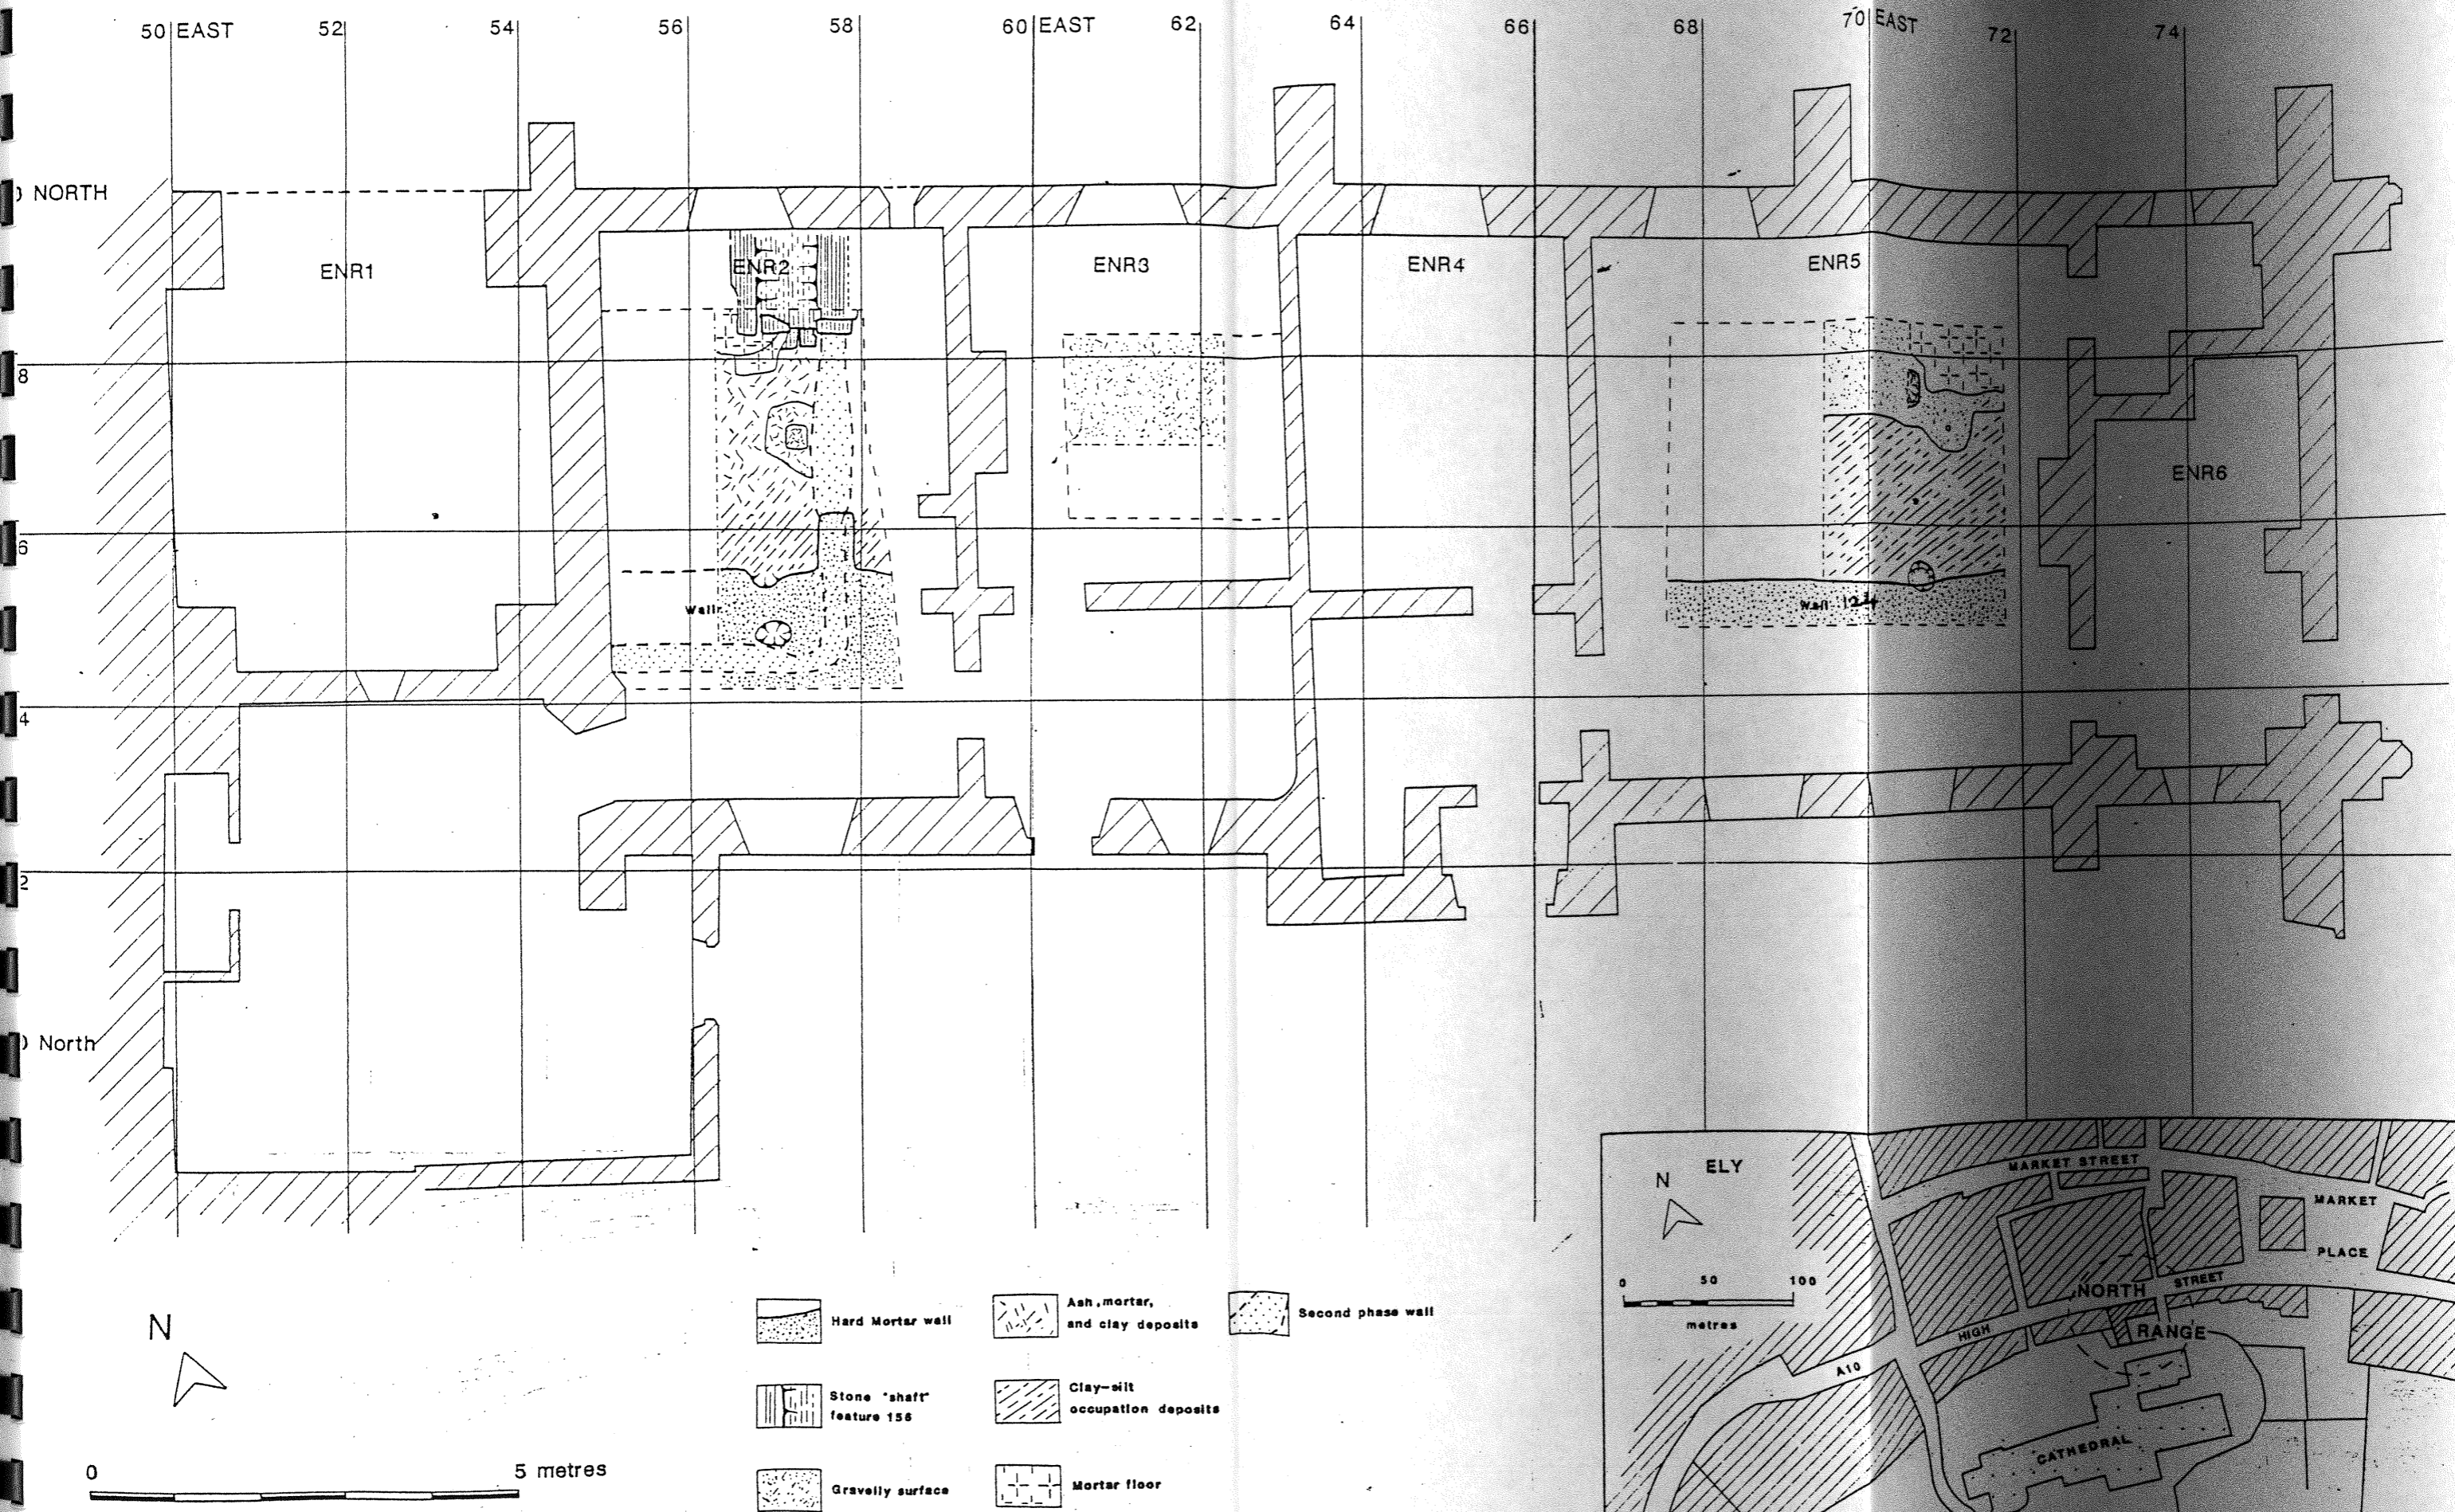
Fig. 1. Site plan showing features belonging to phases 1 to 4

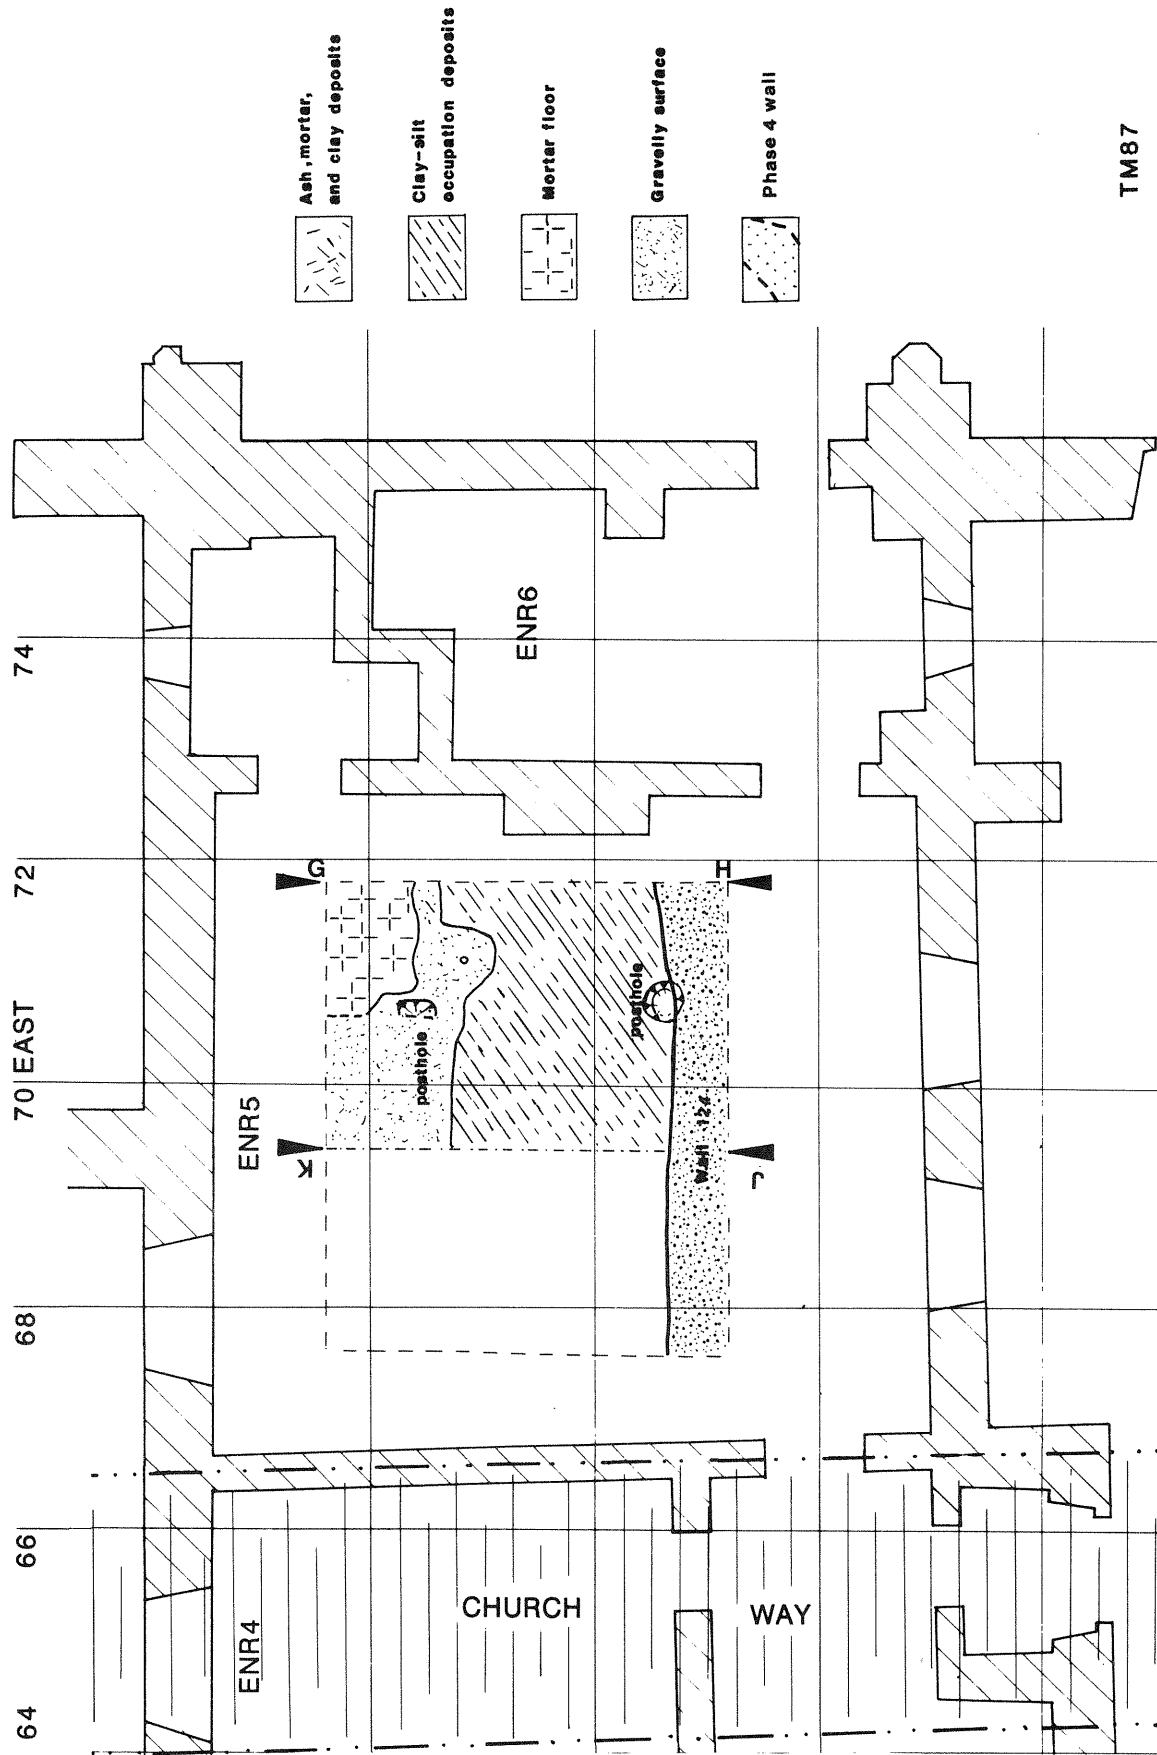
Figure 2b. Ely North Range, east half. Plan of ENR5, features in phases 1 and 2. The church way across ENR4 was of probable medieval origin.

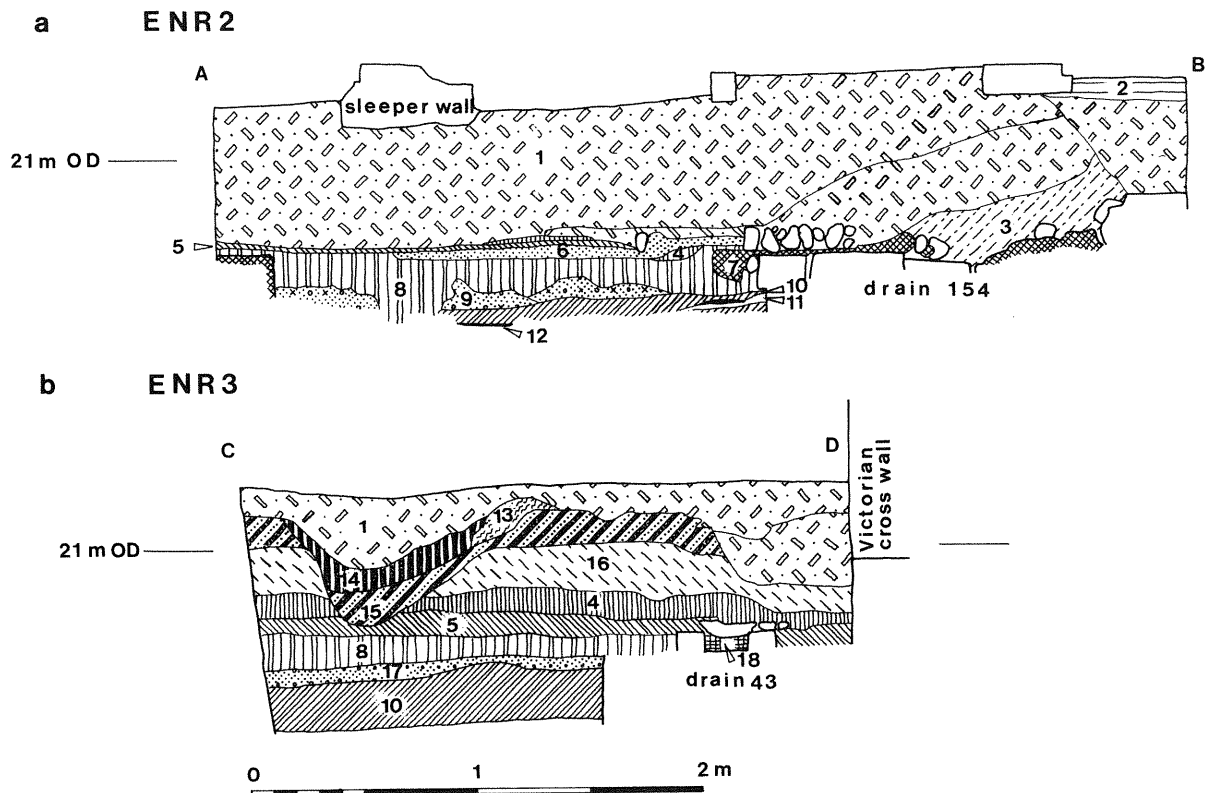
Figure 4. Sections. a. Section along the east edge of trench in ENR2. b. Section along north edge of trench in ENR3. Key: 1. Rubble. 2. Loose grey deposit. 3. Soil with tile and stone chips. 4. Clay. 5. Mortar floor. 6. Sand. 7. Mortar. 8. Brown clay with limestone and charcoal flecks. 9. Pebbles and mortar. 10. Brown silty soil with charcoal flecks. 11. Clay with chalk flecks. 12. Burnt surface. 13. Decayed wood. 14. Clay with ash. 15. Ash and burnt sand. 16. Ashy silt with grit. 17. Sand and gravel. 18. Drain fill.

Demolition deposits were then dumped over the whole site (Figure 4a). They consisted mainly of stone

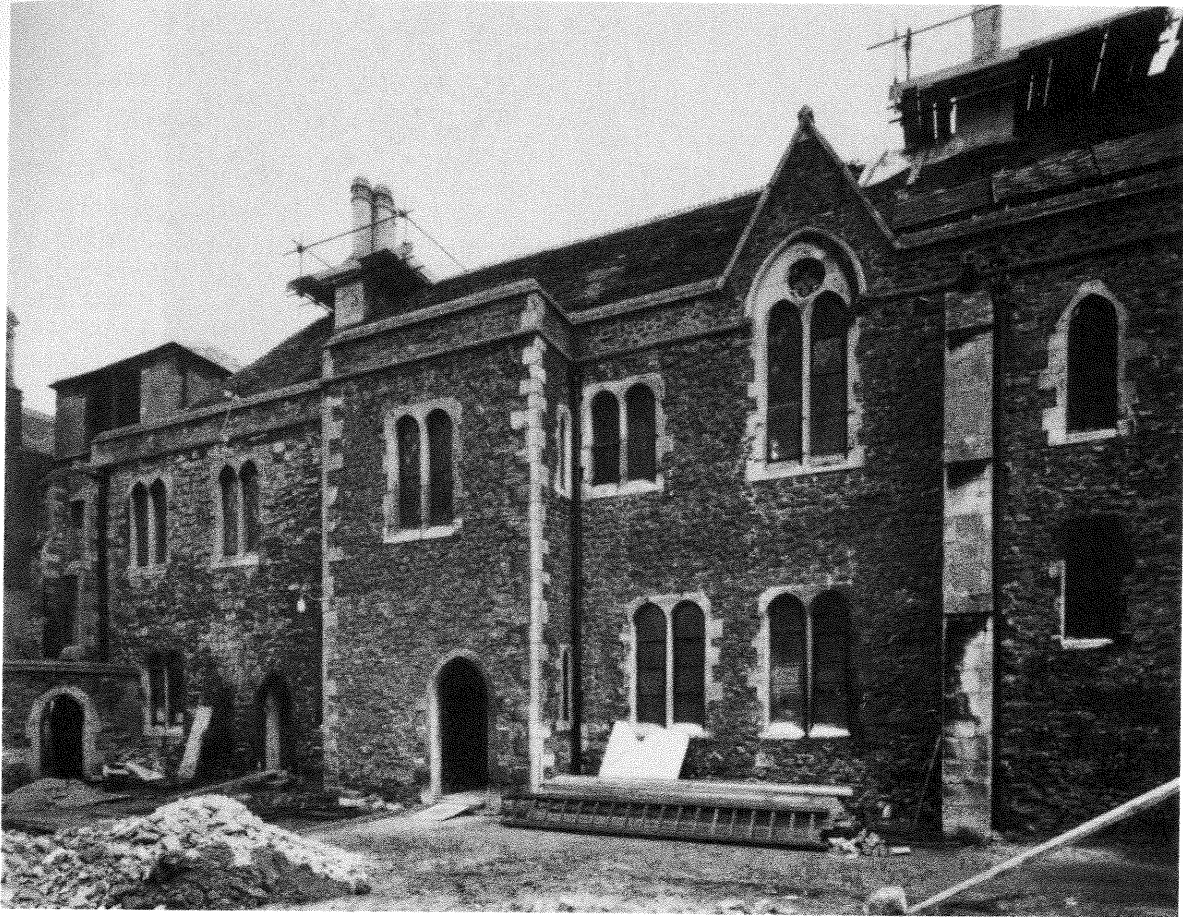
Plate 1. North Range, south elevation.
(Crown copyright)

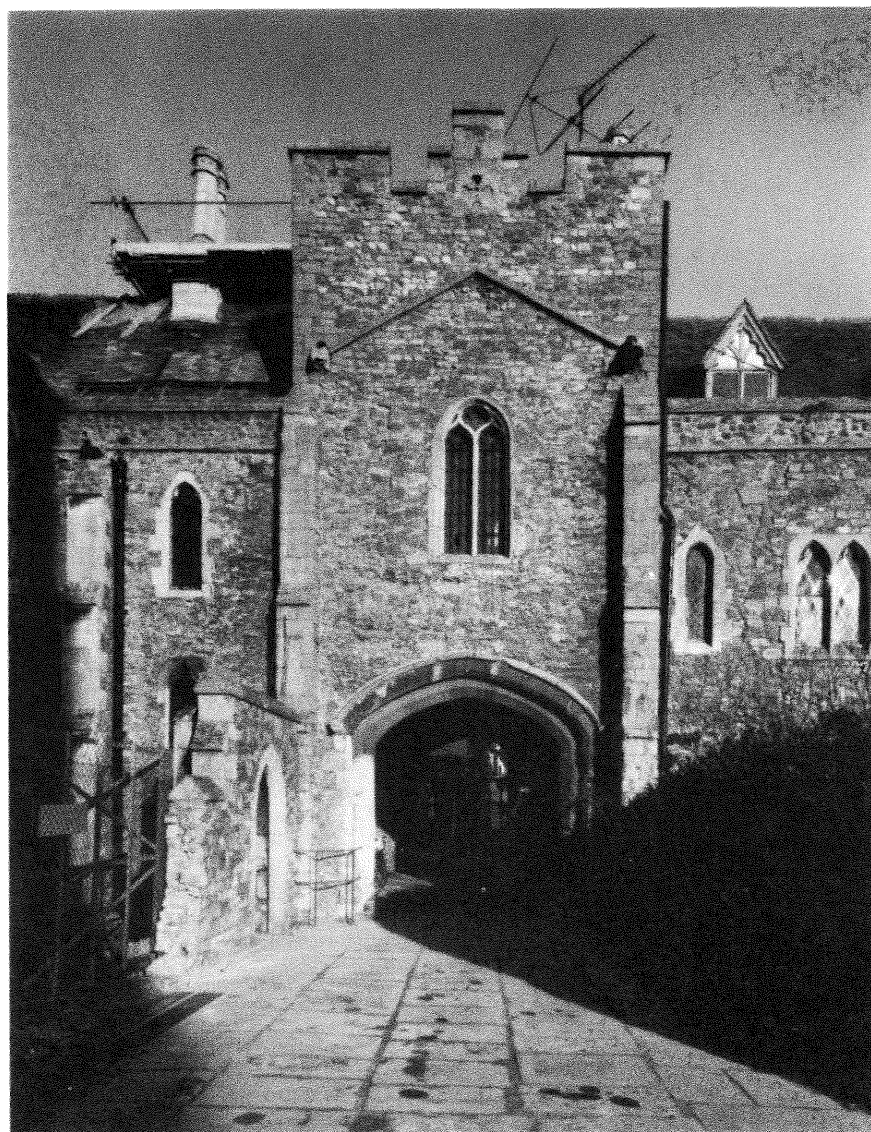
Plate 2. North Range, Sacrist's Gate, south elevation.
(Crown Copyright)

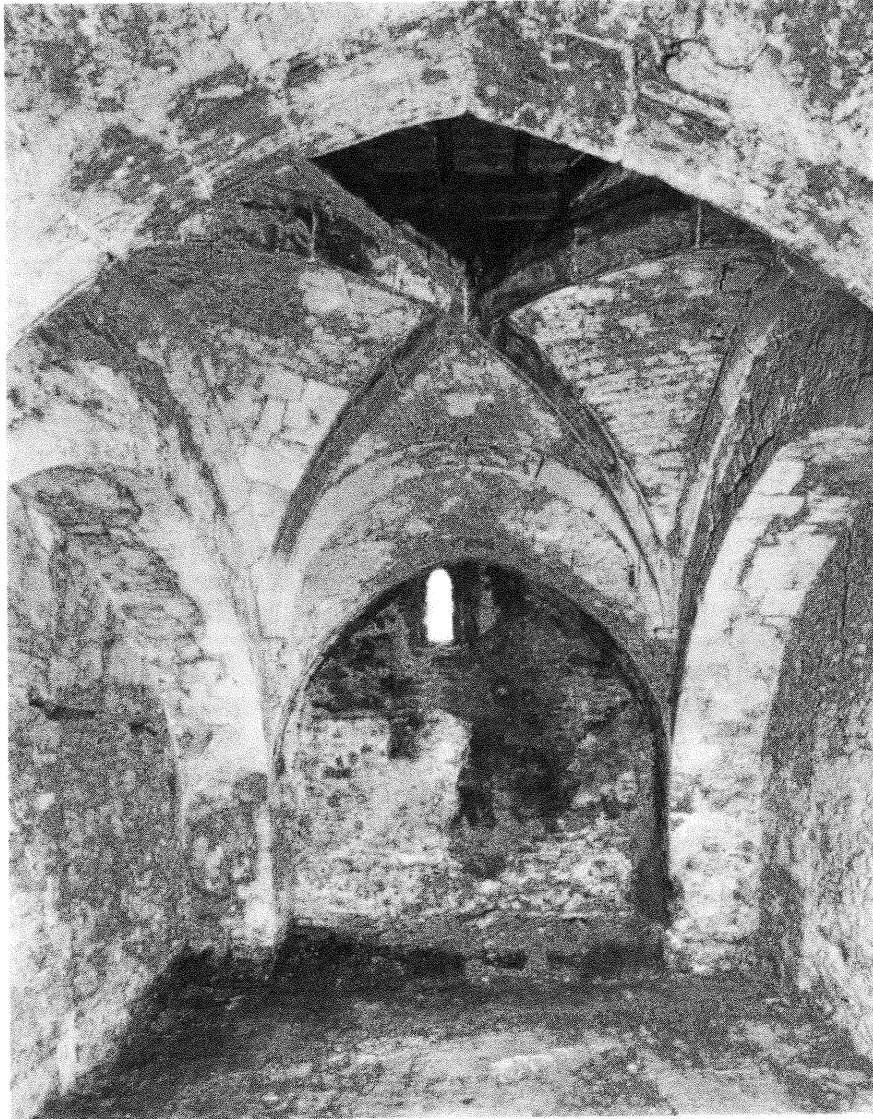
Plate 3. North Range, Goldsmith's Tower, interior of vaulted ground floor, looking south.
(Crown Copyright)

On the ground floor (room ENR1) there is a large arch articulating each wall. Those on the east and west appear always to have been

blind. The vault is quadripartite with sharply chamfered ribs springing from polygonal moulded corbels. The fill of the vault is a mixture of stone and brick, in part destroyed. The floor has been excavated to reveal a brick floor about 0.2 m below the modern street level.

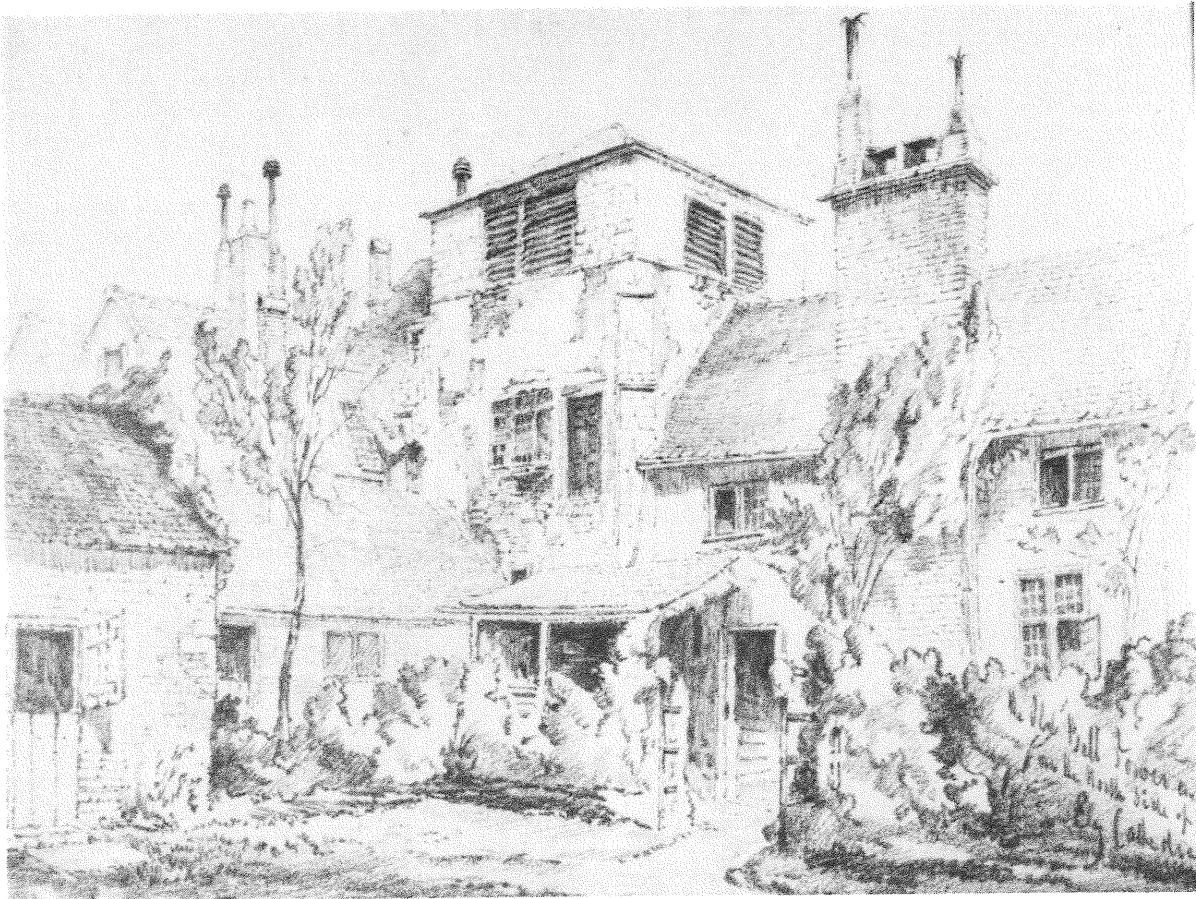
Plate 4. The Goldsmith's or Old Bell Tower from the south-east, 1857. Pencil drawing by Henry Baines.
(Photograph: Crown Copyright)

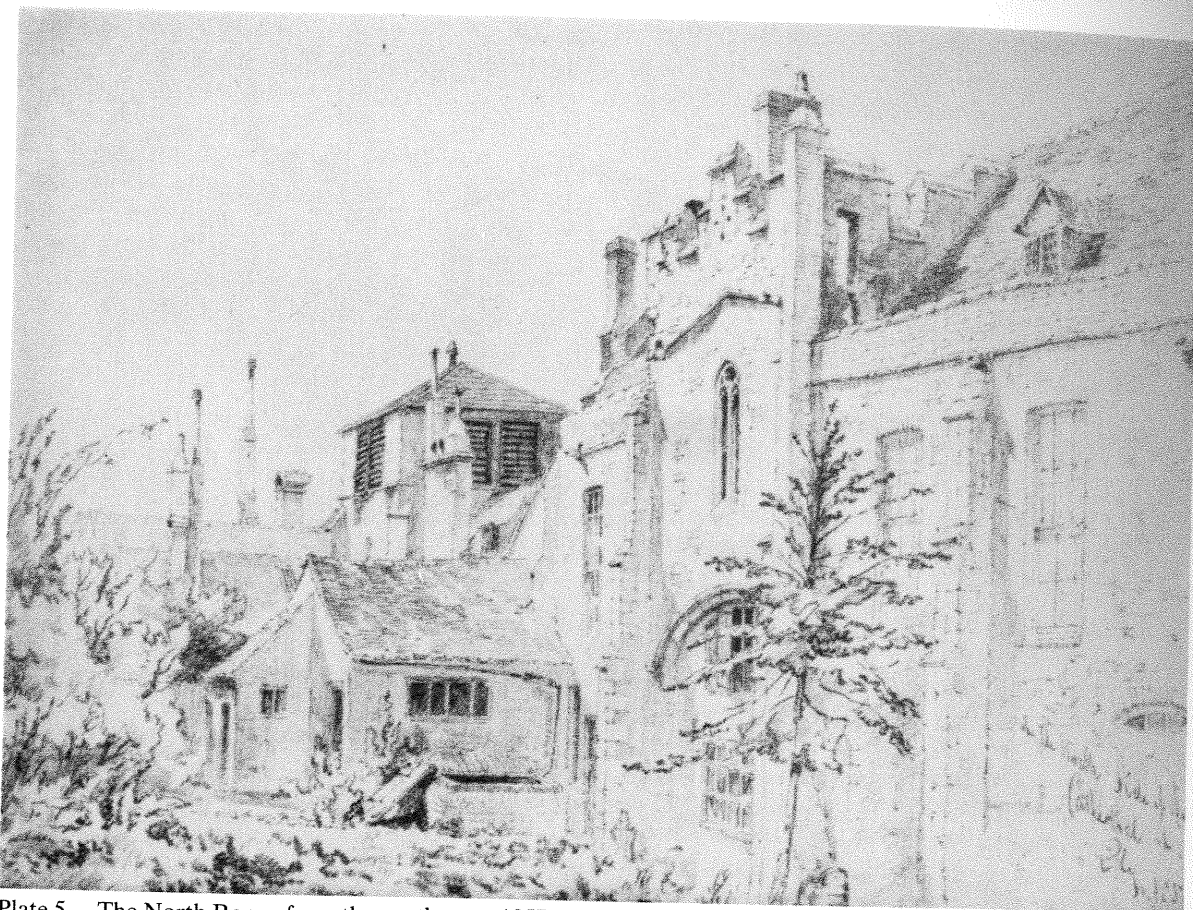
Plate 5. The North Range from the south-east, 1857. The Sacrist's Gate, then blocked, is shown in the foreground. Pencil drawing by Henry Baines. (Photograph: Crown Copyright)

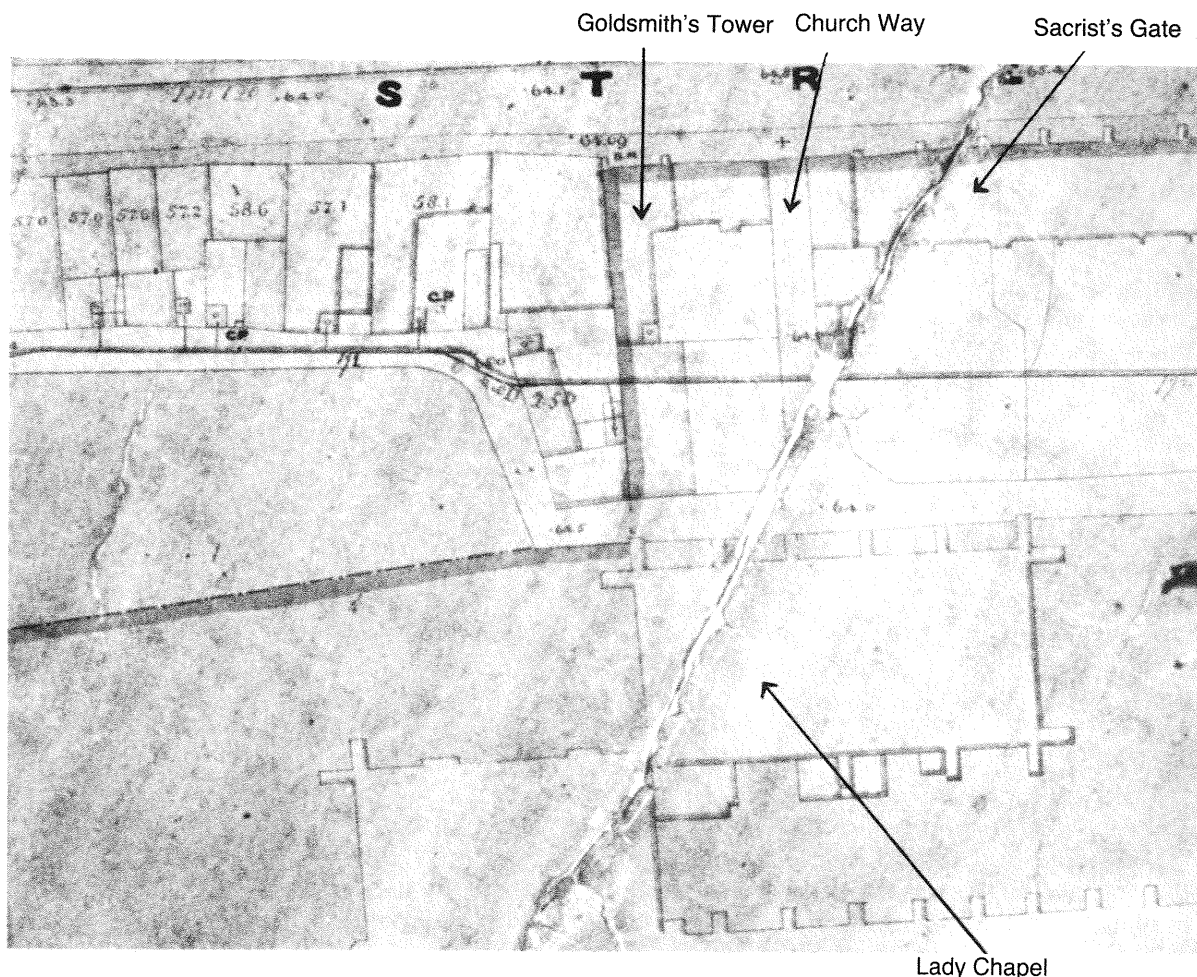
Plate 6. Part of the map of Ely by C.M. Bidwell showing the North Range and church way, 1851. The shaded line marks the parish boundary.

Goldsmith's Tower, to serve as a belfry. In this document, no reference is made to the church way that provided access for the parishioners from the street to their church. It is shown on Bidwell's map of Ely of 1851 (Plate 6). The trenches dug in the courtyard of the North Range in connection with the recent restoration provided some evidence to suggest a medieval origin for the church way. No burials were found in the part of the trench to the south of ENR4, ENR5 and ENR6, while a number of burials were located in the trenches in the west part of the yard. The church way may, therefore, possibly have run along the east boundary of the churchyard prior to Alan of Walsingham's building activity, and continued as a way of access.
