STRETHAM RECTORY 1990

TL 5115/7455

Wendy Horton and Gavin Lucas

Abstract

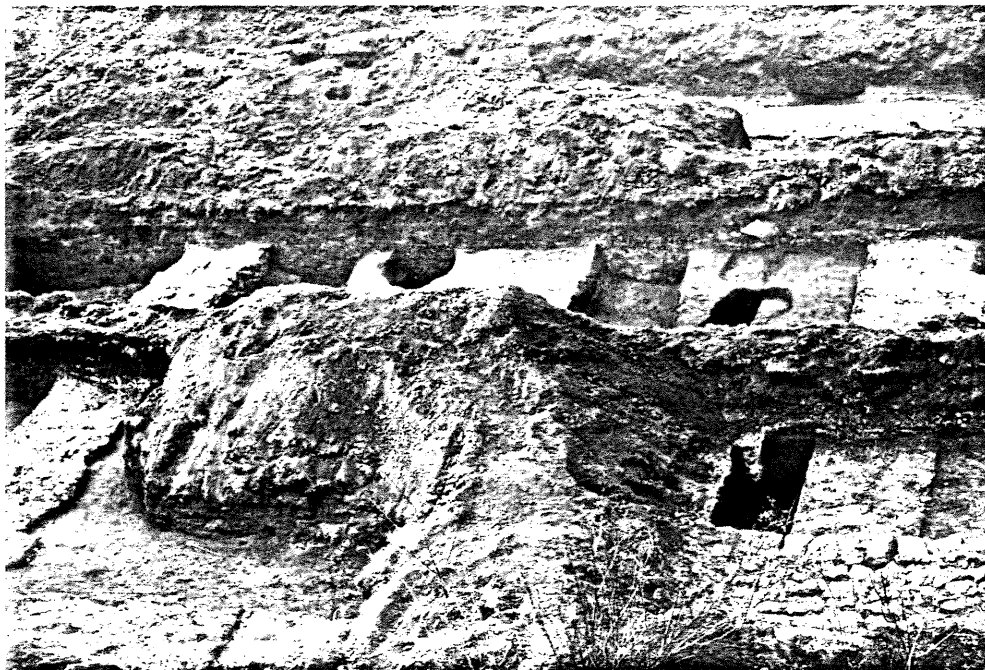
Plate I General view of building.1 (east)

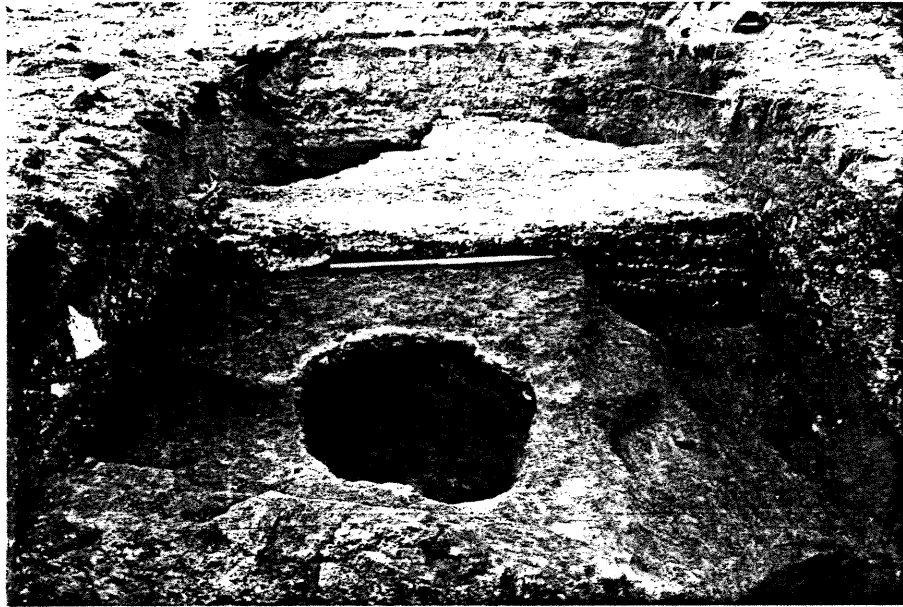
Plate III North end of trench 3 (south)

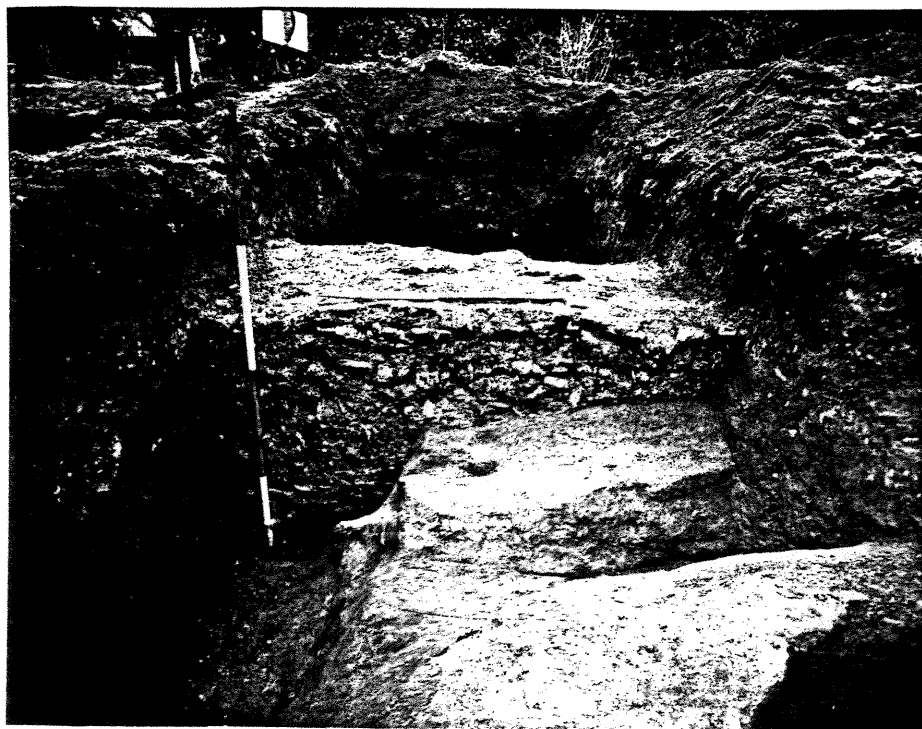
Plate VIII Wall [44] and ditch [47] (north)

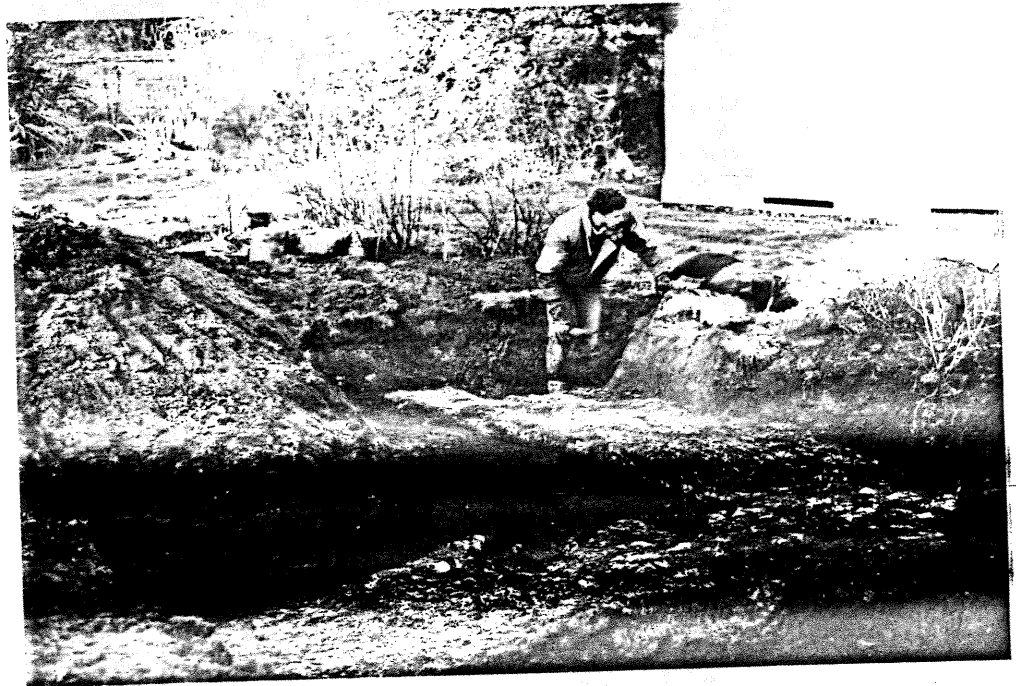
Plate V South-east corner of building.1 (south)

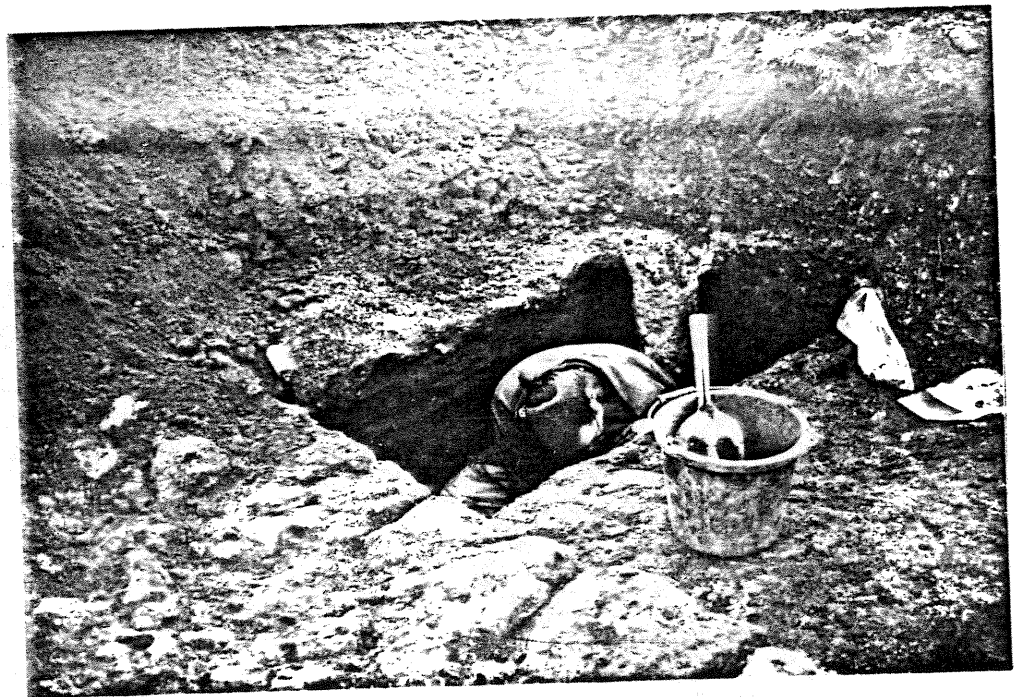
Plate VI Walls [75] and [51] (north)
