MERE WAY ROMAN ROAD AT MILTON - MILTON TO HISTON PIPELINE

Report no. 39

AN ARCHAEOLOGICAL SURVEY OF A PIPELINE FROM MILTON TO HISTON

This report concerns a watching brief which was carried out in October 1991, in advance of and during the construction of a water main by Cambridge Water Company. This concentrated on the excavation of a section through the Akeman Street Roman road (Margary 23b.)

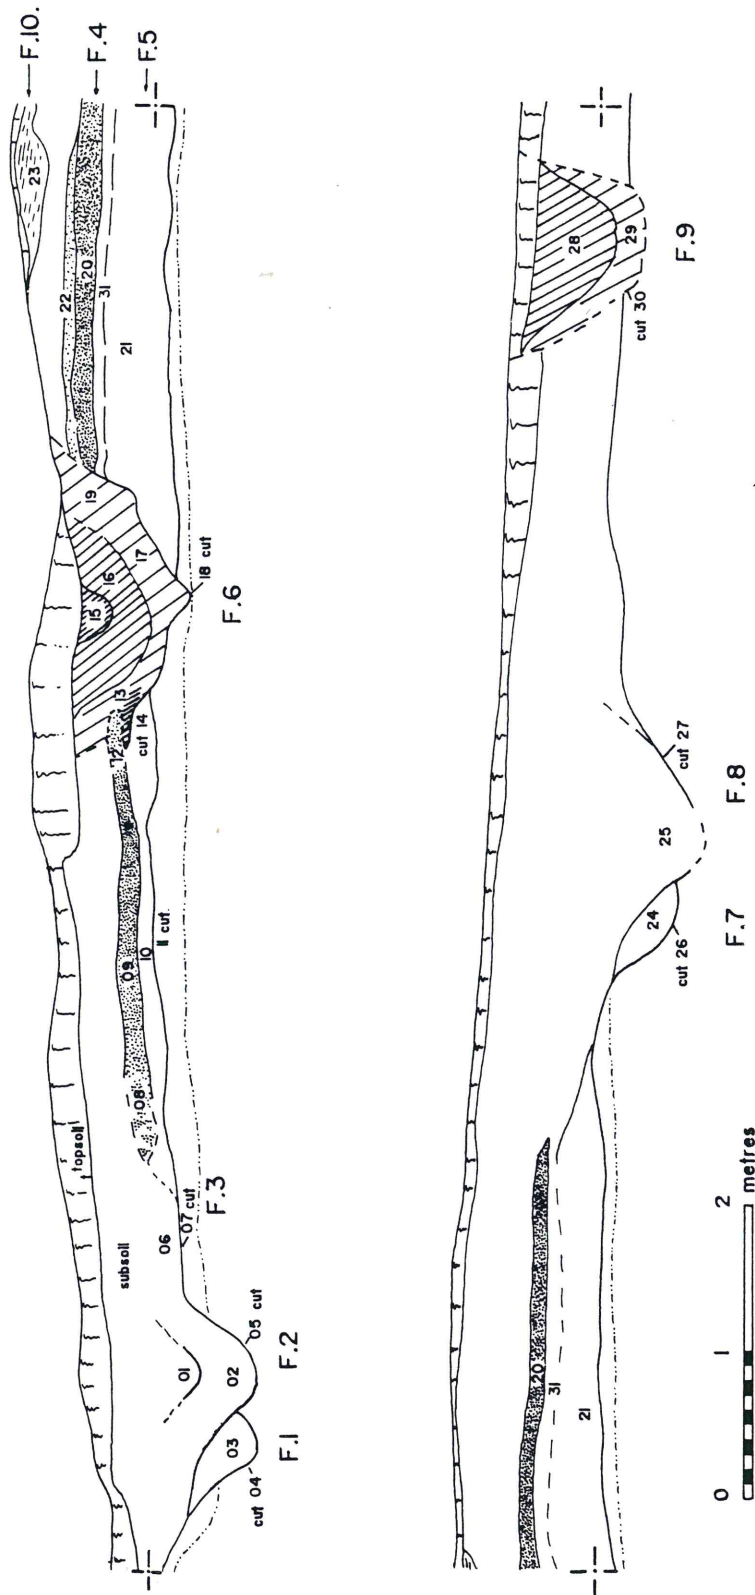
NORTH FACING SECTION THROUGH MERE WAY.

1. Section through Mere Way. (See fig.3.)

The entire road profile appears to survive. The central bank, or *agger*, is between 11 to 12 metres wide and some 65 centimetres high. There are two flanking ditches 1.2 metres wide and 40 centimetres deep. Substantial cobbles, set in gravel, have been reported by a local farmer who scraped soil off the surface when repairing a fence, to insert a post but this may be a later feature.

- 60-70cms deep
see Summary and Fig 3.
- F.1. The remnants of a north-south ditch, (fill 03, cut 04.) cut by F.2. It is a 'U' shaped feature truncated on its western side. The fill is a homogeneous, light yellowish brown, clayey silt. It seems to have silted up naturally. The fill is sealed by a later, similarly shaped feature. (F.2). This seems to represent an earlier roadside ditch.

- F.2. A north-south ditch, (fills 01, 02, cut 05.) Both fills are of light brown, slightly sandy, clayey, plastic, silt. The upper fill (01), is slightly darker than the lower (02), and contains one piece of oyster shell. The homogeneity of the fill indicates natural silting. This is the eastern roadside ditch of the Roman road,

- F.3. A level strip between ditch F.2, and the *agger*. (Fill 06, cut 07.) The fill is similar to that in F.2. It seems to have silted up naturally. This is a gap left between the road surface F.4. and the roadside ditch F.2.

- F.4. The metalled surface of the Roman road. (layers 08, 09, 12, 20, 22.) Towards both edges the surface breaks up, notably more so on the western side, perhaps due to the action of the prevailing wind. The surface is 15 cm. thick on average, and is composed of yellow sandy gravel. This material is the same as the natural gravel underlying the *agger*, and could well have been excavated from the flanking ditches, which cut into the same material. A thin layer of iron pan lies under the metalling, which probably formed while the surface was exposed. A large ditch, F.6. cuts through the surface and the *agger* just east of the centre. Layer 22 is a layer of trampled earth lying directly on the crest of the road surface, possibly the result of resurfacing.

- F.5. The *agger*. (layers 10, 21, 31.) This is made up of hard packed greyish brown clay silt. It was so compact that it created problems both for the J.C.B. and for the pipeline excavations. The material making up the bank does not closely resemble any of the immediately surrounding subsoil or natural. It is similar to the clays which lie below the natural sands, and may have been quarried from a nearby surface outcrop of that material. layer 31 is a slightly darker layer between the metalling and the rest of the *agger*, which may be the result of pressure on the underlying material through the road surface.

- F.6. A large north-south ditch filled by very dark grey humic soil. (fills 15, 16, 17, 19, 13 cuts 14, 18.) This may contain two ditches, of similar date. This is in line with the hedge line of the green lane, and is almost certainly the eastern ditch which enclosed the green lane.

- F.7. The remnants of a north-south ditch, (fill 24, cut 26.) cut by F.8. It is a 'U' shaped feature truncated on its eastern side. The fill is a homogeneous, light yellowish brown, clayey silt. It seems to have silted up naturally. The fill is sealed by a later, similarly shaped feature. (F.8). This seems to represent an earlier roadside ditch.

- F.8. A north-south ditch, (Fill 25, cut 27.) It is filled by light brown, slightly sandy, clayey, plastic, silt. The homogeneity of the fill indicates natural silting. This is the western roadside ditch of the Roman road,

F.9. A north-south ditch, filled with very dark humic material. this runs along the line of the western hedgeline of the green lane, and is probably the western enclosing ditch. (fills 28, 29, cut 30.)

F.10. A layer of soil with a platy structure, visible just under topsoil near the centre of the green lane. This is almost certainly the result of trample associated with the use of the Medieval trackway. (layer 23.)

At this point we can clearly see the proportions typical of a secondary Roman road. We have the small ditches placed well back from the road, measuring about a metre in width, and perhaps half that in depth. The ditches are just over 21 metres apart centre to centre (62 feet), which appears to be a standard measurement. (Margary I.D. 22.)

The *agger* is of hard packed clayey silt. Usually the material for this bank was quarried from the subsoil along the edge of the road, but no such quarry ditches were detected here. Indeed the material which composes it does not resemble any of the surrounding subsoil, and may have been brought here from some distance away. The *agger* was not built directly onto topsoil, but instead a path was hollowed out for it into the underlying geology. It was highly compacted, which indicates the effort which went into its construction.

The road metalling is of similar composition to the underlying geology, and may well have been quarried out from the side ditches or from the hollow under the *agger*.

The ditches associated with the green lane are a similar distance apart, but are positioned some four metres further west. Obviously, then, the trackway has moved. It is interesting to note that it retains similar dimensions.
