The North Clerestory Wall, Holy Trinity Church, Great Paxton

PHOTOGRAMMETRIC RECORDING

1993

Report no. 76

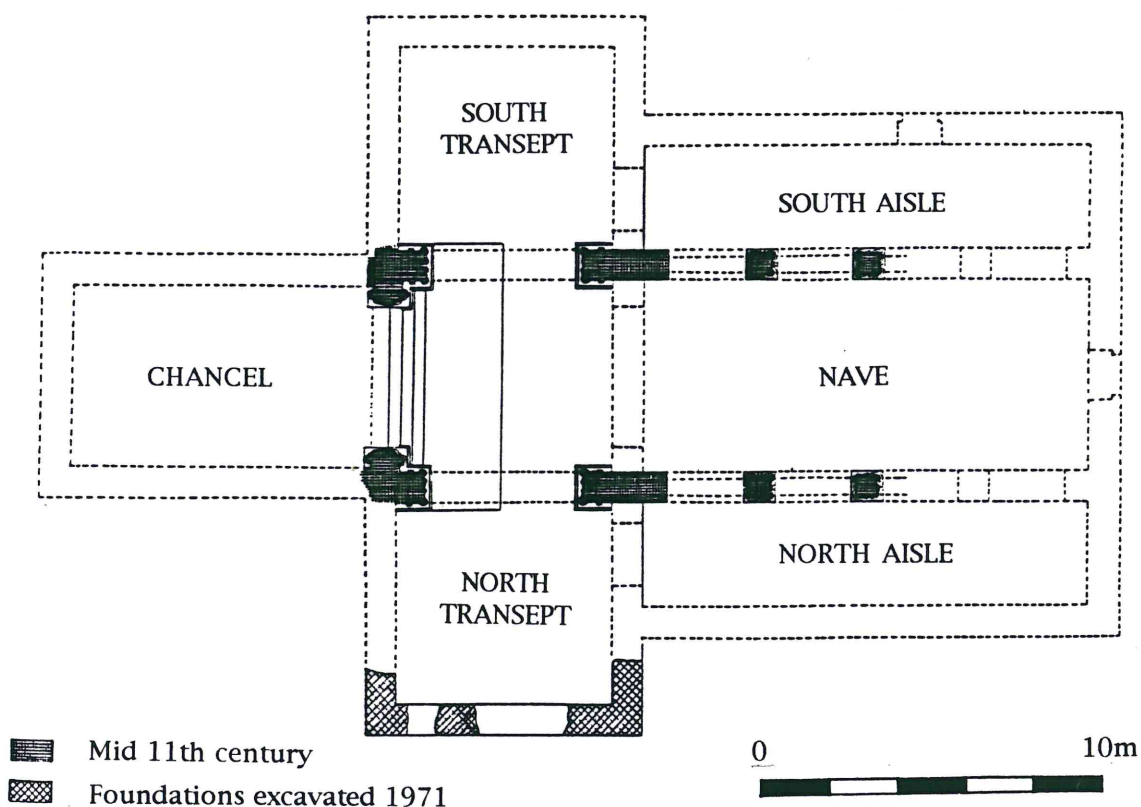
Figure 3 - Suggested plan of the Saxon Church

Other elements of the late Saxon church seem to have stood for two or more centuries before being replaced by the more recent structures which have survived to the present. An original chancel was probably demolished and rebuilt in the late 13th century and evidence for its likely position has recently been acquired by geophysical survey. Ground probing radar was used to investigate the present chancel floor, and revealed no evidence for any crypt but located at least two substantial wall foundations (Stratascan 1992). Likewise, the Saxon aisles and transepts have also been replaced, removed to make way for the present 15th century aisles. The earlier transepts probably extended outwards a further 3.0m beyond the line of the aisles seen today. Excavation in 1971 by the Research Group of the Huntingdonshire Local History Society located the foundations of the north transept, in line with the present northern and central buttresses of the north aisle (Cozens 1971). The foundations had been constructed on damp subsoil, resulting in a degree of subsidence which the excavator considered sufficient to have caused severe damage to the north wall of the transept, a probable reason for this phase of rebuilding.

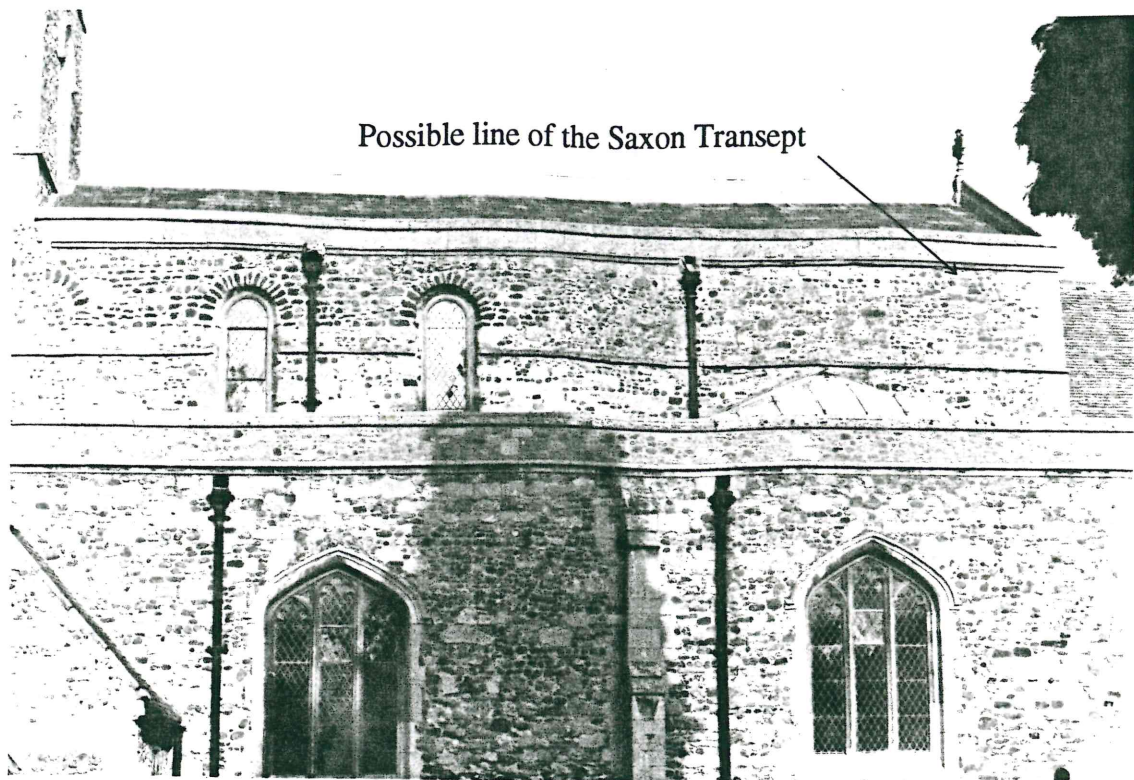
PLATE 1. *Photograph of the South Clerestory Wall.*

Just visible are two diagonal lines at the east end of the Clerestory Wall. These may represent the line of the Saxon South Transept roof.

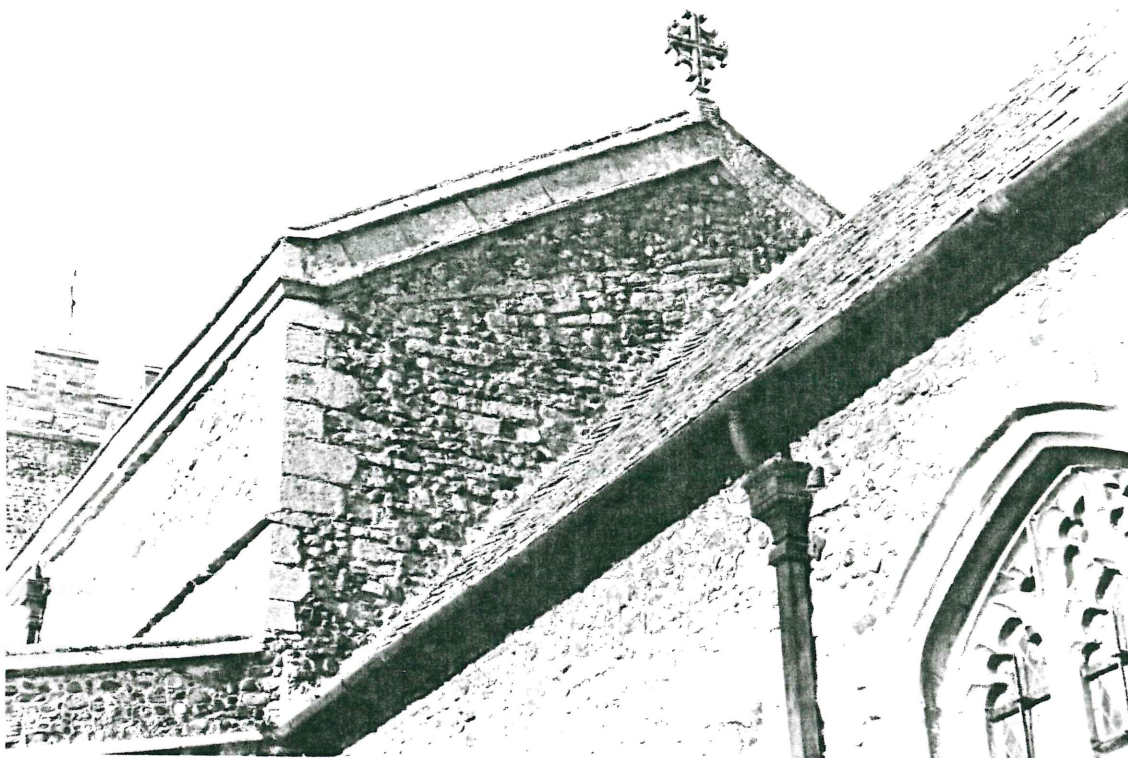
PLATE 2. *Photograph of the East Clerestory Wall*

This shows the probable line of the Saxon Chancel above the present Chancel roof.
