Ryder's Farm

An Archaeological Investigation of a 13th Century Farmhouse in Swavesey, Cambridgeshire

Cambridgeshire Archaeology
Report No. 82

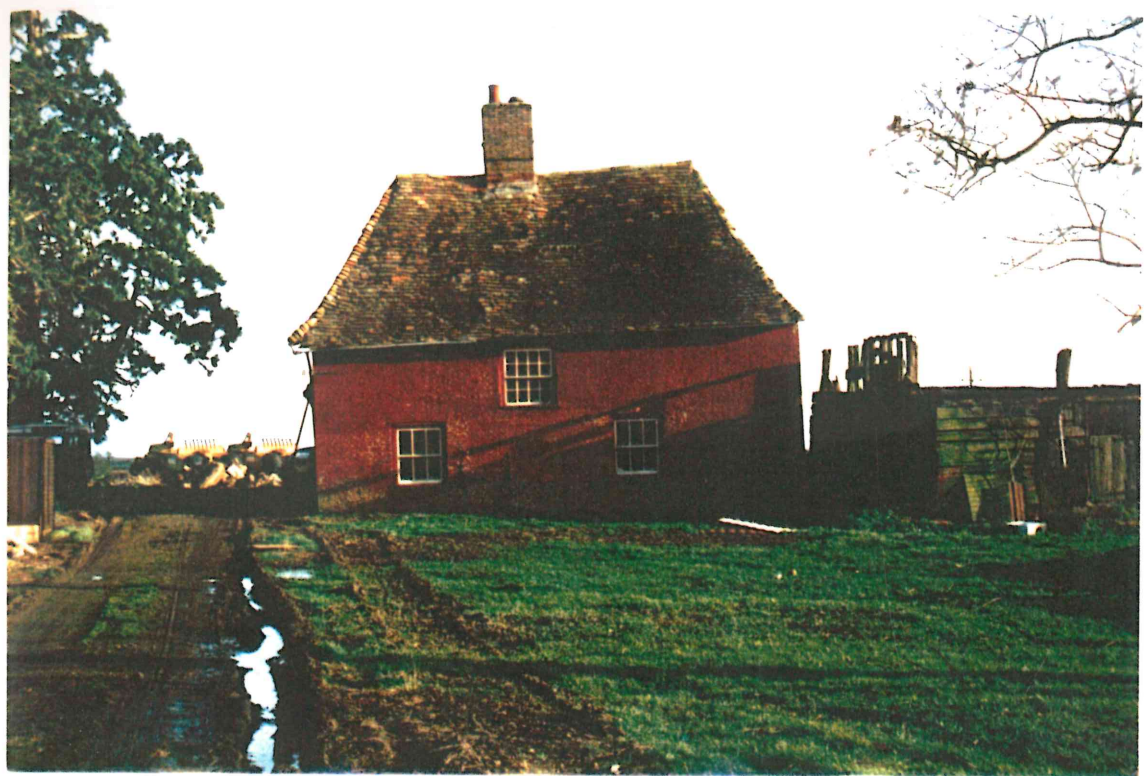
West Facing External Wall of Ryder's farm And 17th Century Barn (by T.Malim, 1993)

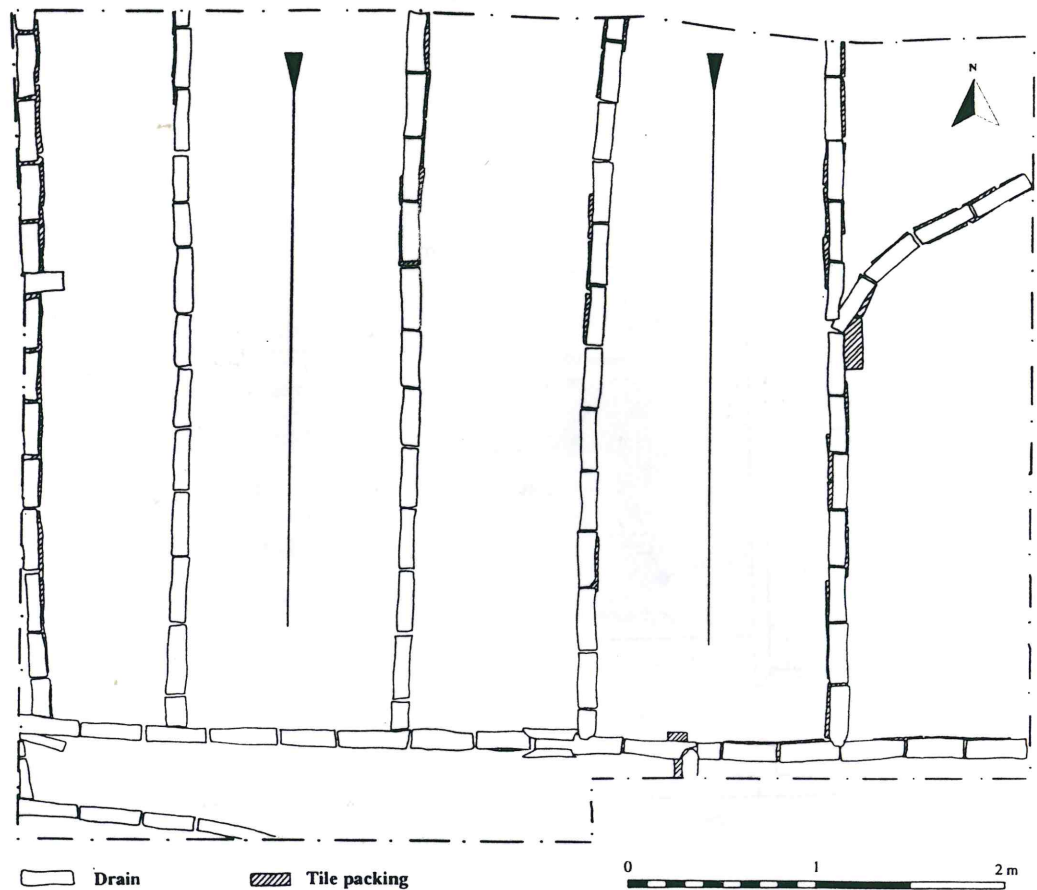
Figure 5 - Plan of Drains Beneath Floor of the Main Hall (by S. Macaulay)

In the main hall sealed beneath a late 18th century tiled floor and post-medieval rubble layer, a mid 17th century, efficient drainage system was identified (fig. 5). Aligned north/south the drains were on a slight gradient of approximately 1:30, draining from the higher ground in the north to the lower farmyard to the south. In installing the
