The Keep Tregantle Fort Antony Cornwall

Building Recording and Investigation

April 2008

Client: Defence Estates

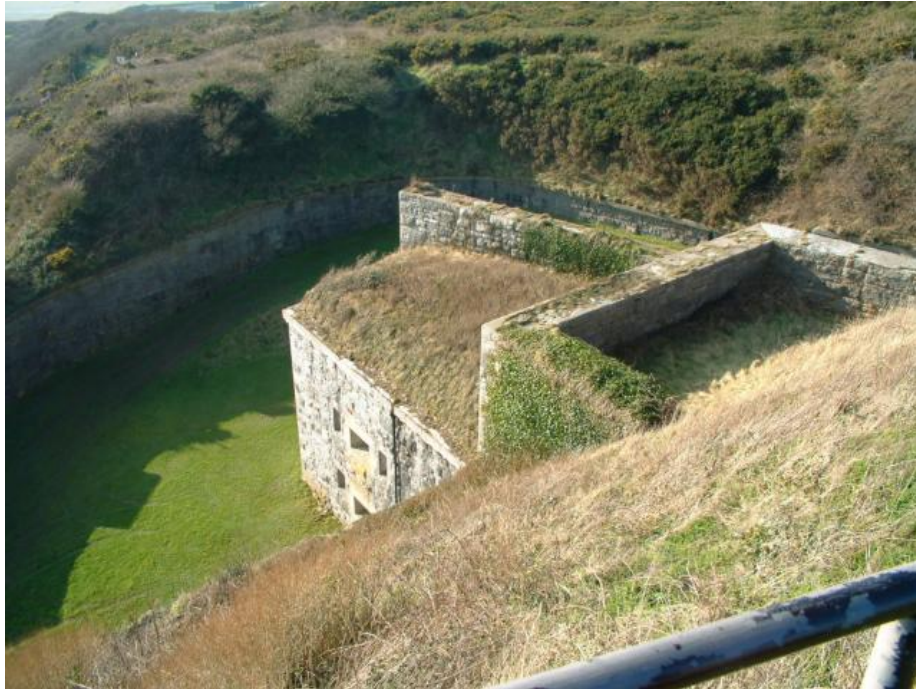
South West
caponier at Fort
Tregantle,
Plymouth

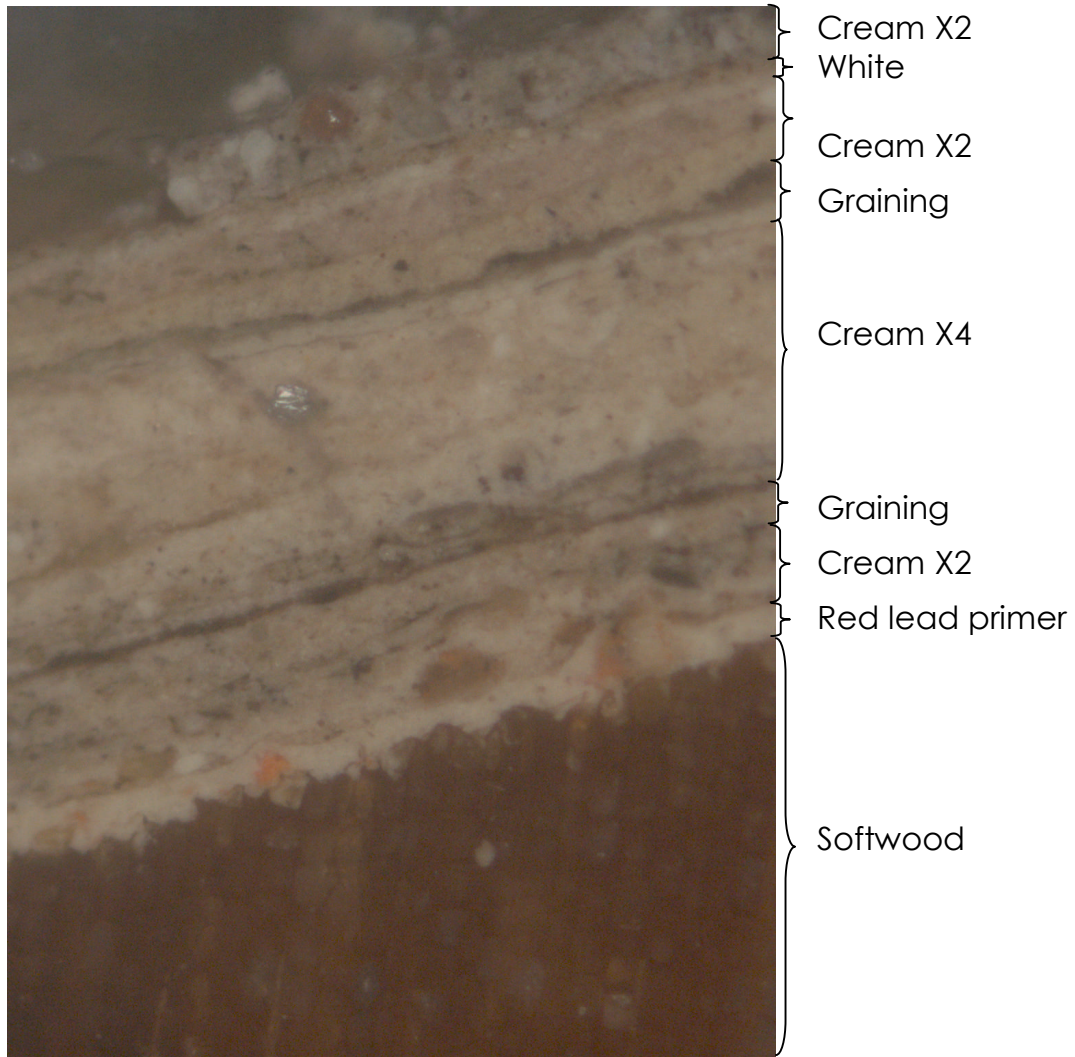
**Architectural Paint Research
Window, Tregantle Fort Keep**

Photomicrograph showing sample 1, taken from the stored sash window, photographed in cross-section under incident light at 100X magnification. Printed magnification not calculated.

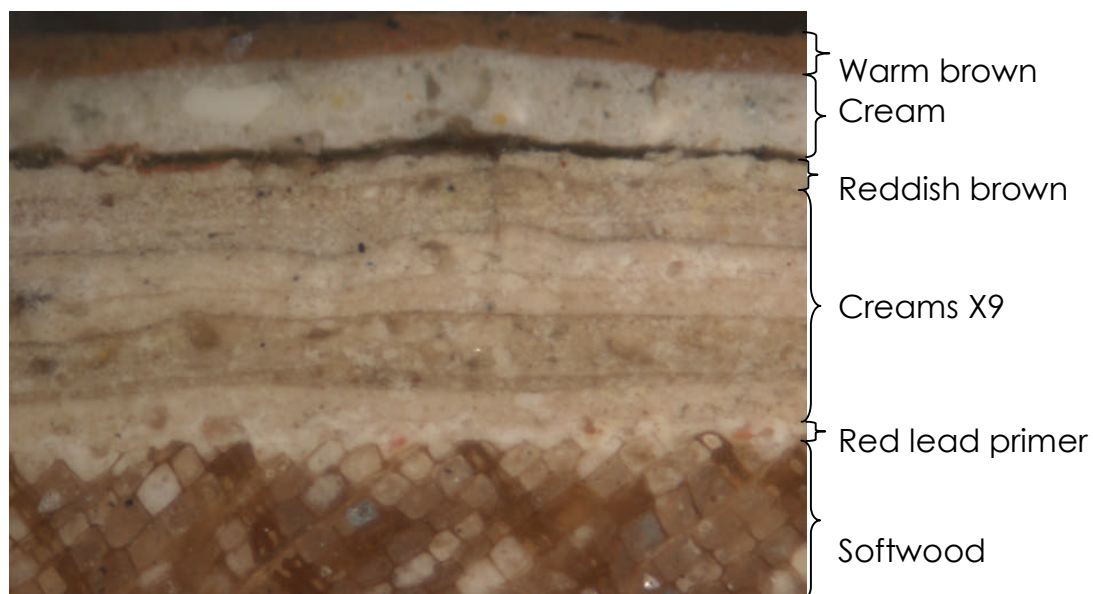
Architectural Paint Research Panelling, Tregantle Fort Keep

Photomicrograph showing sample 5, taken from the inside face of the panel frame in Room 3, photographed in cross-section under incident light at 200X magnification. Printed magnification not calculated.

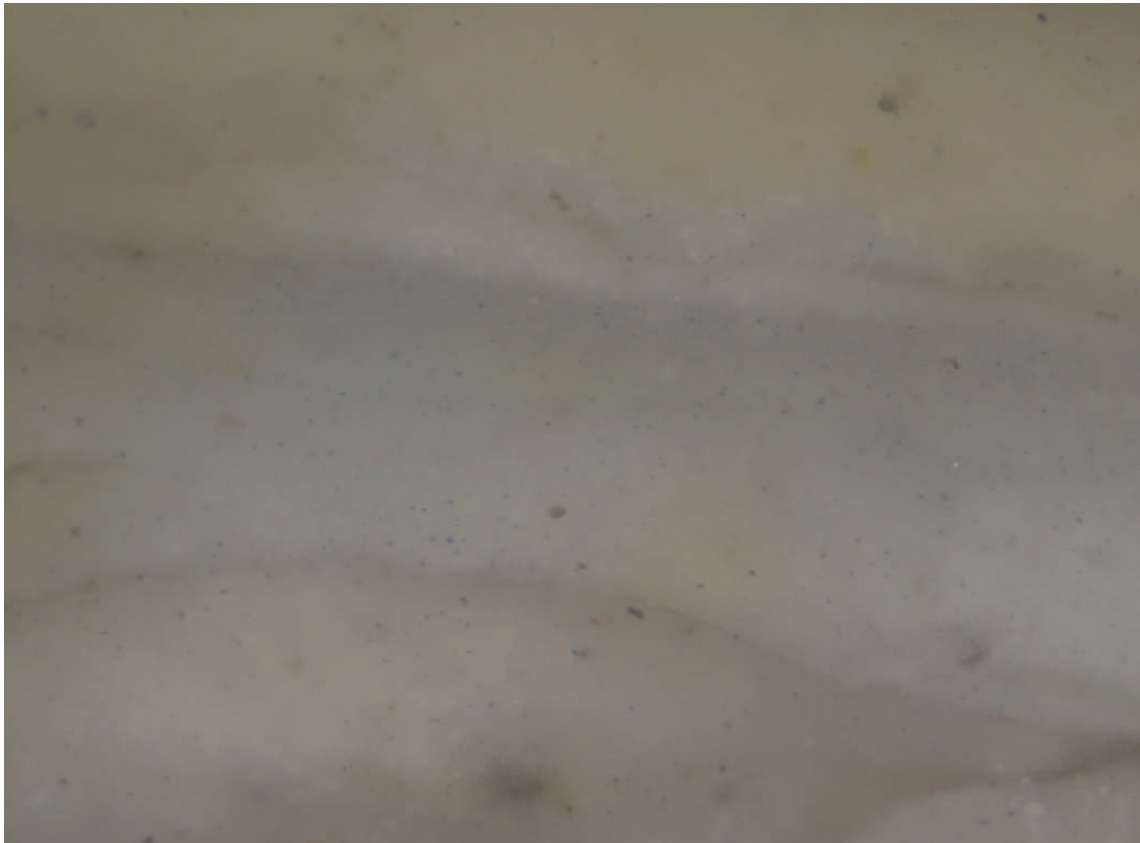
Architectural Paint Research
Painted wall surface, Tregantle Fort Keep

Photomicrograph showing sample 9, taken from the stone wall of Passage A, showing the final decoration stained yellow for significant lead content. Photographed in cross-section under incident light at 100X magnification. Printed magnification not calculated.

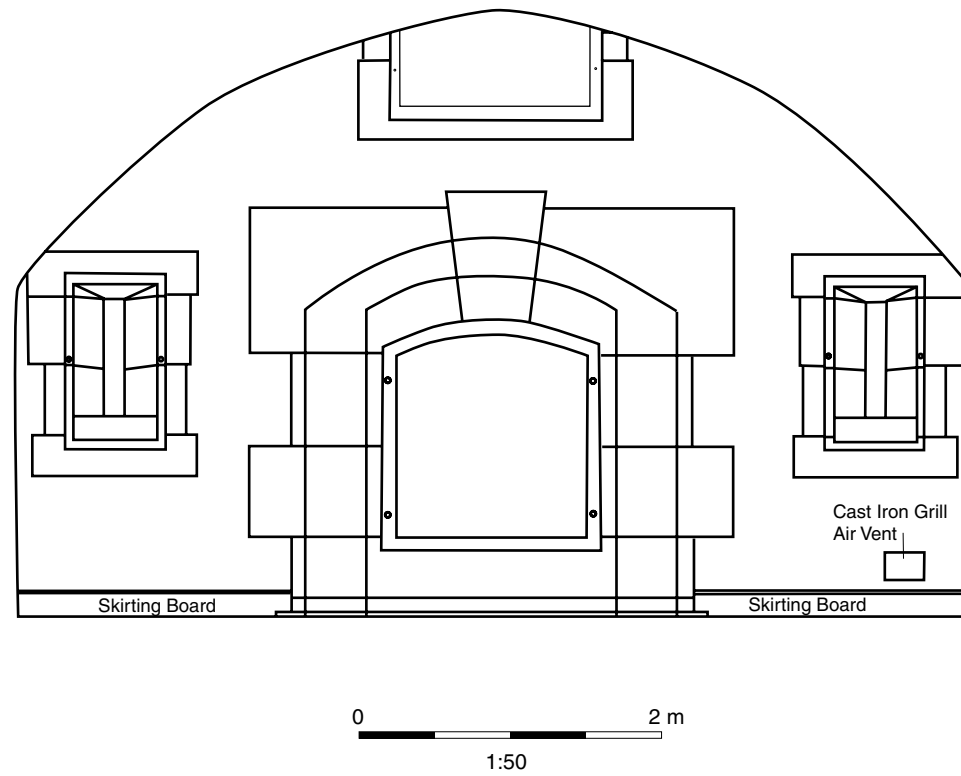
Figure 17: Layout of embrasures and windows in keep

- 4.3.7 *Gun embrasures:* The external face of each room consists of a gun embrasure flanked by a loophole. The embrasures and loopholes facing out of the Keep have been recessed and fitted with removable window frames (Figs 17 and 19) mounted on 1/2" bolts fixed in the masonry and held by a nut, covered by a wood plug in the frame (Frame type 1). Two possible later embrasure window frames were noted without the holes for the bolts and held in place by wedges. This is similar to window frames in other parts of the fort, best example in the Guard Room. The embrasure window have a pair of iron shutters (iron-clad timber boards) with a single view/fire slit (Fig. 18). The embrasures window and shutters for rooms 16 A

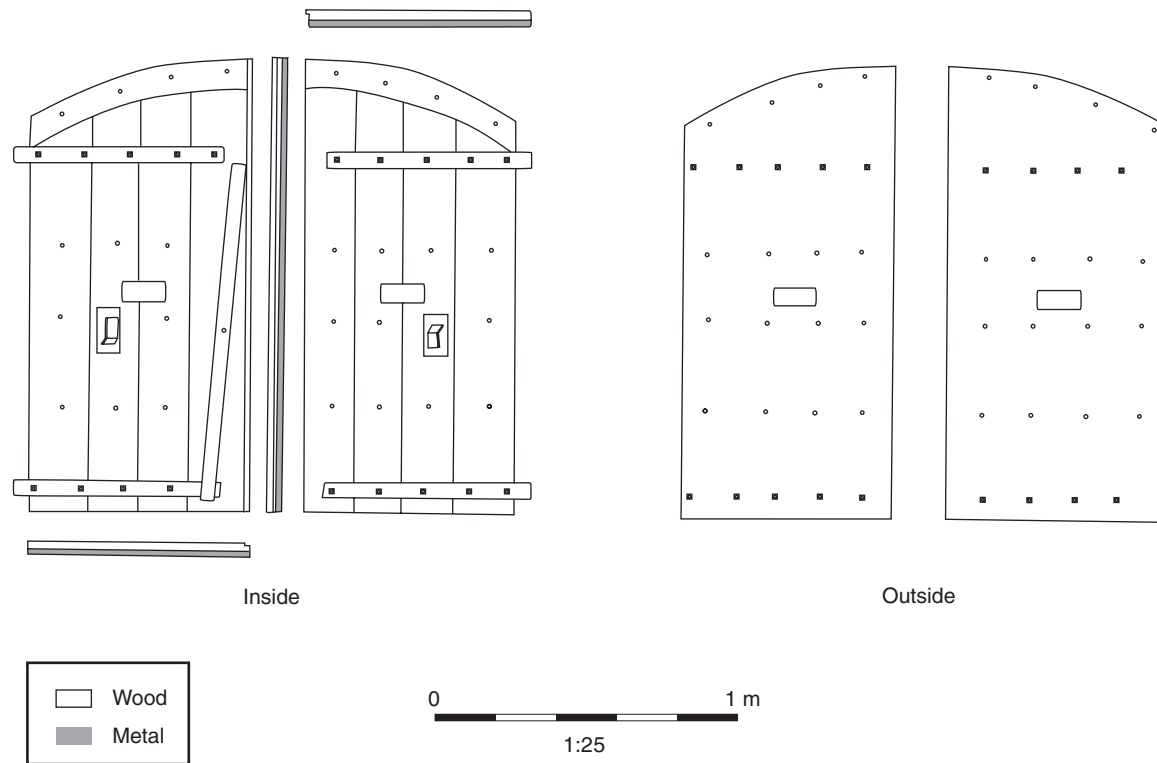
Figure 18: Iron shutters of embrasures

- 10.3.2 The iron shutters for the embrasures do survive around the Keep, but have seized solid or broken off their hinges, which have corroded. The shutters mostly remain in their rooms or in the Keep store. These require careful storage or restoration to prevent further decay, along with the single iron shutters from the caponiers. The caponier shutters are in poor condition and none survive in-situ and have been removed or fallen off the corroded hinges. The shutters are unique to the caponier embrasures and should be preserved or restored. A number of the cast-iron fireplaces and small ranges in both the Keep and caponiers have been removed or damaged. A few complete 19th century fireplaces survive, but are in poor condition and should be guarded against further corrosion. The Keep fireplaces are of three main types (and a few other individual types) and have a cast-iron surround in front of a brick lined firebox built into the stone wall. The floors of a many of the rooms are in a poor state due to water leaking into the building, but are of interest as they show the changing role of the Keep with the gun platforms and some traces of later use.

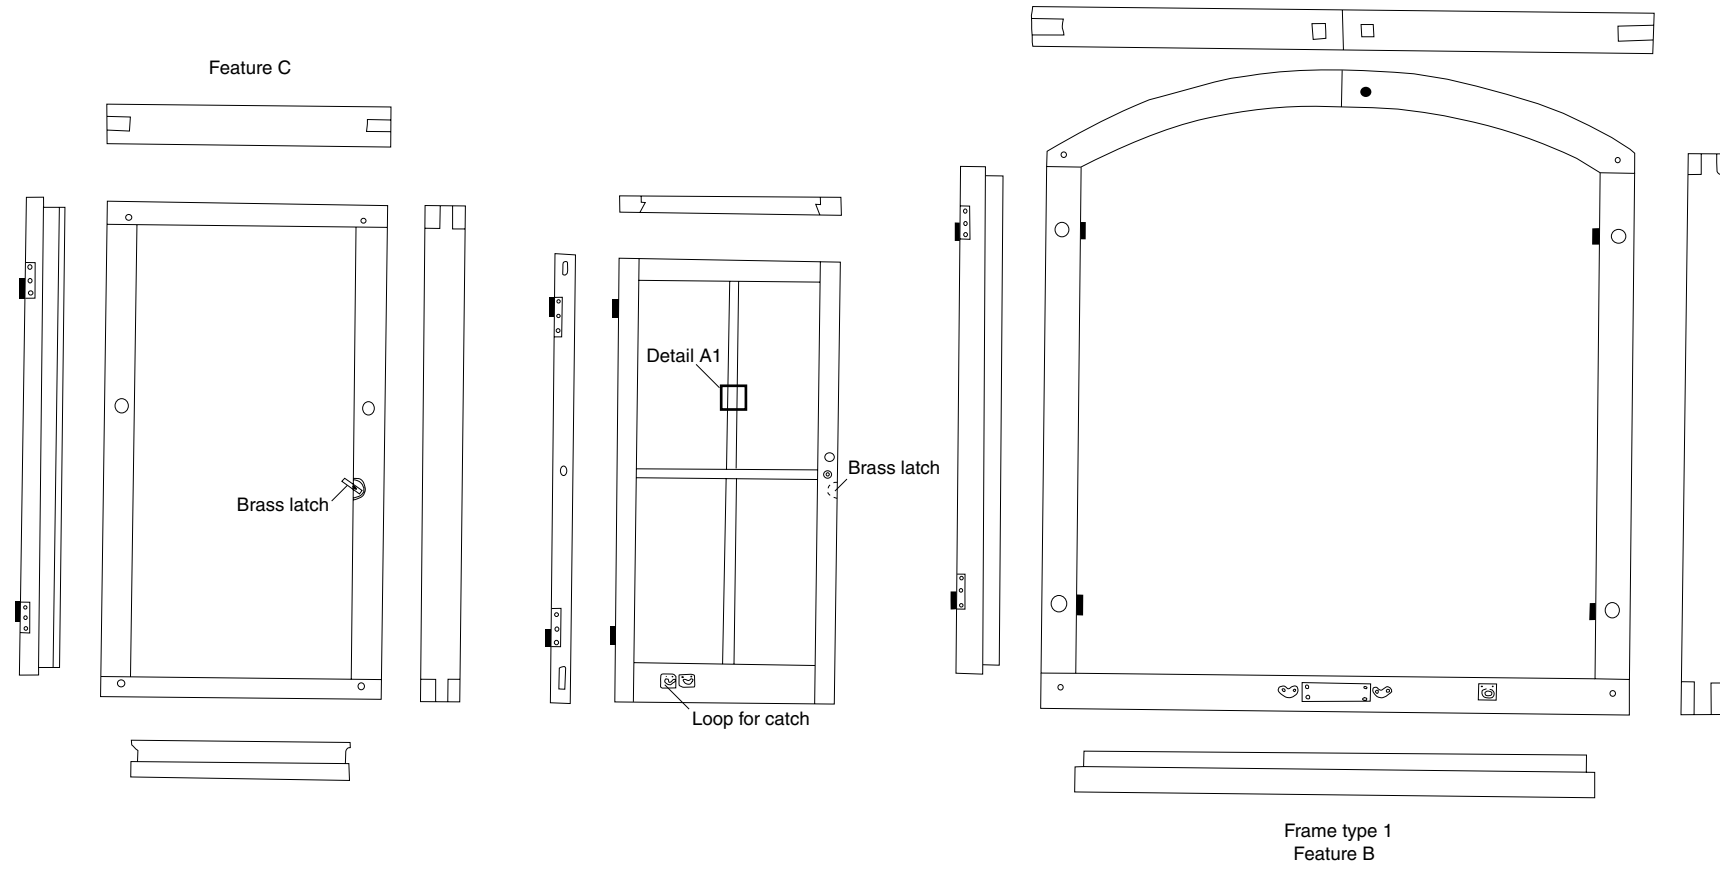
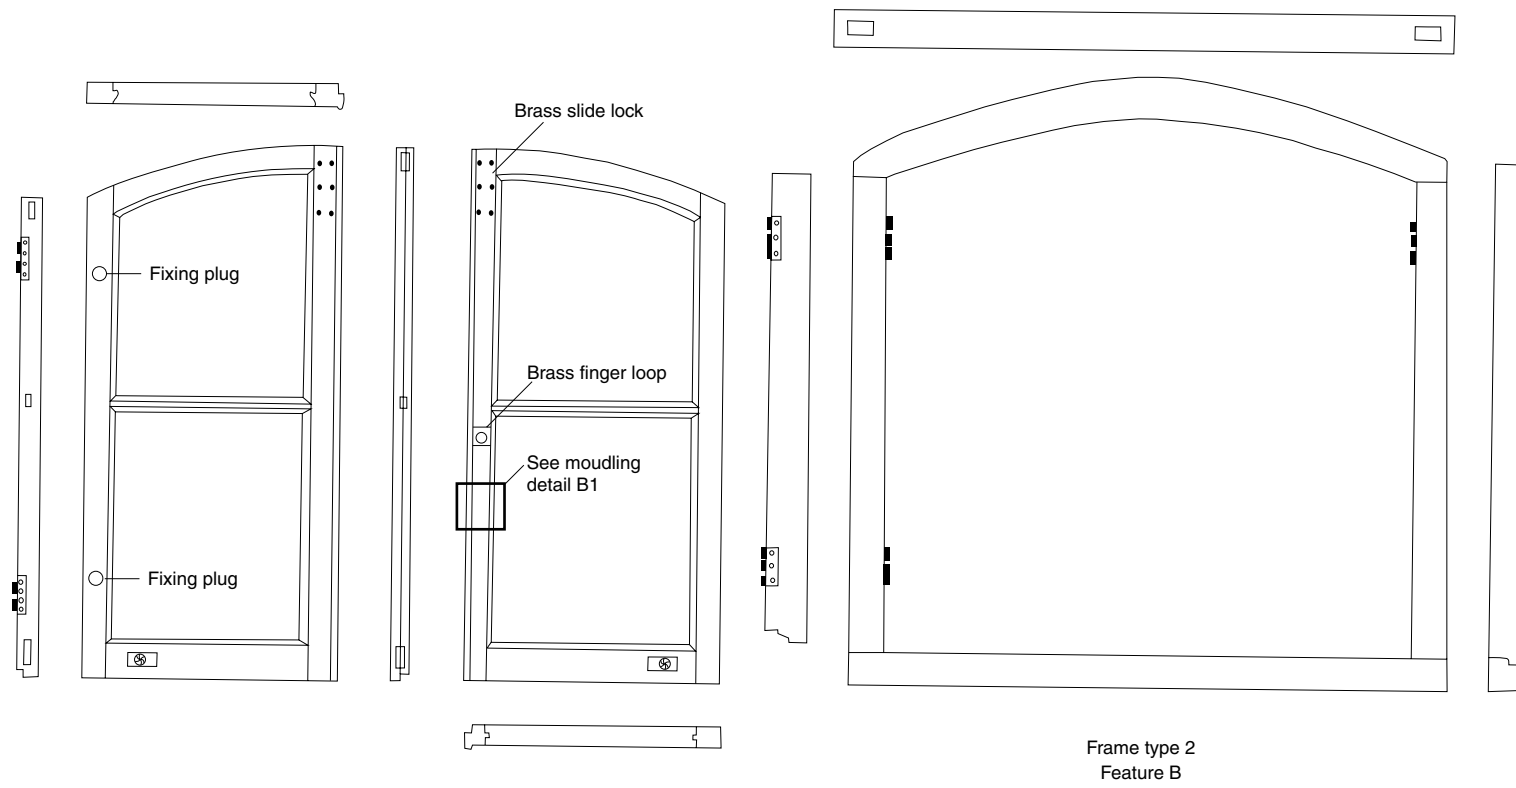
Figure 19: Window and frames of embrasures, (Feature B), and loopholes, (Feature C)

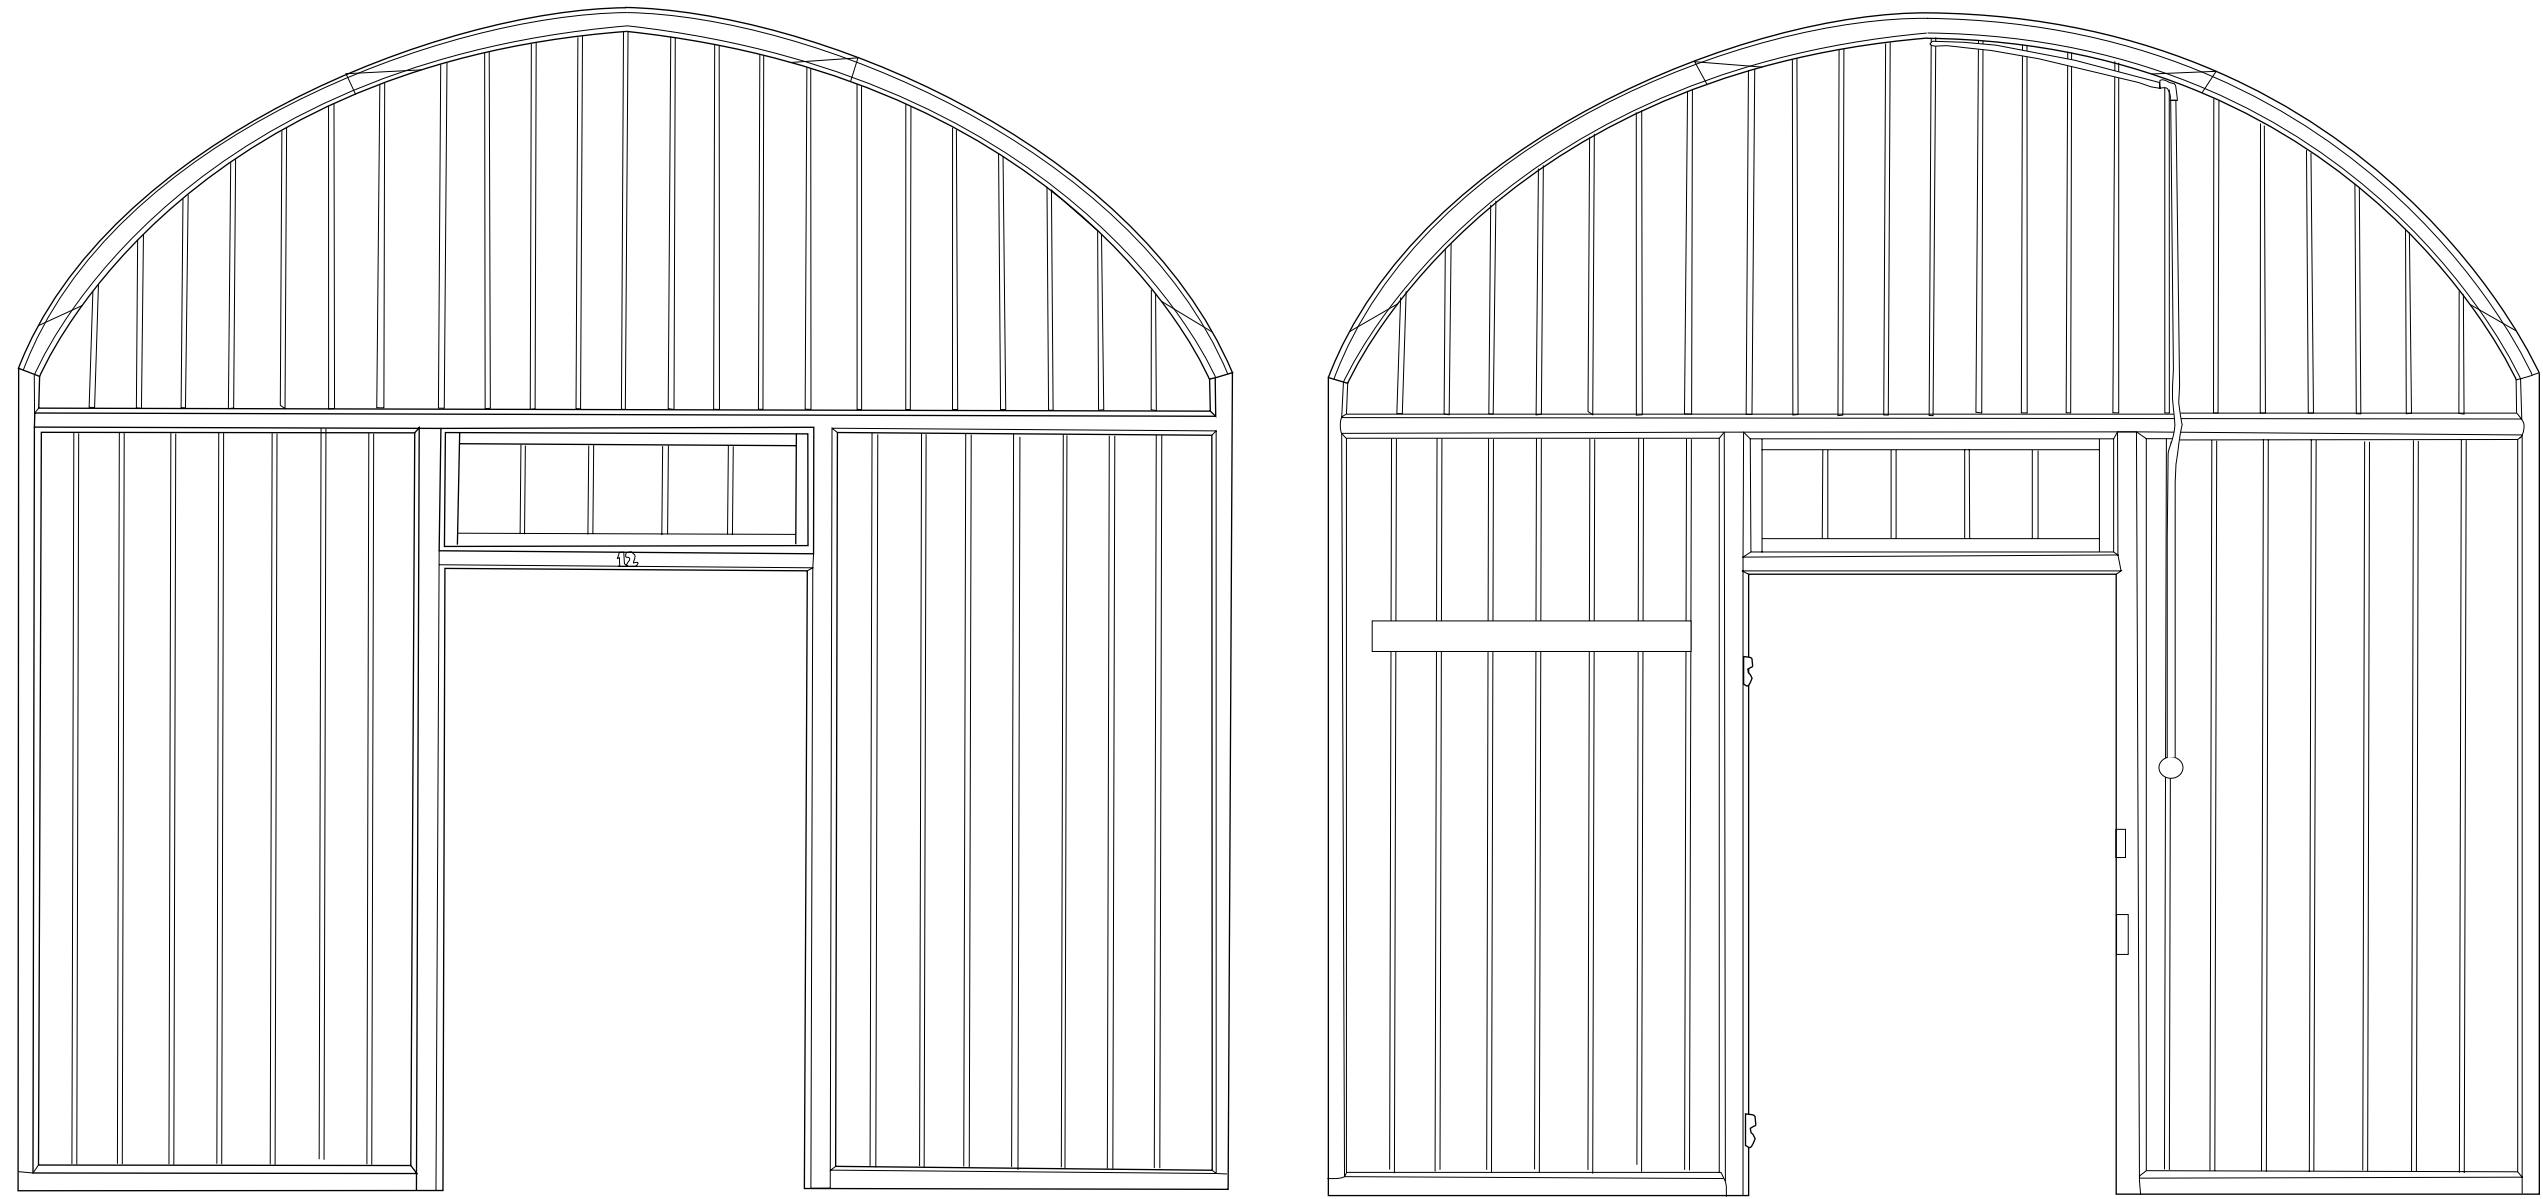
Figure 22: Room 3, Smaller Timber Partition, (Feature N)

N	Partitions panelling	22	Primary tongue and groove partitions the same as Feature M but smaller as they lined the inner side of the corridor.
O	Partitions panelling	21	Primary tongue and groove partitioning to Room 1B. Essentially of the same construction as Features M and N but it has an additional 8-light window to the side of the door.
P	Fireplace	33	Tall fireplace with timber mantelpiece found in Room 1A. Probably inserted in c.1900 and appears to be a Bratt Colbran variant.
Q	Fireplace	33	Secondary fireplace, more elaborate than primary ones, found in Room 3 and probably inserted in late 19th century to replace previous plainer type (S). Reflects the change in use of the room from a gun room (as originally intended) to possibly accommodation for an Officer (before the Keep became largely used for storage. Late 19th-century Messrs Yates Haywood & Co stove and mantel for Officers Quarters 1742 (List and Drawings of Pattern Articles to be adopted by War Dept Works and Buildings 1898).

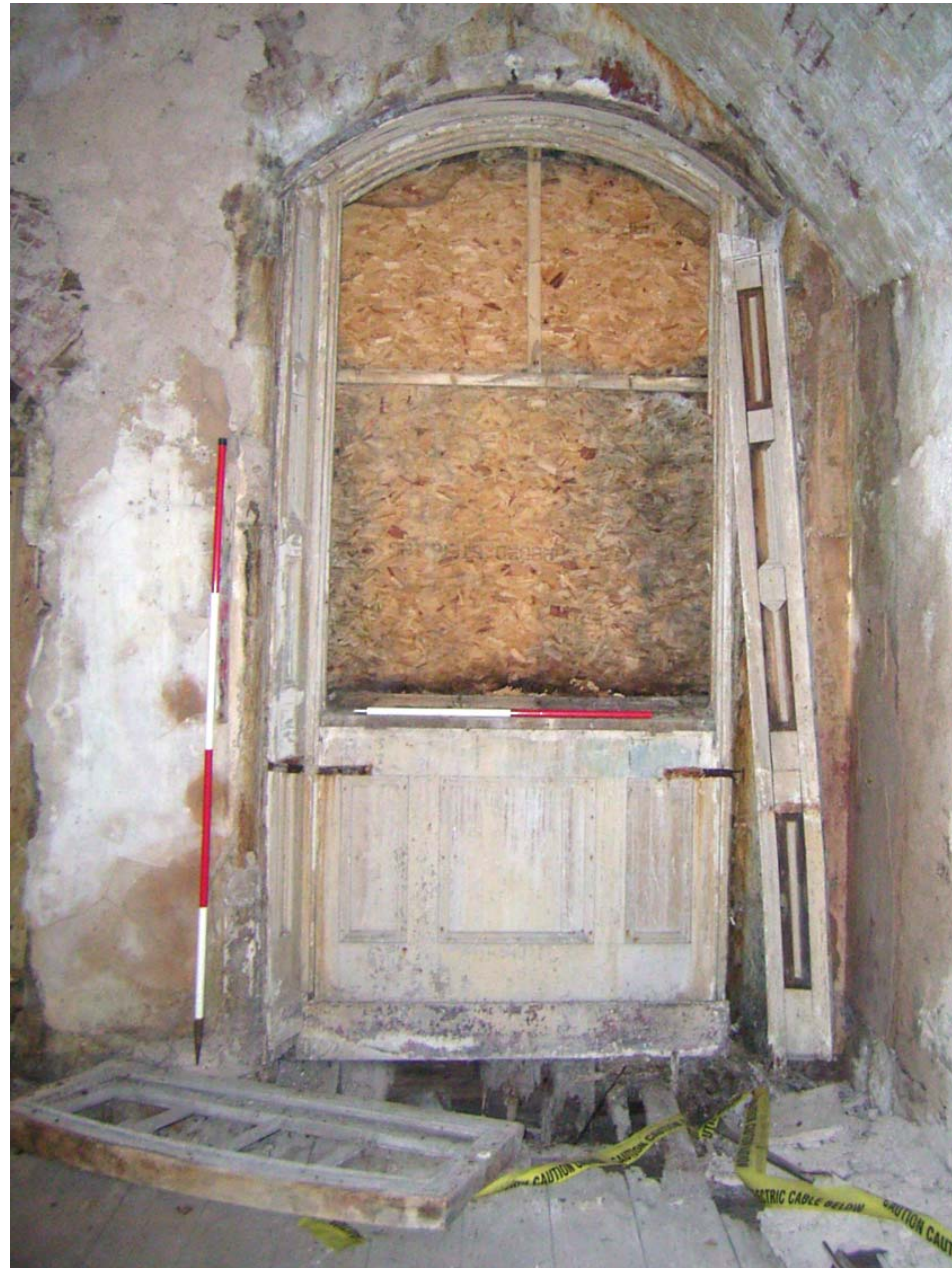
Figure 27: Panellled sash window in room 14, (Feature J)

J	Window	27	Sash window with panelling in Room 14 facing into the courtyard. The sashes themselves are no longer in-situ but the frame and panelling remains. Each of the windows on the eastern side facing into the court would have been similar to this feature. Six over six sashes with upper sash arched. The jambs are splayed and each has four panels with moulding detail similar to that found elsewhere in the Keep. Beneath the opening for the sashes are three panels.
K	Door	25	Primary, 19th-century door frame in opening between Room 7 and Passage B. Doors no longer in-situ but softwood frame remains intact with shallow arched head and margin lights, the upper ones of which would have been glazed but now have simple boards. The lower panels

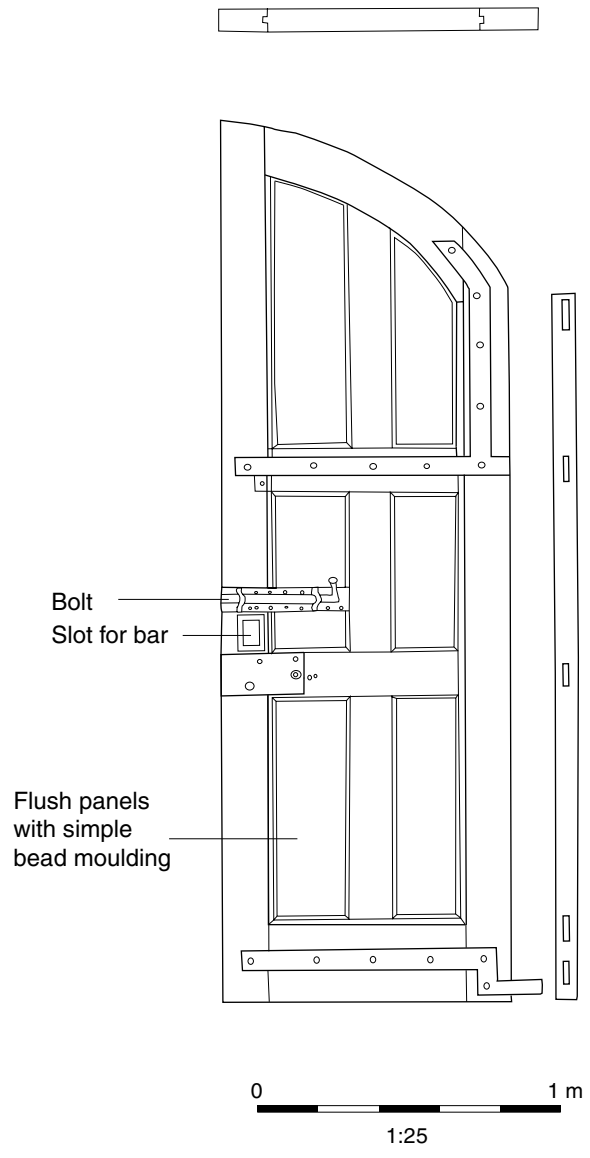
Figure 28: Right keep door inside elevation, (Feature A)

Feature	Type	Fig	Brief description
A	Door	28	<p>Primary double hardwood doors forming main entrance to Keep (to Passage A). Each leaf had six panels with a simple bead moulding (with flush panels) detail similar to that found elsewhere in the Keep. The doorway has an arched head and the doors are hung on two long iron hinges. There is an iron bolt to fix the door and it would have been additionally secured with an iron bar.</p> <p>Neither door remains in-situ but each has been located in the Keep: one is in Passage A while the other is in Room 18A. The primary door frame is also not in-situ but it would have been c.12 cm wide.</p>
B	Shutters	18	Shutters to either side of the gun embrasures found throughout Keep. Timber doors with iron lining facing the external side. Arch headed, each door comprises four vertical boards fixed with two long, iron

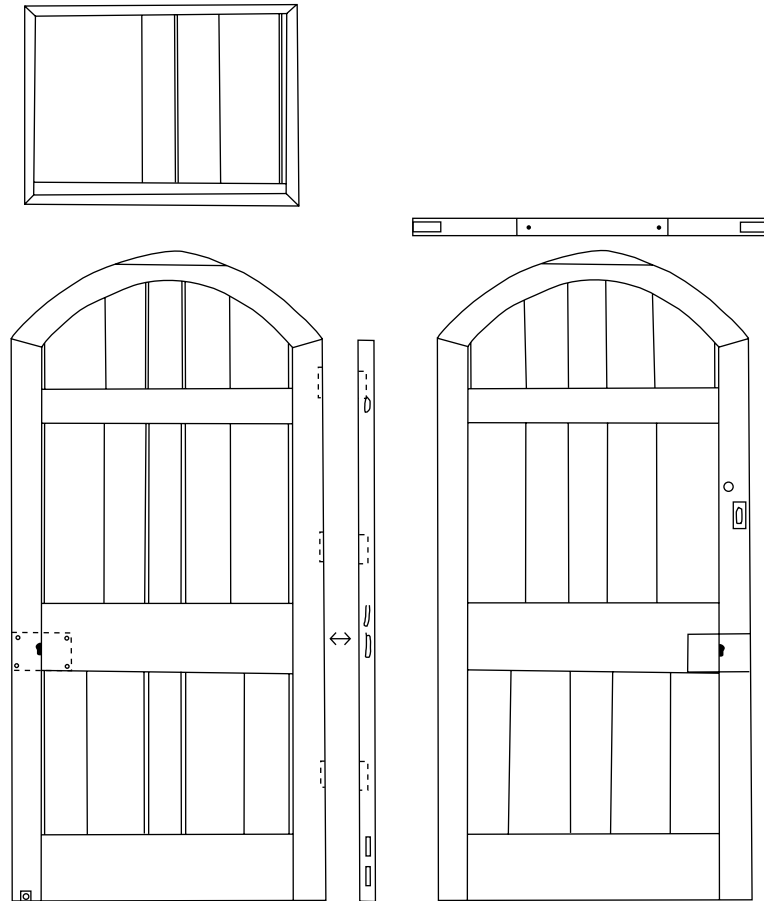
Figure 31: Door from doorways from inner courtyard into rooms 11, 12, 13 and 14 and a later fitted hatchway, (Feature F)

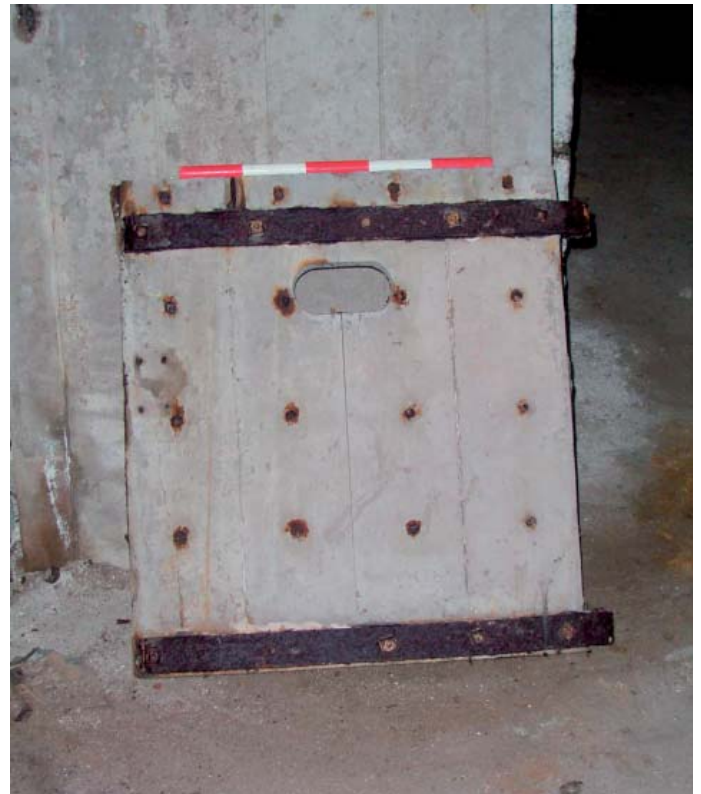
Plate 32: Iron shutter of caponier embrasure, showing wood back, slit and brackets

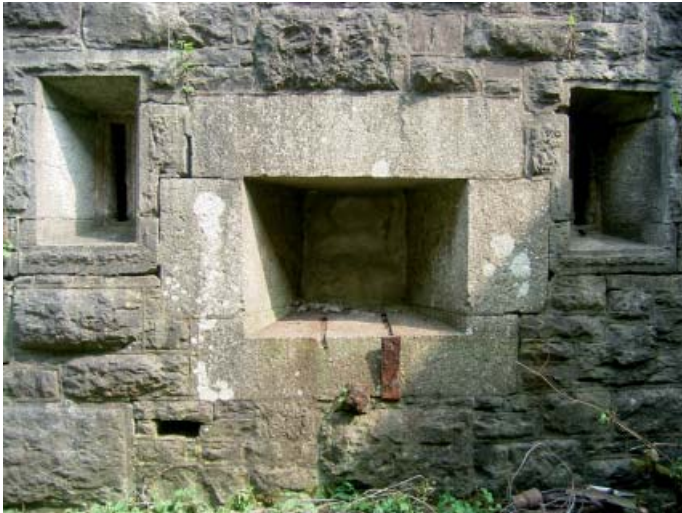
Plate 40: Pivot lug and repair to mounting in north-west caponier from the trails

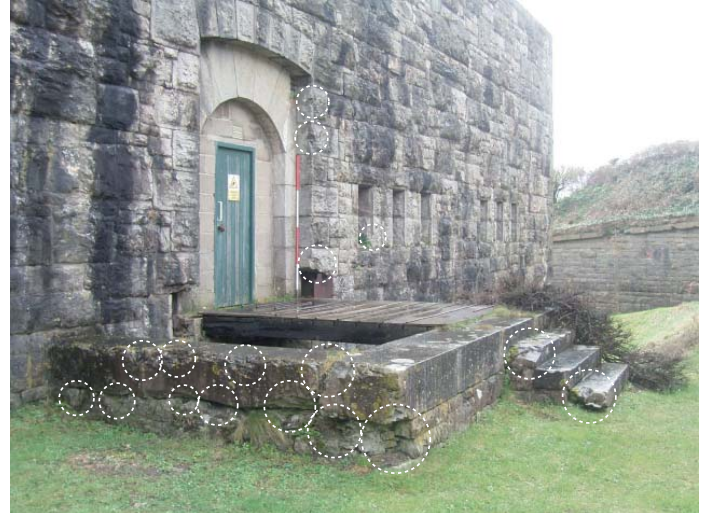
Plate 41: External view of repair to mounting in north-west caponier from the trails

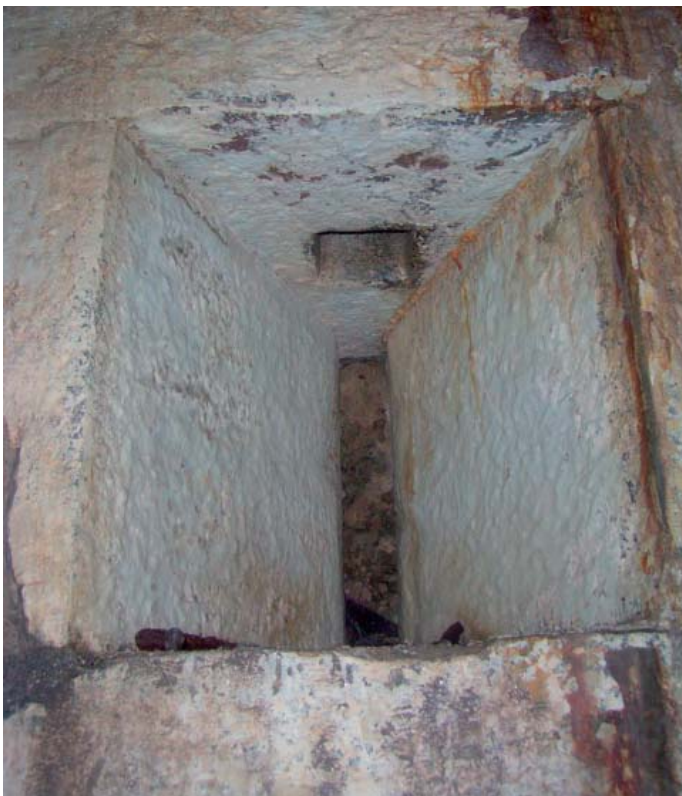
Plate 42: Damage to the south-west drawbridge from the trails of the 32pdr

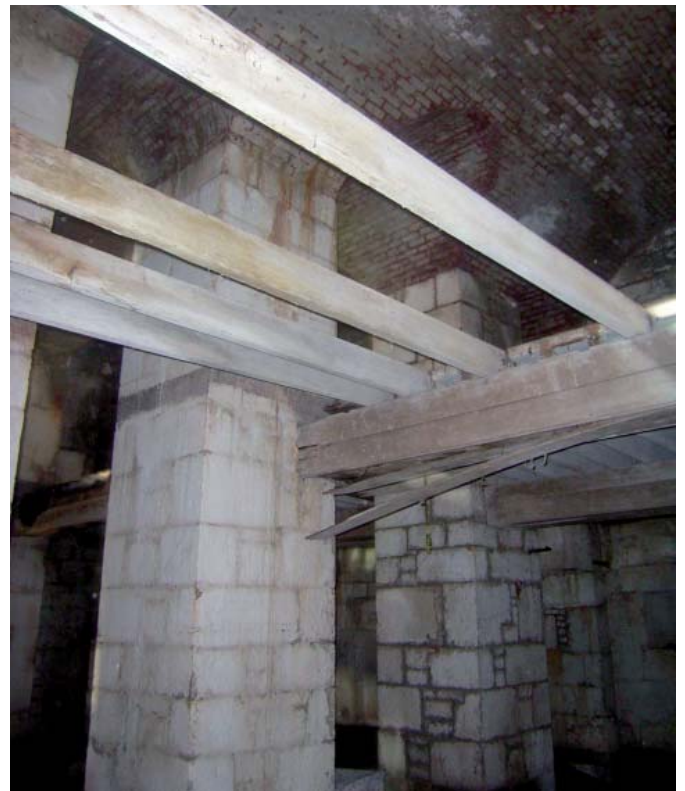
Plate 60: Collapsed floor of upper tier showing layout and construction of caponier
