Ashgrove Farm Ardley Oxfordshire

**Historic Building Recording
and Investigation**

March 2014

Historic Building Recording and Investigation

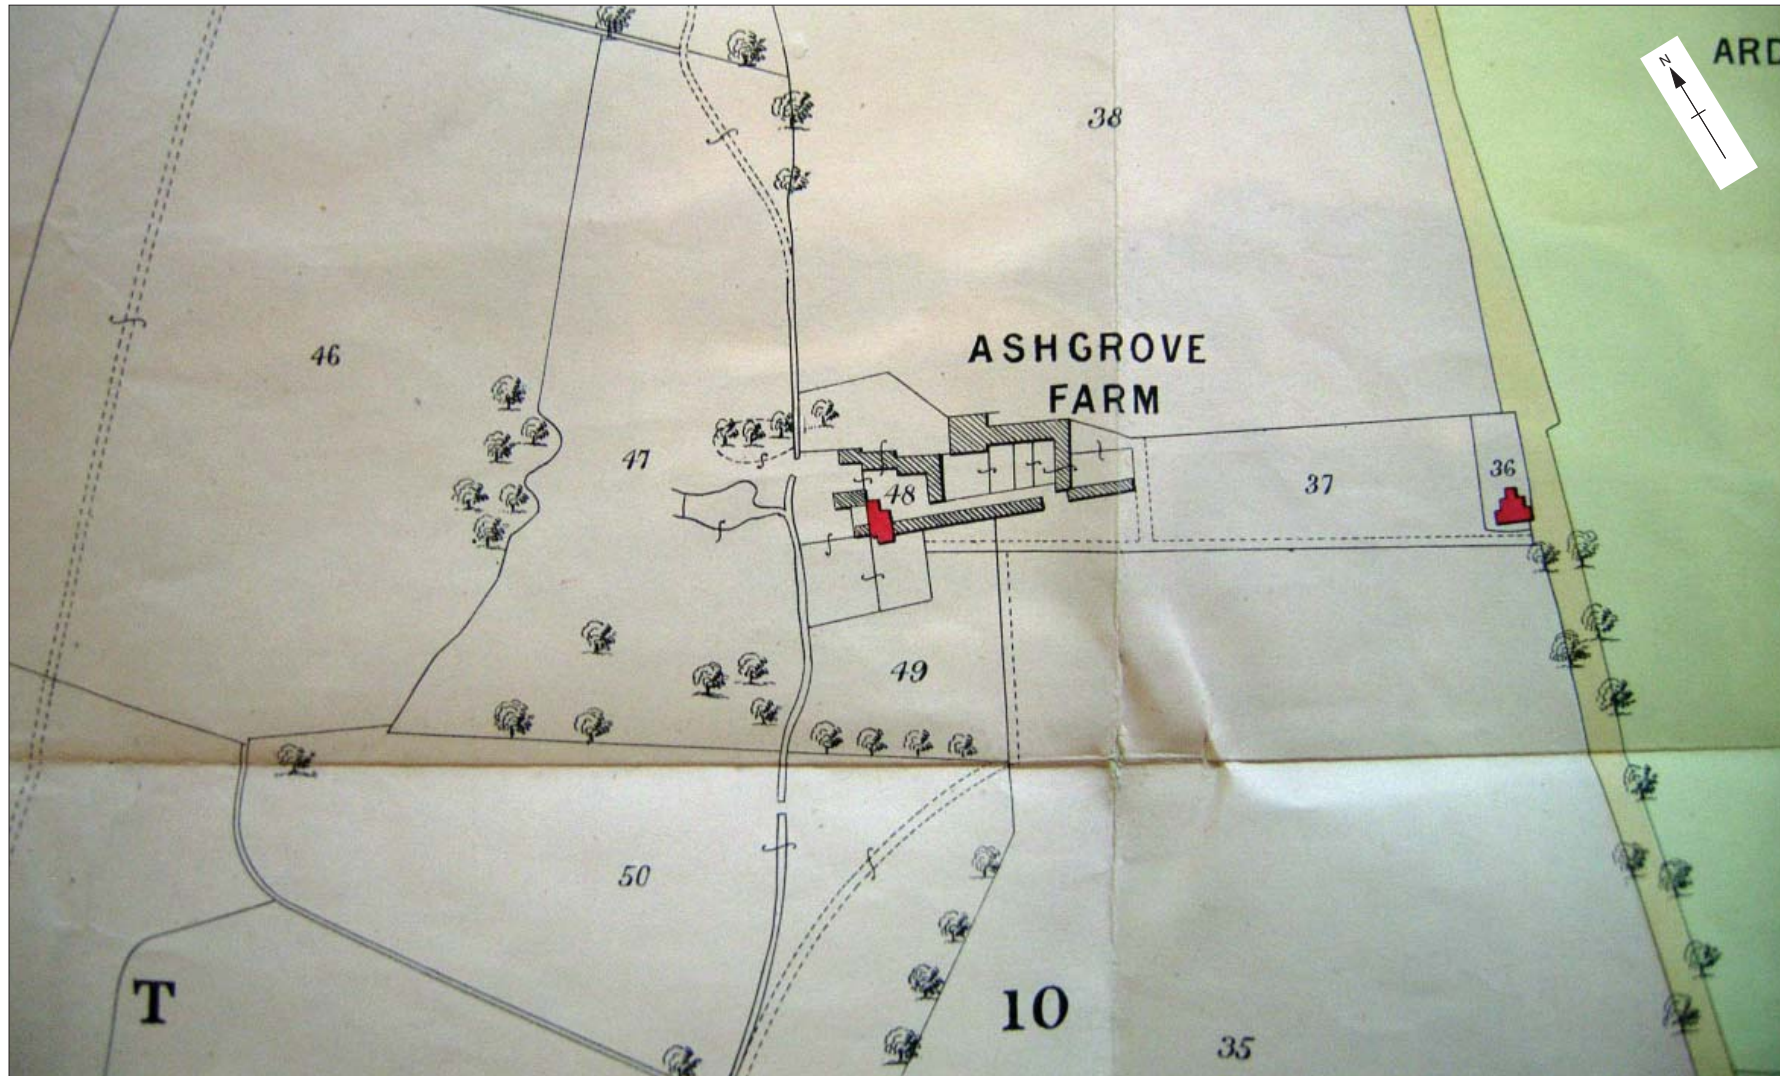
Figure 4: Plan associated with the Sale Catalogue, 1894

2.2.6 The map associated with the Sale Catalogue of 1894 (Fig 4) shows clearly the addition of 'Barn 2' and also the extension of the range of farmhouse buildings to create the stables now referred to as 'Barn 4' and 'Barn 5'. It also shows that the farmhouse has undergone some alteration in this period, namely the addition of the building which forms the main farmhouse and the smaller outhouses.

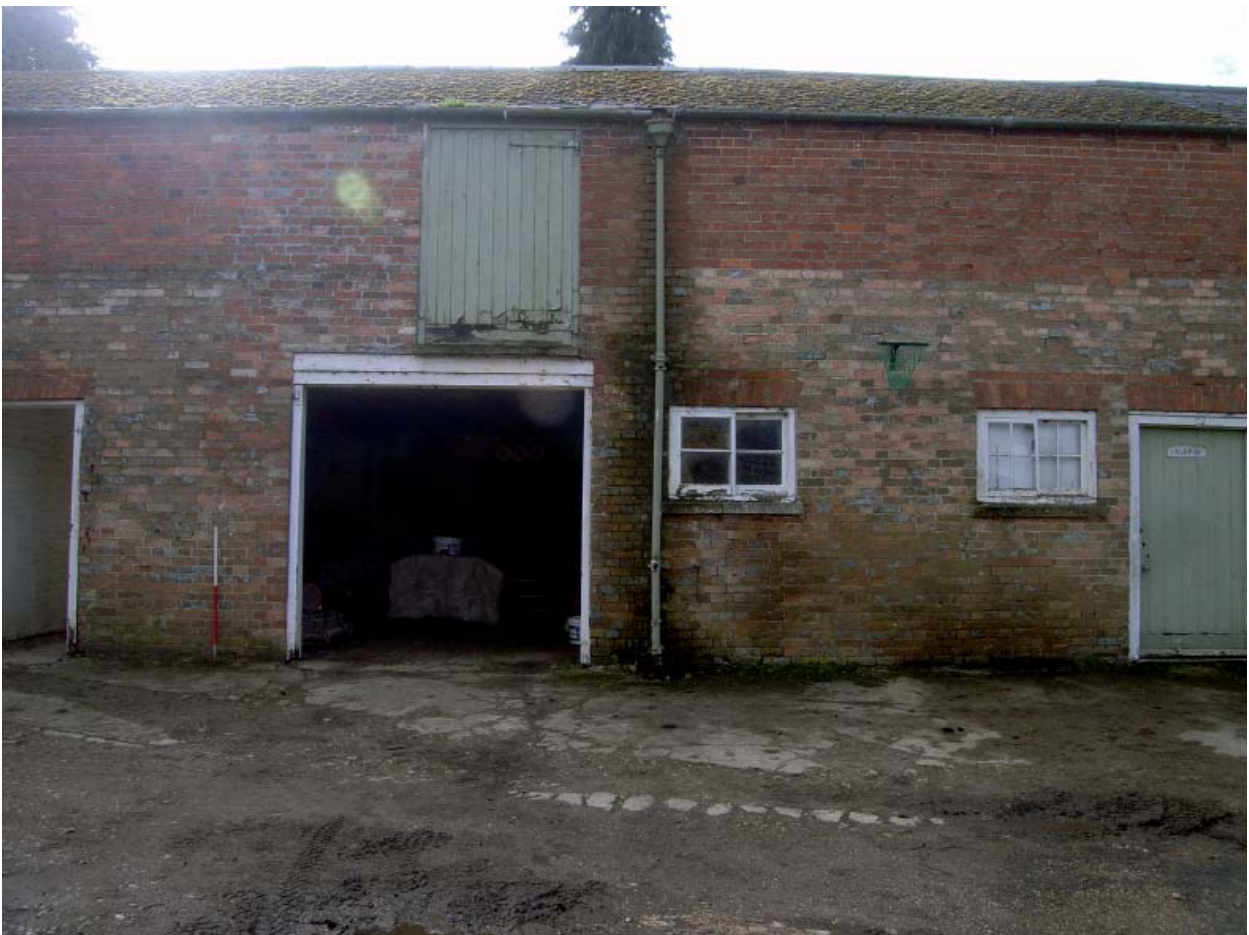
- 3.1.3 The east-west earlier range of buildings are now in domestic use, but would have housed the domestic brewhouse, water pumps, coal sheds etc. listed in the Sale Catalogue. This range has undergone several schemes of alteration, the most extensive being the addition of a first floor which includes a pitching door, although being in such close proximity to the farmhouse was more likely to have been for hauling goods up to the first floor for secure storage (Pl. 2).

Plate 2: Farmhouse building; detail of first floor addition and pitching door; north elevation

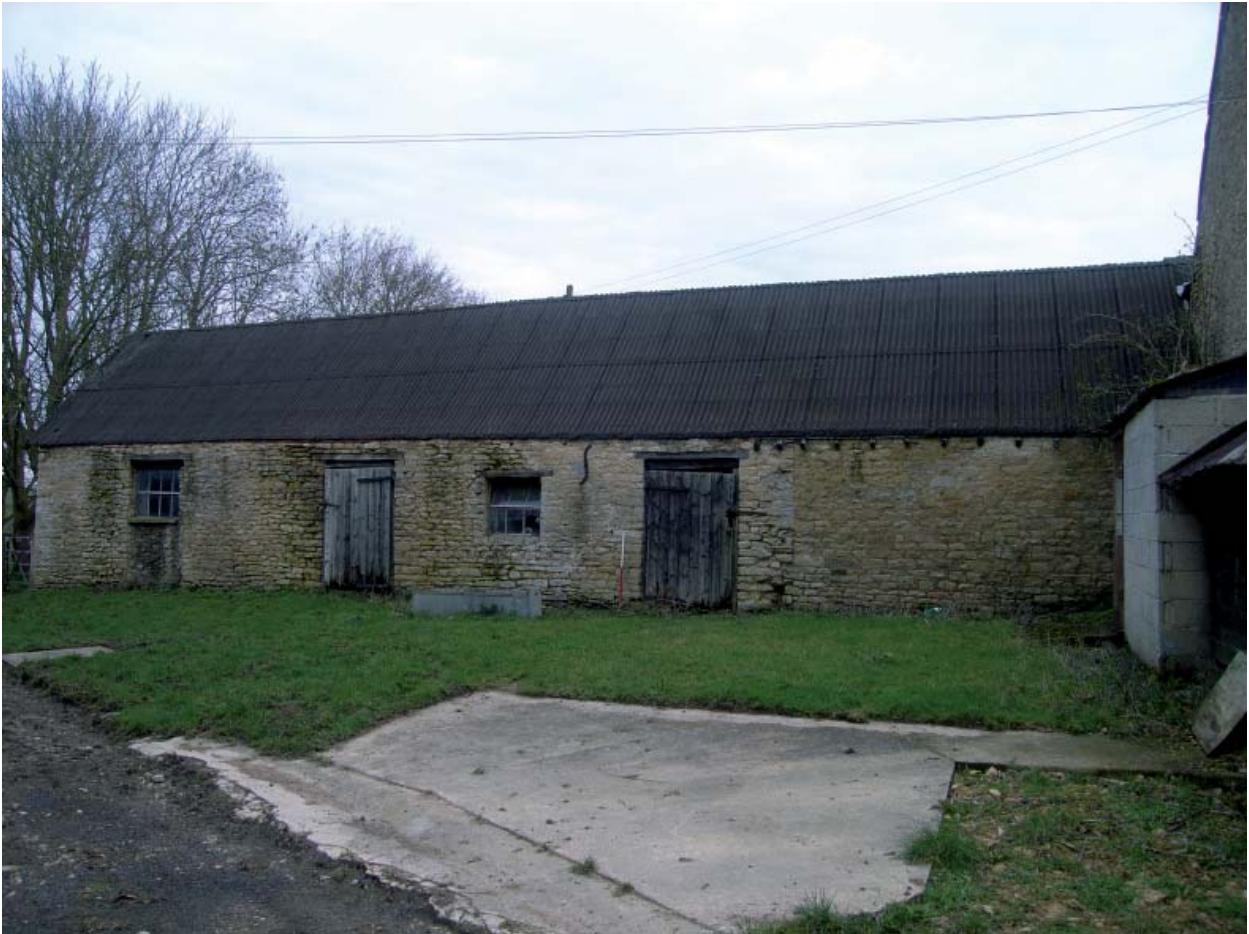
- 3.1.5 The *stable or loosebox* abutting the north-west corner of the threshing barn is not part of this study and was not accessed (Pl. 3). It has doors and windows to both north and south elevations with no internal access to the barn (Pl. 4). A considerable area of rebuilding was observed in the south east corner of this building (Pl. 3); this is later than the rest of the building, abuts the threshing barn and is not reflected on the opposite side of the block and may represent blocking of a larger window or opening.

Plate 3: Stable or loosebox to the west of the threshing barn; south elevation

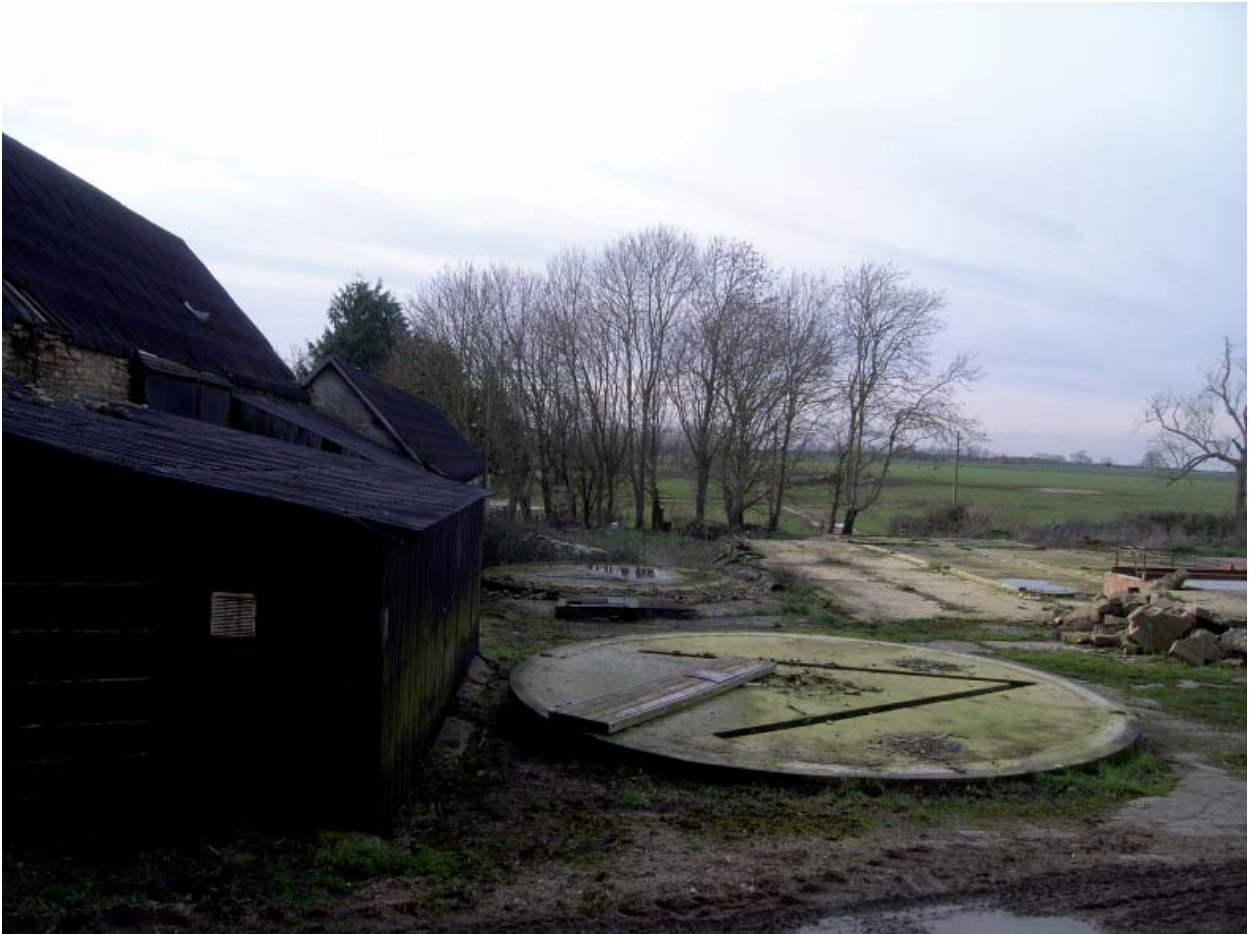
- 3.1.6 Several mid twentieth-century *agricultural buildings* not in this study are also present; the 'black barn' at the north of the site and the steel- and concrete-framed barns in the centre (Pl. 5 & 6) and to the east of the site appear on the maps during the mid twentieth century. Some modern barns and the silos had already been removed to the north of the threshing barn by the time of the survey (Pl. 7).

Plate 7: Silo bases and the bases of removed modern buildings; looking west

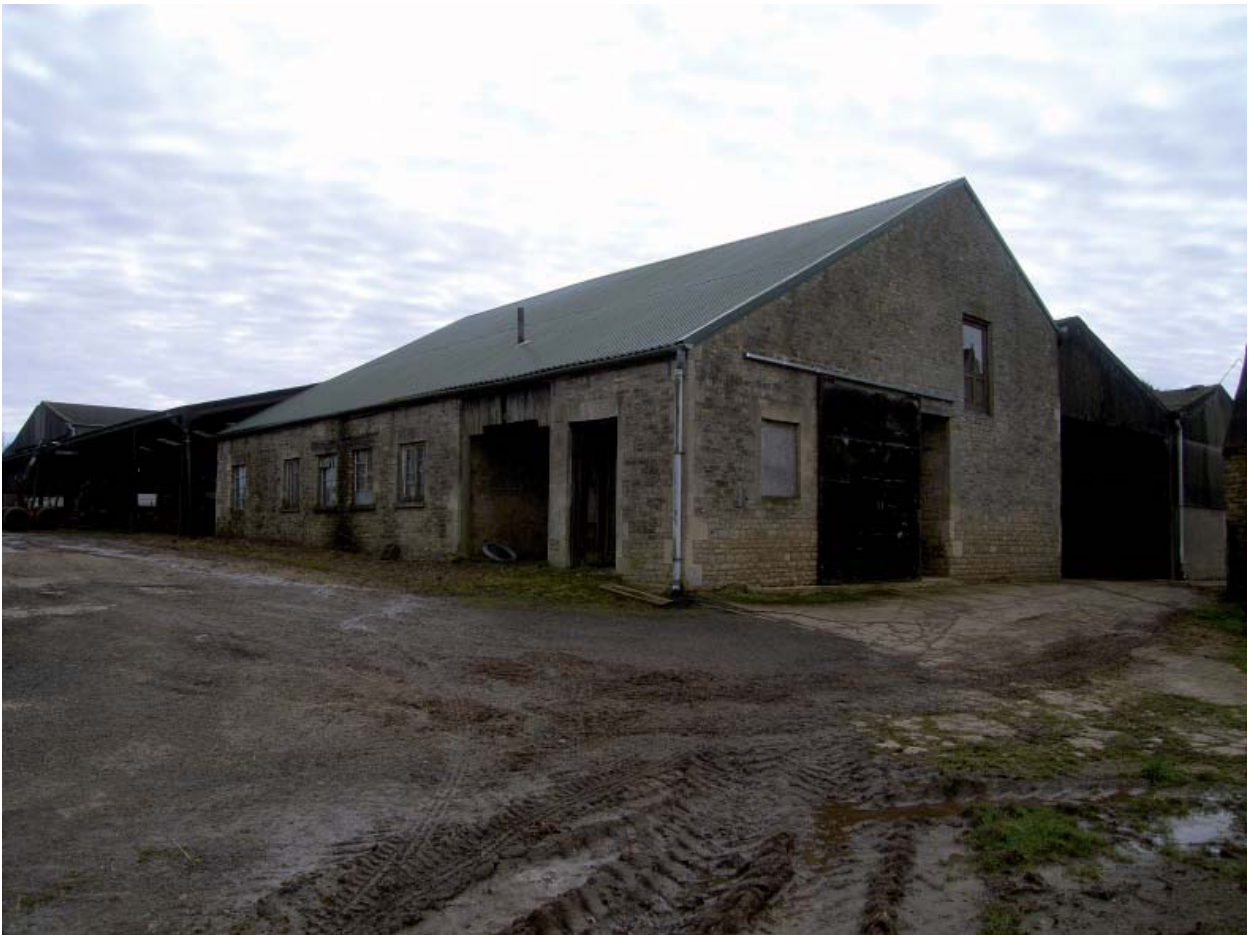
- 5.1.1 Barn 2 (Figs 6&7) is the most grand of the agricultural buildings (Pl. 10). Appearing at a point between the Tithe Map of 1839 and the Sale Catalogue plan of 1894, the walls are of irregular coursed limestone with rusticated limestone quoins with matching dressings to the original external doors, windows and openings.

Plate 10: Barn 2; north and west elevations

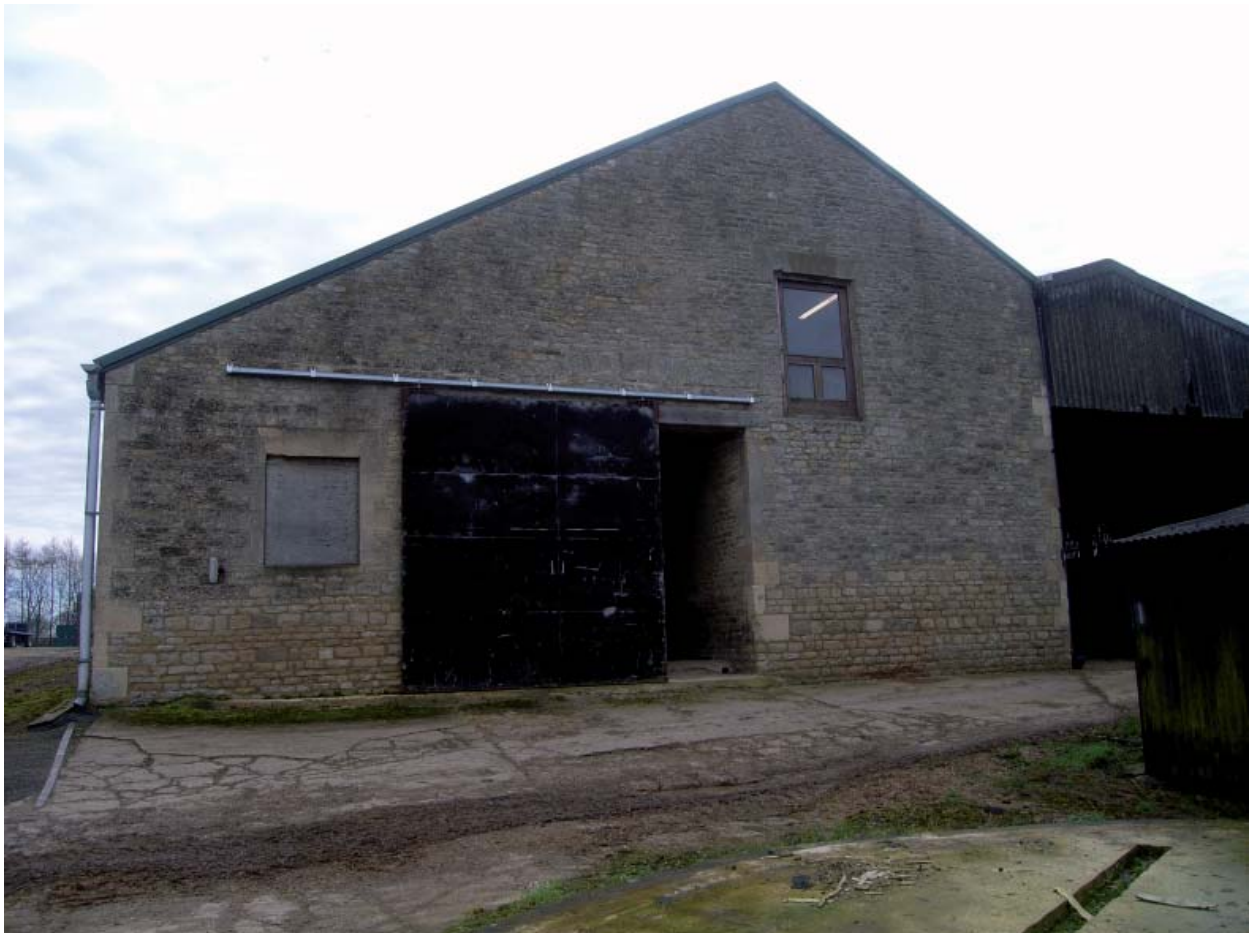
- 5.1.4 The west elevation (Pl. 12) features a modern externally mounted rolling steel door to a large opening below a timber lintel with a simple stone arch above: as the infill below the arch to the top of the lintel is consistent with the surrounding stonework, it can be assumed that the arch is for weight distribution and therefore structural rather than a former arched opening. The window to the left of the door, to the warming room, has been boarded over, but the frame survives beneath. To the right of the door is a pitching door at second storey level, although this has been replaced with a modern glazed door.

Plate 12: Barn 2; west elevation

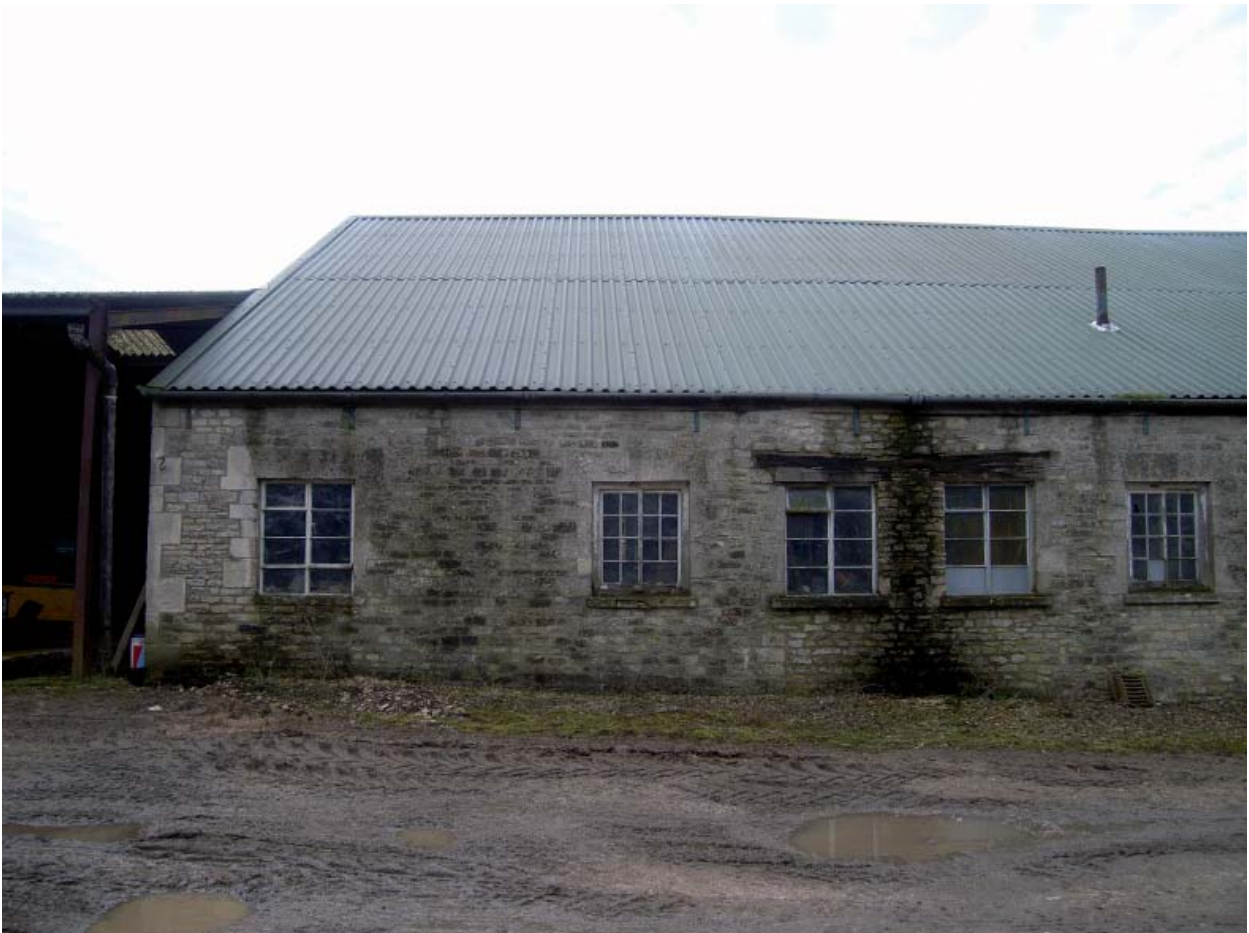
- 5.1.7 The windows are a metre wide, splayed to the internal face, and were originally wooden-framed horizontally sliding sashes, with each sash having eight panes. Many windows have been replaced with frames reclaimed from elsewhere, detailed particularly in the section on the general workshop. Many of the replacements are of Crittall-style metal framed windows; these were common in the mid twentieth century and may be indicative of a scheme of replacement around the time when the farm was expanded with the addition of the modern agricultural buildings (Pl. 14).

Plate 14: Barn 2; east end of north elevation

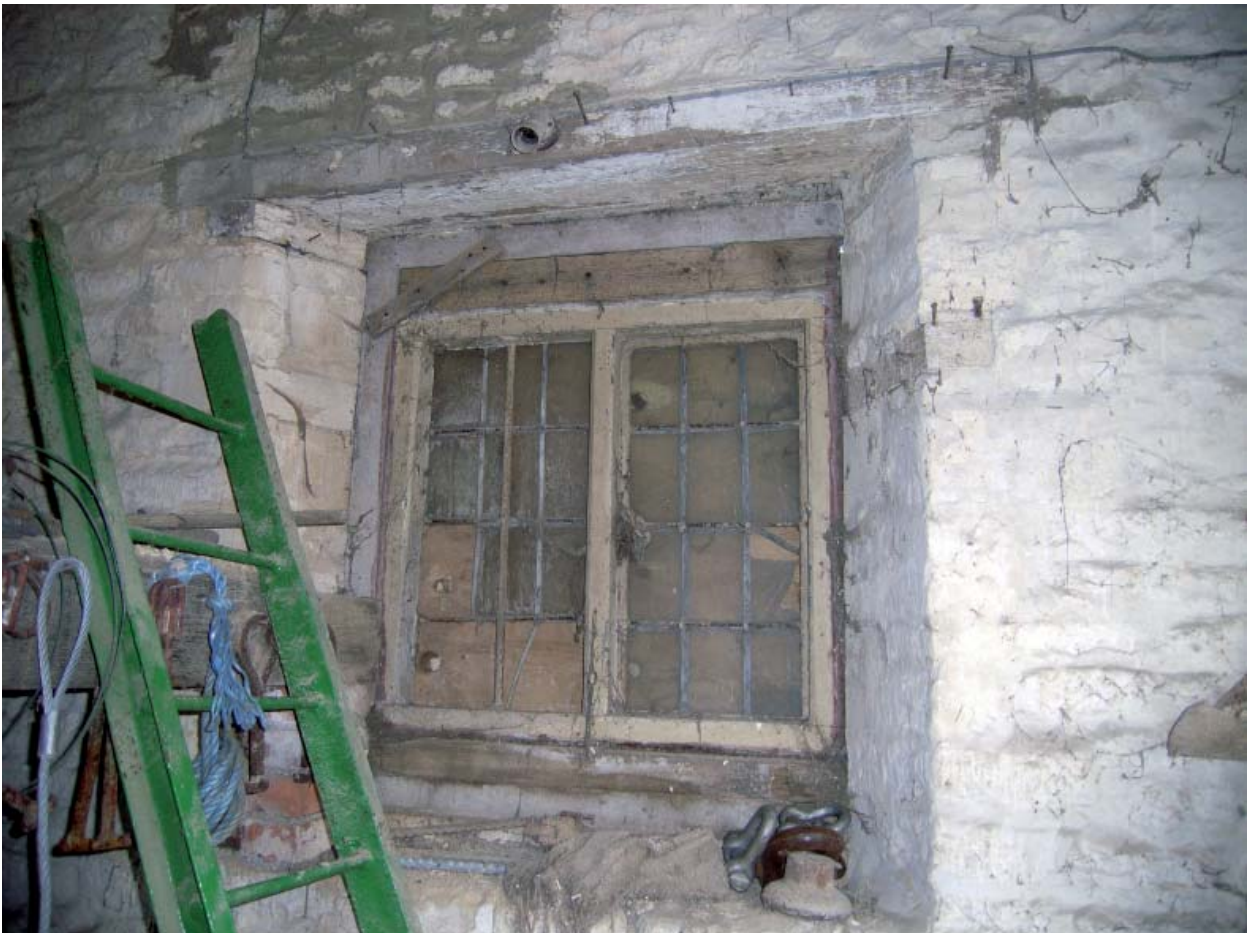
- 5.2.10 The one-bay warming room retains a very small timber mezzanine and shelves which are still used for tool storage. The room is accessed by a later ledged door, but retains a window, boarded externally (Pl. 20). Probably an early replacement due to the extra timber packing around it, the window currently consists of one fixed light and one opening casement, with 12 rectangular leaded panes in each, although a central glazing bar in the fixed light may indicate an earlier glazing scheme. Internally, the window is splayed and below a timber lintel.

Plate 20: Barn 2; Warming Room window

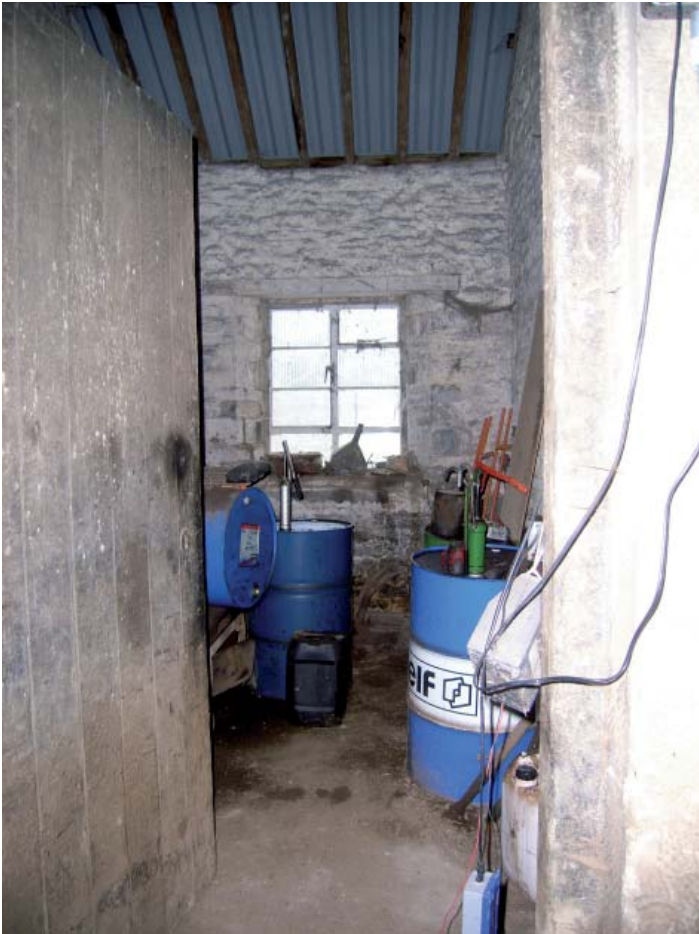
- window is a later replacement which matches the reclaimed windows used in the General Workshop, as described previously (Pl. 23).
- 5.2.15 To the south of the passageway, the building is split into two two-storey compartments: the westernmost of six bays and the easternmost of two bays with a brick wall dividing the compartments.

Plate 23: Barn 2; Oil Drum Store

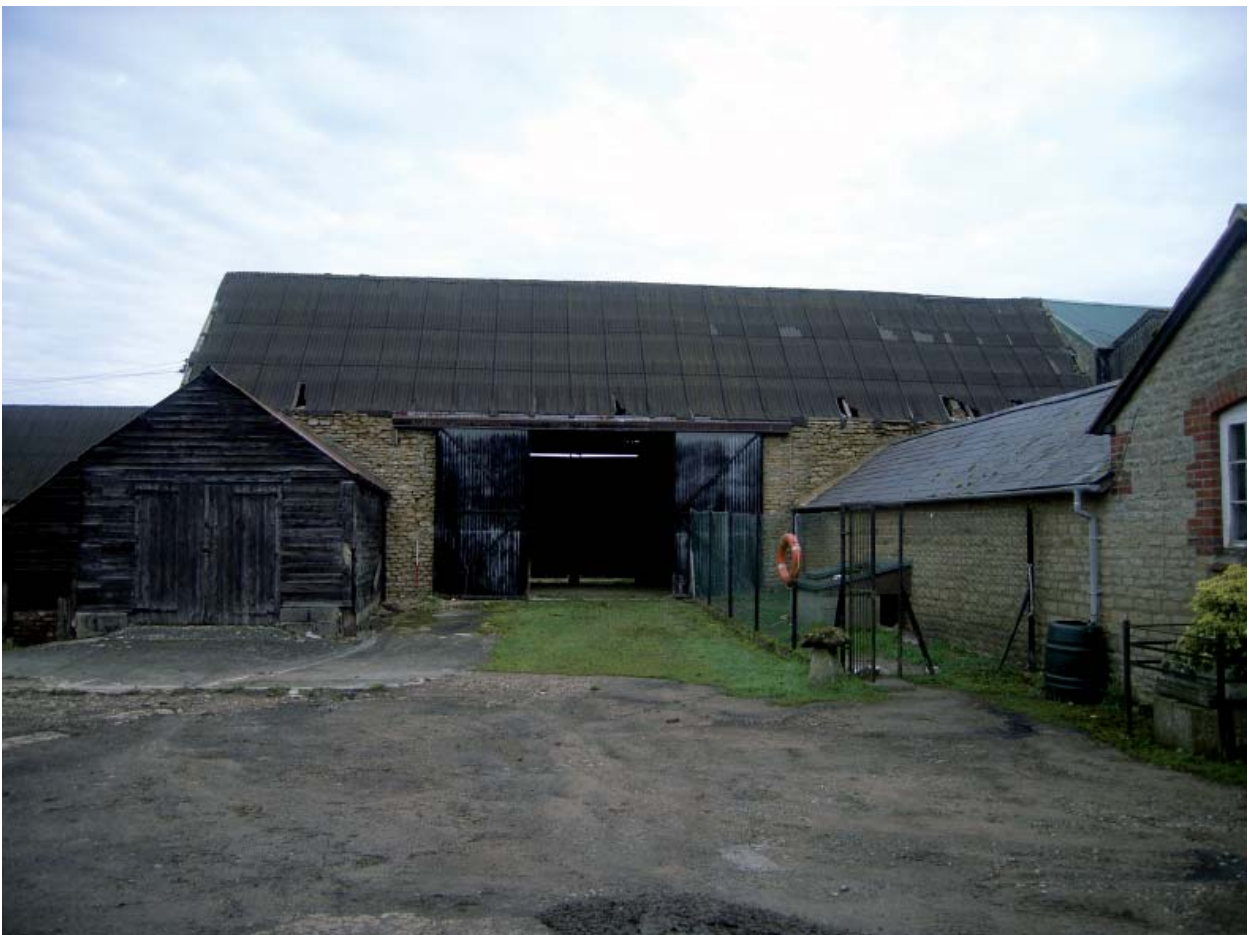
- 6.1.1 The only listed building on the site, and the earliest surviving building on the farm, the threshing barn (Fig 8) had its original slate roof covering removed and replaced with corrugated sheeting, now much degraded, at some point before its Listing in 1988 (Appendix B) (Pl. 30).

Plate 30: Barn 3; south elevation

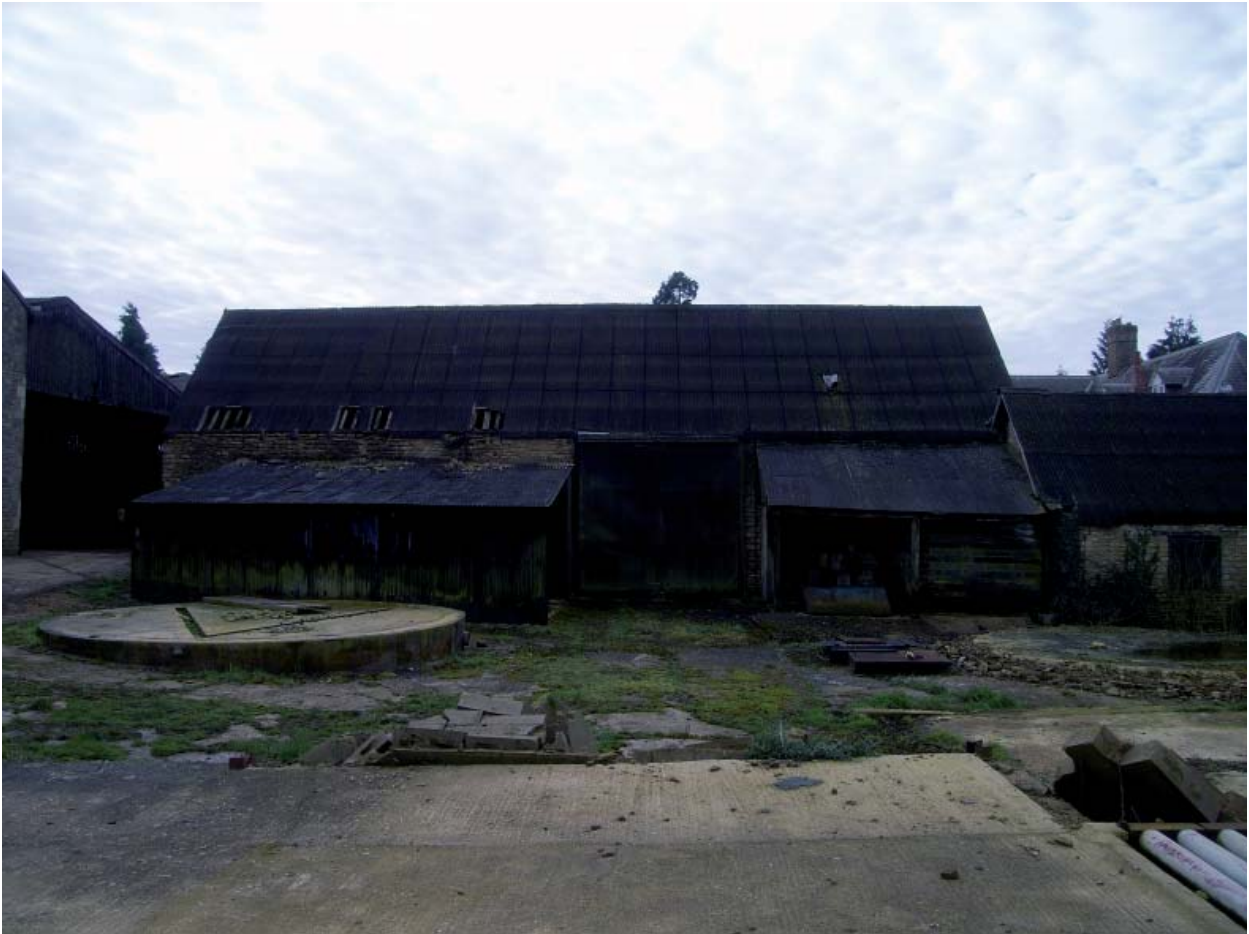
- 6.1.2 The original barn doors have been replaced with steel doors.
- 6.1.3 Much of the exterior is obscured by the adjoining buildings, particularly the north and south elevations (Pl. 31); only the east elevation is free of obstruction (Pl. 32). The walls are of coursed limestone rubble with triangular vents or owl holes at the top of the gable at each end.

Plate 31: Barn 3; north elevation

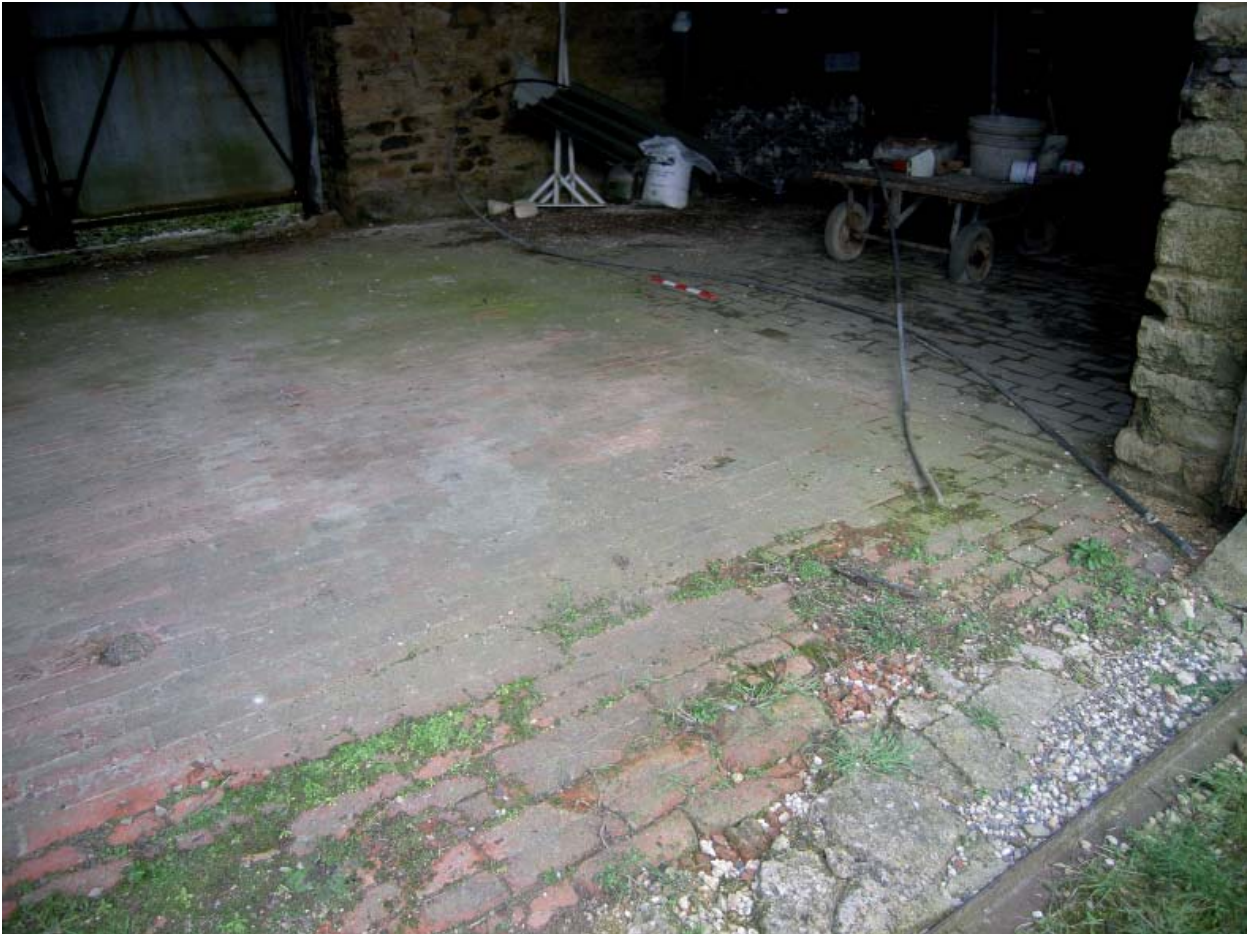
- 6.2.1 The simple roof trusses consist of a stopped chamfered tie beam with a collar binding the principal rafters at the level of the uppermost of the two rows of butt purlins, which are of fairly roughly shaped timber. No carpenter's marks were observed and additional collars have been added for strength to some trusses (Pl. 37 & 38). Some battening is present in small areas and so the common rafters may be may be original, or at least early, however, observing from floor level was difficult and so closer inspection may be worthwhile.
- 6.2.2 The threshing floor and storage bays are laid to brick; the threshing bay brick (220mm x 70mm) is earlier, indicated mainly by wear, and the storage bay brick (220mm x 108mm) laid at a later time (Pl. 39).

Plate 39: Barn 3; threshing floor and storage bay floor looking north east

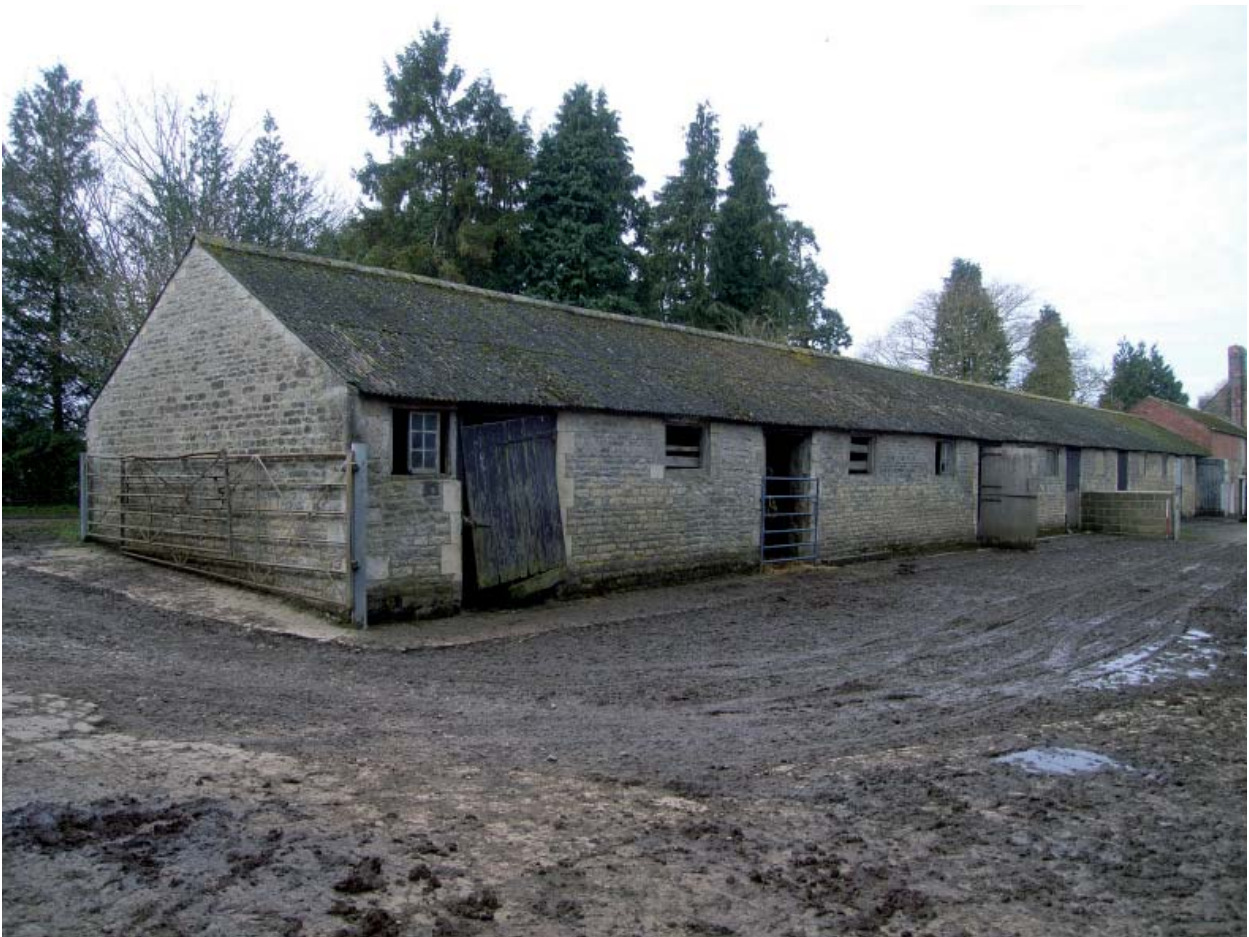
- 7.2.4 One six-paned sliding sash survives in the window frame, and a ledge and braced door hangs in the full-height door opening (Pl. 41).
- 7.2.5 The next three bays form the **Easternmost Stable or Loosebox** with the manger and hayrack surviving to the south wall, albeit with the hayrack removed in the central bay (Pl. 45). It may have been a loosebox, as it is currently, as no indication of partitions for stalls is visible on the wall or manger, however, access to the floor was not possible due to thick straw and manure, and this is the most likely place to display signs of a frame for the partitions.

Plate 41: Barn 5; east and north elevations looking south west

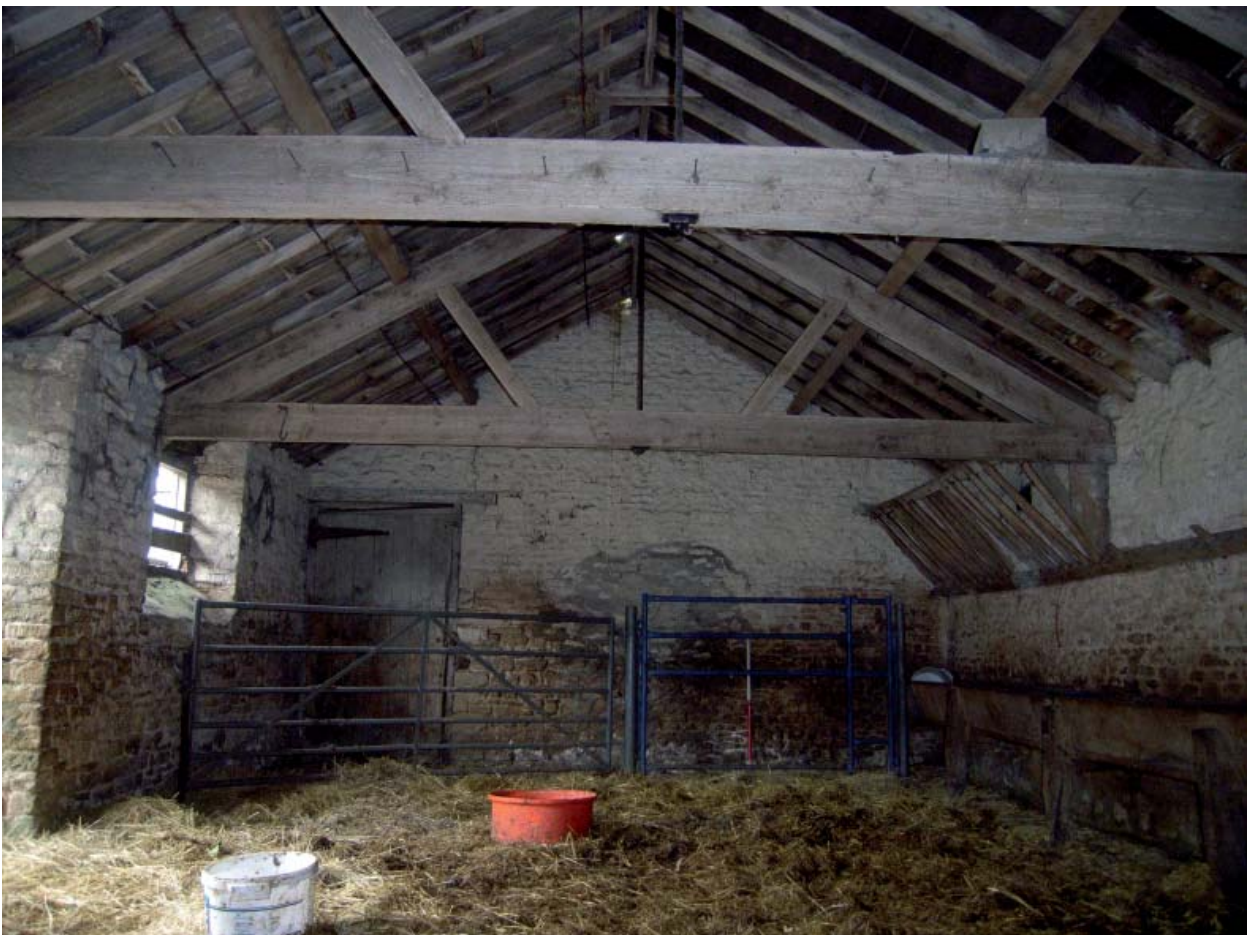
between the principal rafter and tie beam (Pl. 44). Through purlins support the common rafters, but the battens do not survive as the slates to the south pitch have been refitted, or replaced like for like, and a layer of felt obscures any view between the rafters.

Plate 44: Barn 5; truss

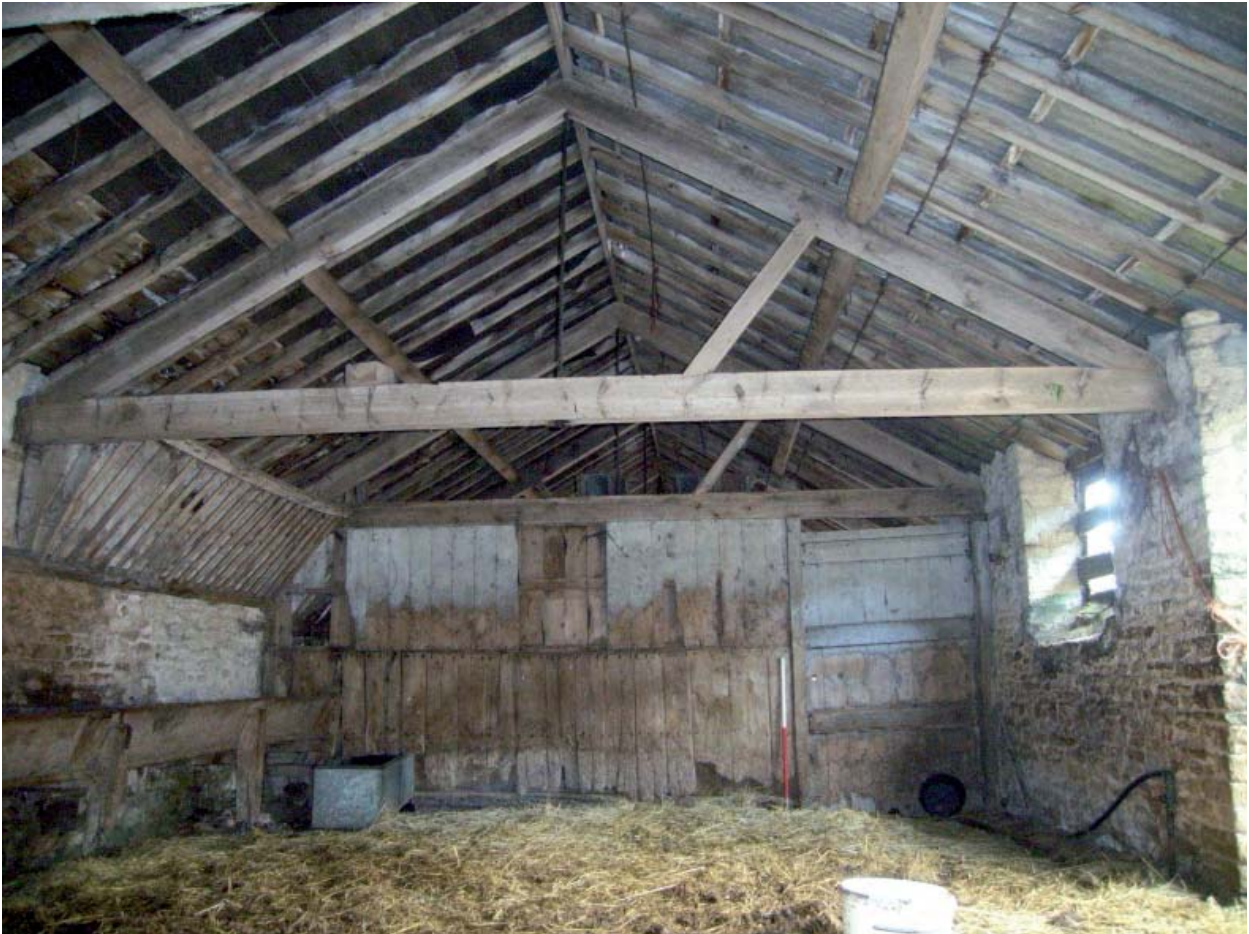
- 7.2.8 The partition wall to the tack room to the east is of coursed limestone rubble, as aforementioned, with a timber door to the northern edge.
- 7.2.9 The partition to the west consists of a timber frame clad with timber planks to tie-beam height. The planks have been worn smooth from years of contact with the horses or cows using the stable. A ledged door to tie-beam height is to the northern edge of the partition (Pl. 47).

Plate 47: Barn 5; Partition dividing the Easternmost and Central Stable/Loosebox

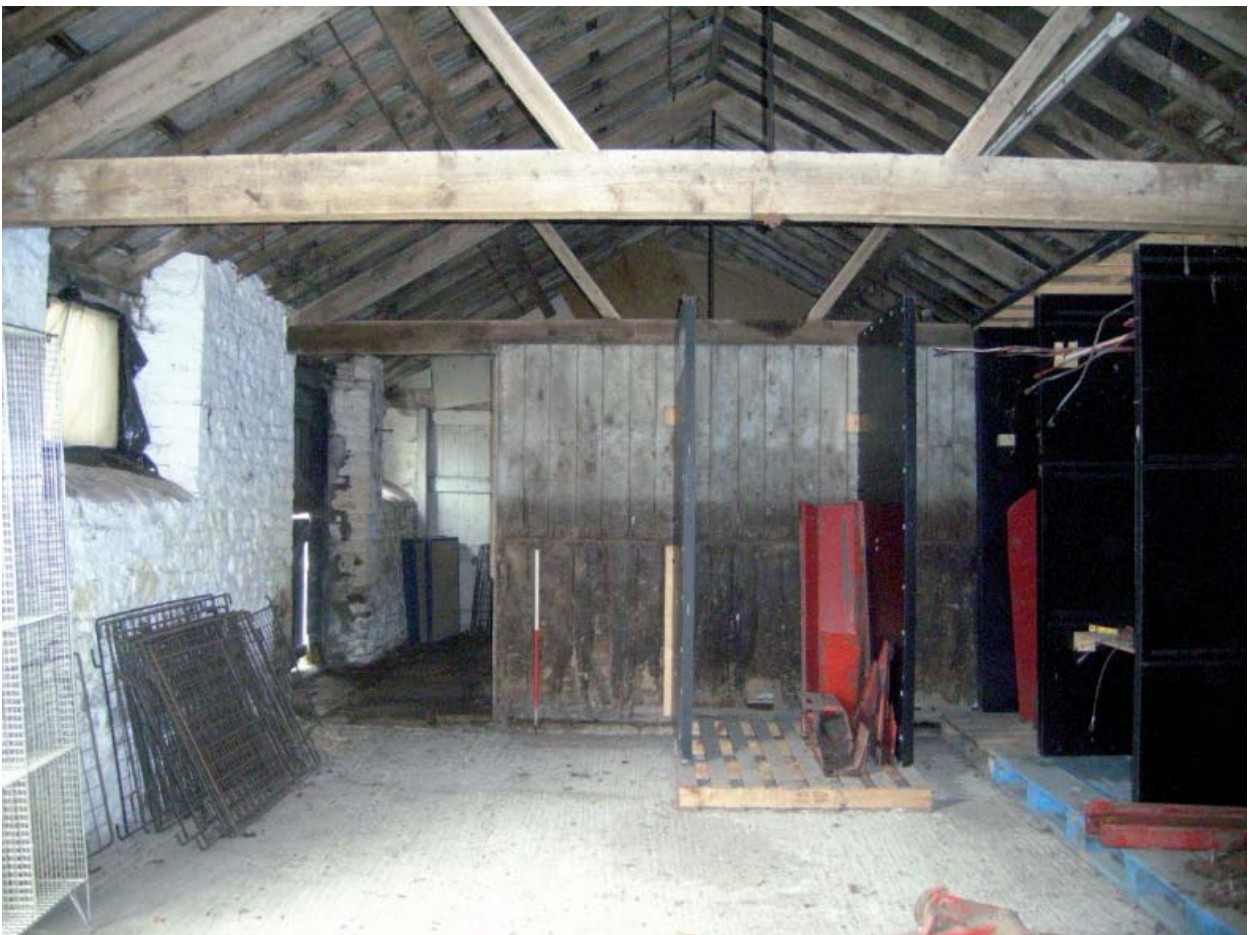
- 7.2.17 A timber partition as per the previous two partitions, albeit missing its door, divides the bay from the room to the west (Pl. 50).
- 7.2.18 The remainder of the range is currently used as a **Large Store Room** and a **Small Store Room** and is referred to as 'Barn 4' in the architect's drawings.

Plate 50: Barn 4 & 5; Partition of Store at west end of Barn 5 and Large Store of Barn 4
