Barns To the rear of The British Queen Public House, 94 High Street, Meldreth

Historic Building Recording

Barns to the rear of The British Queen Public House, 94 High Street, Meldreth

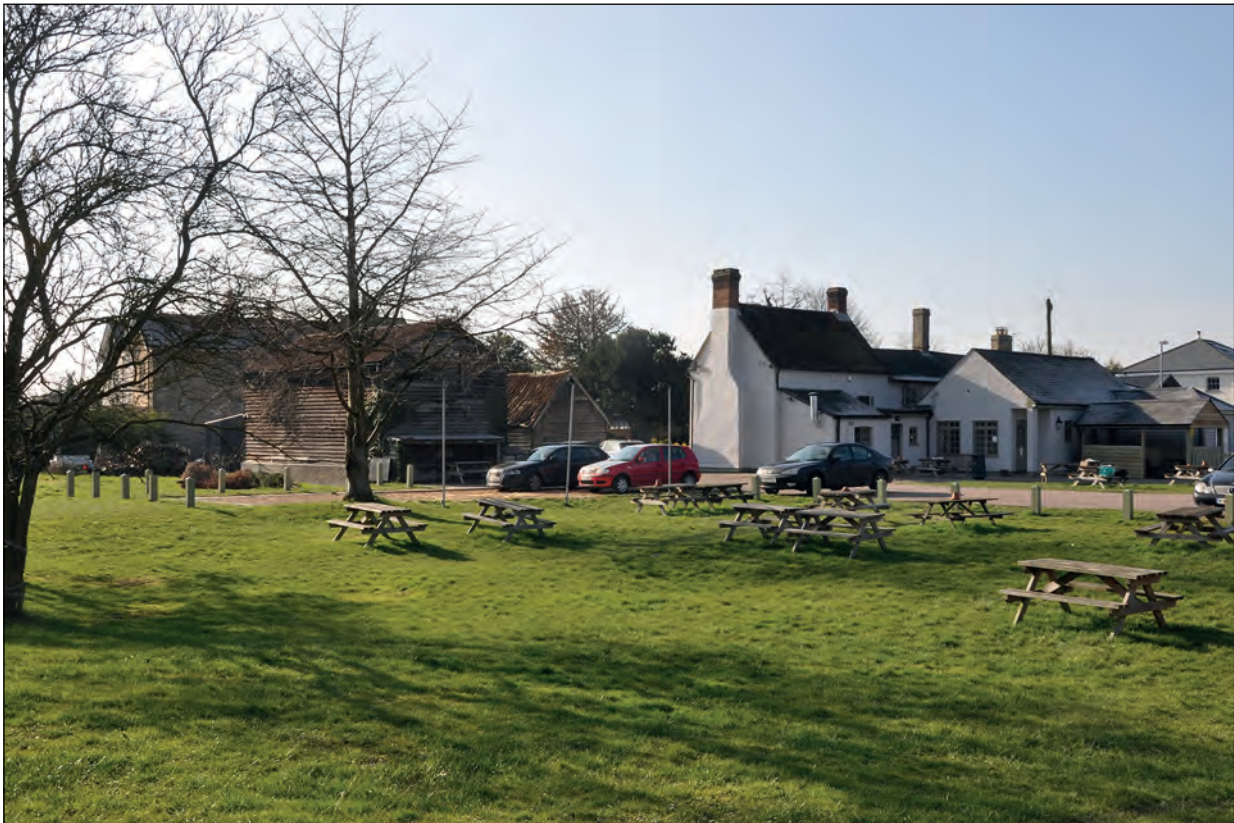
Plate 1: Barn 1 viewed from the north-west

- 4.2.8 The north facing elevation was 5.3m wide with an apex height of 5.25m. The façade was constructed from weatherboard to the apex. A small wooden access door was located off centre on the upper floor (Plate 6). This was constructed from vertical planks fixed with handmade iron nails. It measured 1.10m x 0.88m. Simple strap hinges were located on the left hand side; these were probably manufactured locally during the late 19th or early 20th century.

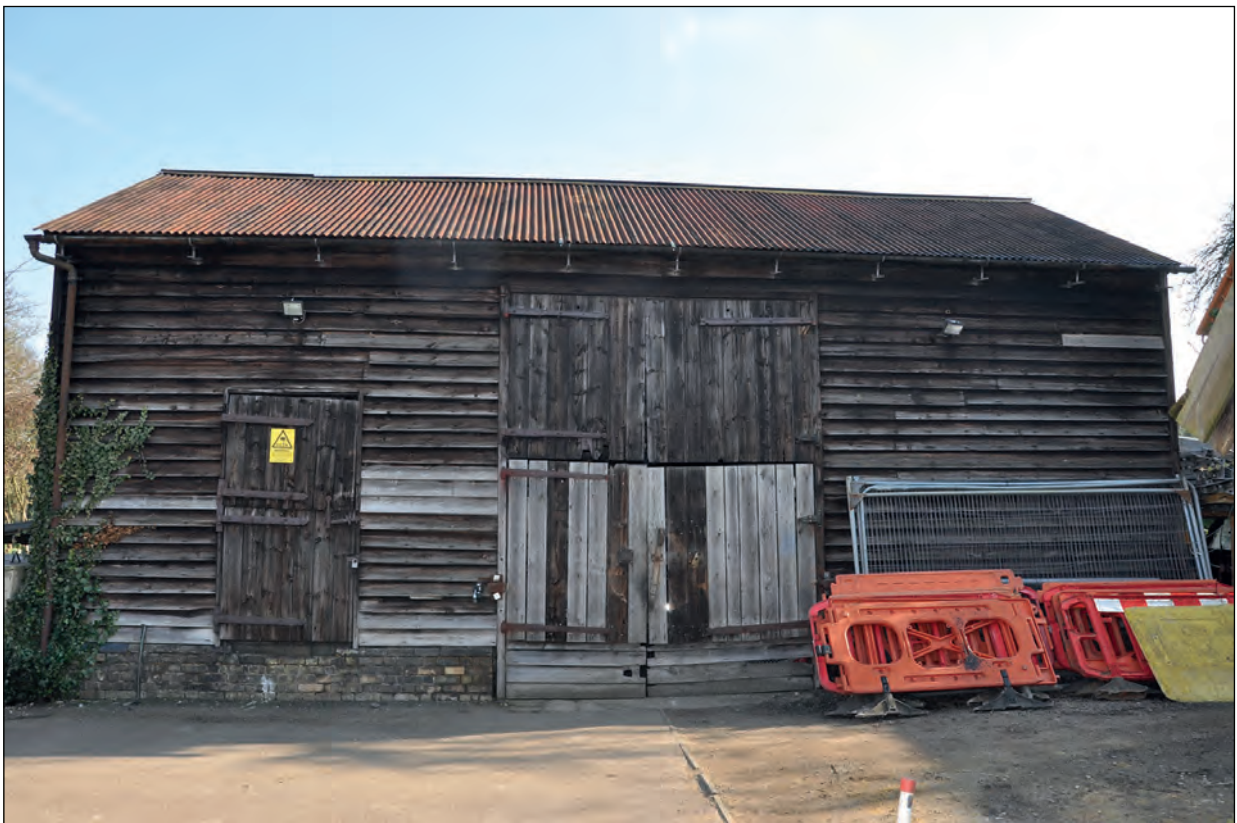
Plate 2: Barn 1 viewed from the west

- 4.2.5 The doors were fixed by iron strap hinges that were not original (Plate 2). The door latch was of a rudimentary design popular from the 18th century onwards; the example on site was of 19th or early 20th century manufacture.

- 4.2.6 A further door was located 1.6m from the northern end of the building (Plate 2). It measured 2.15m high, 1.25m wide and sat on the brick plinth. The bricks directly beneath the door were a slightly brighter colour than those to either side, which suggests that previously there was a step leading to the door. Although it was of a stable-type design, it is unlikely that this was its function as there were no internal features indicative of a horse stall.

- 4.2.12 The duo-pitched roof structure had been replaced relatively recently and was constructed from modern corrugated iron sheets (Plates 2 & 3). It is possible that the original roof covering was constructed from a similar material.
- 4.2.13 The fire that destroyed the adjacent barn in 1885 was said to have taken hold in its thatched roofing. At this time corrugated roofing was becoming popular, mainly due to a reduction in transportation costs with the advent of the railway; the proximity of the barn to Meldreth railway station would make the subject barn a likely example of such a shift in construction.

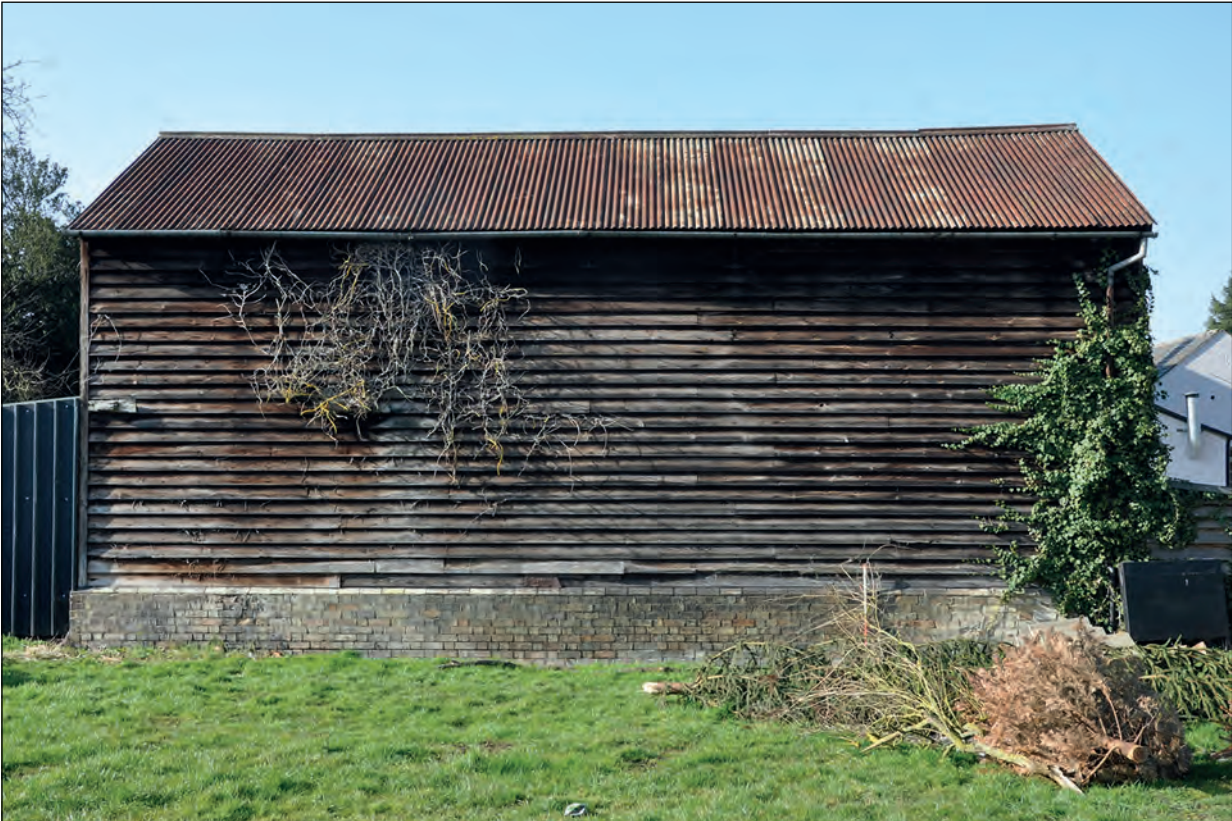
Plate 3: Barn 1 viewed from the east

- 4.2.10 The west facing elevation consisted of a weatherboard façade to an eave height of 4.47m. The wooden structure sat on a yellow brick plinth. The plinth consisted of nine courses of bricks laid in a Flemish bond (Plate 3). The plinth was capped by a stretcher course of plinth bricks (Plate 7). This elevation had no doors or windows.

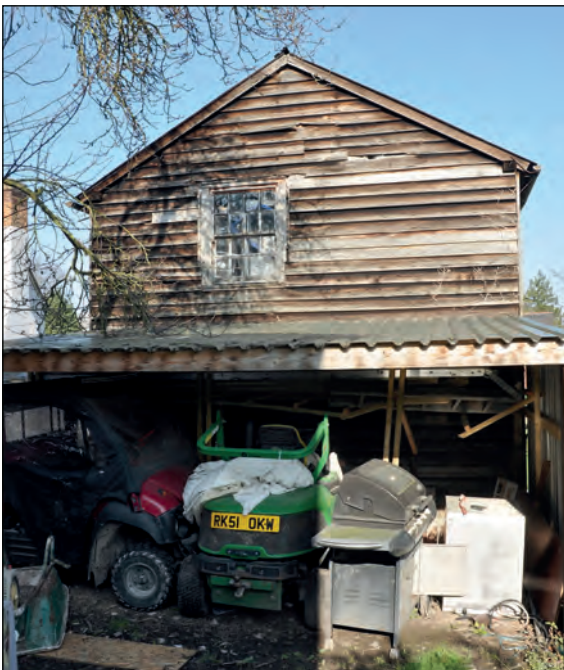
Plate 4: Barn 1 viewed from the south

- 4.2.11 The north facing elevation was 5.3m wide with a height to the apex of 5.25m (Plate 4). It was weatherboarded to apex height. A small sash window measuring 1.10m x 0.88m was located off centre. It was constructed of wood and had eight upper and eight lower panes. The window is thought to be an original feature.

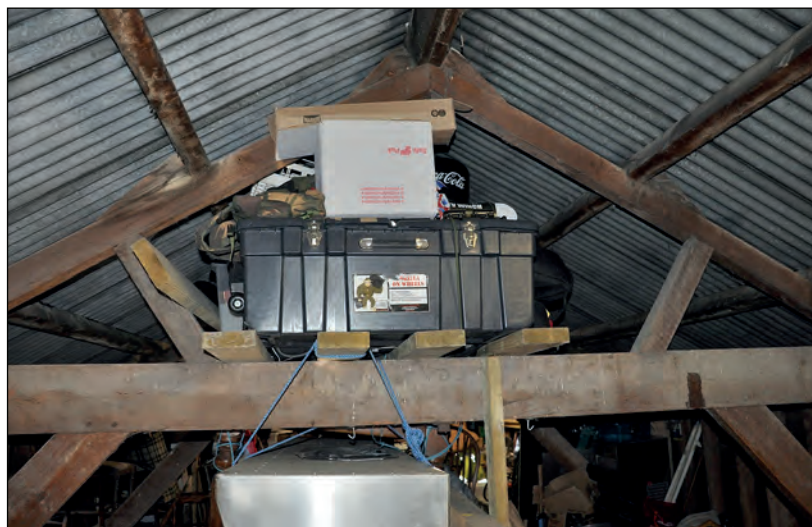
Plate 14: Detail of roof truss

- 4.2.18 Purlins and common rafters were also constructed from machine cut timbers. The modern corrugated roofing material was adhered to these (Plate 14).

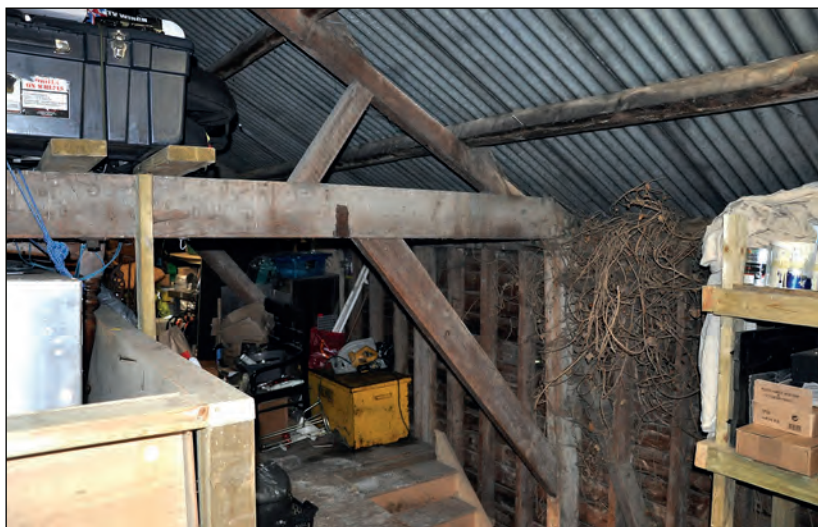
Plate 16: Roof truss and modern roof. Viewed internally

- 4.2.16 The timber frame was constructed from machine cut timbers with the weatherboard nailed straight onto the wall frame (Plate 16). Parts of the wall plate had been replaced.

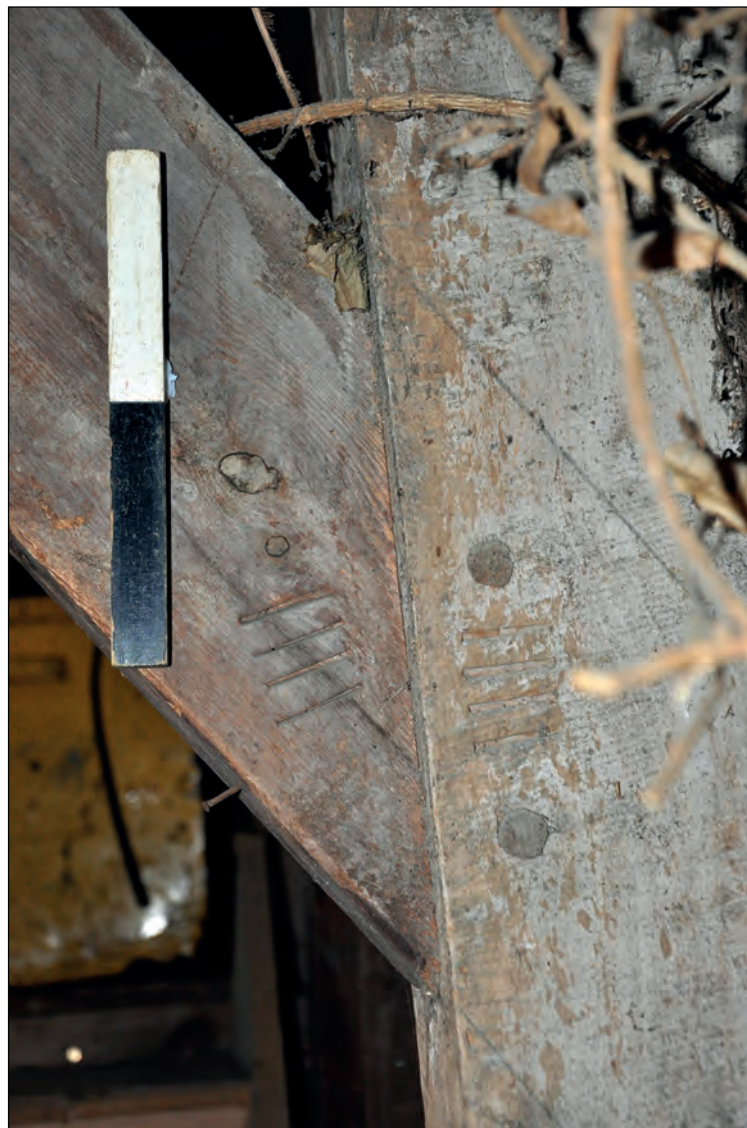
Plate 17: Details of carpenters marks to roof truss viewed from the south

- 4.2.17 The roof structure consisted of two queen post trusses (Plate 18) constructed from machine cut timbers. Carpenter's marks – four vertical lines - (Plate 17) were noted on one of the straight up braces, these corresponded with marks located on the main post.

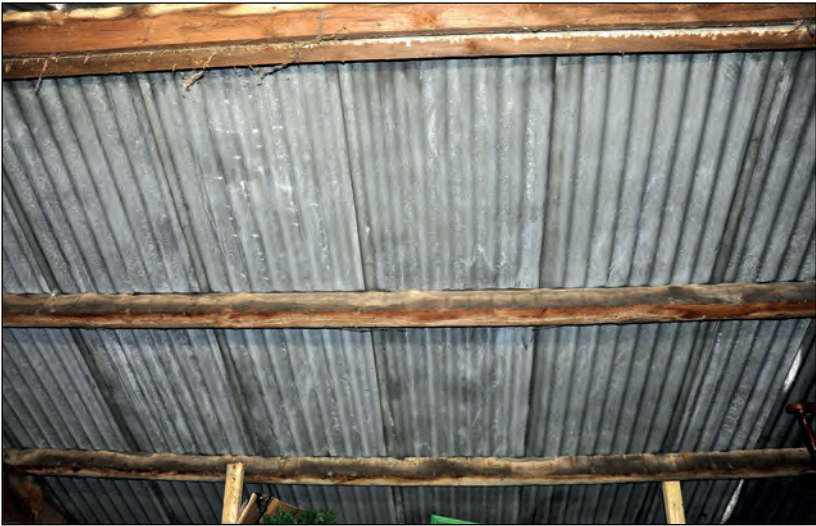
Plate 18: Modern roofing material viewed internally from the east

- 4.2.19 A small box was located at the northern end of the building just below the apex. This was crudely constructed of wood (Plate 18). It was thought that this may have been a pigeon or dove box, although no external entrance could be seen; it may be that an opening was covered when the weatherboard on the north facing elevation was replaced. Alternatively, it may be that this box was used by nesting Barn Owls.

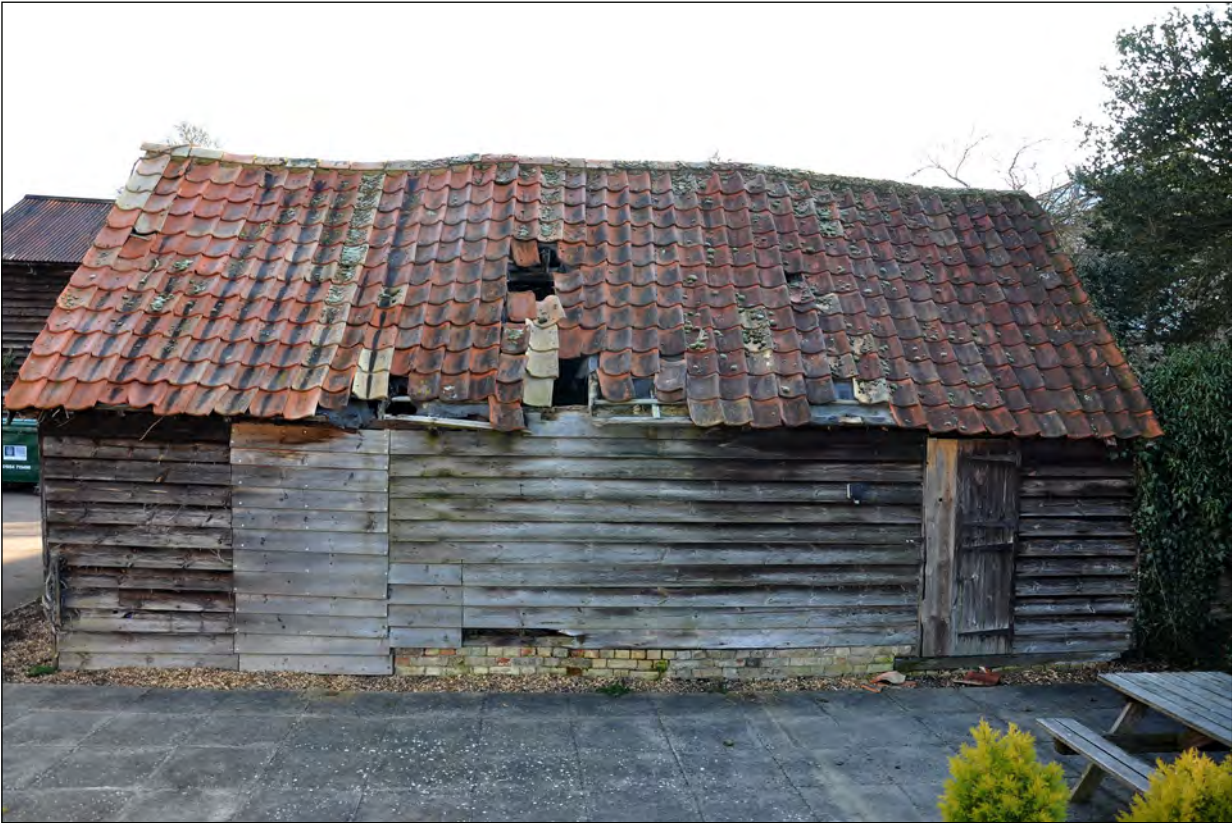
Plate 19: Barn 2 viewed from the west

- 4.3.8 It was divided into three bays; the northern and southern bays were accessed from the western elevation (Plate 19), the central bay from the east (Plate 21). The divisions were constructed from weatherboard adhered to machine cut timbers that were either replacements or added sometime after the initial construction (Plate 27). A door had also been added internally to link the northern and central bays.

- 4.3.10 The roof structure comprised machine cut common rafters in a poor state of repair (Plate 28). The roof was covered externally in pan tiles that would also have been re-used (Plate 19).

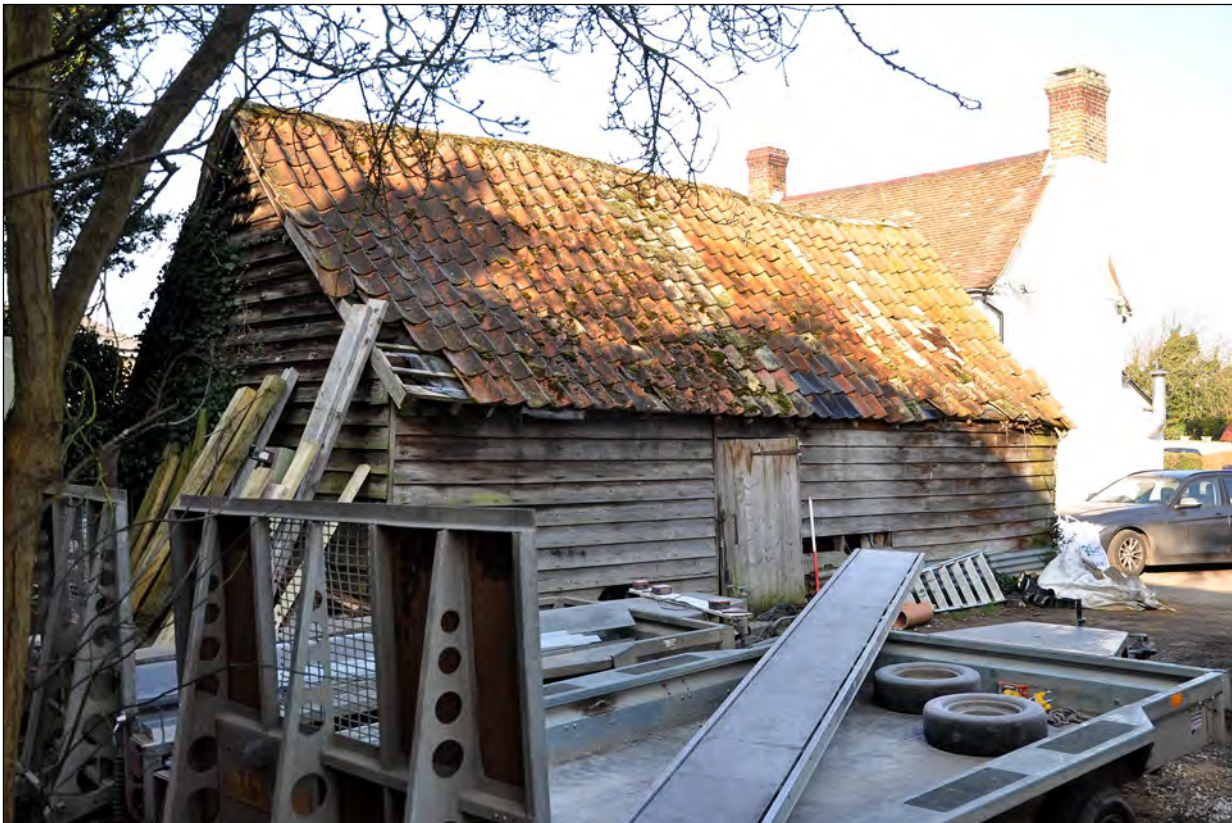
Plate 20: Barn 2 viewed from the south-east

- 4.3.4 The west facing elevation differed only in that it included a single, centrally located door measuring 1.75m x 0.9m (Plate 20), with locally produced door furniture (Plate 25).

- 4.3.6 The north facing elevation had no windows or doors and was also constructed from weatherboard to the height of the apex. The uppermost part of the barn had deteriorated to the point where vines were growing through the structure (Plate 20).

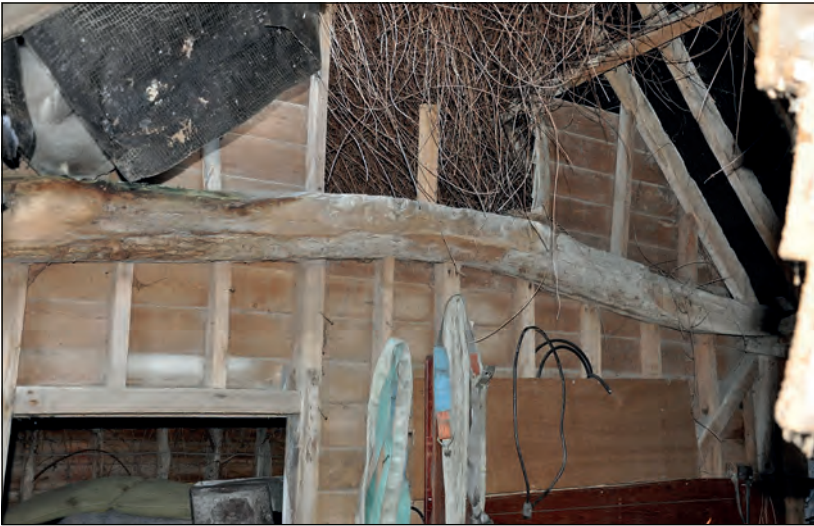
Plate 27: North end of barn internal

- 4.3.9 Earlier, or more likely re-used, timbers could also be seen in the central bay (Plates 27 & 29). Both tie beam (Plate 27) and a brace (Plate 29) were hand cut timbers.
