# Torre Abbey Phase II Evaluation

## Archaeological Evaluation Report

August 2011

OA Job No: 5041

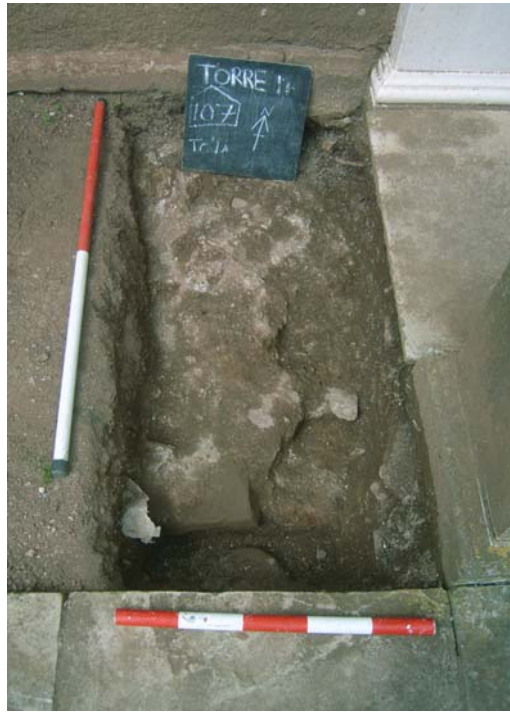
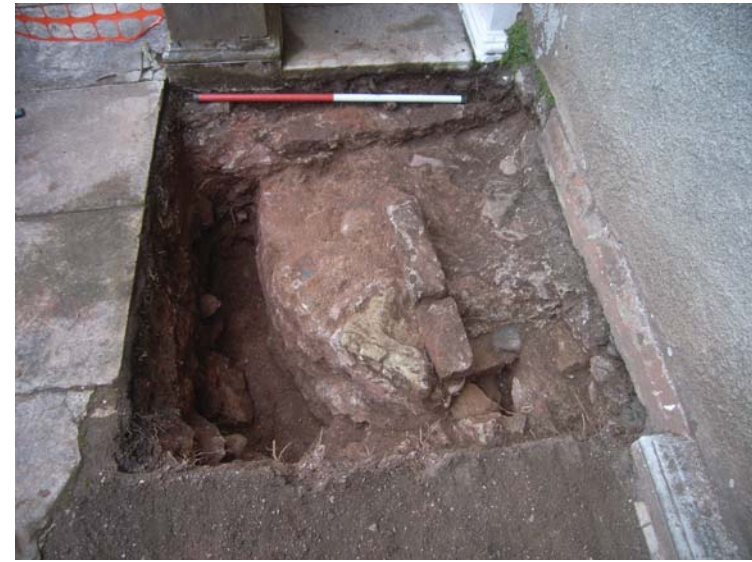
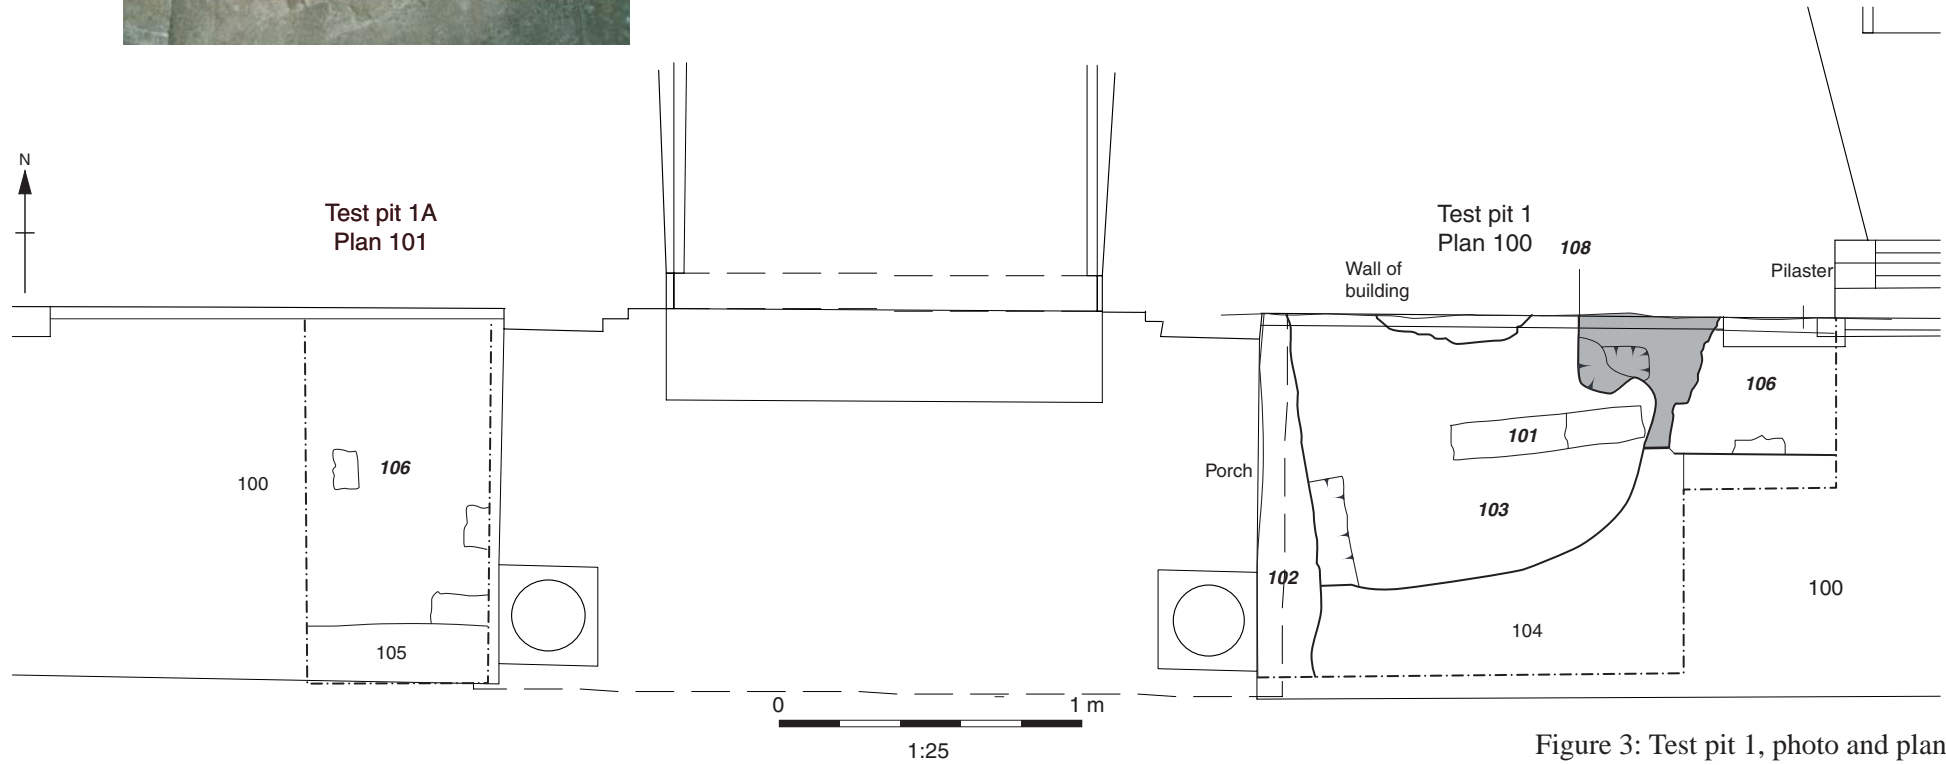
- 3.2.1 Test Pit 1 (Fig. 3) was excavated to the east of the porch of the South Range. The trench was initially excavated to 1.4m x 1.2m. The northern half of the trench was subsequently extended eastwards by 0.5m.

- 3.2.2 The test pit revealed an east-west aligned wall footing (106) and a hemispherical structure (103). The relationship between the two was obscured by later disturbance (108) and it is possible that the two structures are contemporary. Early 20<sup>th</sup> century photographs show vegetation growing up the south facade of the South Range and it is likely that this is the origin of the disturbance.

- 3.2.3 Both structures were butted by the rubble rich deposit (104/105) which forms the make-up for the mid 18<sup>th</sup> century terrace. The pillar bases of the porch structure rested on a single course of stone (102), although where the base of the southernmost pillar extended beyond the southern face of structure 103, the stone course overlay deposit 104.

Figure 3: Test pit 1, photo and plan

5.4.2 Whilst these interpretations are far from conclusive, the apparent instability of the existing porch is almost certainly a result of the fact that the southernmost set of pillar bases are only partially resting on the solid block of masonry that is Structure 103/107, whilst the remainder overhangs the looser terrace deposits to the south.

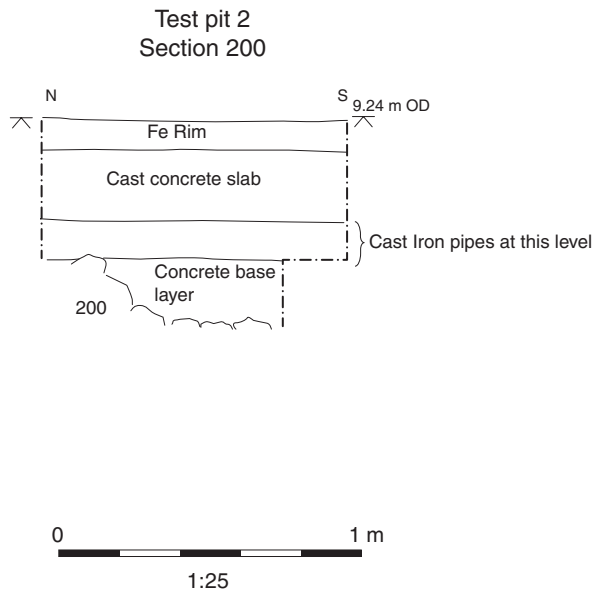
- 3.2.5 Test Pit 2 (Fig. 4) was excavated within the former toilet block in the South-East Wing. As the inspection chamber proved to have been set into a concrete slab over a weak mix base layer (into which cast iron pipe work had been set), the concrete was broken out within the chamber to reveal a layer of stone beneath (200), the top of which was at approximately 8.70m OD. No further excavation was possible within the confines of the inspection chamber.

Figure 4: Test pit 2, section

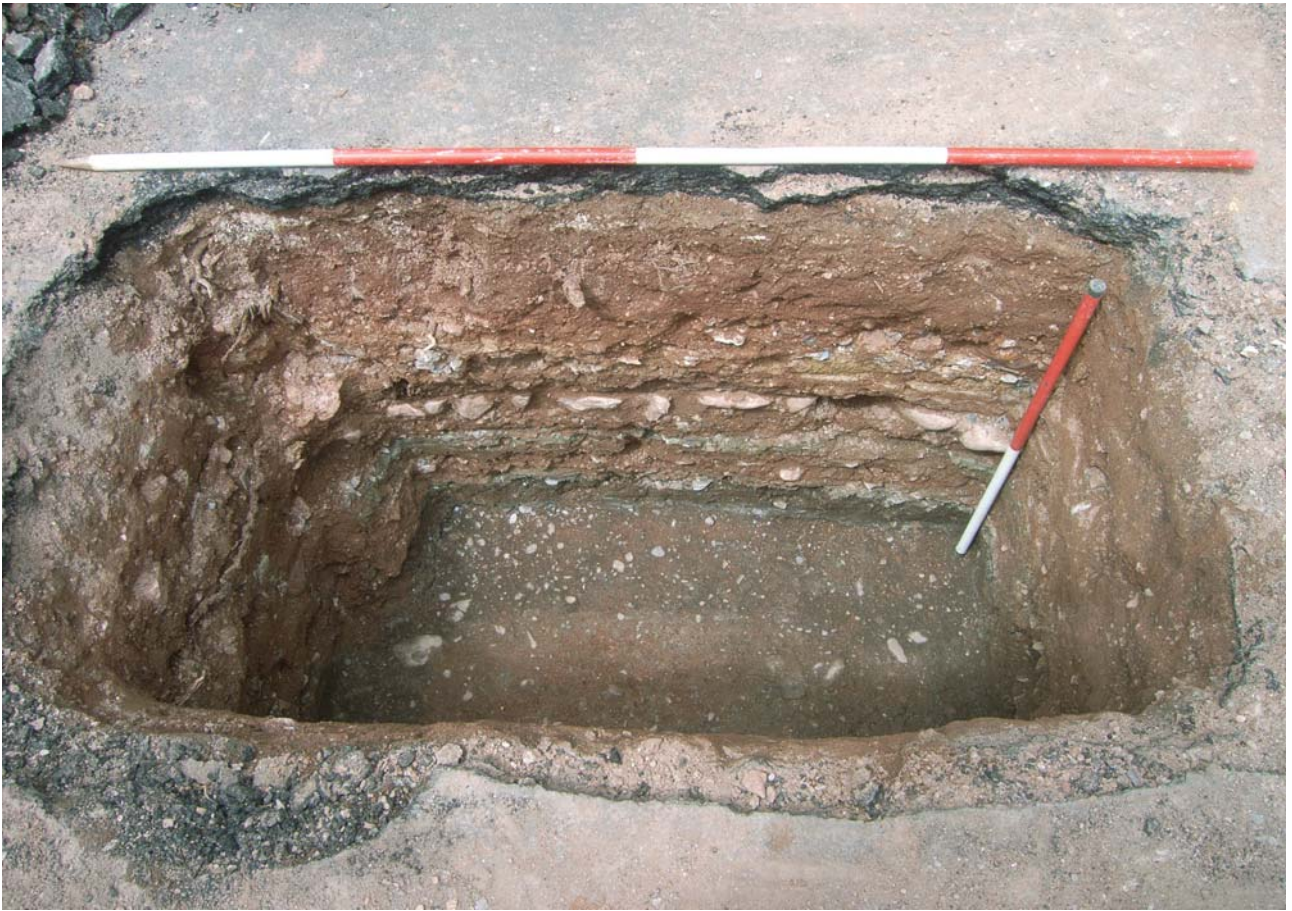
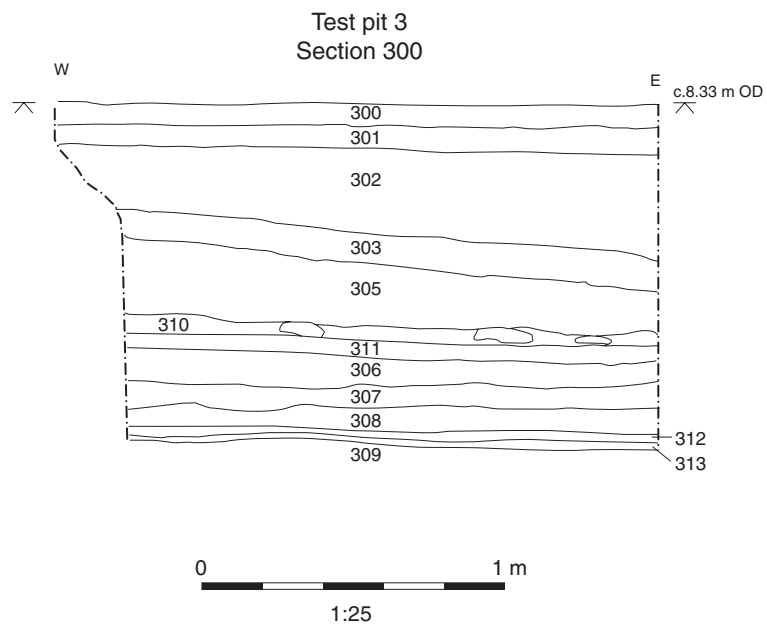
- 3.2.6 Test Pit 3 (Fig. 5) was excavated to the south of the South-East Wing and measured 2m x 1m (aligned east-west). The majority of the excavated material comprised the backfill (301, 302) of a redundant service trench (304), aligned east to west, which contained a broken ceramic pipe. The service trench had truncated a sequence of deposits visible in the south-facing section.
- 3.2.7 The earliest deposit was a very well-compacted metallised surface (309) c1.10m below present ground level (7.22m OD), which was overlain by a 0.05m thick dark brownish grey clay silt layer (313). Above this was a series of later surfaces or compacted layers (312, 307, 311). These were very similar to each other in composition, consisting

largely of crushed and compacted slate. The top of the earliest of these (312) was at 7.28m OD and was overlain by a dark grey brown clay silt (308). The remaining two slate surfaces (307 and 311) were encountered at 7.33m OD and 7.53m OD respectively, and were separated by a layer of reddish brown silty clay containing stone rubble (306).

- 3.2.8 A cobbled surface set in a reddish brown silty clay (310) was encountered at 7.57m OD, and directly overlay layer 311. This was in turn overlain by a further layer (305) of reddish brown clay silt with stone rubble throughout. A layer of lime mortar (303) overlay layer 305 and may have represented a bedding layer for a subsequently truncated surface. The top of the mortar deposit was at c7.83m OD. The remaining deposits within the trench were either fills of the service trench or modern levelling deposits for the tarmac surface (300).

Figure 5: Test pit 3, photo and section

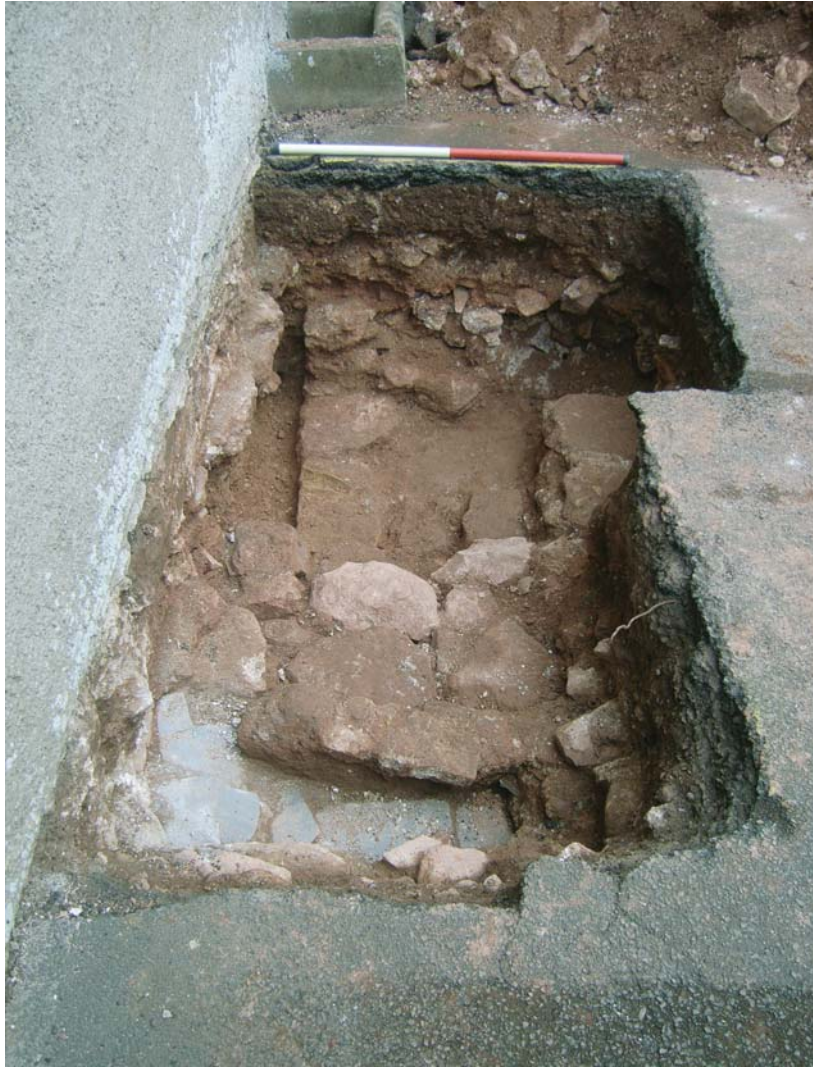
- 3.2.9 Test Pit 4 (Fig. 6) was excavated to the east of the South-East Wing and originally measured 2m x 1m (aligned north-south), although the northern 1m was subsequently extended c.0.2m. A north-south aligned wall footing (404) was encountered at 7.75m OD with a stone-lined and capped drain (410) running along its eastern face and apparently contemporary with it. To the west of the wall, at 7.62m OD, was a very compacted horizon (415) which may represent a surface, although this was only seen in the north-west corner of the trench, so any interpretation is necessarily tentative.

- 3.2.10 Truncating the wall, drain and possible surface was an east-west aligned wall footing (414). A stone-lined, slate-based drain (402) ran along its southern edge and appeared to post-date it. Indeed, this drain may be contemporary with the construction of the extant South-East Wing (see Fig. 6 section 400). The footings (412) of the standing eastern wall (408) of the South-East Wing were constructed primarily over a foundation of loose stone rubble (407), except where they directly overlay wall 414. A sherd of pottery, a fragment of bottle glass and a fragment of plaster were recovered from layer 407. Although none of these finds are particularly closely dated, all are consistent with the mid-18th century construction date of the South-East wing.

- 3.2.11 At the point where wall 408 overlay the earlier footing (414), a brick repair had also been inserted (413).
- 3.2.12 The earlier wall and drain (404 and 410) were also truncated at the northern end of the trench by a cut which forms part of a service trench running from the drainage gully which lies immediately to the north of the trench. The remaining deposits in the trench consisted of a levelling deposit for the tarmac surface.

Figure 6: Test pit 4, photo and plan

- 5.7.3 The possible medieval wall (404) was quite clearly truncated by east-west wall 414, which in turn appeared to be overlain by drain 402 and the foundation (412) of the standing wall of the South-East Wing (408). Drain 402 may be contemporary with the construction of the South-East Wing.

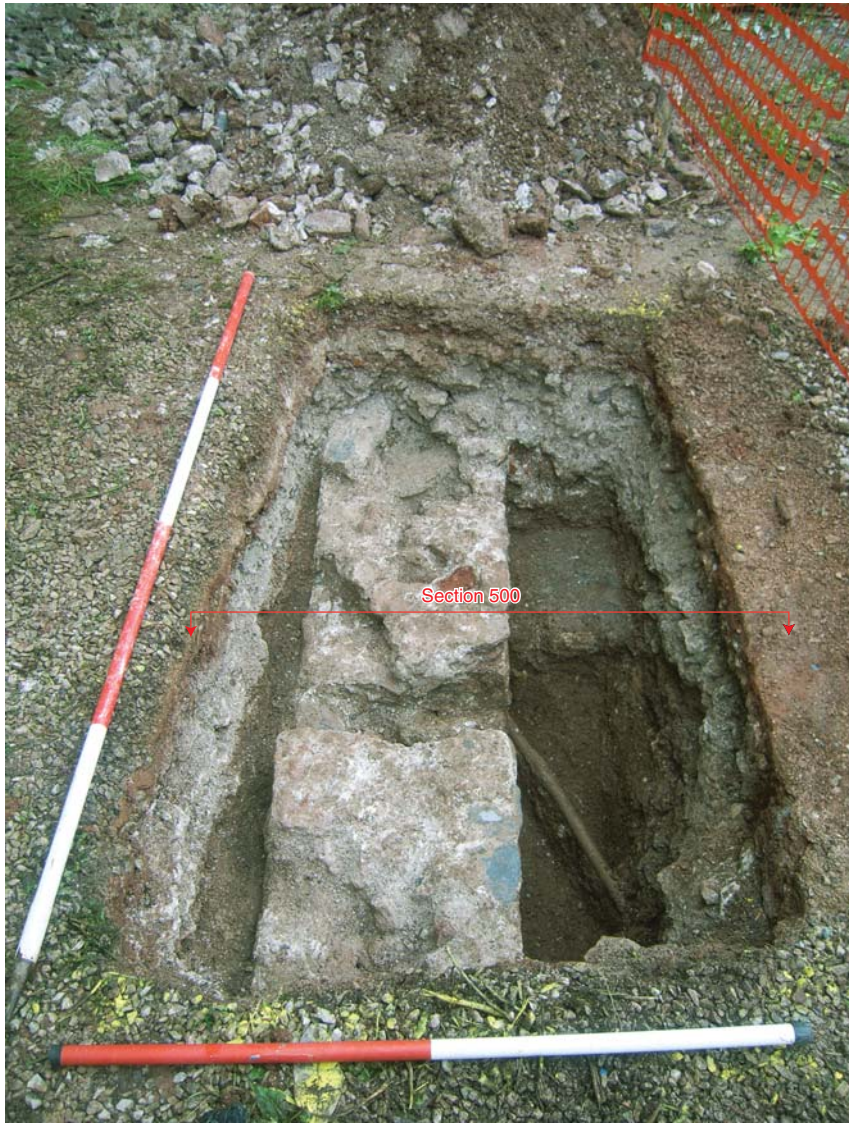
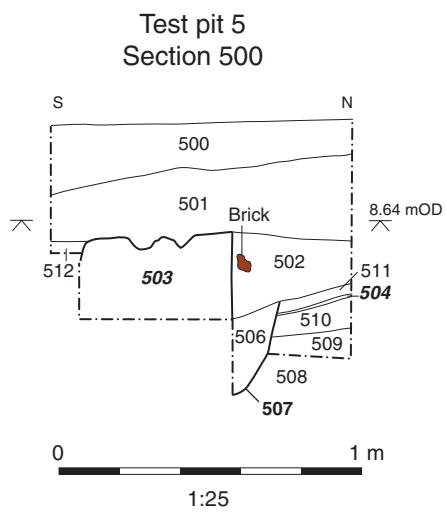
- 3.2.13 Test Pit 5 (Fig. 7) was excavated within the courtyard to the north of the South-East Wing, and measured 2m x 1m (aligned east-west). The earliest deposits encountered were a mid red-brown silty clay with stone throughout (508) overlain by a 0.10m thick, very mixed deposit (509). Overlying 509 was a mortar-rich layer (510) which was overlain in turn by a layer of crushed and compacted slate (504), similar to those seen in Test Pit 3. The top of layer 504 was at 8.04m OD, and was overlain by a further deposit of reddish brown clay silt (511), which may represent the remnant of a later levelling layer.
- 3.2.14 All these deposits were truncated by a north-east/south-west aligned cut (507) for a lead pipe, which was overlain by an east-west aligned stone wall footing (503) at 0.36m

below ground level (8.60m OD). The wall footing was 0.30m deep and was butted by a mixed deposit (502) of uncertain origin. The wall and the mixed deposit were overlain by a layer (501), perhaps associated with the demolition of wall 503. Layer 501 was in turn overlain by compacted stone rich material which forms the existing courtyard surface (500).

Figure 7: Test pit 5, photo and section

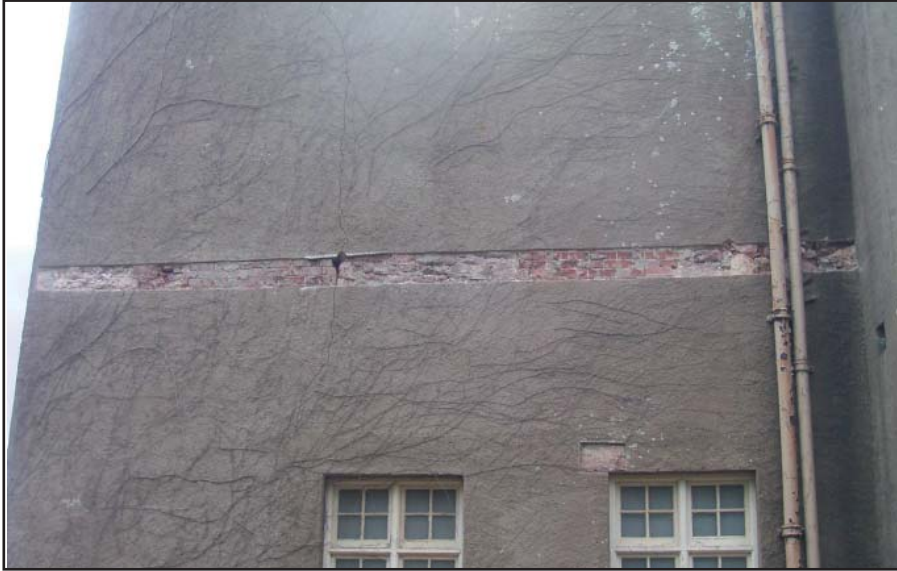
- 3.3.1 In the *east external wall* of the South-East Wing (Area 1) the removal of render at a high level has revealed the primary phase stone construction of this extension. There are two large patches of infill using a red/brown coloured brick in what appears to be a varying Flemish bond. These areas of infill show us the location of former windows. Patch removal of render below the first-floor level reveals further brick infill associated with early ground-floor windows. The brick infill is not bonded into the stonework resulting in the extensive cracking through structural failure seen on this elevation.

Plate 1: Area 1 opening up on east elevation of south east wing

- 5.7.5 The removal of a 400mm strip of render from the east facing elevation of wall 408 revealed the eastern and western limits of the first floor Gothick windows blocked in 1801 during works to the ballroom. As the foundation of footing 412 was predominantly rubble to the north of wall 414, the fact that the northern limit of the window corresponds with both the northern face of 414 and the northern edge of the brick “repair” to footing 412 (413), is almost certainly the cause of the crack visible on the east elevation of the standing wall. It may also suggest that the east-west aligned structures in Test Pit 4 are related to the 18<sup>th</sup>-19<sup>th</sup> century alterations, and are inserted into wall 408 rather than overlain by it. The removal of the remaining render during the Phase II works should go some way to resolving these anomalies.

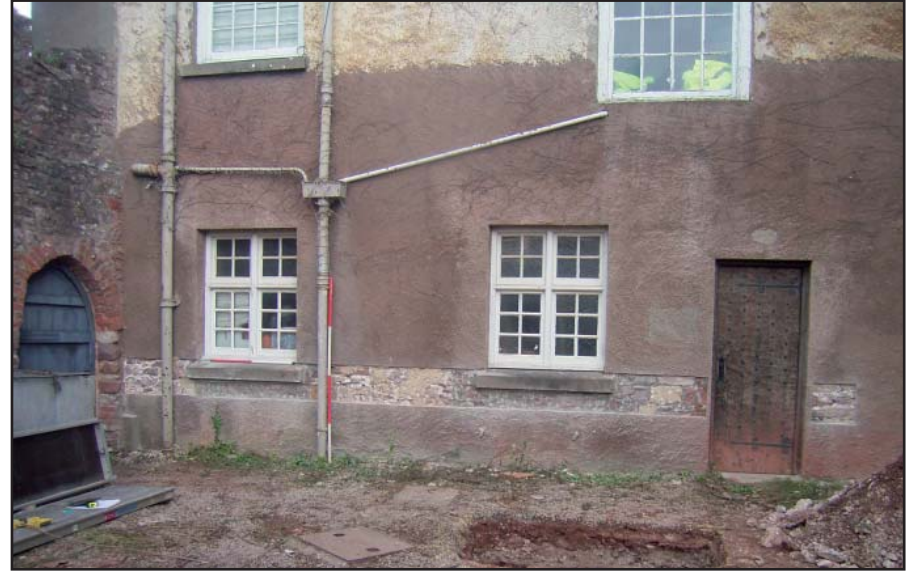
- 3.3.2 On the *north external wall* of the South-East Wing (Area 2) the removal of the hard concrete modern render revealed a mix of primary phase stonework and later brickwork. Adjacent to the eastern window a stone jamb one side and a brick jamb the other side. The western window has brick jambs continuing downwards either side of the window. The bricks measure 225 x 110 x 68mm and are red/orange coloured with sharp arrises, they are laid in alternating pairs of headers and stretchers. The mortar associated with the bricks was unseen as large patches of the removed render covered the joints. The easternmost window is clearly sited at the location of a former opening which was later widened and the western window is located at the site of a former doorway, later blocked and a window inserted. The windows themselves have wooden frames and cross transom and are divided into 4 or 6 lights. The sills are of 20th-century stonework, and plain in style. Removal of mortar beside the doorway revealed the eastern jamb to be brick and the western jamb to be of stone. The style and type of brickwork is the same as seen adjacent to the windows. The stone jamb is earlier in date, and probably of the primary phase (18th century).

Plate 2: Area 2 opening up on north elevation of south east wing

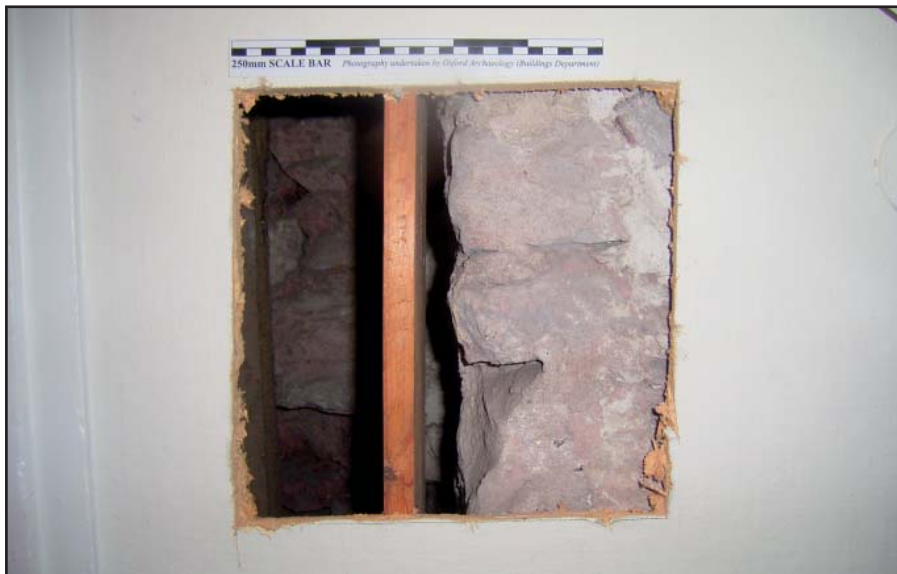
- 3.3.3 Two areas of plaster were removed, on either side of the existing door opening where the intended lift platform would be located.
- 3.3.4 On the south side a section of boarding c.300mm square was removed beneath the existing handrail. This revealed a substantial stone wall c.30mm from the current wall face with a deep offset return on the outer (east) side approximately 300mm from the current edge and 620mm deep. There are traces of horsehair plaster on the stonework within this void. The current walling at the south eastern corner of the reveal is constructed with timber uprights and within the adjacent room (G3) lath and plaster. The base of the void is covered with debris and there is some rubble stonework. The interior stone of the wall within the door reveal is fairly smooth suggesting this opening was part of the early construction of the South Range. The stonework has traces of limewash indicating it was previously exposed.

Plate 4: Area 3 opening up - southern reveal of doorway

- 5.9.4 The return seen in the stonework on the southern door reveal is probably part of the 18th-century construction of the wing joining onto the medieval fabric of the South Range. On the northern reveal the stonework is clearly part of the medieval monastic build. The brick infill on the east wall of the adjoining room observed during the works is of interest and appears to be a blocked in fireplace, although not centrally located within the internal elevation as expected. The report produced by Keystone for Torre Abbey in 2003 suggests that this wall had a 'hiding hole' as reported in *Hiding Places* (Squires 1933, 249) until the 1930s and the appearance of the brickwork would suggest the early 20th century date for the work. The presence of limewash on the stone faces of both reveals suggest that the stonework was previously exposed, but does not necessarily show that they represent a medieval opening.

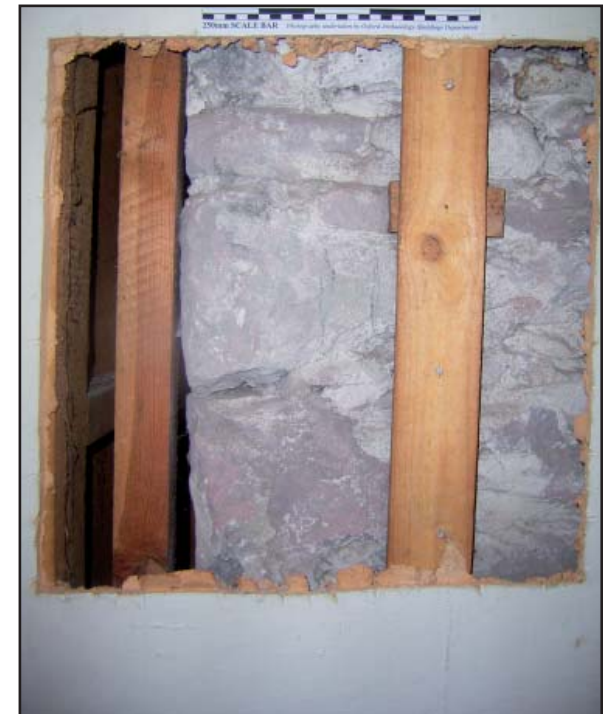
- 3.3.5 On the north side a section of boarding c.500mm square was removed adjacent to the north west corner of the opening. This revealed a further stone surface as seen on the south wall, this again the surface had traces of limewash suggesting it was previously exposed. Unlike the south wall, the stone wall continues to the corner of the reveal and reflects the modern boarding at this point.

- 3.3.6 Both areas of stonework are probably datable to the 13th century, though the former opening here is not necessarily a primary one. A small amount of the wall in the adjacent gallery room (G2A) can be seen between the boarding and the stone surface. This wall has a large area of brick blocking in on the lower section. The bricks are orangey red coloured and laid in an English bond with thick grey coloured mortar. Access to this infilled section was limited and therefore no detailed description of the brickwork and mortar at this point could be taken.

Plate 4: Area 3 opening up - northern reveal of doorway
