**Elizabeth Gaskell  
Building,  
Hathersage Road,  
Manchester**

**Archaeological  
Building Investigation**

**Nuffield Health**

Issue No: 2015-16/1643

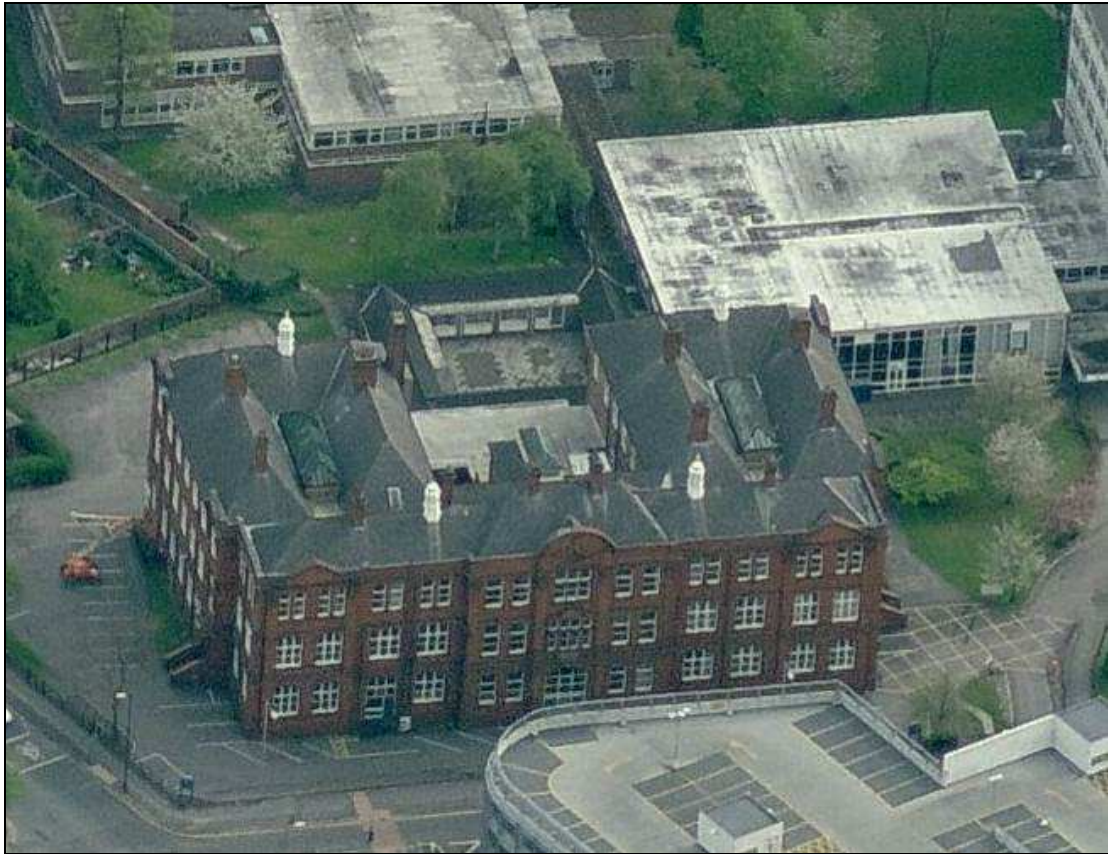
*Plate 1: Recent aerial view across the Elizabeth Gaskell Building, facing south*

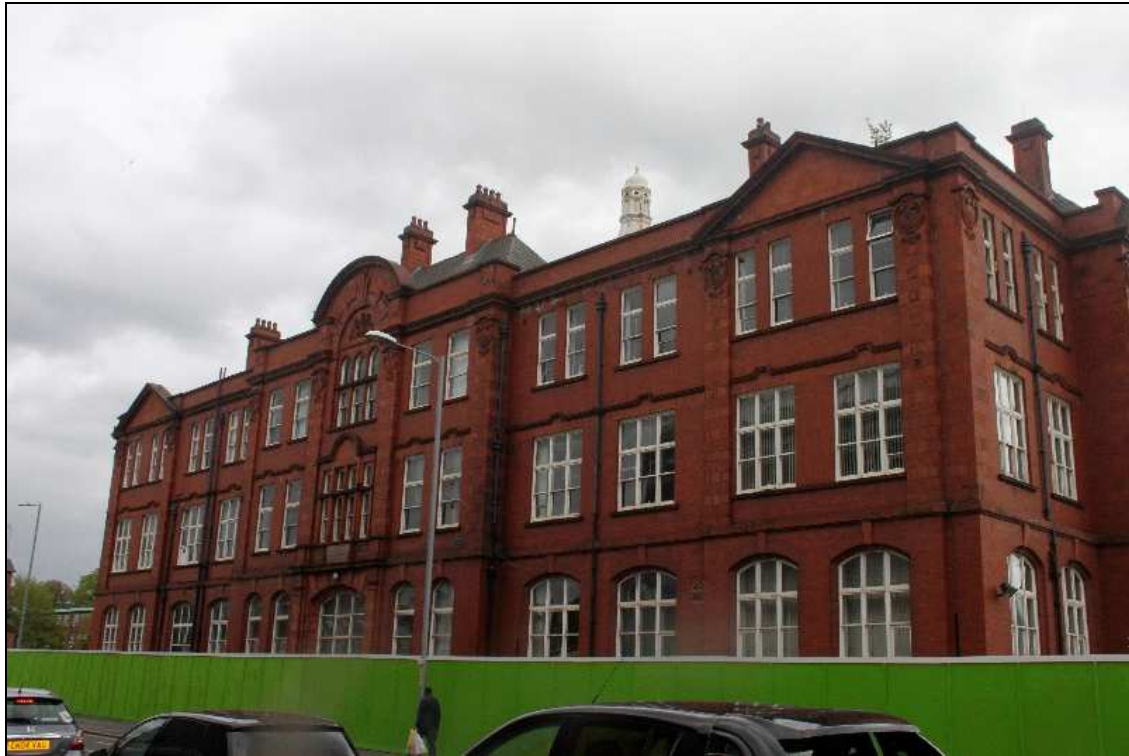
- 4.3.1 **Main Northern Range, Northern Elevation:** the northern elevation was divided visually as well as structurally into three storeys, with a shallow plinth at the base and moulded string courses at first-floor height and again at second-floor height (Plate 2). The elevation had 13 bays to each floor, each typically fitted with a rectangular window. The five central bays and two bays at either end projected forward from the face of the wall, creating further vertical divisions, enhanced at either end by shallow projecting pilasters, each with a cartouche at the head (Plate 3). The pre-eminence of the central bay was then underlined by its own flanking pilasters, which terminated at the head of the wall in a semicircular pediment (Plate 4). Similarly the elevations eastern and western two end bays were topped by triangular pediments and a parapet above the remaining bays linked each of the pediments.

- 4.3.7 A brick chimney stack projected from the ridge of the roof either side of the central bay with another at either end of the roof. Between the end chimneys and the central bay a small white cupola had been erected, probably as a ventilation measure (Plates 2 and 8).

Plate 2: Northern elevation of Main Range

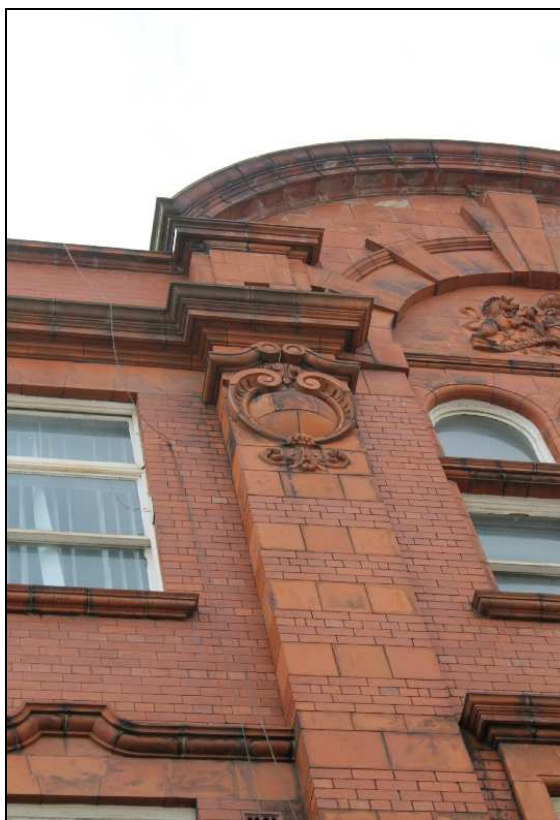
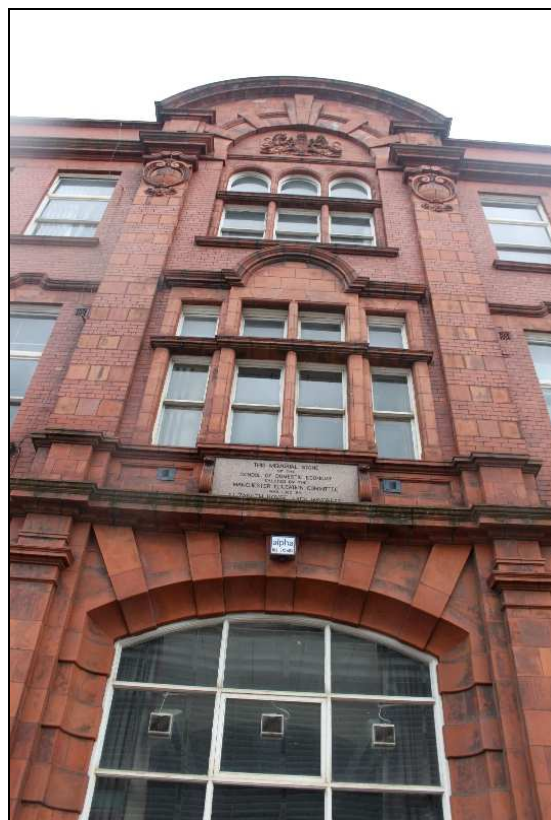
Plates 3 and 4: Cartouche at the head of a pilaster, with central bay to right

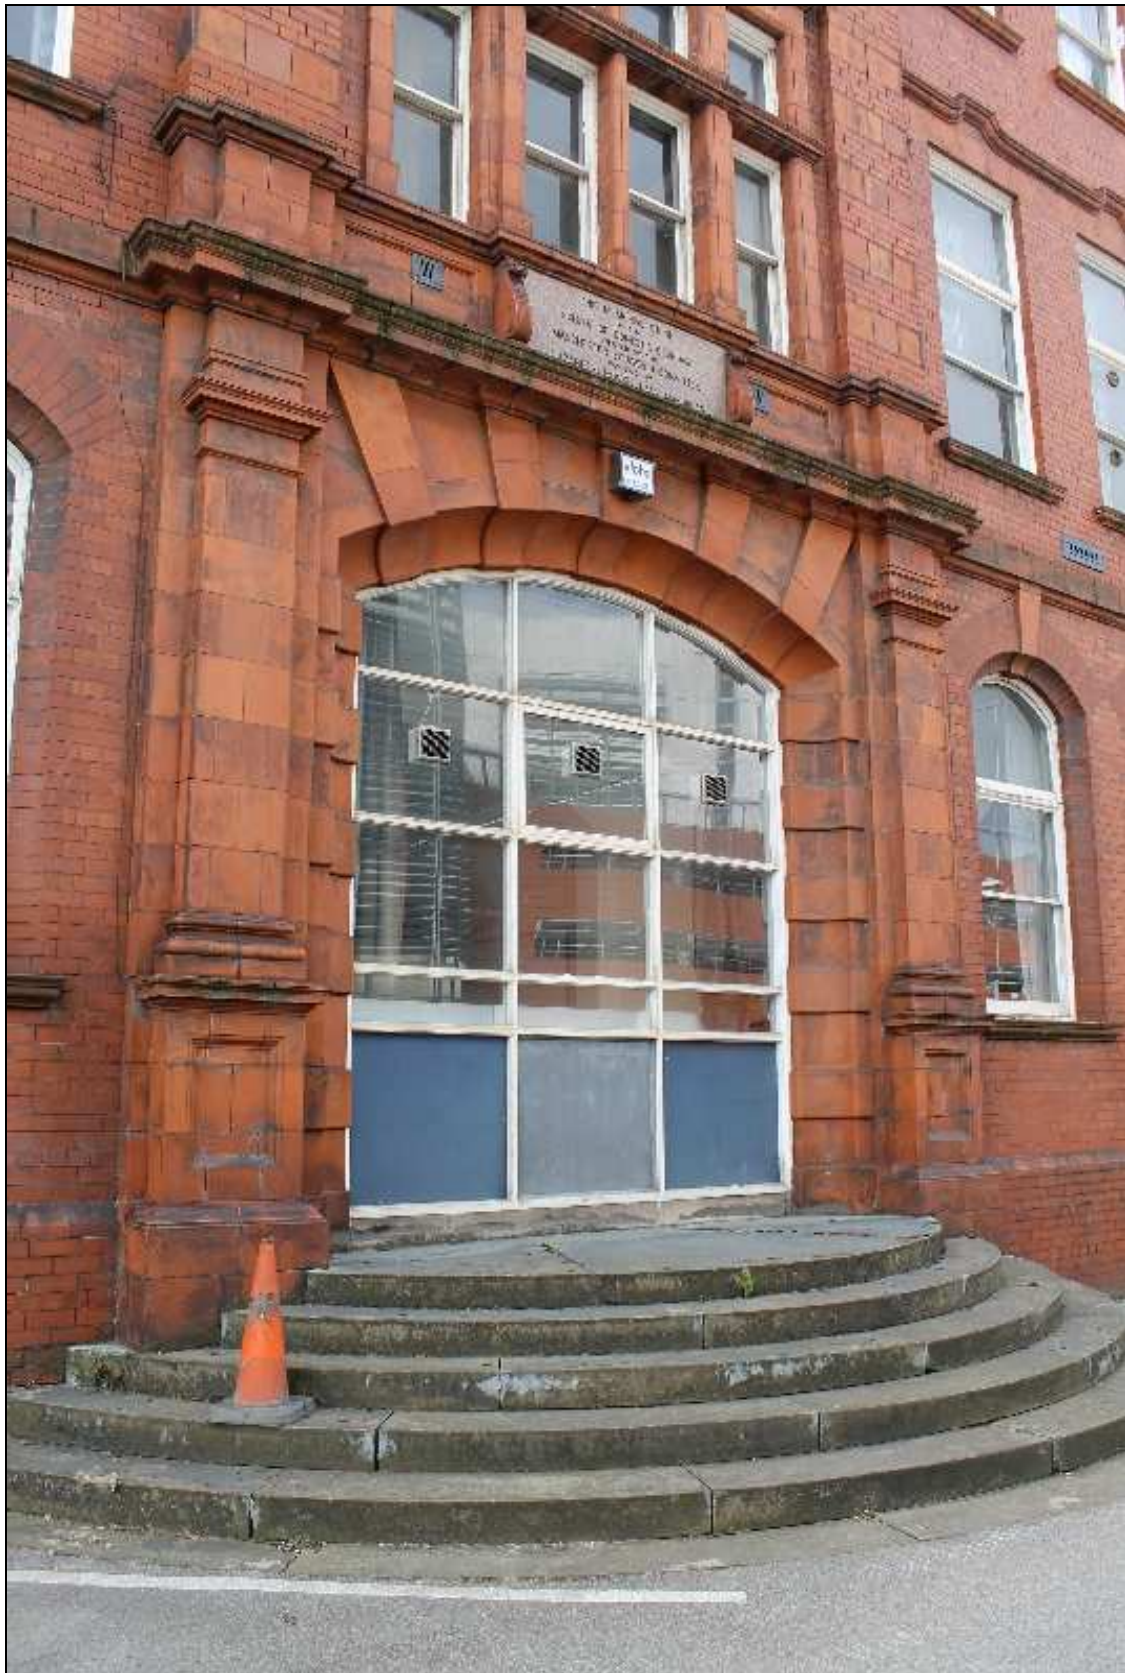
- 4.3.2 At ground-floor level the central bay included what had originally been a large entrance accessed via a set of stone steps constructed on a semicircular plan (Plate 5). The doorway had been glazed and converted into a 12-light window set in timber frames, but it retained its original terracotta pilaster surrounds, incorporating panelled bases and simple capitals. The opening's jambs and cambered arch were also of terracotta, with every other stone projecting forward from the face of the wall.

*Plate 5: Semi-circular steps to original entrance*

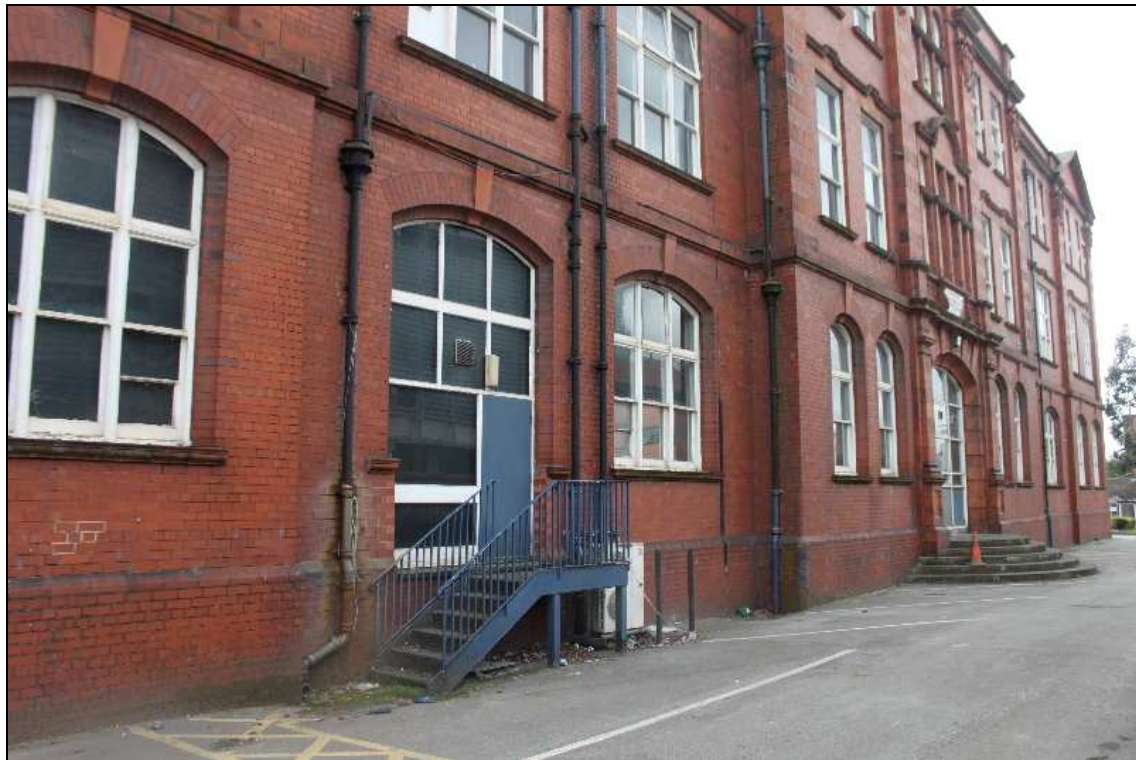
- 4.3.3 Bays 5-6 and 8-9, either side of the central bay were fitted with three light rectangular casement windows, incorporating segmental brick arches, bold projecting terracotta keystones and moulded terracotta sills. The windows within bays 1-4, 10, 12 and 13 were wider by approximately a third and fitted with nine lights, but were otherwise identical in form to those described above. Only bay 11 had been fitted with a doorway, accessed via a set of steel steps and this may have been a later insertion into an earlier window (Plate 6).

*Plate 6: Doorway in bay 11*

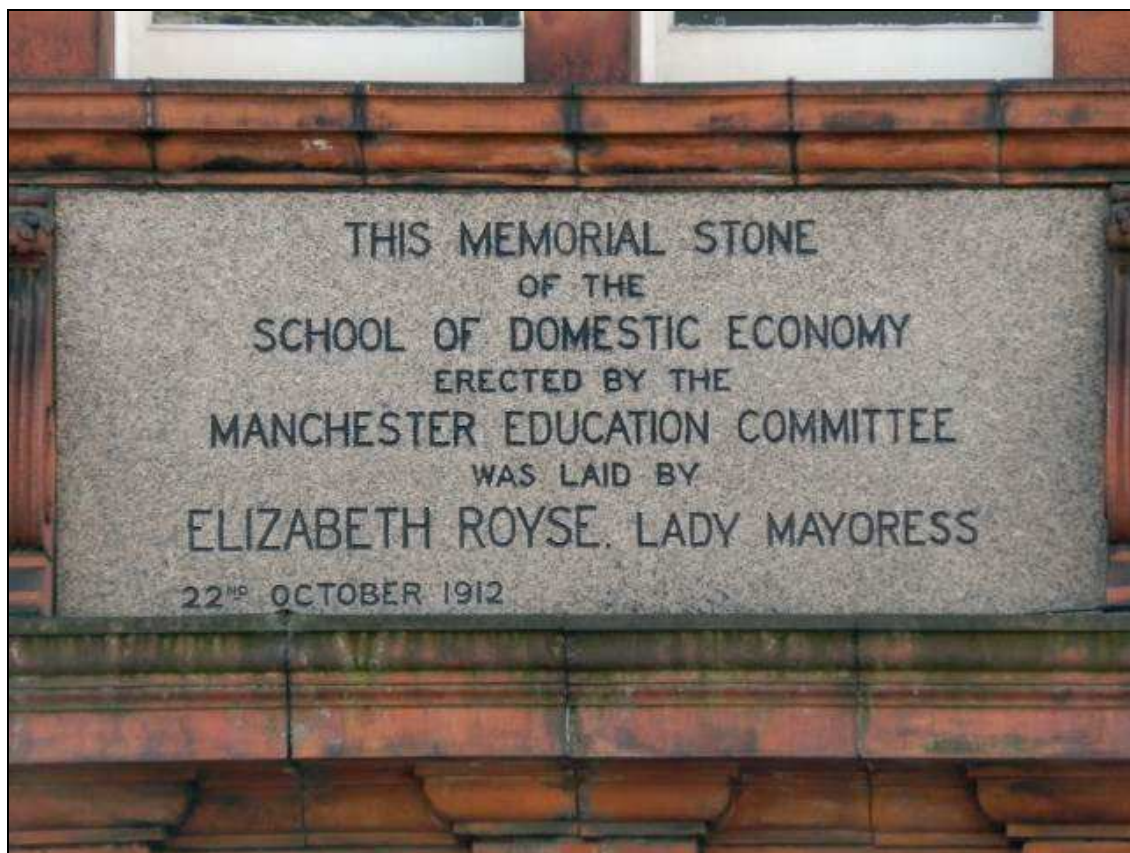
- 4.3.4 The central bay of the first floor included four narrow vertical rectangular windows, divided by terracotta mullions and at the upper third by a moulded terracotta transom (Plate 4). The two central windows projected forward from those flanking on each side and were topped by a semicircular moulded drip course. The drip course then continued horizontally above the remaining two windows, referencing Palladian architecture and the pediment at the head of the wall. The square lintels were formed of interlocking terracotta voussoirs, of a form repeated above most of the first and second floor windows. A marble plaque immediately beneath the window, between two consoles, recorded the date of the building's completion in 1912 (Plate 7).

*Plate 7: Memorial plaque at centre of the northern elevation*

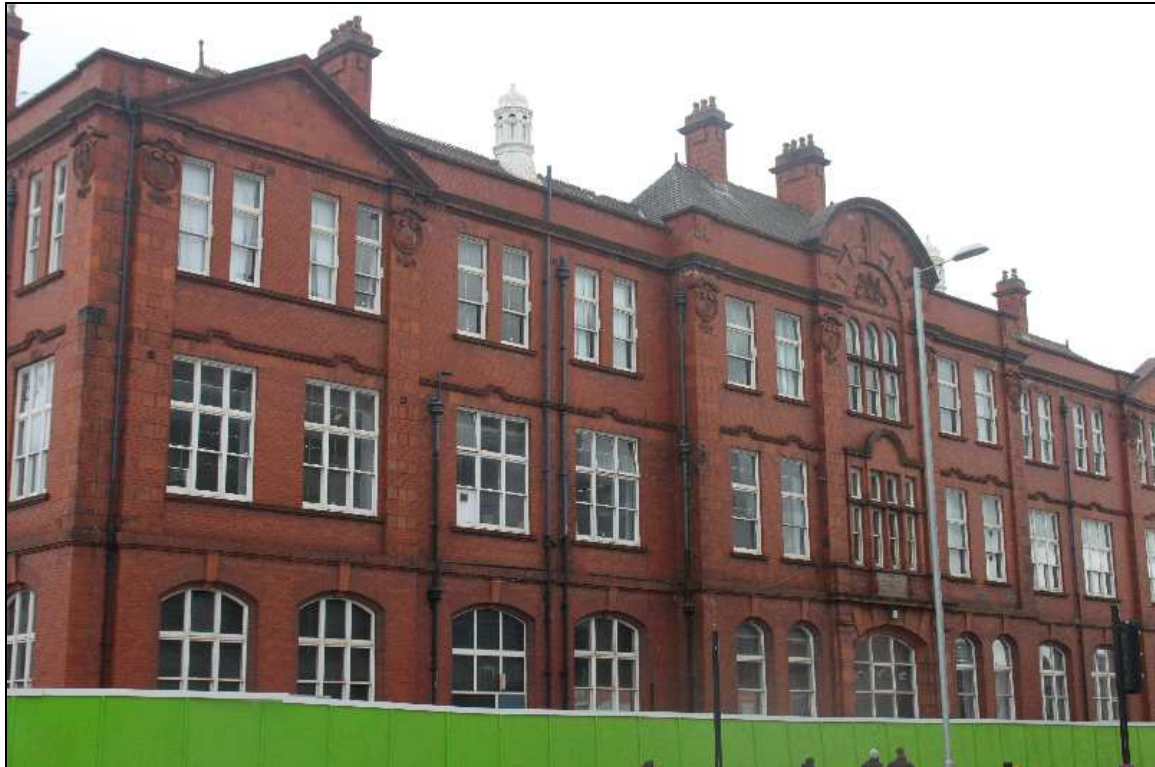
- 4.3.5 Bays 5-6 and 8-9 displayed rectangular windows of similar size to those beneath them on the ground floor but here they were fitted with plain square heads. The same applied to the wider windows within bays 1-4 and 10-13, although at this level the windows within bays 1-2, 12-13 shared a continuous moulded sill. The moulded string-course above rose briefly into a shouldered arch above each of the first-floor windows with the exception of the central bay (Plate 8).

*Plate 8: Northern elevation, showing string courses*

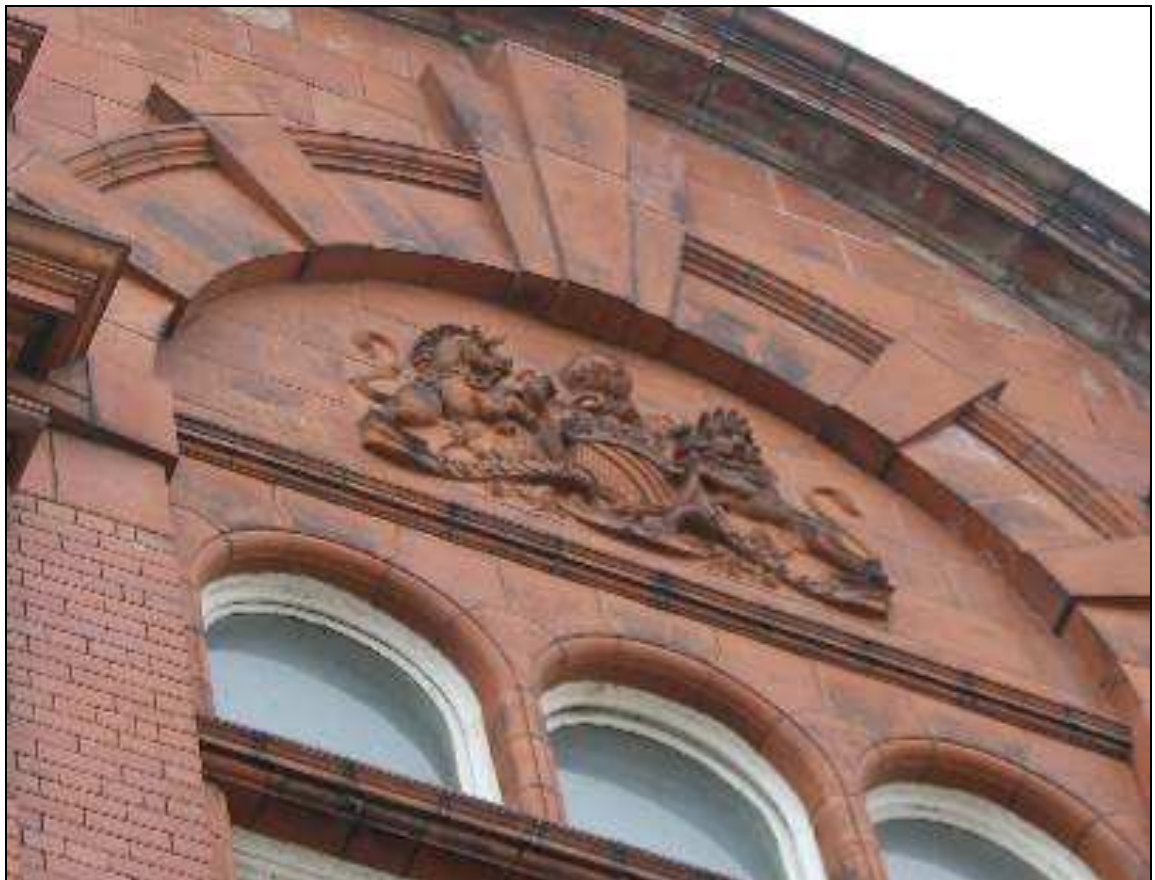
*Plate 9: City of Manchester Crest*

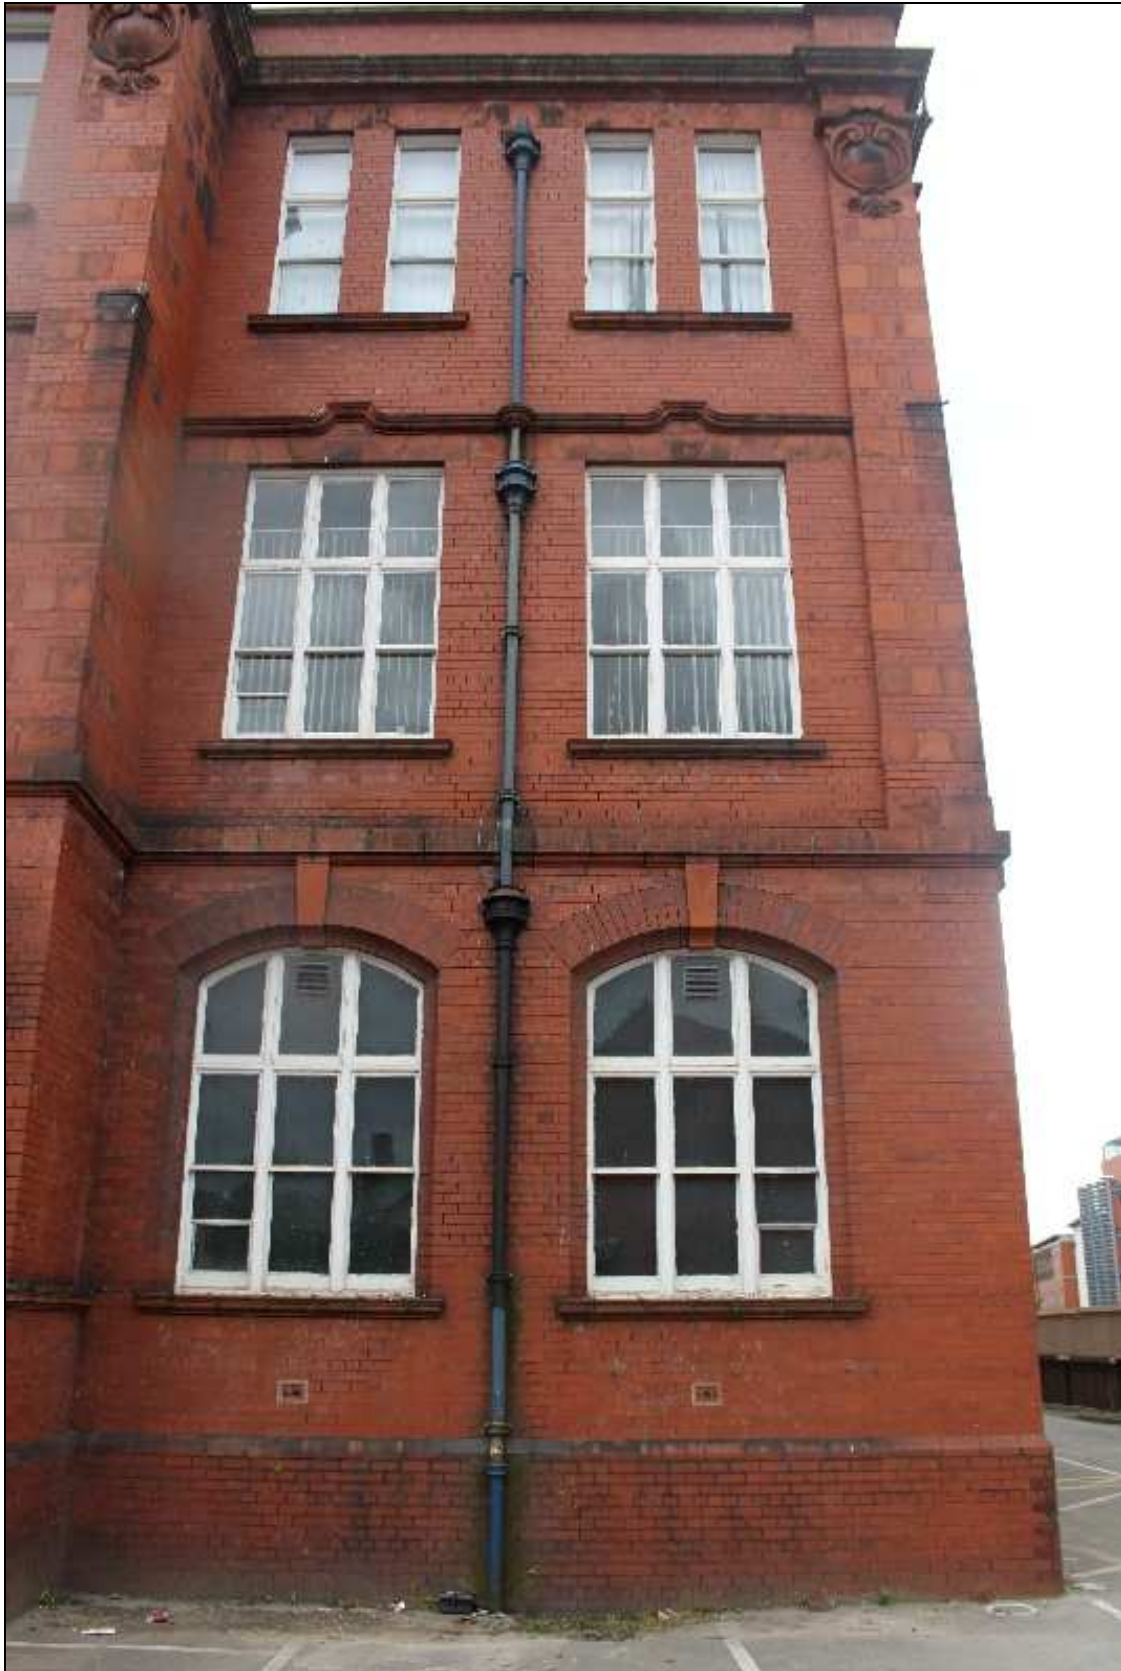
- 4.3.8 *Eastern and Western Elevations:* the eastern elevation extended for two bays, after which the wall was stepped forward to indicate the beginning of the south-eastern wing (Plate 10). Both string-courses and the cornice continued round from the northern elevation and the shallow plinth was also retained. The two ground-floor windows were of nine lights, and had segmental brick arches, bold projecting terracotta keystones and moulded terracotta sills. The first-floor windows were also of nine lights, and employed moulded terracotta sills, but had square lintels formed of interlocking terracotta voussoirs. Both second-floor bays had a pair of narrow rectangular windows, sharing a single terracotta lintel and using interlocking voussoirs as on the floor beneath. The northern end of the elevation was defined by a shallow pilaster of the type previously described upon the northern elevation. The western elevation was identical to the eastern elevation (Plate 11).

*Plate 10: Eastern elevation of main block*

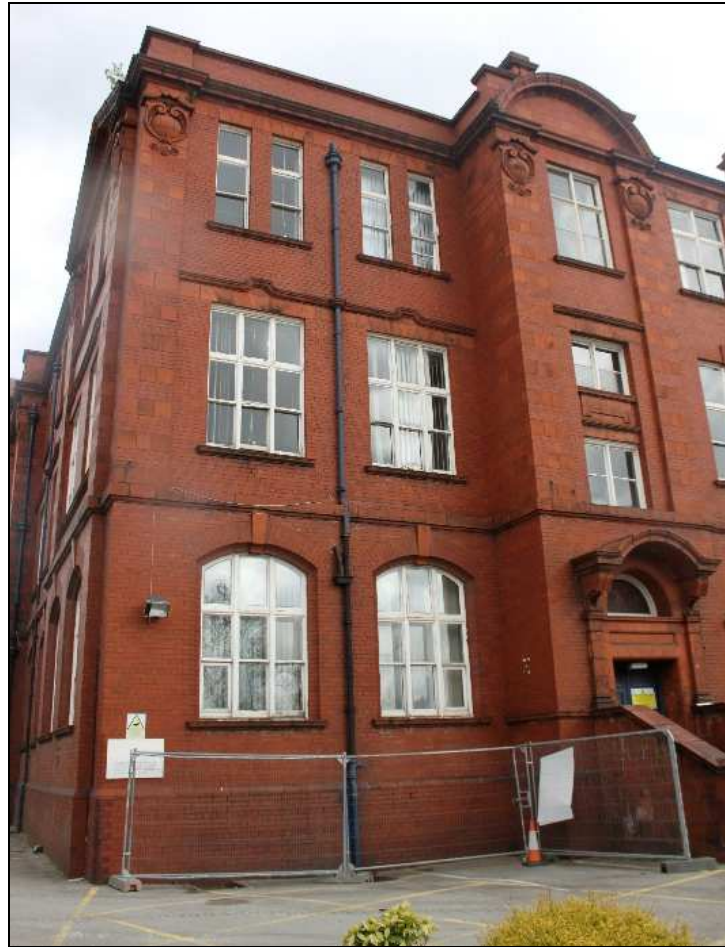
Plate 11: Western elevation of main block

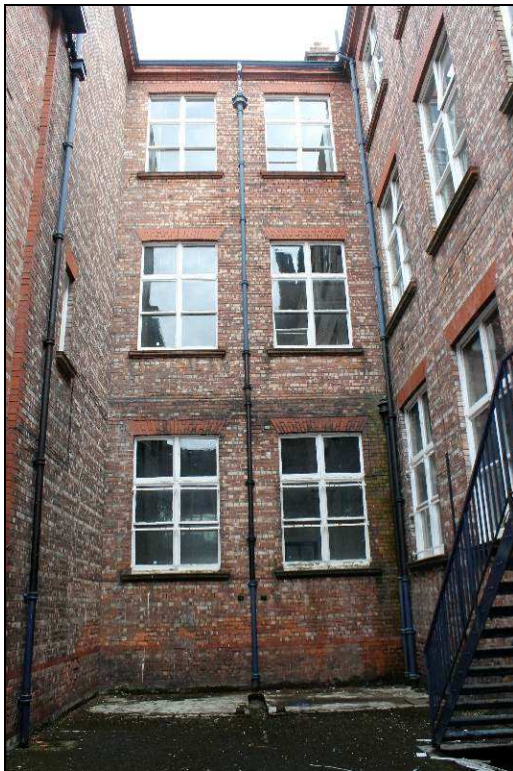
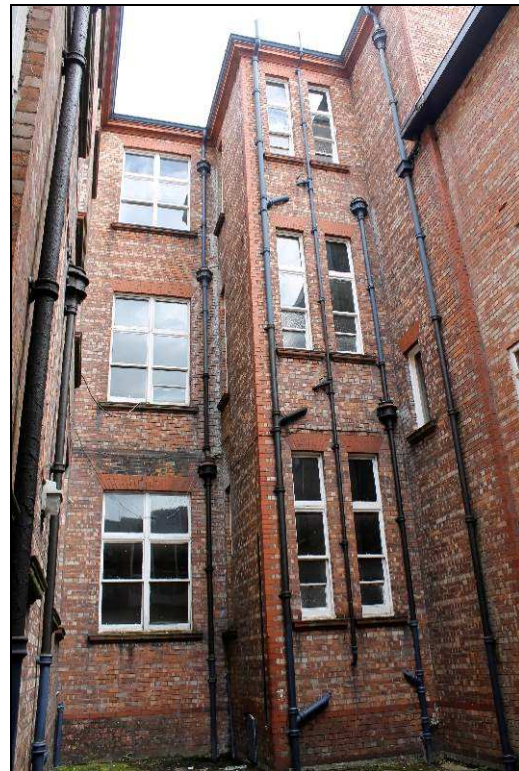
Plates 12 and 13: South elevation to east and west of stair tower

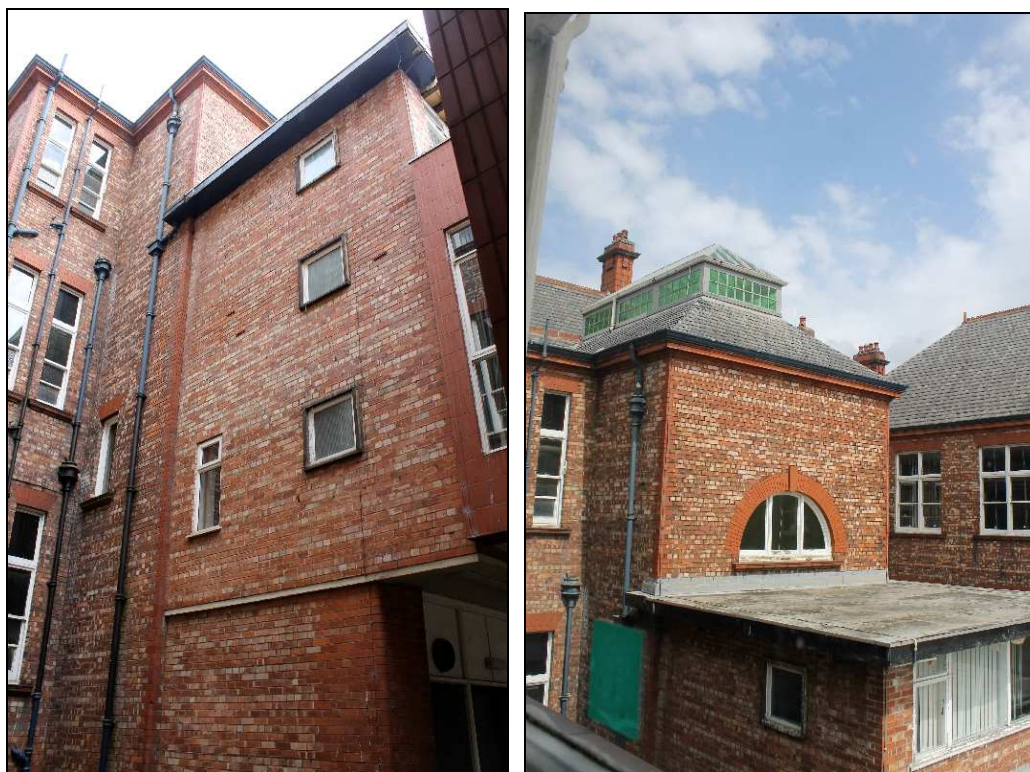
- 4.3.11 **Stair Tower and Extension:** the stair tower was built using the same functional brick employed on the rest of the courtyard elevations, except at the corners where a hard red brick had been used instead. It was a small, square building with a small rectangular window of similar form to that seen on the privy block, towards the southern end of the first floor on both its eastern and western elevations (Plate 14).

*Plates 14 and 15: Stair tower with extension to right and privy tower to left. Southern elevation of Stair Tower in right hand frame, facing north-east*

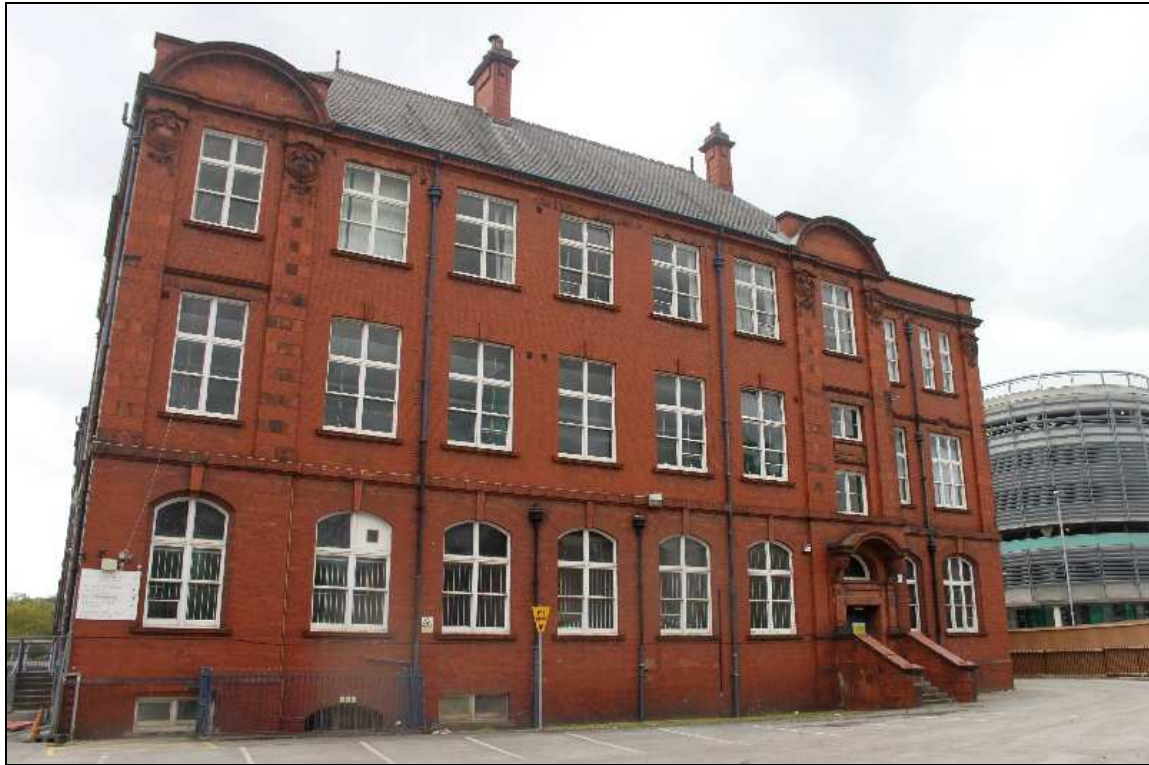
- 4.3.15 *Eastern Elevation:* the eastern elevation was of seven bays, and was less elaborate than the northern elevation (Plate 16). It adjoined the eastern elevation of the main block to the north, from which it was distinguished by being set forward by 1.6m. The southernmost bay had a shallow plinth and both it, and bay 7 at the opposing end stood slightly proud of the remainder of the wall defining the northern and southern limits of the wing. A pair of shallow pilasters rising from the first-floor string-course either side of these bays had a cartouche at the head and were topped by a semicircular pediment.

Plate 16: Eastern elevation of the South-Eastern Wing

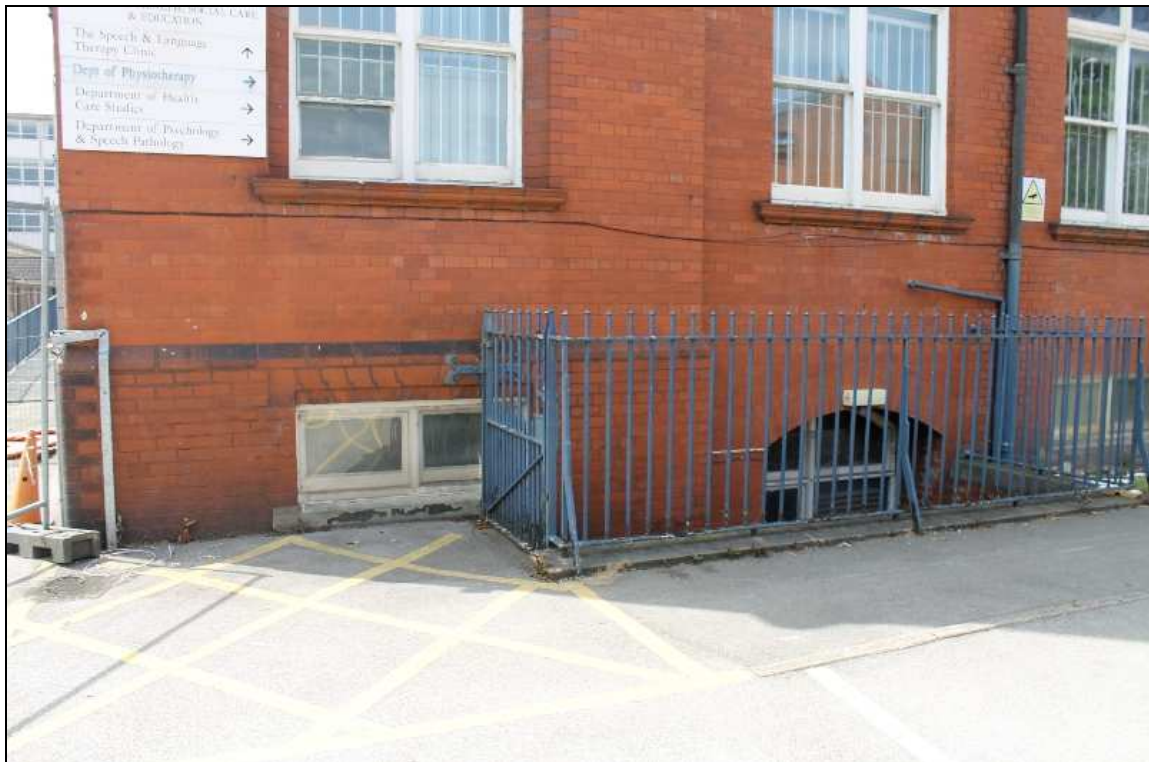
Plate 17: Cellar entrance at southern end of the eastern elevation

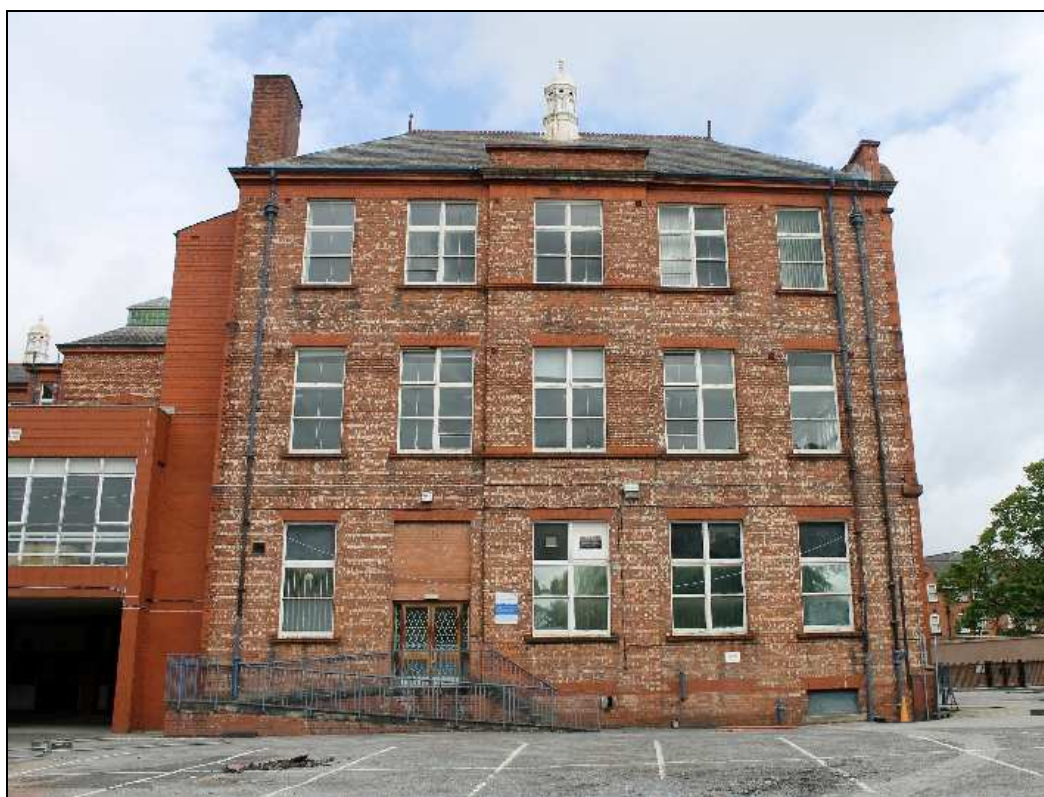
- 4.3.19 *Southern Elevation*: the variable colouring of the brick on the southern elevation of all three main blocks clearly distinguished it as the rear of the building (Plate 18). There were five bays upon each floor, with the central bay projecting forward slightly from the face of the wall and topped by a short parapet with a flat coping above. The rest of the elevation was topped with a moulded cornice, which continued unbroken across the base of the parapet in the central bay.

Plate 18: Southern elevation of the South-Eastern Wing

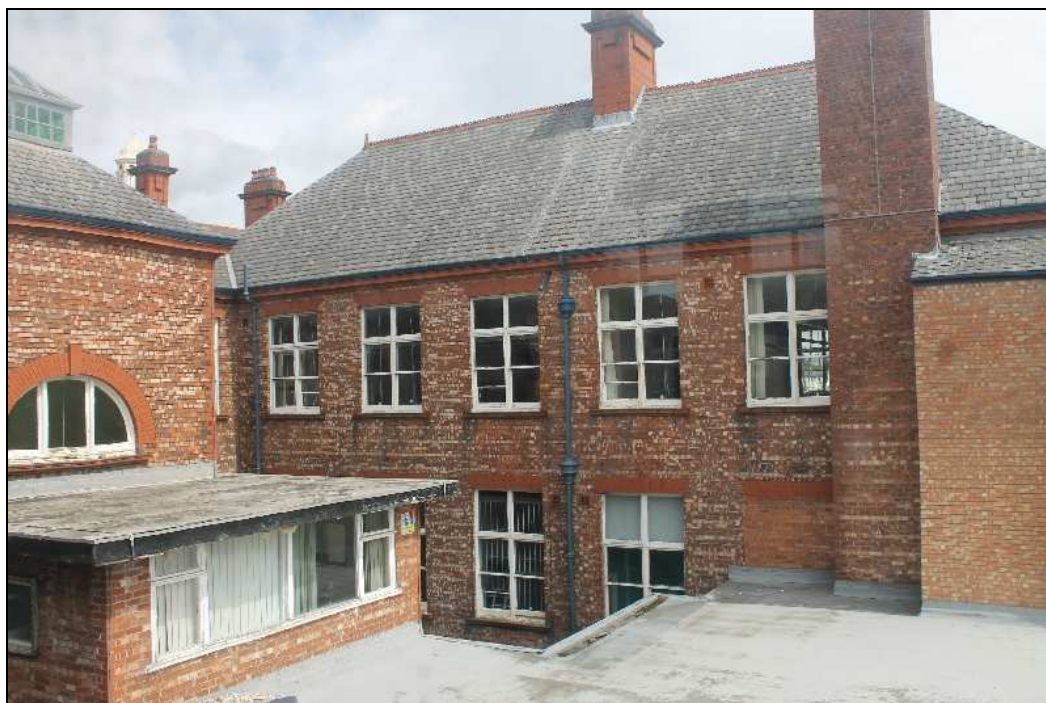
- 4.3.23 *Western Elevation:* the western elevation had been partly obscured by the construction of the raised linking corridor connecting the southern ends of the two wings, but it was possible to identify six approximately equal bays (Plate 19). Each bay had originally been fitted with a six-light rectangular window with shallow cambered arches and moulded terracotta sills, but those of the ground floor and first floor of the first two bays from the south had been removed or partially so during the construction of the linking corridor. The window of the first bay of the second floor had also been modified, and a brick-built lift shaft erected against the wall in front of it. A chimney lay immediately to the north of the lift shaft, fitting tightly against the southern jamb of the surviving second floor window in the second bay from the south (Plate 19).

*Plate 19: Western elevation of the South Eastern Wing, first and second floor visible only*

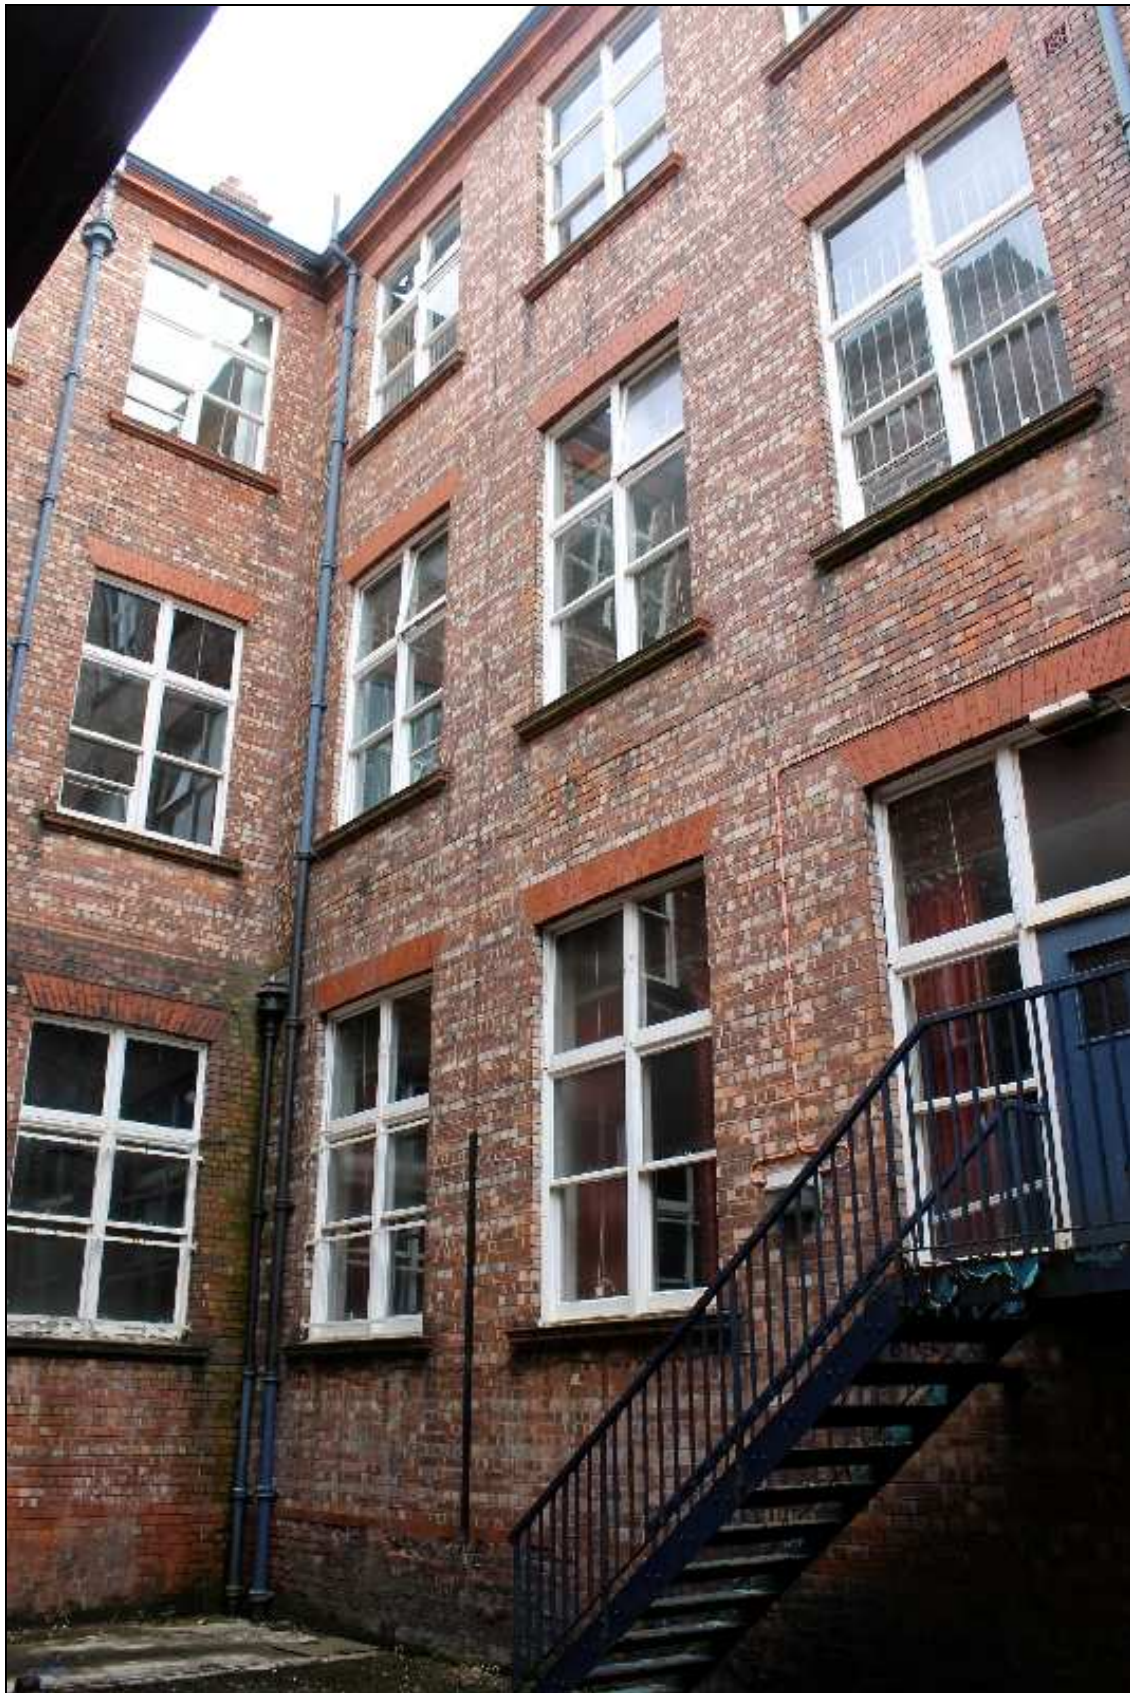
- 4.3.24 Additionally, at ground-floor, level bay 4 from the south had been fitted, perhaps as a modification, with a pedestrian doorway with access via a set of steel steps (Plate 20).

*Plate 20: Western elevation of the South Eastern Wing, ground-floor facing north-east, with doorway to right of frame*

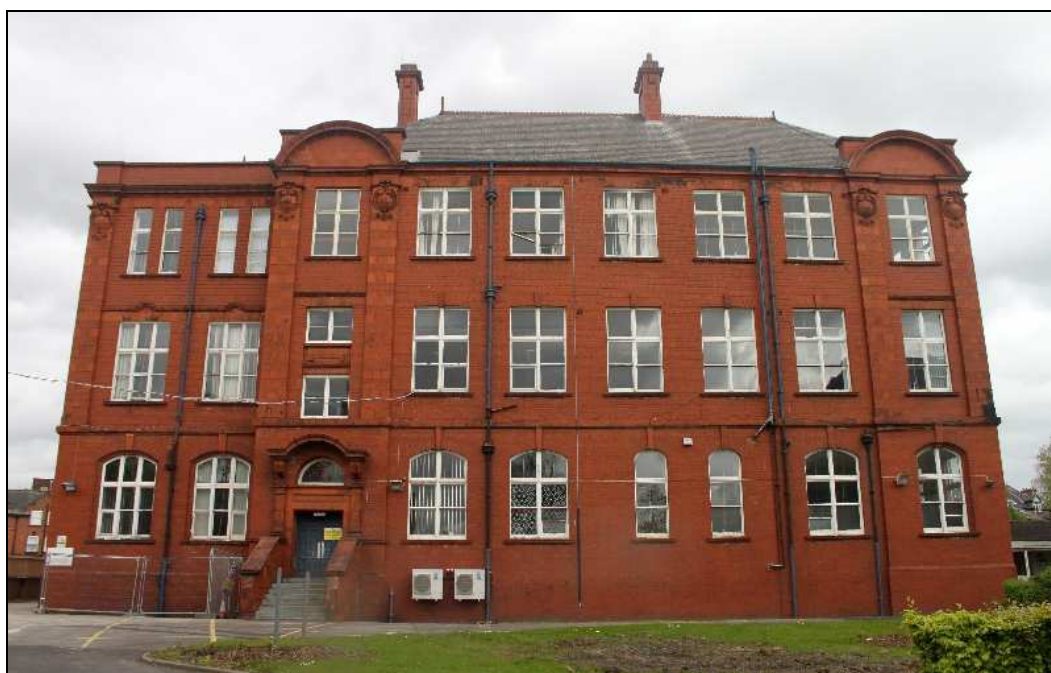
- 4.3.26 *Western Elevation:* the western elevation of the South-Western Wing was almost an exact mirror image of that described on the eastern elevation of the South-Eastern Wing, except for two details (Plate 21). The first was that the absence of a basement beneath this wing meant the basement doorway, staircase and basement windows could be omitted from the design on this side. The second was that in bays 3 and 4 from the south, the six-light windows had been disregarded in favour of a narrow off centre three-light window with a segmental brick arch.

Plate 21: Western elevation of the South-Eastern Wing, ground-floor facing north-east

- 4.3.25 **South-Western Wing:** the roof of the South-Western Wing was of the same design as that of the South-Eastern Wing, but had an additional chimney at the northern end (Plate 21).

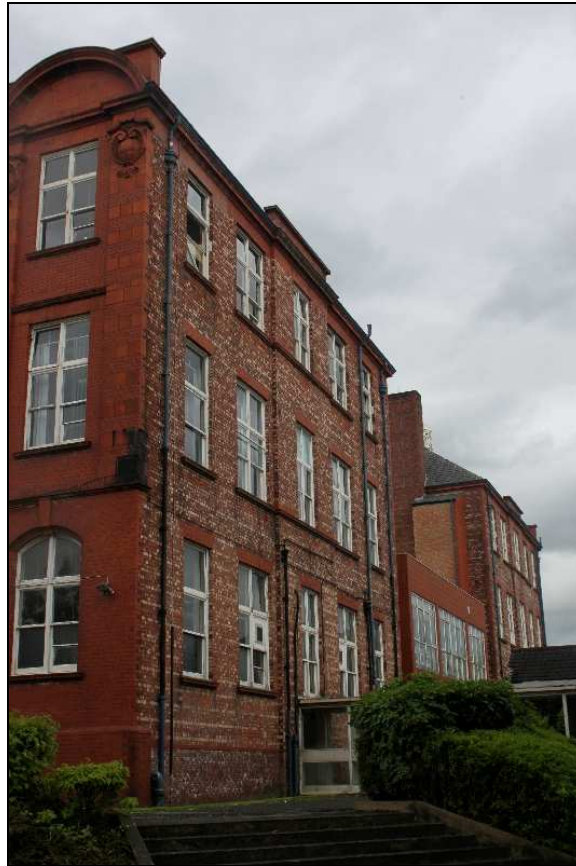
- 4.3.27 *Southern Elevation:* the southern elevation was again almost identical to that described on the south-eastern wing, but there were no basement windows and the lower courses of brick were of a rough character, perhaps due in part to the loss of their fire skins through weathering (Plate 22). Unlike the South-Eastern Wing, all of the ground-floor windows had been retained, but a doorway had been cut through the wall beneath the window in bay 2, connecting the building to the buildings to the south via a glass sided linking corridor.

*Plate 22: Southern elevation facing north-east. Note the glass sided linking corridor at the base*

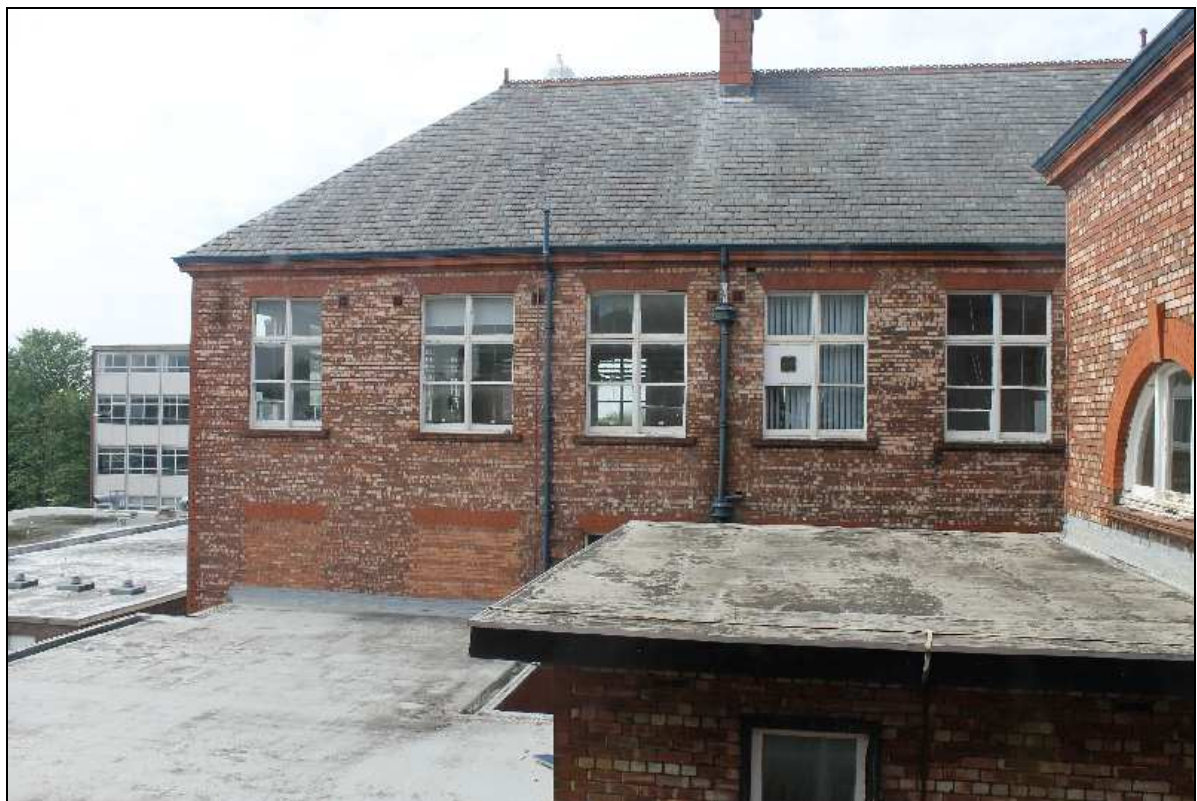
- 4.3.28 *Eastern Elevation:* the eastern elevation largely matched that of the western elevation on the South-Eastern Wing, with six bays on each of its three floors (Plate 23). The linking corridor once again had required the partial blocking and removal of the two southern bays at ground- and first-floor levels, but this elevation did not have either the lift shaft or chimney blocking the second-floor opening. As with the wing's western elevation, the ground-floor windows in bays 3 and 4 from the south were of half width and off centre, but all the windows had the typical shallow cambered arches and moulded terracotta sills.

*Plate 23: Eastern elevation showing first and second floors only*
