**Elizabeth Gaskell  
Building,  
Hathersage Road,  
Manchester**

**Archaeological  
Building Investigation**

**Nuffield Health**

Issue No: 2015-16/1643

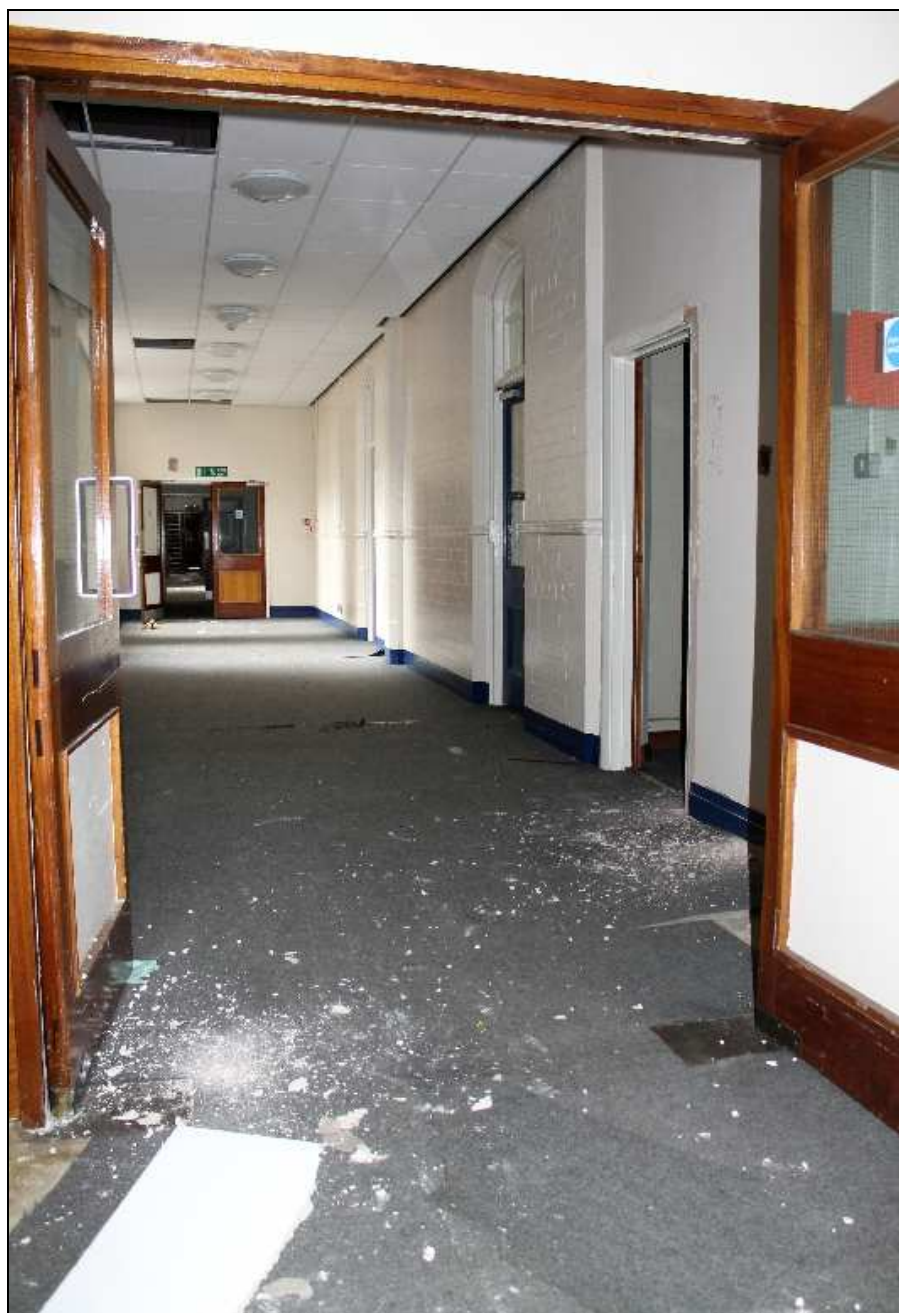
- 4.4.2 **Ground Floor (Fig 2):** internally, the northern range had a corridor running along its southern side with seven large rooms opening off of its northern wall (Plate 24). An open well staircase with a half-pace landing lay at either end of the corridor and an imperial staircase occupied the stair tower to the south of its centre (Plate 25). A pair of swing doors across the width of the corridor either side of the central staircase created a chamber at the base of the stairs. The privy tower observed externally was accessed on each of the buildings three floors by a doorway on the southern wall of the corridor, to the east of the central staircase. To the north of the central stairs there was a timber partition with a set of doors at the centre and a decorative glazed over-light above, defining what had originally been the main entrance lobby (Plate 26).

Plate 24: Main block corridor, facing west

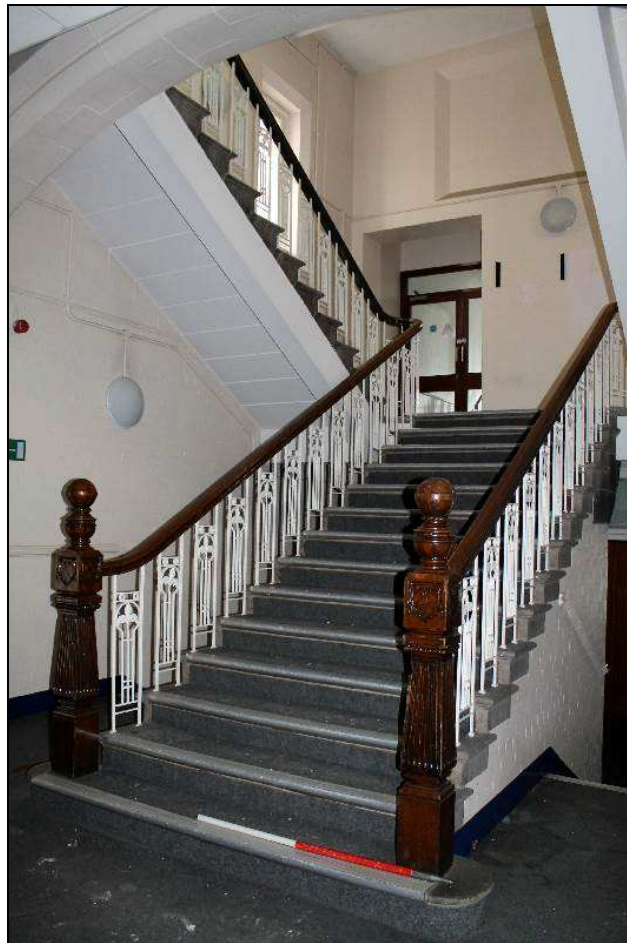
Plate 25: Imperial staircase leading to first floor, 1m scale

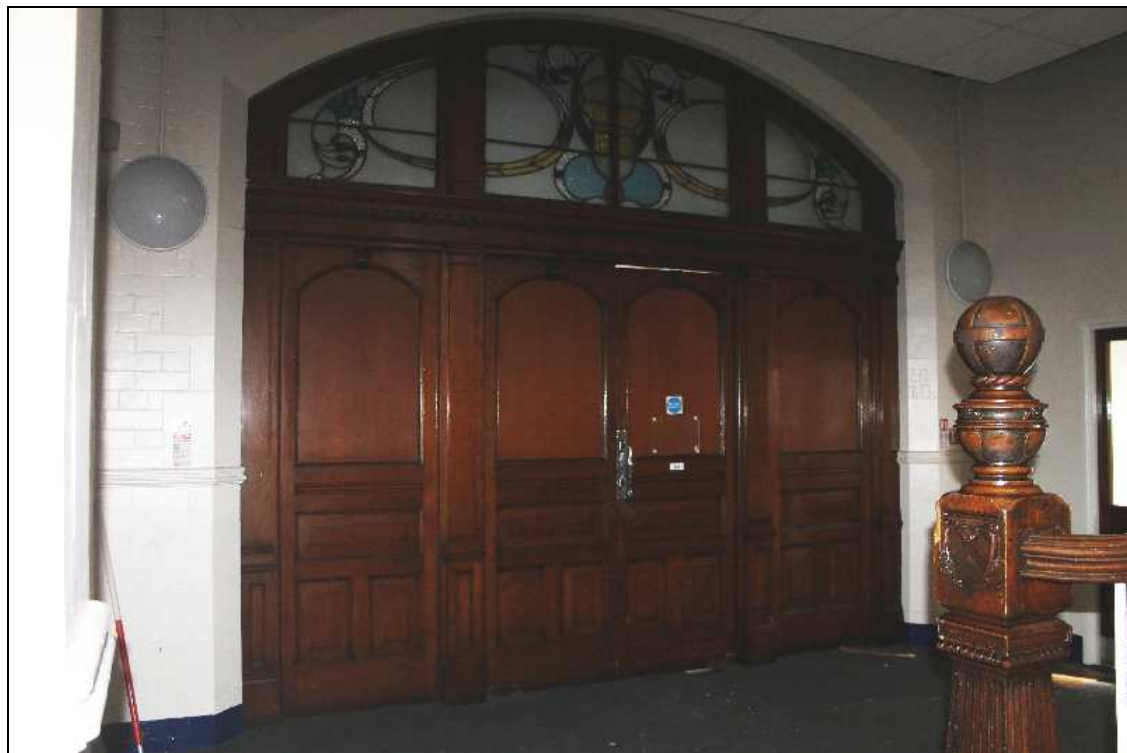
Plate 26: Timber partition defining entrance to original lobby with stairs to right of frame

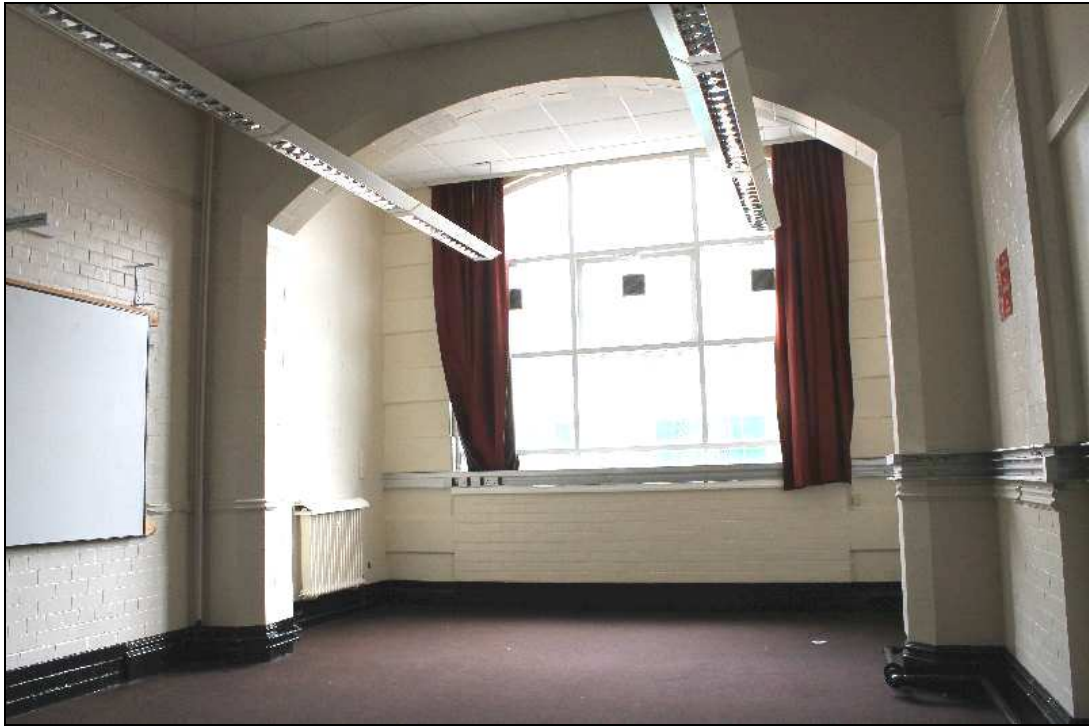
- 4.4.3 From within the original entrance lobby, the brickwork blocking the lower portions of the original northern entrance was clearly exposed beneath the current window (Plate 27). A secondary cambered arch toward the northern end of the room may once have held a second timber partition, creating a small vestibule area to the south of the entrance. The lobby was the most decorative room in the building with a moulded skirting, chair rail and a picture rail to the east and west. There were two blocked pedestrian openings on the western wall and a larger blocked doorway to the east with egg and dart motif surrounds across its upper jambs and lintel (Plate 28).

*Plate 27: Original entrance lobby, facing north*

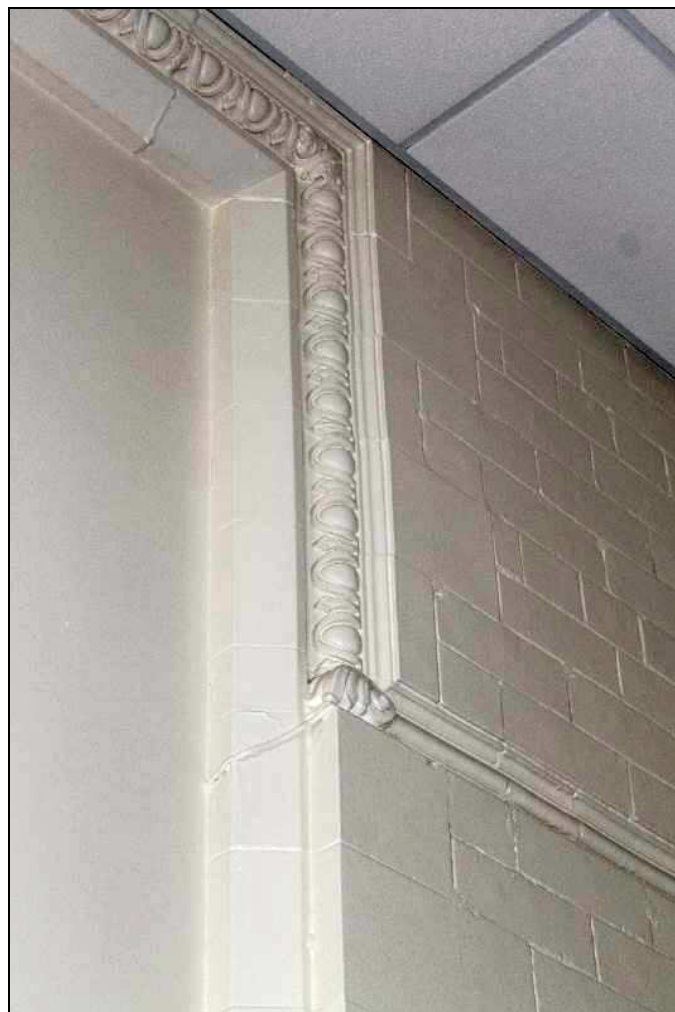
*Plate 28: Egg and dart decoration within entrance hall*

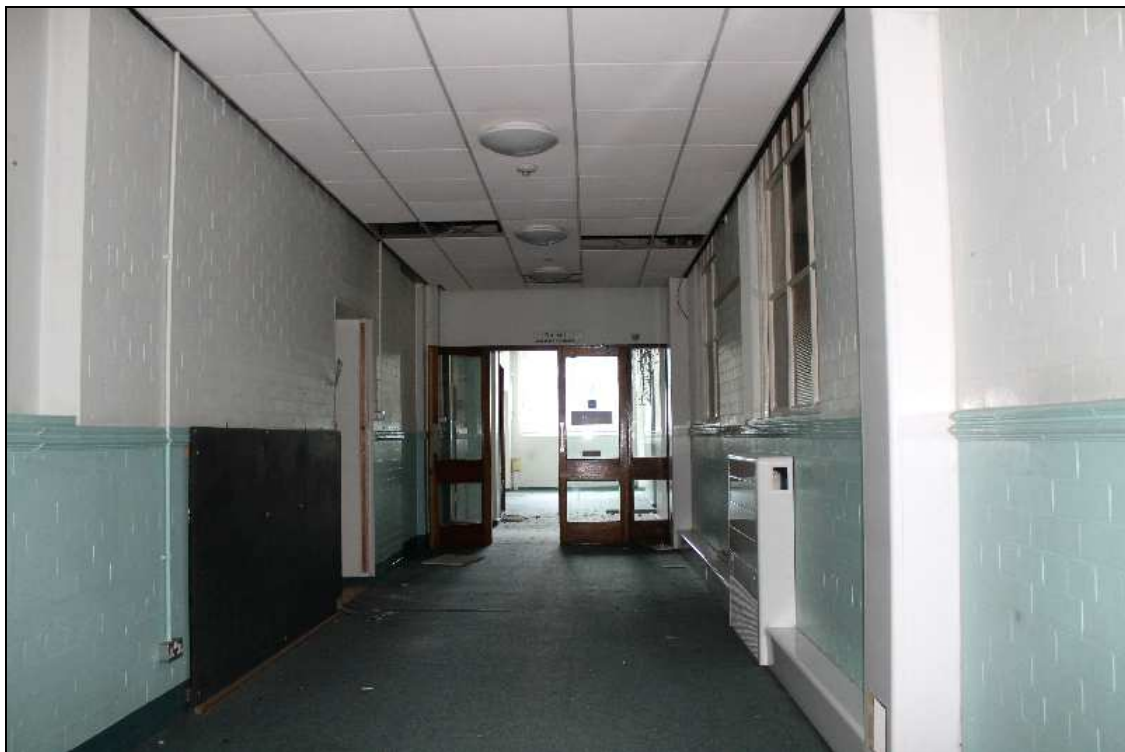
- 4.4.4 The South-Eastern Wing had a central corridor running from the eastern end of the corridor in the main range to the southern end of the building (Plate 29). Two large rectangular rooms lay to each side of the corridor, although the southern two rooms and north-eastern room had been subdivided with modern stud partitions into a series of smaller spaces. The South-Western Wing had the same central corridor, but appeared to retain its basic original layout, with two rectangular rooms to the east and a large toilet block in the south-eastern corner (Plate 30). Another large toilet block occupied the south-western corner of the wing, with three more rooms of diminishing size to the north (Plate 31). A short flight of steps led down to an inserted doorway at the southern end of the central corridor, leading to a glass-sided linking corridor.

*Plate 29: South-eastern corridor, facing south*

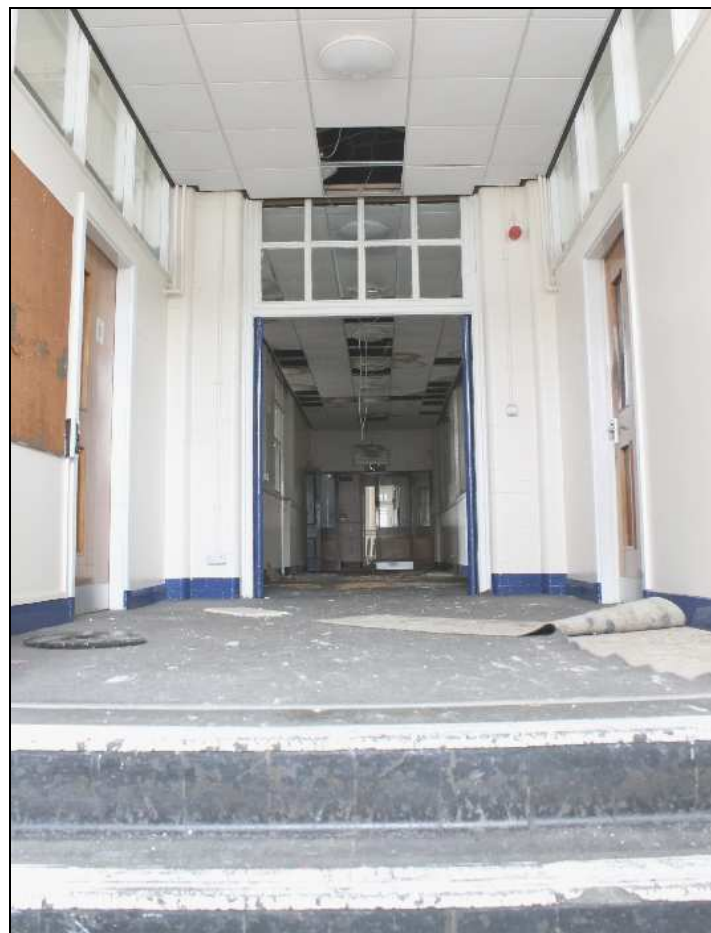
*Plate 30: South-western corridor, facing north*

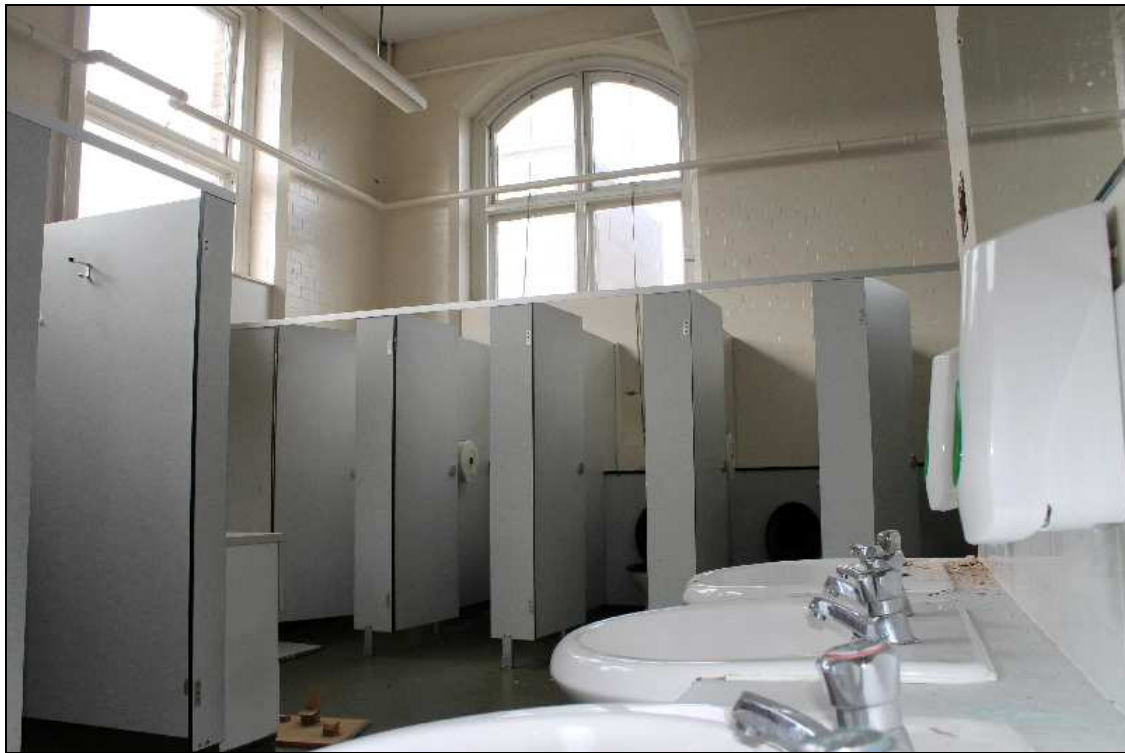
*Plate 31: Toilet block in south-western corner of the South-Western Wing*

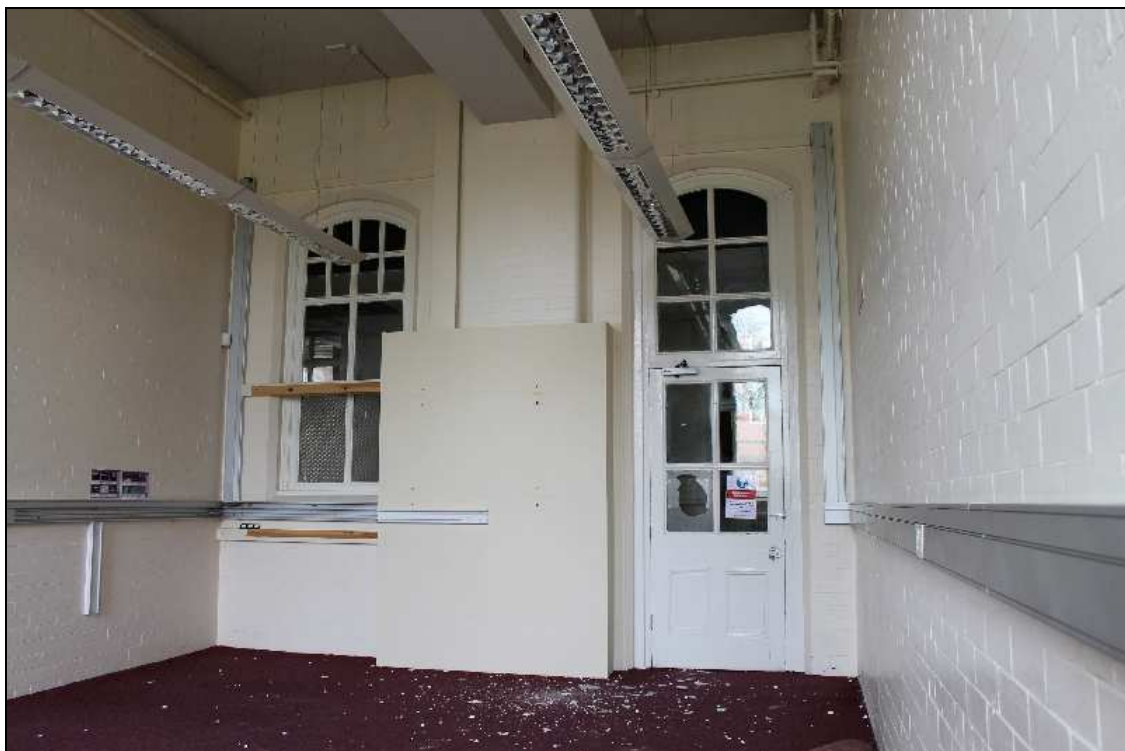
- 4.4.5 Typically, the corridors of all three main ranges were lit by timber-framed windows set within the internal facing walls of each room (Plate 32). The windows varied in size and shape, with some incorporating part glazed panel doors, but most had cambered arches in keeping with the external ground-floor windows (Plate 33). Where they survived the original door handles were chrome plated with a thumb operated latch at the top and scalloped detailing at the top and bottom (Plate 34).

*Plate 32: Typical design of internal windows and doorways lighting the corridors*

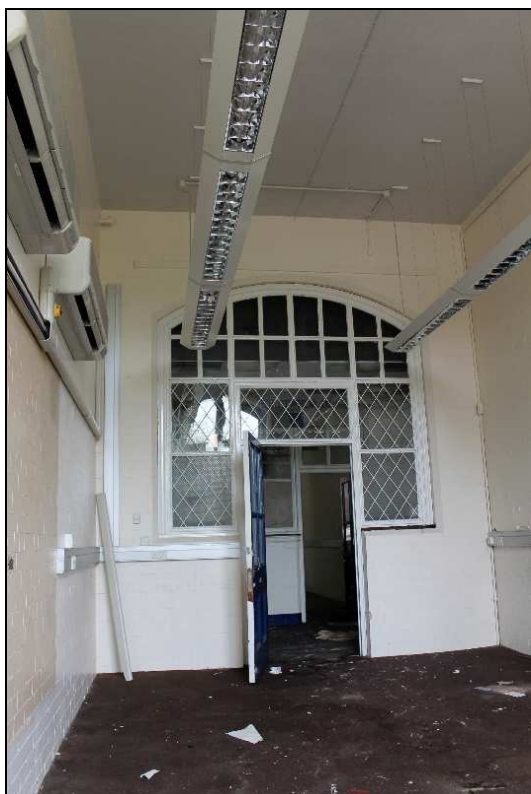
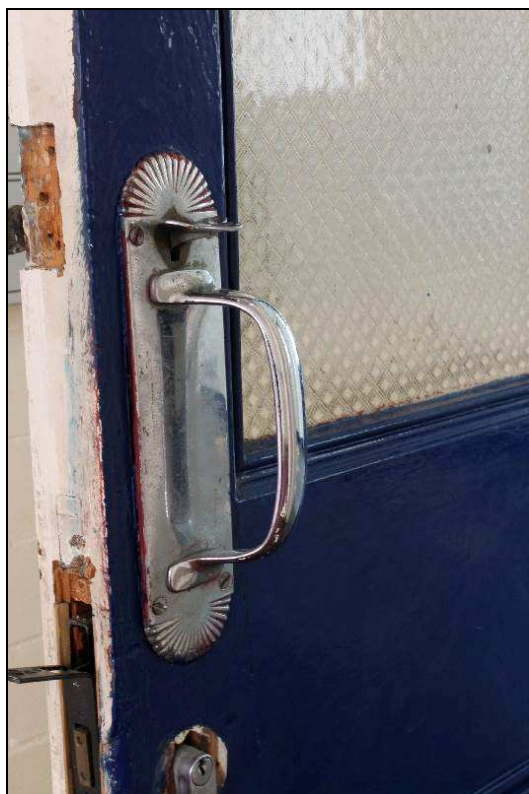
Plates 33 and 34: Larger type of internal window, incorporating a central doorway, and original door handle at ground-floor level

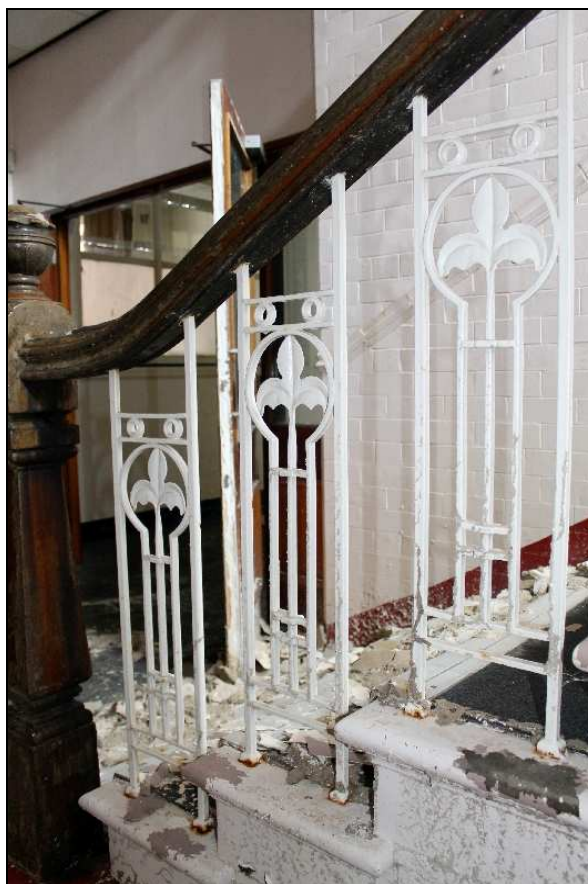
- 4.4.6 Each of the staircases were fitted with moulded stone treads and had carved timber newel posts and timber hand rails above decorative wrought iron balusters (Plates 25 and 35).
- 4.4.7 Although none of the building's original fireplaces were found intact, several blocked examples were noted (Plate 36). They typically sat at the centre of projecting chimney breasts, and had cambered brick arches and brick surrounds. They were not however fitted in every room, perhaps suggesting that the college was fitted with radiators originally.
- 4.4.8 The majority of the rooms were unfurnished at the time of the survey, but rooms 116 and 113 retained their tiered lecture hall arrangement, with the desks displaying the typical markings associated with a class room (Plates 36 and 37).

Plate 35: Wrought-iron staircase rails

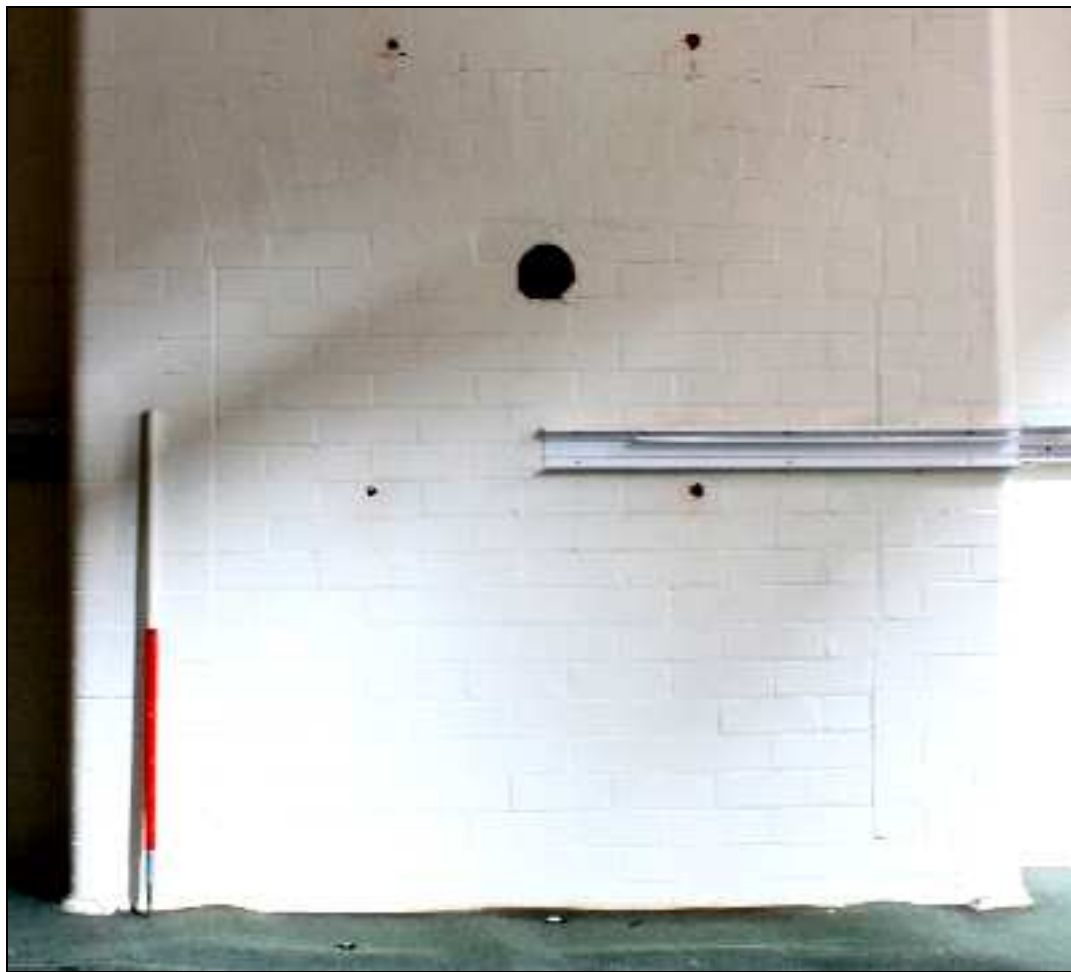
Plate 36: Blocked fireplace in lecture room 101, typical of those in the rest of the building. 1m scale

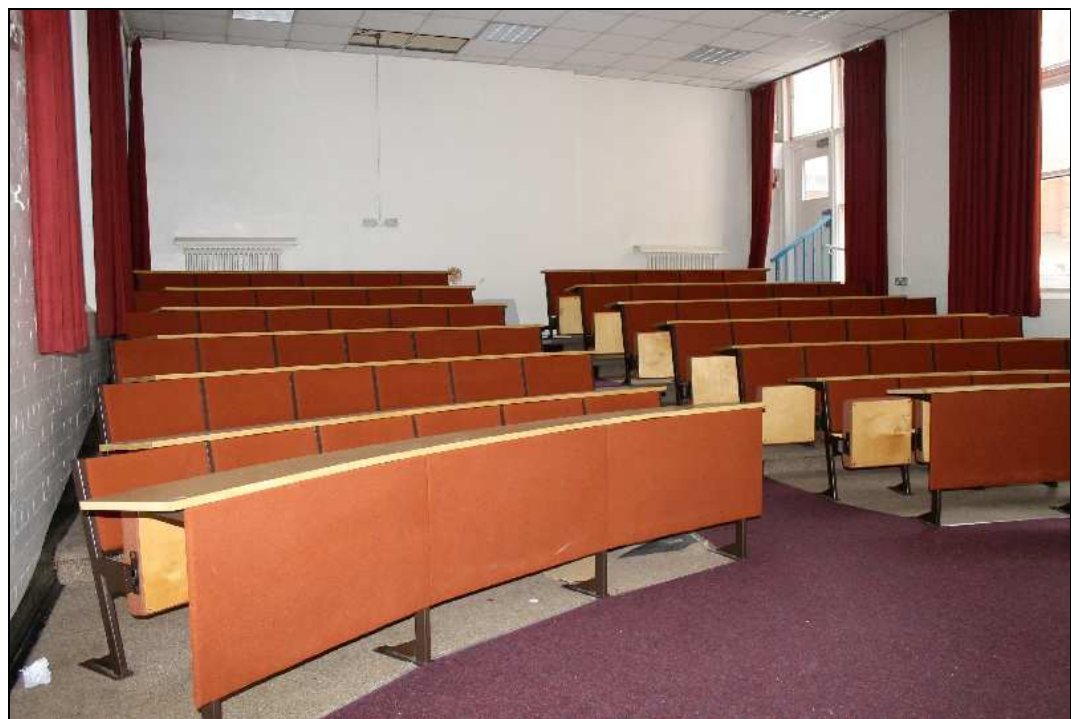
Plate 37: Tiered seating in lecture theatre 116, facing south

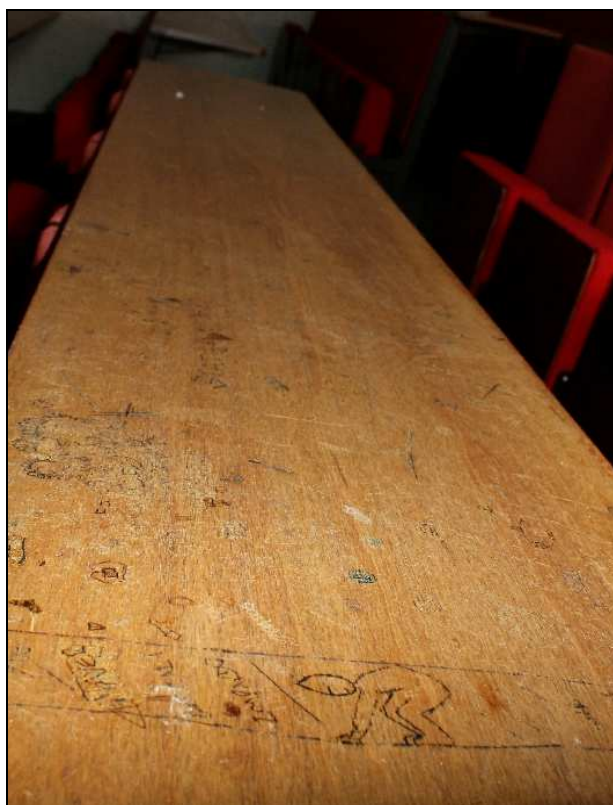
*Plate 38: Desk art in one of the lecture theatres*

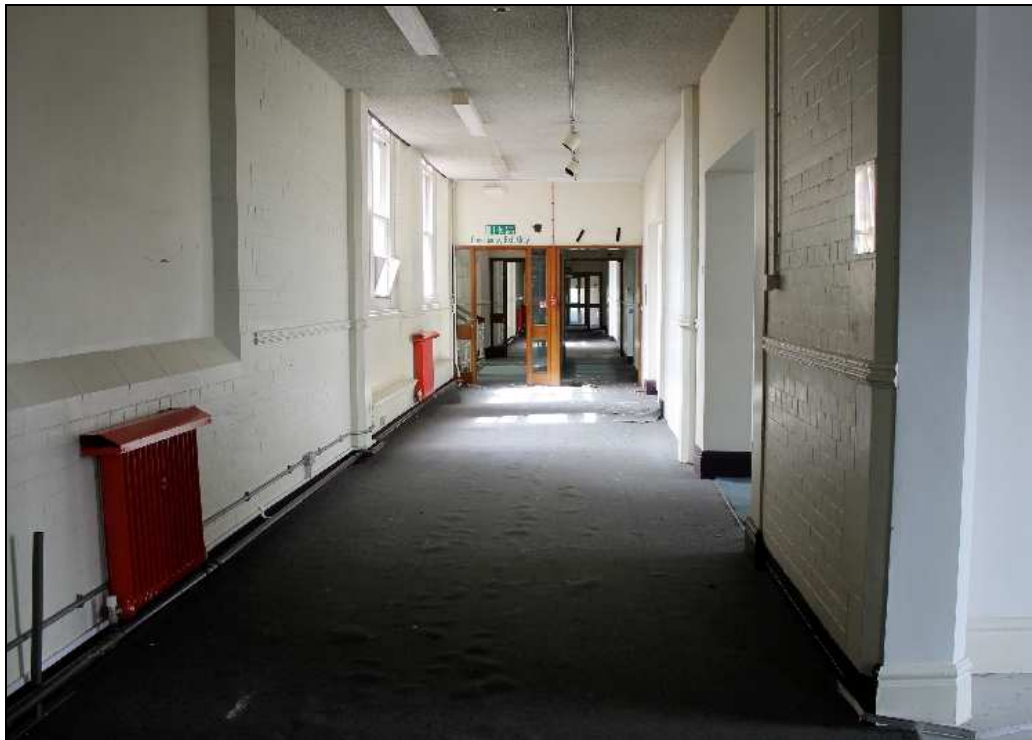
- 4.4.9 **First Floor (Fig 3):** the first-floor had the same basic layout of corridors and staircases as the ground floor (Plate 39). It had eight rooms to the north of the corridor in the main range, although there was evidence towards the eastern end that rooms 218-220 may have originally formed a single space.

*Plate 39: Northern range corridor, facing west*

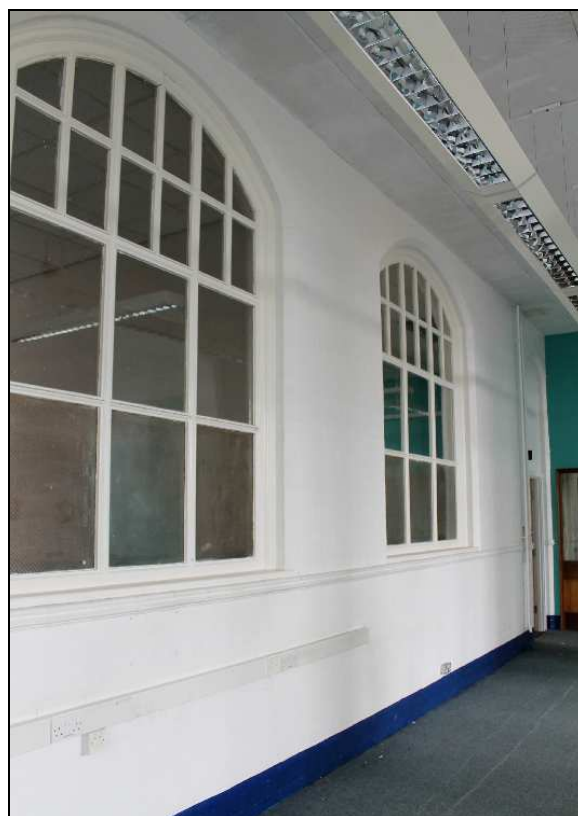
- 4.4.10 The corridor in the South-Eastern Wing extended only half way along the length of the building, and was lit by a pair of cambered arched internal facing windows (Plate 40). It had a large room to the east accessed through a series of tall cambered arches and another to the west with a doorway at the northern end (Plate 41). The latter room had been subdivided across its width at its southern end while the eastern room was connected via an open cambered arch in its southern wall to a large rectangular space at the southern end of the wing which had served as a library (Plate 42).

*Plate 40: Internal windows in corridor in south-eastern wing, facing north*

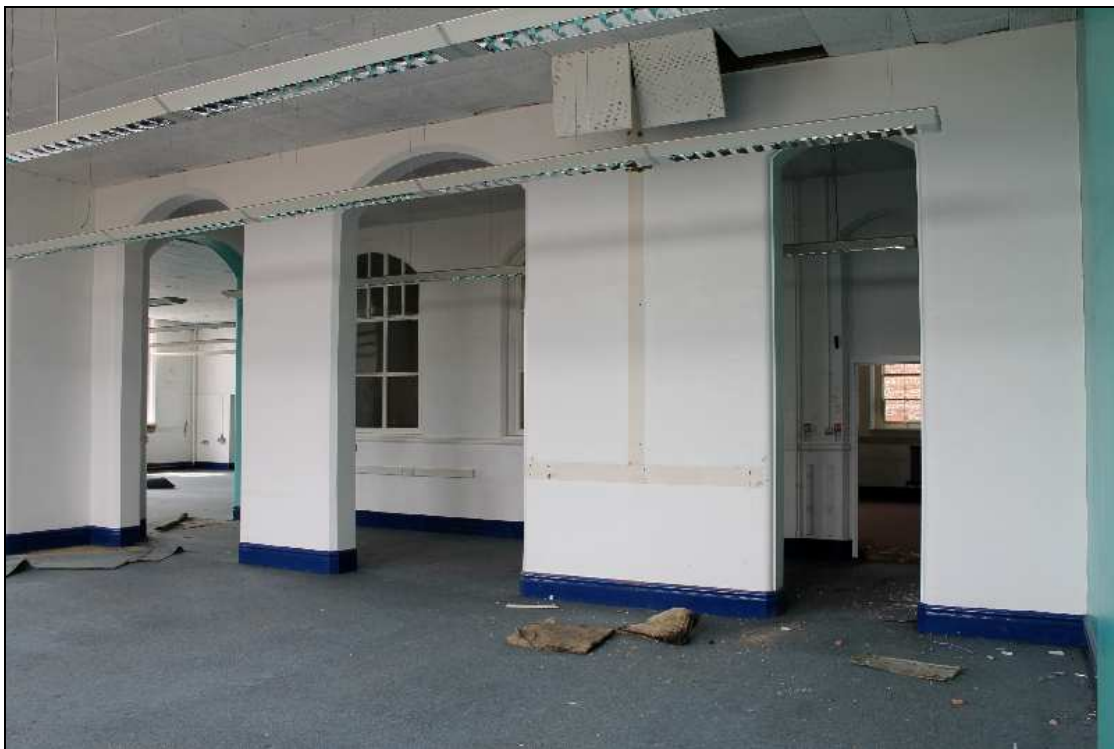
*Plate 41: North-eastern room of library in the South-Eastern Wing, facing south-west*

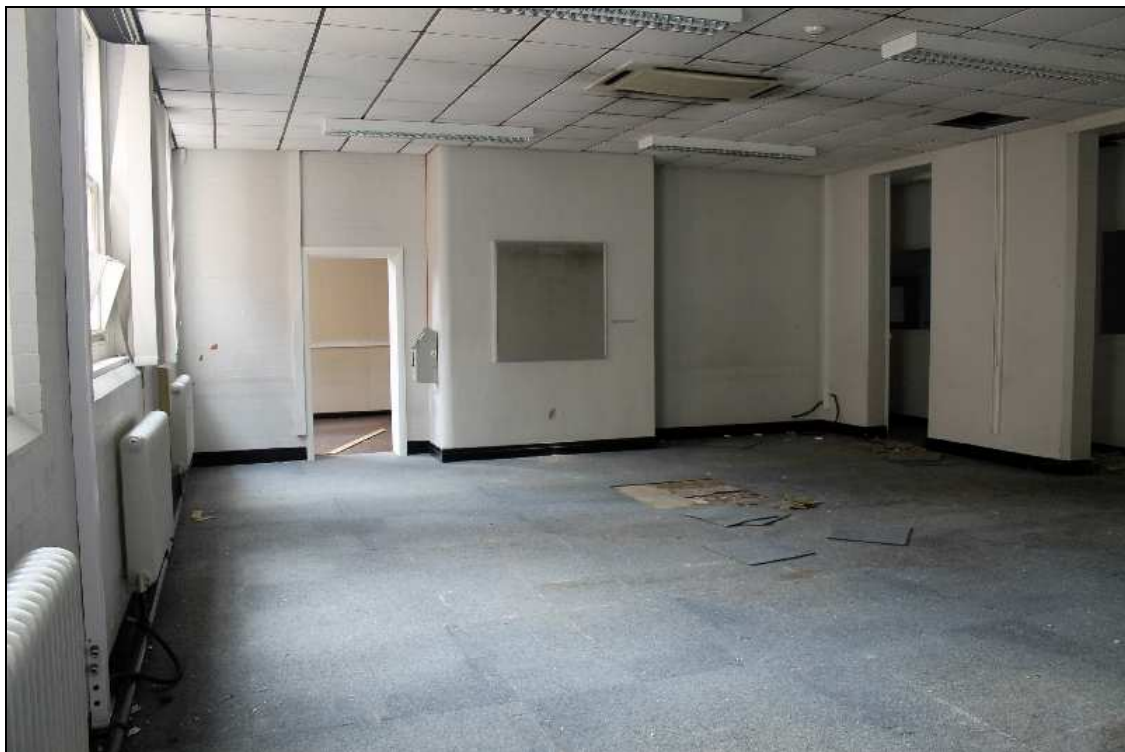
*Plate 43: Room 217a in north-eastern corner of the South-Western Wing, looking south*

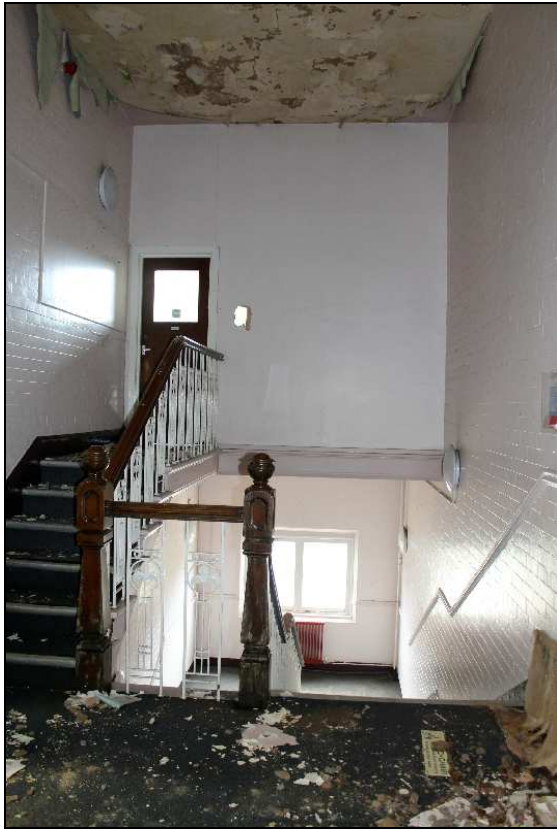
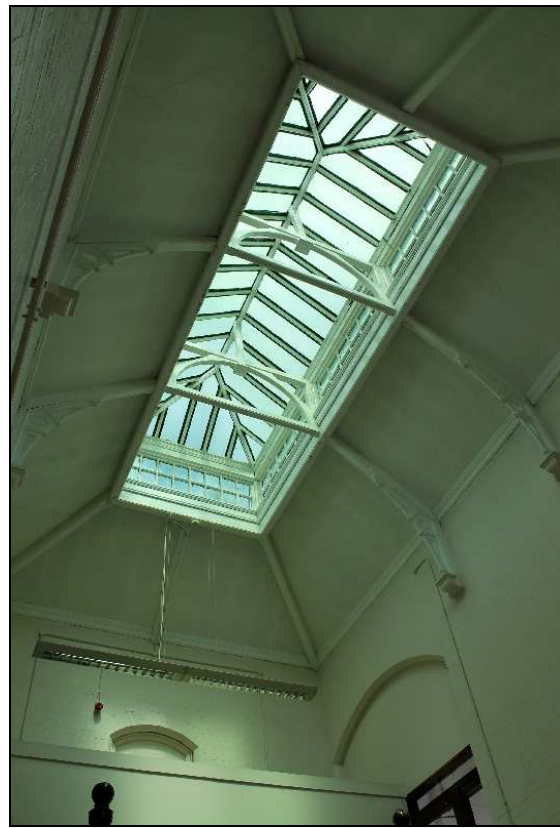
Plates 48 and 49: Room 306 above western stairwell, facing west, and glass canopy over stair tower

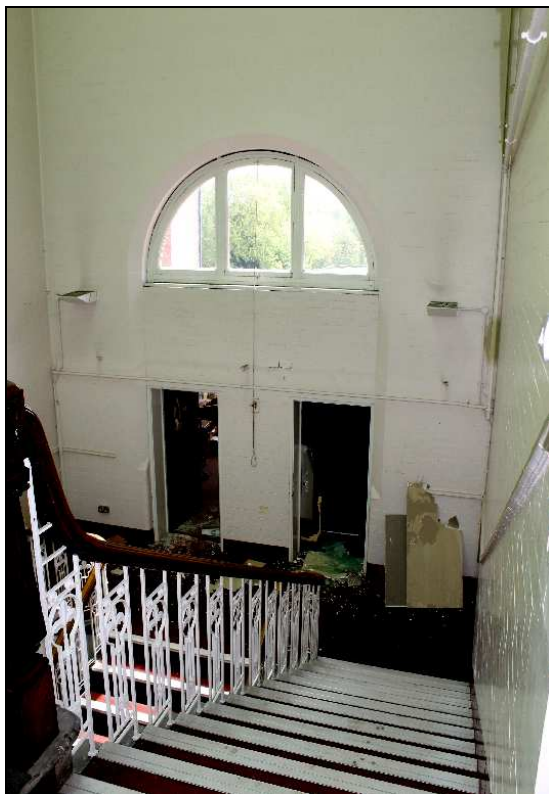
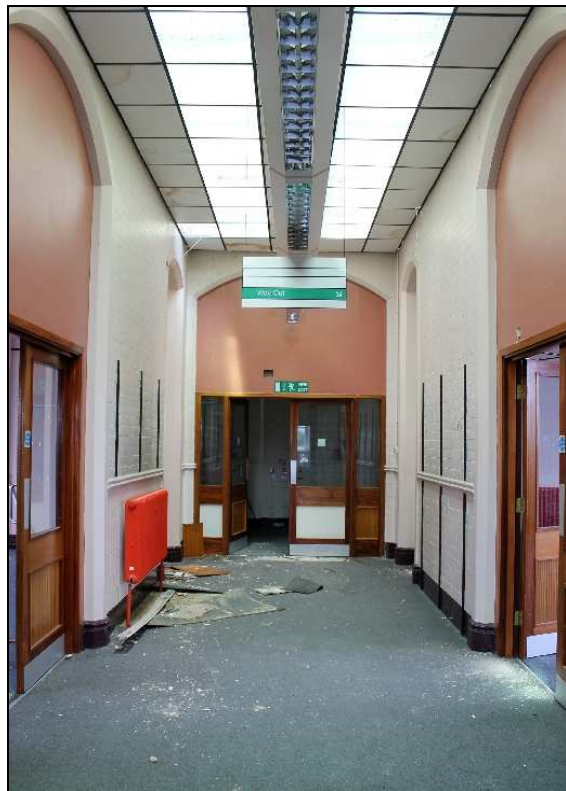
- 4.4.15 The corridor in the South-Eastern Wing was of half length, and had a room to the east and west and another large room to the south which occupied the southern half of the wing (Plates 51 and 52). The room to the west of the corridor included a large blocked doorway at the centre of its northern wall which was also visible from the corridor on the opposing side of the wall (Plate 53). The South-Western Wing was similarly laid out, but the room to the east of the corridor was divided into four smaller spaces and it was unclear how many of these partitions were original (Plate 54). The room at the southern end of this wing was carpeted throughout but preserved beneath it was a polished floor of narrow floorboards that were clearly designed to be originally exposed (Plates 55 and 56).

Plates 50 and 51: Semi-circular headed window over doors opening into rooms 319 and 320 from mid-height landing, and corridor in the South-Eastern Wing, looking north

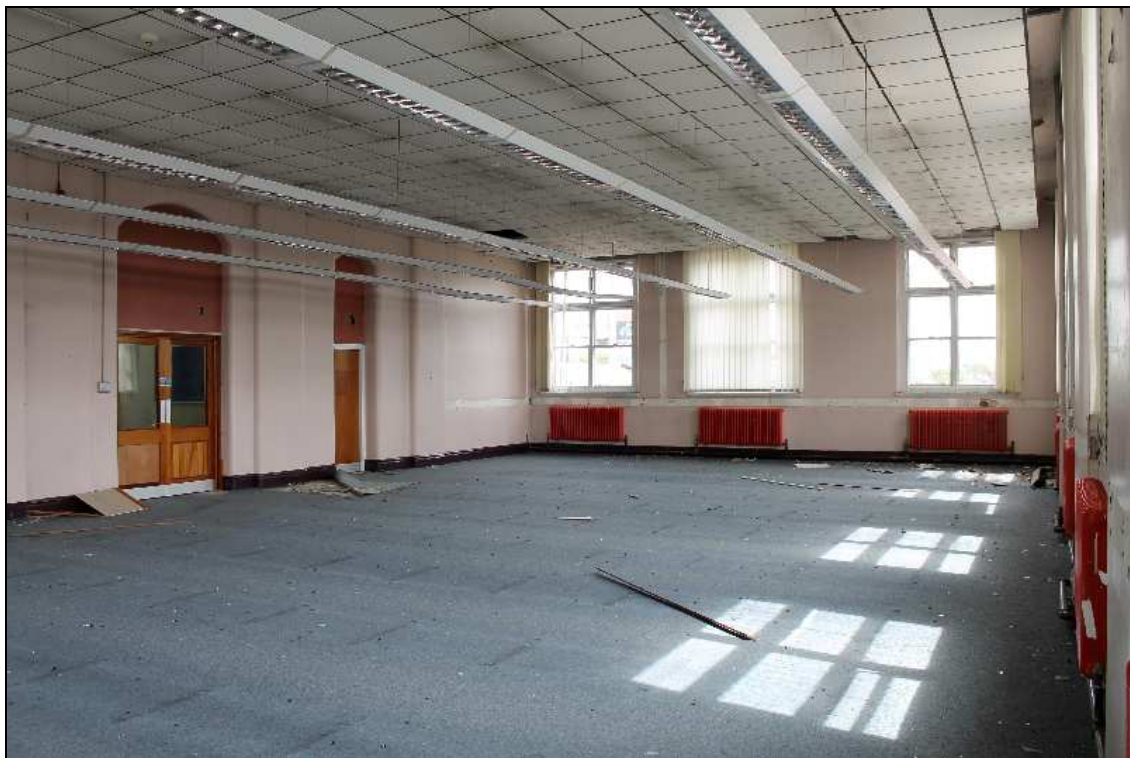
*Plate 52: Room 317 at southern end of the South-Eastern Wing, looking east*

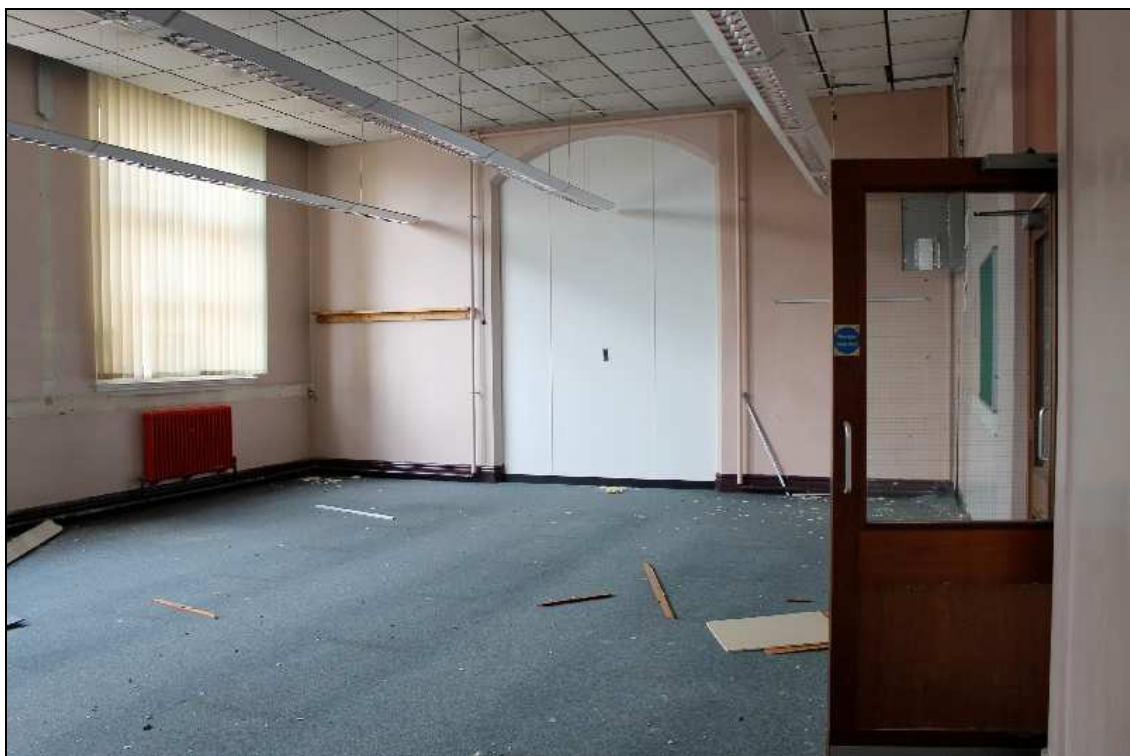
*Plate 53: Large blocked opening in room 318, looking north*

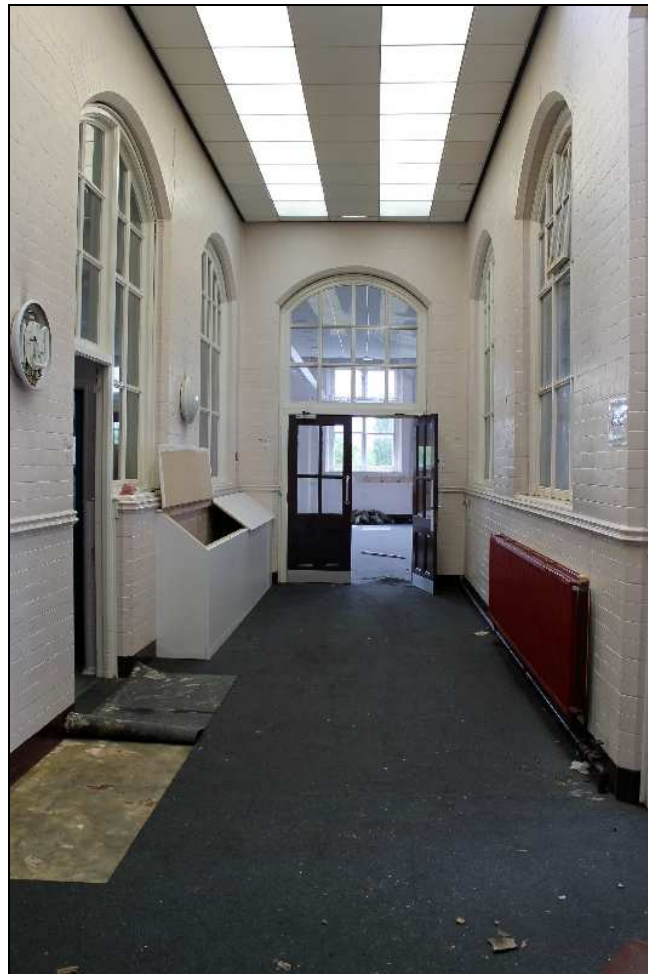
Plate 54: Corridor in South-Western Wing, looking south

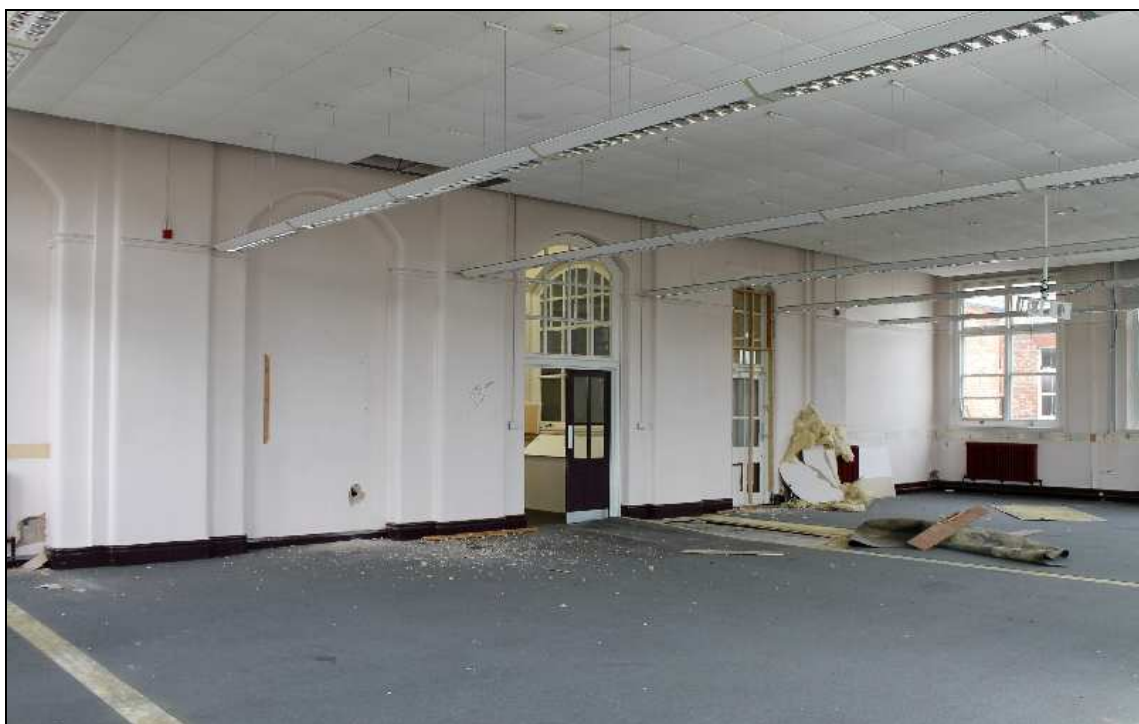
Plate 55: Lecture room 304, facing east

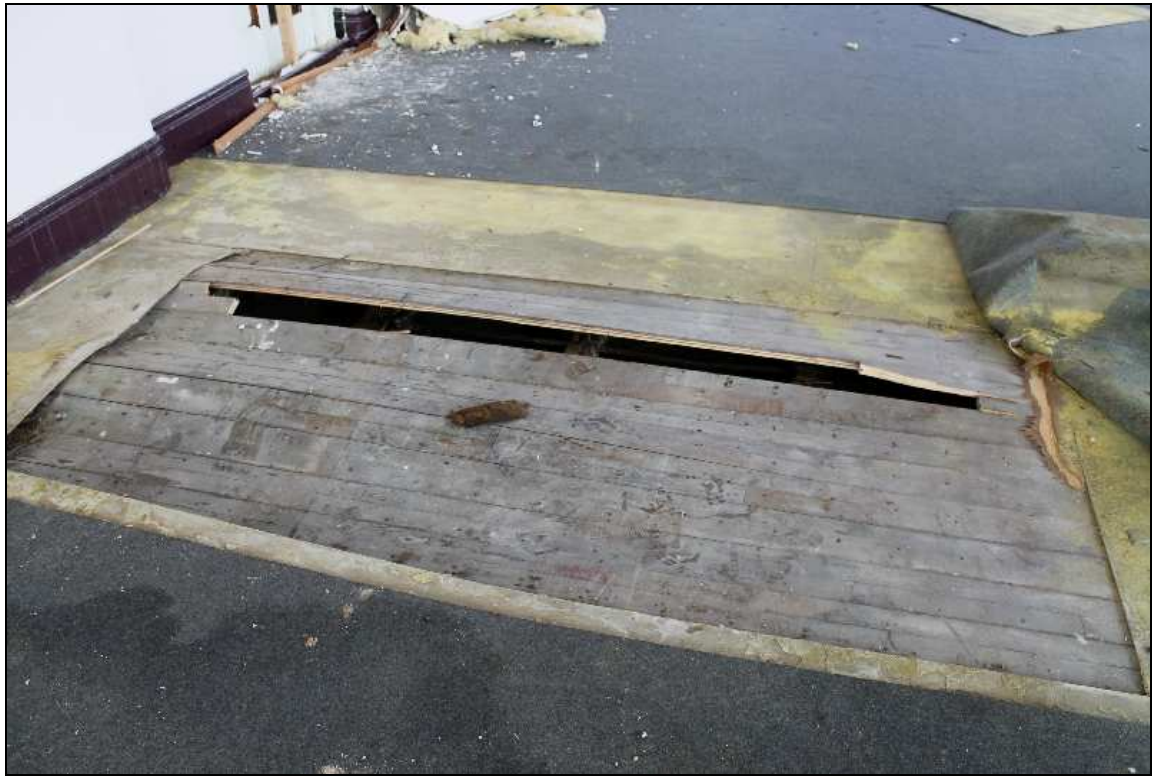
*Plate 56: Original polished floorboard beneath the carpet in room 304*

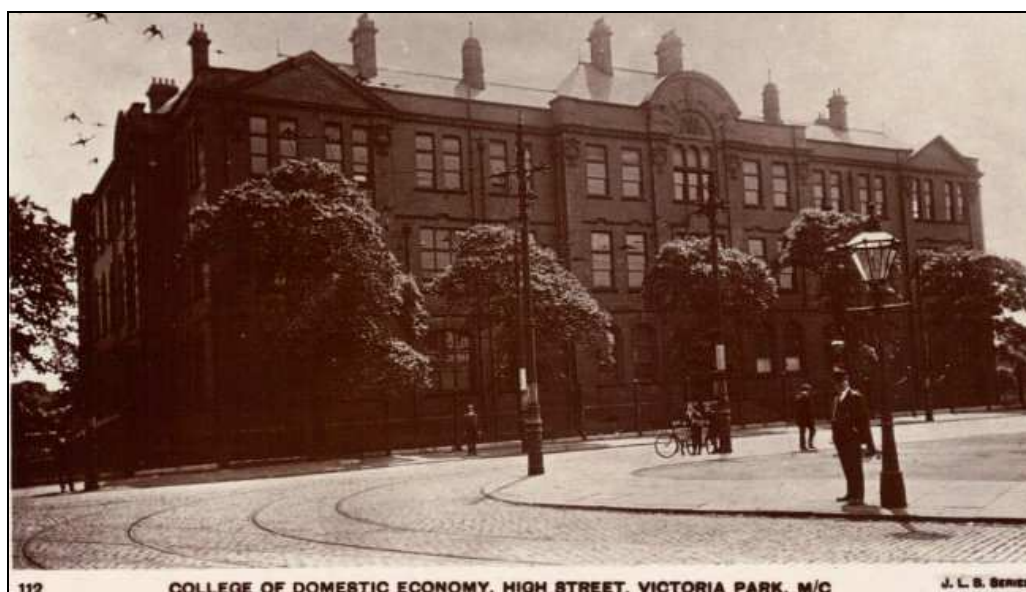
- 5.1.1 The building as completed in 1912 consisted of a main northern range fronting onto a tree-lined Hathersage Road behind a set of iron railings (Plate 57), and an eastern and western wing enclosing three sides of a courtyard to the rear. A stair block with attached privy block projected south from the southern elevation of the main range dividing the courtyard into two. The character of the brick work and architectural details clearly indicate the primacy of the northern elevation of the main range, followed by the eastern elevation of the eastern range and western elevation of the western range. The southern elevations and those facing the courtyard are of a more functional character, and were presumably not expected to be easily visible. The style is classical

Plate 57: College building, early twentieth century facing south west  
([exlibrislinguist.wordpress.com](http://exlibrislinguist.wordpress.com))
