**Elizabeth Gaskell  
Building,  
Hathersage Road,  
Manchester**

**Archaeological  
Building Investigation**

**Nuffield Health**

Issue No: 2015-16/1643

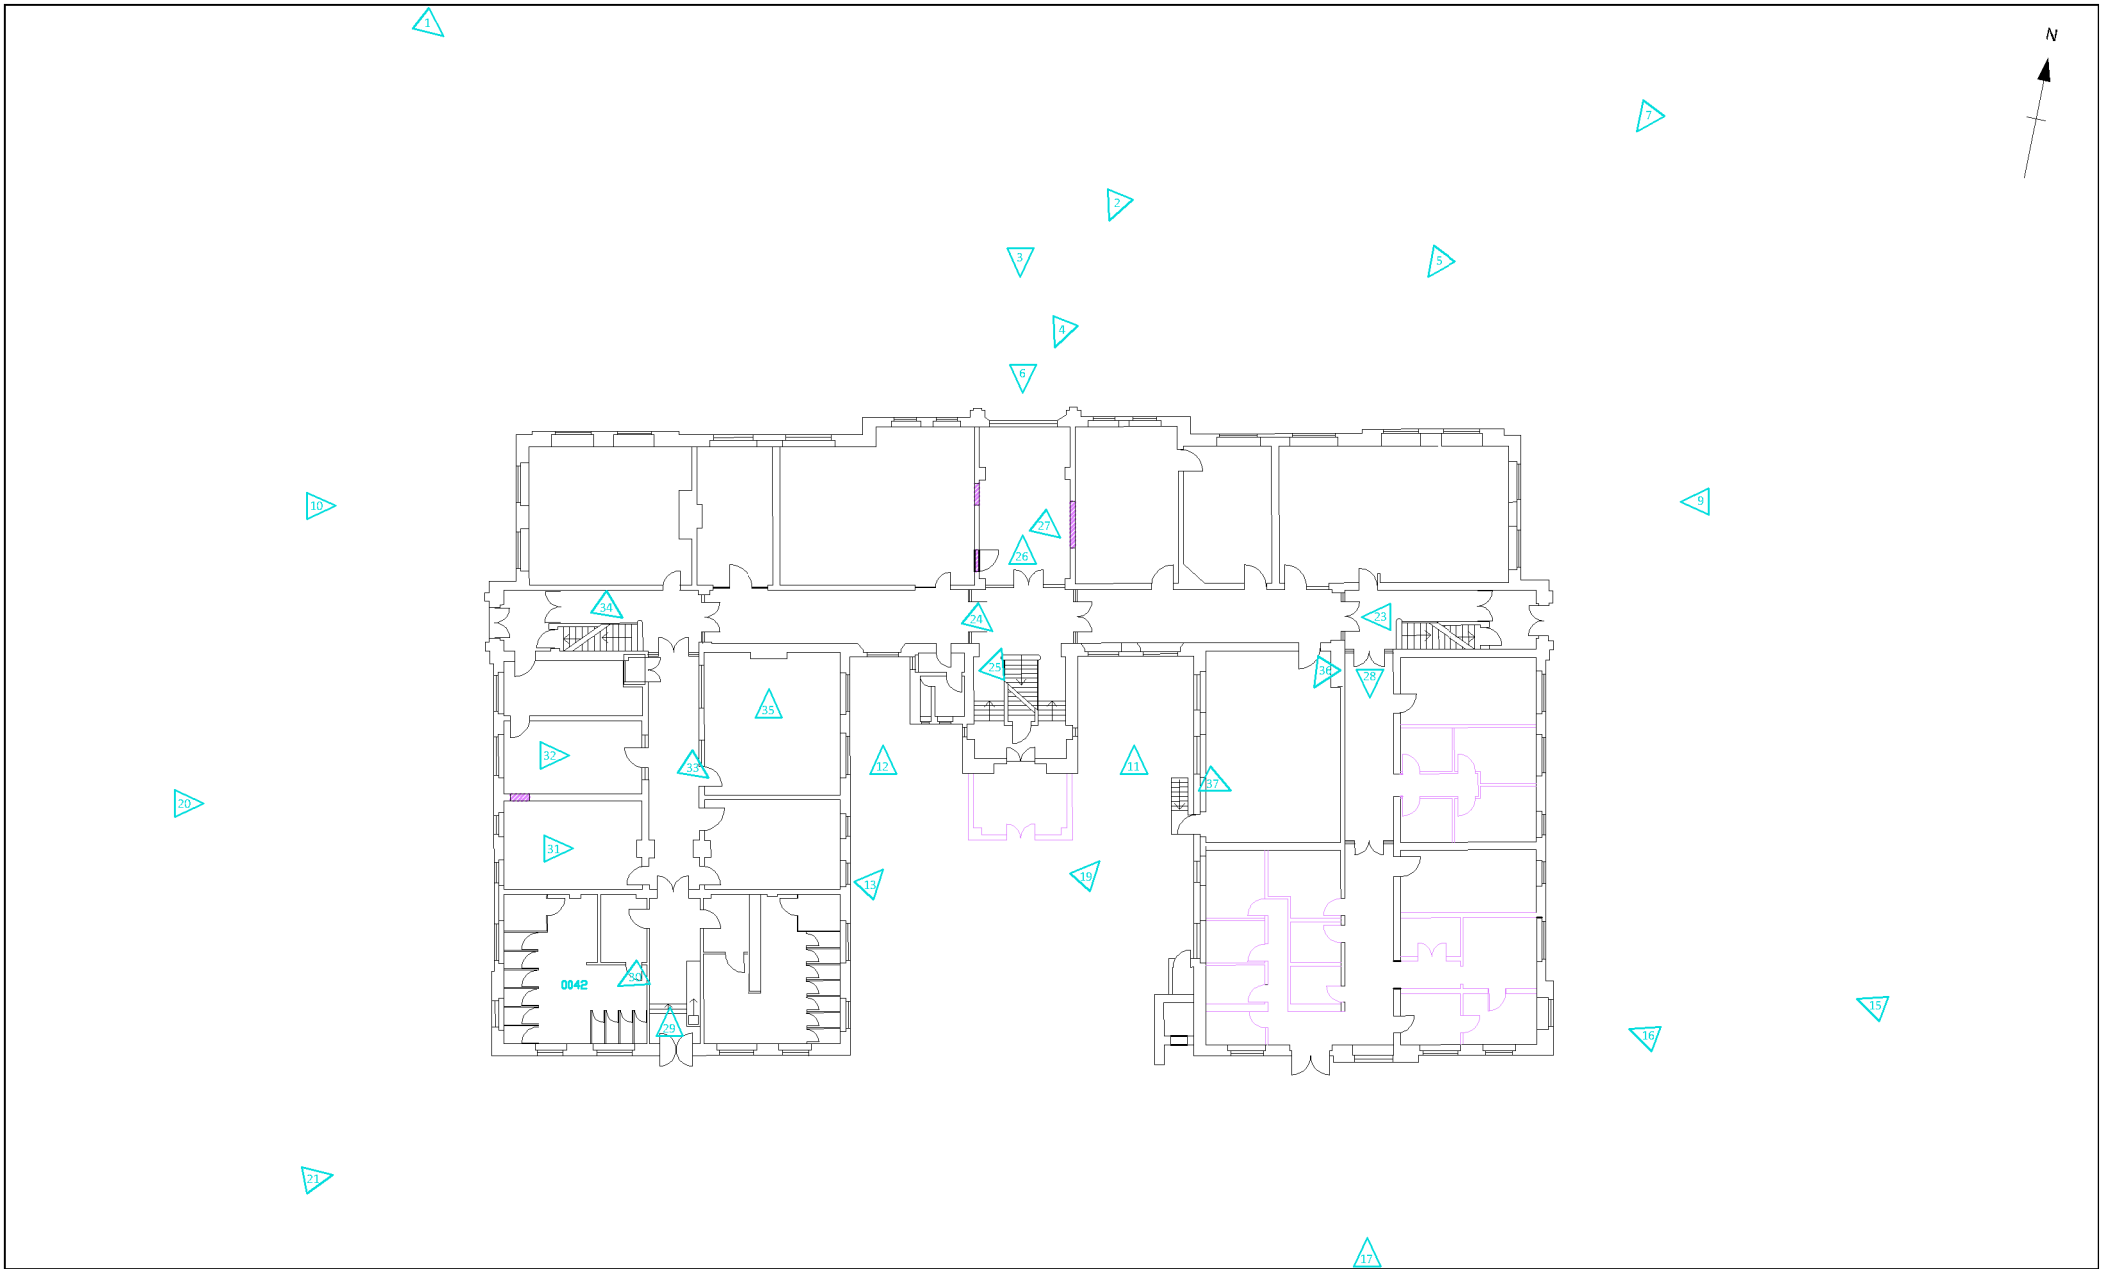
- Original Layout
- Modern Partitions
- Photograph Location and Direction
