Nineteenth Century Almshouses at Oundle Road, Alwalton:
An Archaeological Investigation

Report No. A100

Commissioned By Peterborough Homes Ltd

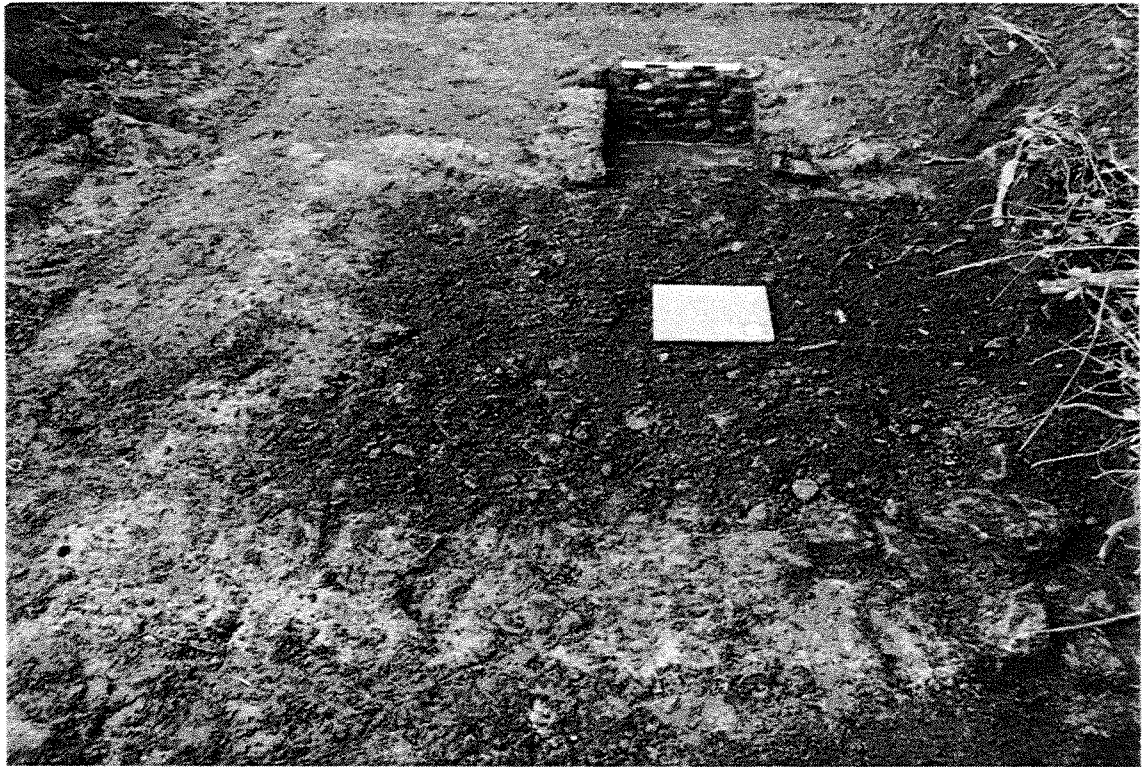
Plate 1 Outhouse with side cell

During the removal of soil along the line of the access road a small building was uncovered (Fig. 1, labelled as outhouse) which had a rectangular shape in plan with a small side cell built into its northern wall (Plate 1). The side cell was excavated to a depth of 300mm, which turned out to be the maximum possible because the water table hindered any further excavation. The soil removed from the cell contained a large amount of coal, rusty metal and occasional fragments of modern pottery; the removal of the soil also uncovered the fine dry stone wall construction of the building.

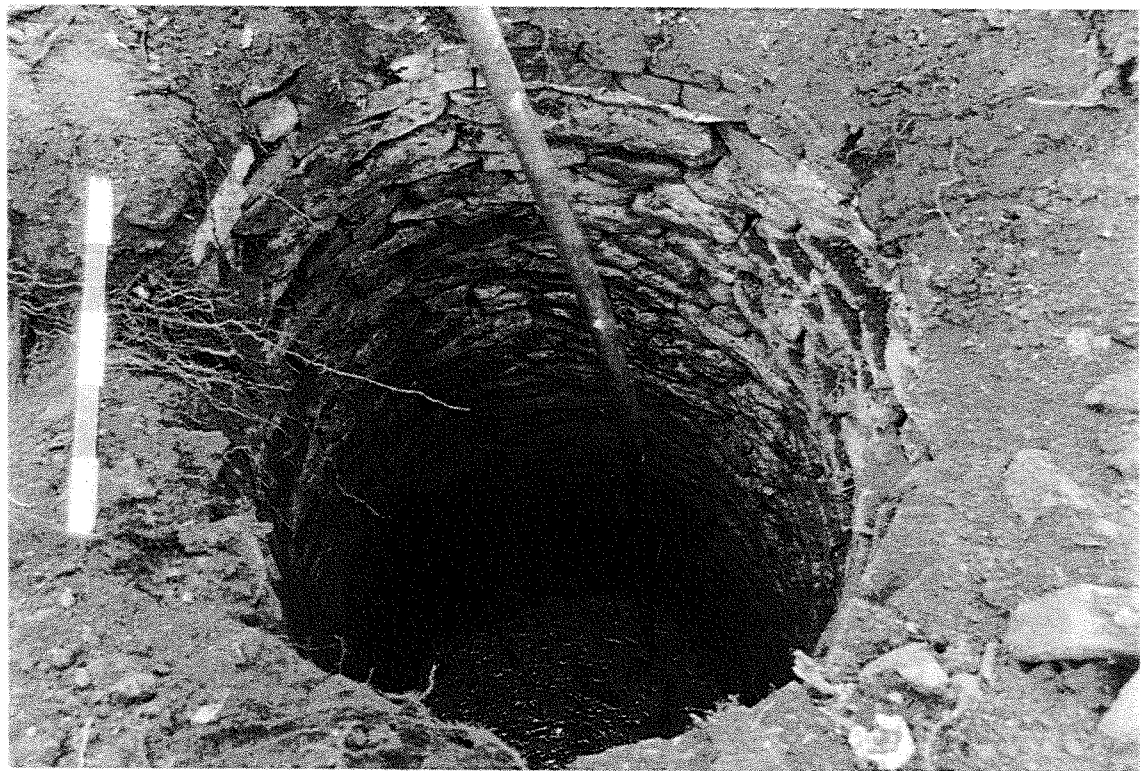
Plate 2 Nineteenth century well

The excavation of the first 1.5 units resulted in the discovery of a well (Plate 2), as shown on the Ordnance Survey map of 1926 (Fig. 1). The well was approximately 6m deep and 1m wide; it dates to the early 19th century which would make the construction of the well contemporary with the building of the Almshouses in c.1802. Further excavation of the foundation trenches revealed a covered stone-built land drain running in a northwest-southeast direction (Plate 3). The drain's construction consisted of sandstone slabs positioned to create a flat-based 'V' shape. Because the drain could not be excavated, owing to the depth at which it was uncovered (1.7m) and the unstable nature of the baulks created by the excavation of the foundation trenches, the feature was recorded photographically.
