The Old Park, Dunham Massey, Trafford, Greater Manchester

Archaeological Investigation and Participation Report

Oxford Archaeology North

February 2017

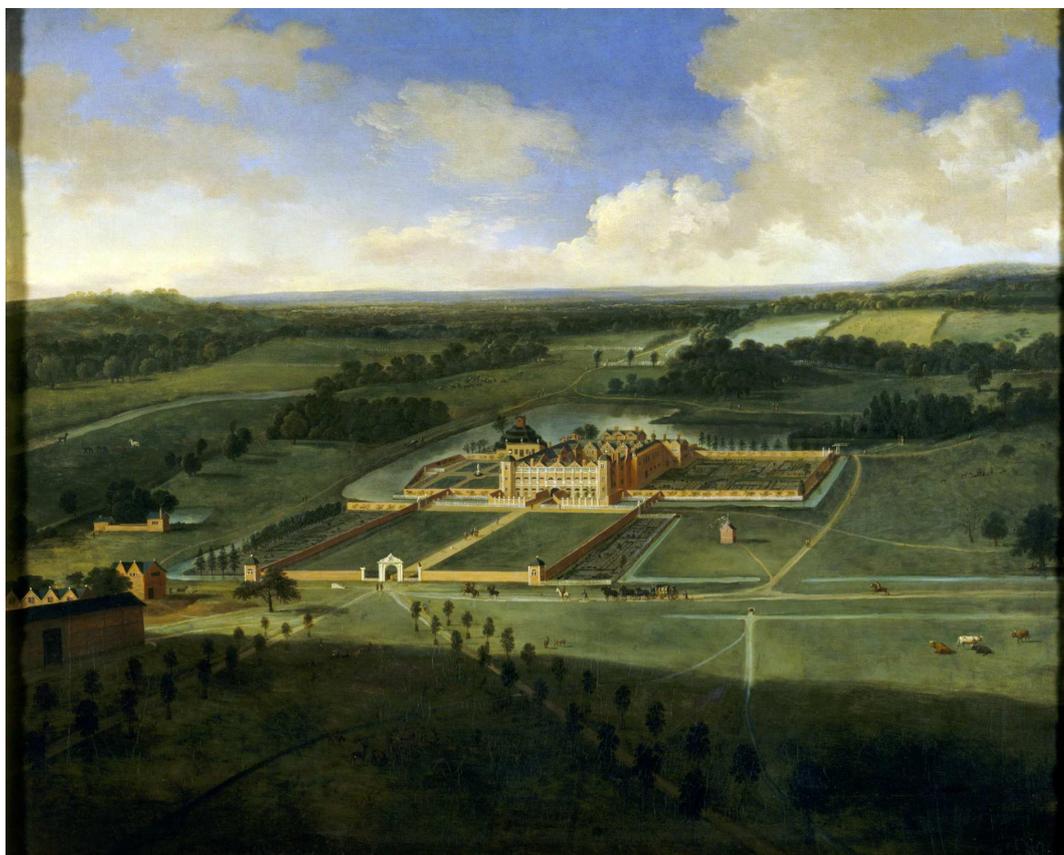
Plate 2: Van Diest (1697) Birds' eye view of Dunham Massey with the supposed gabled stable building just visible in the left foreground

- 3.3.3 Compared to north-east facing focus of Kip and Knyff (1697), Van Diest's (1697) painting (Plate 2) faces more to the north-west, meaning that the onlooker views the front rather than the rear of the large timber frame barn with the waggon door, aligned broadly parallel with South Avenue approaching the main entrance of Dunham Hall. The barn obscures the view of the large stone building, of which four gablets and the roof are visible behind. Whilst the perspective may be skewed in that the large stone building depicted by Kip and Knyff (1697) is now behind and therefore further away than the barn, it appears much smaller when compared with the barn.

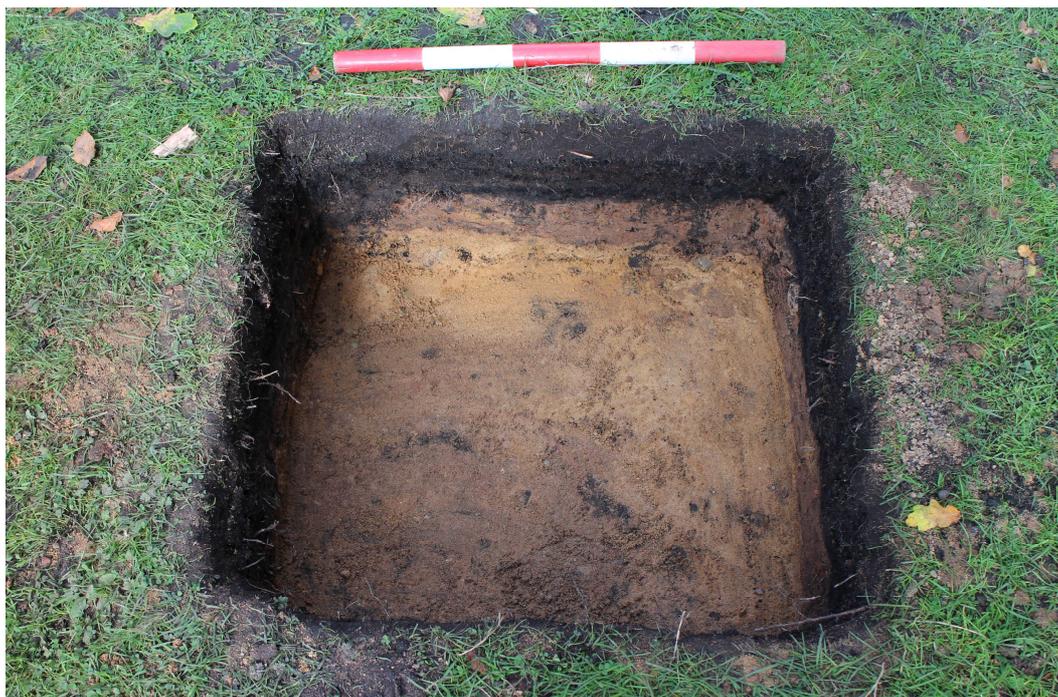
Plate 3: Test Pit **19**, viewed toward the north, showing cinder surface (**1902**) lying below topsoil (**1901**; 0.5m scale)

6.3.1 Test Pits **17 – 21** (Fig 10) revealed two shallow north/south aligned gullies **2006** and **2104**, cut into the underlying natural sands **2105** or subsoil deposit **2003**. That they were cut into different deposits, makes it difficult ascertain whether they were the same feature, despite their proximity and shared alignments. A cinder surface **1802**, **1902**, **2002** and **2101** was revealed within the north/south orientated linear earthwork, explaining the strong geophysical response **M1** (Plate 3). Finds comprised burnt bone, melted glass/slag from the cinder layer **1902**, and window glass from the topsoil **1801**.

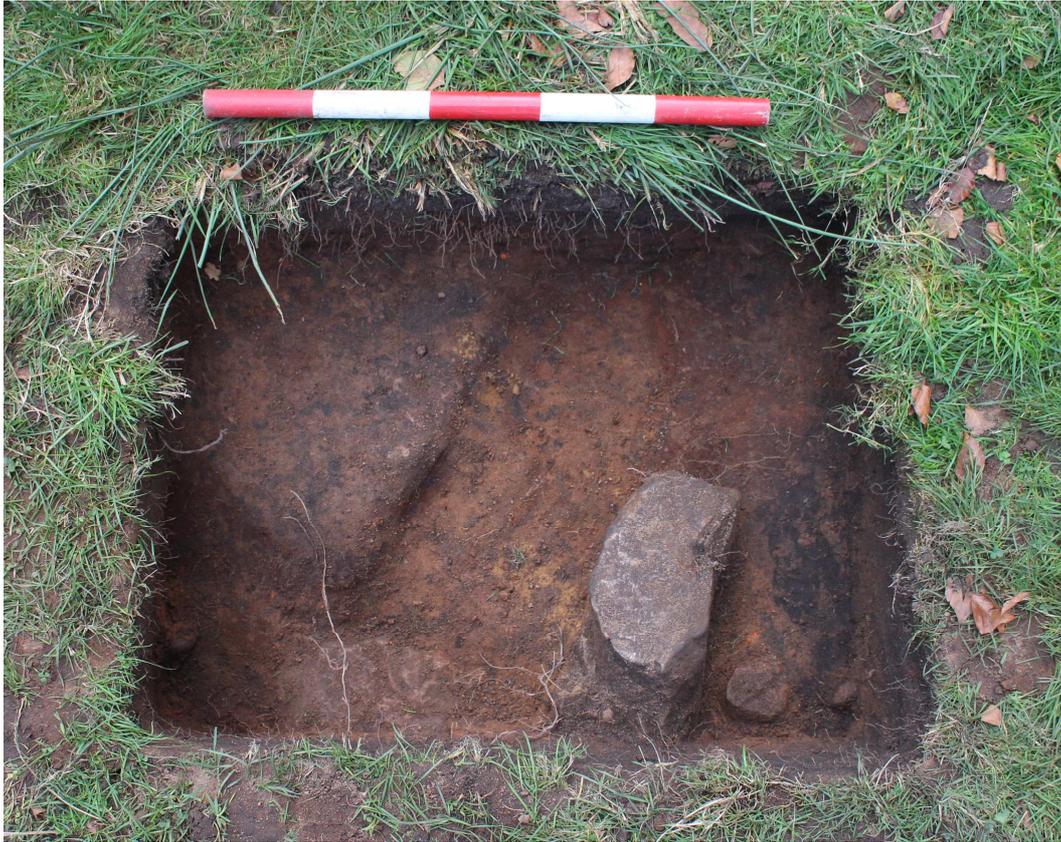
Plate 4: Test Pit **13**, viewed toward the north-west, showing cut feature **1306** (0.5m scale)

6.3.2 Test Pits **11 – 16** (Fig 11) had been placed in order to examine possible rectilinear feature identified by both the geophysical and topographic surveys (**M5** and **T4**). Cut features were identified within Test Pits **13**, **15** and **16**, which appeared to be fairly narrow gullies **1306**, **1503**, **1603** and **1605**, again it was not clear what these features represented (Plate: 4). It is entirely possible that they represented structural elements such as beam slots, but the evidence is lacking. Six pottery sherds, all from a cream ware hollowware vessel were recovered from the top soil in Test Pit **15**.

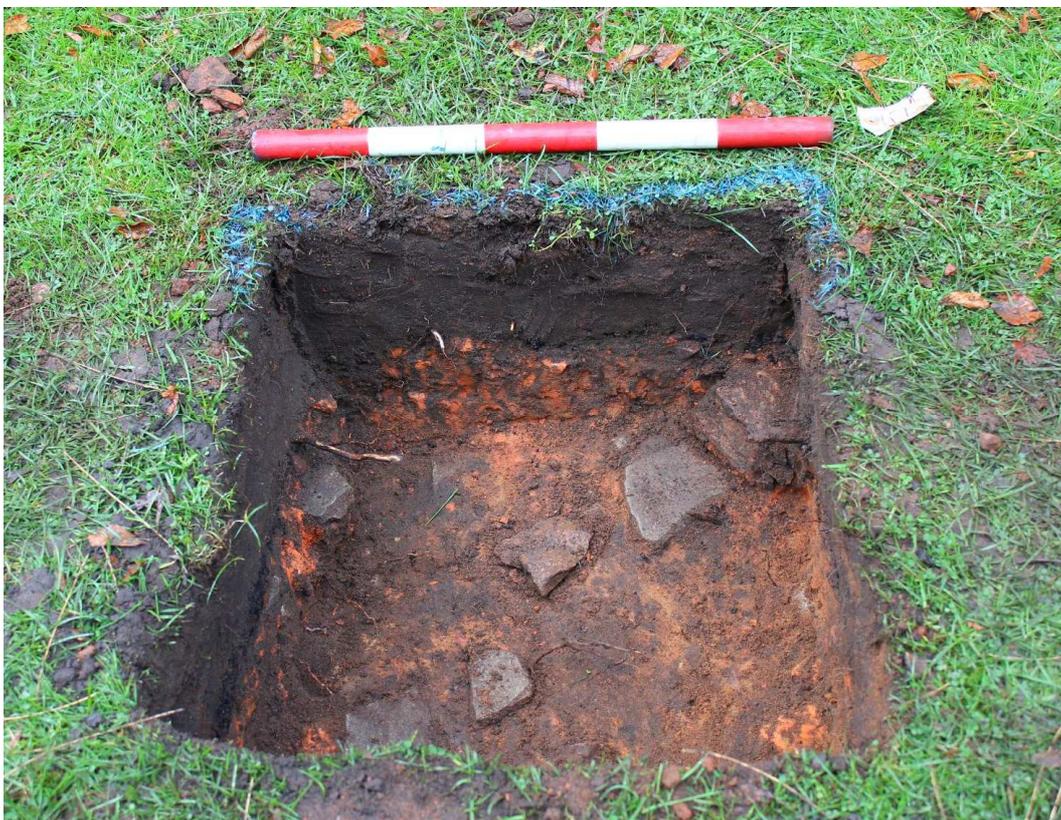
Plate 5: Test Pit **47** during excavation, viewed toward the south-west, showing CBM layer **4705** scattered with possible stone roof tile fragments (0.5m scale)

6.3.4 Test Pits **45 - 48** (Fig 13) recovered more evidence of the clinker layers **4504**, **4505**, **4607**, **4608**, **4705** (Plate 5) and **4804**, with the much the same sequence represented; clinker layers overlain by subsoil sealed by CBM layers extending north-west as far as Test Pit **50**. Test Pit **46** contained two cut features **4605** and **4610**, which were seemingly later than the kiln.

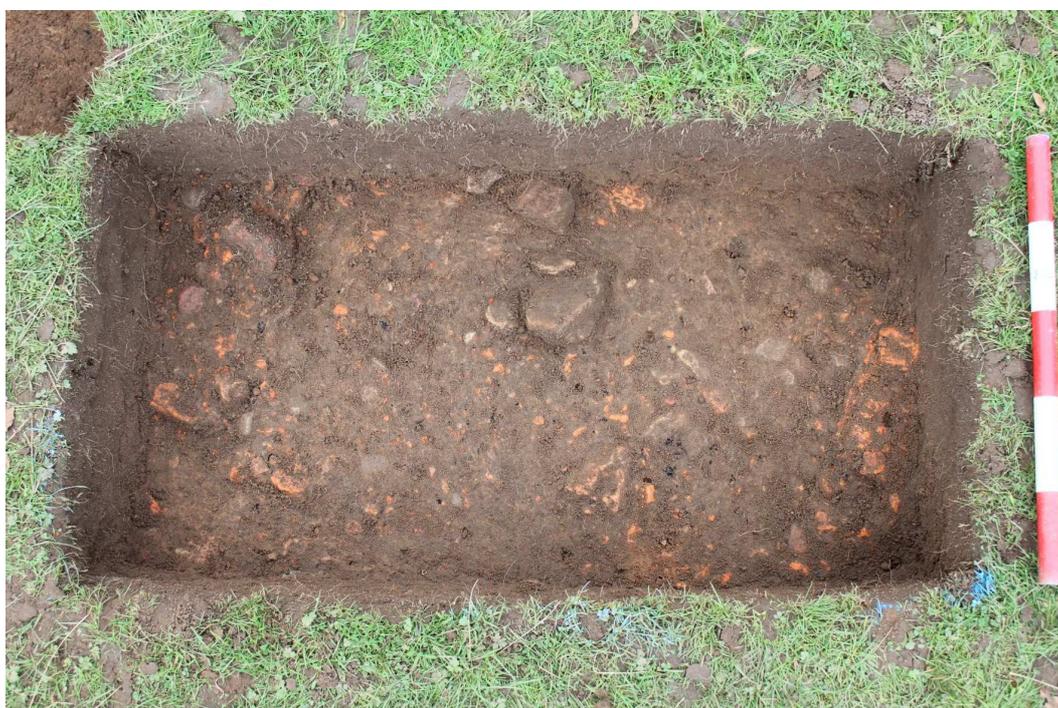
Plate 7: Possible internal surface Test Pit **37**; **3703**. North at top of image (0.5m scale)

6.3.8 The north-west/south-east arm of **MI** identified during the geophysical survey was investigated by Test Pits **22-26**, and **37** and **41**. A cut feature **2505**, was noted over the approximate position of this arm of the response. Two distinct fills **2502** and **2504** both contained brick fragments. TPs **37** and **41** excavated in response to the feature identified within Test Pit **25**. Both Test Pits contained distinct silty-clay CBM bearing layers/surfaces **3703** and **4102** which would have been within side any putative building foot print. Layer/surface **4102** produced a sherd of brown stoneware with freckled glaze, with a date range of the late seventeenth to late eighteenth century. Eighteenth century Dark glazed earthenware and a possible fragment of kiln fabric was recovered from the layer above (**4102**).
