**ALBION MILL,  
BURNLEY ROAD  
EAST,  
NEWCHURCH,  
LANCASHIRE**

**Archaeological Building  
Investigation**

**Oxford Archaeology North**

December 2013

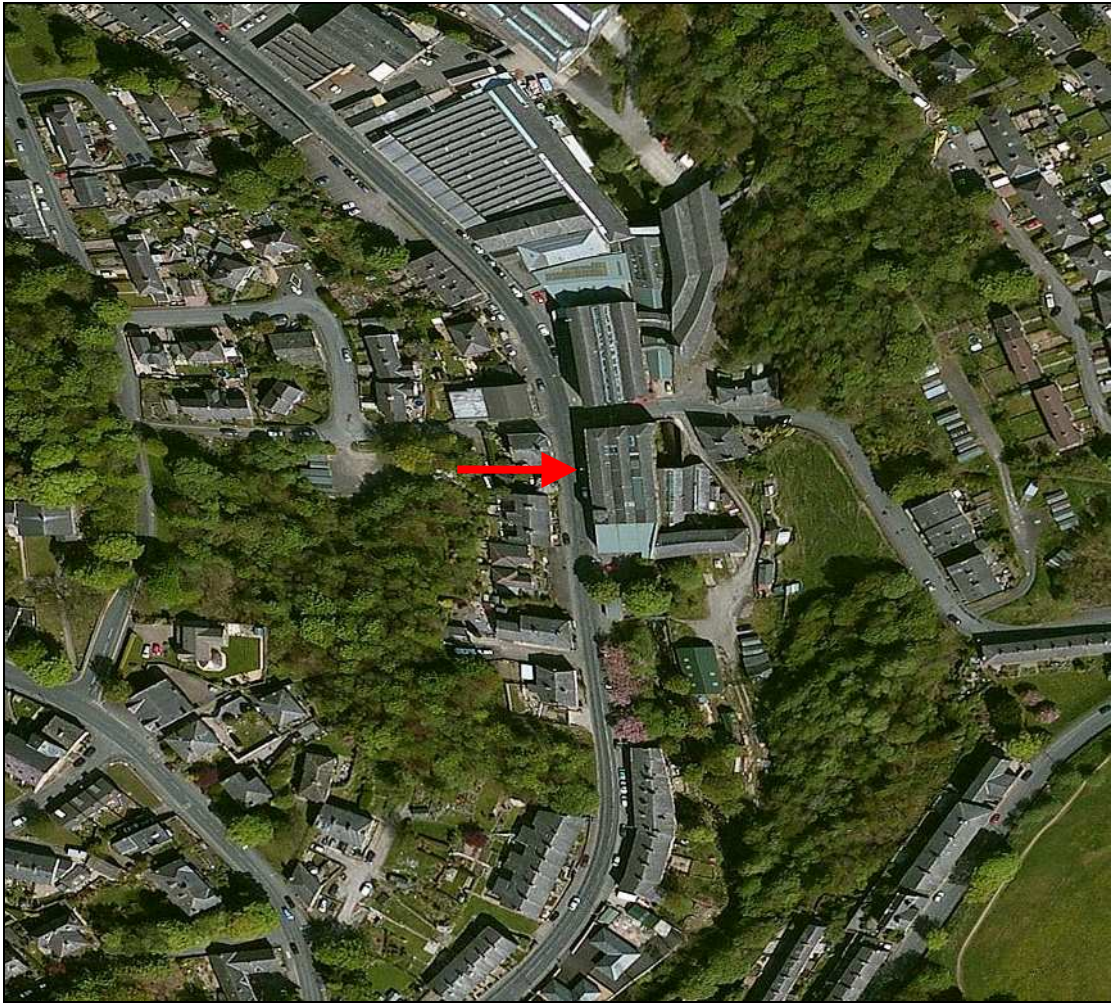
*Plate 1: Recent aerial view of Albion Mill and adjacent mills on Burnley Road East*

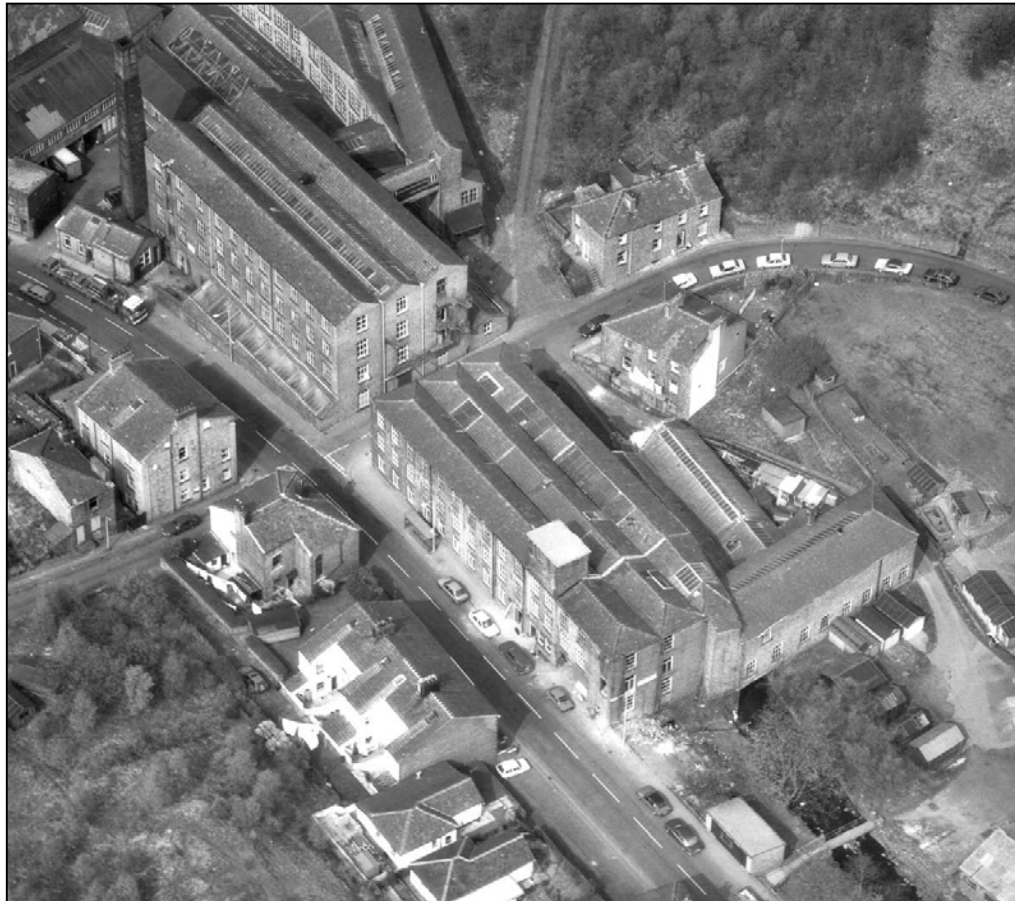
Plate 6: Aerial view of Albion Mill in 1989

- 3.1.10 The Ordnance Survey 1:2500 map of 1962 annotates the mill as a warehouse, although the footprint of the buildings does not appear to have been altered. Whilst the detail on the map is not entirely clear, it seems that the mill chimney is shown. However, this had been demolished by the late 1980s, when the mill was captured on aerial photography carried out by the former RCHME (Plate 6). This photograph also shows the southern part of the mill to have been of three storeys

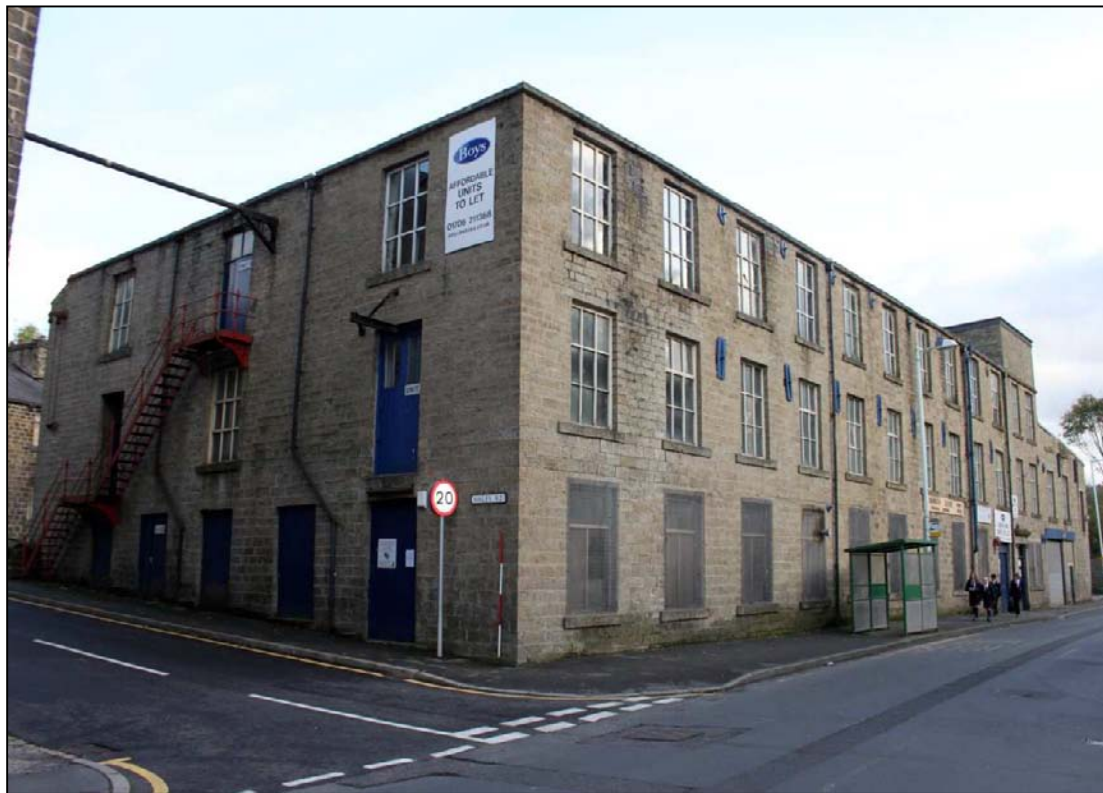
Plate 7: The western and northern elevations of Albion Mill, looking south-east

- 4.2.2 The western elevation, fronting onto Burnley Road East, displays ten windows to each of the first and second floors (Plate 7), and this pattern is repeated on the ground floor, excepting the southernmost bay which provided the main entrance to the building. The lower jambs of this doorway showed signs of having been cut, perhaps with a mechanical saw, and it is possible that this too once served as a window. Alternatively, the original door opening may have been widened for better access.

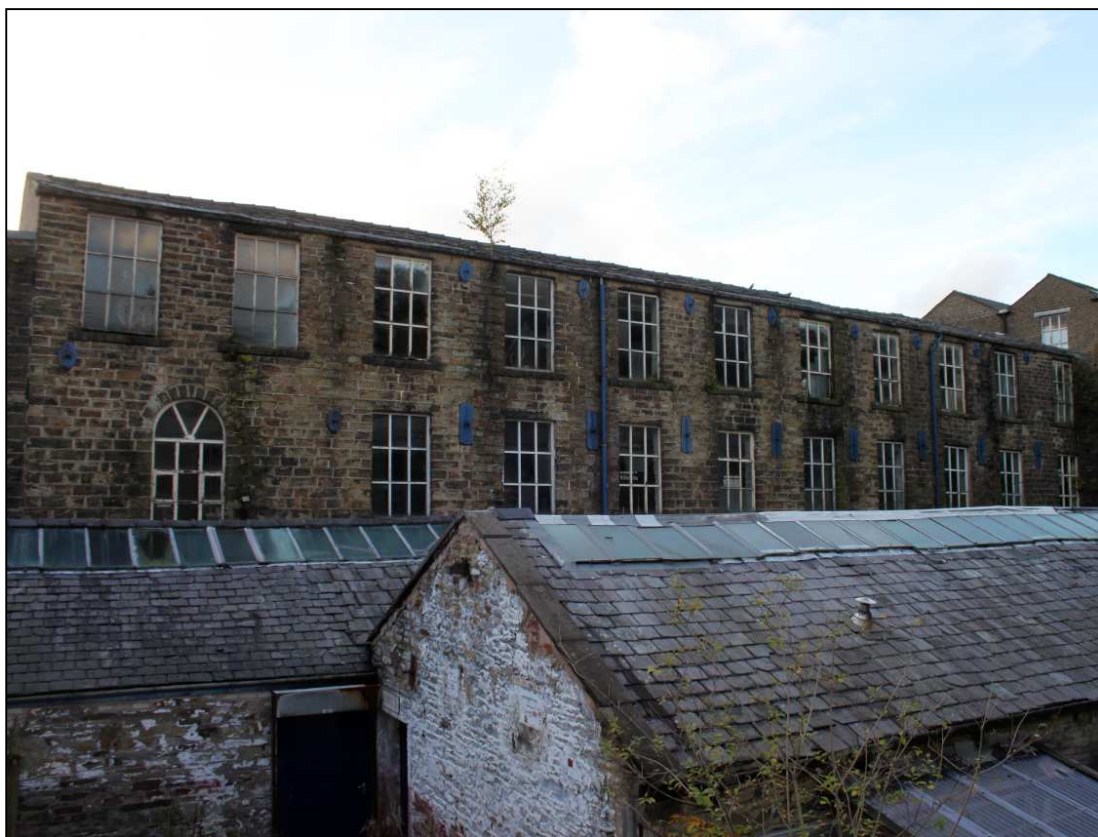
Plate 8: The eastern elevation of Albion Mill, showing the first and second floors rising above single-storey buildings to rear, with contiguous engine house at the southern end

- 4.2.3 The eastern elevation was similar to that of the western, although the occurrence of only nine windows to each floor reflects a slightly different spacing arrangement, and the presence of a narrow tower at the northern end. With the exception of the northern three bays, the ground-floor windows are largely obscured by the roof line of a later extension (Plate 8), but the presence of a cellar was denoted by at least two windows facing directly on to the Whitewell Brook below ground-floor level.

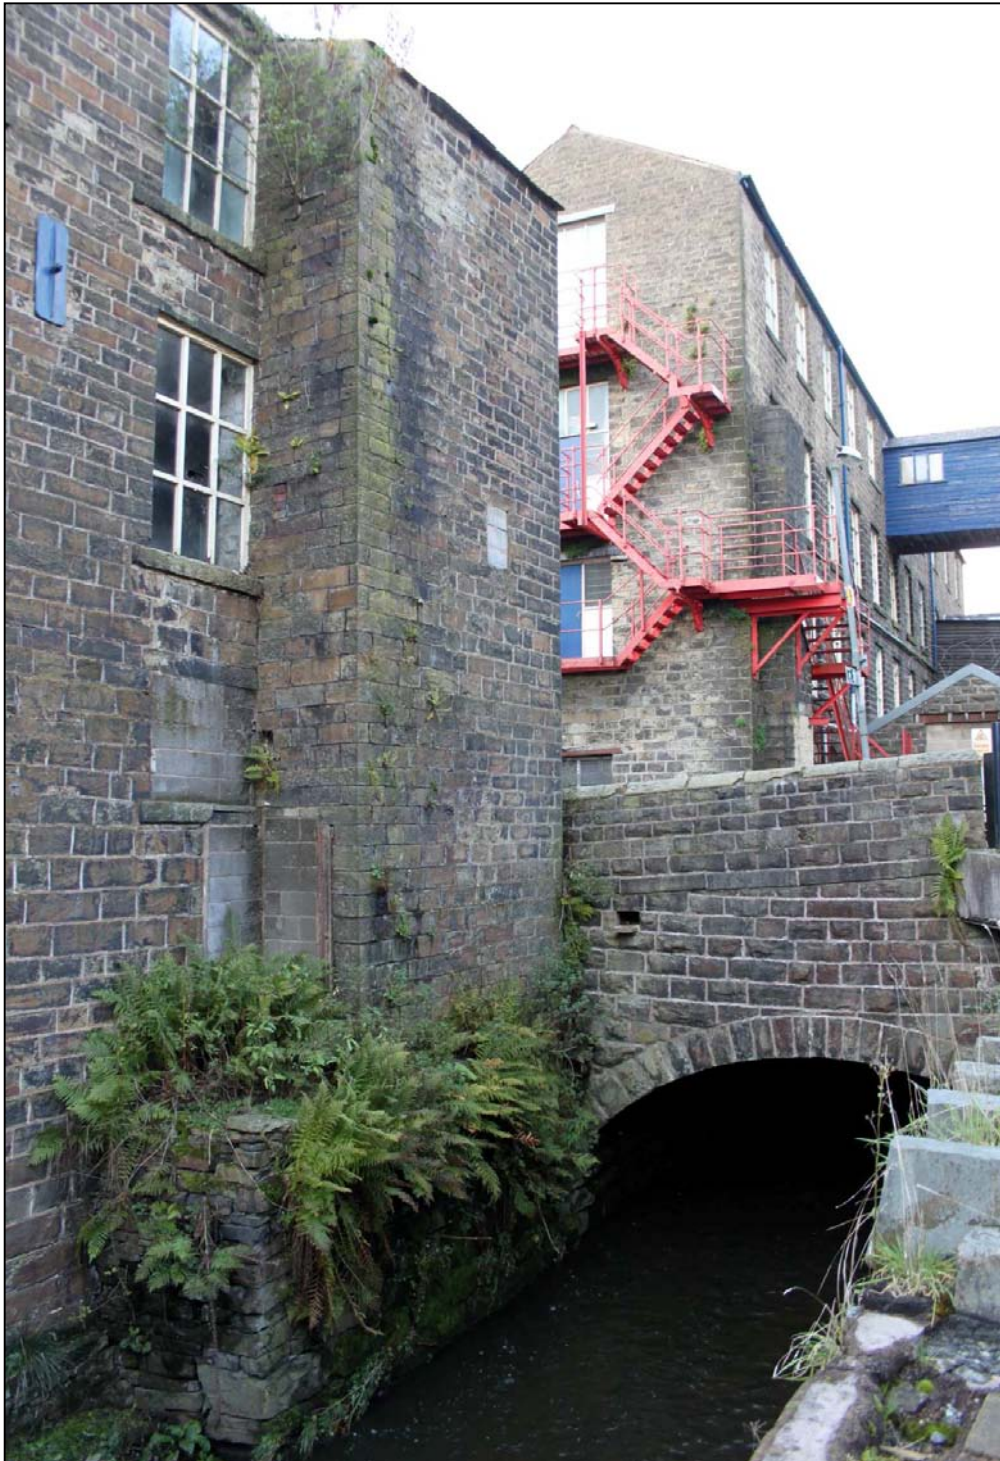
Plate 9: The tower abutting the north-eastern corner of the spinning block

- 4.2.4 A narrow rectangular tower projected from the eastern elevation at the north-eastern corner of the spinning block (Plate 9). Its eastern face incorporated a small blocked rectangular window at first-floor height, while on the southern elevation of the floor below a narrow doorway at the base of tower led out onto a small platform adjacent to the bridge carrying Wales Road across the Whitewell Brook (Plate 9). Both the eastern and western elevations displayed iron wall ties at first- and second-floor height, the lower examples being rectangular, and the higher ones of oval design.

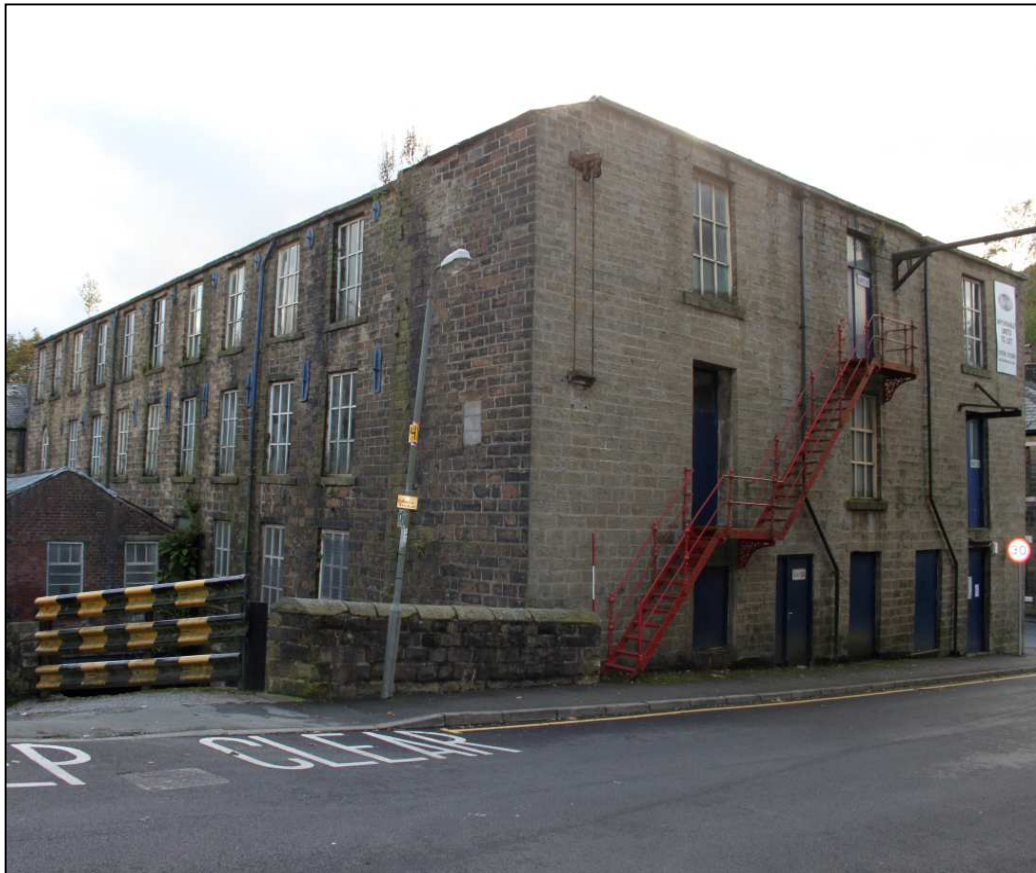
*Plate 10: The northern and eastern elevations of Albion Mill, showing the iron fire-escape stair to Wales Road, looking south-west*

- 4.2.6 The first floor was arranged more regularly, with a loading door below an iron hoist bracket at the centre of the western bay, a three-over-three light window to the central bay, and a second doorway in the eastern bay (Plate 10). The second floor had windows within western and eastern bays, and a doorway in central bay accessed via an iron fire-escape staircase aligned parallel to the elevation and rising from east to west (Plate 10). This staircase also provided access to the eastern doorway on the first floor, and the initials 'CM' were cast into the supporting brackets beneath each of the two flights of stairs (Plate 11). A hoist gantry is bolted to the wall at the east end of the elevation between the first and second floors.

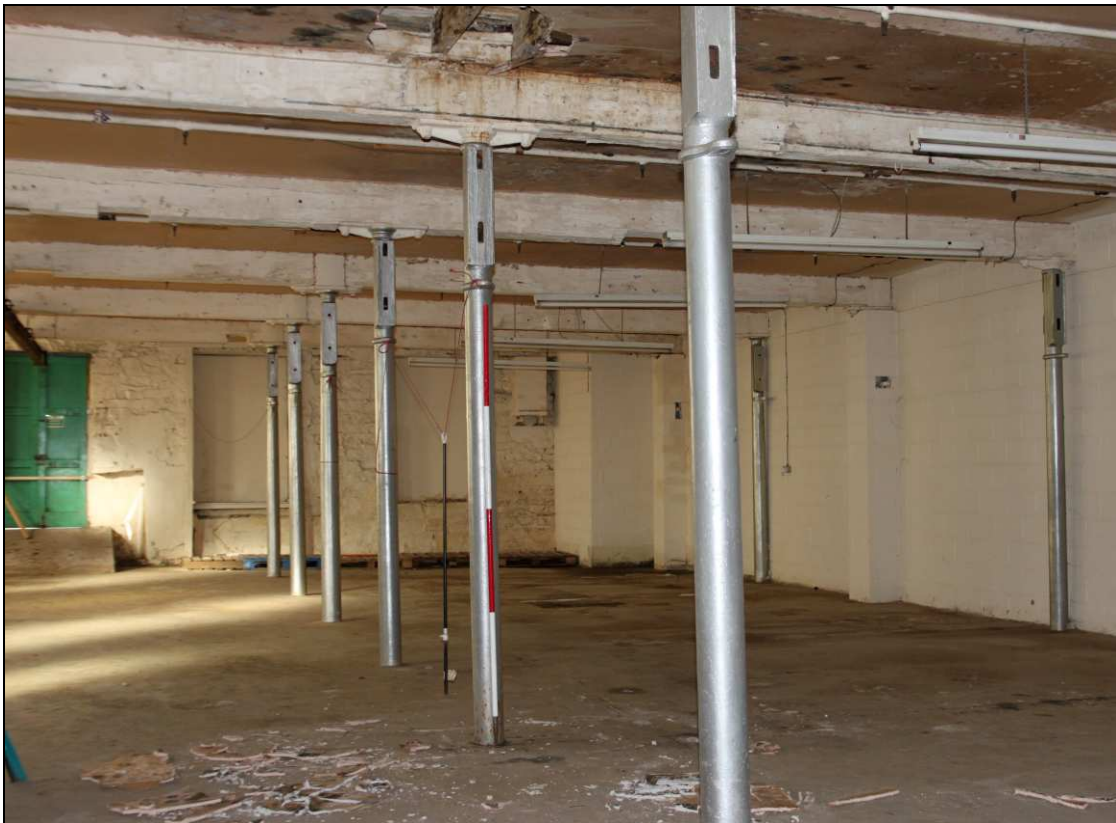
*Plate 12: General view across the ground floor of the western part of the spinning block, showing two rows of columns and modern cinder-block partition*

- 4.2.9 **Ground floor:** the ground-floor was divided into ten bays, with two rows of cast-iron columns arranged along the length of the building to support transverse timbers (Plate 12). The ground floor had been sub-divided by a modern cinder block partition along the length of the building, with a second creating a corridor at the southern end of the building (Fig 3; Plate 18). A modern toilet block had also been constructed in Bays 8 and 9, and a small office had been created to the north with the erection of a stud wall.

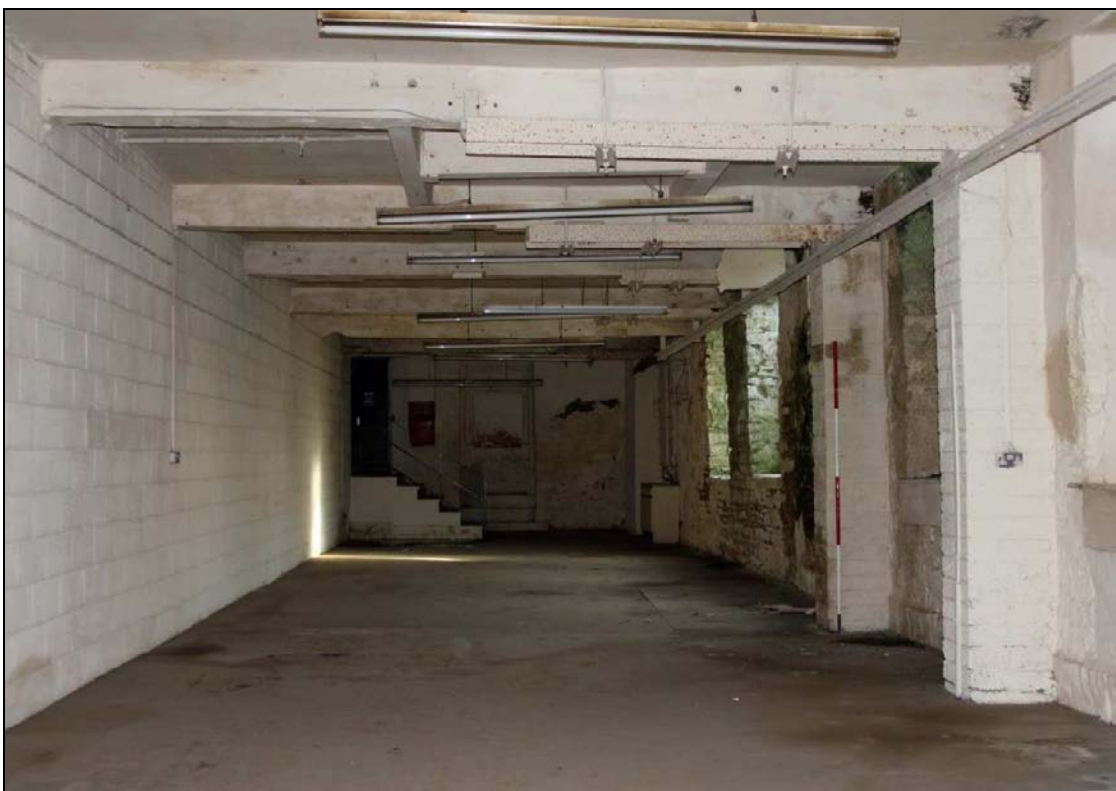
*Plate 13: General view across the ground floor of the eastern part of the spinning block, showing the concrete floor and the late cinder-block partition*

- 4.2.10 The floor was of concrete, which clearly represented a late modification (Plate 13). The concrete retained scars for at least four machine beds at the northern end of the central bay.

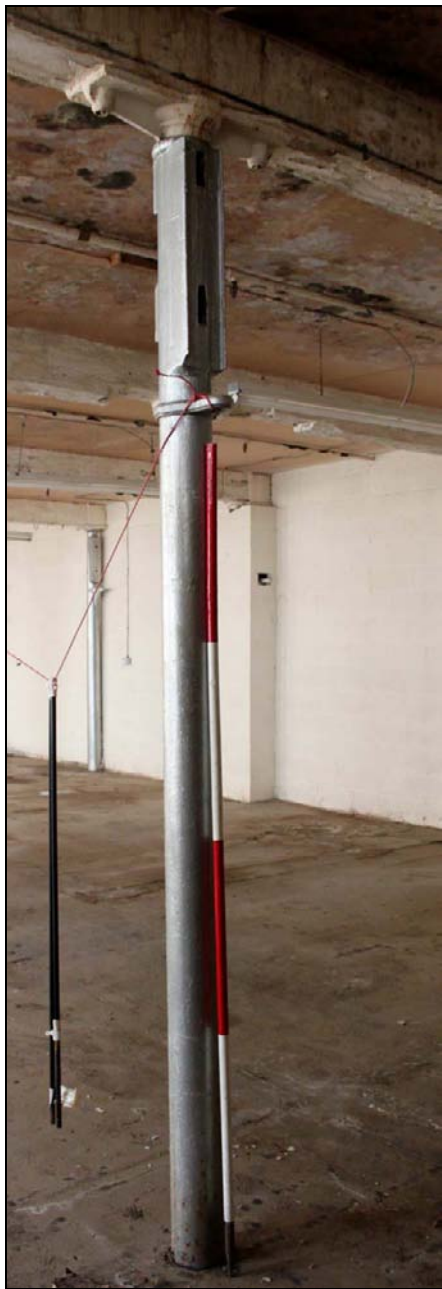
Plate 14: Type 1 column

4.2.11 There are two distinct types of column on the ground floor. Those to the north of Bay 4 had a simple hollow chamfer below a quarter roll mould at the head of the shaft (Plate 14). Each corner of the head plates had been replaced with a curved cutaway to leave the bolt holes protruding to the east and west within two curved projecting tabs. The bolt holes on this type had low profile flanges. The second type incorporated a crush box as part of the casting to reduce the load on the transverse floor beam that the column supported (Plate 15). These columns had been cast with a slightly dished bolting face projecting from one side of the shaft. Two vertically arranged bolt holes with heavy projecting flanges were positioned upon the opposing side of the shaft, and a supporting bracket sat beneath each bolting face.

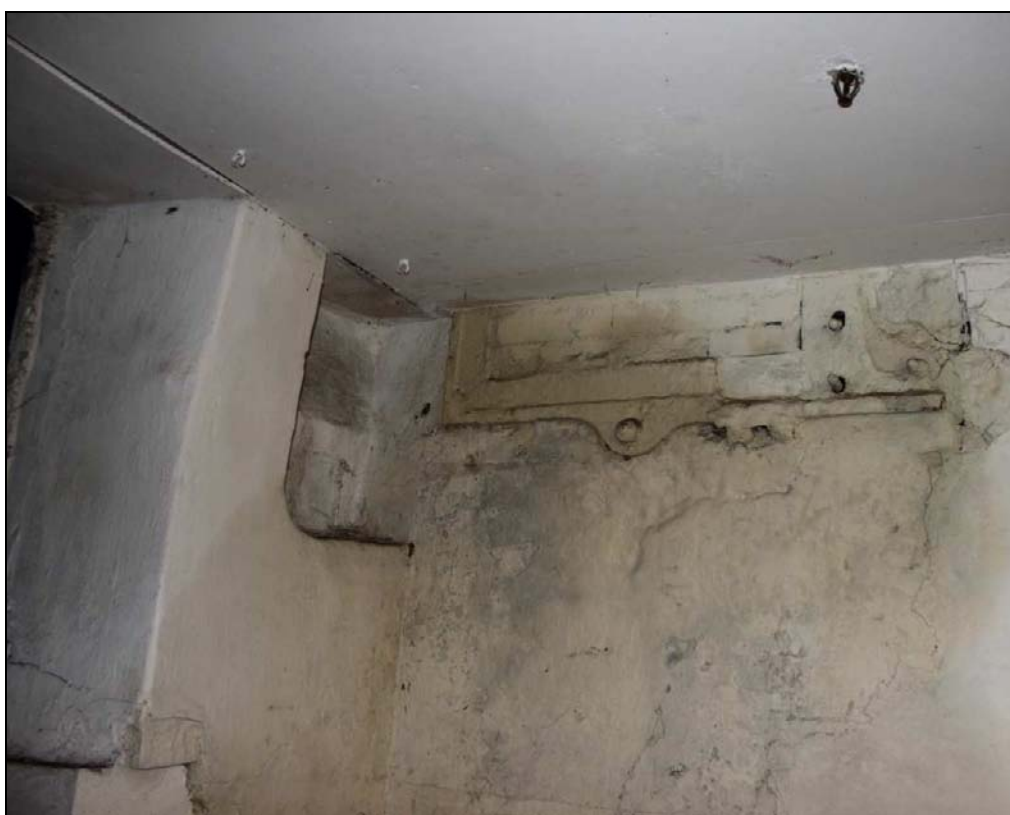
*Plate 16: Bearing box set into the eastern end of the wall dividing the spinning block from the engine house, together with a cut-out in the eastern wall for bevel gearing.*

- 4.2.12 The bolting faces of the columns on the ground floor appeared to have been arranged to distribute power across the building, rather than along its length, as evident on the first and second floors. This may indicate that the columns have been repositioned at some point. Each of the columns had a notable lean towards the west.
- 4.2.13 A large, infilled cast-iron bearing box survives at the eastern end of the southern wall, with a recess in the adjacent eastern wall for a bevel gear (Plate 16). This had presumably been intended to enable power to be transmitted across the width of the building. Pairs of bolt holes were identified in transverse timbers repeating (Plate 17), indicating the location of hangers designed to carry the lineshafting along the building.

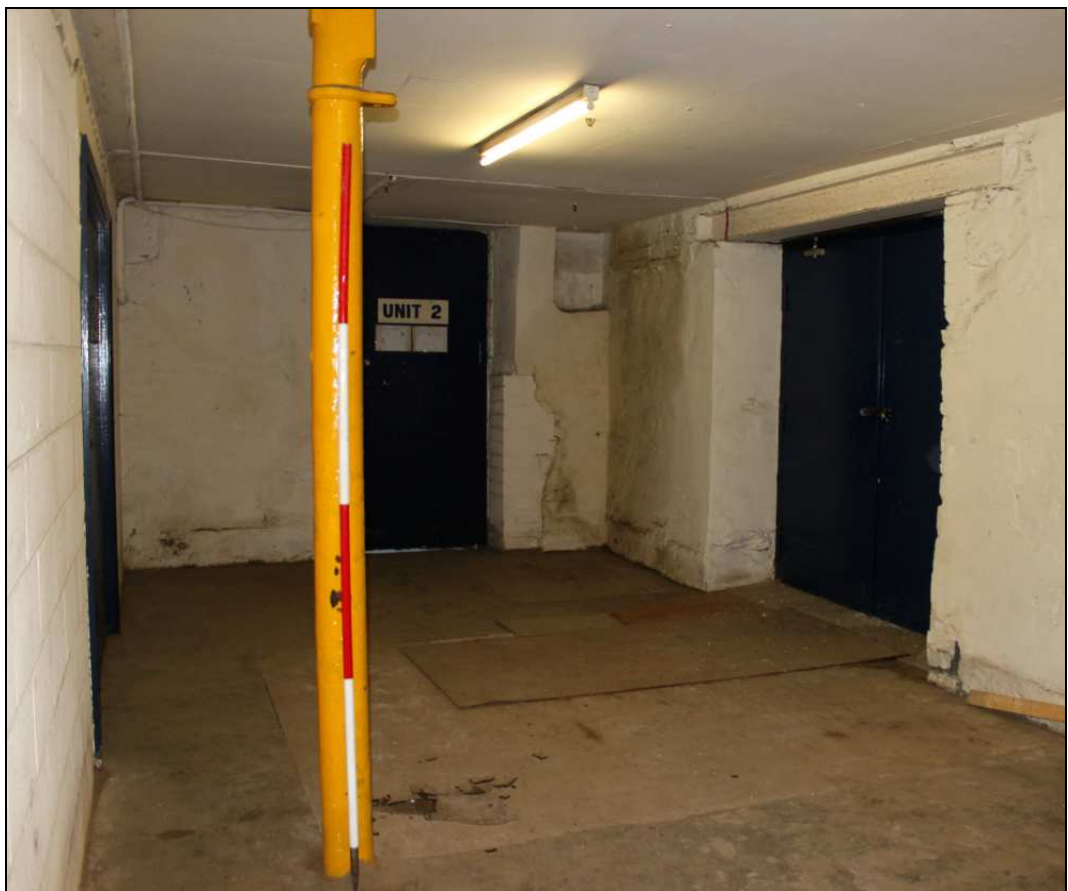
*Plate 18: Double doors affording access to the ground floor of the engine house, with an additional door leading to the link block (Unit 2)*

- 4.2.15 A doorway at the southern end of the eastern wall provided access to the link block (Plate 18), and from this building it was possible to see the locations of three windows upon what would once have been the external eastern elevation of the spinning block. These windows were boarded up, and their lintels obscured by the roof line of the link block, but the jambs and sills were identical to those on this elevation. Between the southernmost window and the present doorway was another doorway, infilled with cinder blocks. This opening aligned with a doorway on the opposing wall in Unit 5, and it seems probable that the latter was designed with this in mind.

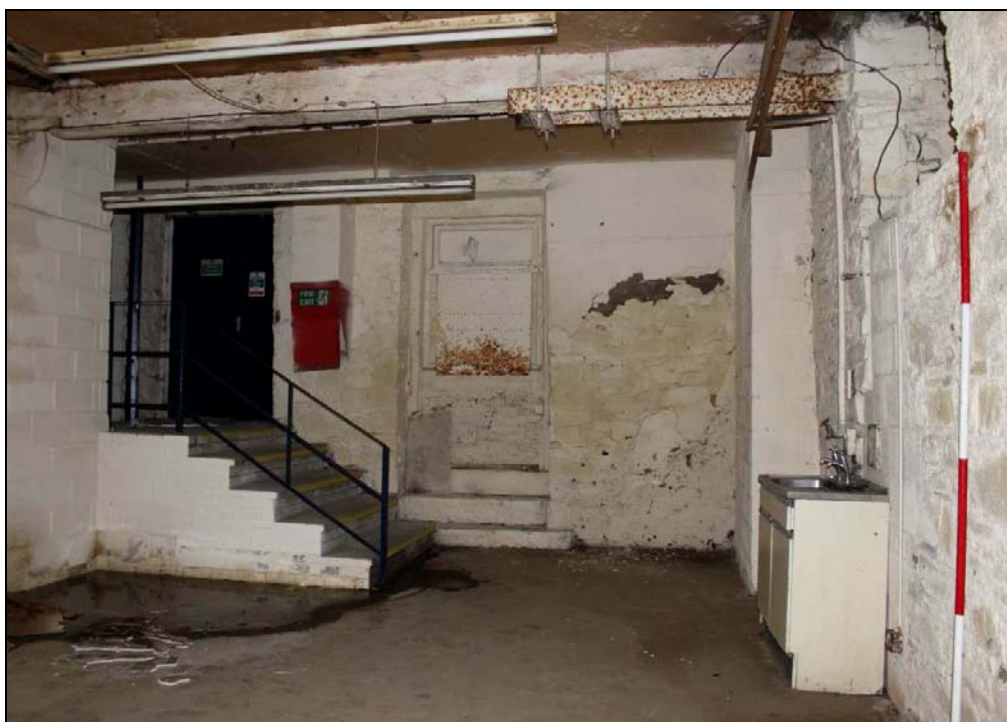
*Plate 19: Original and replacement access steps from the ground floor to Wales Road*

- 4.2.17 Concrete steps set against the northern wall led to an external doorway, affording access to Wales Road. These steps were seemingly replaced an earlier set of steps situated immediately to the east, which had been remodelled as a window and latterly infilled (Plate 19).

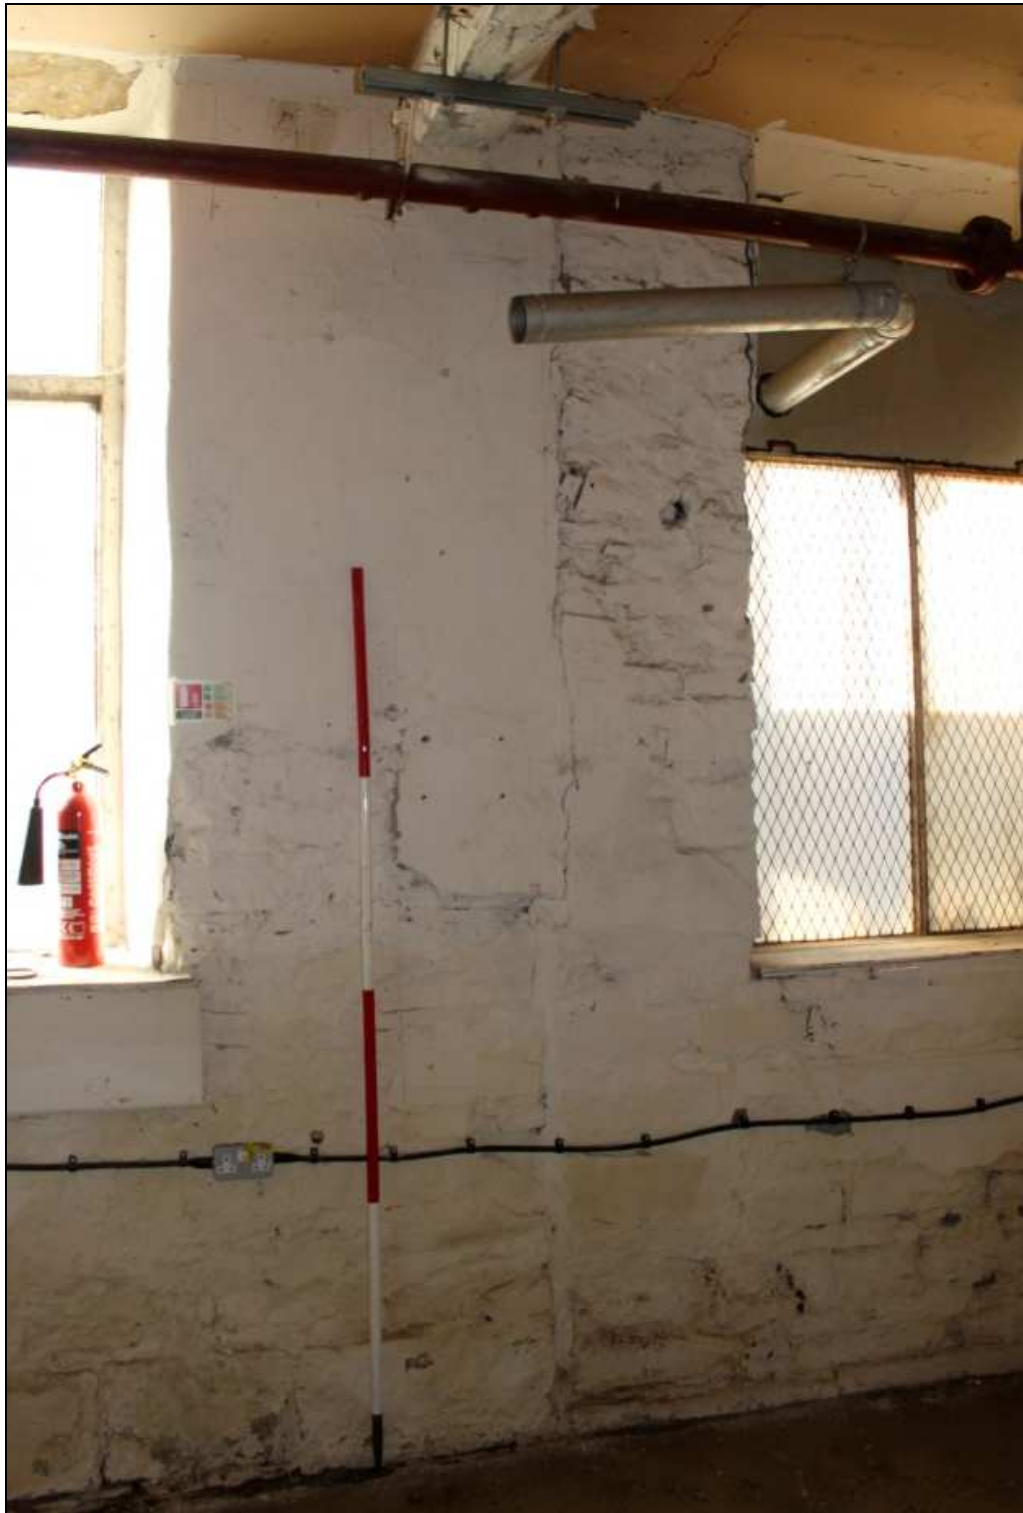
Plate 20: Butt joint in the east wall, denoting a construction break

4.2.18 Between Bays 4 and 5, it was possible to identify on the eastern and western walls a butt joint, denoting a break in construction and almost certainly a different phase (Plate 20). In the light of this evidence, it seems likely that the northern four bays of the spinning block were a later addition.

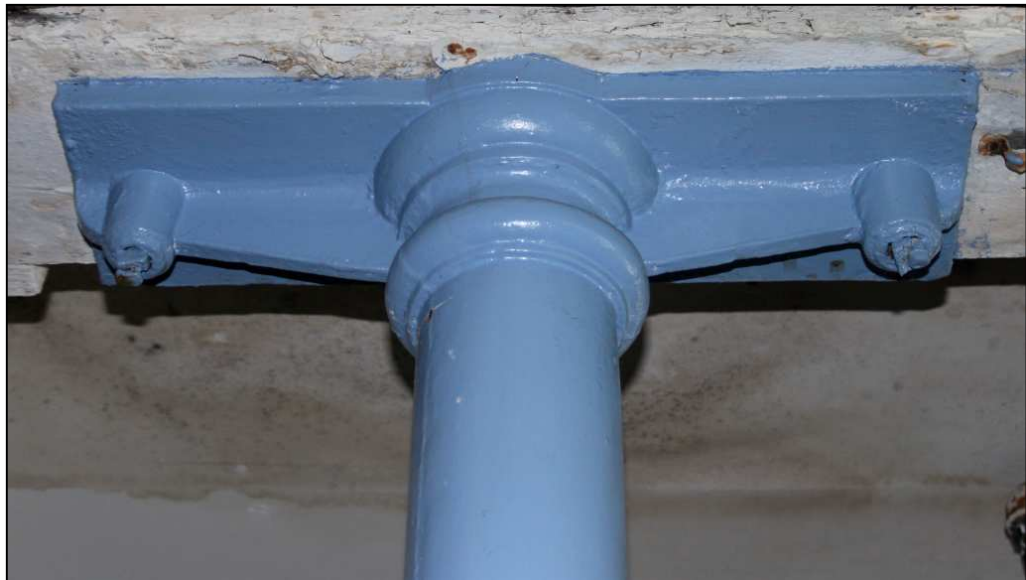
*Plate 22: Detail of Type 1A column head without the lineshaft bolting face*

4.2.22 Three types of column were identified on the first floor of the spinning block. One of these was identical to one on the ground floor (Type 1; Plate 14), although the bolting faces for the lineshaft hangers were absent (Plate 22). The second type (Type 2A) had a simple chamfer at the top where it joined the head plate, with a double curved rib on either side rising from the shaft to head plate. The bolt holes lacked the heavy flanges apparent on examples on the ground floor, and there were no bolting faces for lineshaft hangers. The third type had a simple hollow chamfer below a quarter roll mould at the head of the shaft, but its head plate was treated more decoratively. Each corner of the plate had replaced with a curved cutaway to leave the bolt holes protruding to the east and west within two curved projecting tabs (Plate 23). The bolt holes had low profile flanges, and there was a continuous hollow chamfer around the edge of the plate. This design also incorporated a crush box above to reduce the load on the transverse floor beam above (Plate 24).

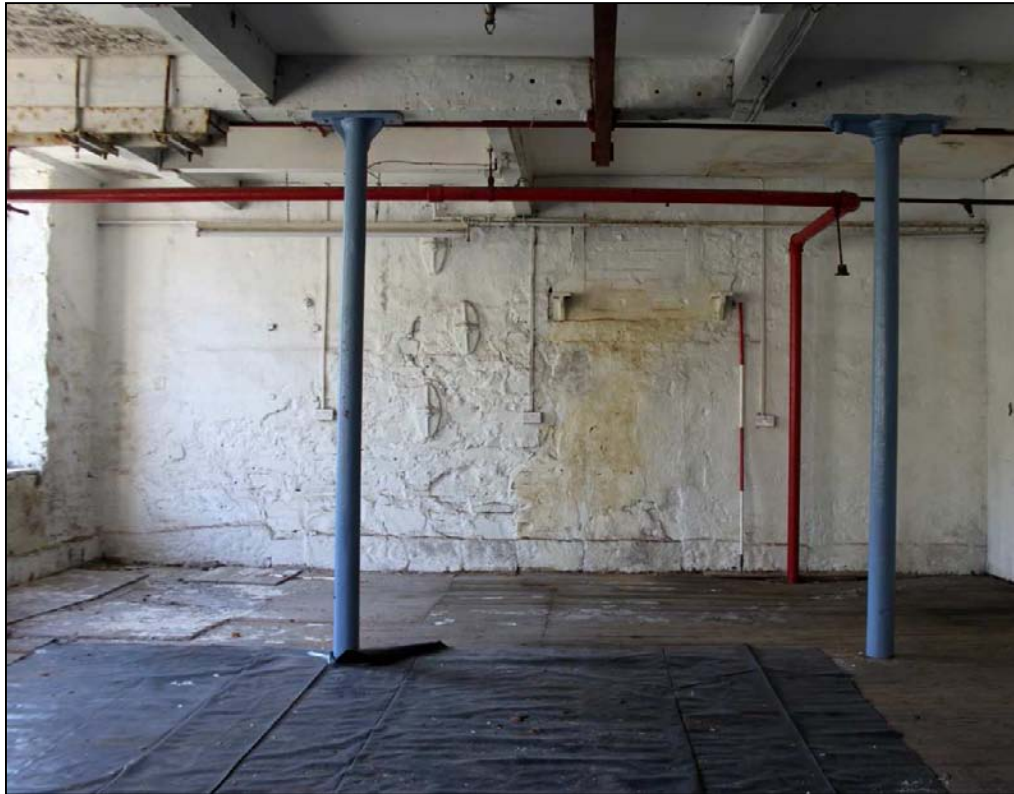
Plate 25: Large bearing box set into the south wall of the spinning block

- 4.2.23 A large, rectangular, cast-iron bearing box, which had been infilled with brick, was set into the southern wall of the building (Plate 25). There was also a smaller bearing box on the opposing northern wall (Fig 4), and pairs of bolt-holes on each of the transverse timbers between the two represented the location of the lineshaft hangers.

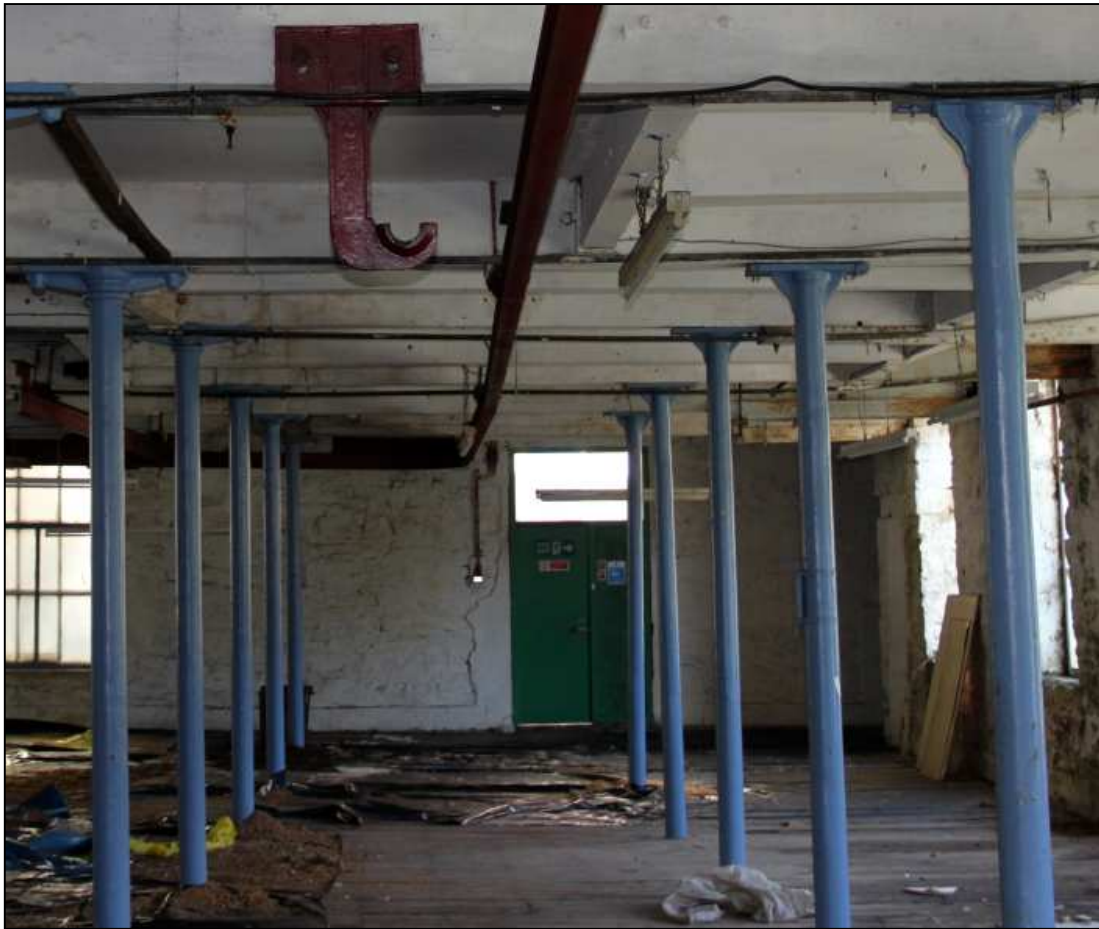
*Plate 26: Surviving lineshaft hanger on the first floor of the spinning block*

- 4.2.24 Another blocked small bearing box was also identified on the southern wall, and a fourth example was noted in the northern wall. The latter also aligned with pairs of bolt-holes on the faces of the transverse beams. A single lineshaft hanger survived *in-situ* (Plate 26).

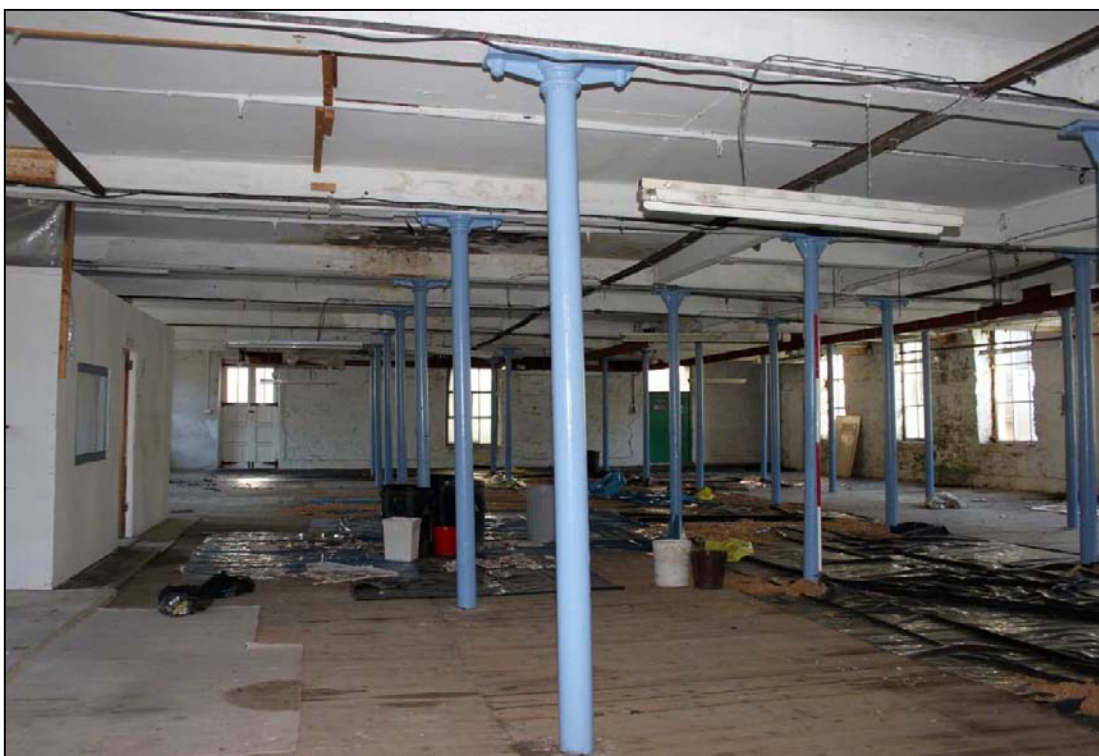
*Plate 27: View north across the first floor, showing the two doors in the north elevation*

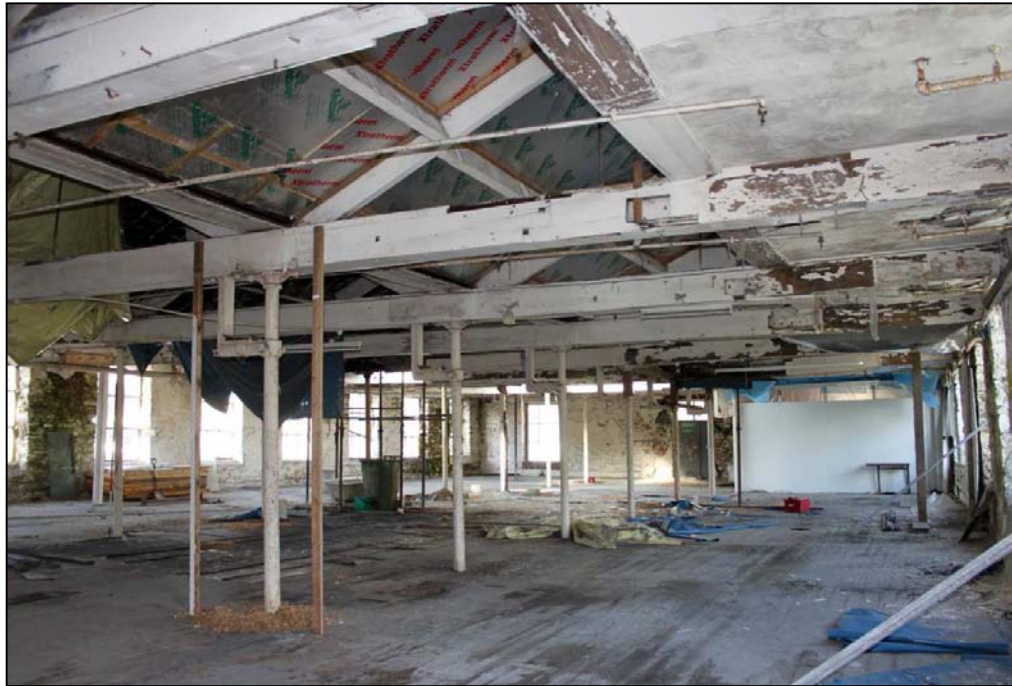
*Plate 28: General view across the second floor of the spinning block*

4.2.28 *Second floor:* the second-floor was of ten bays, with two rows of cast-iron columns, each set at thirds along the length of each tie beam (Plate 28). The floorboards were aligned north/south, and were each approximately 6" wide. The triple-span roof employed king post trusses, each central post rising to the apex from the centre of its tie beam to intersect with shallow angled principle rafters. The purlins were affixed between principles rafter faces, carrying common rafters on their backs. Wooden battens were nailed to the upper faces of each rafter, onto which were affixed the slate roof tiles.

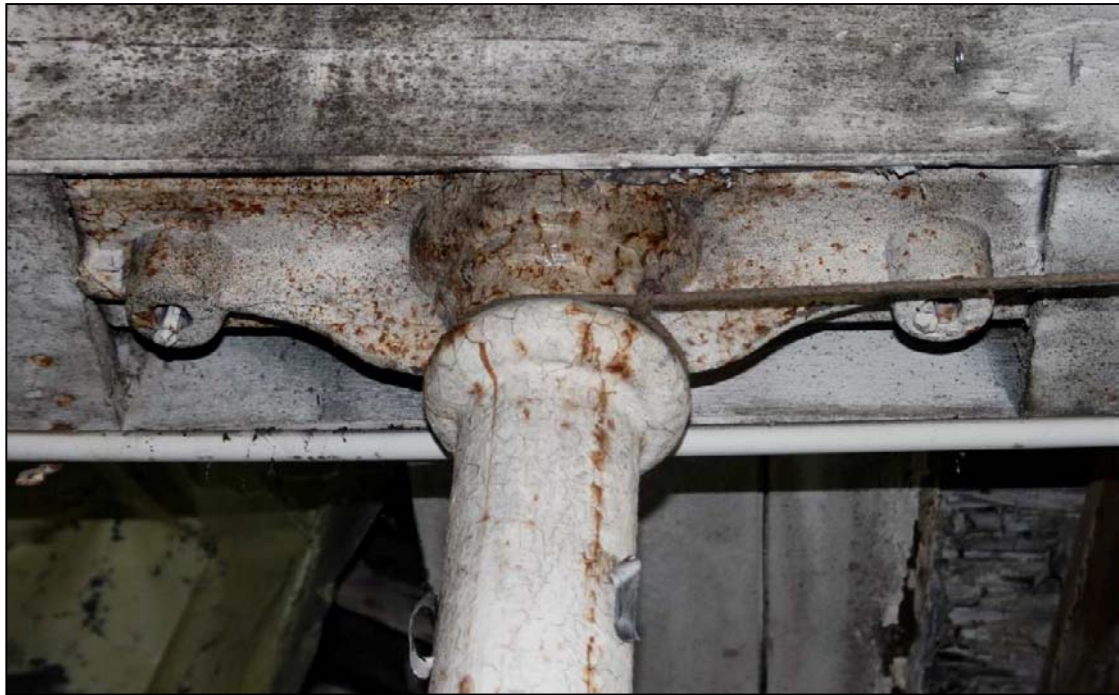
Plate 29: Detail of the Type 1B column capital

4.2.30 The second type of column incorporated a simple astragal set below two transverse supporting ribs, double curved along their lower edges, and rising to a quarter roll mould immediately below the head plate. Each head plate was attached to the tie beam with a single bolt each side of the column. Some of these columns had been cast with a bolting face for the lineshaft hanger on one side, approximately 0.5m from the top and supported by a small bracket below. On the opposing face two heavily flanged vertically arranged bolt holes were threaded through the diameter of the column shaft to the bolting face.

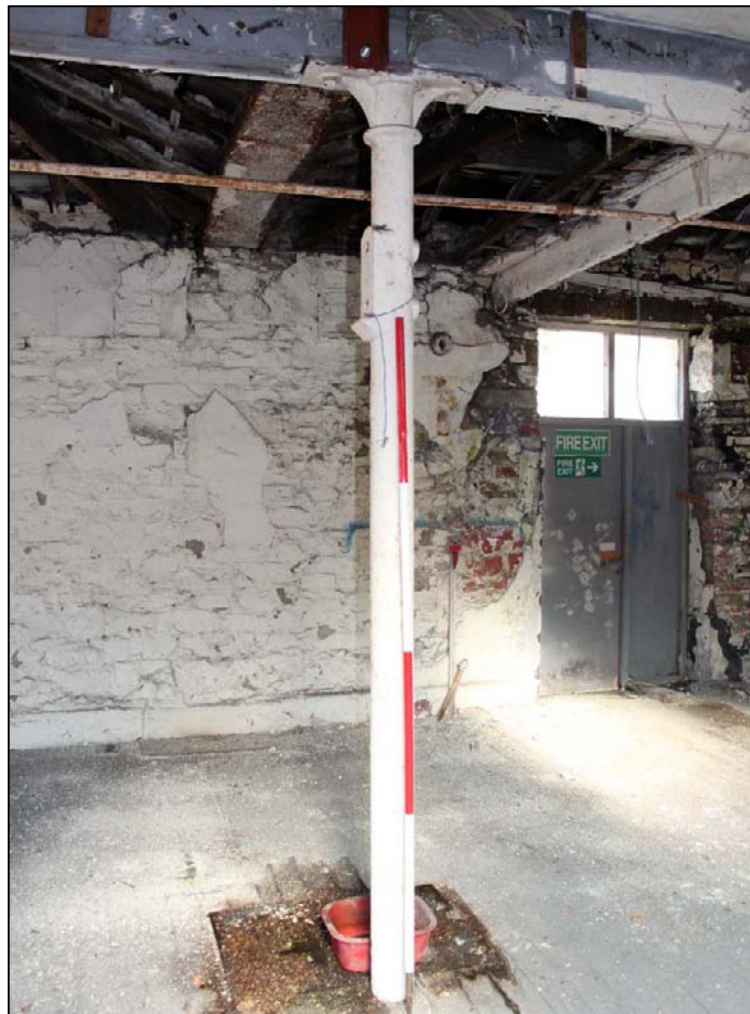
Plate 30: Type 4 column on the second floor of the spinning block

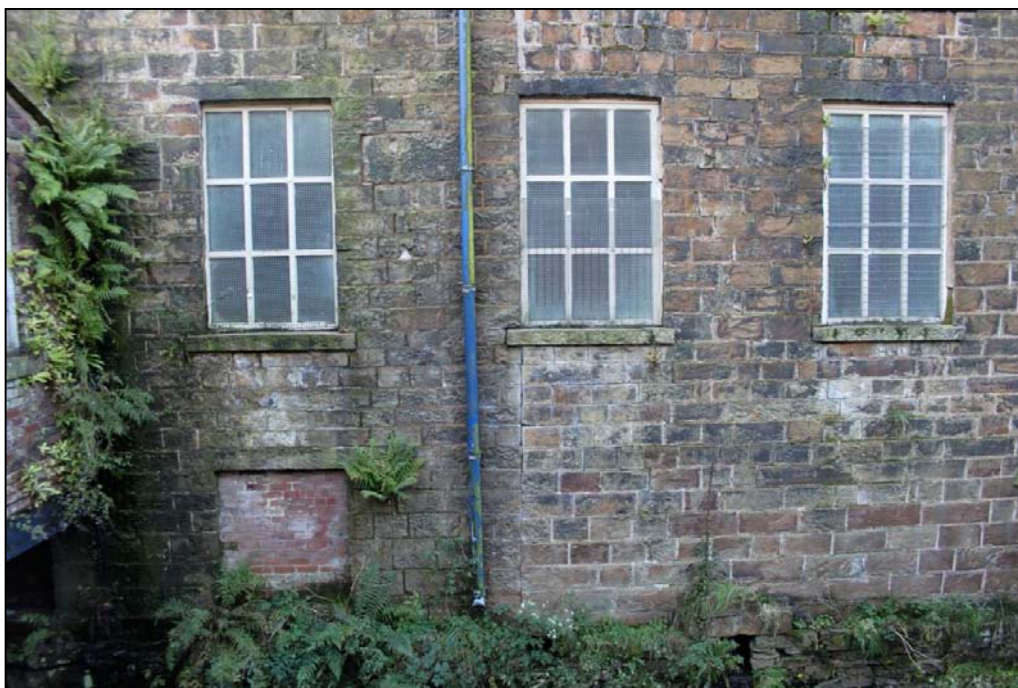
*Plate 31: Blocked basement window in the eastern wall of the spinning block, also showing the construction break between Bays 4 and 5*

- 4.2.34 The spinning block incorporated a basement, although all access to this part of the building has been sealed for some time, and it was thus not investigated during the archaeological survey. Light to the basement was provided by at least three windows, which remain as brick-blocked apertures close to the level of the Whitewell Brook in the eastern elevation of the building (Plate 31). These were only noted in the original section of the spinning block, to the south of the construction break noted between Bays 4 and 5 (Plate 31).
