**ALBION MILL,  
BURNLEY ROAD  
EAST,  
NEWCHURCH,  
LANCASHIRE**

**Archaeological Building  
Investigation**

**Oxford Archaeology North**

December 2013

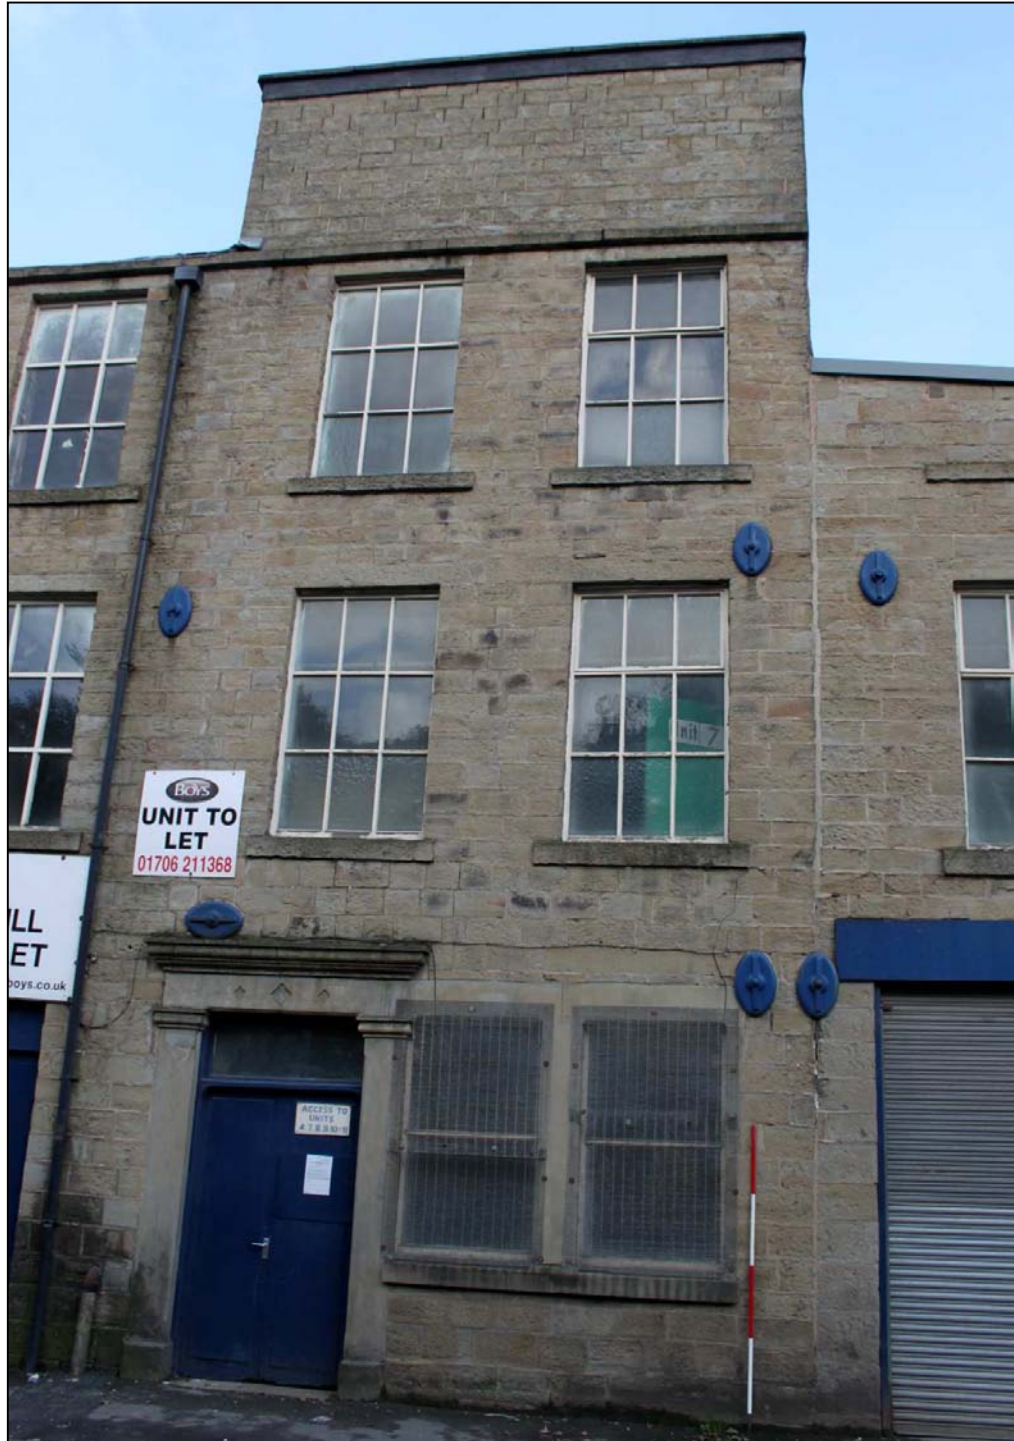
Plate 32: The west-facing elevation of the engine house

- 4.3.1 **Exterior:** the three-storey engine house was of two bays, and of an identical width to the spinning block, with which it shared its northern wall and triple-span slate roof. The western external wall, fronting onto Burnley Road East, was of coursed dressed sandstone construction, with plain projecting window sills and flat lintels above (Plate 32). The western elevation of the engine house was approximately 11 courses higher than the spinning block, the wall here having been extended in height to accommodate a water tower (Plate 32).

- 4.3.2 The western elevation had a pair of nine-light windows on the first and second floors, with a ground-floor doorway surmounted by a simple classical entablature resting on square-section pilasters topped by plain capitals (Plate 32). A pair of rectangular windows with projecting sills chamfered along their top edge, and plain flat lintels above, lay to the south of the doorway. It was clear from their relative position in relation to the other windows and the surrounding stonework that these two windows were not original.

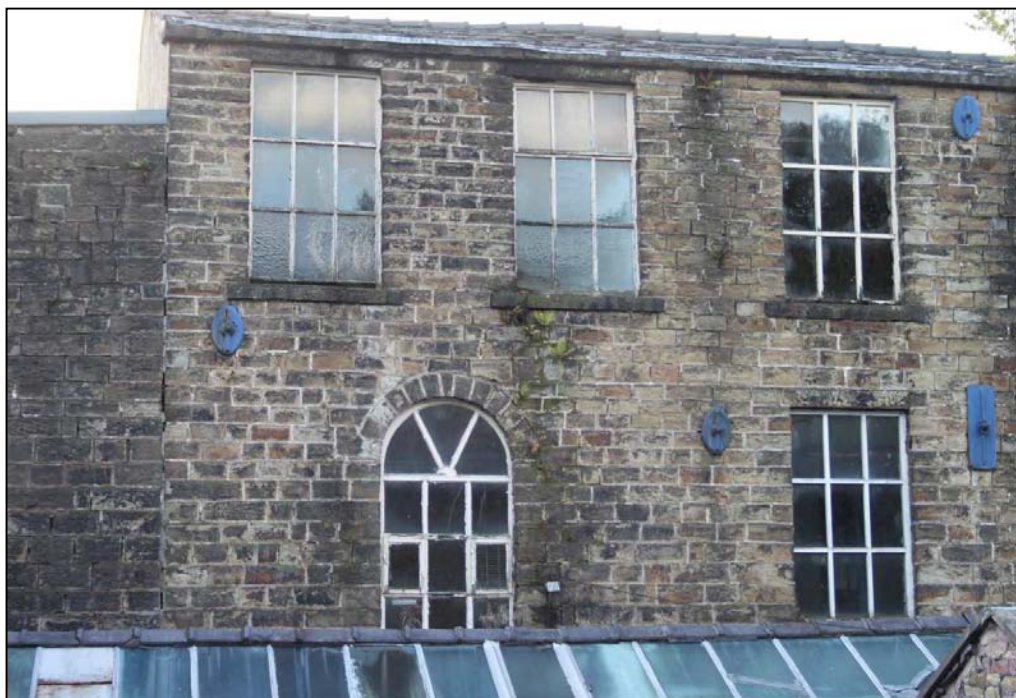
Plate 33: East-facing elevation of the engine house

- 4.3.5 On the first floor there was a single, centrally placed, large, 12-light window with a three-light semi-circular headed fan above, and typical of the nineteenth-century textile mill engine houses (Plate 33). The second floor had two rectangular nine-light windows, identical to those on the western elevation at the same level.

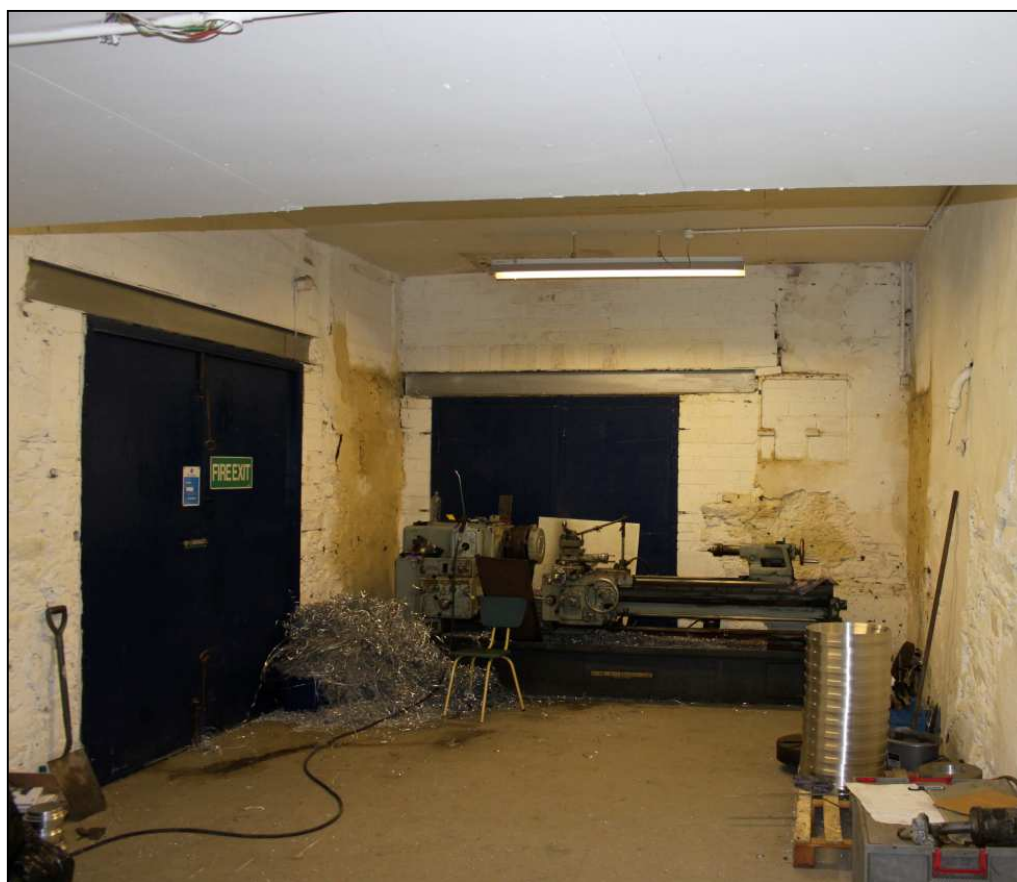
Plate 34: Interior of the engine house at ground-floor level

- 4.3.7 A doorway in the eastern wall led onto the ground floor of what had once been the engine room. This room had sandstone walls coated in white paint, a concrete floor and a plaster board ceiling, which revealed little evidence of its previous use (Plate 34). Near the eastern end of the north wall was a second set of double doors, which led through into the southern bay of the spinning block (Fig 3). Situated immediately adjacent to these doors was a blocked bearing box, which had carried the main drive shaft into the spinning block (Plate 35). A second casting set into the southern wall housed the end bearing. A third bearing box was identified in the western wall of the engine house, adjacent to another set of double doors that afforded access to the link block (Plate 36).

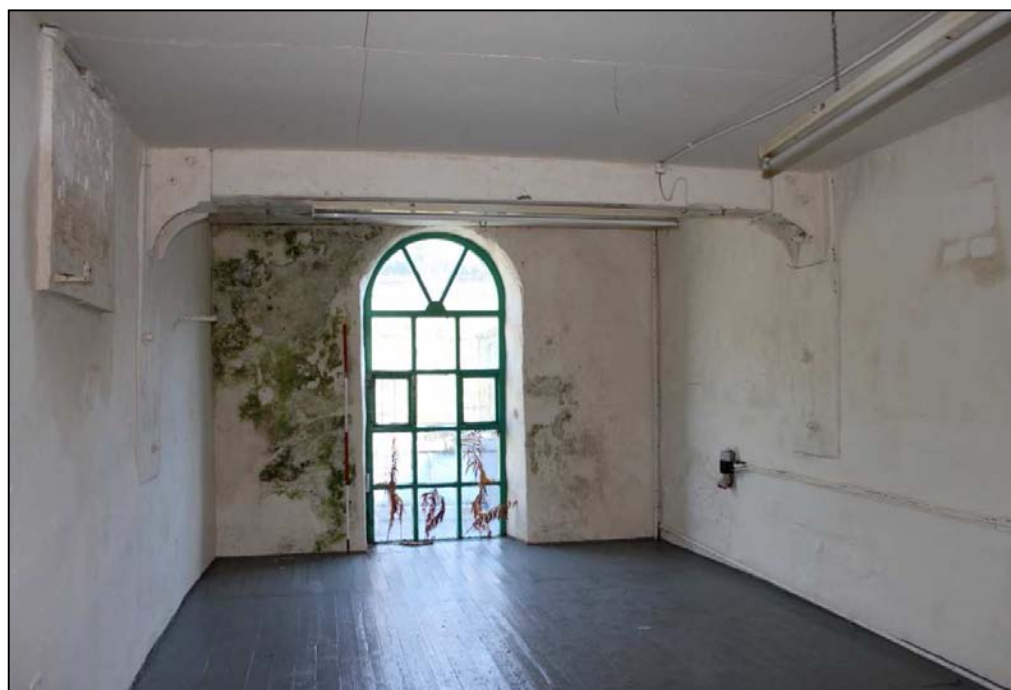
Plate 37: The first floor of the engine house

- 4.3.8 *First floor:* a doorway in the eastern wall at the top of the staircase led into the first floor of the engine house (Fig 4). This room had painted floorboards, aligned east/west, plastered walls coated in white paint, and a ceiling clad in plaster board, all of which had been inserted following the removal of the steam engine. The only natural illumination into the room was afforded by the large 12-light semi-circular headed window in the eastern wall (Plate 37).

- 4.3.9 A large rectangular wooden beam in the eastern half of the room was affixed on iron hangers with large, flat, iron wall bracket plates between the northern and southern walls (Plate 37). At the centre of the northern elevation was a large cast-iron bearing box projecting slightly from the wall face. Another, smaller bearing box lay directly opposite on the southern wall, almost certainly intended to house the end bearing (Fig 4). Both bearing boxes had been blocked with brick.

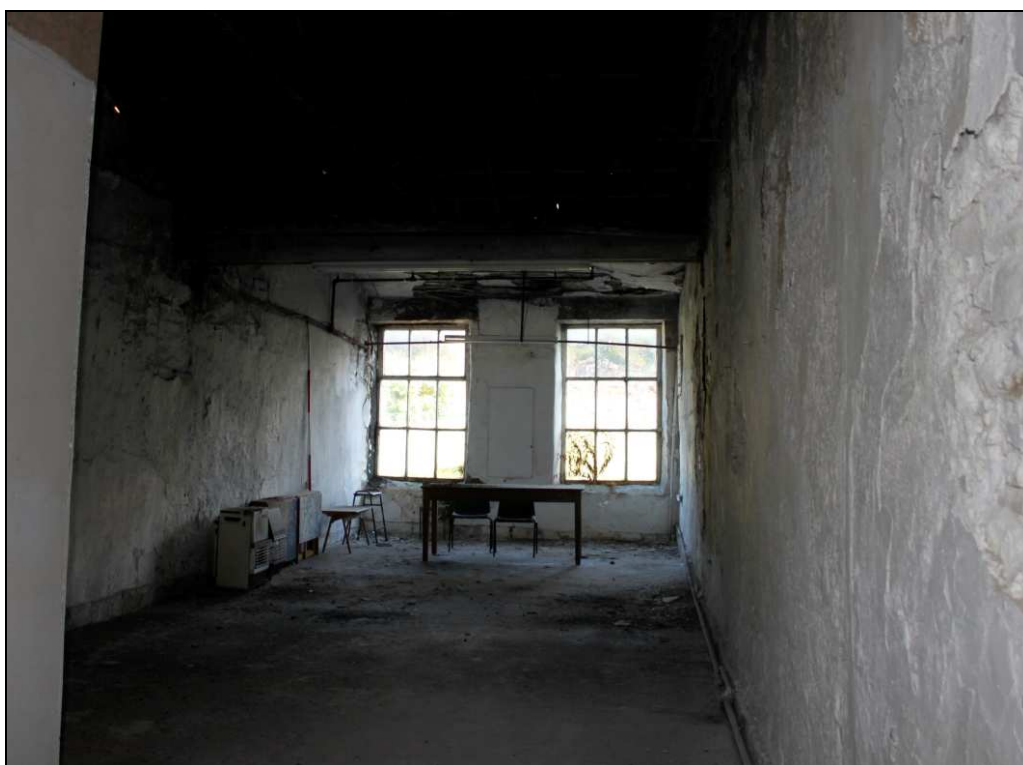
*Plate 38: The second floor of the engine house, looking towards the eastern wall*

- 4.3.12 A pair of large rectangular nine-light windows is present in the eastern wall (Plate 38), with another pair on the western wall. Most of the original lath and plaster ceiling had been removed, but a short section survived in poor condition at the eastern end of the room (Plate 38). Without a ceiling it was therefore possible to establish that the roof was a continuation of the triple-span roof above the second floor of the spinning block, with large rectangular longitudinal beams at the base of each valley. The western end of the roof structure had been modified, however, with a flat roof to accommodate the water tower over the stairwell.

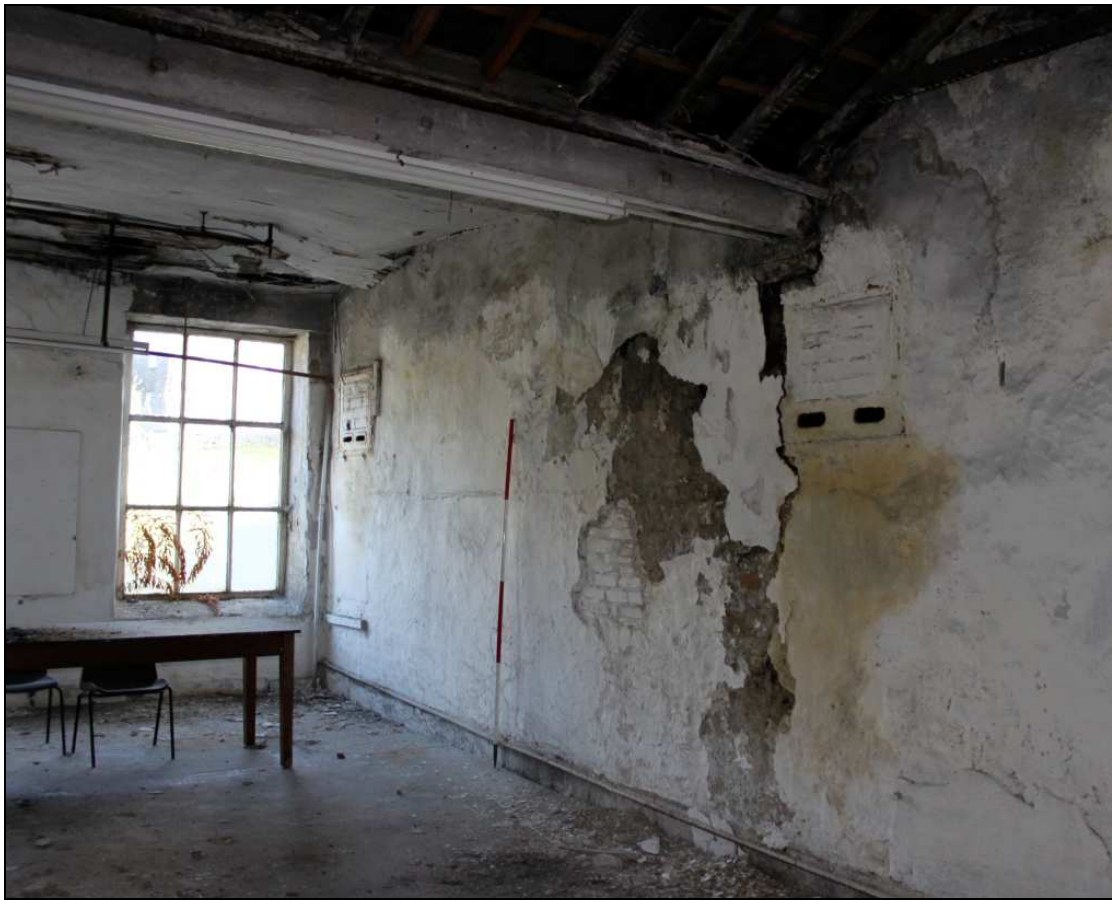
*Plate 39: The second floor of the engine house, showing bearing boxes set into the south wall*

- 4.3.13 There is evidence for at least three cast-iron bearing boxes set into the northern wall (Fig 5), with reciprocating boxes in the southern wall (Plate 39). The central bearing box was of the larger type noted on the first floor. All of the bearing boxes were blocked with brick. The southern wall also had what appeared to be infilled sockets, which may have supported cross beams associated with the engine frame, or a gantry providing access to the beam level.
- 4.3.14 Following the removal of the steam engine, a floor was inserted to create the second floor. The floor covering comprised large plywood sheets, which may have been laid on wooden floorboards, although this was not confirmed.

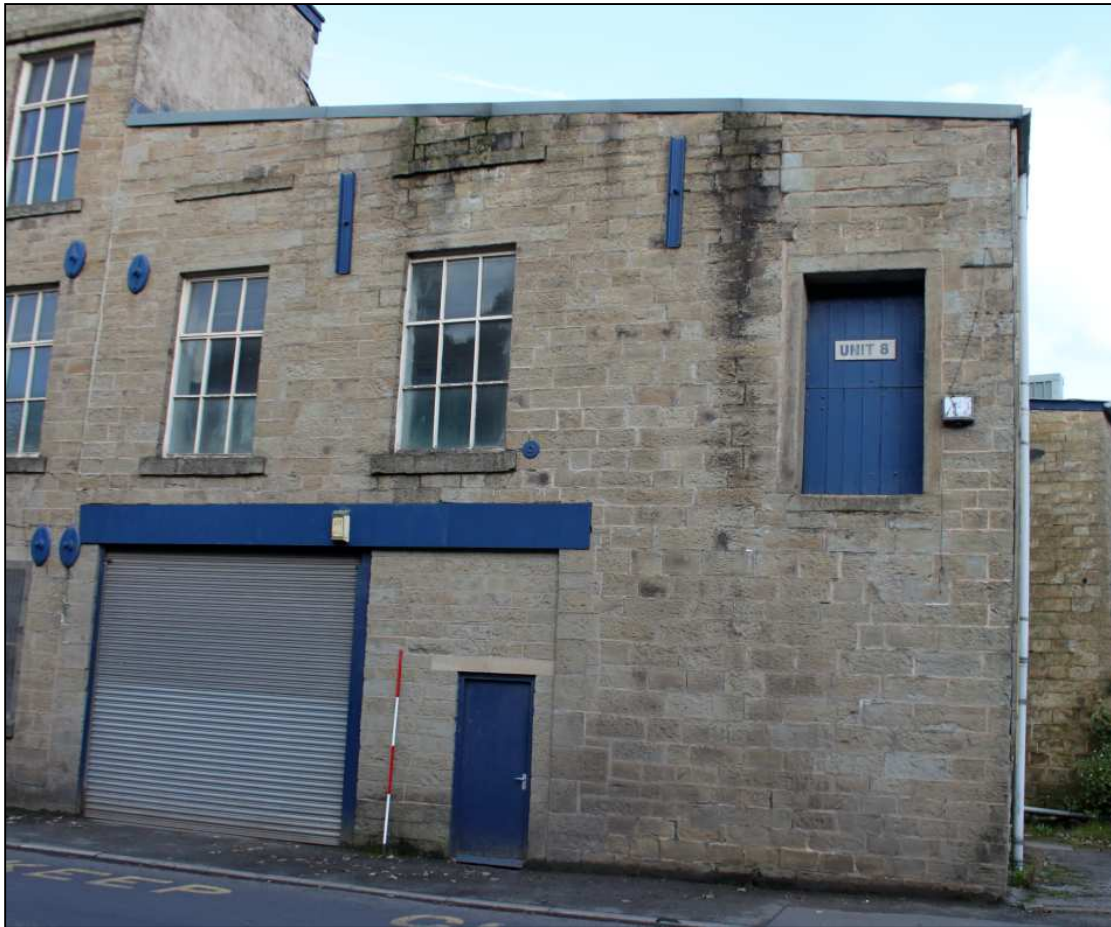
Plate 41: The front elevation of the boiler house/warehouse

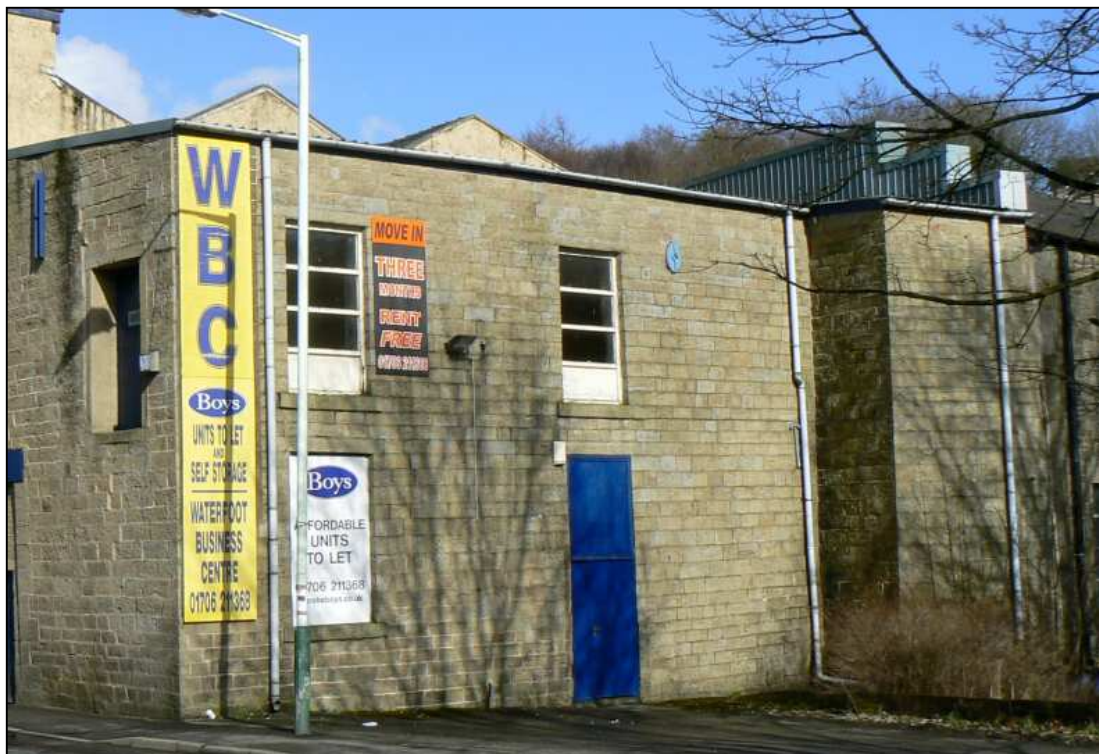
Plate 42: The south elevation of the boiler house/warehouse

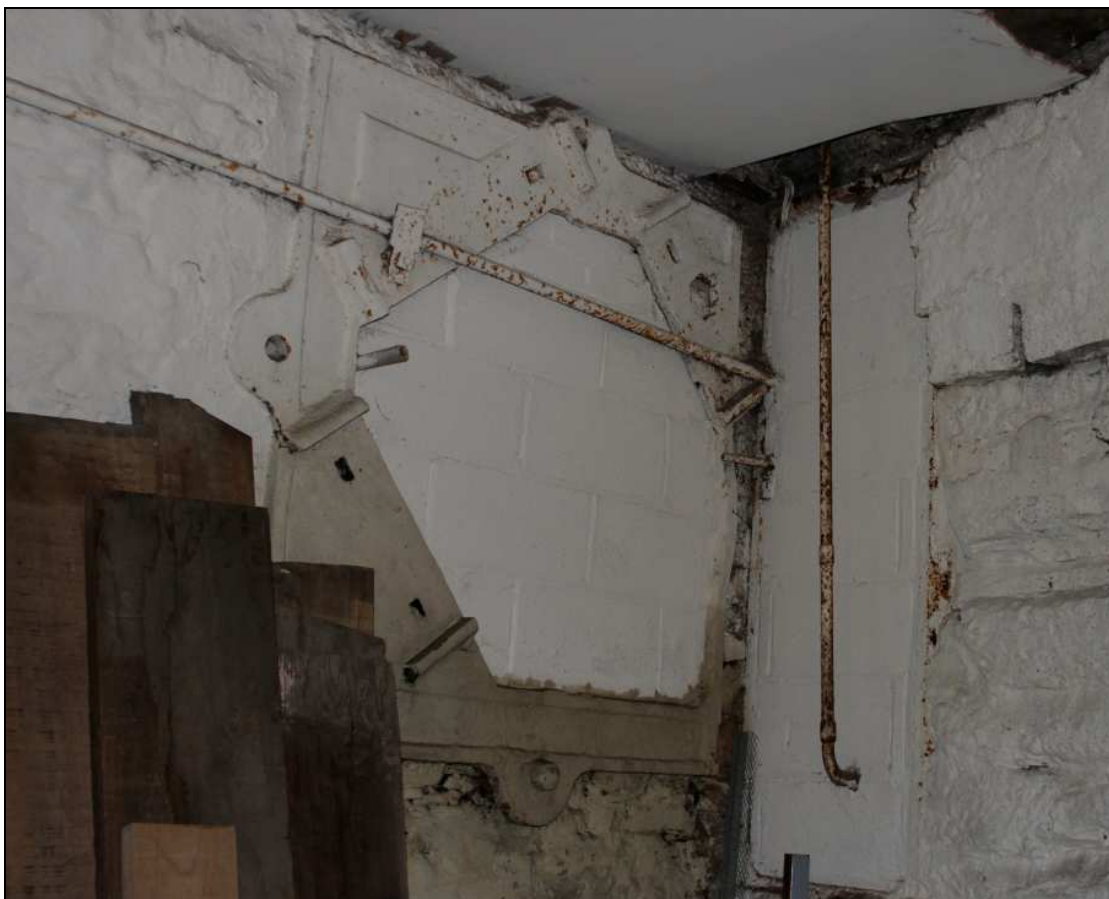
*Plate 46: Substantial bearing box set into the north wall of the boiler house/warehouse*

- 4.4.15 Power was transferred into the room through a single, large, blocked bearing box in the centre of the northern wall. There are three iron trimmers spanning between the timbers of this bay, which may have supported the drive.

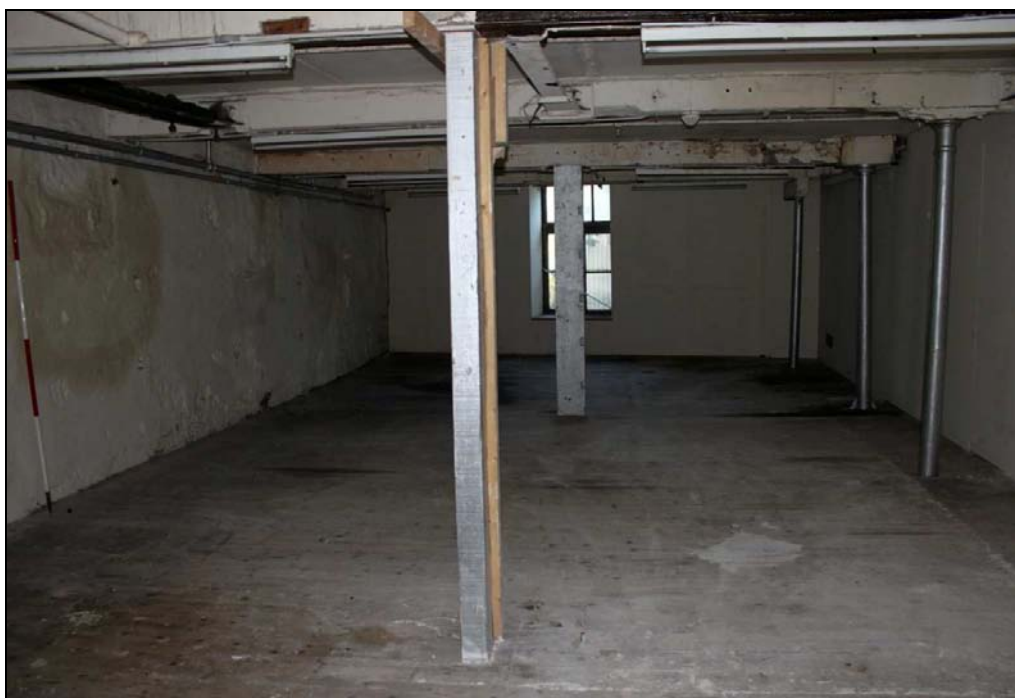
*Plate 47: View across the first floor of the boiler house/warehouse*

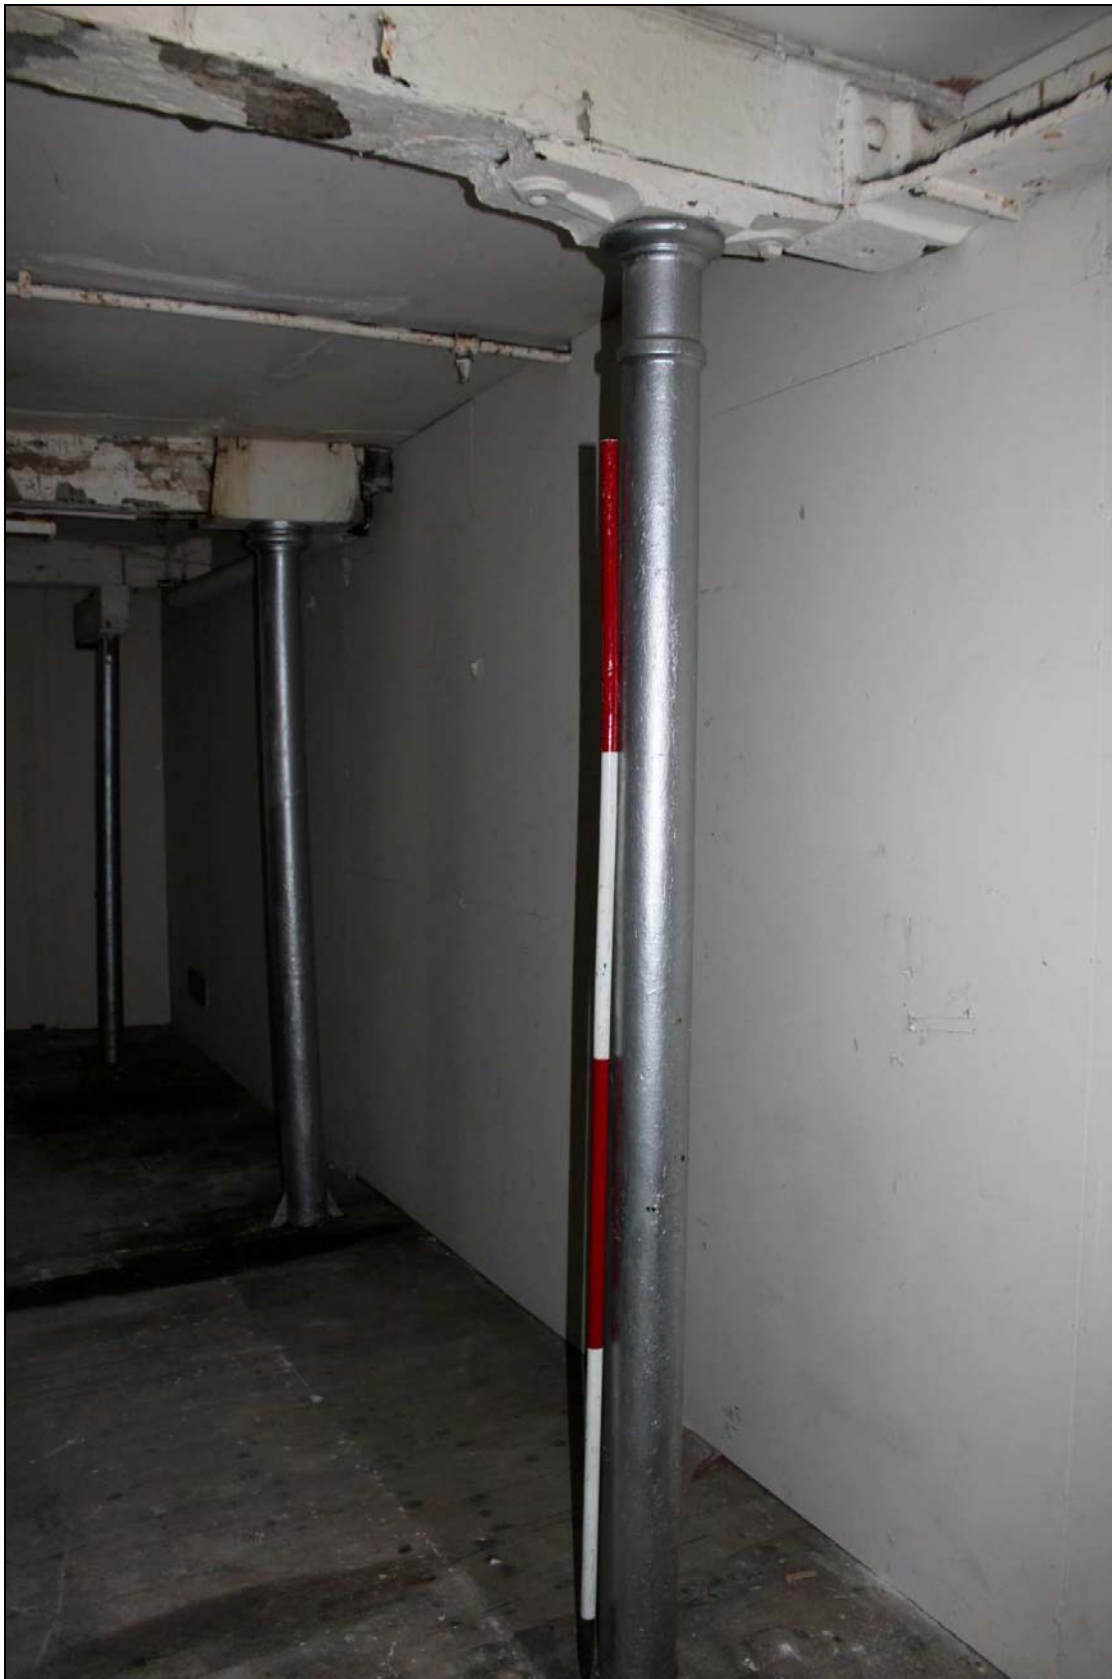
*Plate 48: Detail of the columns on the first floor of the boiler house/warehouse*

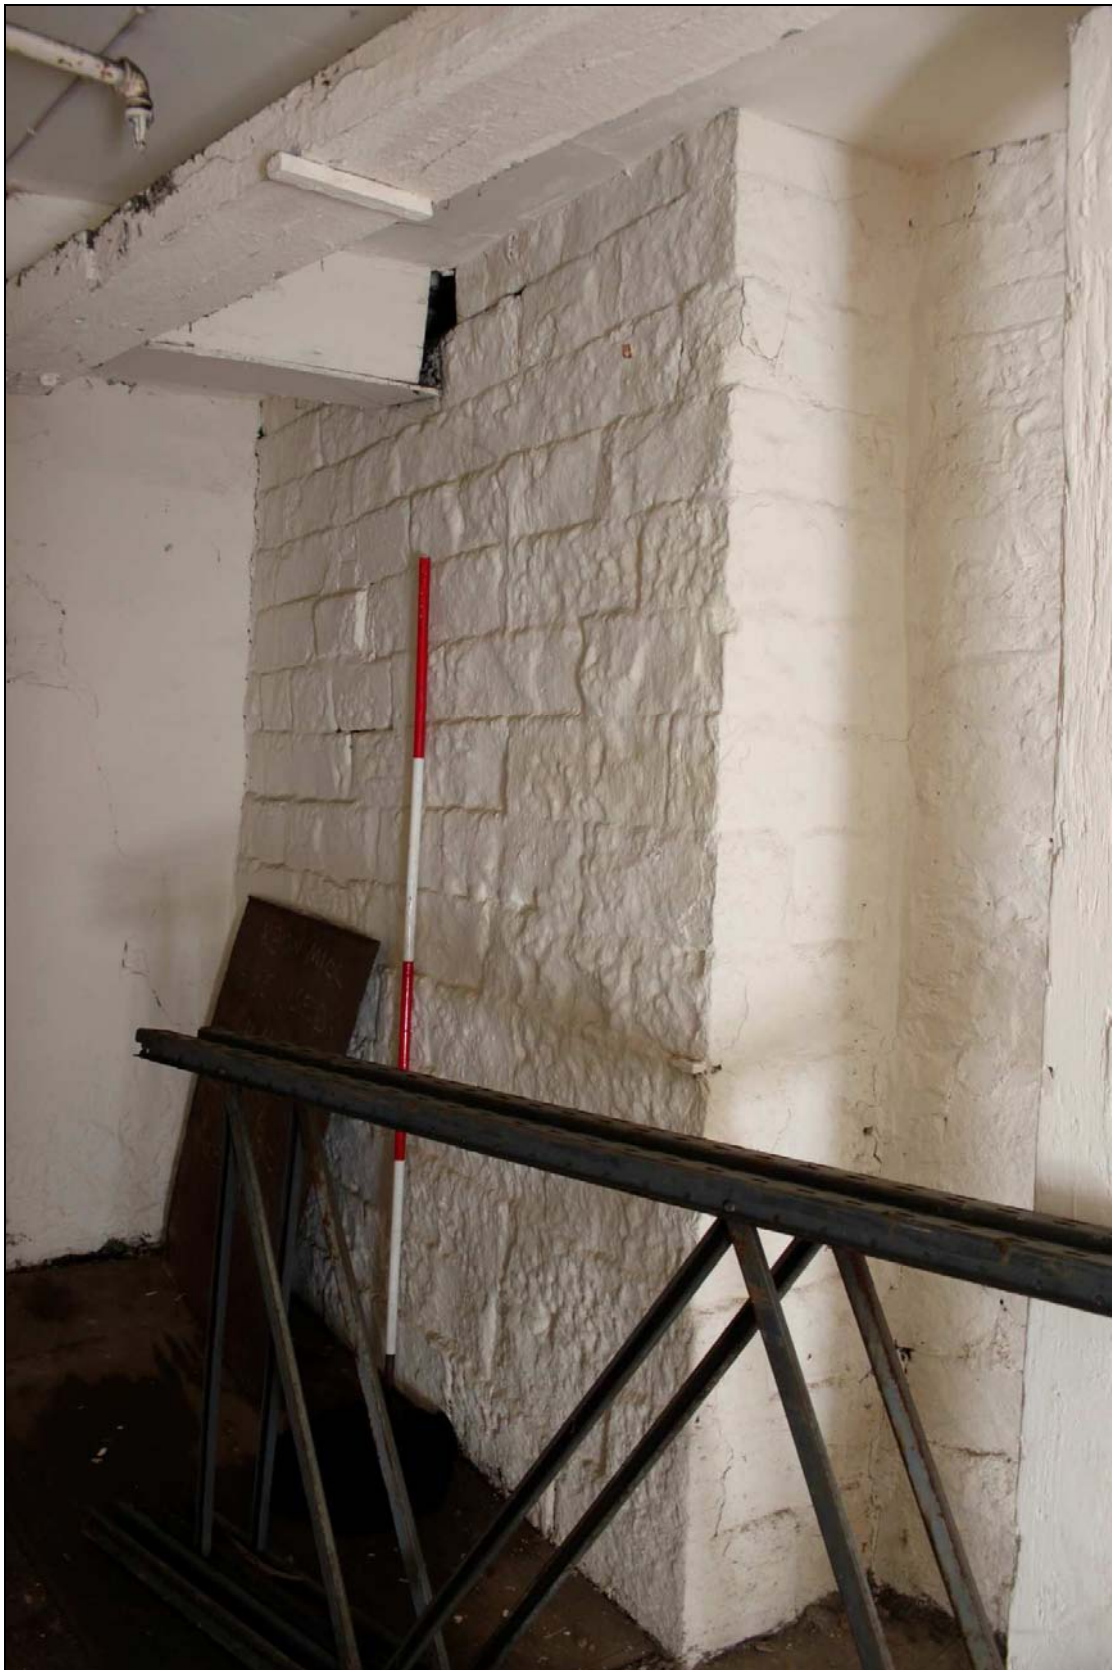
*Plate 49: The chimney passing through the first floor of the boiler house/warehouse*

- 4.4.14 The room is lit by five large rectangular windows, two to the west, two to the south, and another at the northern end of the eastern elevation. At the eastern end of the southern wall, as on the floor below, the chimney stack projects partially into the room (Plate 49), and there is a metal doorway at the southern end of the eastern elevation providing access to the first floor of the warehouse.

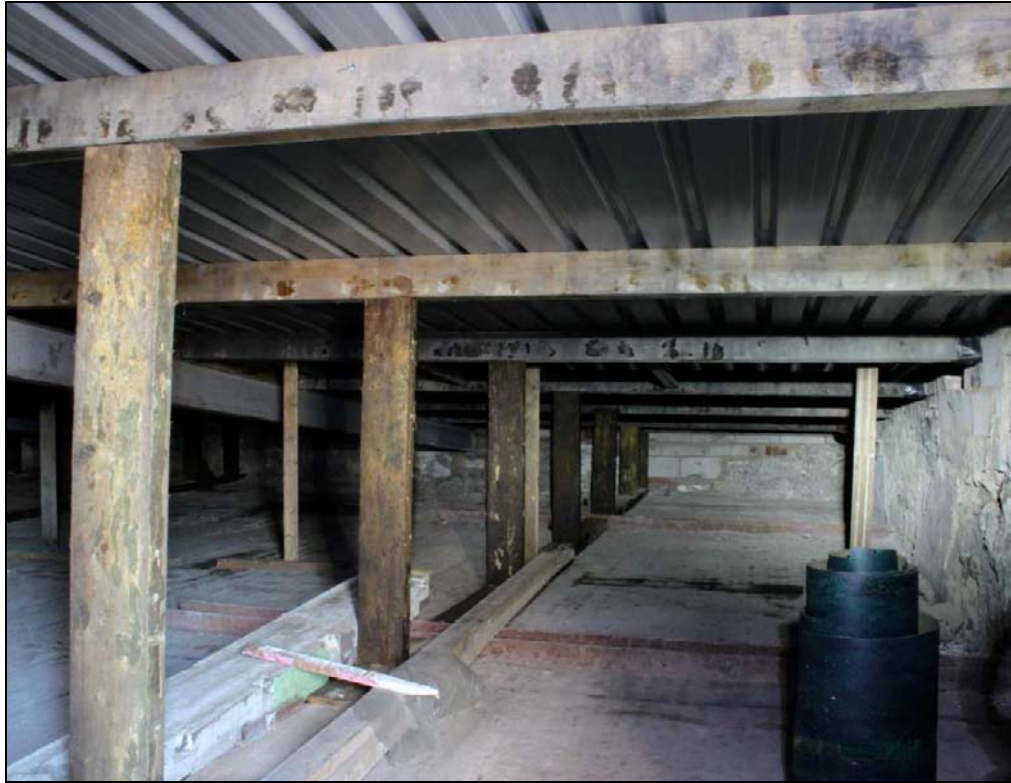
4.4.16 *Second floor:* the second floor of the building was removed after the late 1980s, but was still accessible as a low crawl space opening off a metal horizontally sliding doorway in the southern wall of the second floor of the engine house (Plate 50). Inspection was limited to observations from this doorway, but it was possible to see the wooden floor boards remained, and the truncated openings on the external eastern and western elevations.

*Plate 50: The modern roof space in the boiler house/warehouse*

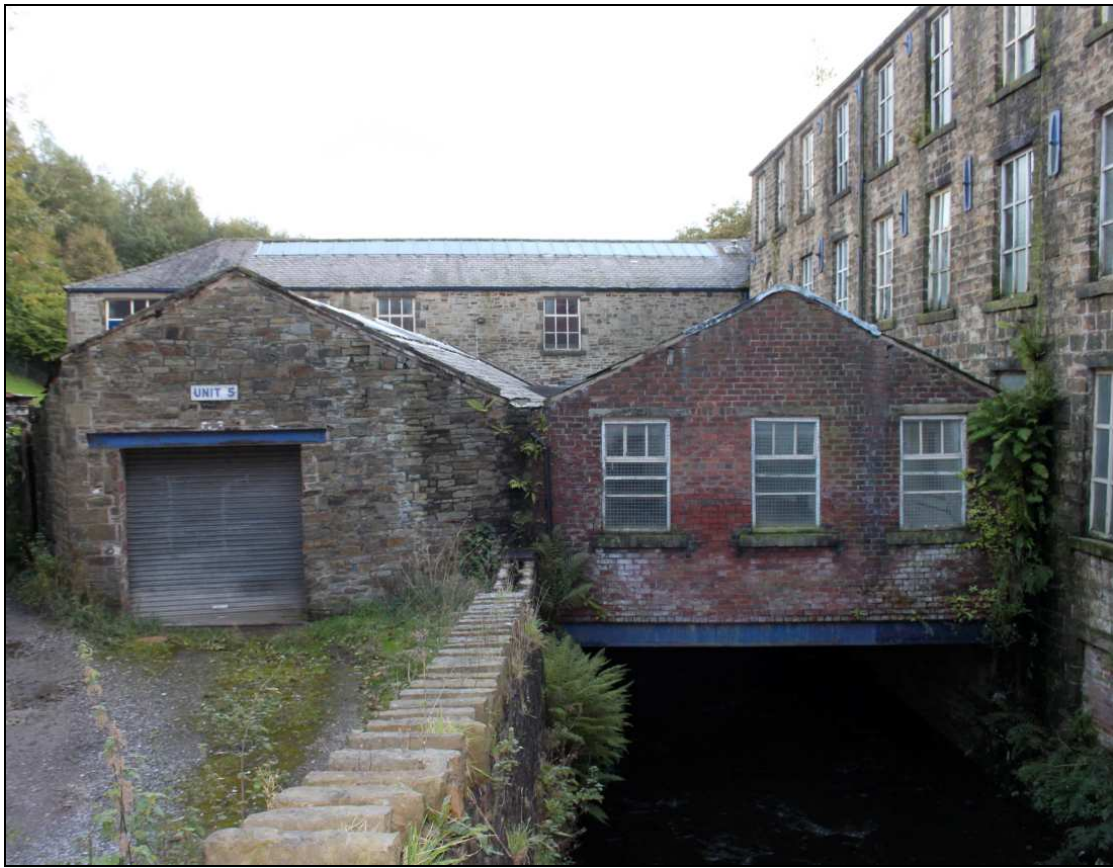
- 4.5.1 **Exterior:** the link block comprises a single-storey rectangular building that spans the Whitewell Brook, and abuts the engine house and southern part of the spinning block (Plate 51). The building has a shallow pitched slate roof that incorporates a continuous bank of roof lights either side of the ridge. Structurally, only the roof, internal floor and the northern gable wall could be attributed to the building, with the southern wall forming part of the warehouse block, the eastern wall part of Unit 5, and the western wall part of the spinning block and engine house (Fig 2).

- 4.5.2 The fabric of the northern wall comprises machine-made red bricks, laid in English Garden Wall bond, suggesting it to have been of a later build to the rest of the buildings in the mill complex. The north wall is built upon a steel I-section beam that spans the Whitewell Brook (Plate 51). Essentially, the building is a covered bridge that forms a link between the spinning block on the western bank and Unit 5 on the eastern bank.

*Plate 51: The north elevation of the link block, spanning the Whitewell Brook*

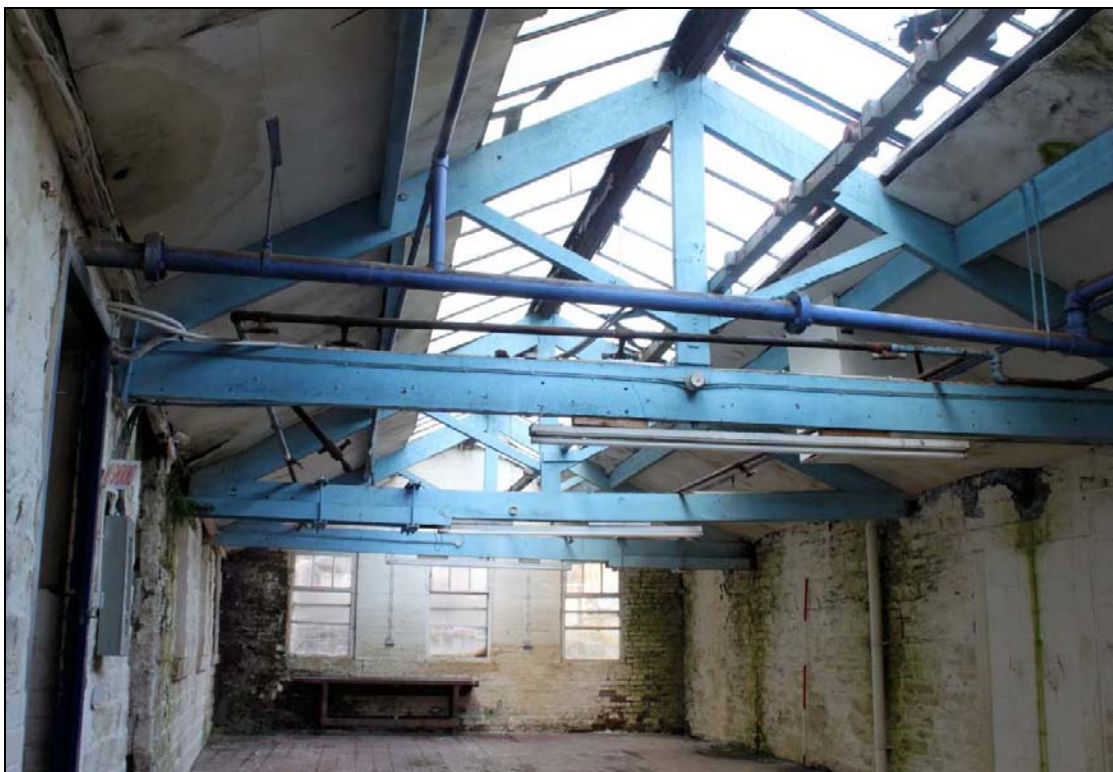
- 4.5.3 The north elevation incorporates three equally-spaced rectangular glazed windows, with projecting sandstone sills and flat lintels. The glazing comprises three horizontally arranged lights beneath a bank of three small rectangular lights (Plate 52). The warehouse forms the southern elevation, which does not contain any windows.

- 4.5.5 The seven roof trusses are each of king post design, with mid-height purlins and bracing struts rising from king post to rafter. These are bolted together, and the central truss is marked 'III' in Roman numerals. Each truss was painted light blue (Plate 52). The building is fitted with automatic fire sprinklers throughout.

*Plate 52: The interior of the northern part of the link block*

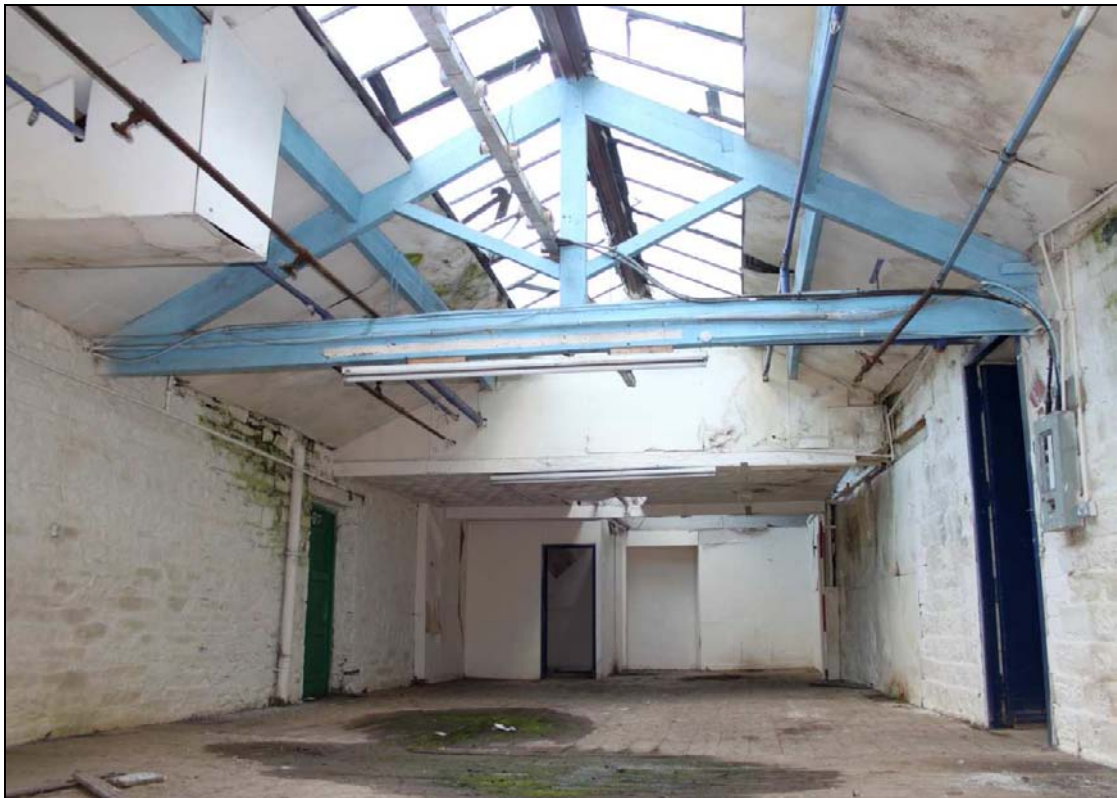
- 4.5.4 **Interior:** internally, the floor comprises north/south-aligned wooden floorboards, with a short section in the centre of the building that are aligned east/west. The walls are without plaster and painted white, although the southern wall was almost completely obscured by modern stud work (Plate 53). A large metal lintel was just visible above this stud wall at eaves height with roughly coursed sandstone rubble above it and brick below (Plate 54). This suggests that part of northern wall of the warehouse had been taken down to allow access between the two buildings, and the lintel inserted to support the wall above. This opening evidently fell out of use subsequently, as it was infilled with brick.

*Plate 53: The interior of the southern part of the link block*

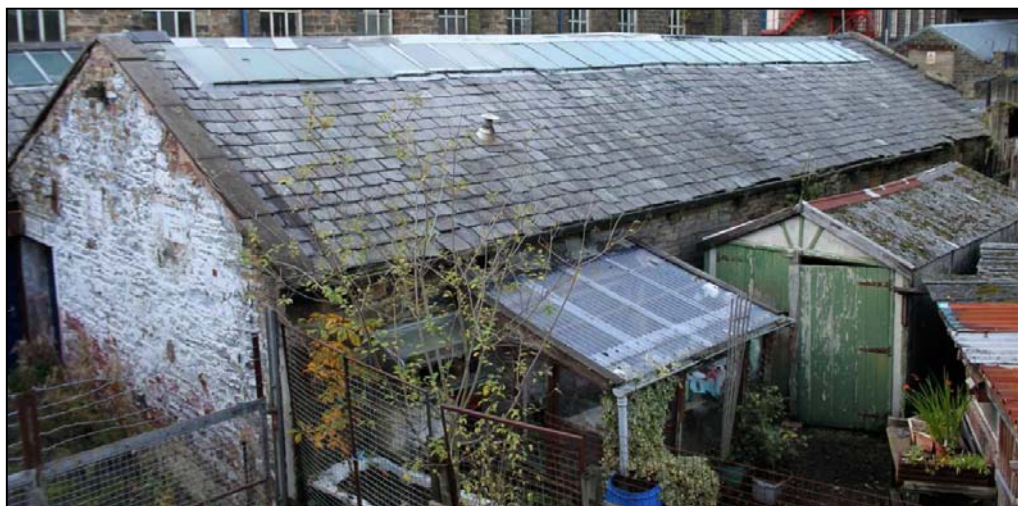
- 4.6.1 **Exterior:** the building referred to as Unit 5 lies on the eastern side of the Whitewell Brook, abutting the link block (Plate 55). This element of the mill complex was excluded from the survey specification, as it will be unaffected by the development proposals. However, whilst no internal access was possible, the building clearly forms part of the mill, and its exterior has therefore been recorded to allow a complete record of the site to be compiled.

Plate 55: View across Unit 5, looking north-west

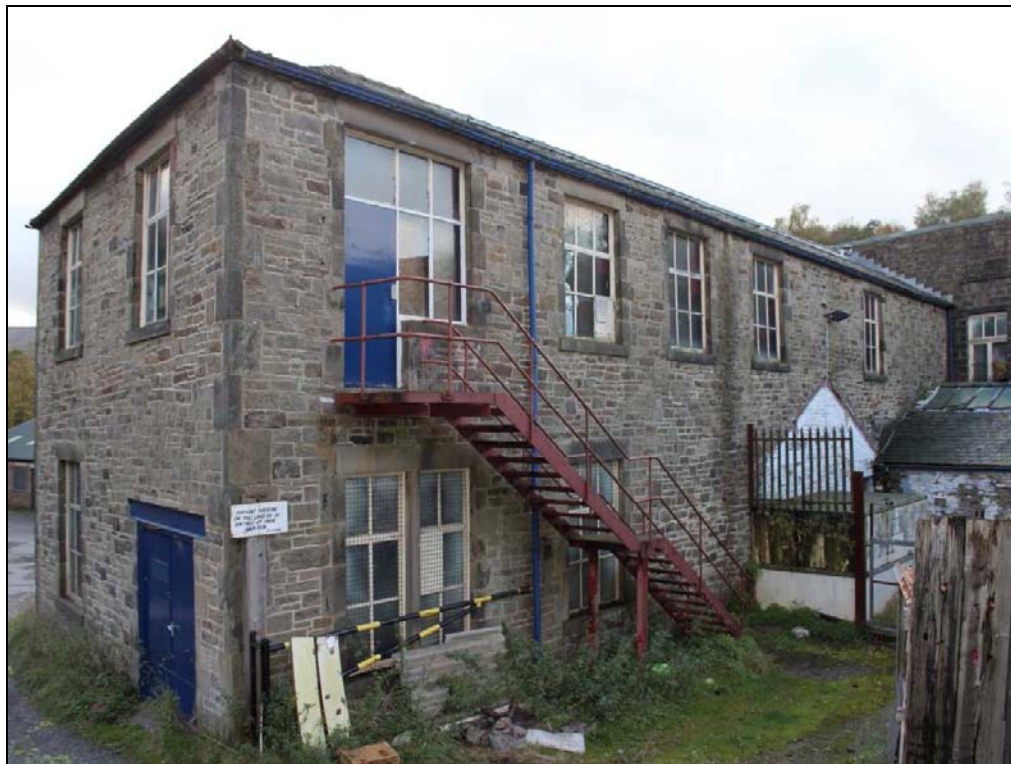
- 4.7.1 **Exterior:** the warehouse comprises a two-storey rectangular structure of eight bays, with a pitched slate roof hipped at its eastern end. It extends east across the Whitewell Brook from the western wall of the boiler house/warehouse, which resulted in a slight misalignment with the rest of the complex (Fig 2). The fabric of the building comprises roughly coursed sandstone blocks bonded in a pale lime mortar, with squared blocks at the quoins and jambs of each opening. The windows have projecting sandstone sills with flat lintels (Plate 56).

Plate 56: The north elevation of the two-storey warehouse

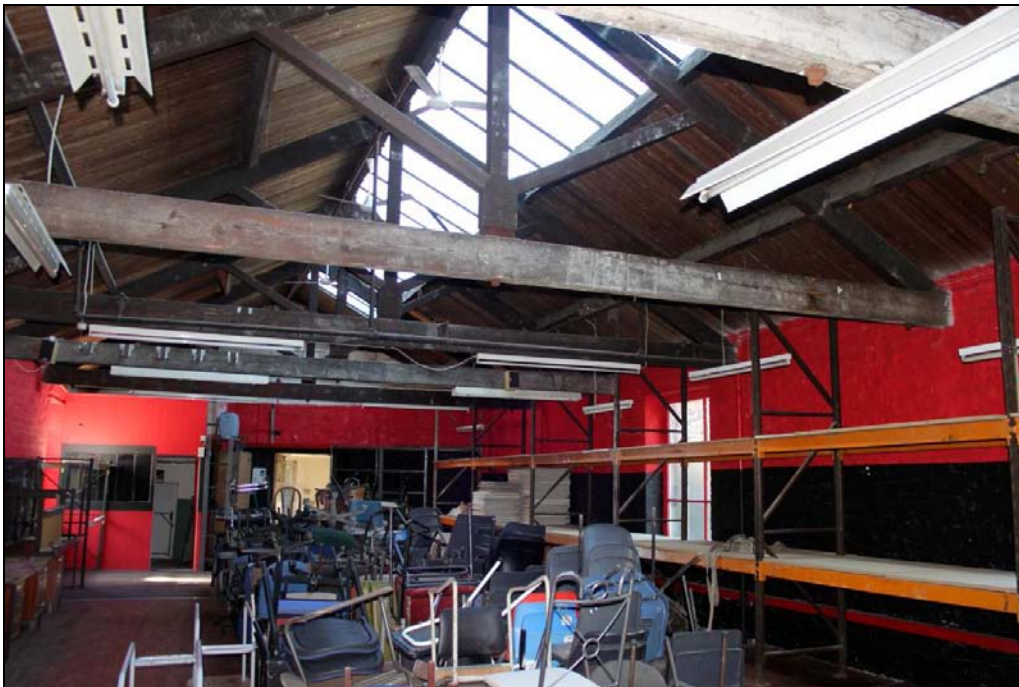
- 4.7.11 *First floor:* the lower halves of the walls of the first floor were painted black with the remainder in red (Plate 57), and whilst this was almost certainly a much later decorative scheme, it obscured a more detailed inspection of the wall construction on this floor. The floor was of varnished wooden floor boards, and the king post roof open to the timber rafters. The timbers had been bolted together with iron fittings, and several tie beams displayed the scratches associated with Baltic consignment markings. A continuous bank of roof lights along the upper third of the northern pitch of the roof provided illumination.

*Plate 57: View across the first floor of the warehouse block*
