A Post-Medieval Dovecote at Oxcroft Farm, West Wrattling:  
An Archaeological Recording Brief

B Robinson and T Sutherland

1995

Report No A120

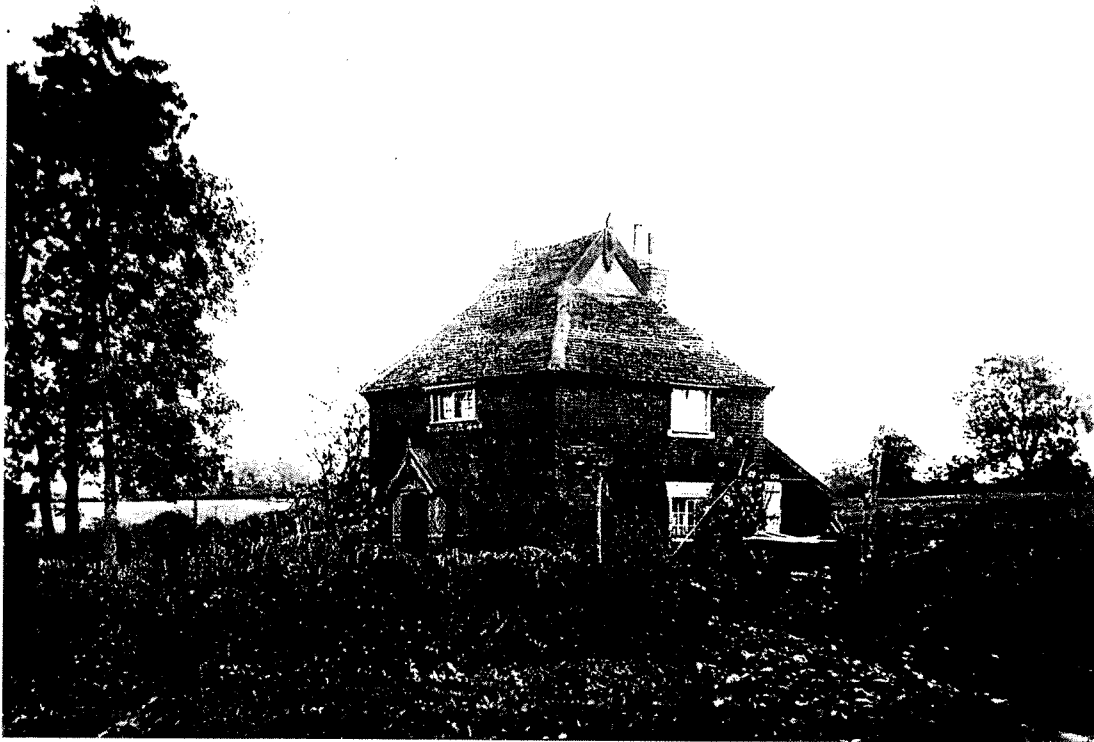
*Plate 1* The dovecote c. 1930 (photo. taken by Cambridge Antiquarian Society, glass plate negative held at Cambridgeshire Collection).

A photograph dated 1930 (Cambridge Antiquarian Society Village Survey 1914-30, Balsham 61, Cambridgeshire Collection, Cambridge Central Library, reproduced as Plate 1 above) shows the doorway in the centre of the north-west elevation and no ground floor windows on this elevation. This photograph also clearly shows the south-west elevation, and reveals that the present ground floor window is larger than the former insertion. The windows on the upper floors, on both elevations, remain in the same position. The photograph also shows a wooden out-shot on the south-eastern elevation where a later brick extension stood until demolished on the 16th May, 1995.

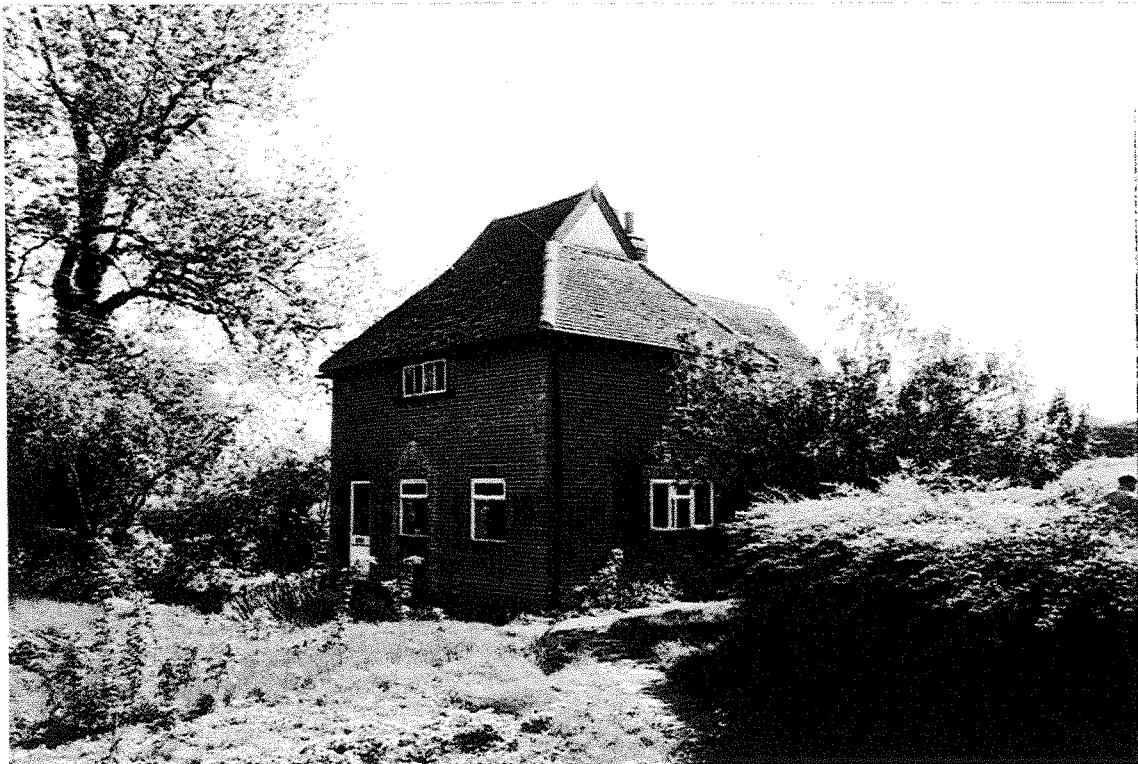
*Plate 2* The dovecote from the west (showing scar of porch and new door position), 1995

The main entrance has been moved from an earlier location in the centre of the north-west elevation to one side in order that two windows could be inserted on the ground floor. This central position was probably the site of the original entrance to the dovecote, and was later adopted for the site of the front door and porch during its conversion to a dwelling (see below). A door-sized patch of brickwork was also noted in the west corner of the south-west wall on the ground floor; this would be a curious position for an opening and therefore probably simply represents a repair.

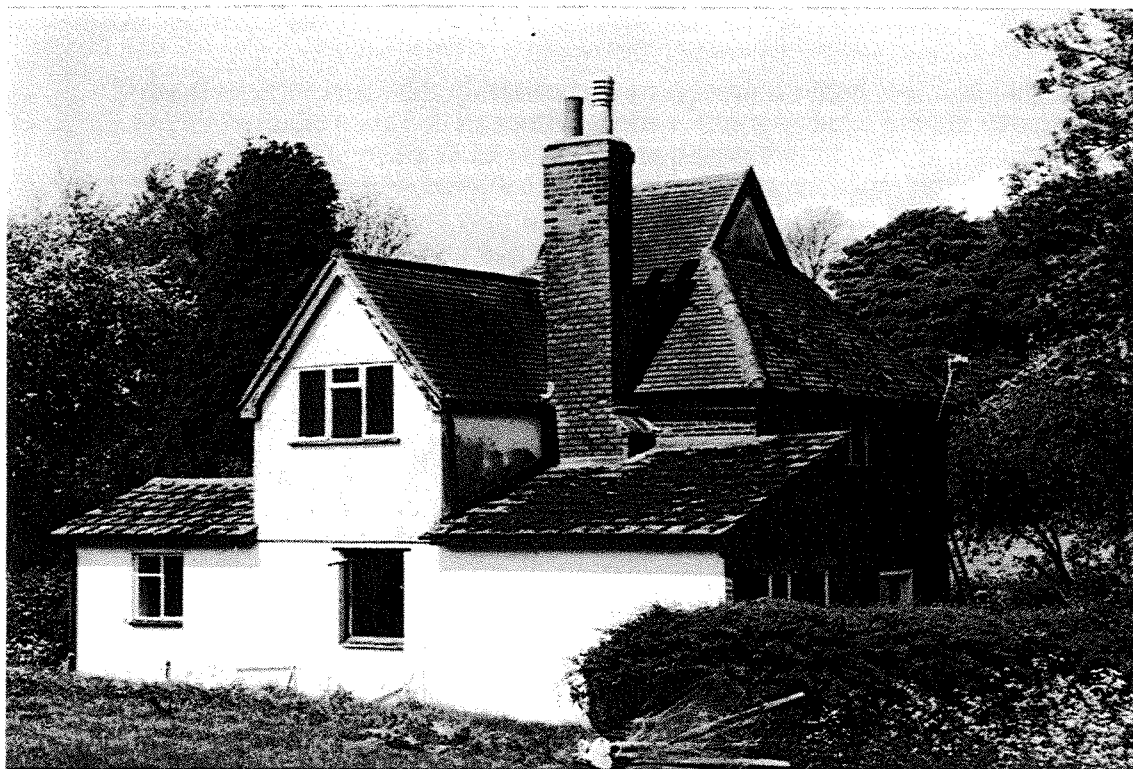
*Plate 3* The dovecote from the east (showing extension demolished 1995)

The south-eastern elevation has seen the most drastic additions to the building. A chimney stack was constructed with very few, if any, ties to the main structure. The stack was built of very soft sandy brick and has subsided slightly on its south-west side. It is probably as a result of this that the top nine courses have been rebuilt. Bees have constructed several nests in the brickwork thereby weakening the stack still further. The foundation to the stack runs to six courses below current floor level.

Some time after 1930, this elevation had an extension added to it, and judging by two breaks in the bonds on its south-east face, this may have been in two phases. An initial phase appears to have been a two storey extension to the dovecote. Later, two extensions were added to each side of this addition; one on the south-western end with a ridged roof and one on the north-eastern side which had a lean to or single sloping roof adjoining that of the initial extension.

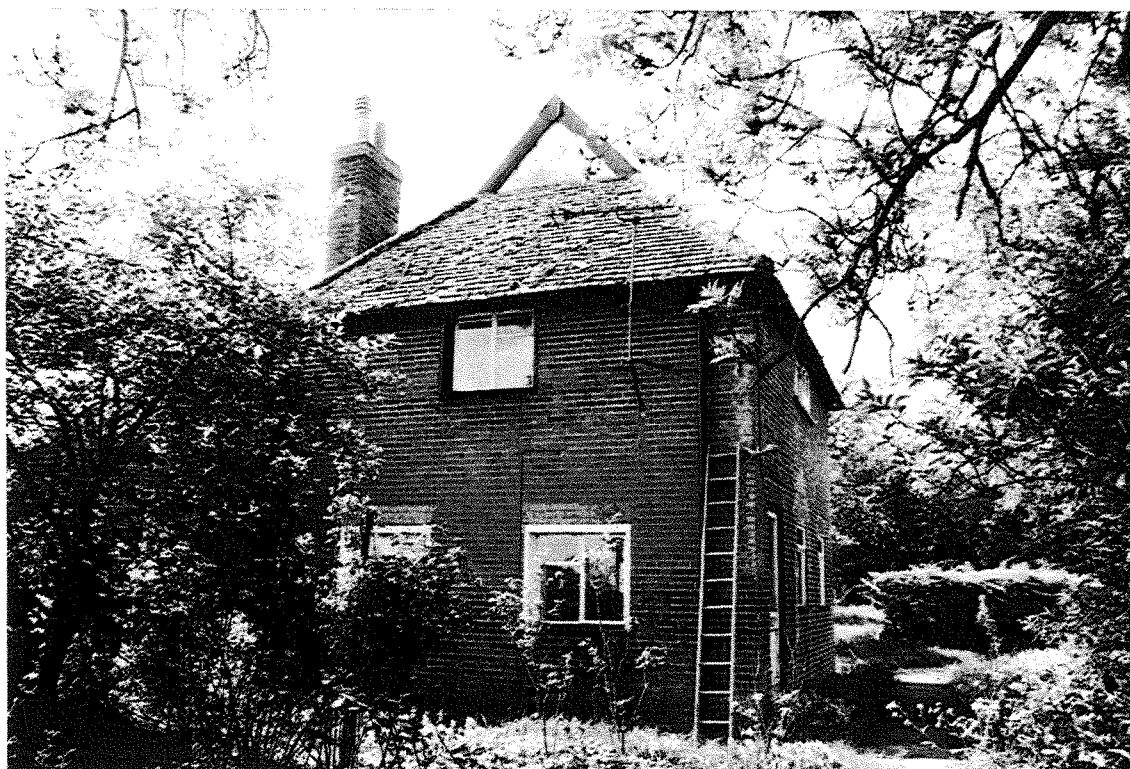
*Plate 4* The dovecote from the north-east (showing inserted windows and new door position)

The north-eastern elevation has three inserted windows, one in the centre of the first floor and two on the ground floor. These three windows appear to be contemporary with each other and with the window in the upper floor on the south-western elevation. Although all four windows have inserted galvanised steel frames they also have timber lintels as opposed to the brick lintels of the other windows and so may represent the positions of earlier insertions.
