**ORCHARD STREET
WING,
CHURCHGATE
MILL,
LAVENDERS
BROW,
STOCKPORT**

**Archaeological Building
Investigation**

Oxford Archaeology North

October 2013

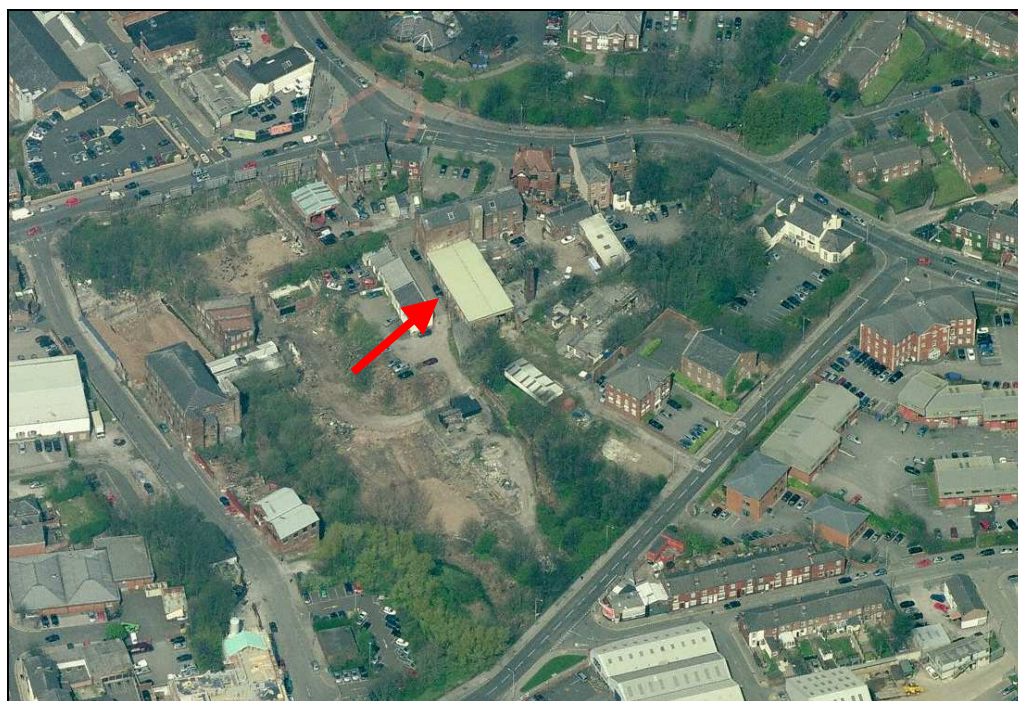
Plate 1: Aerial view Hopes Carr, with arrow marking the position of Orchard Street Wing

- 1.2.1 The site (centred on NGR 389926 390241) lies on the south-eastern fringe of Stockport town centre (Fig 1). The remains of the former Churchgate Mill complex are bounded to the west by Orchard Street, to the north by Lavenders Brow, to the south by Waterloo Road, and to the east by Churchgate (Plate 1). The principal surviving element of the former mill complex is the three-storey (plus attic) block that fronts onto Lavenders Brow, which retains much of its early to mid-nineteenth-century fabric; the significance of this structure is reflected in its inclusion on the Local List of historically important buildings that is maintained by SMBC. The element of the former mill complex that forms the focus of the present study fronts onto Orchard Street, abutting the south-western elevation of the Lavenders Brow range. This single-storey block represents the remodelled remains of a former multi-storey block.

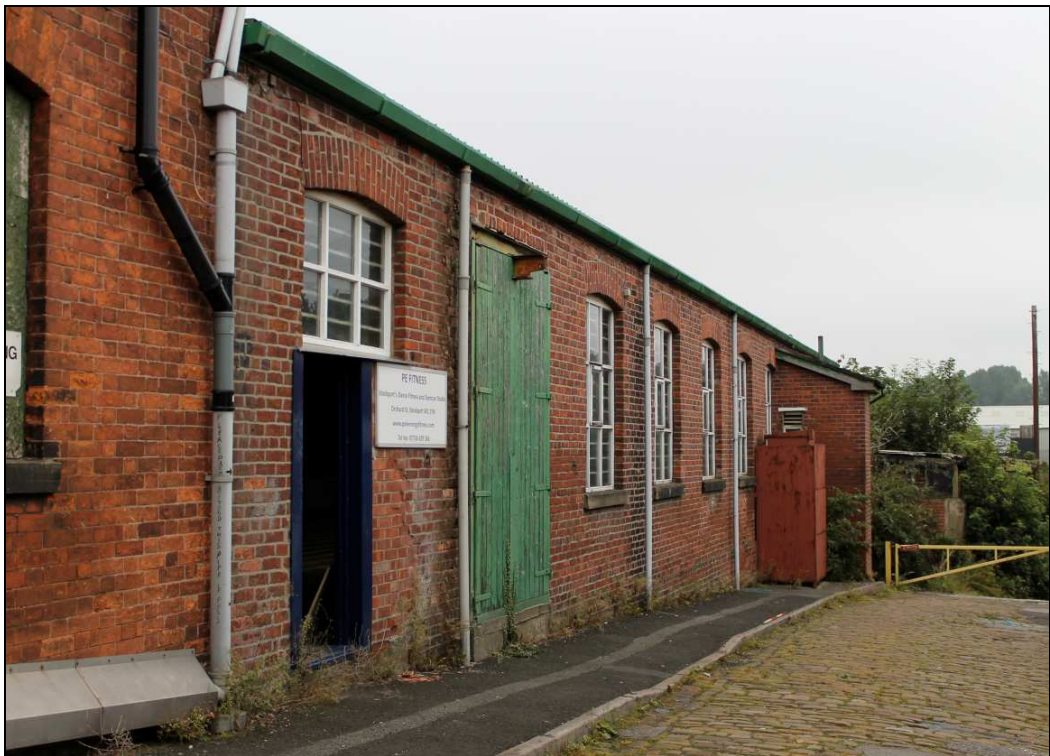
Plate 5: The west-facing elevation of the Orchard Street Wing, overlooking Orchard Street

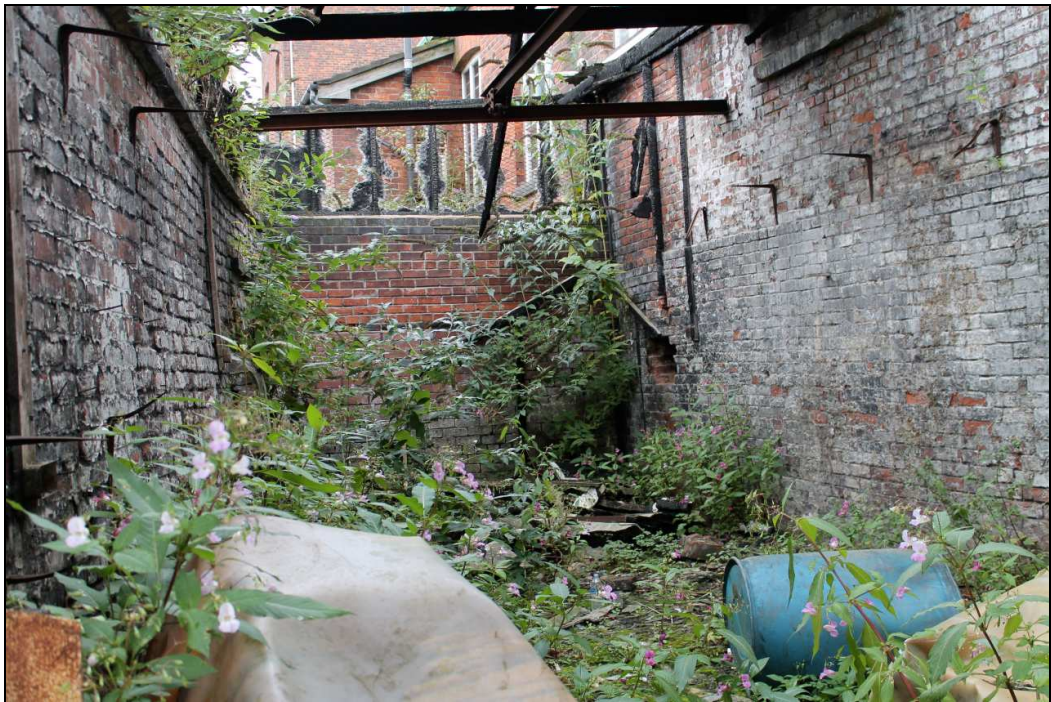
- 3.1.3 The fabric of the building incorporated hand-made bricks which, at the south end, were clearly bonded with lime-based mortar (Plate 6), consistent with a construction date in the first half of the nineteenth century. The rest of the building had been repointed recently, so it was not possible to observe the mortar. The south elevation had been rebuilt completely in engineering brick, probably during the twentieth century. The yard walls comprised machine-pressed brick bonded with hard grey cement, where visible, and the exterior covered with a skim of concrete.

Plate 6: Hand-made bricks visible at the south end of the building

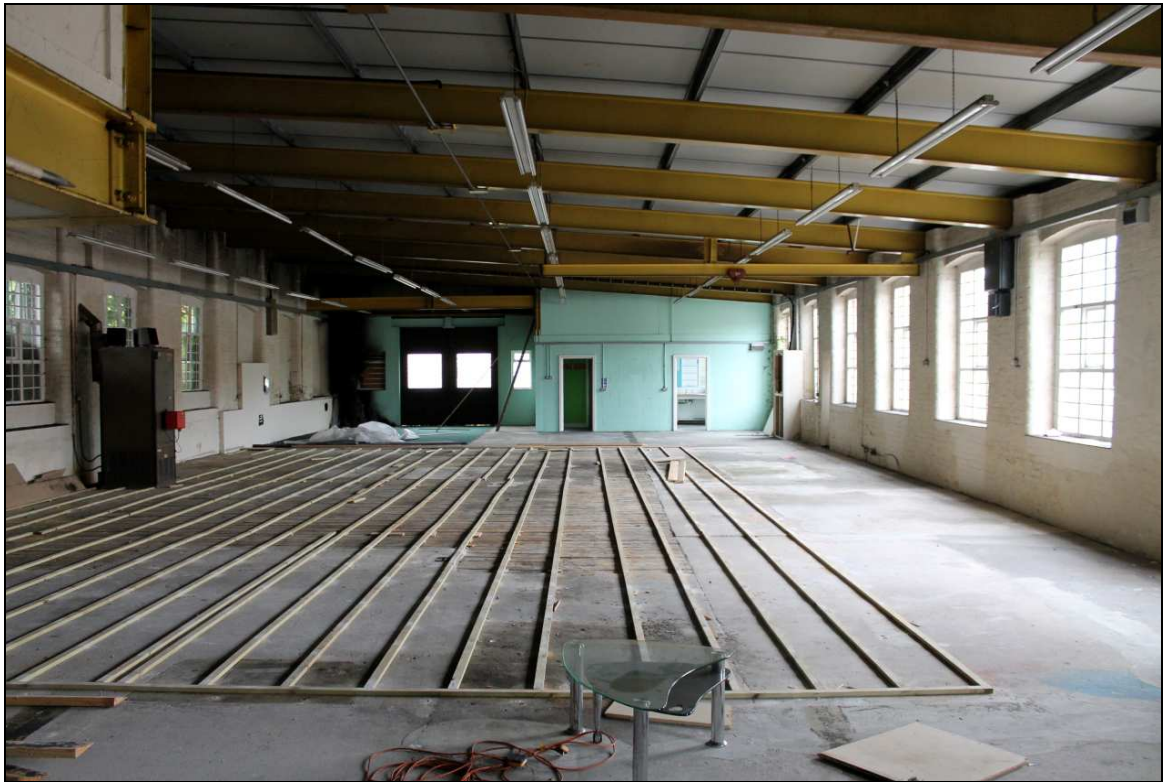
Plate 7: Internal layout looking south, showing the modern sloping roof

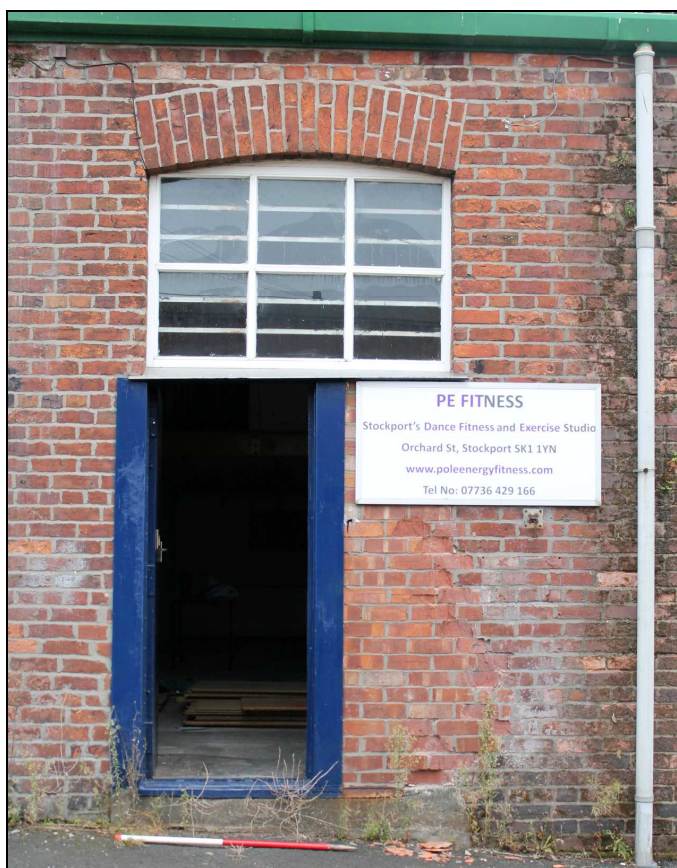
- 3.2.3 Modern access into the building from Orchard Street was afforded via a 2 x 0.93m door in the northern bay of the west elevation, which probably represented the remodelling of an original window (Plate 9). The door was faced on both sides with thin steel sheeting and had two locks. A larger, 3.25m high by 1.96m wide, double loading door occupied the adjacent bay to the south. Both doors were raised up slightly from current ground level on a concrete plinth (Plate 10). An 'I'-section steel beam formed a lintel above the loading door, with another 'I'-section beam running out from it, now cut off, representing the remnants of a hoist. At the southern end of the building was a modern double loading bay door giving access into the southern yard area.

Plate 9: Entrance door from Orchard Street

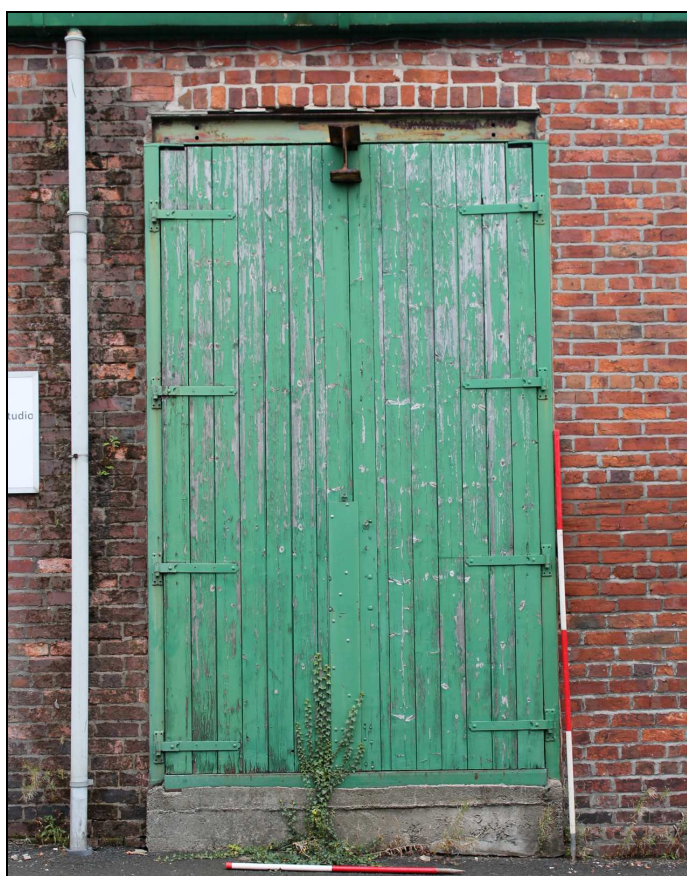
Plate 10: Loading door from Orchard Street

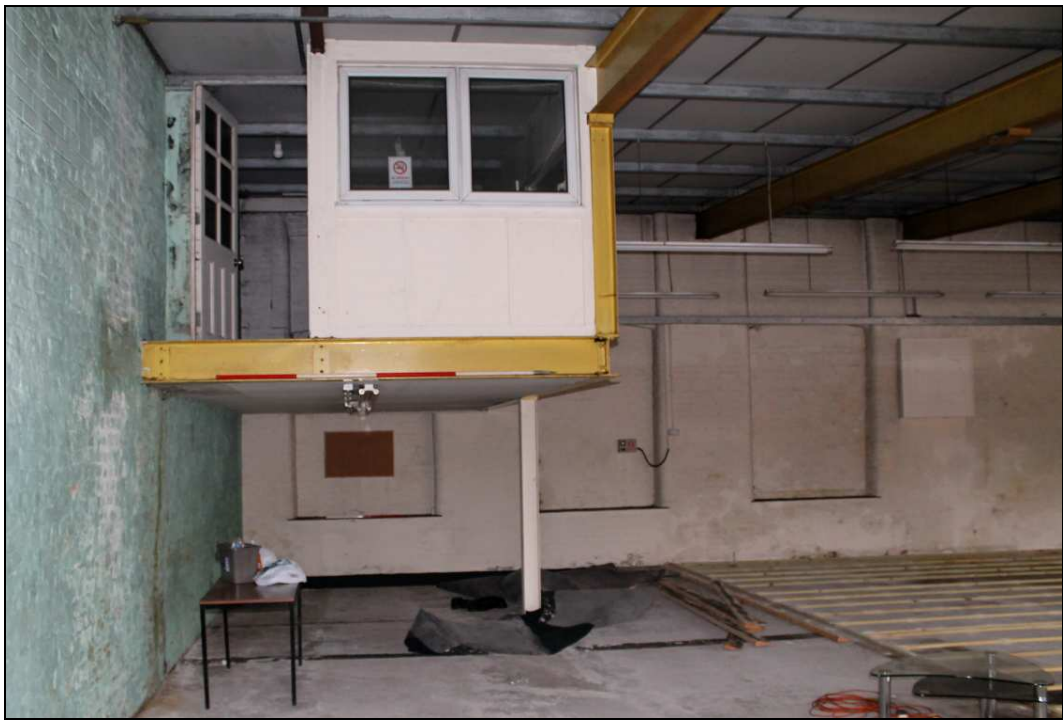
- 3.2.4 The modern roof covering, presumably installed when the building was reduced to a single storey, comprised steel sheets and sloped down from east to west. The roof was carried on modern 'I'-section steel beams, aligned east/west, with smaller steel joists aligned north/south to support the roofing material. The steel beams appeared to have been inserted into the original brickwork on the western side of the building, whilst the housings on the east appeared intact, suggesting that these were the positions of the wooden beams that had supporting the original upper floor. Another 'I'-section steel beam had been placed below the last beam to the south. This did not slope, and was possibly intended for some type of lifting equipment, now removed. A further horizontal beam had been placed below the central beam, and may similarly have been intended for lifting equipment. Another two horizontal steel beams had been inserted at the south-east corner of the block to form an 'L'-shaped structure. This was supported in the centre of the east/west beam by a single 0.23m by 0.2m modern steel 'I'-section column, which supported a 6.55m by 3.16m mezzanine floor that was raised 2.6m above the ground level and walled with white PVC partitions (Plate 11).

Plate 11: The mezzanine floor situated in the north-east corner of the building

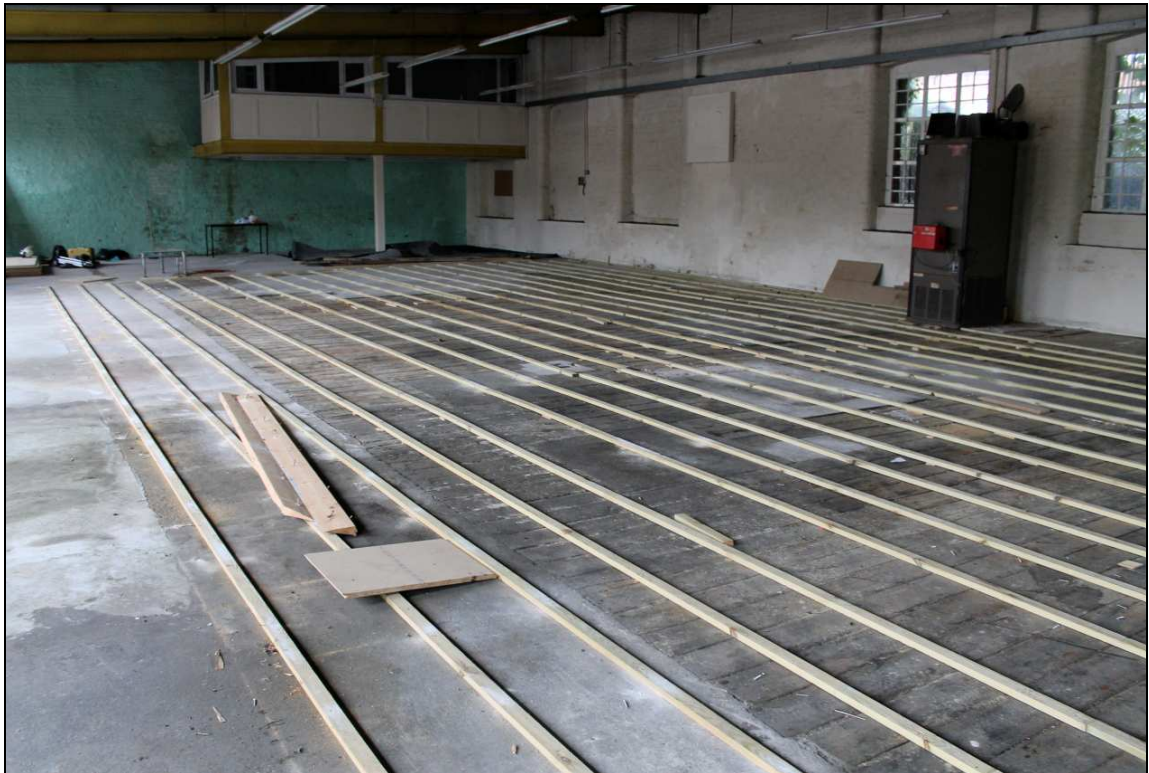
- 3.2.5 The floor was comprised mainly of concrete, and had an irregularly-shaped area of wooden floorboards in the centre. Below the boards was a gap of c 0.15m, packed with rubble and wood chippings. Within the floorboard area were four concrete pads of various sizes (Plate 12). The largest pad contained a cast-iron rectangular setting. The position of the 'I'-section beam below the central roof beam ended at the north-western of these pads. The northern, smallest, pad contained the base of a steel 'I'-section column that had been cut off at ground level (Plate 13). To the north and south of this column base were two identical bases, all cut off at ground level.

Plate 12: Concrete floor arrangement, looking north-east

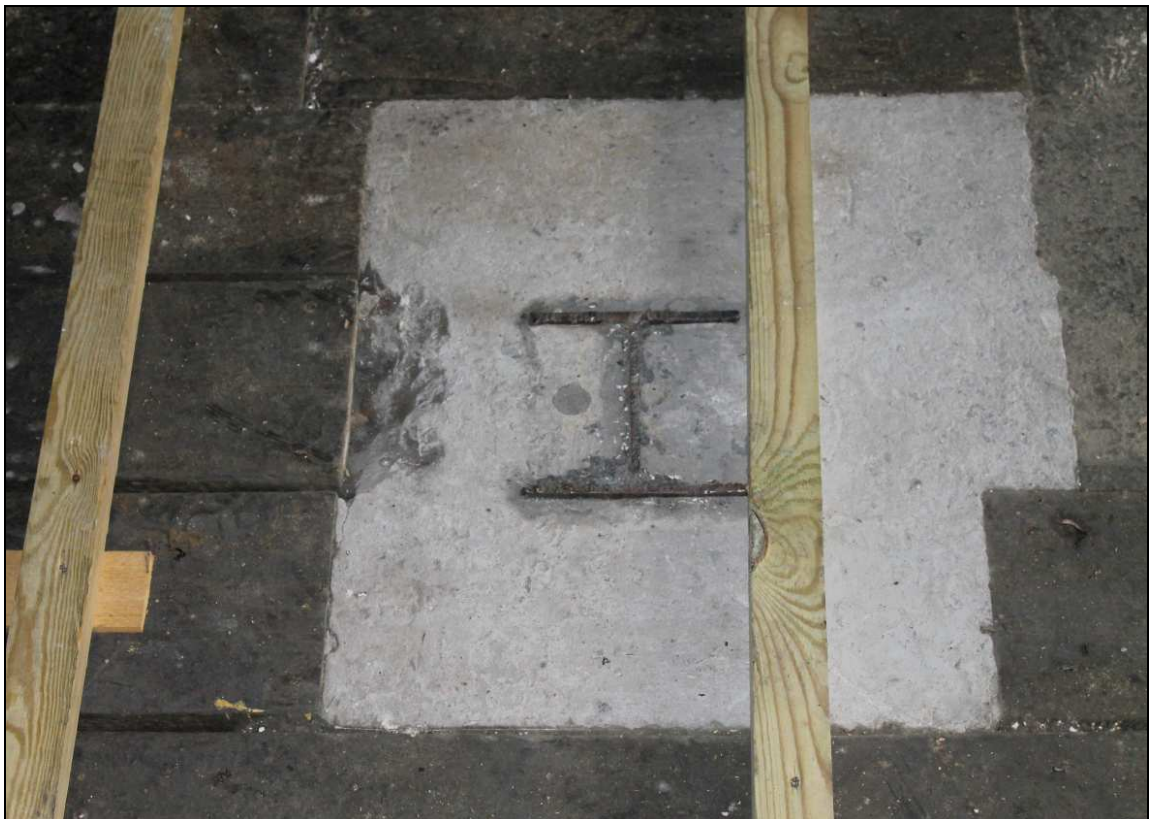
Plate 13: Cut-off 'T'- section column

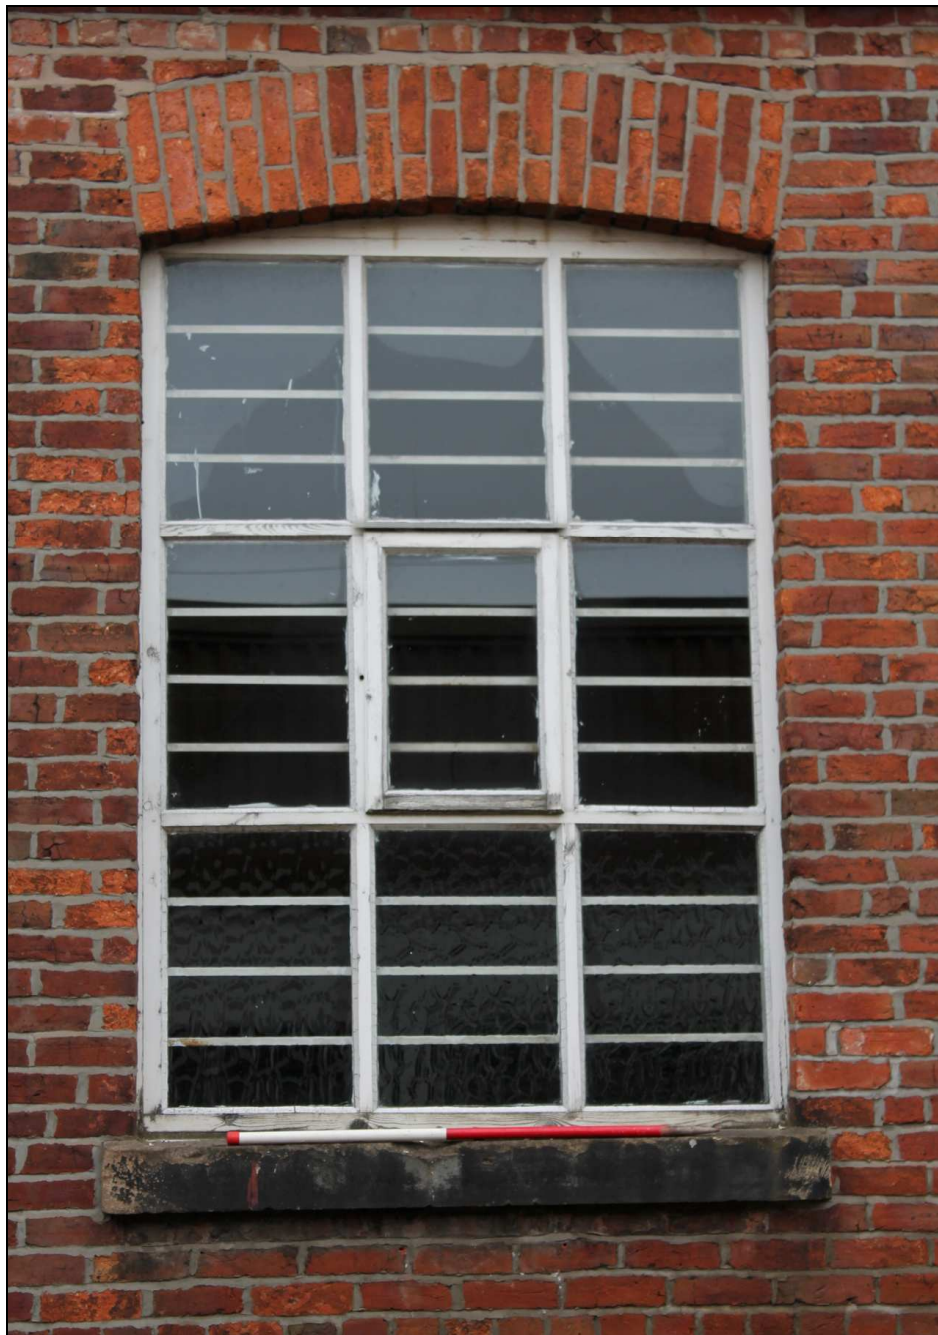
- 3.2.6 The remains of the 'I'-section columns, or stanchions, were set at intervals of approximately 6m, and were aligned north/south. The stanchions did not sit below any of the current roof beams and, together with the two level beams and the irregular concrete and flooring, are likely to represent the remains of former machinery. These steel and concrete components were clearly a late addition to the building, probably contemporary with its reduction to a single storey and the insertion of the steel roof.
- 3.2.7 Eight windows survived along the western elevation. These were 1.67m wide by 2.65m high, with a 1.77m wide stone sill and arched, brick lintels. The timber frames housed nine panes, in three rows of three, the central pane opening (Plate 14).

Plate 14: Detail of one of the windows in the west elevation

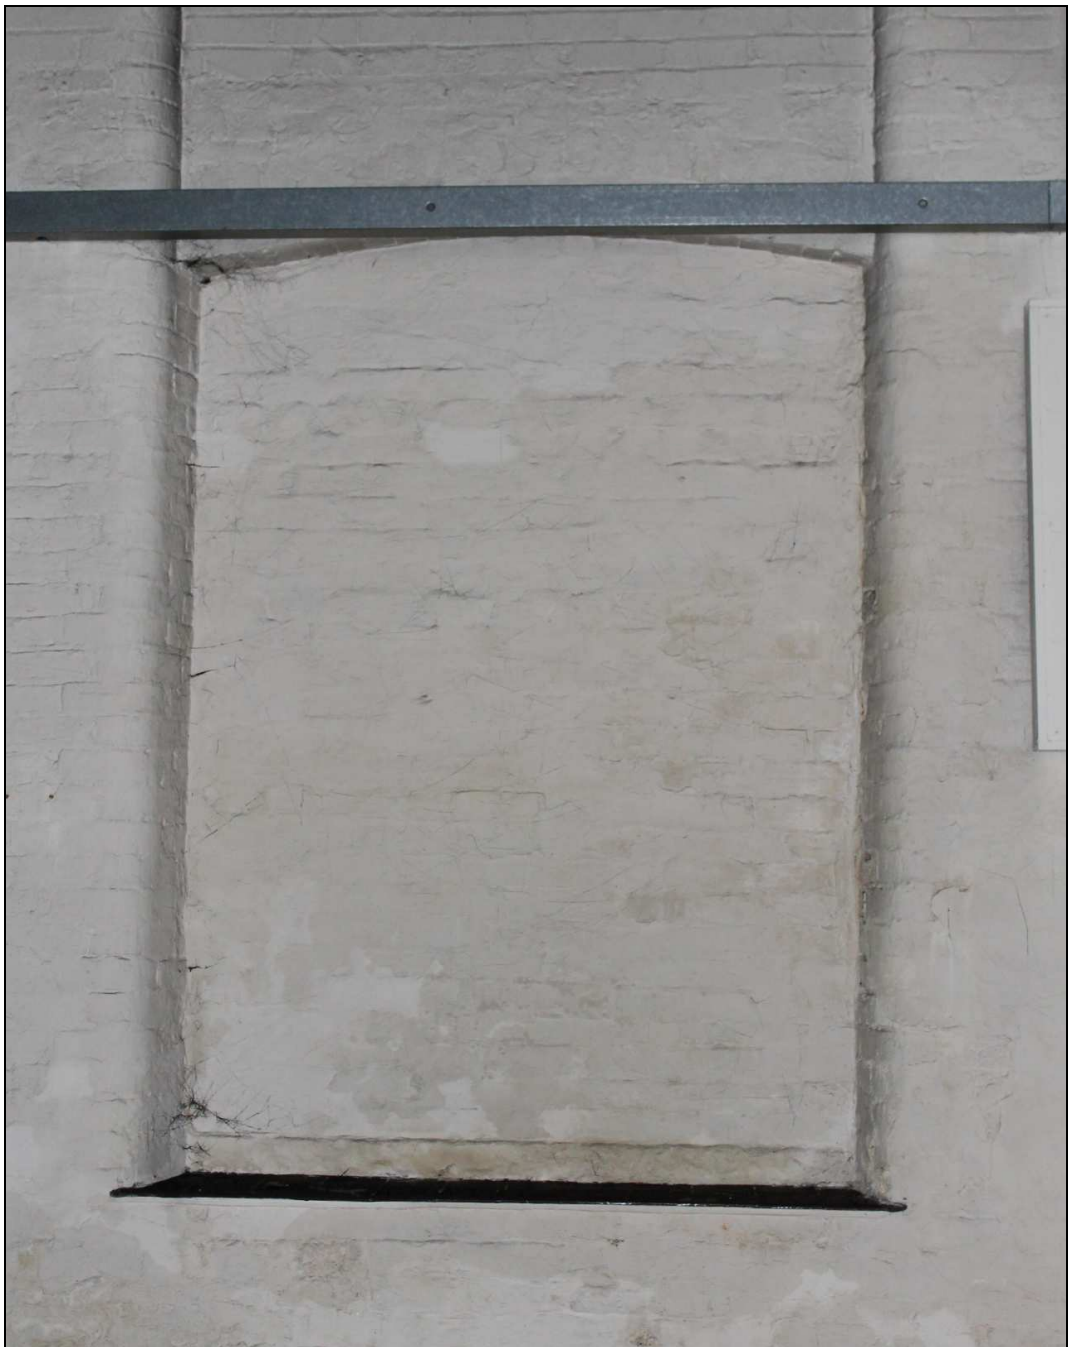
- 3.2.8 At the north end of the elevation, above the entrance door, was a ninth, smaller, window that measured 1.63m wide and 1.15m high. It was slightly offset from the door, and the arch was at the same height as the other windows, suggesting that it had been remodelled to accommodate the late insertion of a door (Plate 9).
- 3.2.9 Two different types of windows were present in the eastern elevation of the building. A row of three windows in the northern bays, together with another row of three at the southern end (Fig 3), each measured 1.71 wide and 2.45m high, and had arched lintels with bull-nosed bricks forming the sides. These windows had all been blocked with hand-made bricks (Plate 15).

Plate 15: Blocked window in the eastern elevation

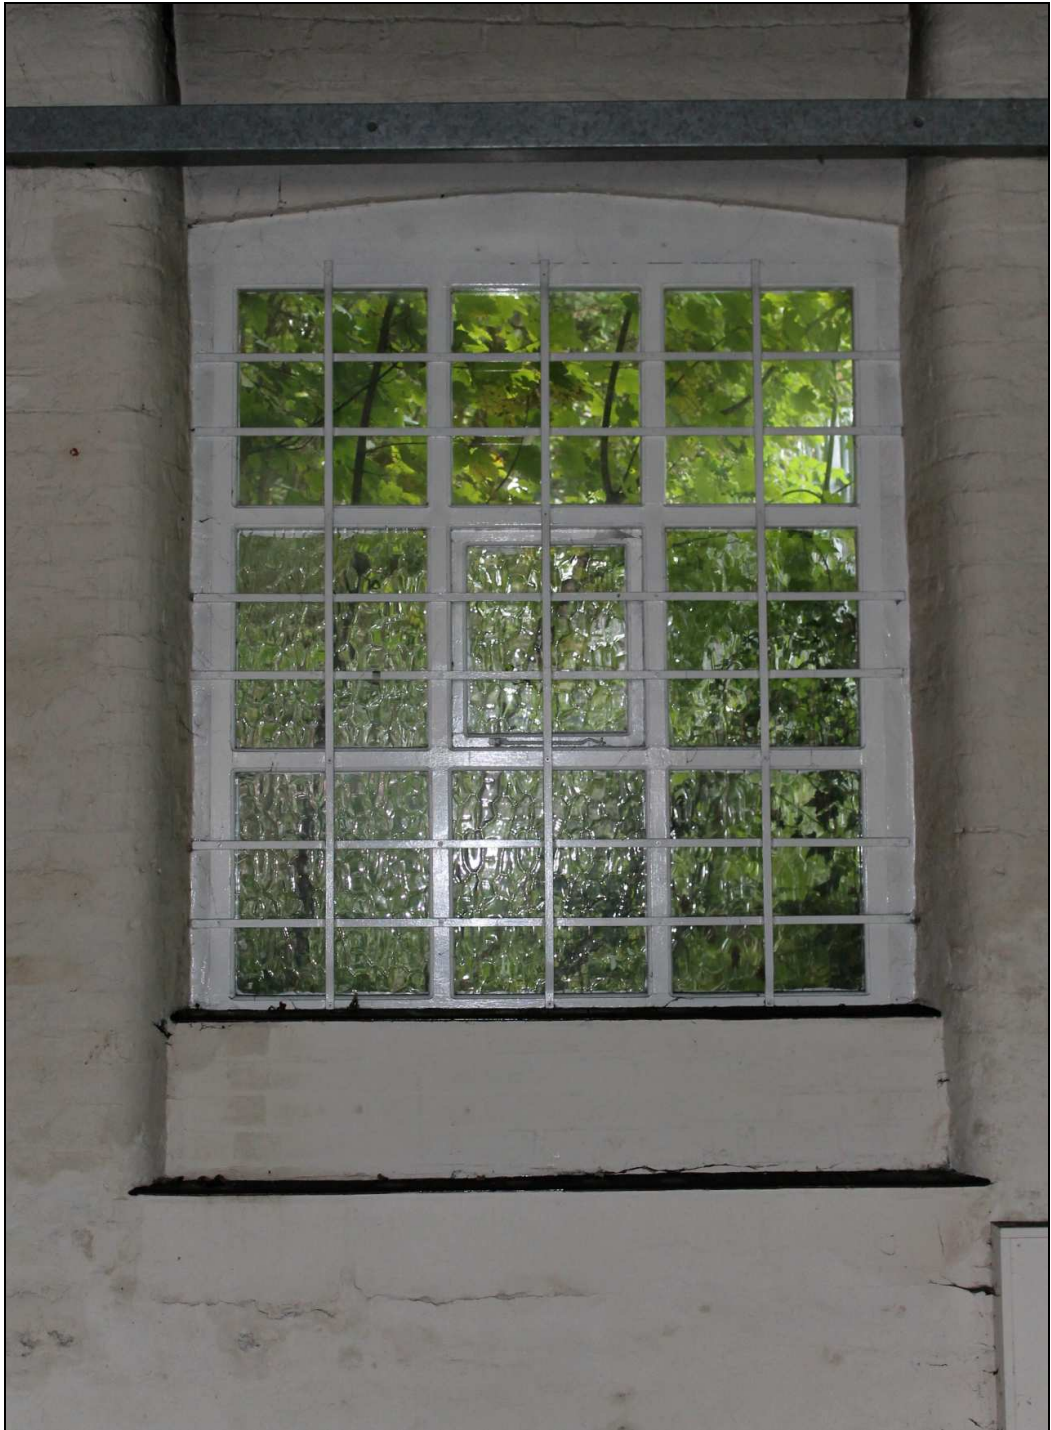
- 3.2.10 Between these two blocks of windows, and with a 4.4m gap from the northern block, were three different windows. These were each 1.67m wide by 1.95m high with a stone external sill, and two internal sills, the higher set back slightly. The edges of the window apertures comprised bull-nosed bricks, and the window frames housed nine panes in three rows of three, with the central pane opening (Plate 16). The lower sill almost certainly represented the original window aperture, which have been remodelled slightly and a small window frame inserted subsequently.

Plate 16: Central window in the eastern elevation

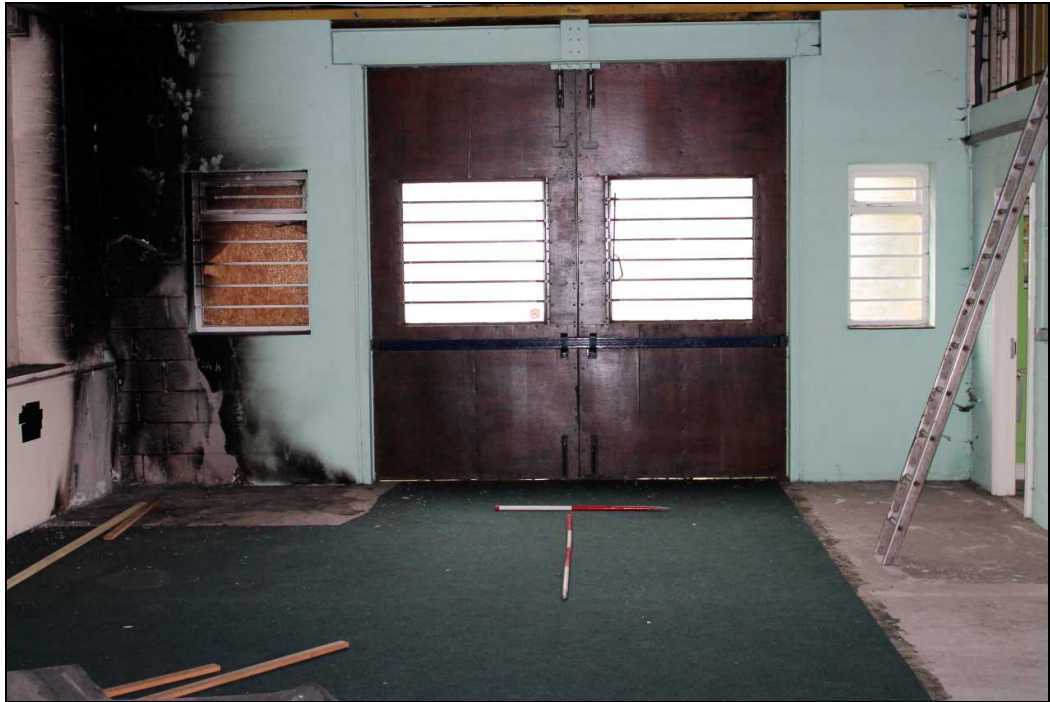
- 3.2.11 The entire southern elevation had been rebuilt in engineering brick, and had a 3.07m wide loading bay door inserted into the eastern end, with a steel 'I'-section joist above it. To either side of this were small rectangular windows, each measuring 1.2m high. Both had two panes, a larger lower pane and a smaller opening upper pane, both fitted with horizontal security bars (Plate 17).

Plate 17: Southern loading bay door and flanking windows

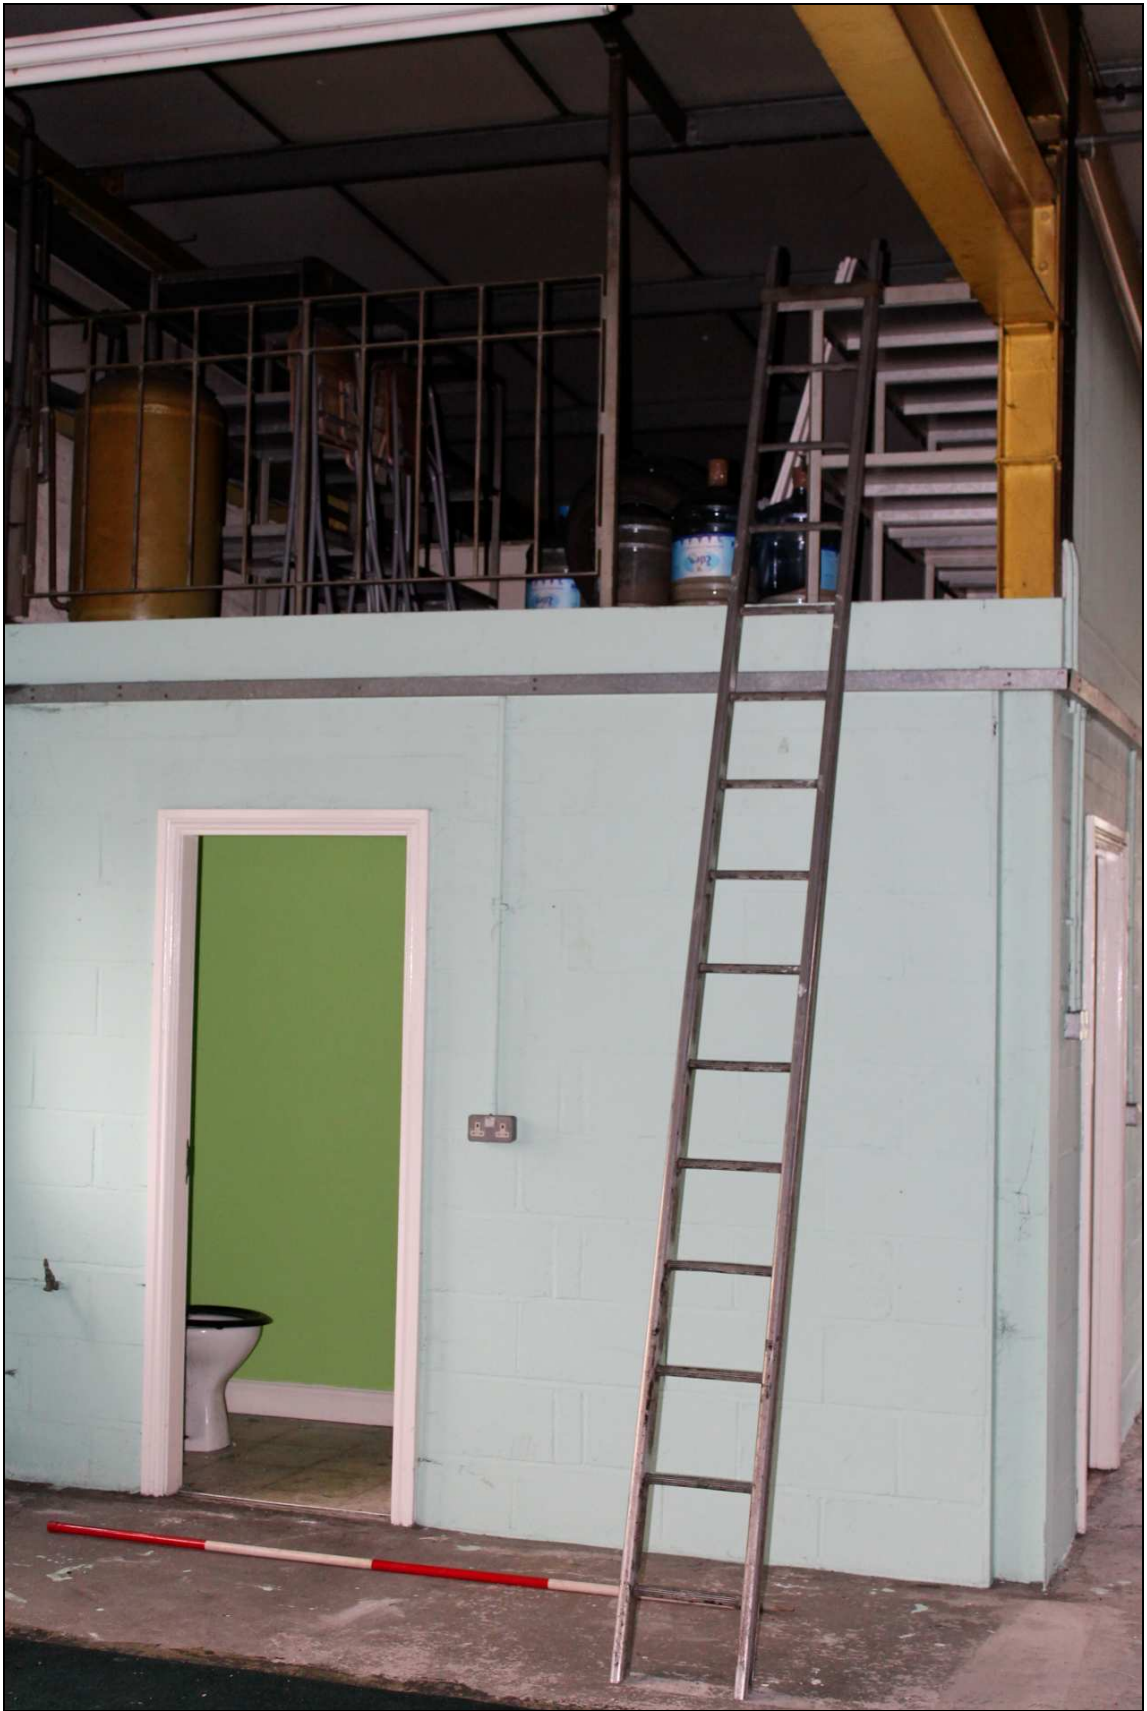
- 3.2.12 Abutting the rebuilt southern elevation, in the south-west corner of the building, was a small structure of cinder-block construction, measuring 6.34 x 3.28m. The structure was split into three rooms by 80mm thick stud partitions. A small gents toilet was accessed through a doorway in the east wall, a ladies toilet with two cubicles was accessed through a doorway in the north wall, and a kitchen was also accessed through a doorway in the north wall. The gents toilet, both ladies cubicles and the kitchen had small two pane rectangular windows. The one in the gents toilet was identical to the ones flanking the loading bay doors, but with frosted glass. The two windows in the ladies' toilet cubicles measured 0.50 x 0.76m, with a smaller opening top pane and frosted glass. The kitchen window was 0.52 x 1.12m high, with two panes side by side, the left one opening. All had bars on the windows, and all the doorways were 0.8m wide (Plate 18). The internal walls did not ascend to roof height, and the block had a fenced-off storage area above it accessed by ladder.

Plate 18: South-west kitchen and toilet block with storage above, looking south-west

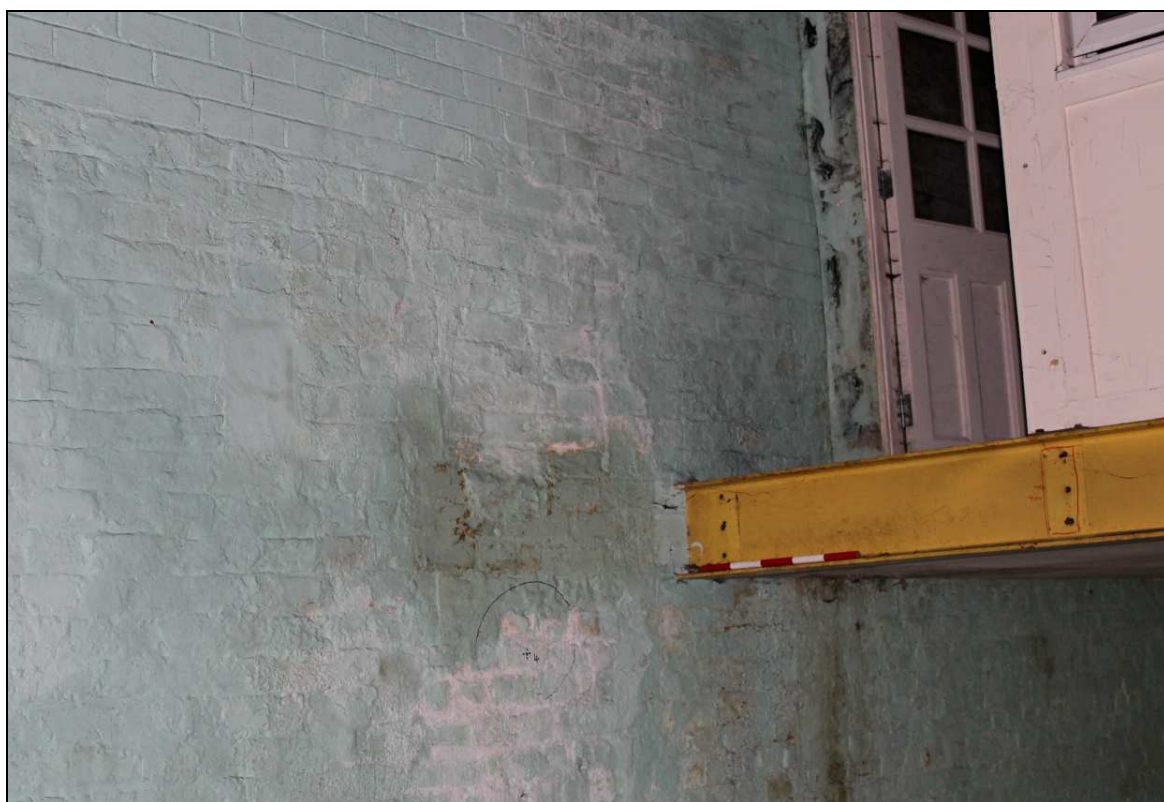
Plate 20: Blocked aperture in north elevation

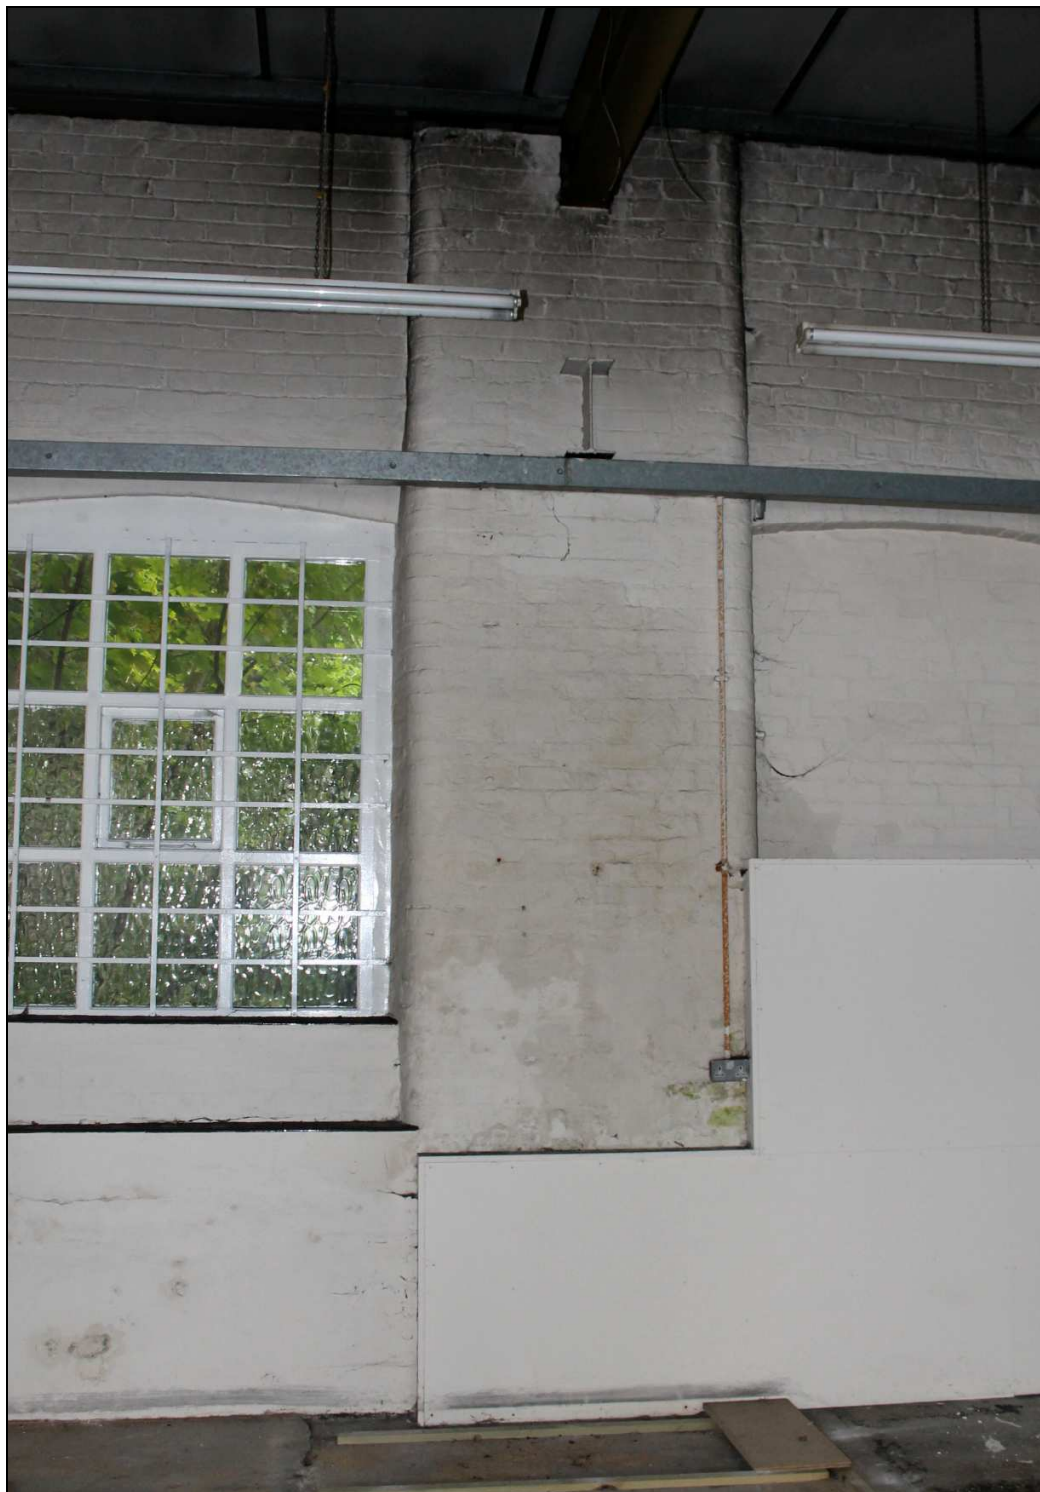
- 3.2.14 The stubs of two steel 'I'-section beams were set 6m apart into the interior east elevation, at a height of 3m above floor level (Plate 21). These beams lined up with the southern and central stanchions set into the concrete floor, and almost certainly formed part of the modern structure that once occupied this part of the building.

Plate 21: Southern of two 'I'-section beam stubs in the east elevation

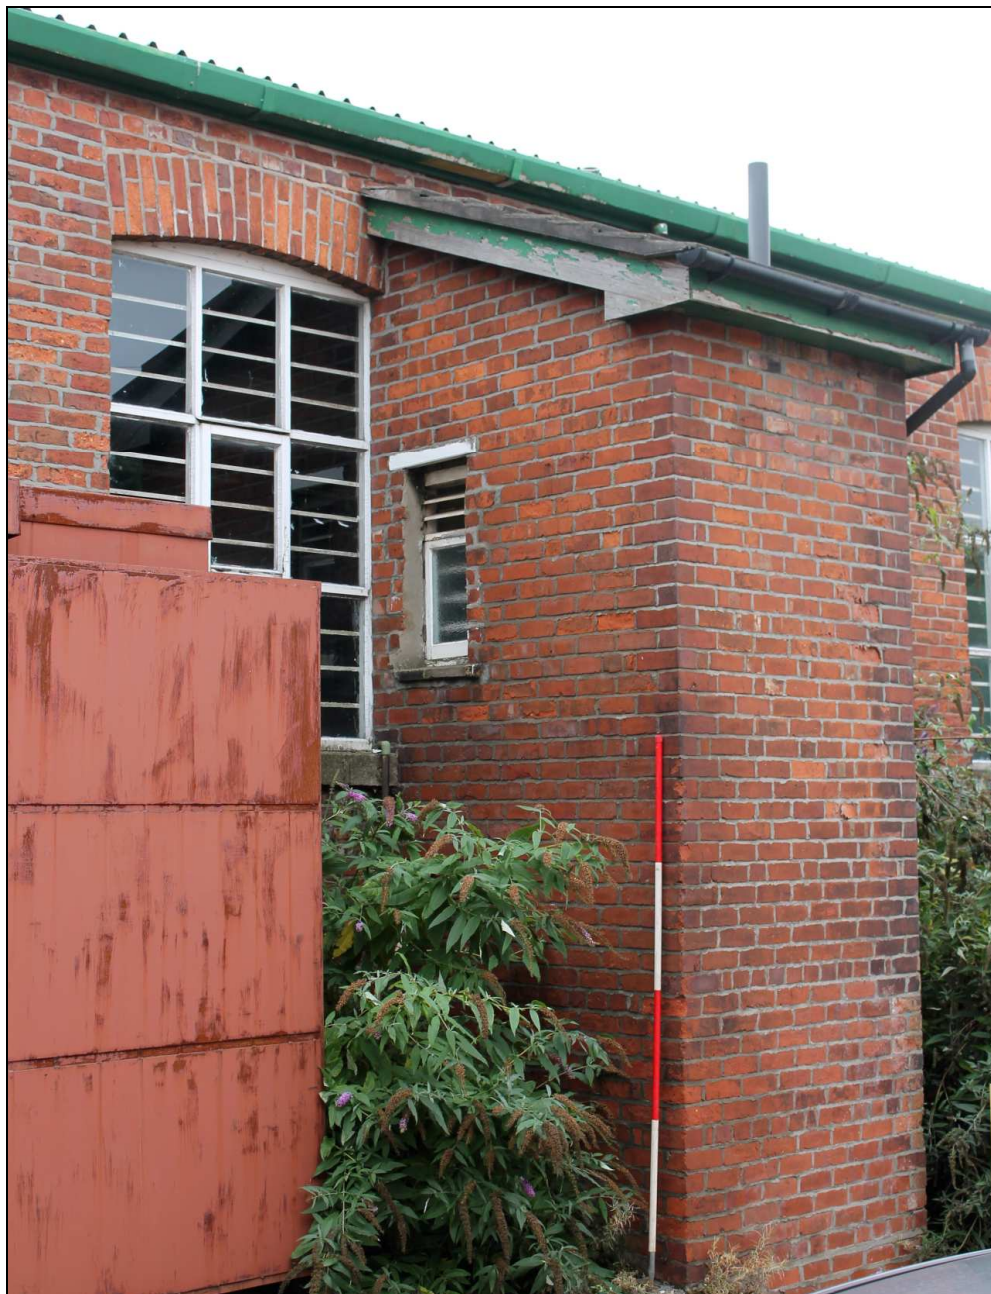
3.2.15 A small rectangular projection, measuring 2.14 x 1.58m, and with internal dimensions of 1.9 x 1.1m, abutted the western elevation of the building, between the seventh and eighth bays (Fig 2). The fabric of this structure comprised hand-made bricks, similar to those used in the construction of the main building, although its footprint is not marked on the Ordnance Survey map of 1895 (Plate 5), suggesting that it may have been a later addition. Two small windows, 0.42m wide and 0.92m high with a stone sill and fitted with two panes, were inserted in the north and south walls of the structure. The brick-built walls supported a modern sloping roof, which is likely to have been fitted when the main block was reduced to a single storey. The rainwater goods were similarly of a modern date (Plate 22). The structure may have been intended as a privy tower, but was used latterly as a small storeroom. It was accessed via a 0.70m wide doorway from the body of the building.

Plate 22: Projecting structure abutting the west-facing elevation

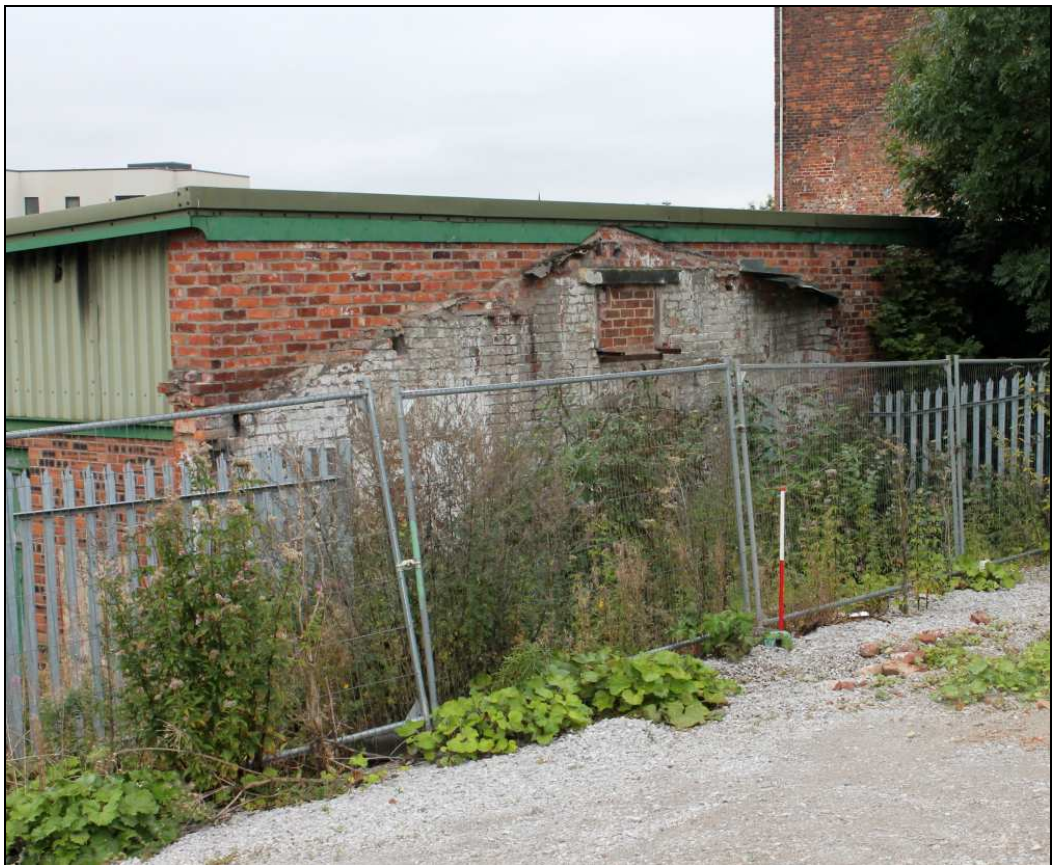
- 3.3.2 The roof scar of the demolished boiler house was visible on the east-facing elevation (Plate 23). This was 9.47m wide and ascended, at its apex, almost to the top of the first-storey wall, at a height of *c* 5.6m above ground level. It appeared to asymmetrical, with the southern side having a very slightly steeper pitch. Window apertures beneath the roof scar had been blocked with hand-made bricks and plastered on the exterior elevation, indicating they pre-dated the boiler house and were blocked on its construction.

Plate 23: Roof scar of the demolished boiler house

- 4.3.2 A larger boiler house had been built by the later 1860s, abutting the southern end of the eastern elevation of the wing block; the roof scar for this boiler house can be seen on the eastern elevation of the building. It is probable that this was the reason for the blocking of the southern three windows in this elevation. A square aperture, now blocked, visible near the apex of the boiler house roof scar suggests, that steam was being piped from the boiler house into the Orchard Street Wing during this period.
- 4.3.3 The outbuilding to the south-west of the wing block was added at some point after the 1860s. The fabric of the building is consistent with a construction date of 1870-90, although a precise date is not known. The intended function similarly remains uncertain, although it is likely to have been for storage purposes.

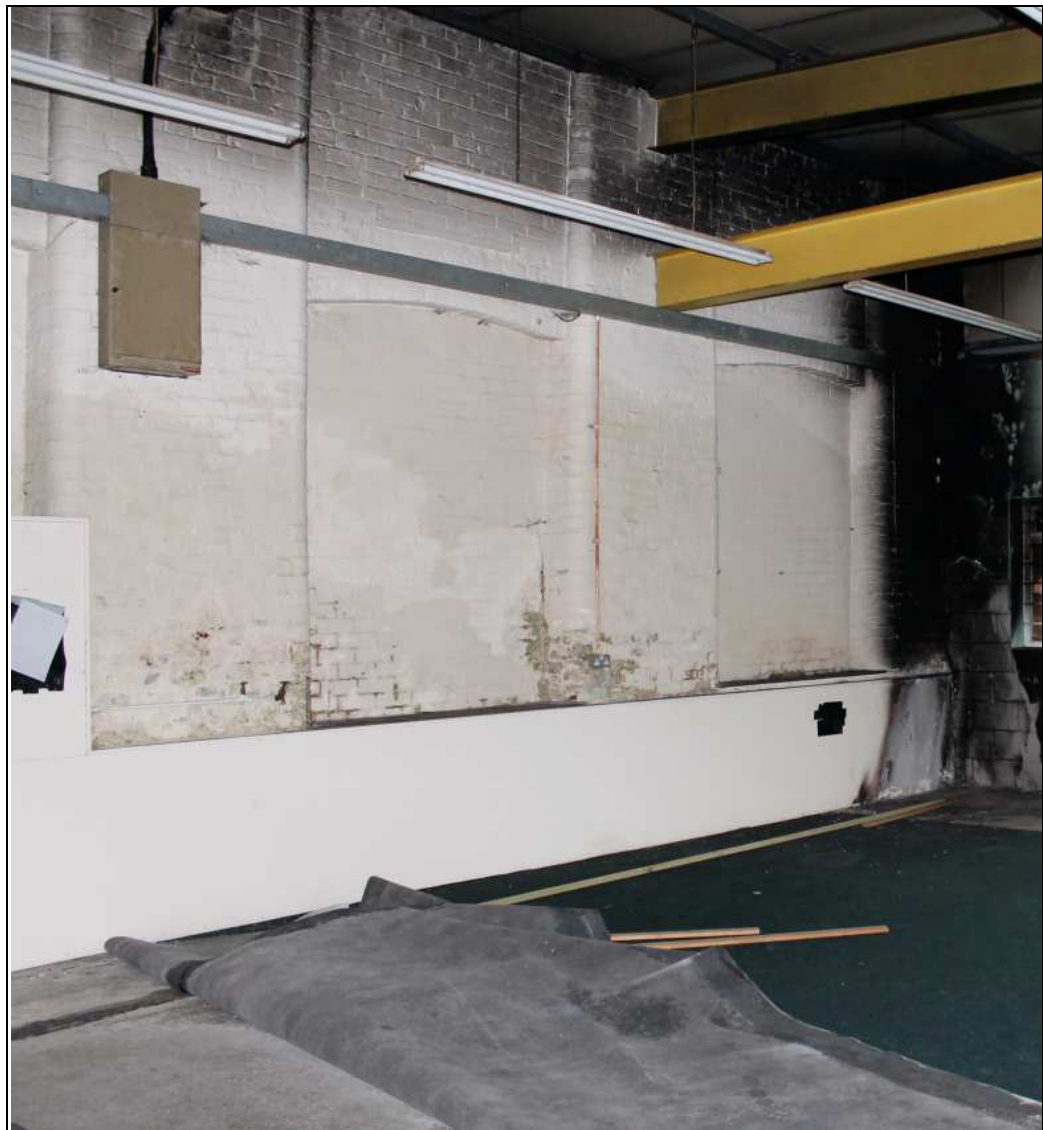
Plate 24: Blocked windows with stone sills visible on interior east elevation of main block
