**ORCHARD STREET
WING,
CHURCHGATE
MILL,
LAVENDERS
BROW,
STOCKPORT**

**Archaeological Building
Investigation**

Oxford Archaeology North

October 2013

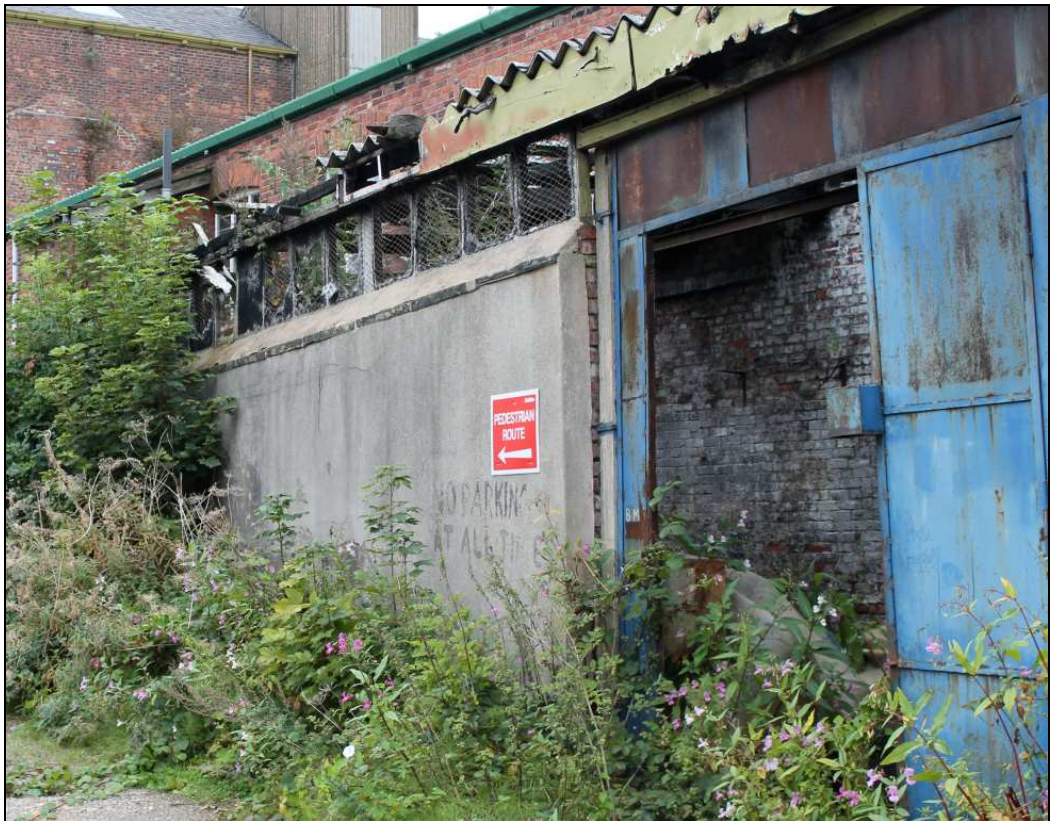
- 3.4.2 The walls survived to a maximum height of 3.6m (Plate 25). At the top of the walls were upright steel struts for an upper 1m course of fibreglass sheeting. Above this were steel beams angling down from the western wall of the south block to support a roof. The roof remained in places, and appeared to be corrugated chrysotile asbestos cement sheeting. Within the entrance way was the remains of a steel double door.

Plate 25: Western wall of the modern outbuilding

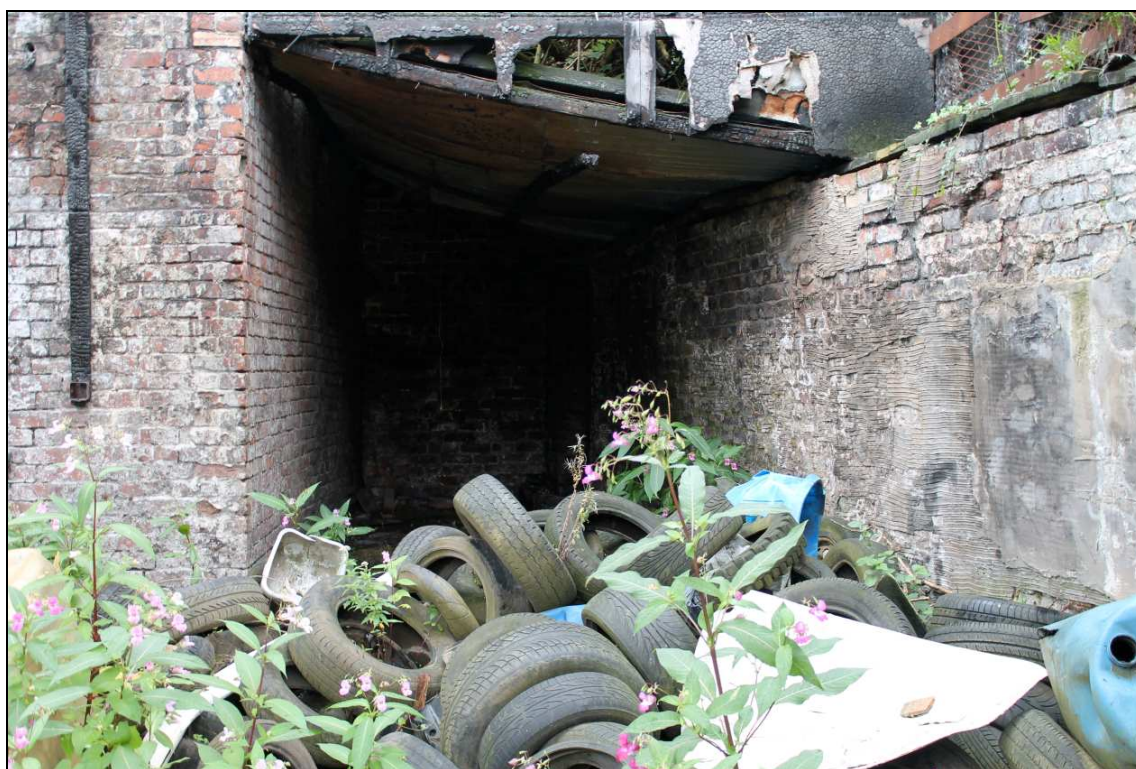
- 3.4.3 Within the covered south-eastern part of the outbuilding, a concrete floor surface had been raised by 0.42m. This created an open-fronted area, measuring 4.27 x 2.72m, reducing to 1.8m wide at the rear. The fabric of the roof comprised similarly modern materials, but with 80mm thick wooden sheets rather than chrysotile sheeting (Plate 26).

Plate 26: South-east enclosed area of outbuilding looking east

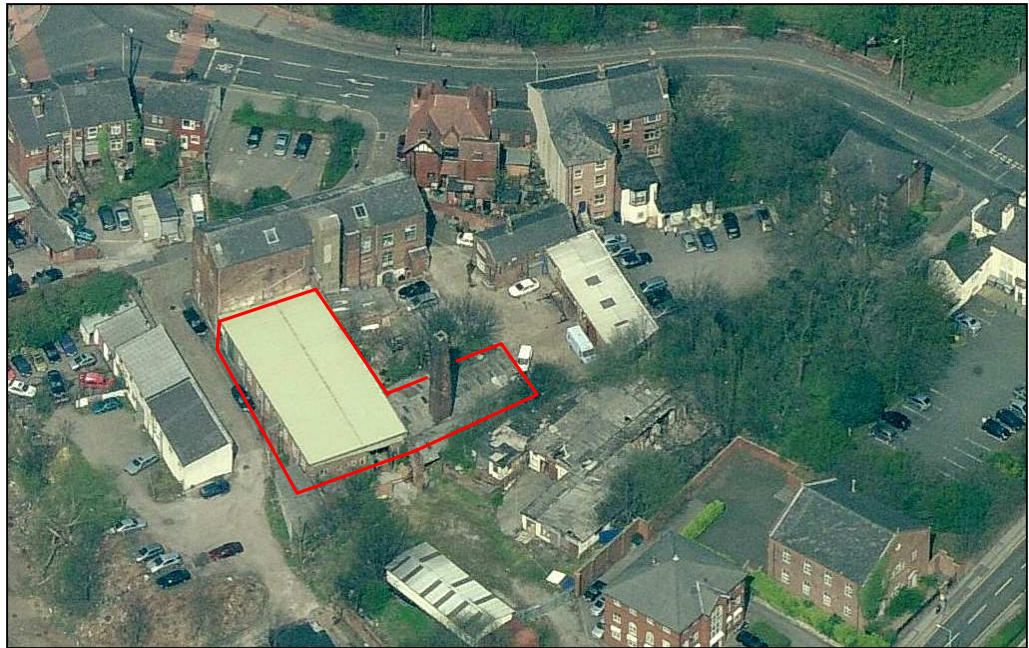
Recent aerial view of the former wing of Churchgate Mill, marking the buildings of interest
