FRECKLETON STREET LINK, PHASE 1 ADVANCE WORKS, BLACKBURN, LANCASHIRE

Archaeological Watching Brief

Oxford Archaeology North

June 2016

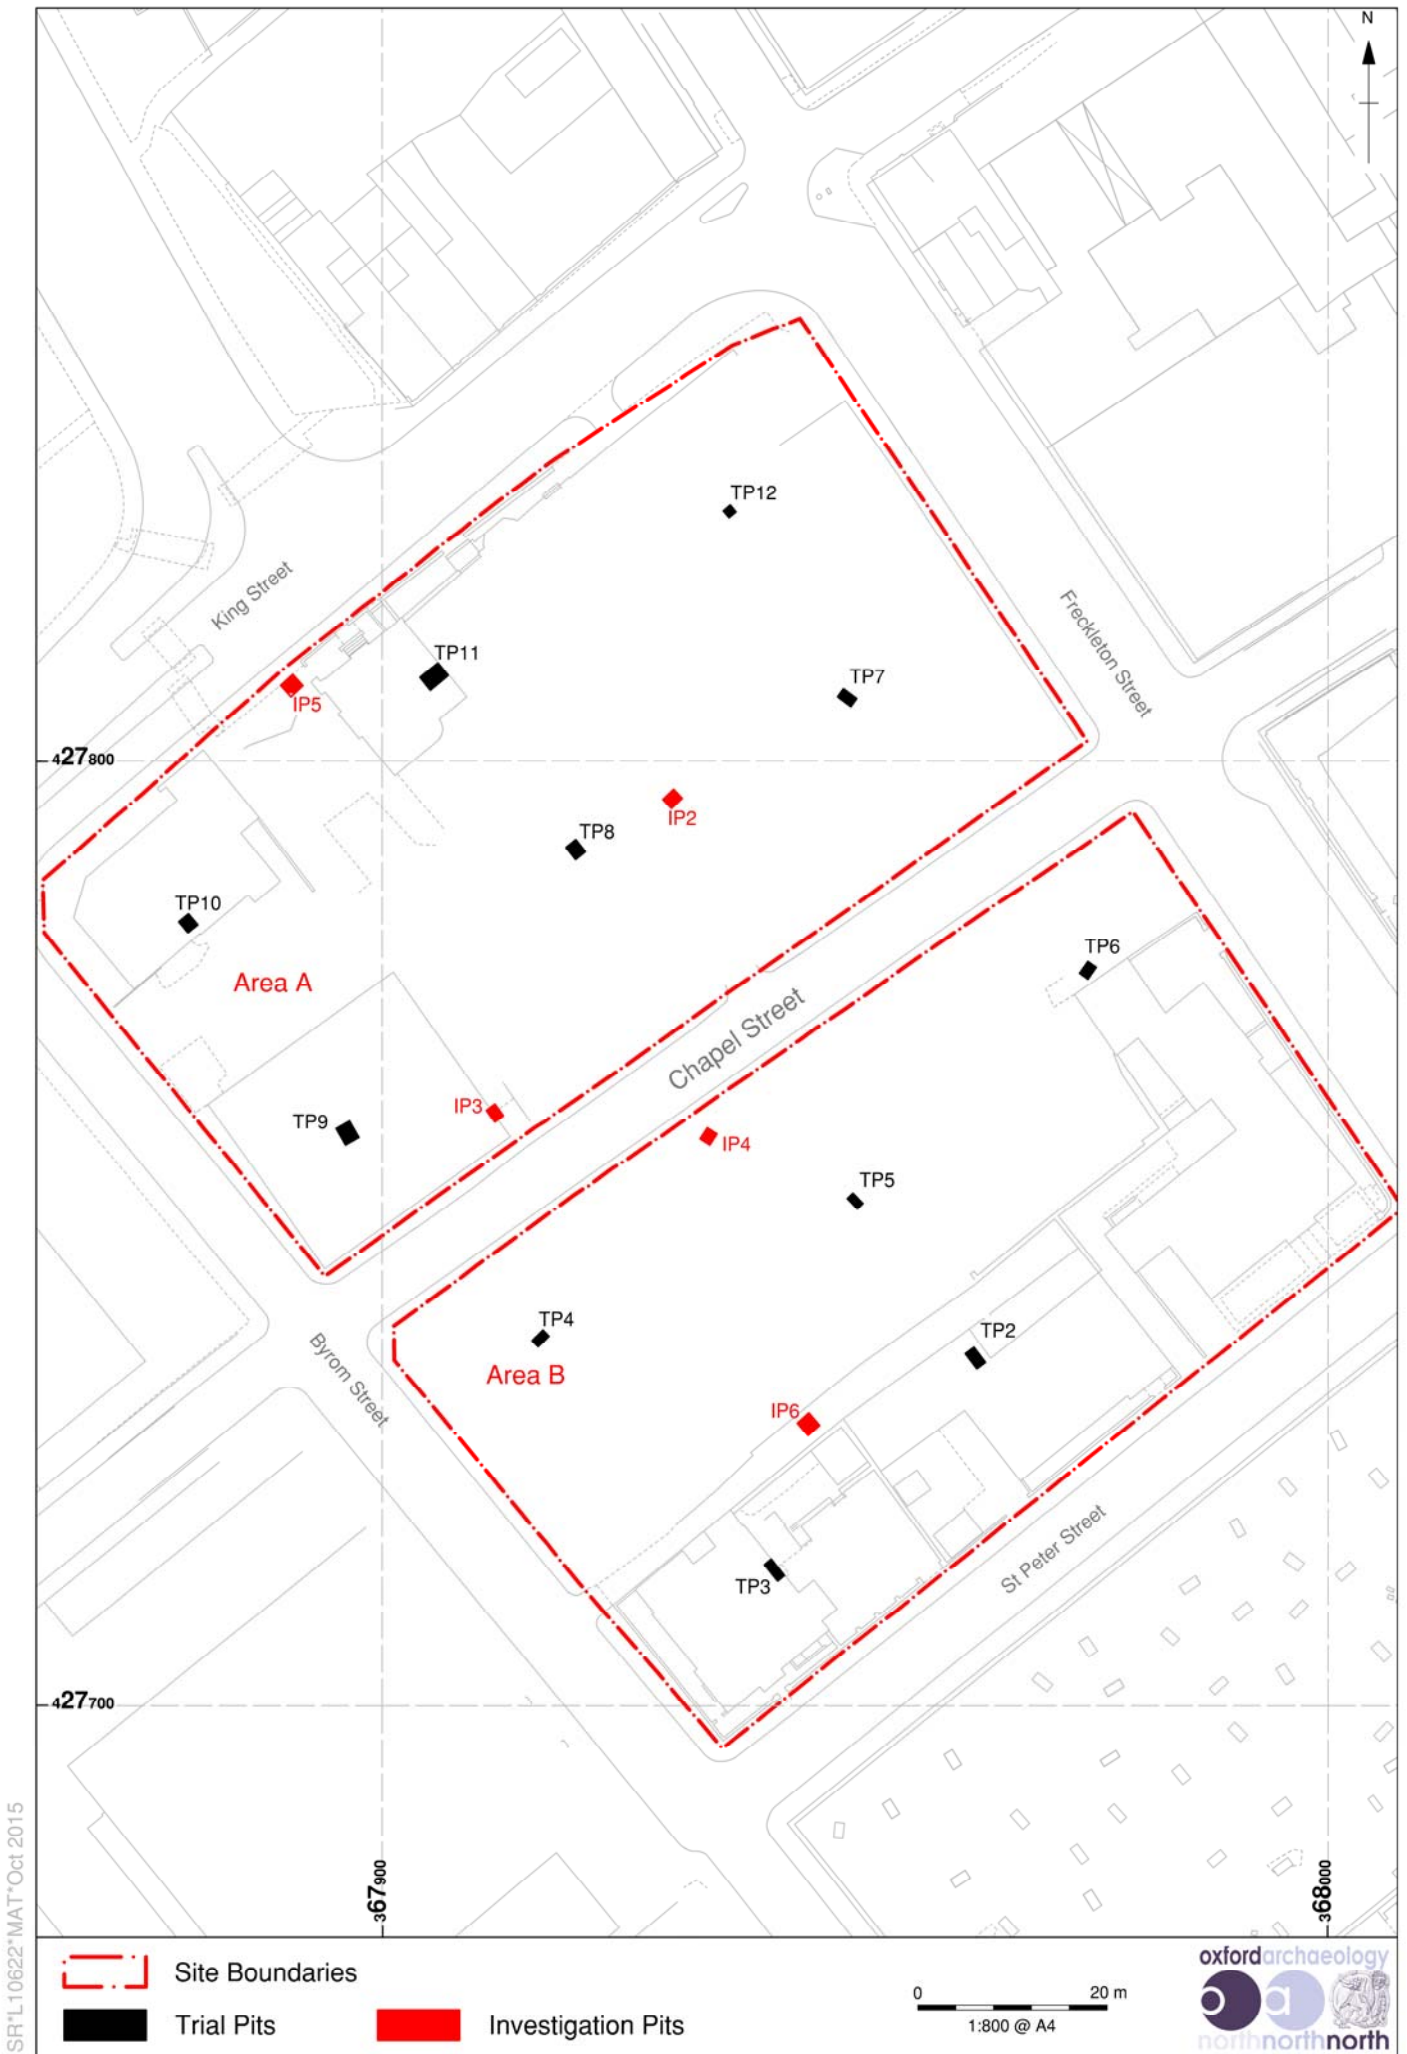
Figure 2: Location of trial pits and investigation pits

- 3.2.17 **Test Pits:** A series of eleven test pits were excavated in both areas A and B, in order to check soil conditions and compaction along with the depth of differing deposits. Their locations are noted on Figure 2.

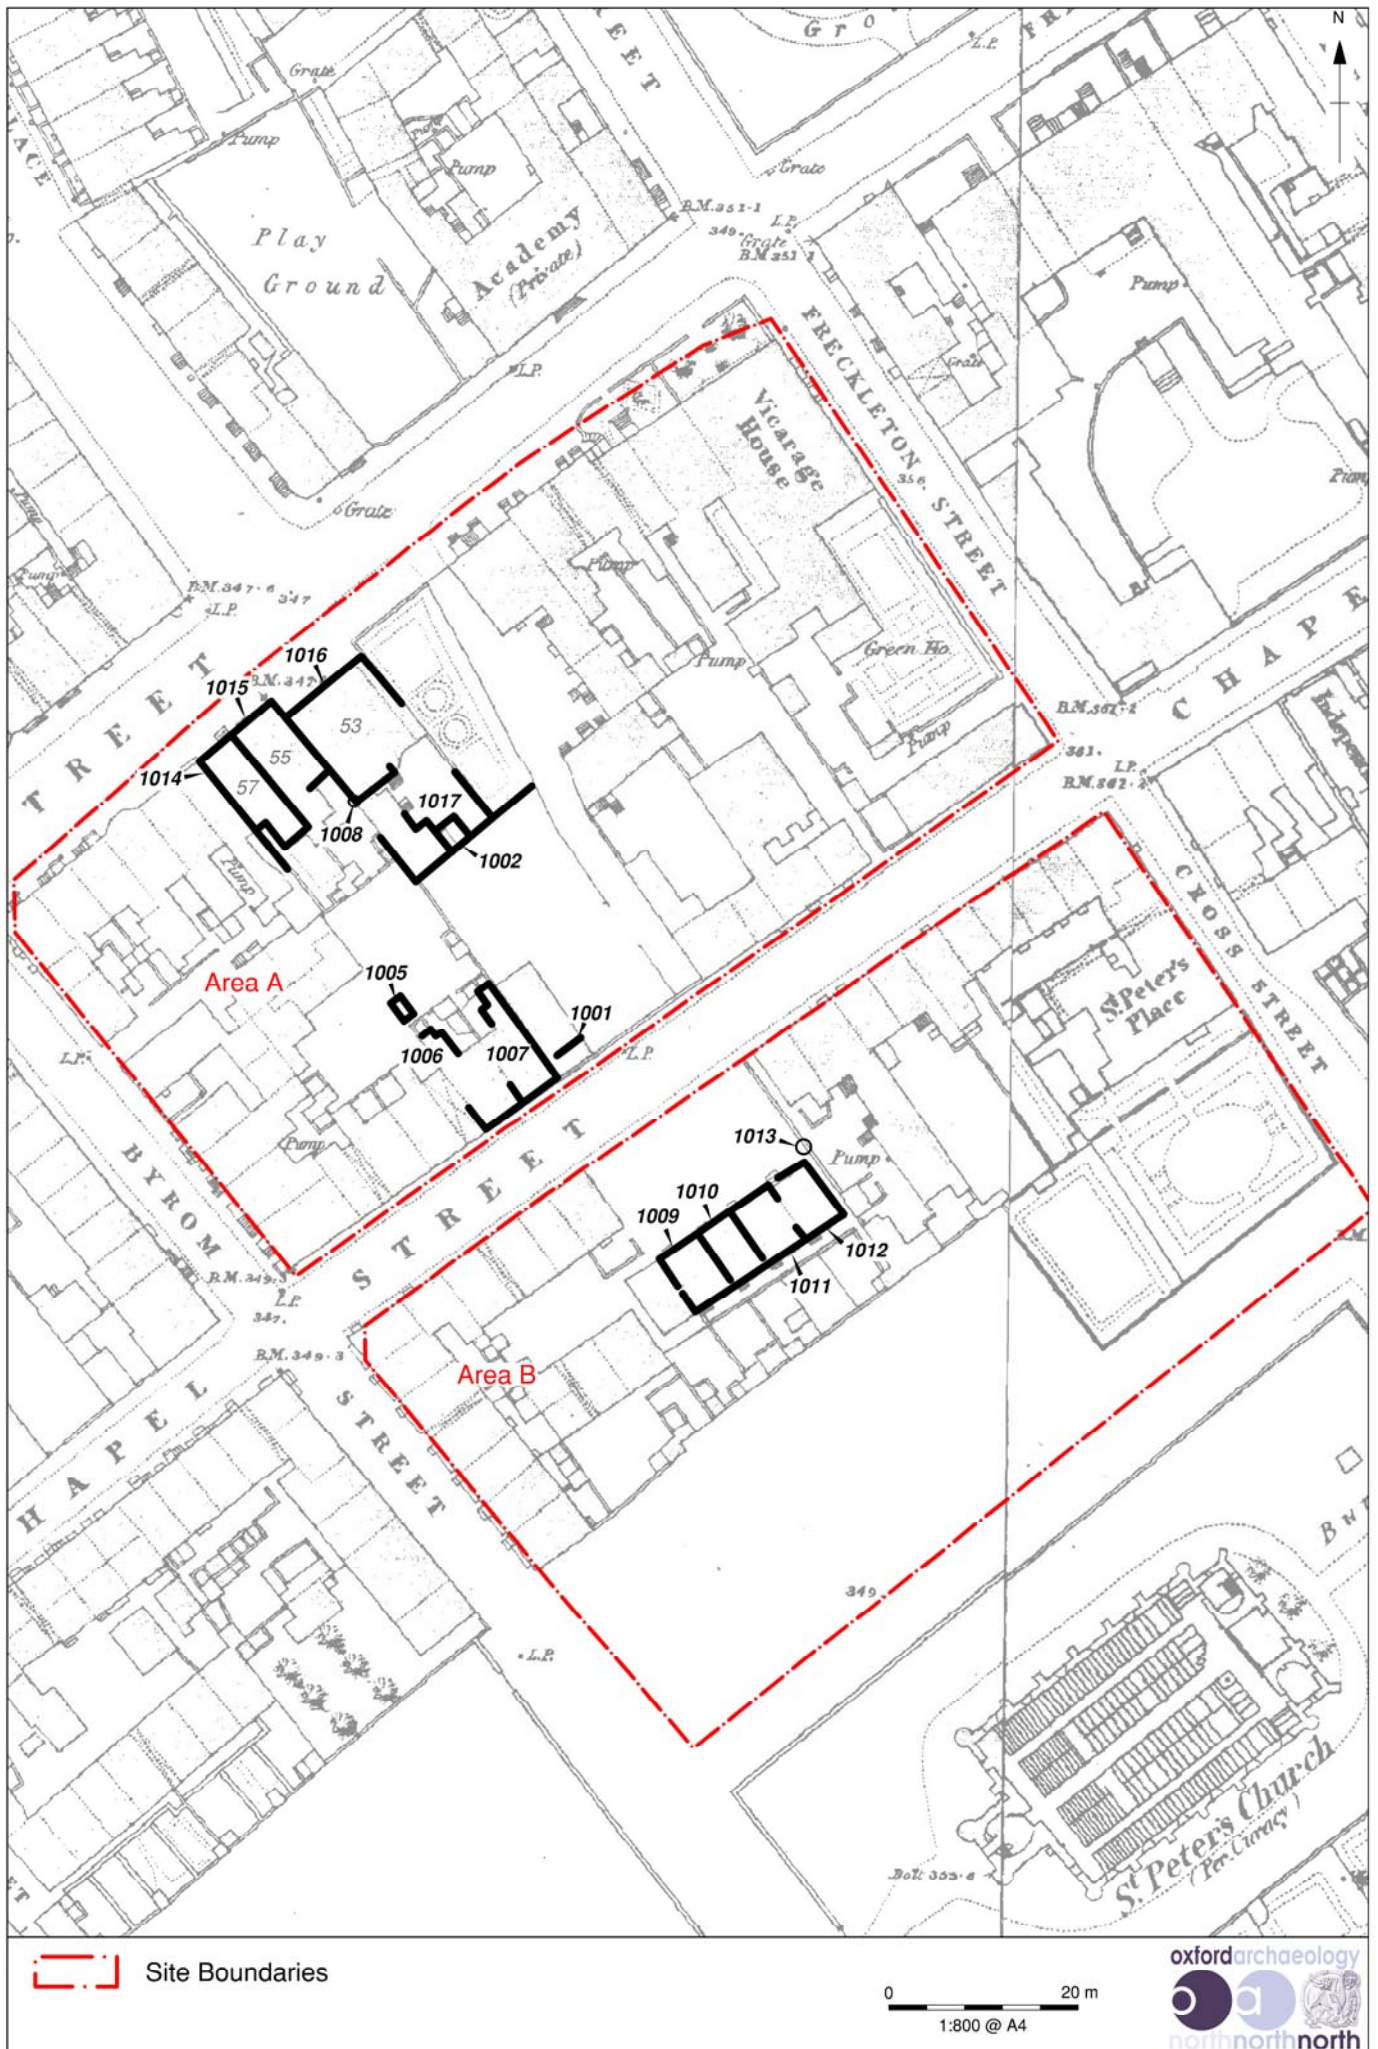
Figure 3: Structure locations

3.2.2 **Area A; King Street Block:** was bracketed to the north-west by former King Street, to the south-east by Chapel Street, to the south-west by former Byrom Street and to the north-east by Freckleton Street (Fig 3). The primary deposit across the area (**1003**) comprised a layer of loose dark brown and black clayey silty sand, forming a made ground layer containing large quantities of rubble, brick, metal etc. It was of varying depths and in-filled the surviving below ground structures. The deposit probably represents material deriving from the demolition of the former buildings occupying the site. Extant structural remains were identified in two locations and have been grouped together and identified as Structure 1 and 2.

3.2.3 **Structure 1:** was located in a position fronting onto former Kings Street, just off centre and to the west of Area A (Fig 3). The structure comprised a number of walls (contexts **2001**, **1008**, **1017**, **1014**, **1015** and **1016**), which defined several internal rooms relating to a number of properties previously identified on the first edition OS map of the area, numbers 53, 55, and 57 King Street. The various aspects of the structure are described below as they occur from west to east.

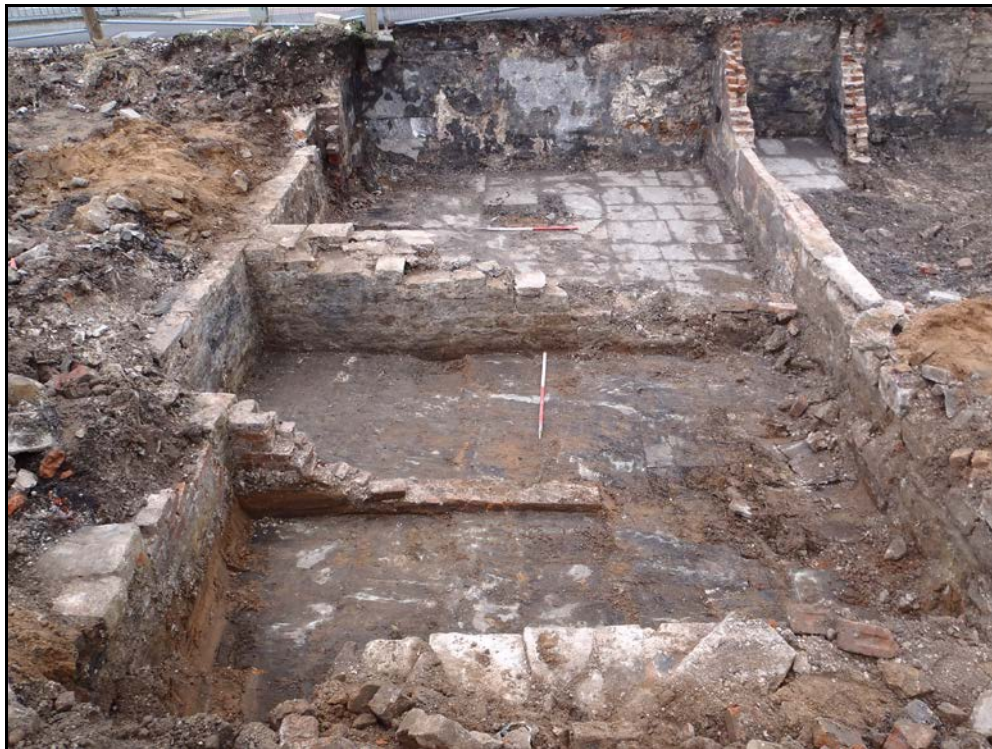
3.2.4 Wall **1014** represented the western limit of the structure and can be related to cellars of former 57 King Street (Fig 3; Plate 1). The cellar was divided into three rooms, with stair access most likely situated in the southern corner, but were not uncovered during the course of the investigation. A flagstone floor was observed, surviving in a good condition, placed directly onto the natural sand **1004**. The building itself was constructed in a combination of dressed sandstone and red brick. The sandstone blocks varied in size, while the bricks were un-frogged and hand-made, and the structure bonded with a white lime mortar. Evidence survives on some of the walls of a lime rendering. The structure measured a total of 9.25m long and 5m wide, with a surviving height of 1.8m in places. Structure **1014** can be located on the 1848, 1894 and 1911

Plate 1: North-west-facing view of cellar 1014, formally 57 King Street

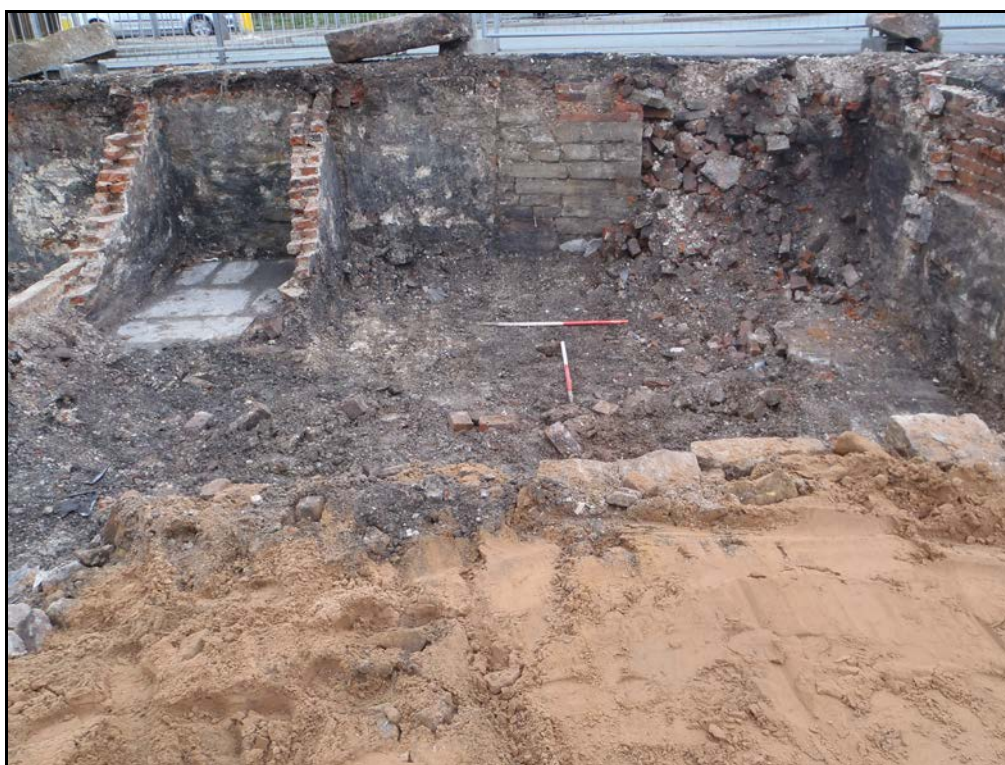
- 3.2.5 Structure **1015** represent the north-western limit of the cellars associated with former 55 and 57 King Street (Fig 3; Plate 2). It was constructed from both dressed sandstone blocks of varying size and un-frogged red brick, bonded with a white lime mortar. Evidence of a lime render was found on some of the surviving walls. Part of a flagstone floor survived in the north-west corner of the structure. It may have originally been divided into more than one room, but this was obscured by re-deposited natural deposits that were not removed during the course of excavations. It measured 4.75m long, but continued under the re-deposited natural to the south-east. It was 6m wide and had a surviving depth of 1.8m. Again, it can be related to buildings identified on the 1848, 1894, and 1911 OS maps as an individual dwelling, but by 1931 it appears to have merged with number 57 King Street.

Plate 2: North-west-facing view of cellar 1015, formally 55 King Street

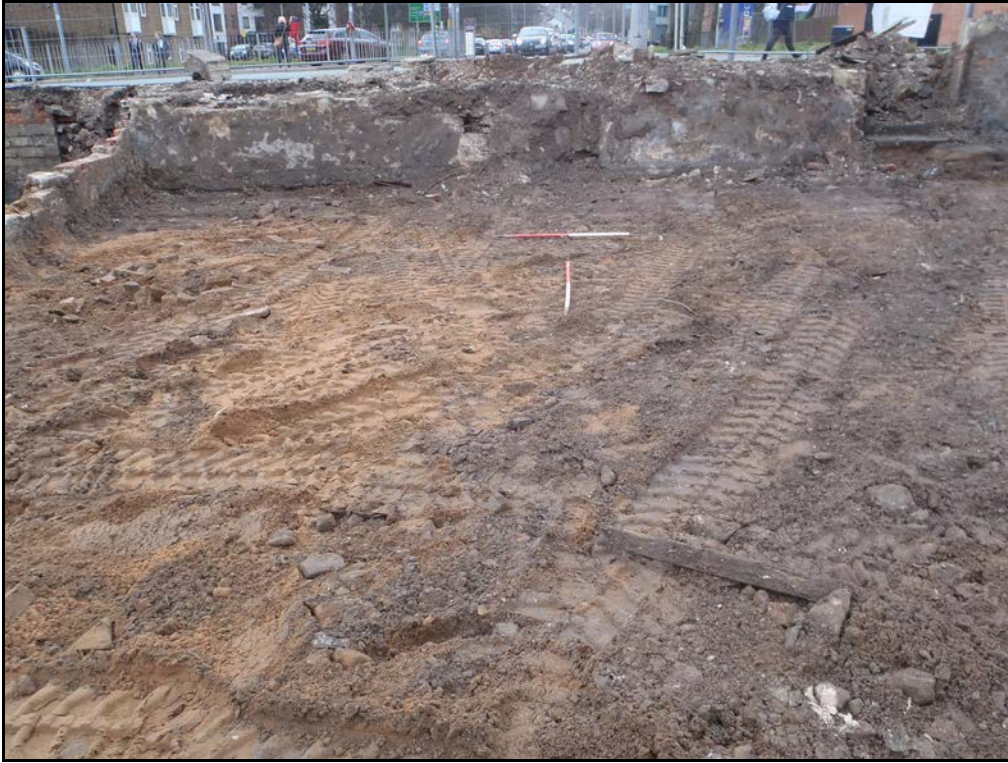
- 3.2.6 Wall **1016** represents the remains of the largest cellar area uncovered during the course of the current investigation, located immediately to the east of and adjoining wall **1015**, with a length of 15.75m and a width of 10.5m (Fig 3; Plate 3). The maximum height of the surviving walls was 2m. Structure **1016** represents the remains of 53 King Street and, as such, can be associated with the previous use of the building as a police station. It can be located on all historic OS maps from 1848 through to 1931. It was constructed of dressed sandstone blocks of varying size and un-frogged red bricks, bonded with a white lime mortar. Again, evidence of a lime render was observed on some of the walls. Part of a dividing wall was evident as a scar on the north-west wall, and would have extended on a north-west/south-east alignment. The remains of a flagstone staircase survived in the north-east corner of the building, but the floor itself was completely missing. A further structure (**1008**), representing a second well, occupied the southern corner of the structure and was again keyed into the wall.

Plate 3: North-west-facing view of building 1016, formerly 53 King Street

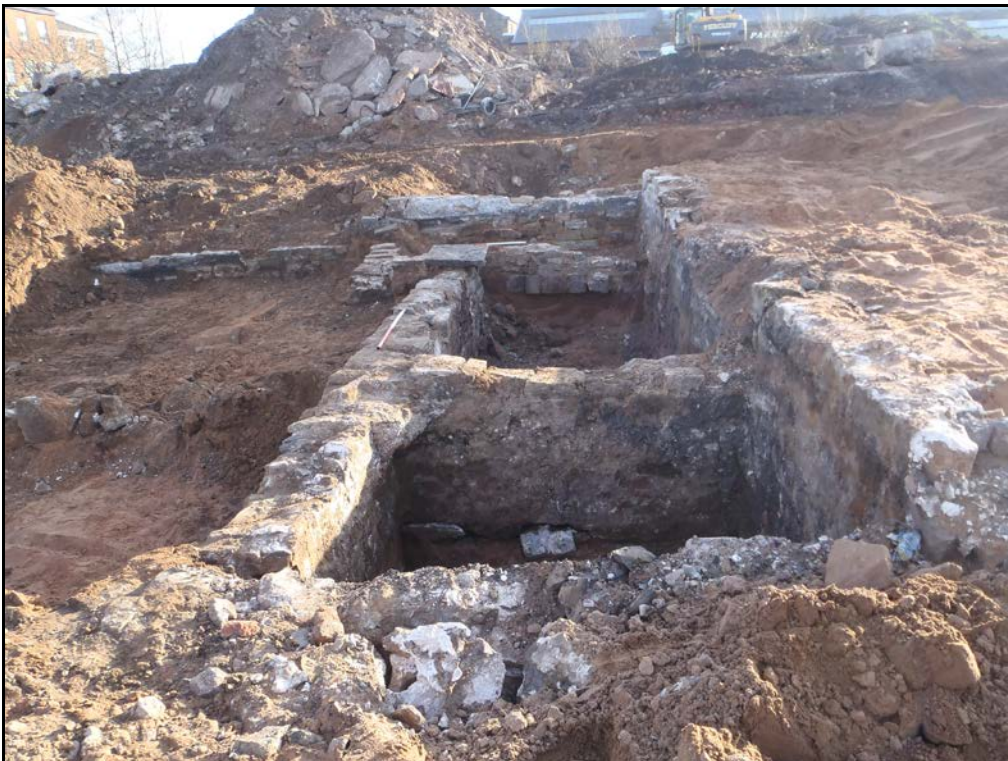
- 3.2.8 Wall **1017** was located immediately south-east of wall **1016** (Fig 3), and represents a series of four rooms with a combined measurement of 11.5m in length and 10m wide, with a minimum surviving height of 1.15m (Plate 4). It was constructed of dressed sandstone blocks of varying size, with occasional un-frogged red brick set within it, perhaps indicative of repairs to the structure, bonded with a grey lime and sand mortar. It was constructed within a construction cut truncating the natural sand **1004** and had been heavily damaged on the north-east side by the disused fuel tanks associated with the former builders' yard. A stone-lined drain was observed in the north-east room extending on a north-east/south-west alignment. No floors were preserved for this particular structure. The north-west wall formed part of the cellar associated with structure **1016**, while the south-east wall was represented by

Plate 4: North-east-facing view of cellars 1017

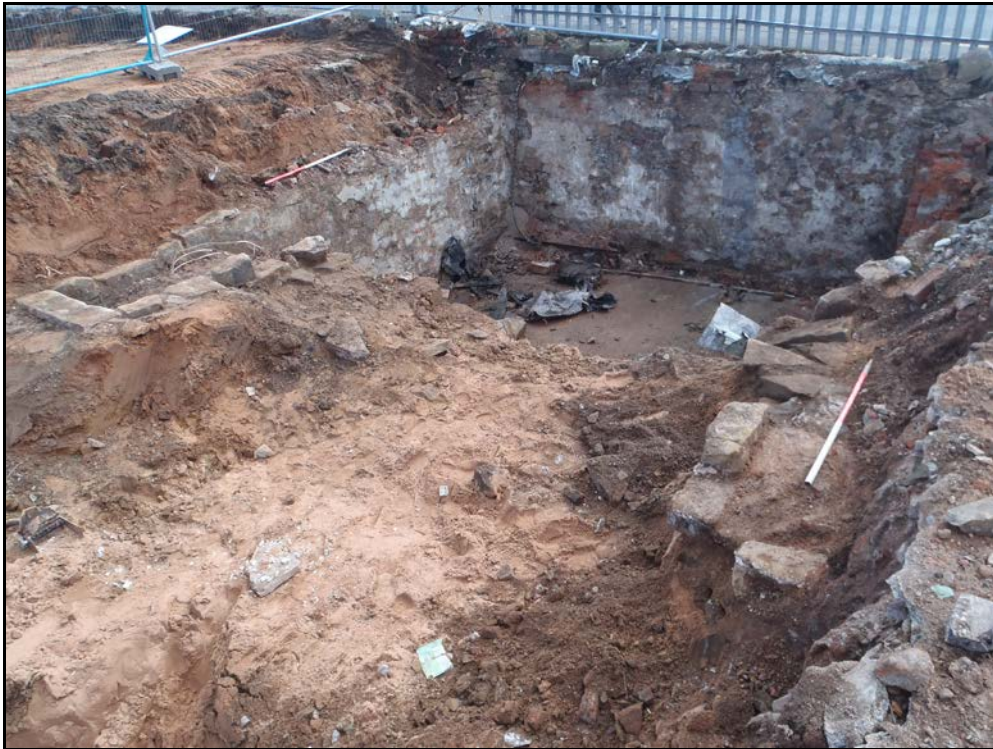
- 3.2.12 Walls **1006** and **1007** represent the remains of two cellars that were once joined properties fronting onto Chapel Street (Fig 3; Plate 5). They can be located on the 1848, 1893, and 1911 OS maps. By the 1931 OS map they appear to have become one single dwelling. Both structures were constructed with red un-frogged hand-made bricks, that had noticeably been poorly fired. They were bonded by a pink and white sand and lime mortar and had a lime render on the surviving internal surface. Both buildings measure 7.5m in length, while **1006** is 2m in width, **1007** is slightly larger at 2.55m in width. They were preserved to a minimum of 2.3m in depth and had a concrete floor. Both cellars were accessed via several stone flag stairs. The stairs to **1006** lay to the north-west, while the stairs to **1007** lay to the north-east of the building. Evidence of a dividing wall survived in fragments, although this had clearly been removed, most likely when the buildings had been amalgamated into a single dwelling.

Plate 5: East-facing view of cellars 1006 and 1007

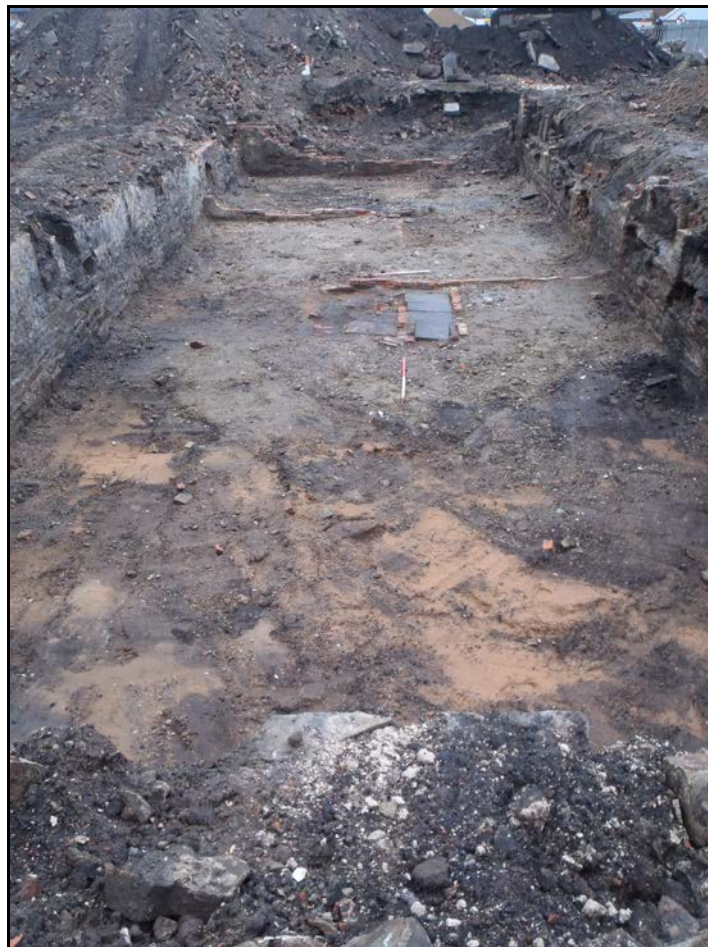
- 3.2.15 **Structure 3;** from west to east the various elements of Structure 3 can be identified as wall **1009**, **1010**, **1011**, and **1012**. Collectively the structures represent the remains of various cellars forming back to back housing in the centre of Area B (Plate 6). They were constructed from a combination of dressed sandstone blocks of varying sizes and un-frogged red bricks, bonded with a light pink mortar. Each cellar measured 6.8m in length, while their width varied between 4.6-4.7m, and, on average, survived to a height of 1.3m in relation to the outer walls. The internal dividing walls for each cellar were constructed of a single skin of un-frogged red brick with only small fragments of them surviving. Evidence of a lime rendering was observed on some of the walls. A partial floor composed of un-frogged red brick and sandstone flags was recorded within the cellar defined by wall **1011**, however, the floors for the other cellars were absent. No evidence for staircase access to the cellars was observed. This may indicate that the subterranean areas were reached via internal wooden staircases that have not survived. Evidence of windows was recorded for all four cellars, set within the north-west range of walls, while cellar **1011** was unique in retaining the remains of a window in the south-east wall. The four cellars can be located on the early 1848 OS maps.

Plate 6: South-west-facing view of cellars 1009, 1010, 1011 and 1012

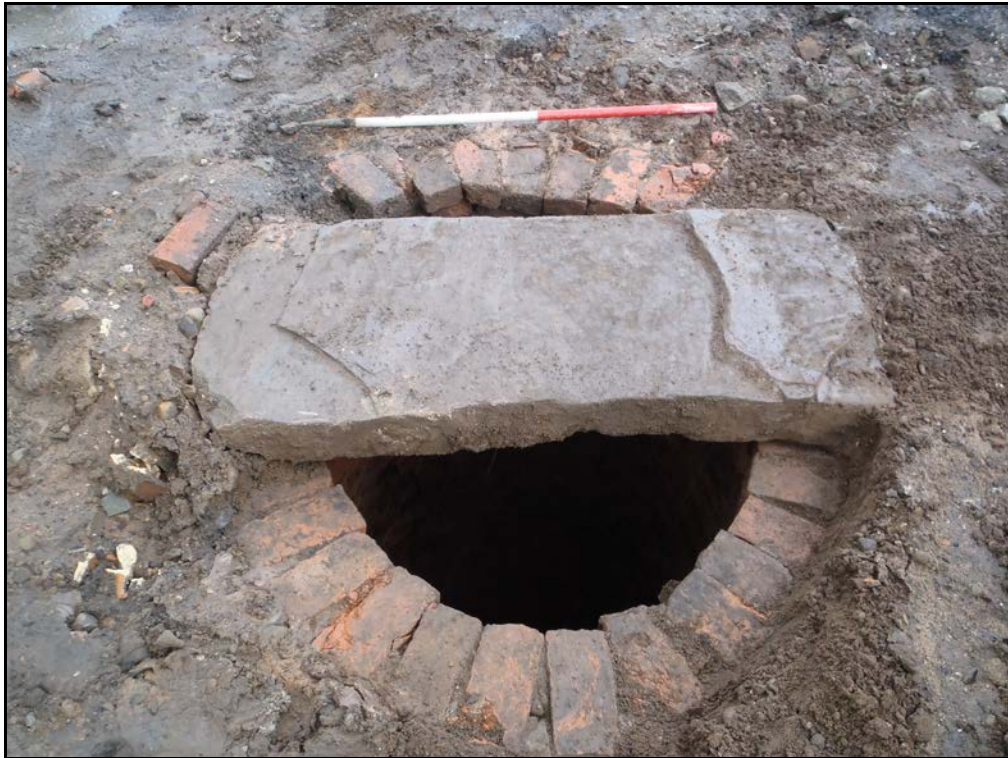
Plate 7: West-facing view of well 1013

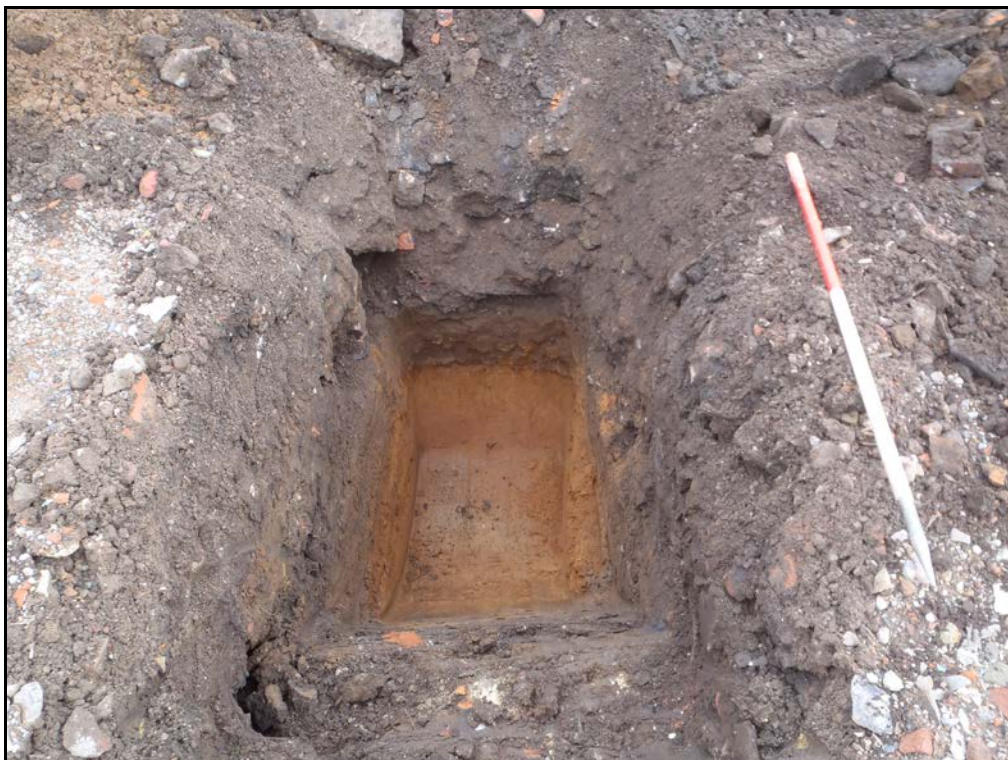
- 3.2.18 **TP02:** was located in Area B, measured 2m in length and 1.1m in width, and extended to a total depth of 2.3m below the current ground surface. Deposits

observed within the pit consisted of made ground **1003** for a depth of 1.2m overlying natural sand **1004** for a minimum of 1.1m in depth. See Plate 8 as an example of what the majority of test pits looked like.

Plate 8: South-east-facing view of Test Pit 02
