# Hampton Court Palace Tiltyard and Bowling Alley (Time Team Palaces Special)

## Archaeological Evaluation Report

April 2010

**Client: Videotext Ltd, Time Team**

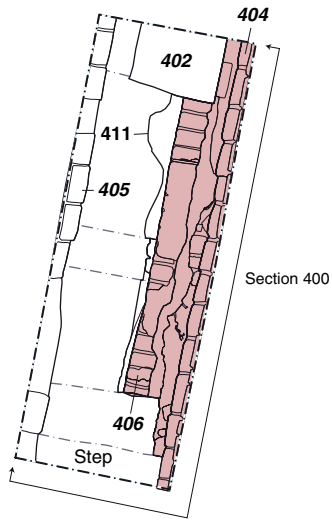
Figure 6: Tiltyard, Trench 4, plan and Section 400

- 3.1.23 The lowest recorded deposit in Trench 4 was 409, a naturally deposited gravel layer, which was observed below 9.47m OD. This had been cut along the length of the eastern side of the trench by construction cut 411 (Fig. 6, plan; Plate 6). Within this cut, which was not bottomed during fieldwork, a N-S aligned brick-built foundation 406 was exposed to a depth of 0.60m. The face of the foundation was laid as brick headers only, measuring 95 mm x 40 mm (3 ¾ in x 1 ½ in). These red bricks were bonded with a yellow-white lime mortar, which was not pointed. The construction cut was backfilled with a grey-brown sandy-silt with frequent lime mortar inclusions (410).

- 3.1.24 Above foundation 406, was a 0.06 m thick layer of hard light grey lime mortar 412. Over the mortar layer was a further levelling deposit of broken brick and roughly hewn lumps of chalk and greensand (413) This layer was 0.10 m in depth. (Fig.6, section 400)

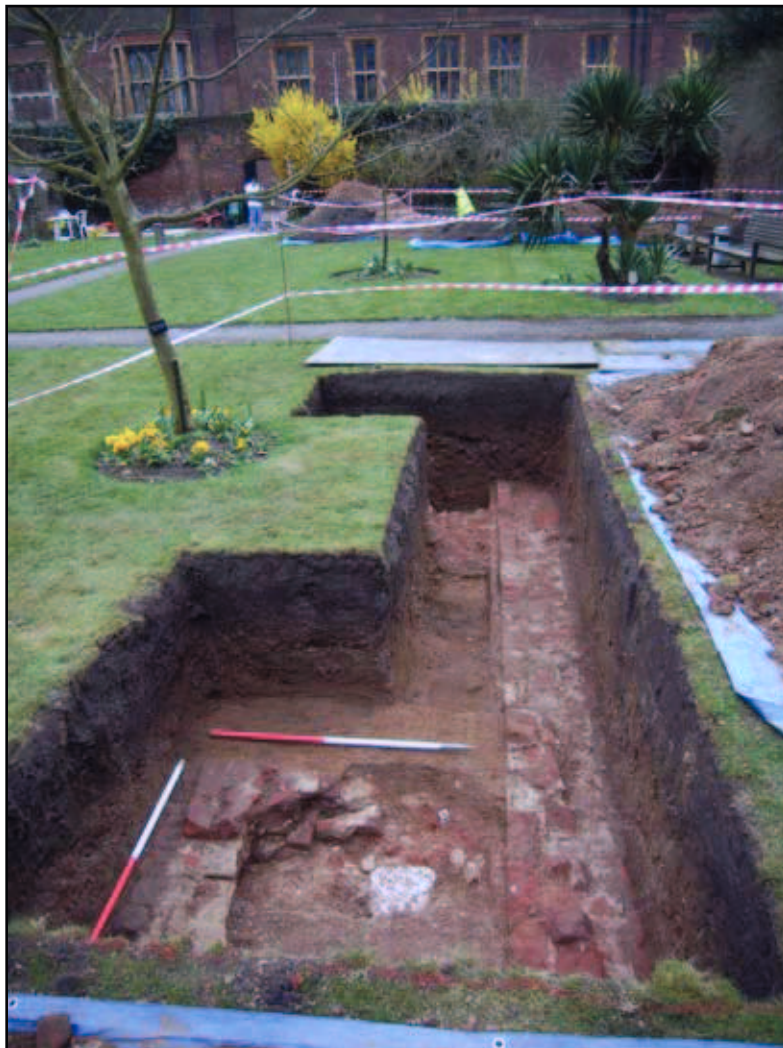
Plate 2: Bowling Alley, Trench 2 looking along bowling alley wall *305*

- 3.1.16 The earliest element encountered in Trench 3 was a N-S aligned brick and mortar built foundation [306], on which wall elements [305] and [304] were laid (Fig. 5, section 300; Plate 2). Foundation 306 was exposed only on the eastern side of wall 305 at the southern end of the trench (Fig. 3). It extended 0.25 m to the east of the line of the wall, and ran beyond the ends of the trench to both north and south. Its surface was at 8.30 m OD.

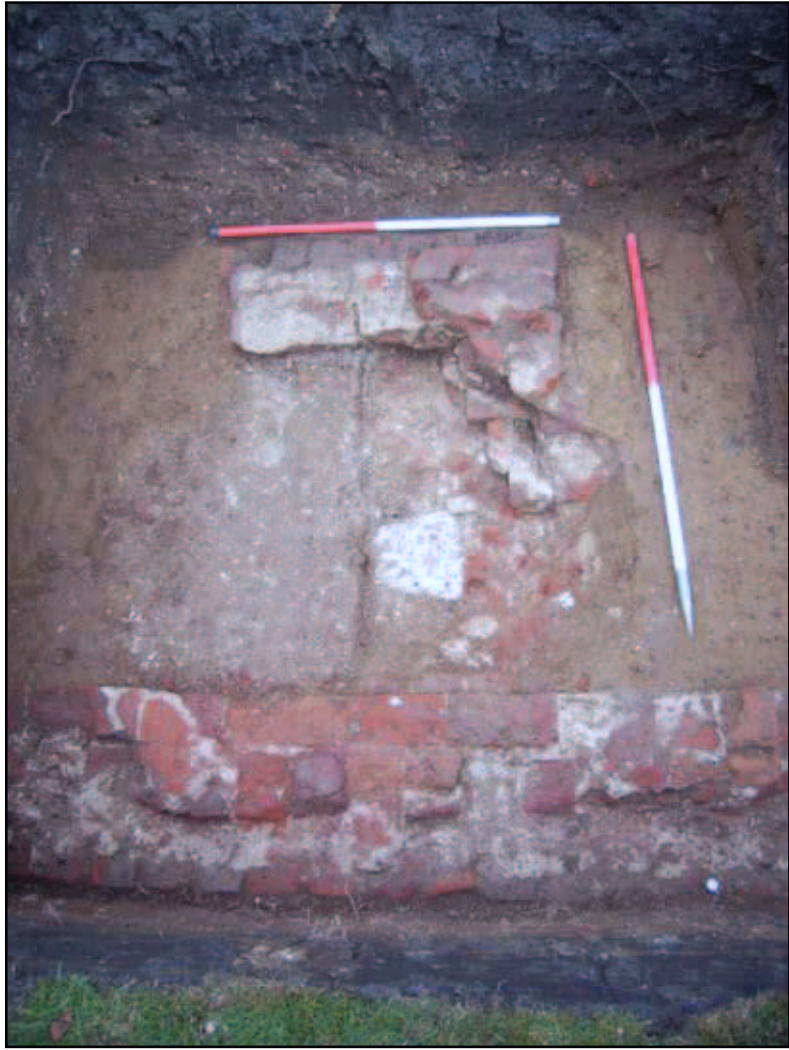
Plate 3: Bowling Alley, Trench 3 buttress *310/311*, and foundation 309

- 3.1.21 The lower two courses of buttress 311 sat directly upon foundation 309 and although heavily truncated would have formed a rectangular base measuring 1.20 m E-W and 1.0 m N-S. It was two brick courses high. A further single course of bricks [310] was set in from the edge of 311 by 100 mm on the eastern edge and by 40 mm on the north and south edges (Plate 3). This would have provided a rectangular base 1.10 m E-W and 0.92 m N-S. The bricks forming both 311 and 310 were red in colour and measured 225 mm x 102 mm x 55 mm (9 in x 4 1/8 in x 2 7/8 in) and were bonded with a creamy lime

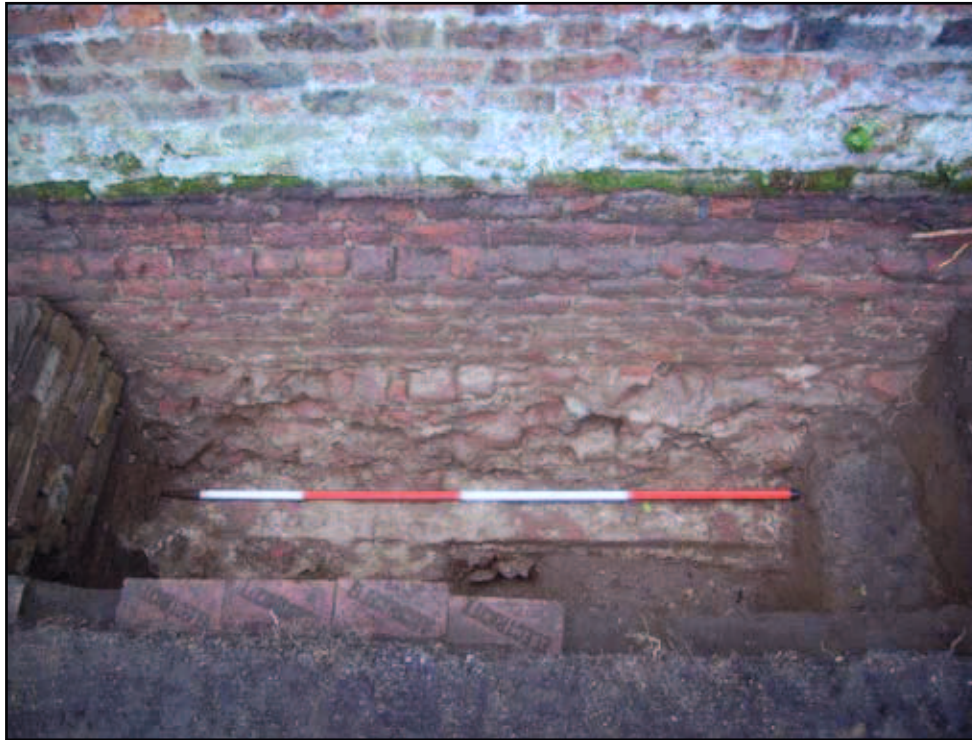
Plate 5: Tiltyard, Trench 4 showing tower wall brickwork 406 below later garden wall **404**

- 4.1.26 Trench 5 produced no significant archaeological evidence. However Trench 4 produced evidence of a N-S aligned brick wall foundation 406 that had been truncated above 9.90m OD, and which was subsequently reused as the base to the current garden wall. This foundation no doubt belonged to the NE Tiltyard Tower which formed a pair with the extant SE Tower. It seems likely that Wall Foundation 406 supported the outer, westernmost wall of the tower, particularly as Trench 5, located to the west yielded no significant evidence.

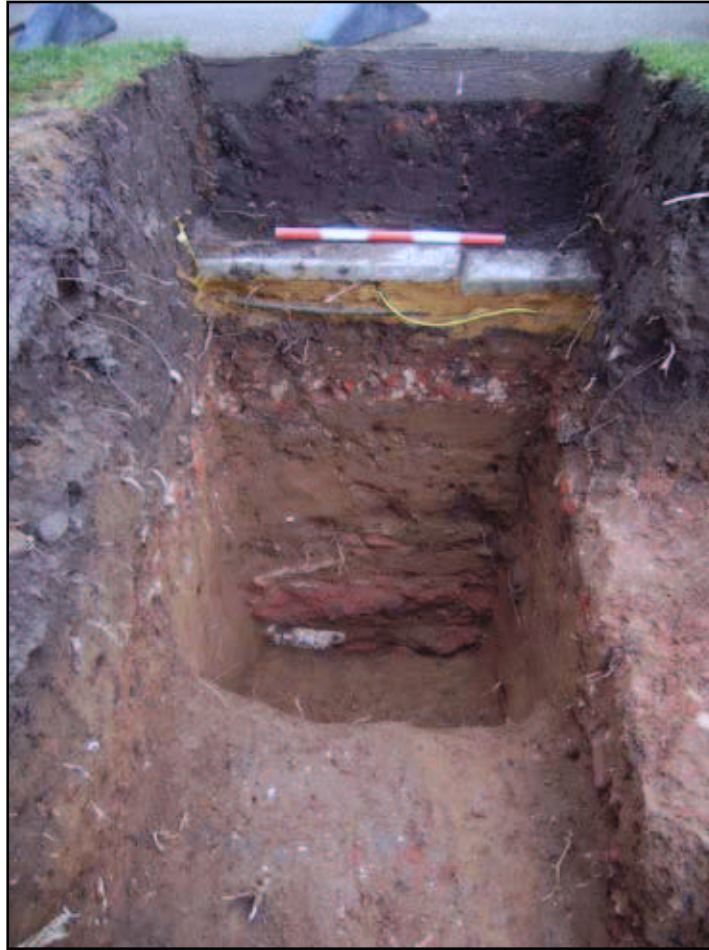
Plate 7: Tiltyard, Trench 6, fill of robber trench 618 (loose rubble fill 620 with sandy clay 619 above) exposed in southwest sondage.

- 3.1.29 In the SW sondage (Fig.7, Plate 7) a loose yellow-brown sandy clay (627) was recorded below 8.15m OD and continued below the base of excavation at 7.83m OD. This layer was overlain by a compacted yellow sand-clay deposit (629). A linear robber cut [618] with near vertical sides and aligned N-S cut these deposits. The cut was filled with a compact brick and mortar rubble deposit (620) with an upper fill of dark yellow-brown clay sand (619). No continuation of the footing 621 found in the NW sondage was located. It would seem that if it had continued this far it had been totally robbed out subsequently.

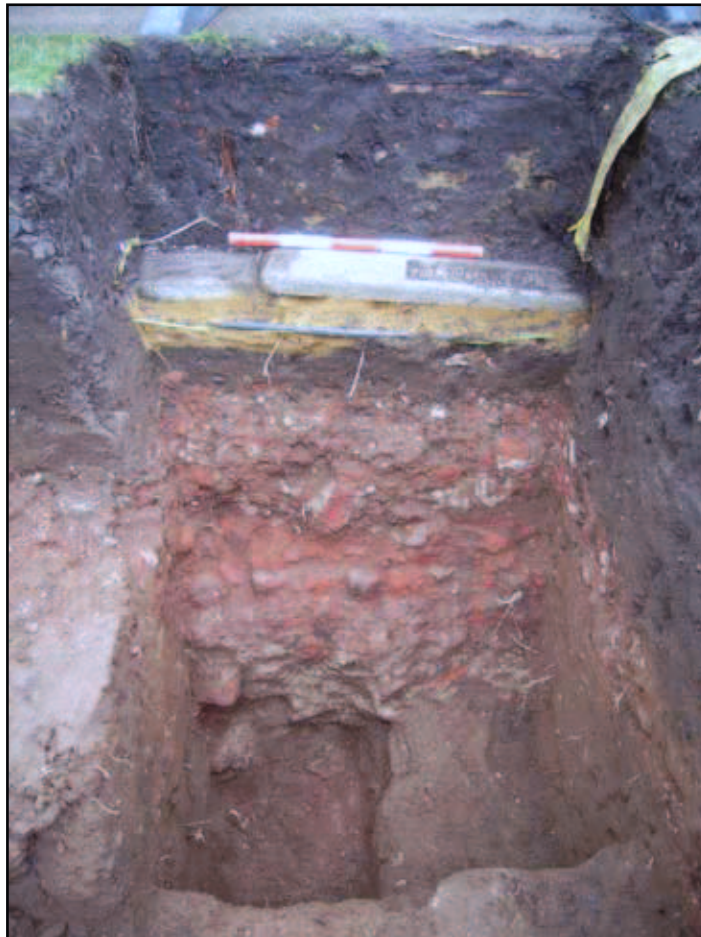
Plate 8: Tiltyard, Trench 6, tower wall foundation **621** exposed in northwest sondage

- 3.1.28 The main rectangular trench (5 m x 3 m) was extended by small sondages at its NW and SW corners. At the base of the NW sondage (Fig. 7; Plate 8) at 7.60 m OD, a loose rubble deposit (623) was observed though not excavated. This was overlain by a solid conglomeration of similar material bonded with lime mortar [621], which probably represented the remains of a substantial foundation. The top of this foundation was at 8.40m OD, and it was at least 0.70 m deep. The foundation appears to have been aligned N-S and to have extended to the west beyond the limit of the trench. It appears that the face of the foundation had been cut away by subsequent robbing and although no cut was defined the robber trench [630] appears to have been aligned N-S and

- 4.1.27 In Trench 6, the two sondages on the W edge of the trench revealed the alignment of another probable Tiltyard Tower wall, possibly the E wall of the SW Tower. In the NW sondage, the rubble core of a wall foundation [621] survived below 8.40m OD. The face had been robbed out by cut 630. In the SW sondage of Trench 6, a further robber cut [618] was observed which appears to have completely removed any structural remains. The cut was however filled with brick and mortar rubble (619). The alignment of this cut is slightly to the W of the alignment of cut 630 to the N. The orientation of the wall foundation which can be assumed to have ran between the two sondages was more NNE-SSW than strictly N-S. The wall appears to have continued beyond both of the sondages to the north and south, suggesting an overlying wall of more than 5 metres in length. That the robbing activity appears to have occurred on the eastern side of the foundation wall suggests that this was also the likely exterior face of the building, where dressed stone or fine brickwork would have featured. This would therefore point to the main body of the tower being situated immediately to the west of Trench 6. This inconveniently contradicts the findings of the Ground Penetrating Radar survey upon which the trench was located which indicated a rectangular feature, a potential building footprint, with its western limit on the western edge of the trench.
