**Peel Fold Mill,
Stanhill Road,
Oswaldtwistle,
Lancashire**

**Archaeological
Investigation
Final Report**

Oxford Archaeology North

March 2013

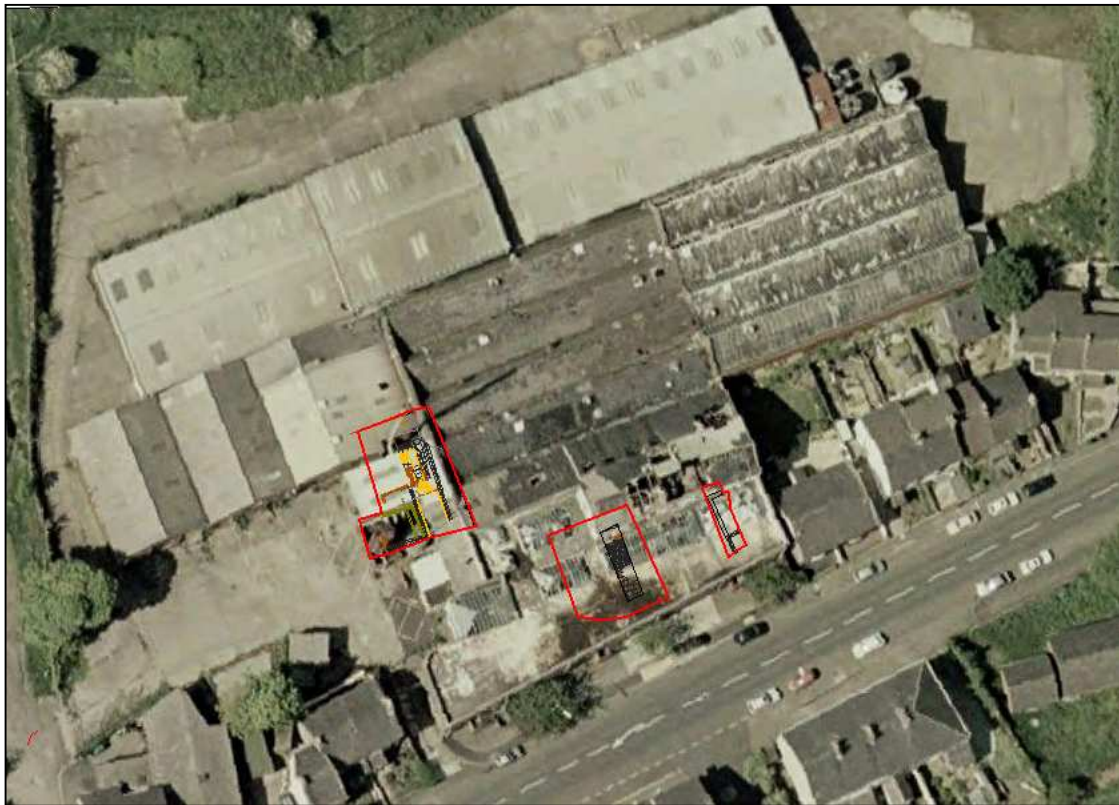
Plate 6: Location of the excavated areas, superimposed on an aerial view of the site prior to the demolition of the mill

- 3.3.5 The mill finally wove out in 1963, and the site was occupied subsequently by FB Estcourt Ltd, shippers and manufacturers of food specialities. The original square chimney for the mill was removed in 1993, and the remainder of the site was cleared during the early twenty-first century (Plate 6).

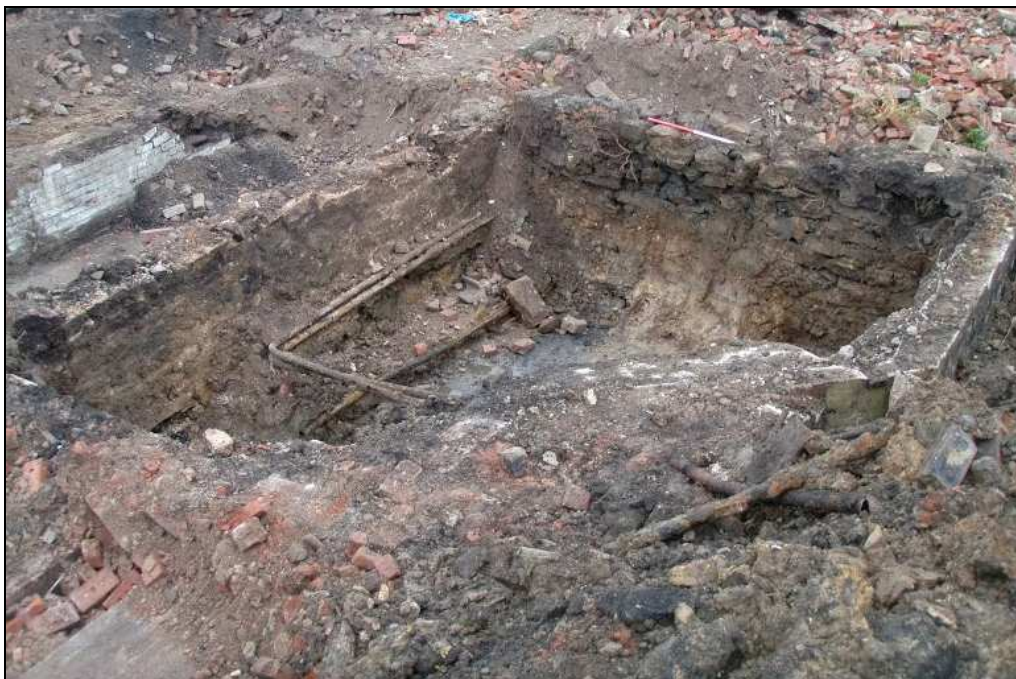
Plate 7: View across the remains of the engine house, looking south-east

4.2.1 Trench 1 measured 18 x 12m, and was placed across the footprint of the former engine and boiler house for Peel Fold Mill (Fig 3). Excavation of the south-western part of the trench revealed the remains of a square-shaped room, which almost certainly represented the original engine house. The southern and eastern walls of the room retained historic fabric in the form of sandstone rubble laid in random coursing (Plate 7). These walls survived to a maximum height of 1.7m, and were built directly onto the natural clay geology.

- 4.2.2 The western and northern walls of the room had been rebuilt in machine-pressed brick and concrete, indicative of remodelling in the mid-twentieth century, presumably as part of the remodelling of the buildings carried out by the Peel Fold Manufacturing Company. The western edge of the trench was formed by a concrete structure, which similarly represented twentieth-century remodelling of the original engine house. This included a concrete floor that incorporated a 'T'-shaped channel, which acted as a conduit for electric cables. However, all interior features in the engine house, including the original floor and foundation beds for the steam engine, had been removed and the building was backfilled with rubble in a matrix of clay. The clay was cut by two steel pipes, which had evidently been installed following the removal of the steam engine.

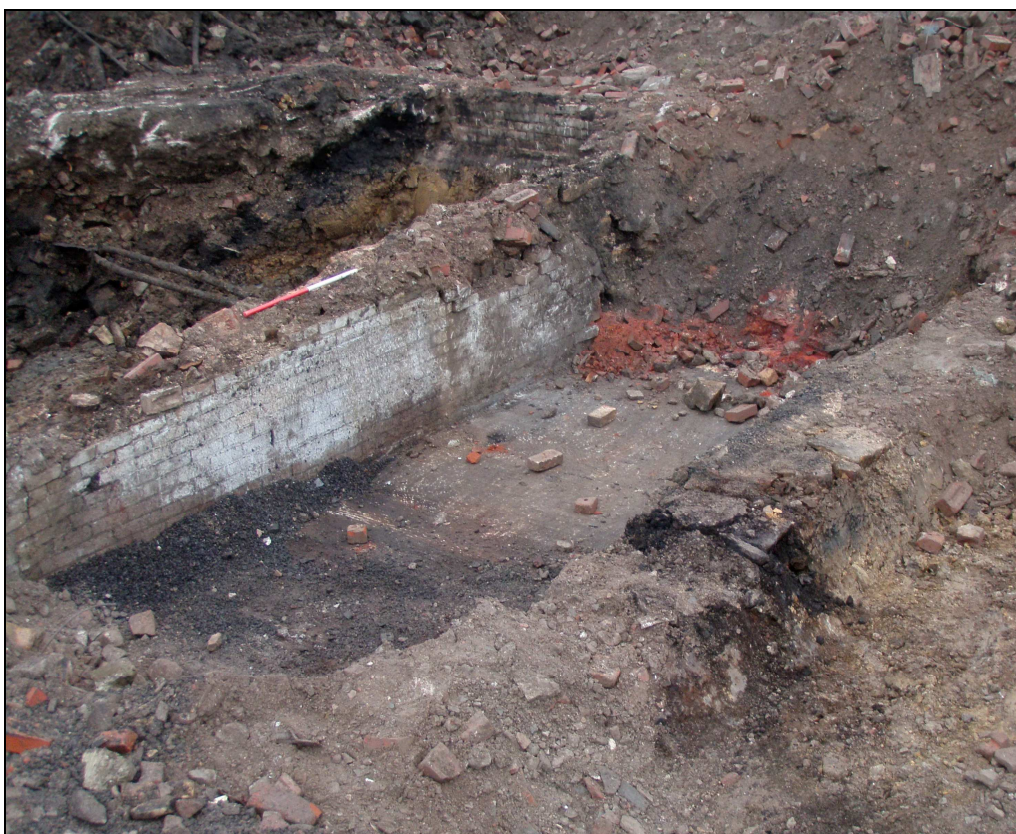
Plate 8: View across the southern part of the boiler house, looking north-west

- 4.2.3 Excavation immediately to the east of the engine house exposed the remains of the boiler house. The southern part of this building had been destroyed entirely in the mid-twentieth century, and a concrete surface laid (Plate 8). However, physical remains of the original boiler house survived in the northern part of the trench (Plates 9-11).

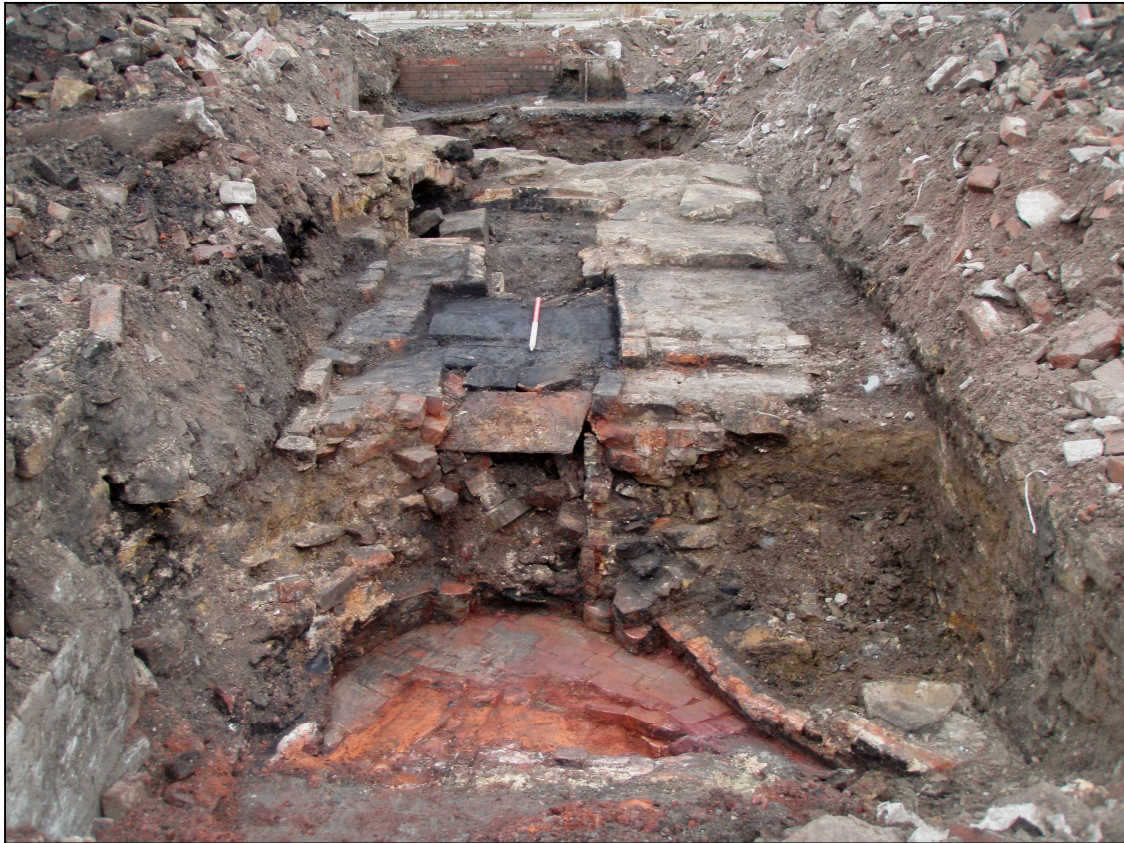
Plate 9: View across the northern part of the boiler house, looking north

- 4.2.4 The surviving remains of the boiler house comprised a north/south-aligned flue, composed of random sandstone rubble and refractory bricks. The flue terminated at the base of a circular chimney, which was similarly lined with refractory bricks. The remains of a second flue entered the chimney on its western side, seemingly representing a later addition to the steam-power plant (Plate 11). This flue had been blocked by a modern brick-built wall, beyond which all remains had been destroyed entirely.

- 4.2.5 At the southern end of the flue were the remains of what is likely to have been the housing for a boiler, although the majority of this had been destroyed. However, a short section of the boiler room floor survived intact, with two narrow flues present along each side. The floor and the flues all displayed evidence of very high levels of heat and were filled with fuel ash deposits associated with boilers.

- 4.2.6 The configuration of the exposed flues was consistent with the layout typical of an egg-ended boiler. This early type of steam boiler was of a cylindrical form with hemispherical, or 'egg-ended' domed ends, which were designed to resist pressure (Watkin 1994, 120). Whilst this form of boiler remained popular at colliery sites, their application to steam-powered textile mills was superseded in the second half of the nineteenth century by Lancashire boilers, which were capable of generating higher steam pressures (Williams and Farnie 1992).

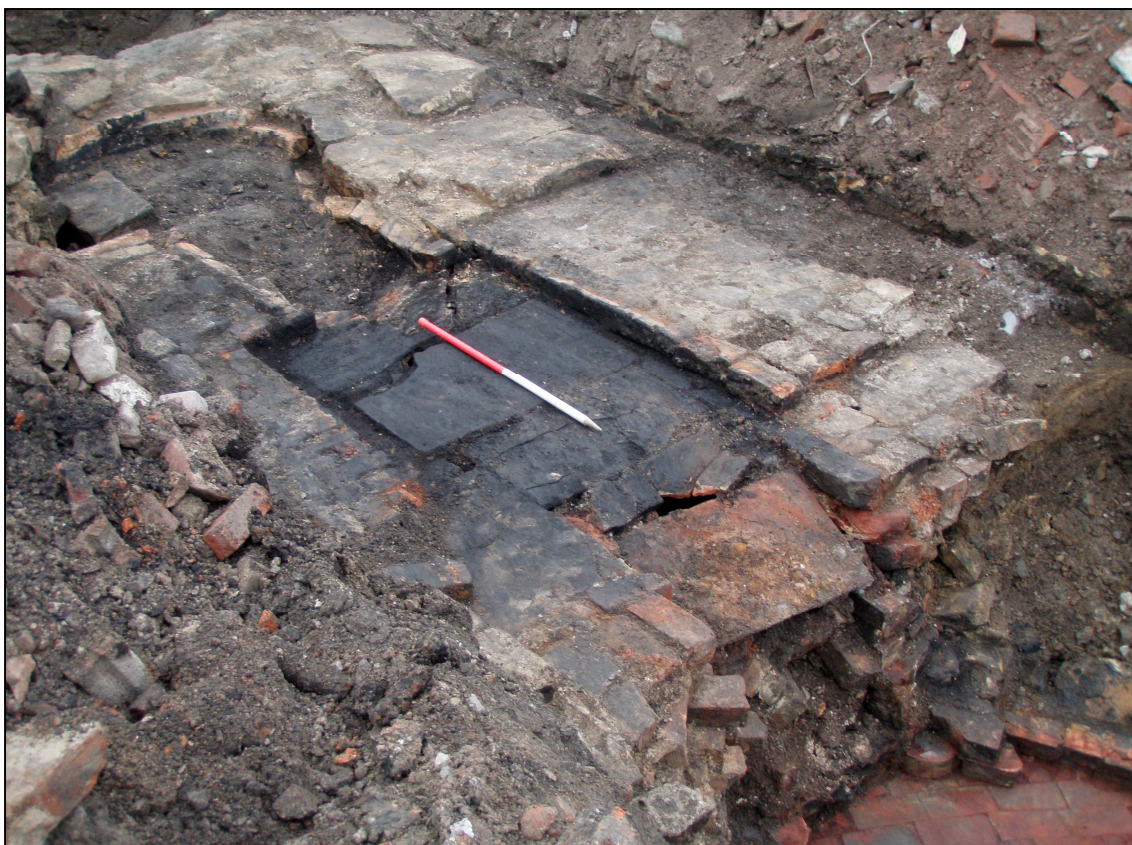
Plate 10: View across the foundations of the mill chimney, looking north-east

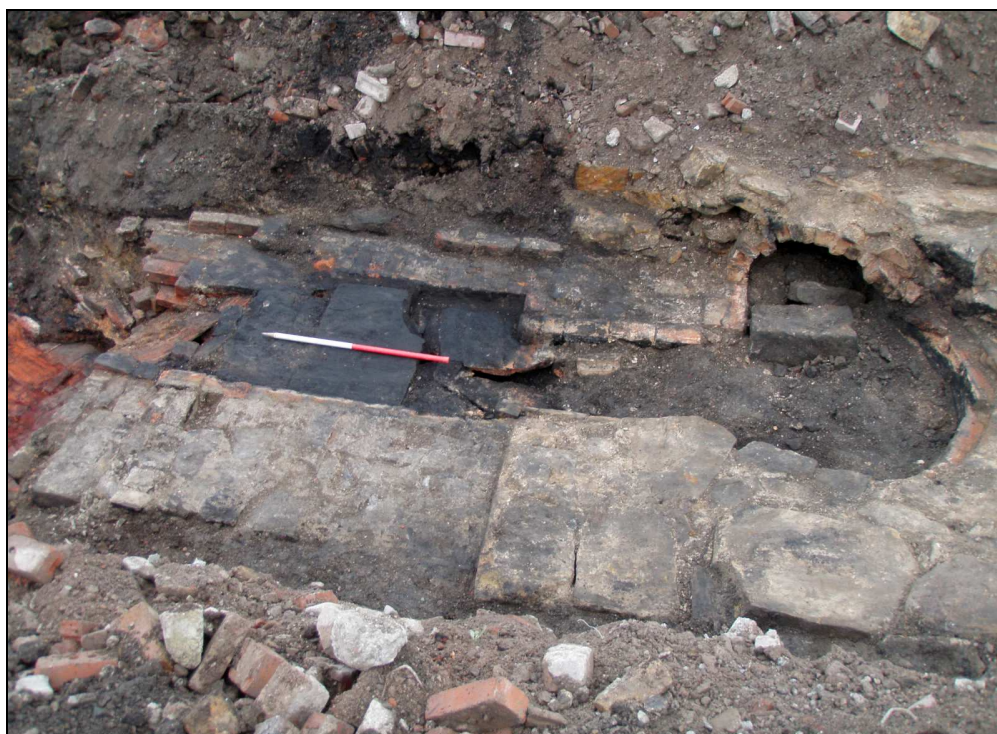
Plate 11: View across the foundations of the mill chimney and ancillary flue, looking west

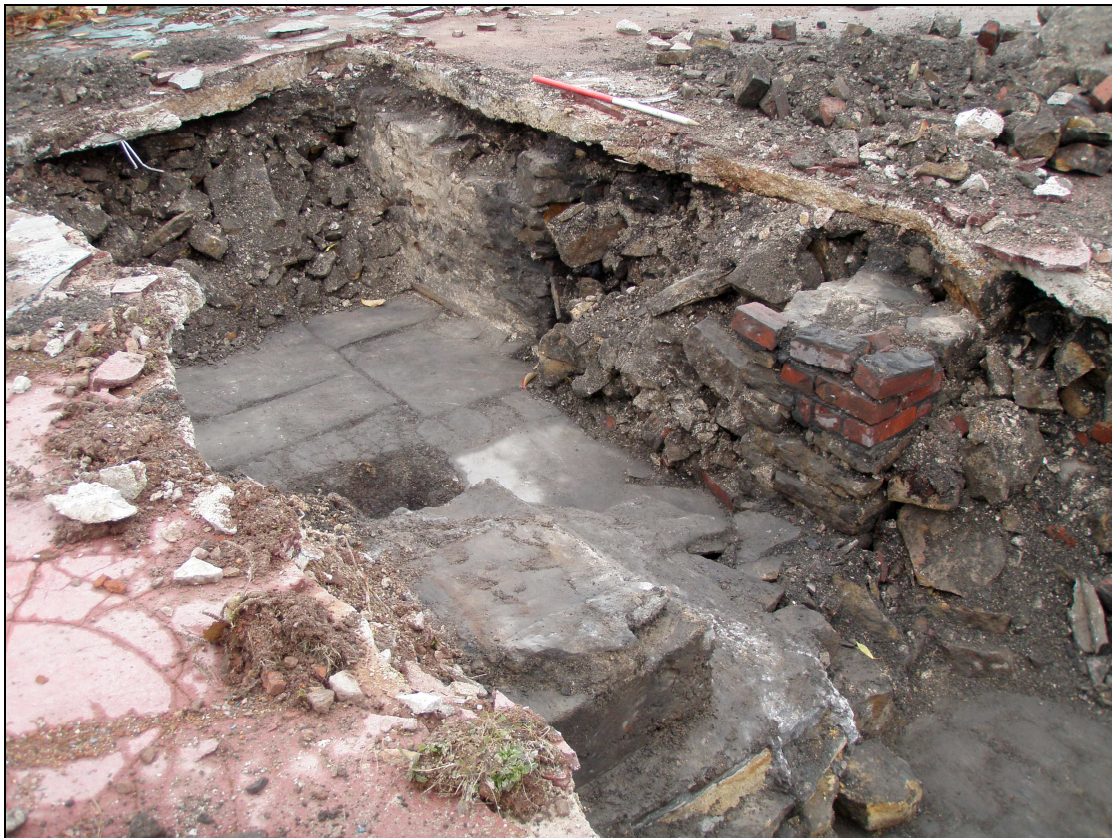
Plate 12: View across the southern part of Trench 2, looking south-west

- 4.3.2 **Trench 2:** this trench measured 10 x 1.5m, and was excavated to a maximum depth of *c* 1m (Plates 12-13). Excavation of the southern part of the trench revealed an *in-situ* surface of flagstones, which was exposed at a depth of *c* 1m below the existing ground level. This surface was interpreted initially as the floor of the eighteenth-century cottages. However, further investigation concluded that the flagstones had probably been re-used to form a floor within the 1950s extension to the mill.

- 4.3.3 The stub of a wall composed of small sandstone blocks was revealed in the south-western corner of the trench, surviving to a height of 0.9m (Plate 12). The remains of a second wall, similarly of sandstone-block construction, were exposed in the east-facing section of the trench some 1.6m to the north. The position of this wall corresponded with the rear wall of the cottage as depicted on historical mapping (Fig 2). A square concrete pad situated immediately to the east of this wall (Plate 12) represented a later modification associated with the construction of the single-storey extension to the mill in the 1950s. The position of the concrete pad corresponded broadly with the proposed location of a column base for the 1950s building, as shown on the building control plan (Plate 5).

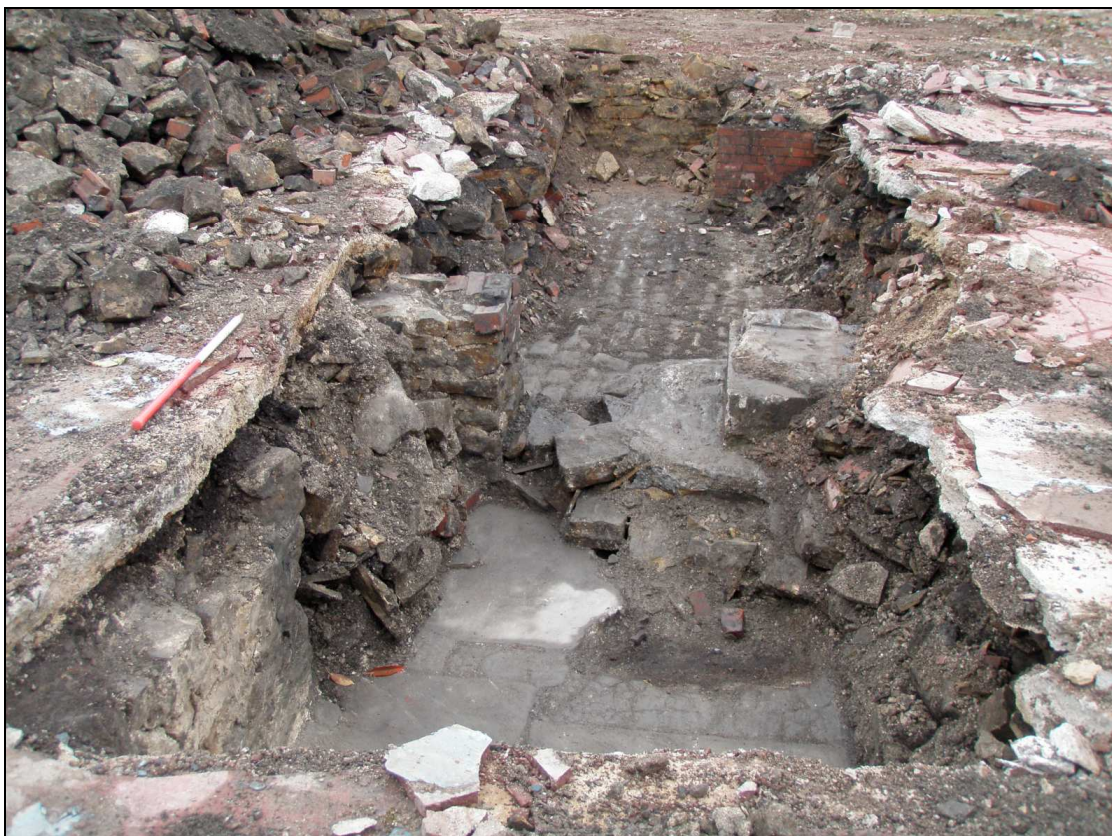
Plate 13: View along Trench 2, looking north

- 4.3.4 A surface composed of sandstone setts was exposed in the northern part of the trench (Plate 13). This clearly represented a small yard to the rear of the cottages (Fig 2). A third sandstone wall was exposed at the northern end of the trench. This almost certainly represented the southern wall of the former weaving shed, and its location corresponds with the position of the mill wall on the Ordnance Survey map of 1893 (Fig 2). These remains were subject to further investigation subsequently, when a larger excavation area was placed across the footprint of N^{os} 24 and 26 (Fig 4); the results obtained from this stage of the archaeological investigation are presented below (*Section 4.3.6*).

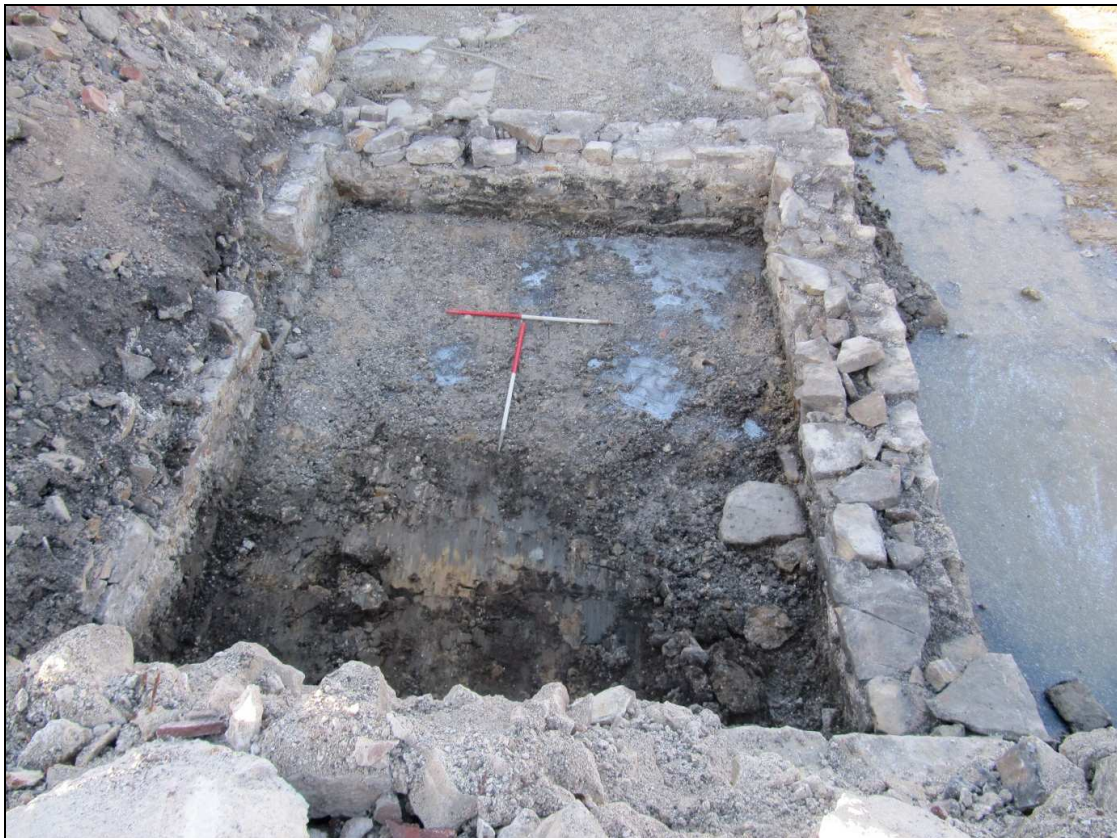
Plate 14: View looking west across the remains of N° 24 Stanhill Road

- 4.3.7 **N^o 24 Stanhill Road:** the buried remains of this cottage were encountered in the north-eastern part of the excavated trench, and comprised several walls (**101-106**). The faces of all of the component walls were constructed from squared stone blocks that were laid in rubble coursing and bonded with lime-based mortar. They contained a core of stone rubble, which was similarly set in a matrix of lime-based mortar. No remains of the original internal floor survived *in-situ* (Plate 14).

- 4.3.8 The stone-built rear wall of the cottage (**101**) was 530mm wide. It was aligned broadly north-east/south-west, and survived to a height of *c* 500mm (equating to six courses). The vestiges of red and blue painted plaster survived on the internal elevation of the wall.

- 4.3.9 The south-western end of wall **101** was keyed into wall **102**, which formed the western wall of the cottage and formed a partition from the adjacent property. Wall **102** was similarly 530mm wide and survived to a height of *c* 500mm (equating to six courses). Several fragments of pottery dating to the early nineteenth century were recovered from the central cavity of the wall (*Section 4.4.2 below*). The internal elevation of the wall also retained vestiges of red and blue painted plaster.

- 4.3.10 The eastern wall of the cottage (**106**) formed the eastern edge of the excavated area. Aligned parallel to wall **102**, wall **106** had a width of 530mm and survived to a height of 1.6m. It was keyed into walls **101** and **105** at its north-western and south-eastern ends respectively.

- 4.3.13 The room retained no physical evidence for any fixtures or fittings, such as a floor or a fireplace. However, a deposit of ash and degraded lime mortar that had probably formed a levelling layer for a flagstone floor was revealed beneath the demolition rubble infill of the cottage.

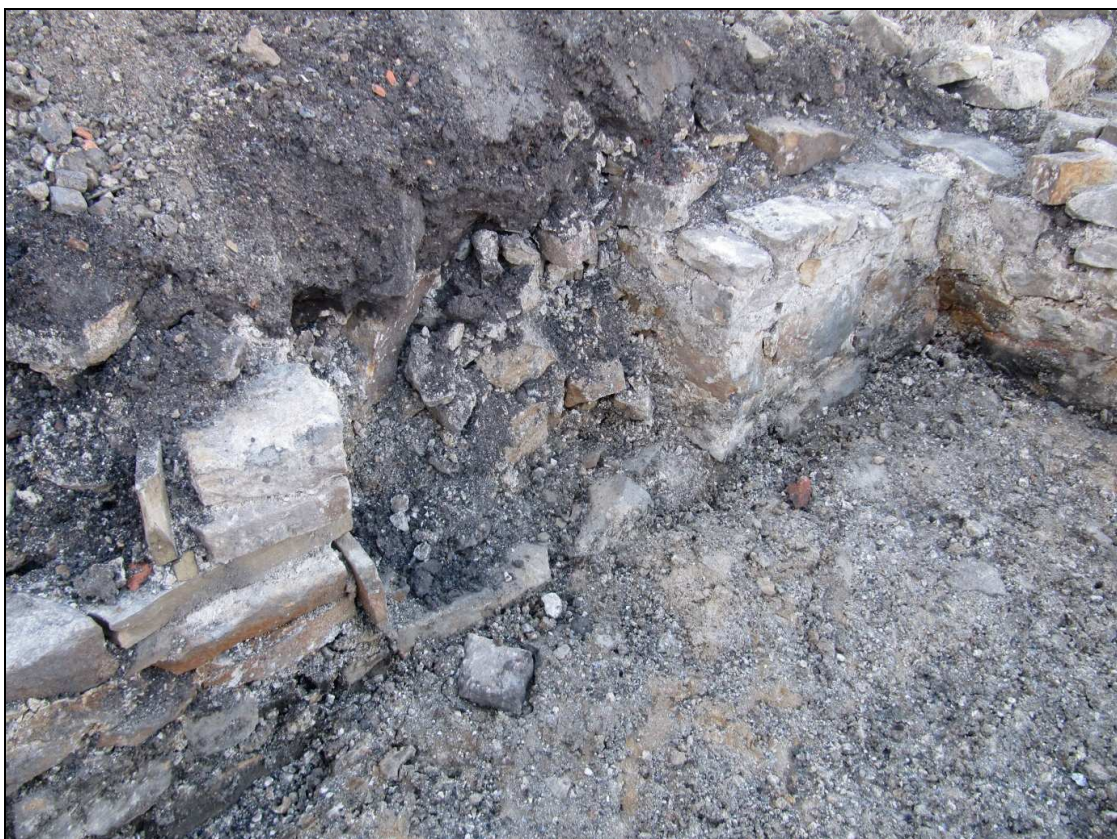
Plate 15: The threshold between the front and back rooms in N° 24 Stanhill Road

- 4.3.12 An 820mm-wide gap was evident in wall **103/105**, situated 1.6m from its south-western end. The gap housed a single rectangular slab of gritstone, which was 30mm thick and set upon a bed of sand. This gap almost certainly represented the doorway between the front and back rooms in the cottage, with the granite slab forming the threshold.

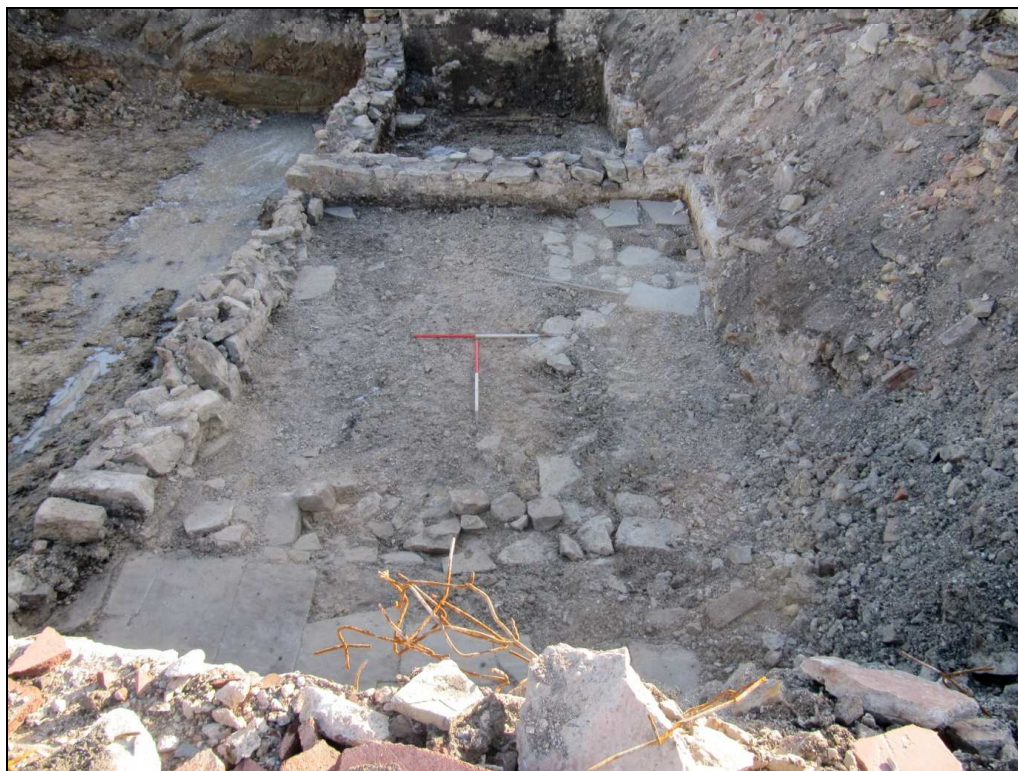
Plate 16: View across the excavated remains of N^o 26 Stanhill Road

- 4.3.14 **N^o 26 Stanhill Road:** the buried remains of this cottage were exposed immediately to the west of N^o 24 Stanhill Road (Fig 4). The surviving structural components were very similar to its neighbour, comprising squared stone blocks that were laid in rubble coursing and bonded with lime-based mortar, with a central core of stone rubble (Plate 16).

- 4.3.15 The north-east/south-west-aligned rear wall of the cottage (**107**) was 530mm wide, and survived to a height of *c* 400mm. The north-eastern end of the wall abutted wall **102** (Fig 4), suggesting that this cottage had been built as a later phase of construction. The vestiges of blue painted plaster survived on the internal elevation of the wall. The south-western end of wall **107** was keyed into wall **108**, which formed the western wall of the cottage and formed a partition from the adjacent property. Wall **108** was similarly 530mm wide, but only a single course of masonry survived *in-situ*.

- 4.3.16 The fragmentary remains of north-east/south-west-aligned partition (**109**) were also exposed. The construction of the partition was similar to the external walls, comprising stone rubble bonded in a lime-based mortar. However, it created a back room somewhat smaller than that revealed at N^o 24.

- 4.3.17 The fragmentary remains of a flagstone floor (**111**) were exposed in the front room of the cottage. The flagstones appear to have been laid upon an 80mm thick bedding of lime mortar (**118**). Further excavation revealed another flagstone floor (**113**) beneath bedding layer **118**. This probably represented an earlier phase of flooring, although it had similarly been set onto a thin bed of lime-based mortar.
