**Whitworth Art  
Gallery,  
Oxford Road,  
Manchester**

**Archaeological  
Excavation**

**Final Report**

**University of Manchester**

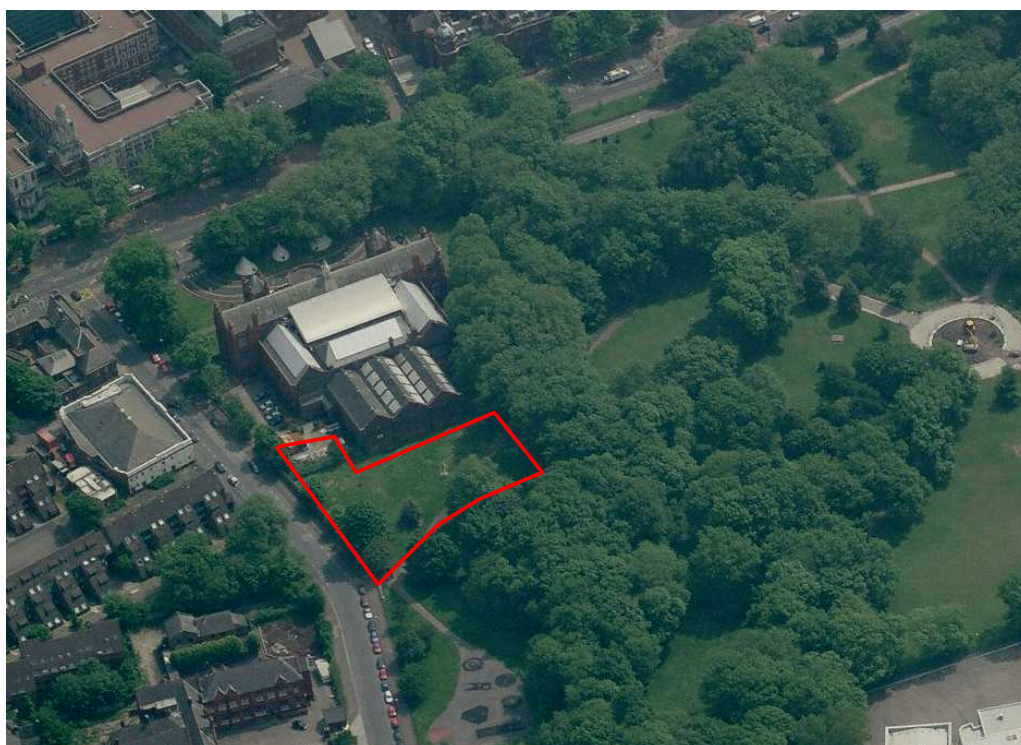
*Plate 1: Recent aerial view of the study area, looking east*

3.2.1 **Location:** the study area (centred on NGR SJ 8488 9597) is situated alongside Oxford Street, in the Township of Chorlton-on-Medlock, on the southern side of the city centre (Fig 1). The site is bounded by Oxford Street to the east and Denmark Road to the north, and lies within the north-east corner of Whitworth Park (Plate 1).
