# **Ditherington Flax Mill, Shrewsbury, Shropshire**

## **Archaeological Watching Brief**

**Oxford Archaeology North**

April 2016

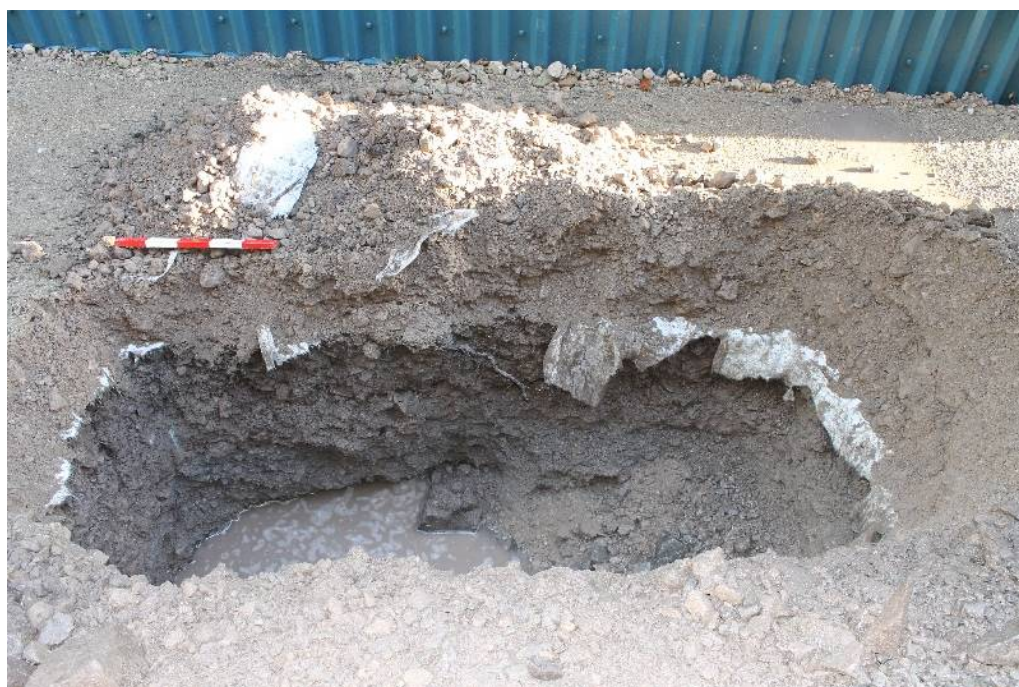
4.2.1 **Test Pit 101:** was located towards the southern end of the site, immediately to the west of a modern steel clad industrial building and to the east of the remains of the lean-to structure associated with the Main Flax Mill. It was aligned north/south, at a height of approximately 55m AOD. Its excavation revealed a homogenous deposit of loose modern graded sub-base stone, from the surface to a depth of 1.5m (Plate 1). The water table was encountered at 1.2m making further investigation unsafe due to collapsing sides.

4.2.2 Undisturbed natural geology was not encountered and no archaeological deposits were revealed.

*Plate 1: West-facing section of Test Pit 101, 0.5m scale*

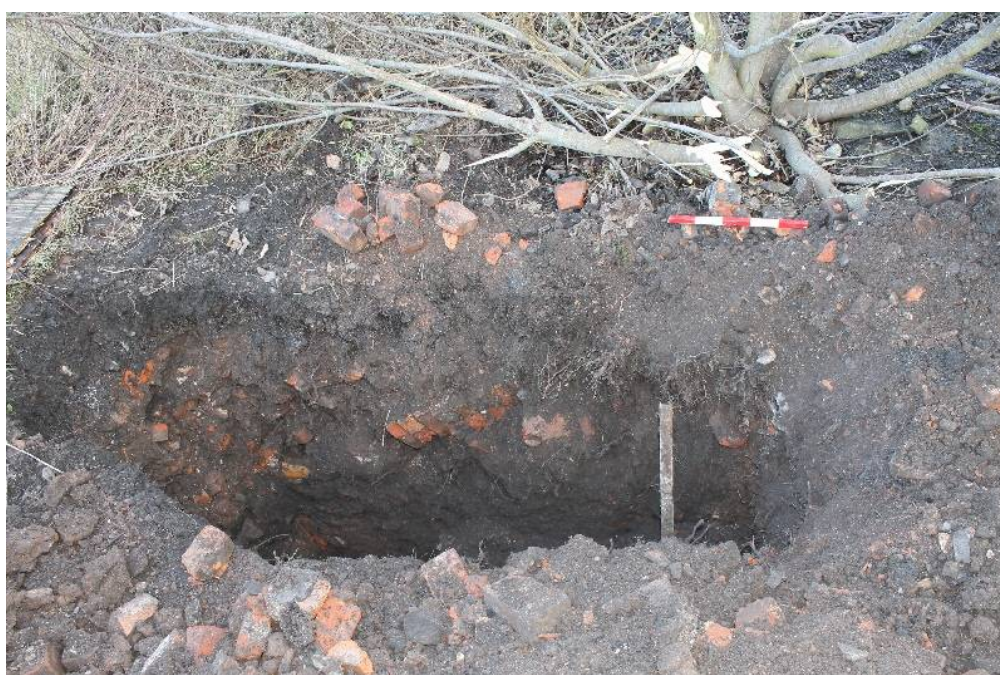
- 4.2.3 **Test Pit 102:** was positioned within an area of vegetation to the west of the concrete platform marking the former location of the demolished single-storey shed. It was aligned east/west, at a height of approximately 58m AOD. The pit was excavated to a depth of 2.3m, revealing a 2.10m thick mixture of dark black brown clay silt and ceramic demolition rubble to the base (Plate 2). A modern concrete slab was encountered at the eastern end 0.80m below the present ground level, although it was not possible to determine if it was *in situ* or part of the demolition deposit. The clay silt was sealed by a dark black brown organic topsoil 0.20m thick.
- 4.2.4 Undisturbed natural geology was not encountered and no archaeological deposits were revealed.

Plate 2: Southern-facing section of Test Pit 102, 0.5m scale

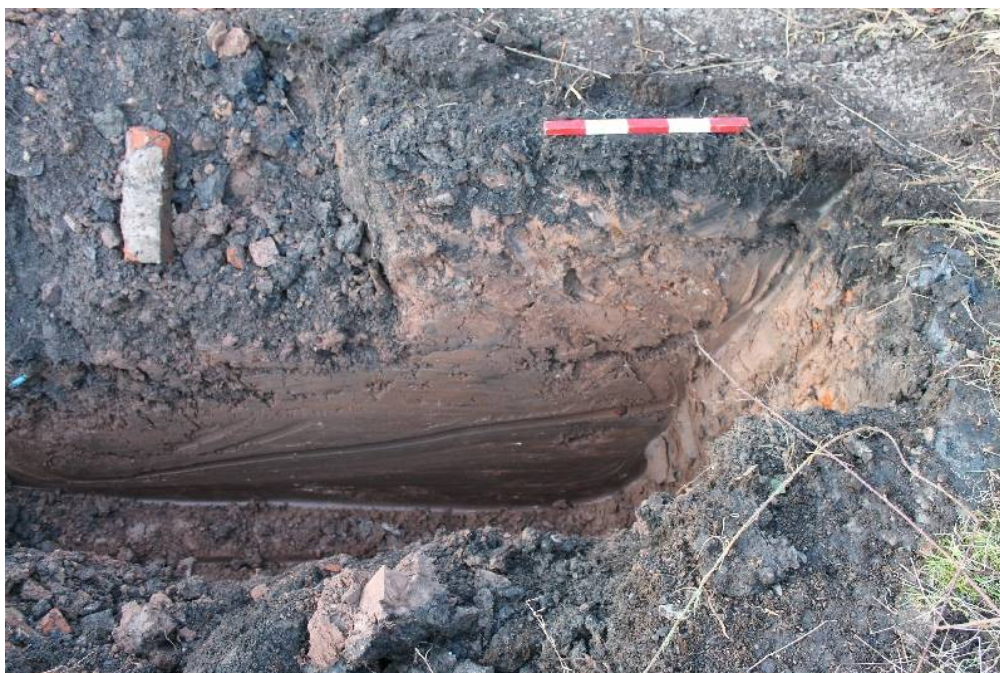
- 4.2.5 **Test Pit 104:** was located within an area of vegetation at the northern end of the site, to the north of the concrete slab marking the former location of the demolished single-storey shed. It was aligned north/south and lay at a height of approximately 58m AOD. It was excavated to a maximum depth of 1.60m revealing a deposit of mid yellow brown natural clay till 1.30m thick (Plate 3). This deposit was sealed by a layer of dark black brown organic topsoil 0.30m thick and identical to that noted within Test Pit 102.
- 4.2.6 No archaeological deposits were revealed.

*Plate 3: East-facing section of Test Pit 104, 0.5m scale*

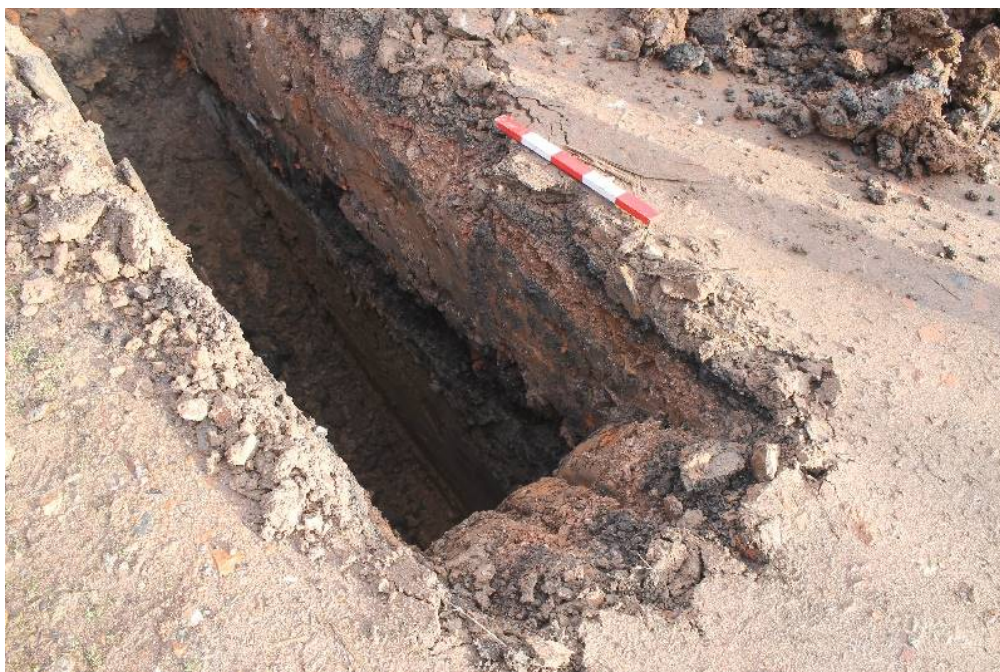
- 4.2.7 **Test Pit 110:** was positioned within the centre of the former line of the canal, some 23m to the east of the Apprentice House. It was aligned north/south at a height of approximately 56m AOD and extended to a maximum depth of 2.30m. At the base of the pit a layer of clean yellow brown clay was recorded in excess of 0.90m thick and consistent with the local natural till (Plate 4). Above this deposit sat a layer of mixed organic black and grey fine clay silt 0.60m thick, which itself was sealed by 0.75m of compacted modern sub-base that formed the base of the present roadway above.

*Plate 4: West-facing section of Test Pit 110, 0.5m scale*

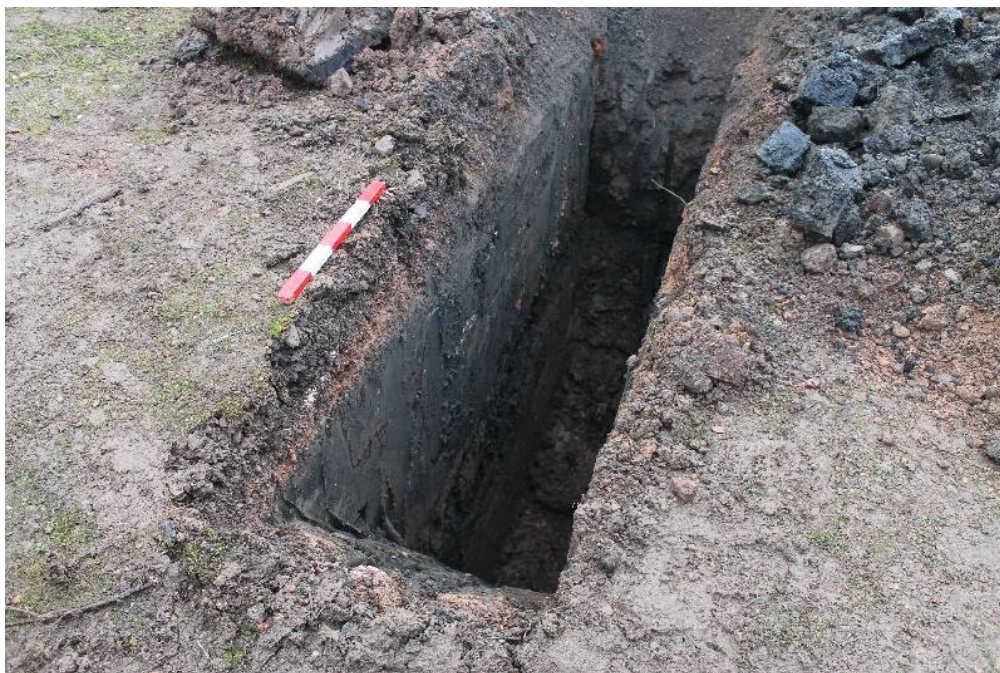
4.2.8 **Test Pit 111:** lay to the north of Test Pit 110 and was also located within the former line of the canal. It was aligned north/south at a height of 56m AOD and was excavated to a depth of 2.30m, revealing a clean mid yellow brown clay in excess of 0.50m thick consistent with the appearance of undisturbed natural till in the area (Plate 5). Overlying this deposit lay a dark black organic silt 0.40m thick, possibly forming as the result of organic material sitting within an anaerobic environment. This layer was sealed by a similar silt layer 0.70m thick but this material was mid grey in colour. The upper portions of the pit comprised 0.45m of dark brown clay silt with common inclusions of ceramic demolition rubble, beneath 0.15m of graded sub-base.

*Plate 5: West-facing section of Test Pit 111, 0.5m scale*

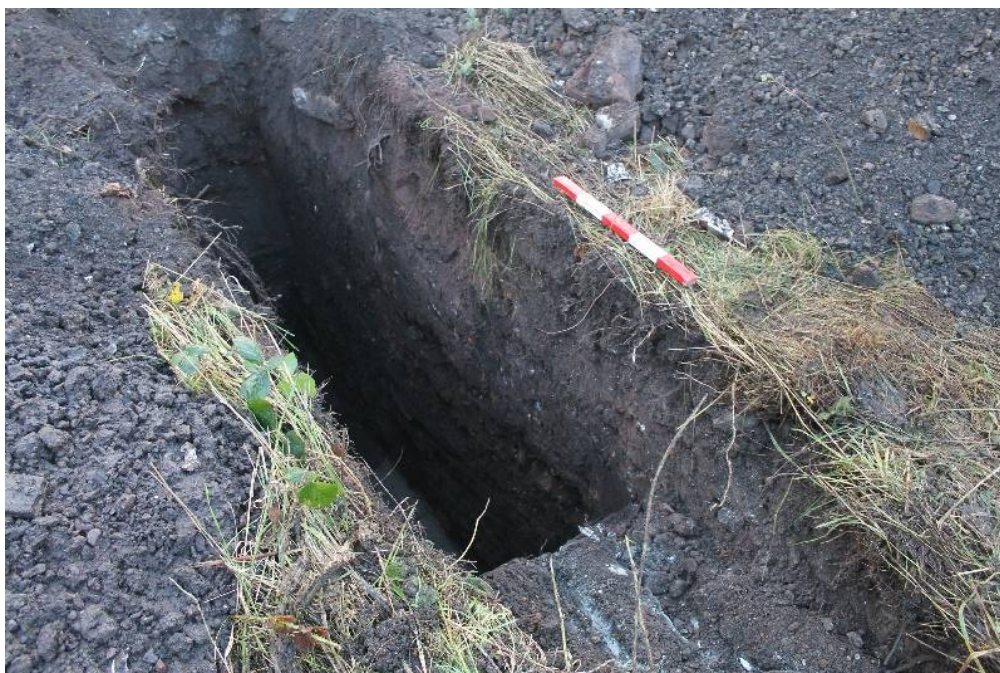
4.2.9 **Test Pit 114:** was located at the southern end of the railway triangle to the west of the mill complex. It was aligned east/west, sat at a height of approximately 51m AOD and was excavated to a maximum depth of 2.50m. An homogenous dump of dark black brown loam, at least 2.10m thick, extended to the base of the pit and included common ceramic and other waste material dating from between the late nineteenth to the late twentieth centuries (Plate 6). The water table was encountered 2.30m below the present ground surface, and the depth of undisturbed natural was not identified. A loose dark brown loamy topsoil 0.20m thick sealed the dump material.

*Plate 6: North-facing section of Test Pit 114, 0.5m scale*

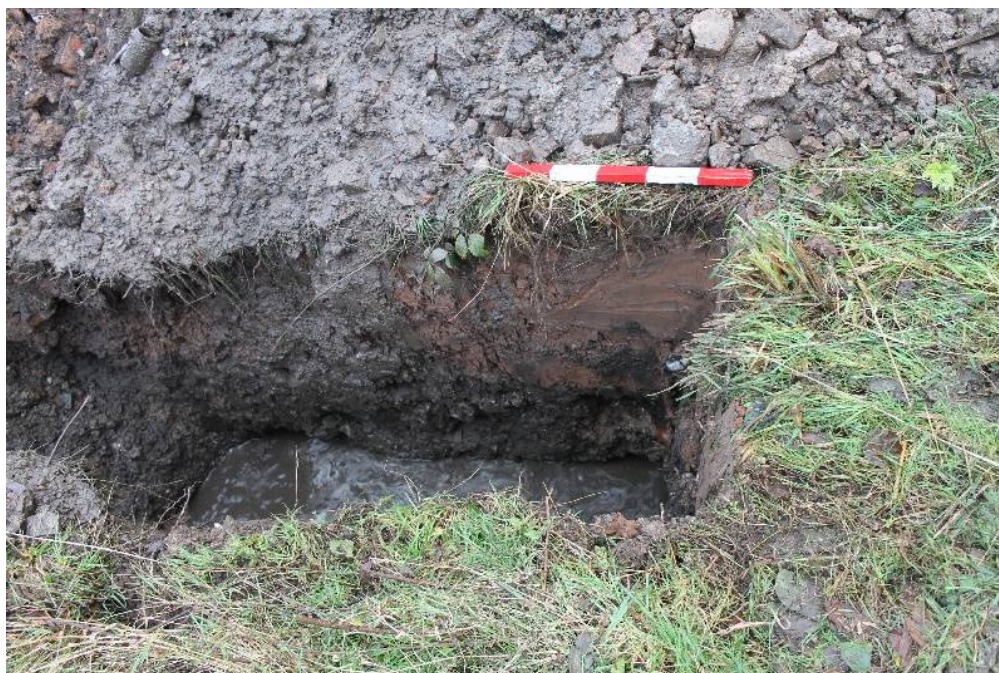
4.2.10 **Test Pit 115:** was located near the centre of the railway triangle and was aligned north/south. It lay at a height of approximately 51m AOD and was excavated to a maximum depth of 1.6m. The water table was encountered just 1.30m beneath the present ground surface, preventing further excavation but the lower 0.85m of the pit comprised a loose dark brown loam with demolition rubble throughout consistent with that described within pit 114 (Plate 7). Above this deposit sat a layer of mid yellow brown clay 0.60m thick, which from its character was probably re-deposited natural till that had been mixed with demolition rubble. This layer was sealed by a deposit of mid grey brown loamy topsoil 0.15m thick.

*Plate 7: West-facing section of Test Pit 115, 0.5m scale*

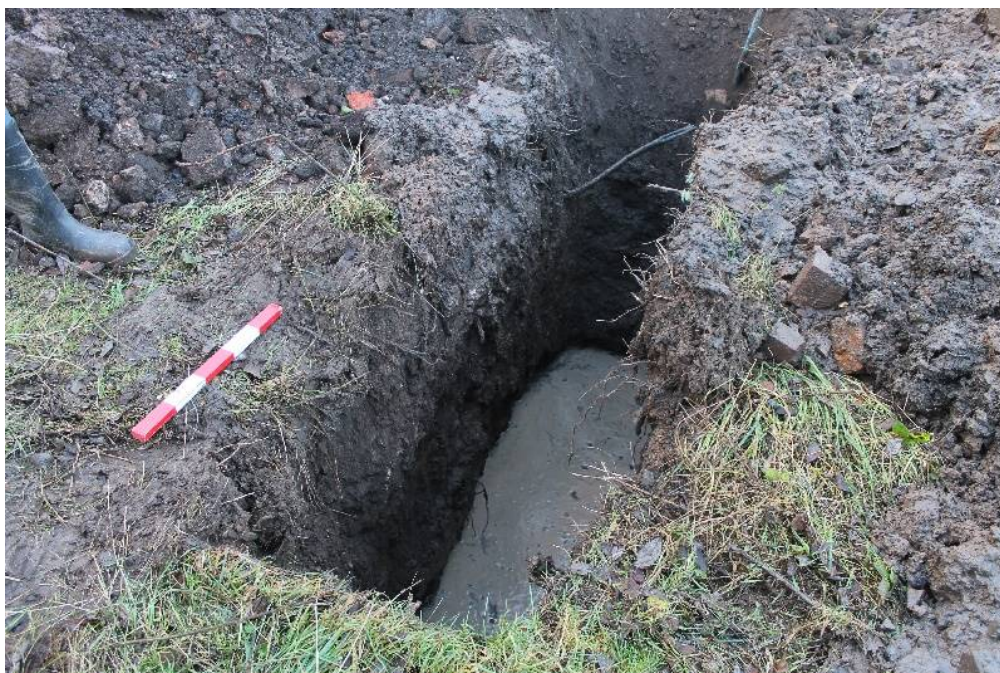
- 4.2.11 **Test Pit 116:** sat within the railway triangle, between pits 114 and 115 and just to the north of the sewage pumping station at a height of approximately 51m AOD. The pit was excavated to a maximum depth of 2.50m below the present ground surface on an east/west alignment, with ground water encountered at 1.80m. The base of the pit comprised an homogenous dump of dark black brown loam, which extended to a depth of least 2.30m and included common ceramic and other waste material dating from between the late nineteenth to the late twentieth centuries (Plate 8). This deposit was sealed by a loose dark brown loamy topsoil 0.20m thick.
- 4.2.12 Undisturbed natural deposits were not encountered, although the last bucket excavated did include a small amount of water logged coarse mid brown sand, probably derived from an alluvial deposit.

*Plate 8: North-facing section of Test Pit 116, 0.5m scale*

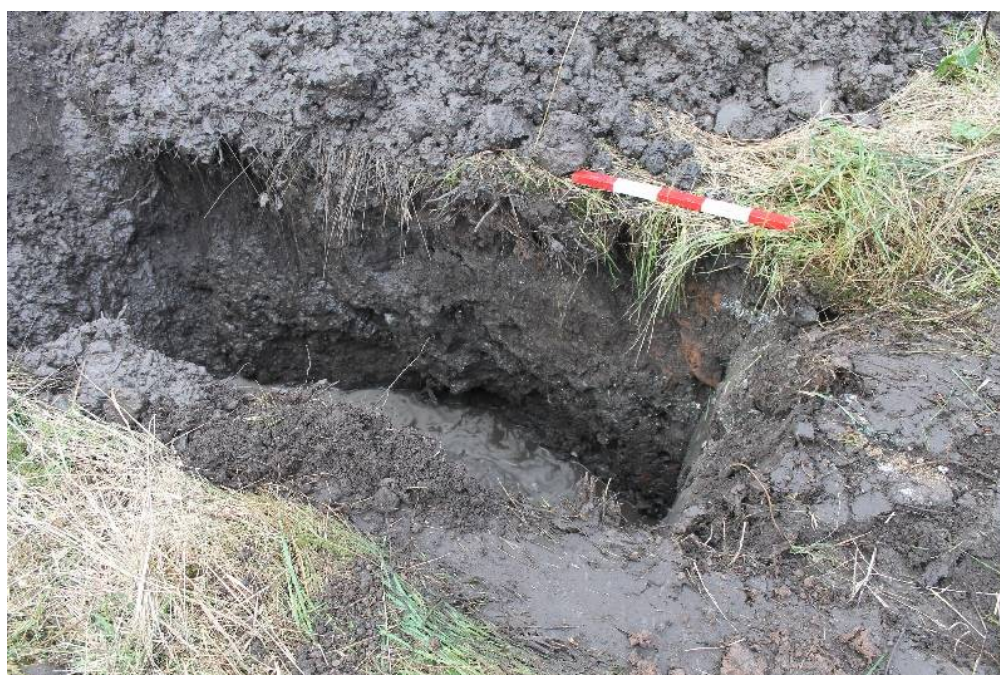
4.2.13 **Test Pit 117:** was located at the northern end of the railway triangle at a height of approximately 51m AOD and was aligned north/south. The pit was excavated to a maximum depth of 1.50m with ground water encountered 1.20m below the present ground surface. The lower 1.35m of the pit was composed of loose dark brown loam, with fragments of demolition rubble throughout, consistent with that described with in pits 114-116 (Plate 9). This deposit was sealed by a deposit of mid grey brown loamy topsoil 0.15m thick.

4.2.14 Undisturbed natural deposits were not encountered and no archaeologically significant material was identified.

*Plate 9: East-facing section of Test Pit 117, 0.5m scale*

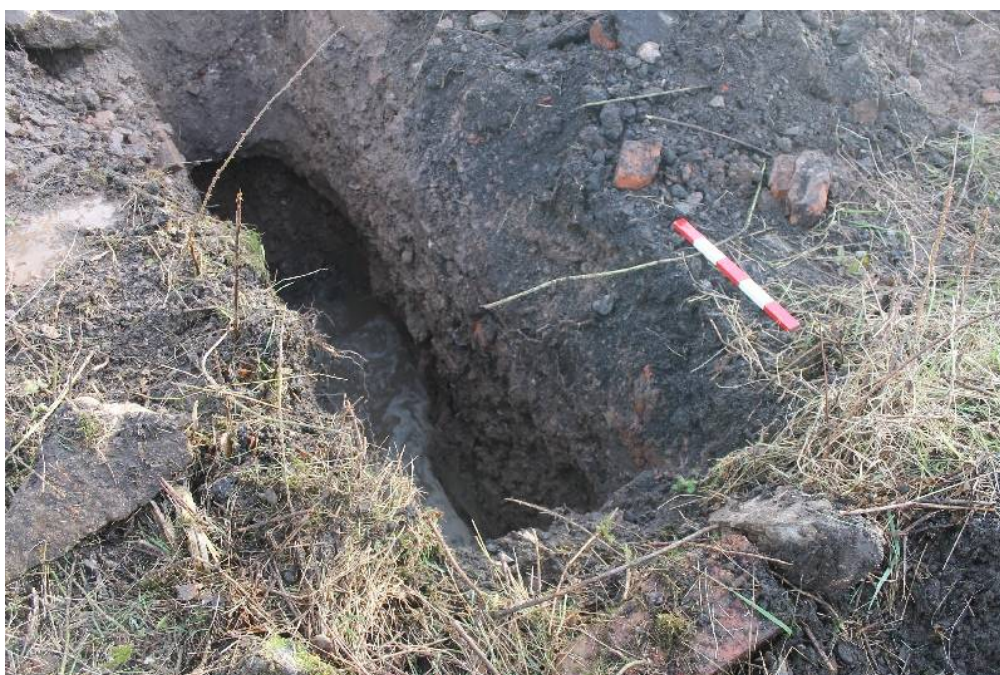
- 4.2.15 **Test Pit 118:** lay at the northern end of the site, just to the west of the concrete slab associated with the former single-storey shed building and in the area once occupied by the circular gas holder. It was aligned east/west, lay at a height of approximately 58m AOD and was excavated to a maximum depth of 3m. Ground water was encountered at a depth of 2m below the ground surface preventing further excavation; however, the lowest deposits comprised a mixture of dark brown clay silt, mid yellow brown clay and demolition rubble 2.30m thick (Plate 10). This deposit was sealed by a similar layer of mixed dark brown clay silt and demolition rubble 0.50m thick, which in turn lay beneath 0.20m of loose dark black brown organic clay silt topsoil.
- 4.2.16 Undisturbed natural deposits were not encountered and no archaeologically significant material was identified.

*Plate 10: Test Pit 118, facing south-east, 0.5m scale*

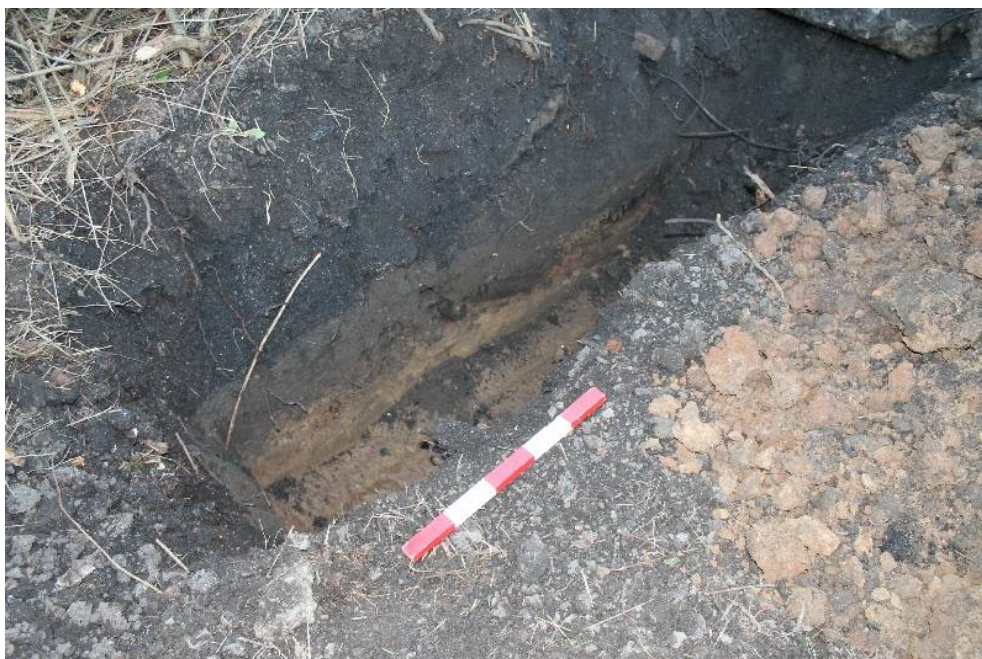
- 4.2.17 **Test Pit 119:** was located in the area to the east of the Apprentice House and west of the former line of the canal. It was aligned east/west, sat at a height of 57m AOD and was excavated to a maximum depth of 0.95m. At the base of the pit undisturbed natural clay till was recorded to a depth of in excess of 0.15m and was sealed by a layer of dark yellow brown clay silt 0.30m thick, which appeared to be a buried topsoil (Plate 11). Overlying this deposit lay 0.50m of loose fine blackish brown silt mixed with fragments of residual slag.
- 4.2.18 No significant archaeological deposits were encountered.

*Plate 11: Test Pit 119, facing south, 0.5m scale*

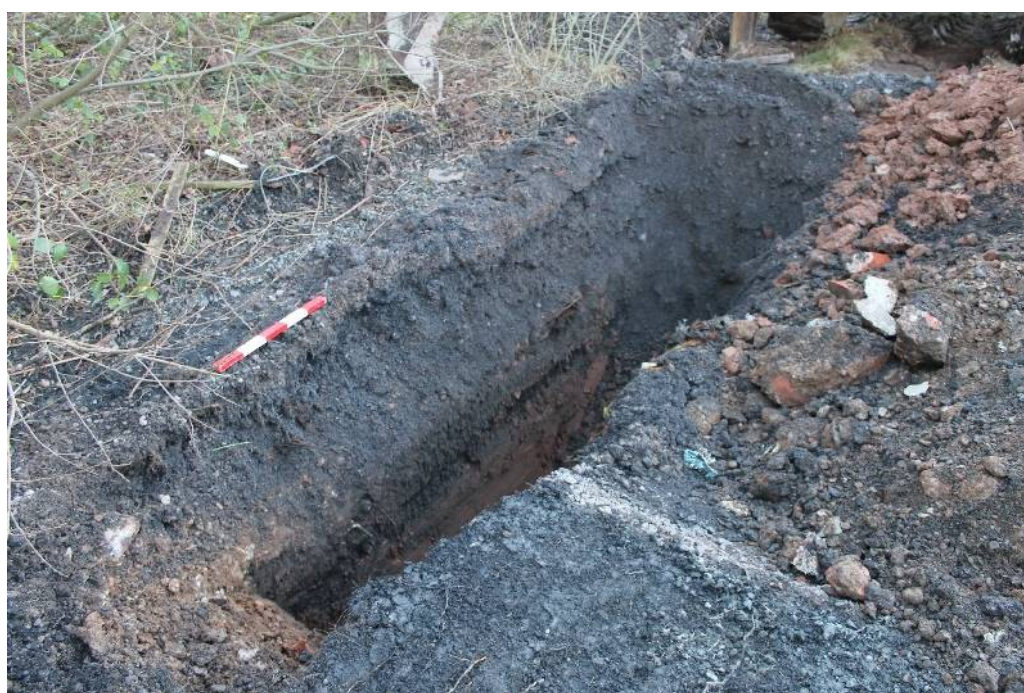
4.2.19 **Test Pit 120:** was located at the northern end of the site, to the west of the former line of the canal and near the boundary shared with the gardens of the housing estate to the north. It was aligned north/south, sat at a height of approximately 57m AOD and was excavated to a depth of 1.45m below the present ground surface. Natural clay till was recorded at 0.85m below ground level and was sealed by a dark blackish brown clay silt mixed with lenses of darker material indicative of dumping and levelling activity (Plate 12).

4.2.20 No archaeologically significant deposits were encountered.

*Plate 12: Test Pit 120, facing south-east, 0.5m scale*

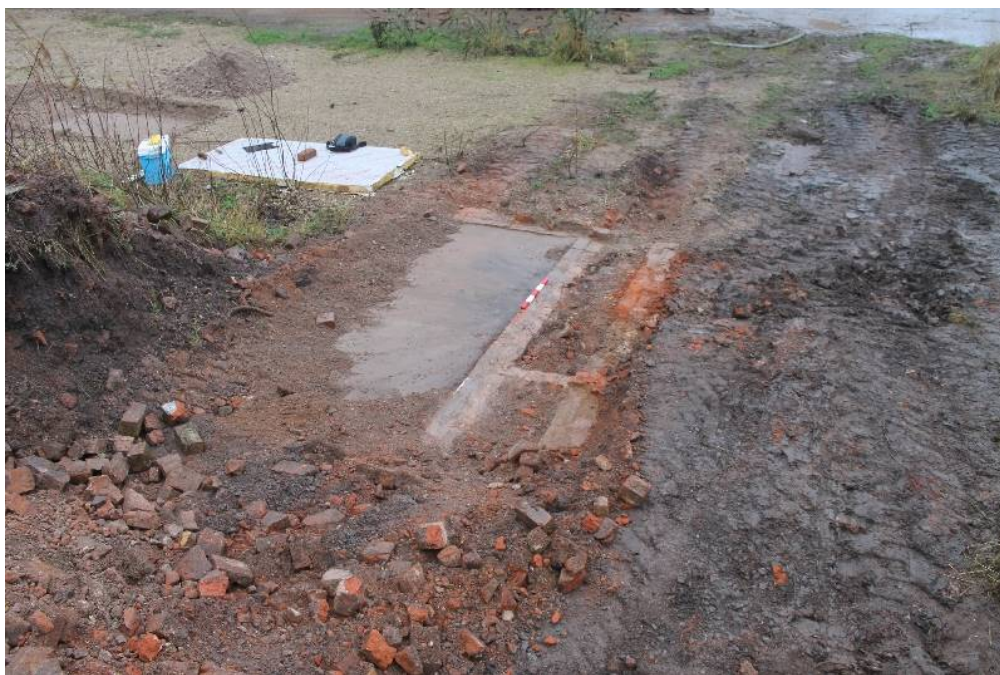
- 4.2.21 **Test Pit 121:** was located near the northern boundary of the site, north-west of the Apprentice House and east of the concrete bulk storage platform associated with the demolished single-storey shed. It was aligned north/south, sat at a height of approximately 57m AOD and was excavated to a depth of 1.35m below the present ground surface. Undisturbed natural clay till was encountered 0.80m below the surface and was overlain by a mid-brown clay mixed with demolition rubble 0.50m thick.

- 4.2.22 A thin deposit of compacted rubble 0.10m thick, sealed this layer of demolition rubble and formed the foundation of a north/south aligned red brick wall of which only the lower two courses survived (Plate 13, Fig 3). The wall extended across the full length of the stripped area for a length of in excess of 3m, was two courses wide and constructed in un-frogged soft red brick 230mm long, 105mm wide and 73mm thick.

- 4.2.23 A second slightly wider but parallel brick wall foundation ran along the western edge of the stripped area, divided from the first by an area of dark brown silt and rubble. The two walls were connected by a single course of brickwork, which spanned the space between them at right angles towards the northern end of the stripped area. A third brick wall on an east/west alignment was exposed in the southern section, extending to a depth of 1m beneath the present ground surface (Plate 14). The eastern half of the stripped area, to the north of this wall had been finished with a firm lime or weak concrete floor surface. The walls and flooring had been covered with a thin deposit of mid brown silt and then partly overlain by a modern spoil heap to the north.

*Plate 13: Test Pit 121, after cleaning of overlying surface deposit, 0.5m scale*

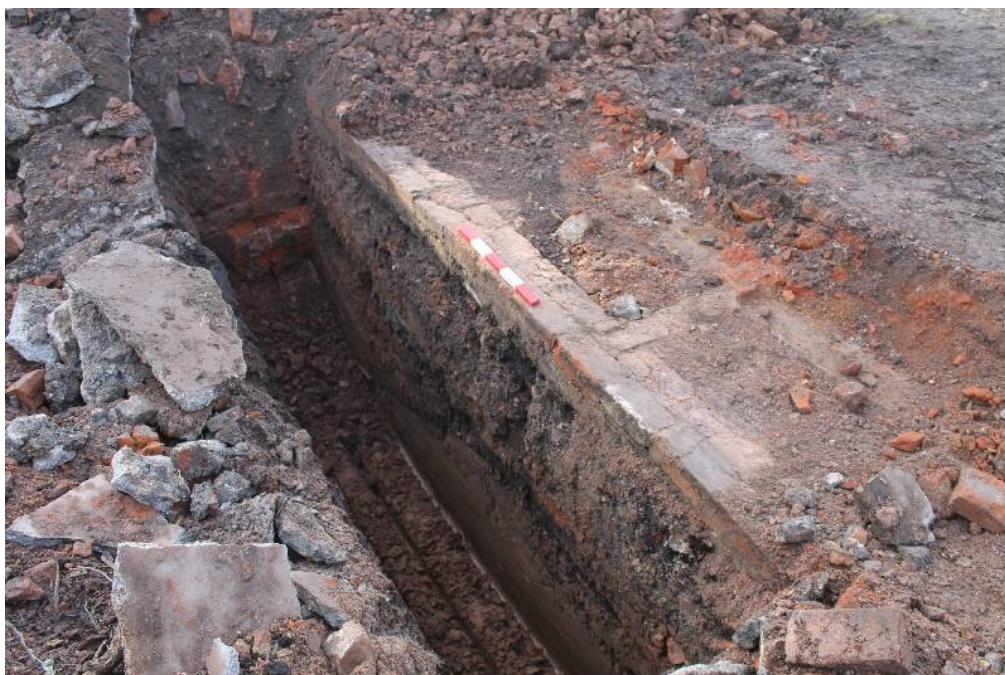
*Plate 14: Test Pit 121, after excavation, facing south-west, 0.5m scale*

- 5.2 The only sub surface structural evidence revealed were the three brick walls at the northern end of the site revealed in Test Pit 121 and these can probably be identified as a part of the cow house or shed depicted on the plan of the site in 1855. The presence of demolition material beneath these walls suggests that brick structures existed within this area of the site, which predate this map.

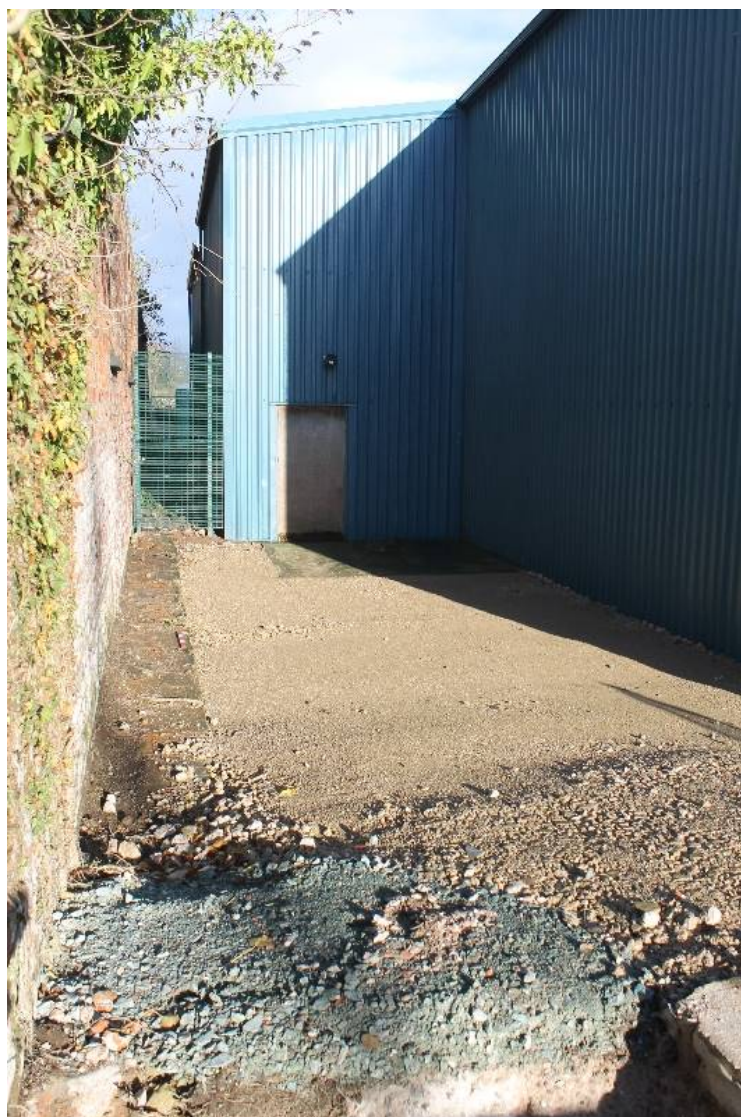
- 5.3 Test pit 101 failed to identify the base of the canal due to the height of the water table but the quantity of modern graded sub-base suggests this part of the canal may have been left open until the late twentieth century. The organic silt material identified within Test Pits 110 and 111 probably accumulated at the base of the canal after it had fallen out of use with the natural clay apparently proving suitable as an impermeable base. If this was the case, then we can establish a depth for the canal of between 1.40 and 1.70m. Notably, the coping stones of the western edge of the canal can still be seen above ground to the west of Test Pit 101 (Plate 15).

*Plate 15: Looking north along the length of the former location of the canal. Note the presence of the canal's original edging stones beside the western retaining wall*
