Halton East, Halton, Cheshire

Archaeological Watching Brief

United Utilities

Issue No: 2009-10/979

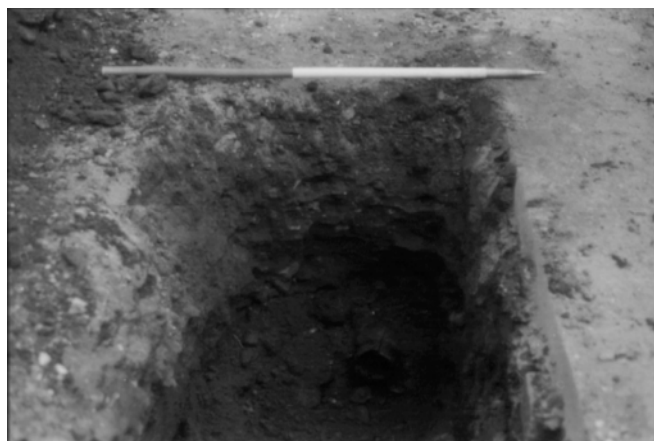
Plate 6: Working shot of Trench B

- 4.1.3 Trench B, to the south-west of the Castle Hotel was 2.80m in length and 1m in width. The trench was excavated to a maximum depth of 1.30m. The solid geology was not exposed at the base of the trench, as the depth of the excavation was determined by the requirements of the services. A layer of made ground 1.10m was deposited as backfill over an existing water main. This layer was sealed by a compacted 0.15m thick levelling layer of limestone overlain by the 0.08m thick tarmac surface of the car park. No archaeological features were encountered.

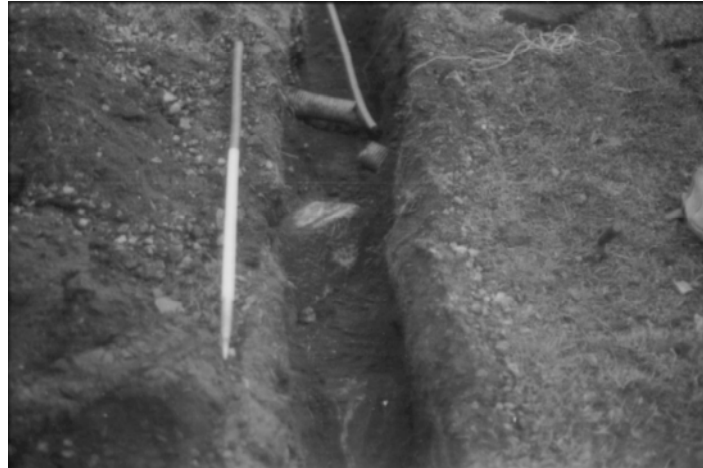
Plate 7: Working shot of Trench C showing position of worked stone

- 4.1.4 Trench C, was excavated on a path immediately to the south-east of the Castle Hotel, adjacent to a pumphouse. The trench was 0.50m wide and 0.70m long and was excavated to a maximum depth of 0.42m. The solid geology was not exposed at the base of the trench, as the depth of the excavation was determined by the requirements of the services. A layer of gravel in the centre of the trench 0.72m wide, to a depth of 0.42m, had been presumably deposited as backfill following the insertion of a modern, plastic water pipe. Surrounding the gravel layer was a layer of made-ground comprising loose, greyish brown, silty-sand to a depth of 0.42m which incorporated a worked sandstone block, 0.18 by 0.16m, jutting out of the base of the trench at an oblique angle. The

oblique position of the stone suggests that it was deposited with the backfill. Similar stones were observed in the walls, houses and gardens of the neighbouring area. The backfill layers were sealed by a layer of topsoil 0.10m thick. No archaeological features were encountered.
